AIRWAYS – Andy Herd Building

Quantitative Detailed Engineering Evaluation Report

Project number: 3474

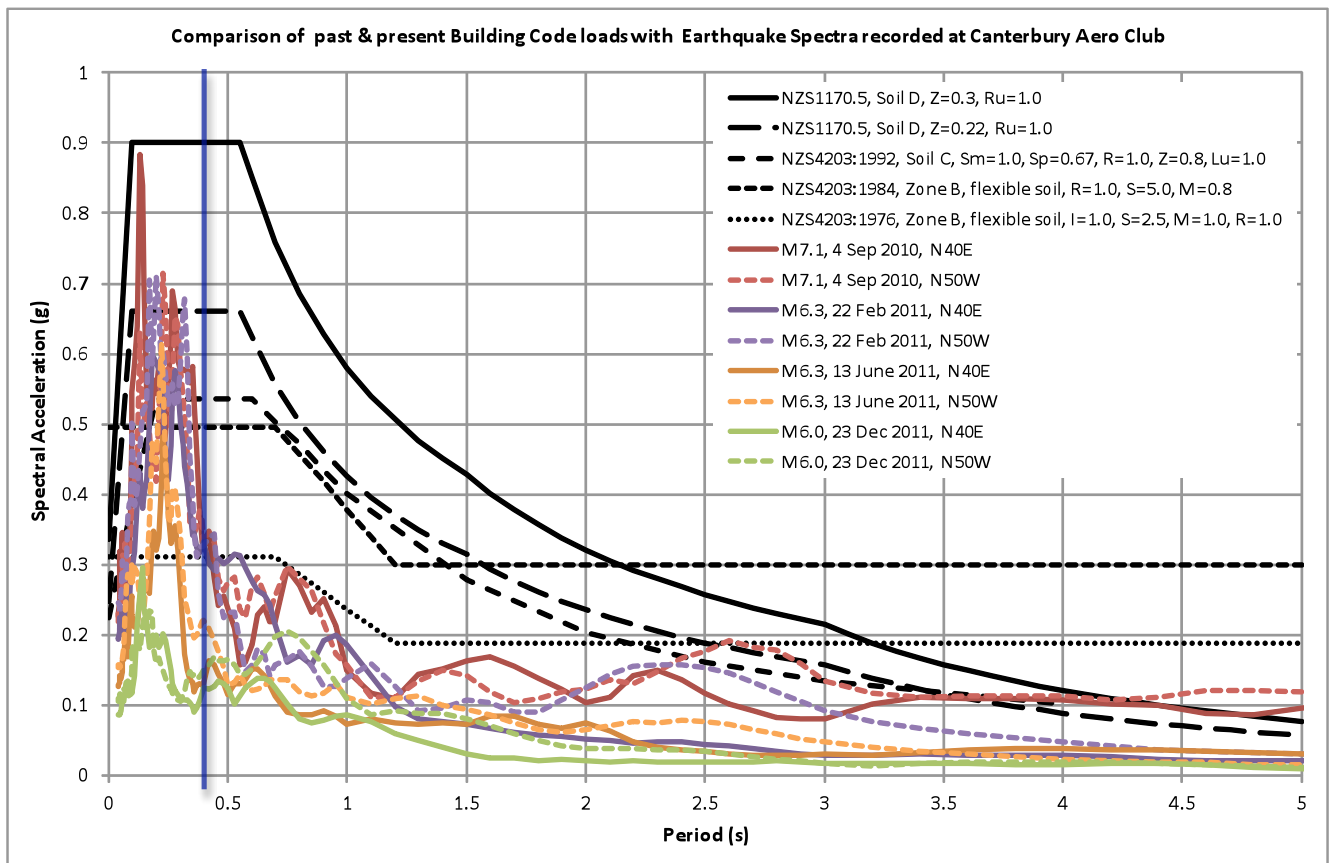
The figure below plots earthquake acceleration spectra recorded at the Canterbury Aero Club for the four largest magnitude earthquakes. To allow comparison with past and present Building Code seismic loads, elastic design spectra from NZS4203:1976, NZS4203:1984, NZS4203:1992 and NZS1170.5:2005 have also been plotted. The figure gives an indication of the level of load experienced by buildings during the recent earthquakes compared to loads they would have been designed to, as a function of building period. Low rise structures generally would have a period between 0.4 to 1 second.

The vertical blue line indicates the approximate assessed period of the Andy Herd Building, at 0.4sec.

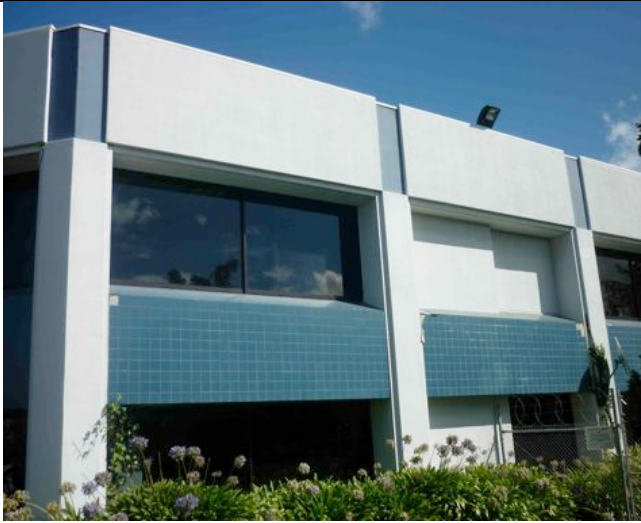
Photo 1: Building elevation showing tile damage

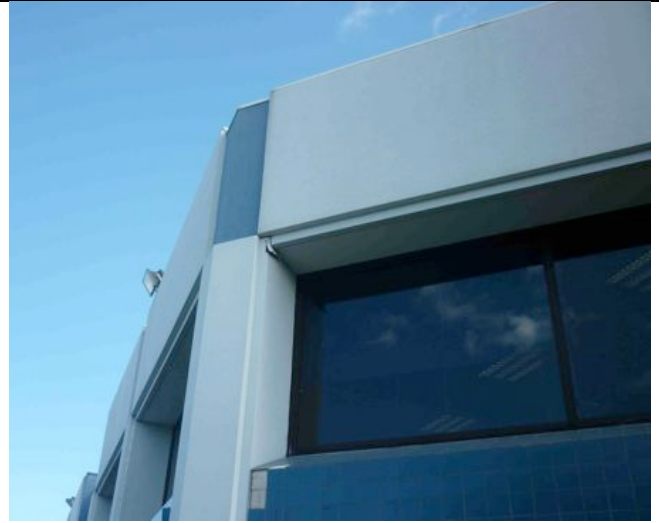
The external cladding panels have typically shown crushing at the interface of the spandrels and column encasements. This is due to the rotation of the spandrel pressing on the column section and subsequently crushing the concrete. These panels are not structural, and their connection to the steel structure has previously been viewed with no concern over the integrity.

Photo 2: Spandrel / column cladding crushing

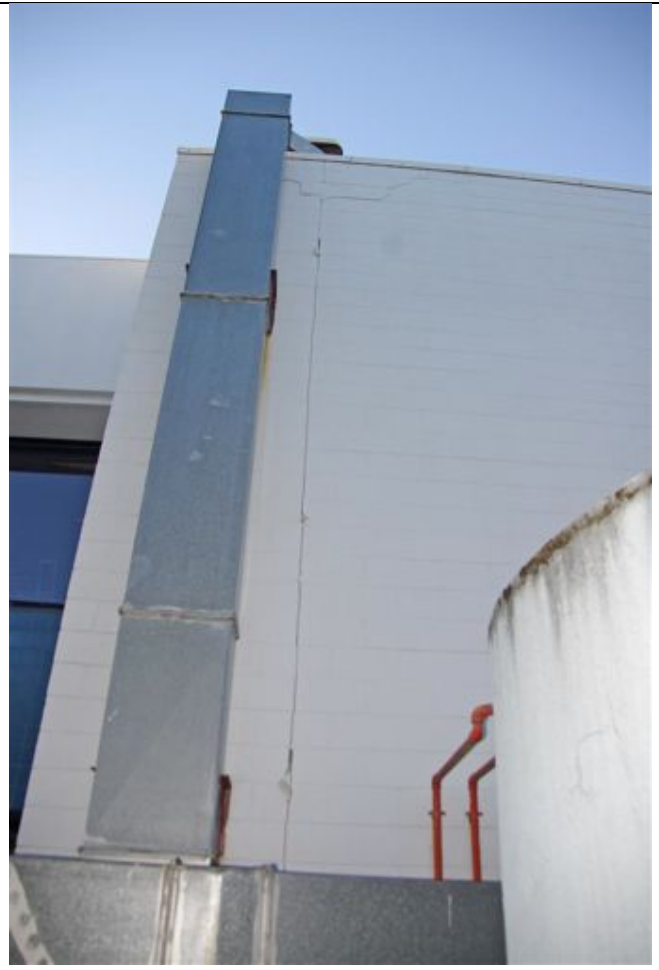
The western perimeter blockwall housing a secondary stairwell has shown typical opening of the movement joint and some cracking through mortar planes at the top section. Viewed from the top, it also appears that the flashing has moved, suggesting that some out-of-plane motion has occurred, but internally there is no sign of this. Damage around the movement joint has been designed for and only minor in nature.

Photo 4: Western blockwall cracking

- Rake-out cracked mortar and re-grout/re-point.
- Alternatively, seal cracks larger than 0.2mm using a pressure injected epoxy(A). If the masonry is not solid filled, Sikadur Injectokit TH is likely to be appropriate. If solid filled, Sikadur Injectokit LV or Sikadur 52 is likely to be appropriate.
- Reinstall rendered finish to match existing.

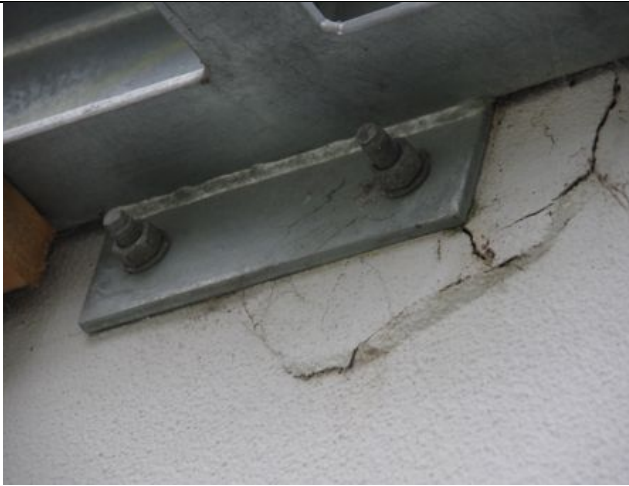
The damage to the external walkway on the south façade seems to be caused by poor detailing of the cantilevered steel connection. The connection plate seems to be bolted to the non-structural column encasement concrete of approximately 100mm thickness. The plate was bolted in a manner that allowed bending of the bolt, and has caused spalling of the concrete in some areas. A repair detail has been specified by Structex and is awaiting building consent.

Photo 5: External walkway spalling of concrete at joint

- Break-out loose concrete.
- If reinforcement is exposed, allow engineer to inspect condition of reinforcement. Repairs may be required.
- For corroded reinforcement, wire brush off loose material and spray with a rust convertor.
- Patch repair spalled areas using Sika MonoTop-412N and Sika MonoTop-910N primer in accordance with Sika specifications. For smaller patch repairs, use Sikadur 41 with Sikadur 32 tie coat.
- Repaired surface could be concealed by re-rendering to match existing or painting.

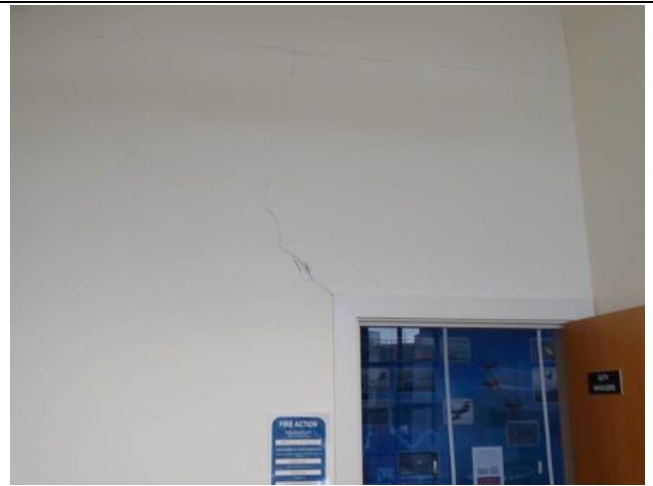
Internal lining damage observed is typical of what has been experienced across the city, is minor in nature, and to be expected in the level of shaking. Falling ceiling tiles have proved a problem for all of the Airways buildings Structex is involved with, a problem that is shared in other buildings with this type of system. The predicament occurs due to the lack of compatibility between the ceiling grid frame and the response of the buildings structure, leading to crushing or buckling of the grid and tiles popping out.

Photo 6: Typical internal lining damage

- Repair and/or replace damaged GIB wall and ceiling linings in accordance with GIB recommendations. Refer www.gib.co.nz/earthquakebulletin - this document outlines appropriate repairs depending on the specific type of damage encountered. Sand, prime and repaint over to match existing.
- We suggest replacing heavy suspended ceiling panels at the western end of the office area with a lightweight system.

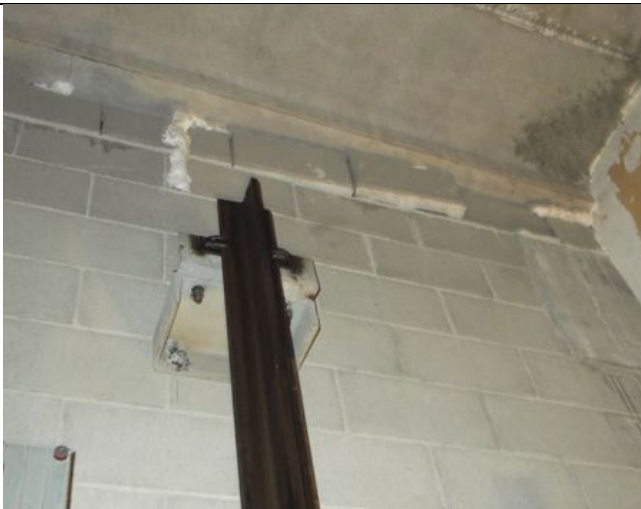
Loose blocks were found at the top section of the south wall of the lift shaft, a problem that seems to be have been created due to construction sequencing. The top course of blocks has been left unfilled and unreinforced because they could not be installed as specified simply because the Double-T roof units were already in place, restricting access. Structex have

Photo 7: Lift shaft Blockwall – loose blocks at top

instructed removal of these blocks as a safety precaution, which the contractor has already attended too. This section of wall is intended as a fire wall, therefore a replacement top section needs to be specified to maintain compliance.

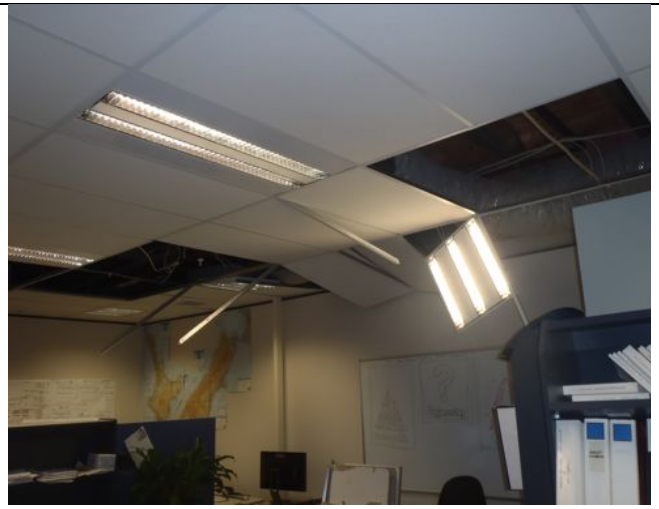
Photo 8: Typical suspended ceiling damage at Airways

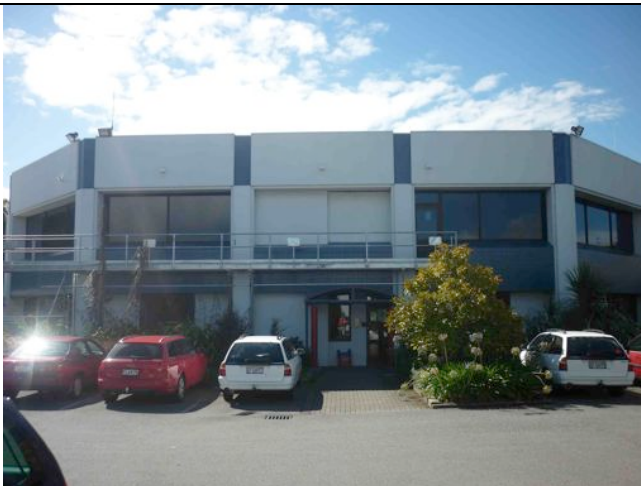
Photo 9: South elevation showing external walkway

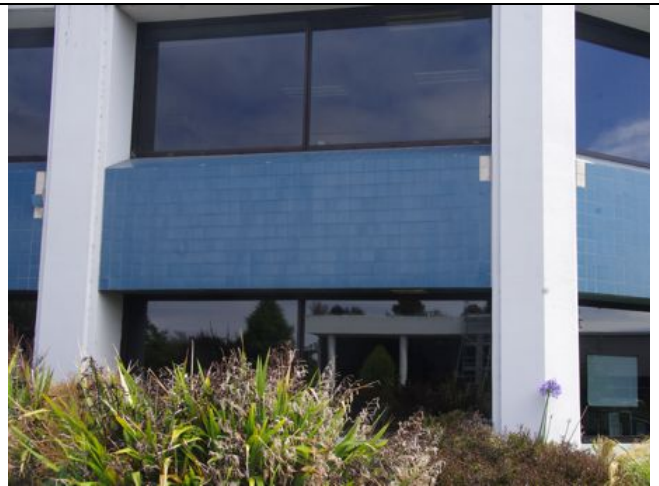
Photo 10: Further external tile cladding damage
