Technical Due Diligence Report

For and on behalf of
**AUGUSTA FUNDS
MANAGEMENT LTD**

510 Mount Wellington Highway,
Auckland

OCTOBER 2018

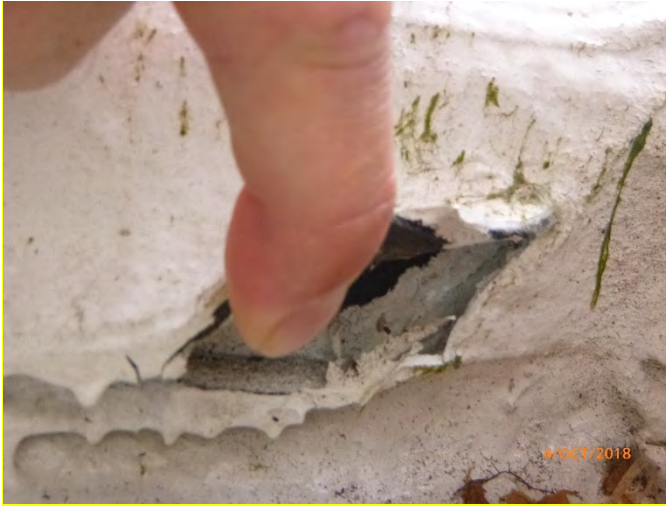
Photograph 7

- 3.2.3 The internal gutters on the warehouse have recently been leaking. The building manager has informed us that these have recently been repaired. However, on inspection, the repairs are of a poor quality with some surfaces already lifting away. It appears that the old surfaces were not correctly prepared prior to the repair as grime could be seen under the sections of the repairs that are peeling back. The contractor needs to return to site and address the repairs correctly.

Poor repairs to Dicker Data Warehouse internal gutters.

■	<p><u>Internal Gutters to Warehouse:</u></p> <p>Repairs have recently been completed to the internal gutters but these are of a poor quality. The repairs are already peeling back and it appears that there was no preparation of the substrate prior to work taking place. The membrane needs to be stripped back and the repair taking place correctly.</p> <p><u>Recommendation:</u> Request that the repairing contractor returns to site and correctly completes the repair.</p> <p><u>Timescale:</u> 6-12 months.</p> <p><u>Estimate cost:</u> \$Nil Work has been completed by a contractor in recent months and should return to site and complete the work correctly.</p>
■	<p><u>Blockwork North Face:</u></p> <p>There are cracks in the blockwork typically at the construction joints. These have been pointed in a sand cement mortar and not a flexible mastic seal. As a result they have cracked and allow moisture to enter the building.</p> <p><u>Recommendation:</u> The mortar should be raked out and the construction joint should be injected with a flexible sealer.</p> <p><u>Timescale:</u> 6-12 months.</p> <p><u>Estimate cost:</u> \$3,000</p>

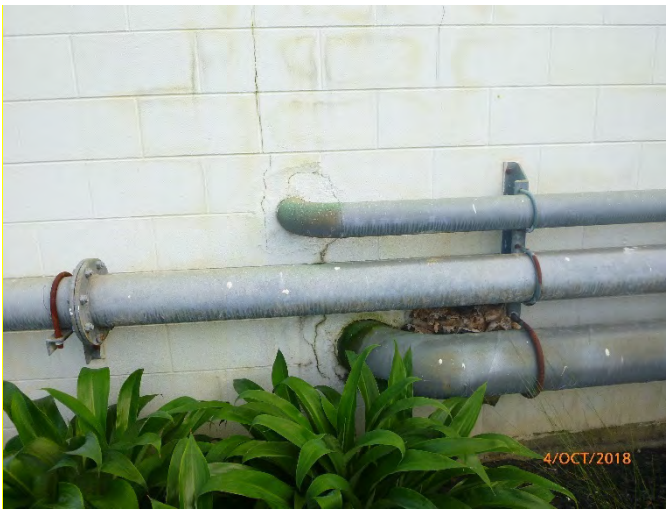
Photograph 8

Typical service penetration through warehouse block walls.

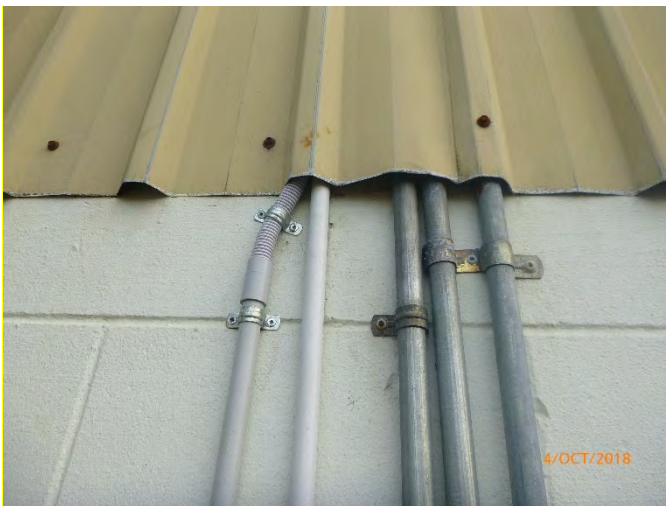
Photograph 9

Services forced through bottom of cladding in Repco Warehouse.

<p><u>Steel vertical Cladding over Blockwork:</u></p> <p>Various penetrations through cladding is poorly formed or not sealed. Some services have been pushed through bottom edge of cladding. Some penetrations have had large cut outs and no seal provided. Various patches including compound, sealant, flashing tapes. South canopy transition joints poorly detailed.</p> <p><u>Recommendation:</u> Install correct flashing details.</p> <p><u>Timescale:</u> 6-12 months.</p> <p><u>Estimate cost:</u> \$5,000</p>
	<p><u>Steel vertical Cladding over Blockwork:</u></p> <p>The decorations are soiled and are in need of immediate redecoration.</p> <p><u>Recommendation:</u> Wash down and redecorate.</p> <p><u>Timescale:</u> 6-12 months.</p> <p><u>Estimate cost:</u> \$150,000</p>
	<p><u>South Canopy:</u></p> <p>The canopy is poorly detailed. The flashings and internal gutters could not be inspected but there is some evidence that they may be leaking. The connection to the main building appears to be relying on a cut back older structure. Below the canopy there is cement sheet cladding which is extensively damaged and may contain asbestos. The asbestos register should be checks and the cladding stripped safely and replaced. If asbestos then repair needs to be completed immediately or made safe. New head flashings should be installed and the roof and internal gutters inspected and repaired. The doors below the canopy should have the impact damage repaired and repainted.</p> <p><u>Recommendation:</u> Complete repairs identified above.</p> <p><u>Timescale:</u> If asbestos - immediate otherwise 6-12 months.</p> <p><u>Estimate cost:</u> \$7,000</p>

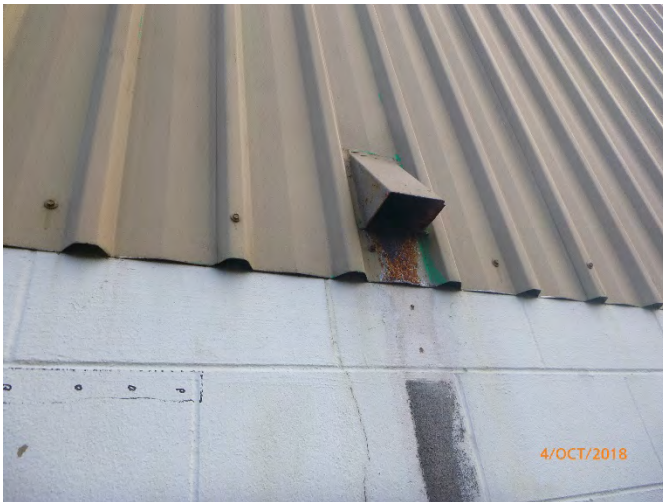
Photograph 10

Surface corrosion at penetration on Recco Warehouse wall cladding.

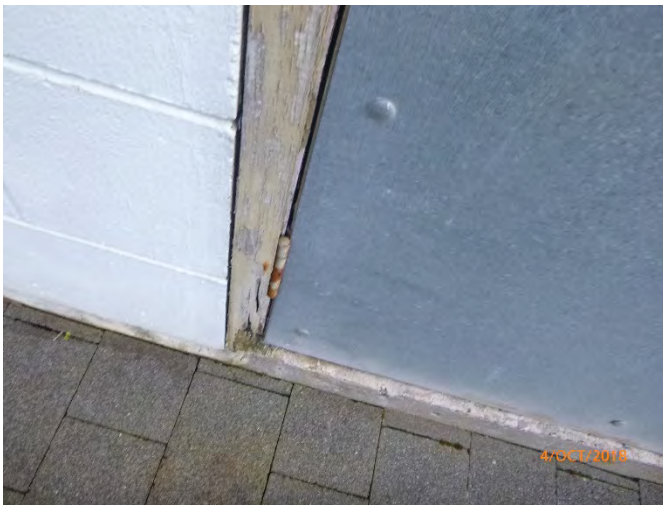
Photograph 11

Fire exit door to Recco Warehouse. Timber decay to frame.

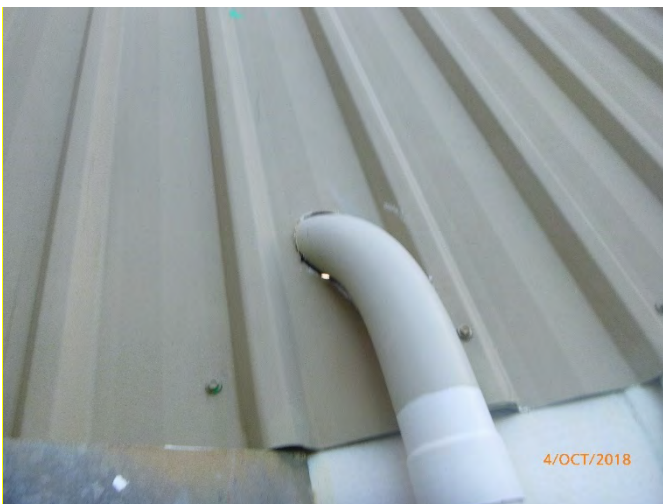
Photograph 12

Typical penetration through Recco Warehouse steel cladding.

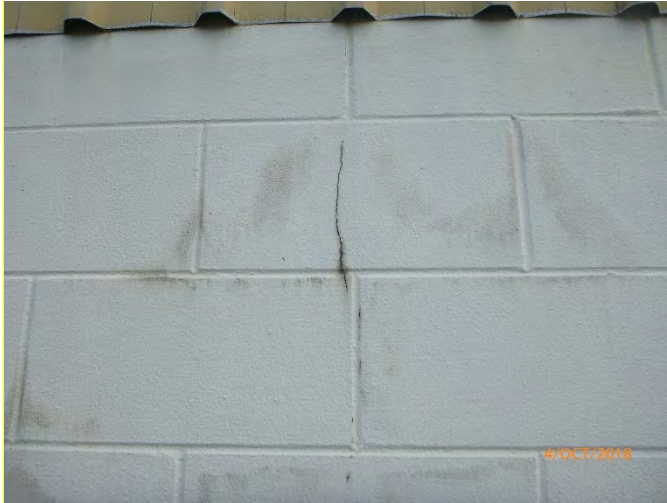
Photograph 13

Typical cracks through Warehouses concrete block wall.

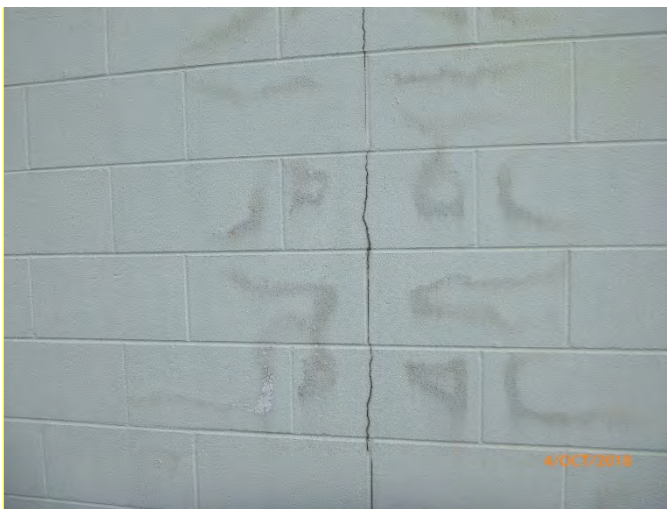
Photograph 14

Crack in block wall due to use of sand/cement mortar in place of flexible seal.

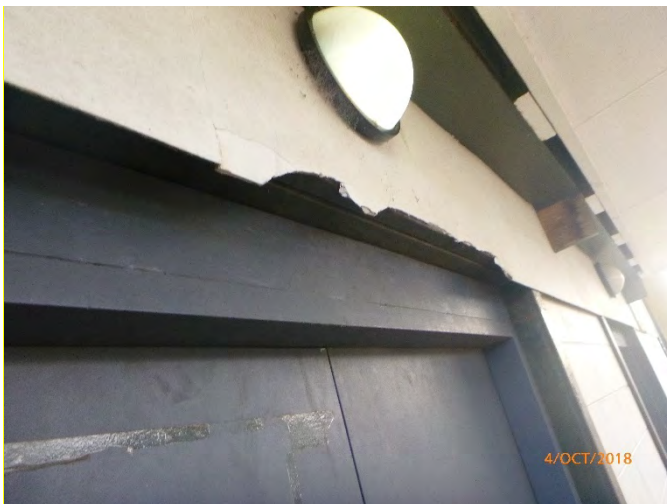
Photograph 15

Damage cladding over South Repco Warehouse external doors.

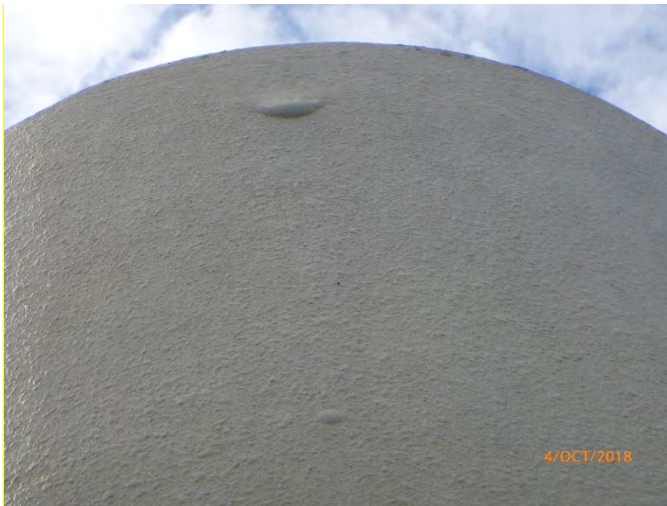
Photograph 16

Typical blistering paint to stairway wall
McConnell building.

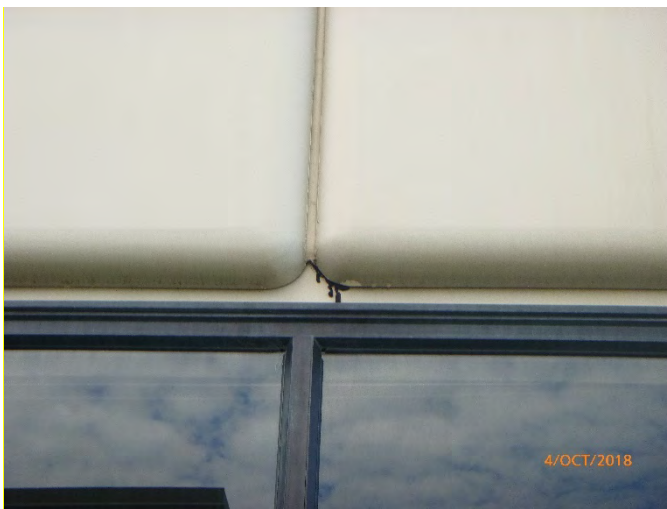
Photograph 17

Weeping seal through cladding on Repco
Office Building.

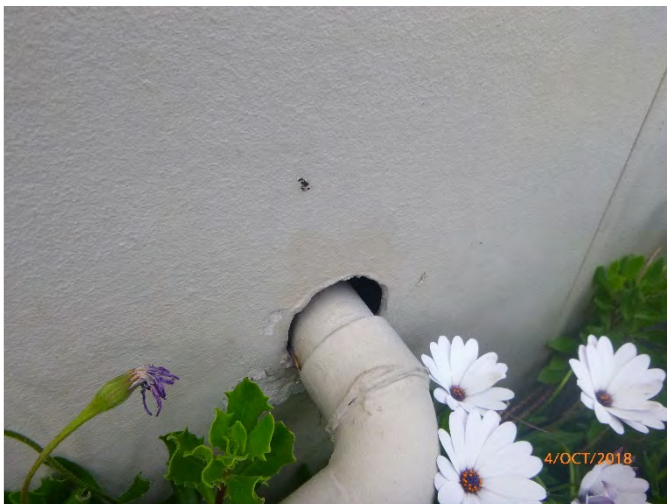
Photograph 18

Typical service penetration through North
Repco Office wall.

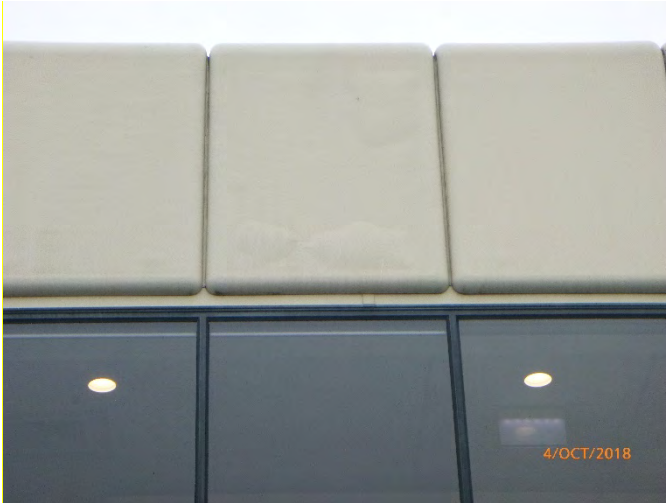
Photograph 19

■	<p><u>Cladding</u></p> <p>The cladding on this building is largely GRP cladding with various basic flashings and a strong reliance on sealant. There is evidence of blistering and a degradation of surfaces on many panels. At some window openings there appears to be bleeding from what may be failed concealed seals and/or closed cell air seals.</p> <p>The air seals located within the GRP panels parapets have generally perished and have reached the end of their useful life. The brackets for the GRP panels at the parapets were also observed and found to be corroding.</p> <p>There is additional fibre cement cladding on the North face which may potentially have asbestos present. We recommend the asbestos register is reviewed to determine if this is the case. The cladding is damaged, has poorly formed penetrations and poorly detailed around windows. If asbestos, repair needs to be completed immediately or made safe.</p> <p>Internally, particularly at first floor level, but including some locations on the ground floor, there is evidence of water ingress through the cladding.</p> <p><u>Recommendation:</u> The cladding system is considered to be nearing the end of its life and a recladding would be recommended in the next five years.</p> <p><u>Timescale:</u> Within the next five years or sooner subject to further investigations,</p> <p><u>Estimate cost: \$600,000</u></p>

Blistering GRP cladding.

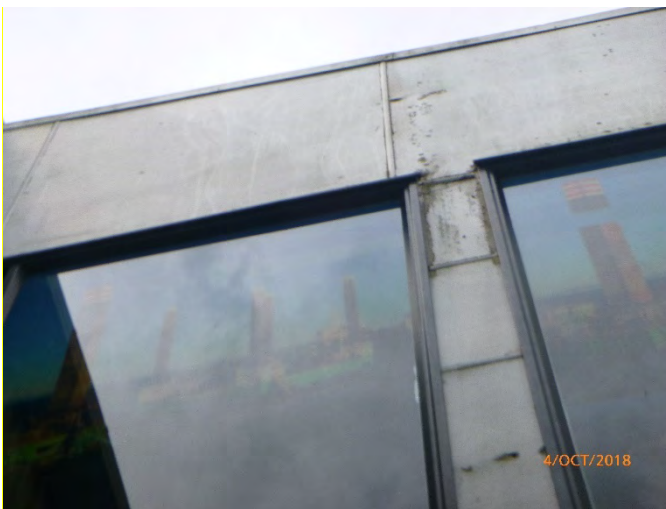
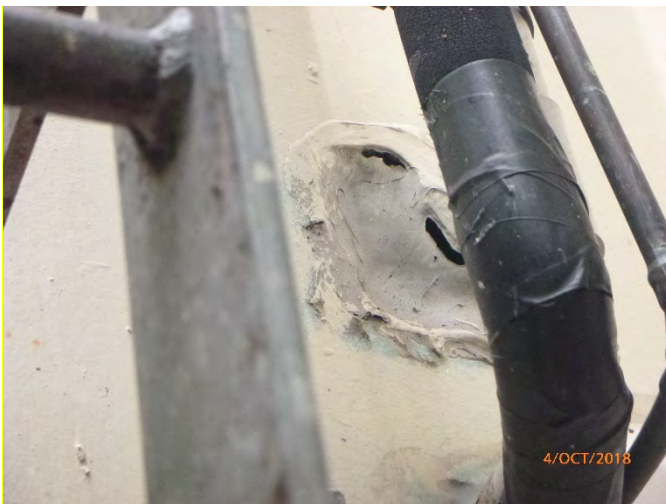
■	<p><u>Internal Courtyard Cladding</u></p> <p>The fibre cement sheet cladding in the internal courtyard is in a very poor condition and requires immediate replacement. Detailing and workmanship is very poor, fixings have blown, cladding has cracked, jointers are damaged, ground clearances are inadequate and there is a reliance on sealant. A number of repairs have taken place using sealant which have failed. It is highly likely that there will be a need to replace extensive timber frame work.</p> <p>If asbestos then repair needs to be completed immediately or made safe.</p> <p><u>Recommendation:</u> The cladding needs immediate remediation.</p> <p><u>Timescale:</u> Immediate.</p> <p><u>Estimate cost: \$90,000</u></p>

Defective cladding throughout internal courtyard - Repco Offices.

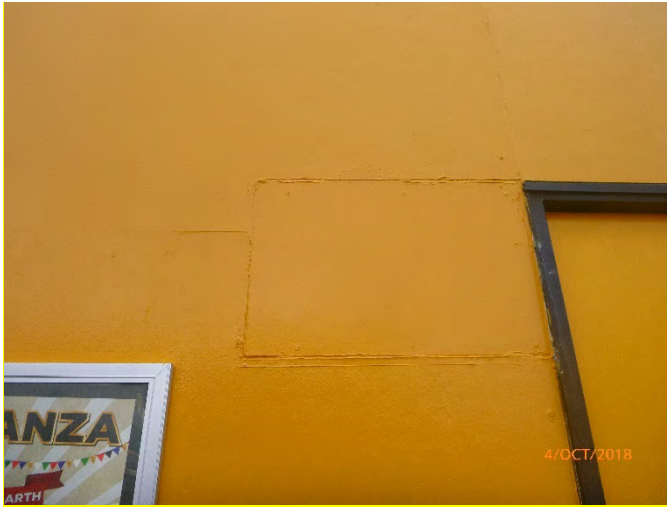
Photograph 22

Patched cladding Repco Retail.

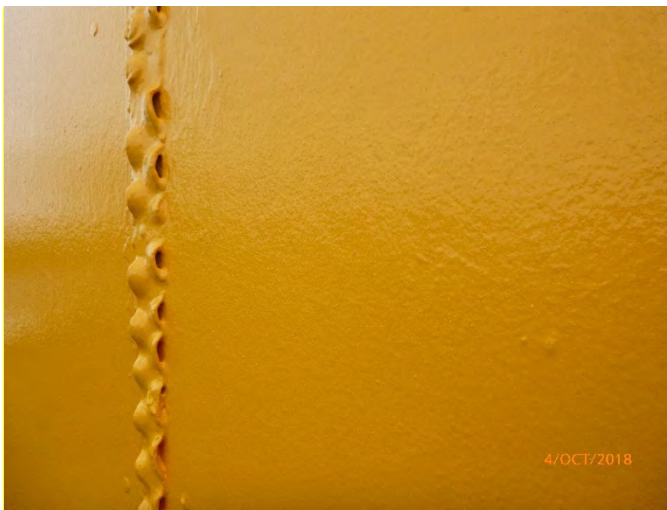
Photograph 23

Heat damaged plastic jointer Repco Retail. Note that despite damage the defect has been painted over.

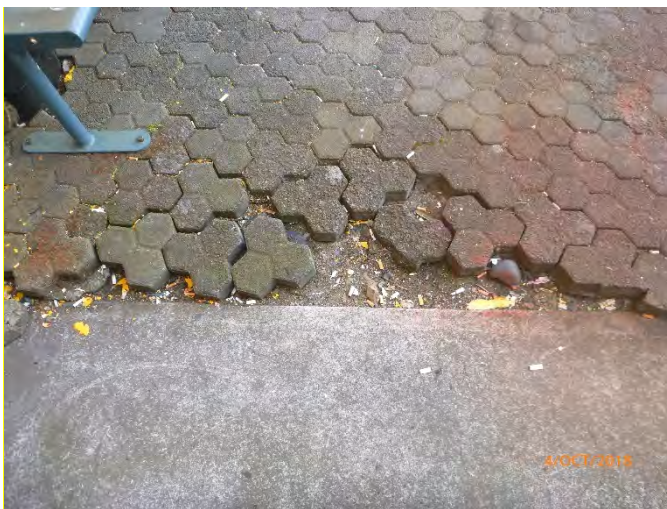
Photograph 24

■	<p><u>Paving</u></p> <p>The paving to the north of the building is damaged and partly incomplete and provides a trip hazard. The paving leading to the Repco entry is uneven with some rocking pavers.</p> <p><u>Recommendation:</u> Repair paving immediately as it is a trip hazard.</p> <p><u>Timescale:</u> Immediate.</p> <p><u>Estimate cost: \$1,500</u></p>
■	<p><u>Window Gaskets</u></p> <p>The window gaskets have shrunk, are starting to degrade or have detached from the glazing bead in many locations. The window gaskets need to be checked and replaced throughout.</p> <p><u>Recommendation:</u> Replace the gaskets that have shrunk, failed or detached.</p> <p><u>Timescale:</u> 24 months.</p> <p><u>Estimate cost: \$40,000</u></p>
■	<p><u>Solid Plastering to Stairway Structure:</u></p> <p>Blistering of paint work potentially has moisture trapped behind. Redecorate walls.</p> <p><u>Recommendation:</u> Redecorate during next decoration cycle.</p> <p><u>Timescale:</u> 4-5 years.</p> <p><u>Estimate cost: \$8,000</u></p>

Paving in poor condition to North of Repco Offices present a trip hazard.

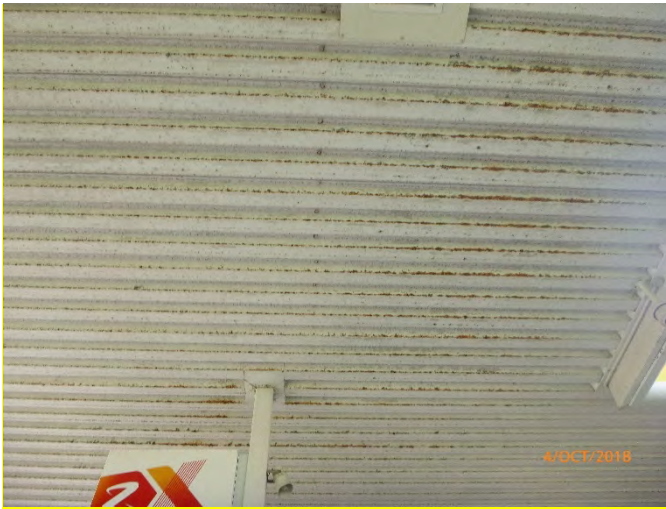
Photograph 26
Early corrosion underside of Z fuel station canopy roof.

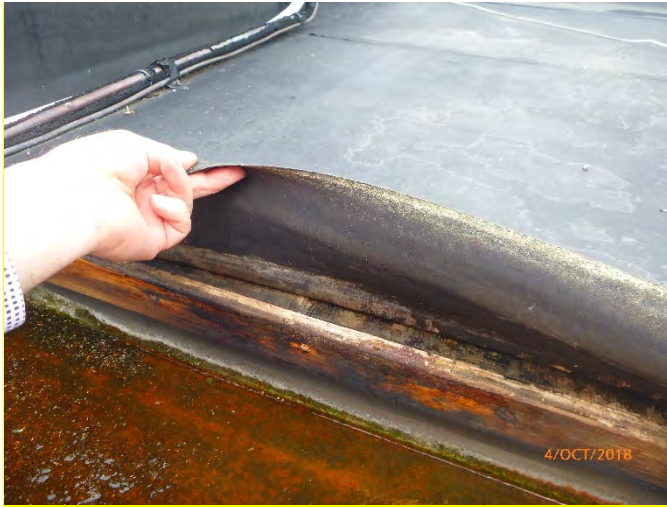
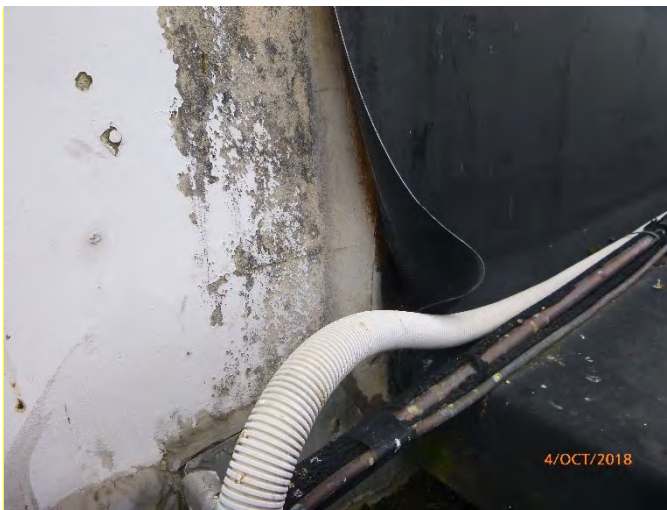
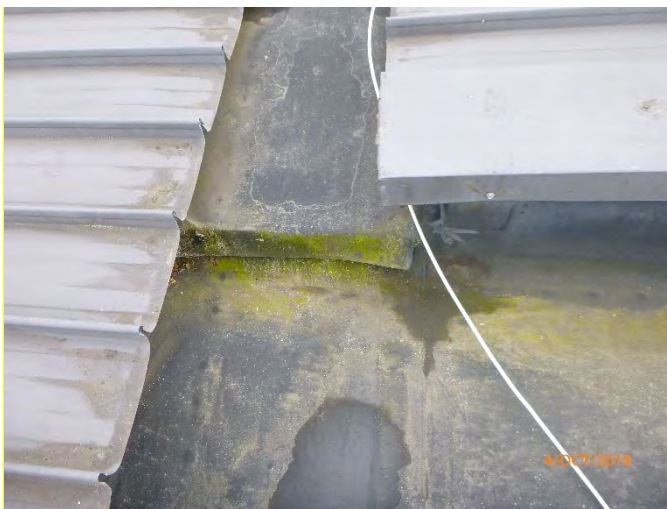
■	<p><u>Roof</u></p> <p>The butyl rubber flat roof adjacent to the internal courtyard and the butyl rubber internal gutters are in poor condition, have been poorly detailed, lapped joints are lifting and membrane has de-bonded at the eaves. The butyl membranes and repairs to underlying substrates require immediate attention to prevent continued water ingress to the first floor offices and damage to the structure.</p> <p>Services have been incorrectly secured on the roof and penetrations through the steel roofing are poorly formed and will leak or at risk of leaking. There are no back flashings. Correct plant mounting systems are required and penetration flashings and back flashings should be installed.</p> <p>There is some surface corrosion to the roofing and the paint system is tired. The corrosion should be treated immediately and the roof painted in the next two years.</p> <p><u>Recommendation:</u> Replace all butyl rubber membranes to flat roofs and internal gutters immediately. Corrosion on roofing and correctly securing plant should take place immediately. The roof needs to be painted in the next two years.</p> <p><u>Timescale:</u> Immediate/2 years</p> <p><u>Estimate cost: \$35,000 for immediate work</u></p> <p><u>Estimate cost: \$50,000 for roof repaint within 2 years</u></p>

Lifting membrane roof over McConnell Dowel Offices.

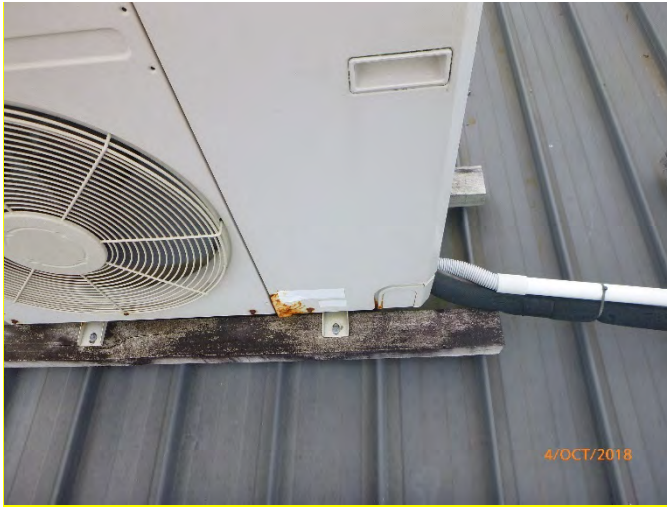
Photograph 31

- 3.2.9 Plant located on the roof has been poorly fixed to the roof structure and may be a source of moisture ingress below. The plant is seated on timber framed decks that are not suitably fixed to the roof. In some locations, heat pumps are strapped upright with 25x1mm galvanised steel straps screwed to the roofing.

Poor installation of roof top plant.

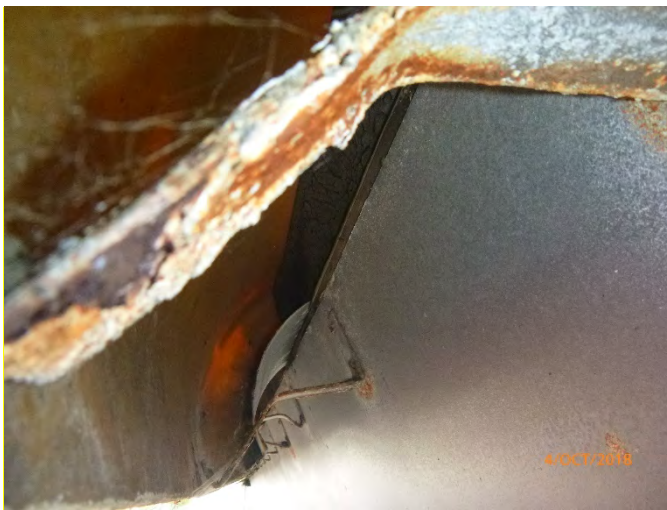
Photograph 32

Corrosion of fixings to GRP cladding.

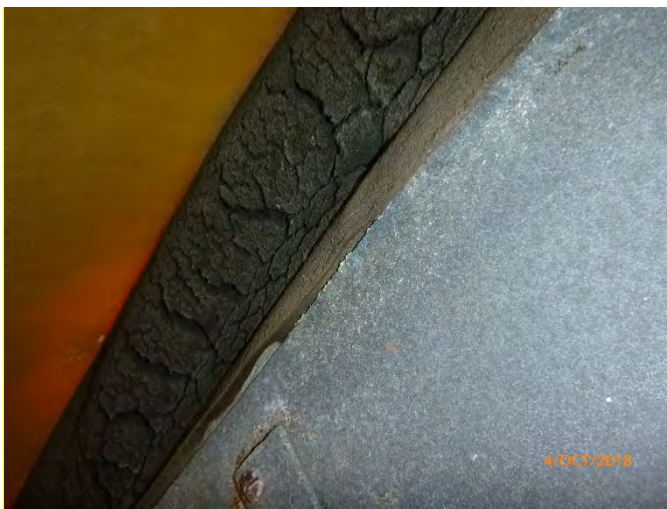
Photograph 33

Perished closed cell seals in parapet formed in GRP panels.

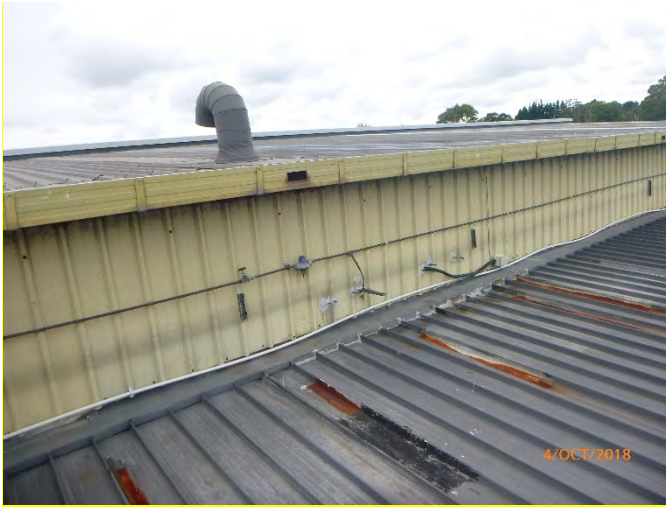
Photograph 34

Early surface corrosion of seemed upstand roof over McConnell Dowel Roof.

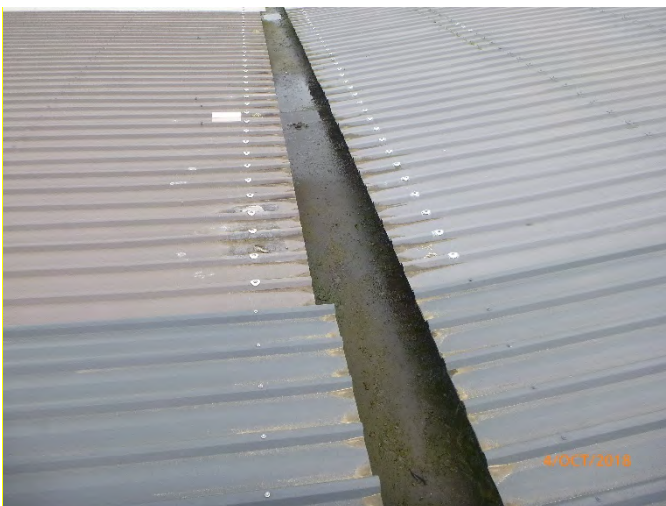
Photograph 36

Standing water in internal gutters.
Note patch repairs to steel roofing.

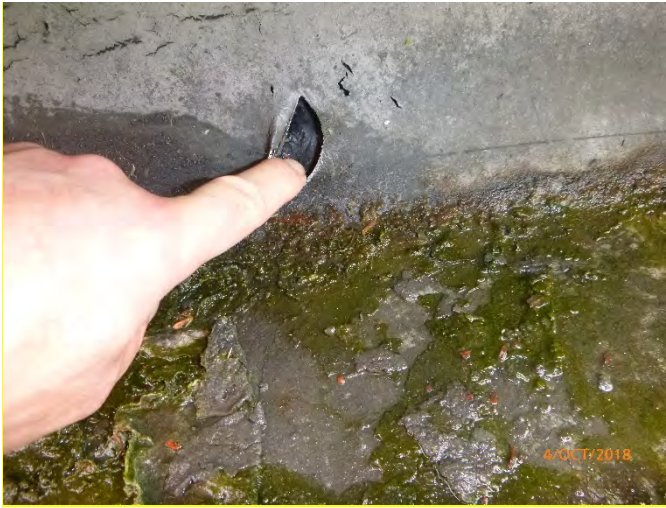
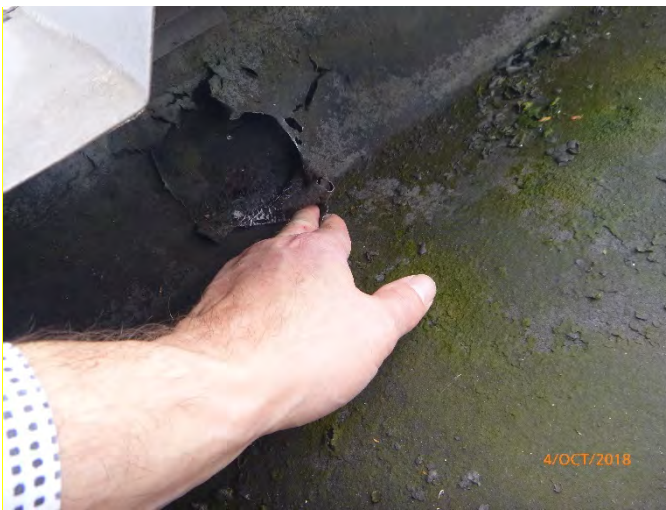
- 3.2.16 The internal gutters are in poor condition. There are numerous tears in the membrane and lifting lapped joints. The outlets are poorly flashed and detailed. The south hopper has had repairs completed poorly with the application of sealant.

Split membrane in internal gutters over Recco Warehouse.

<p><u>Internal Gutters:</u></p> <p>The internal gutters are in poor condition. There are numerous tears, lifting lapped joints and poorly dressed outlets. The hopper outlet detail on the south face rely on sealant to maintain weathertightness. The internal gutters need to be relined and the substrate repairing as required. The hopper should be dressed correctly during the works.</p> <p><u>Recommendation:</u> The internal gutters need to be relined and any damaged substrate replaced immediately.</p> <p><u>Timescale:</u> 0-6 months.</p> <p><u>Estimate cost:</u> \$75,000</p>
	<p><u>North Open Storage/Canopy</u></p> <p>There appears to be deflection in the portal frame roof steelwork. On review of the drawings it appears that the bolted connection of the roof steel should have been to adjacent to each column but on site it has been placed centrally. This frame is also not a true portal frame as claimed by the drawings.</p> <p><u>Recommendation:</u> We recommend a structural engineer reviews the construction.</p> <p><u>Timescale:</u> Immediate.</p> <p><u>Estimate cost:</u> \$5,000 for Structural Engineer Report.</p>

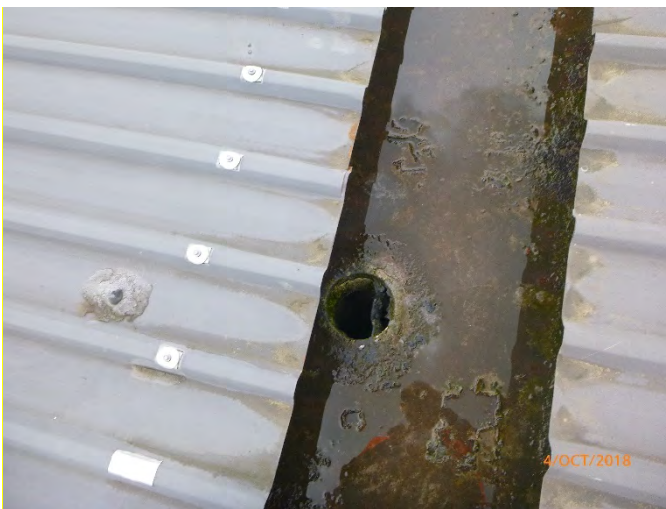
Photograph 39

Poorly dressed outlet in internal gutters.

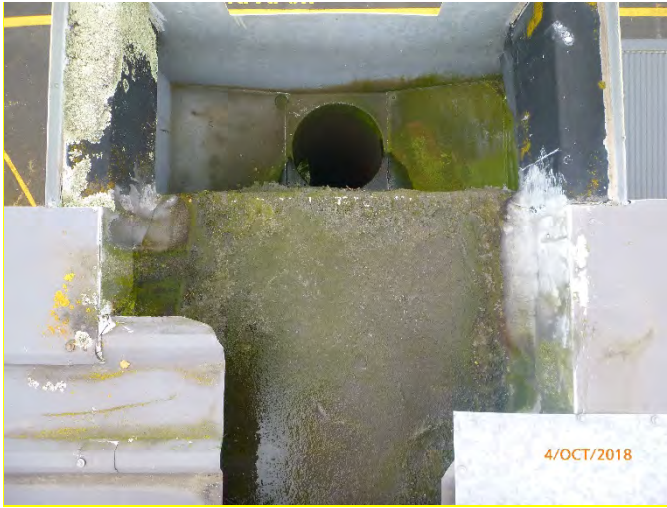
Photograph 40

Hopper junction has strong reliance on sealant.

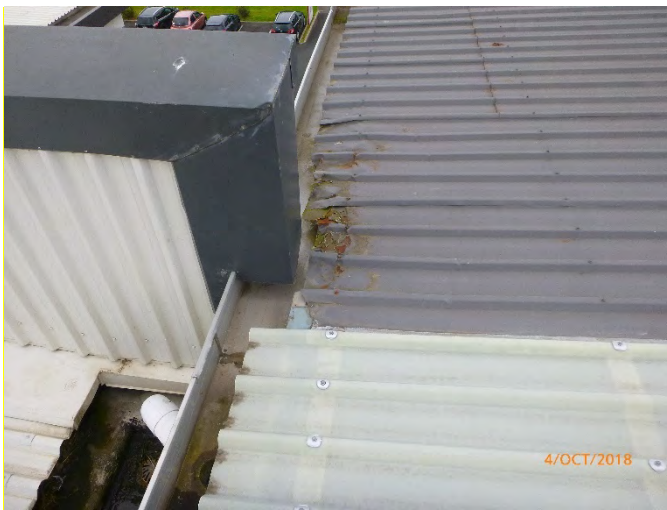
Photograph 41

Connection between Dicker Warehouse and Repco Warehouse. Note damaged roofing and corrosion.

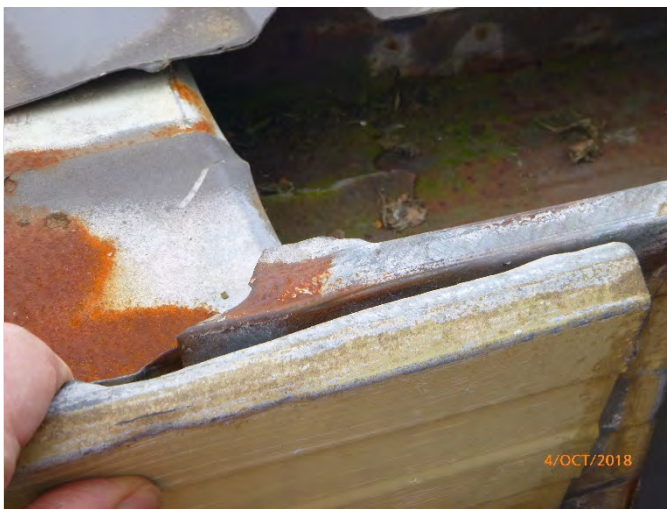
Photograph 42

Corrosion in Repco Warehouse East Gutter.

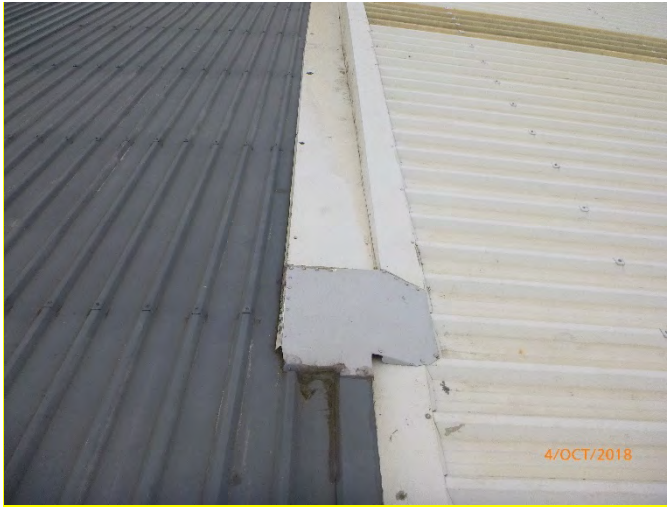
Photograph 43

Poorly formed barge flashing at Open Warehouse/Main Warehouse transition.

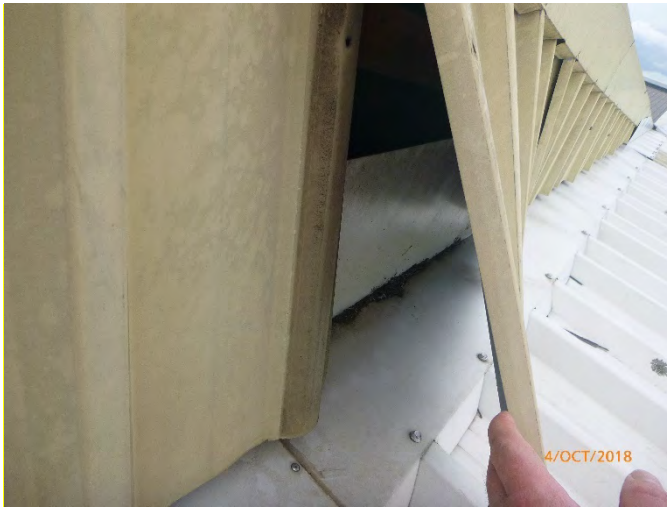
Photograph 44

Unfixed cladding at Apron flashing at Open Warehouse/Main Warehouse transition.

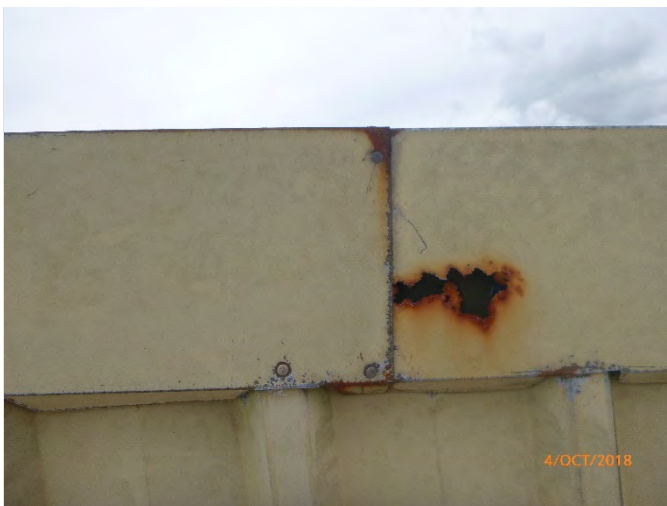
Photograph 45

Heavy corrosion on the above mentioned barge flashing.

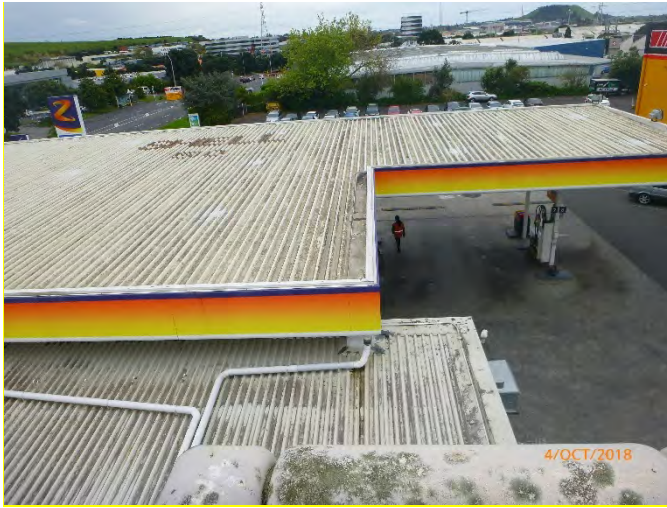
Photograph 46

Note heavy grime build up on Z Fuel Station Roof.

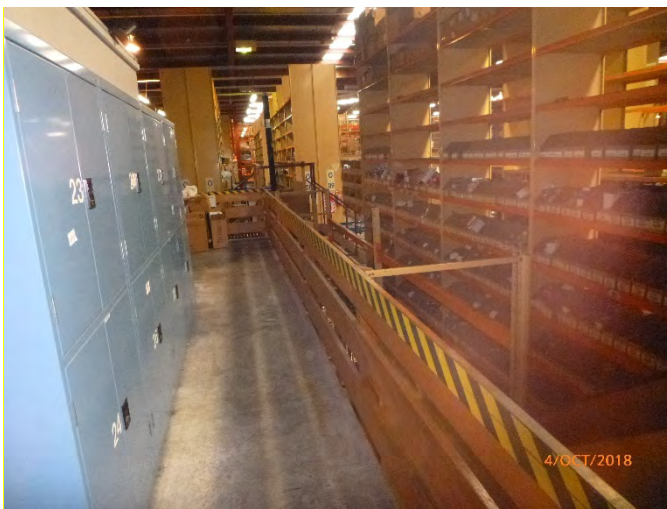
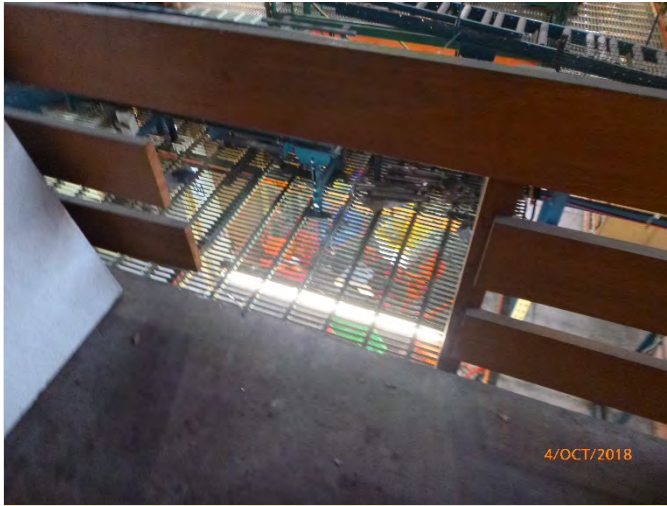
Low balustrade in Repco Warehouse.

Missing sections of balustrade in Repco Warehouse.

<p><u>Balustrades to Gantries in Warehouse:</u></p> <p>Balustrades are below current regulation height. One section of balustrade missing and provides a fall from height risk.</p> <p><u>Recommendation:</u> Provide additional rail above existing and install missing rails.</p> <p><u>Timescale:</u> Immediate.</p> <p><u>Estimate cost:</u> \$10,000</p>
	<p><u>Blockwork South, Part West and East Face:</u></p> <p>There are cracks in the blockwork typically at the construction joints. These have been pointed in a sand cement mortar and not a flexible mastic seal. As a result, they have cracked and allow moisture to enter the building. The mortar should be raked out and the construction joint should be injected with a flexible sealer.</p> <p>There are further cracks to the blockwork which are allowing moisture penetration and is likely to be the result of an inadequate number of construction joints. These are unlikely to be structural. They will need to be either raked out and resin inject repaired with additional construction joints installing with flexible seals.</p> <p>Various penetrations through blockwork poorly sealed or seal broken down. Some pipework is suspected as weeping and need repairs. Repoint/seal around penetrations.</p> <p>The blockwork is heavily soiled on all elevations and needs redecoration.</p> <p><u>Recommendation:</u> Repair blockwork throughout and redecorate.</p> <p><u>Timescale:</u> 6-12 months.</p> <p><u>Estimate cost:</u> \$40,000</p>

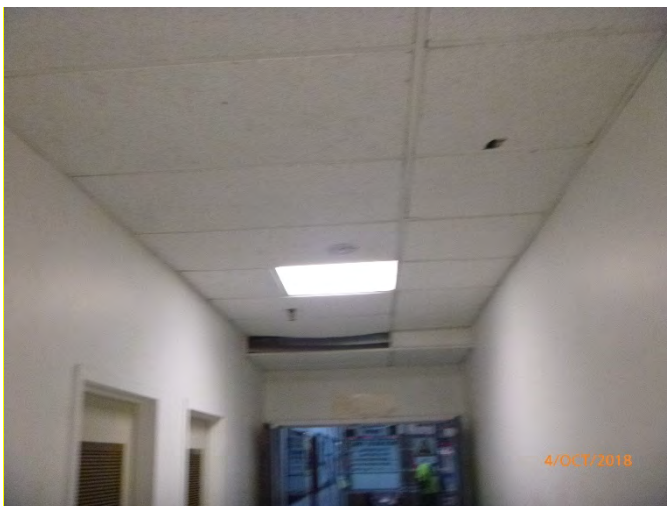
Photograph 51

Repco Rear Corridor ceiling.

■	<p><u>Rear Ground Floor Corridors, Locker Rooms and Canteen:</u></p> <p>The corridors between the offices and warehouse are tired and the ceilings in the corridors, locker rooms/ablution, store and service rooms and canteen are in very poor condition.</p> <p>Double doors to canteen have a damaged hinge set which requires immediate repair.</p> <p>Recommend the corridors are painted and the ceiling are replaced.</p> <p><u>Recommendation:</u> Complete an upgrade of the area.</p> <p><u>Timescale:</u> 12 months except hinges to canteen door to be completed.</p> <p><u>Estimate cost: \$40,000</u></p>

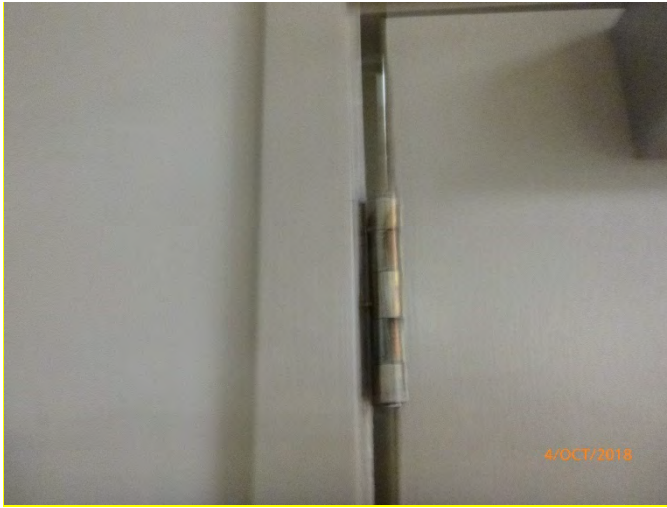
Photograph 52

Damaged hinge to Repco Canteen Door.

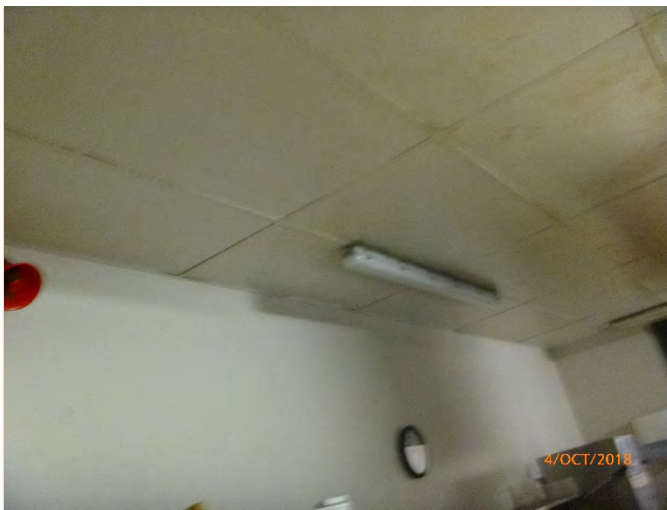
Photograph 53

Poor ceiling condition in Repco Canteen Kitchen.

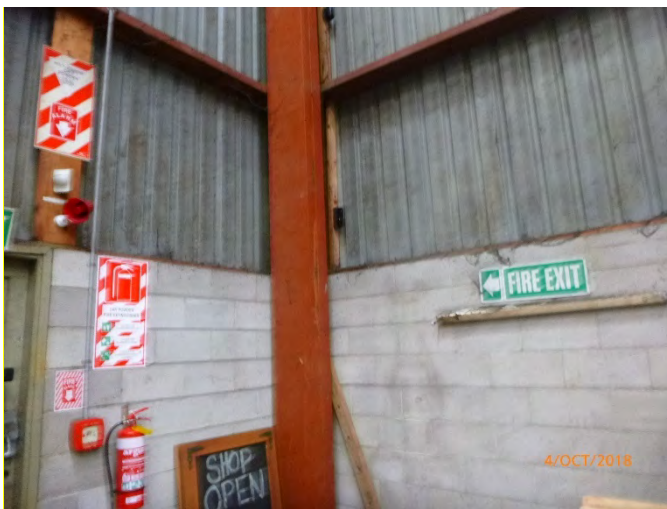
Photograph 54

Repco Warehouse. Note water staining as a result of cracks in block walls.

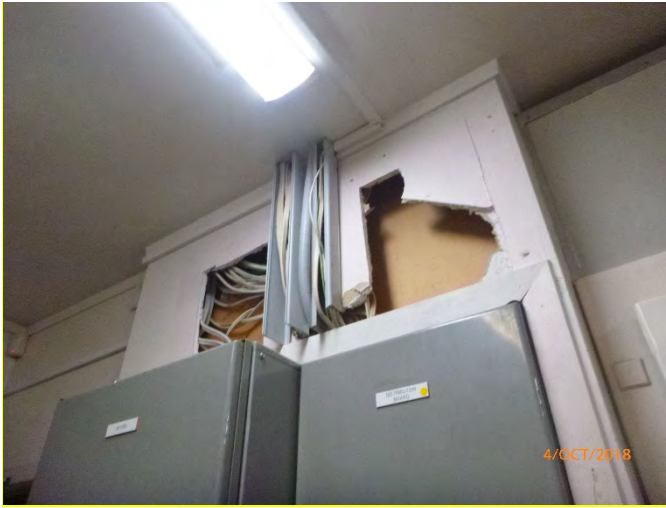
Photograph 55

Missing plasterboard in Z store room.

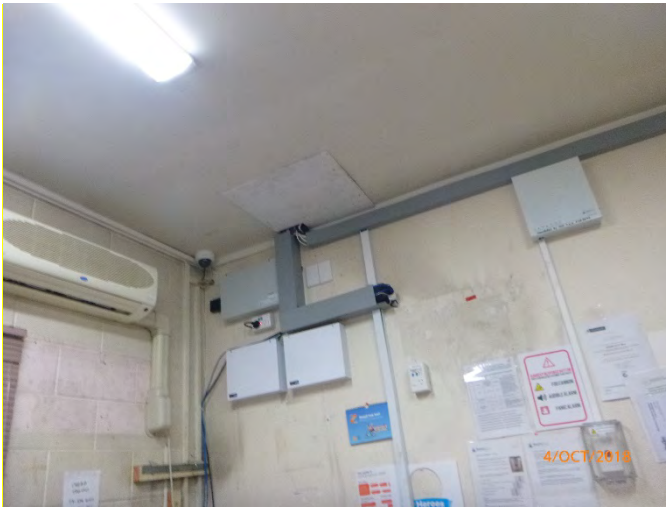
Photograph 56

Patch repair ceiling in Z staff office.

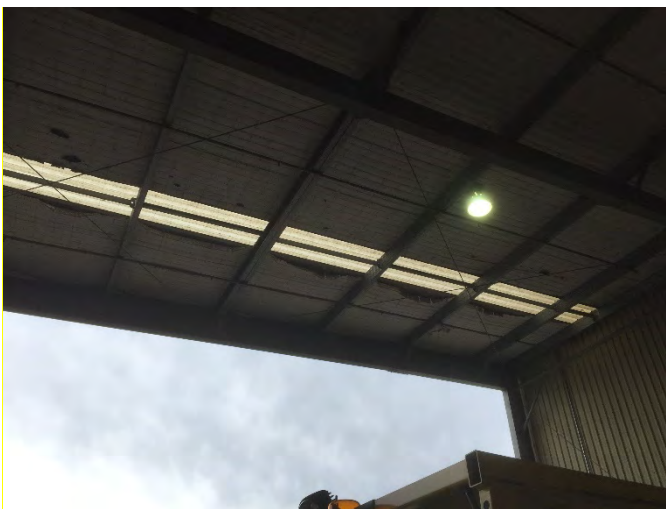
Photograph 57

Damaged roofers underlay in Open Warehouse.

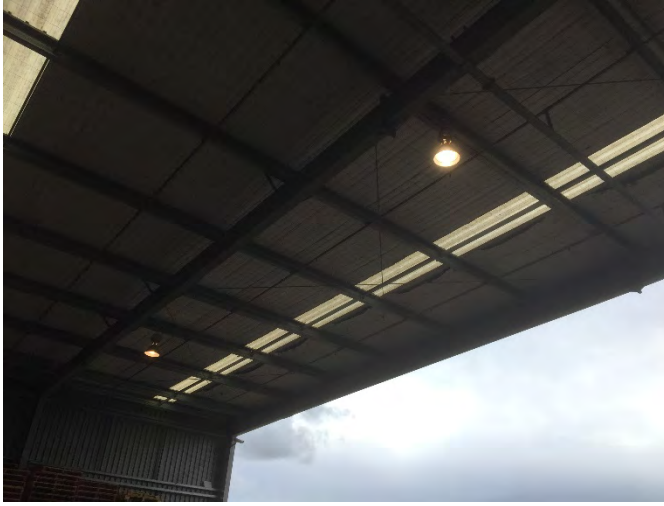
Photograph 58

- 3.1.7 The office building inside the warehouse appears to be timber framed and is in good condition.
- 3.1.8 The open warehouse is a later extension of steel framed construction. There appears to be some deflection in the steel roof beams. The building consent documents relate this as a portal frame which is not the case in this instance. There is a bolt connection detail at the centre of the steelwork roof beams which is shown to be at either end on the building consent documents. We would recommend a structural engineer review the design and performance of the steelwork.

Potential deflection in steel frame of open warehouse. Note the bolted joint is central and not either end of frame as per building consent documents.

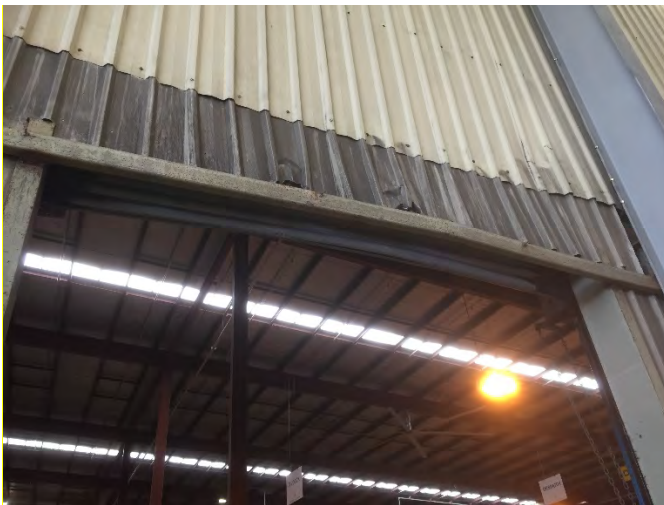
Photograph 59

- 3.1.9 There is impact damage to the head of a structural opening on the north elevation which requires a structural engineers review.
- 3.1.10 Other than that mentioned above, there is no evidence of any failure of the structure during our limited visual inspection.

Damage to head of door opening to North of Repco Store.

<p><u>North Access Opening to Large Canopy.</u></p> <p>Impact damage has taken place at one door head. It is unlikely to have caused any structural damage but should be reviewed by a structural engineer.</p> <p><u>Recommendation:</u> The damage should be inspected by a Structural Engineer. The cladding, girts, roller doors and associated damage should be addressed immediately.</p> <p><u>Timescale:</u> Immediate</p> <p><u>Estimate cost:</u> \$10,000</p>
