Technical Due Diligence Report

For and on behalf of
**AUGUSTA FUNDS
MANAGEMENT LTD**

265 Albany Highway,
Auckland

OCTOBER 2018

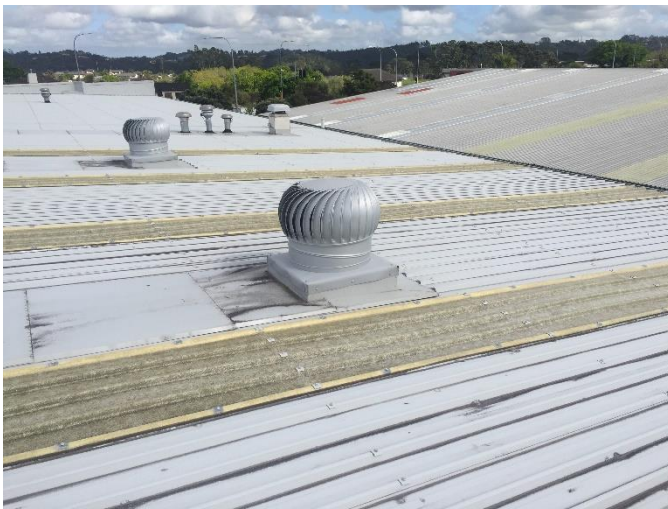
Photograph 8

- 3.2.15 The translucent roof sheets to the Stihl Building are suffering from UV degradation and have become opaque. We recommend the translucent roof sheets are replaced.

The translucent roof sheets to the Stihl Building are UV degraded and have become opaque. We recommend the translucent roof sheets are replaced.

<p><u>Stihl - Translucent Roof Sheets</u></p> <p>The roof coverings are in a poor condition due to a lack of maintenance and the translucent roof sheets are UV degraded.</p> <p><u>Recommendation:</u> Consideration should be given to replacement of the translucent roof sheets.</p> <p><u>Time scale:</u> Year 3.</p> <p><u>Cost:</u> \$10,000</p>

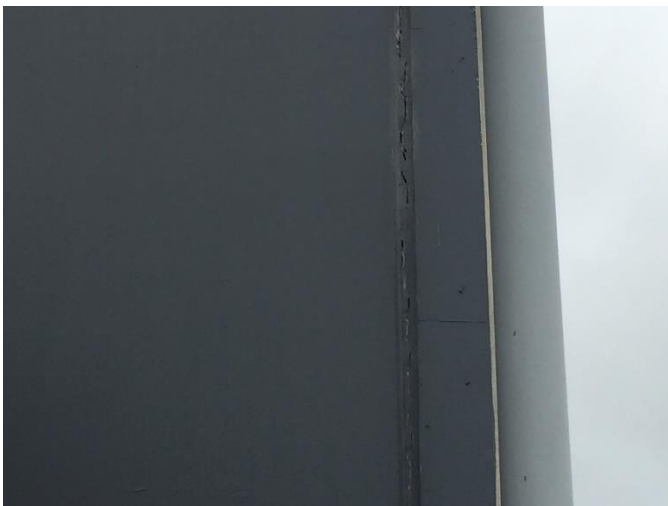
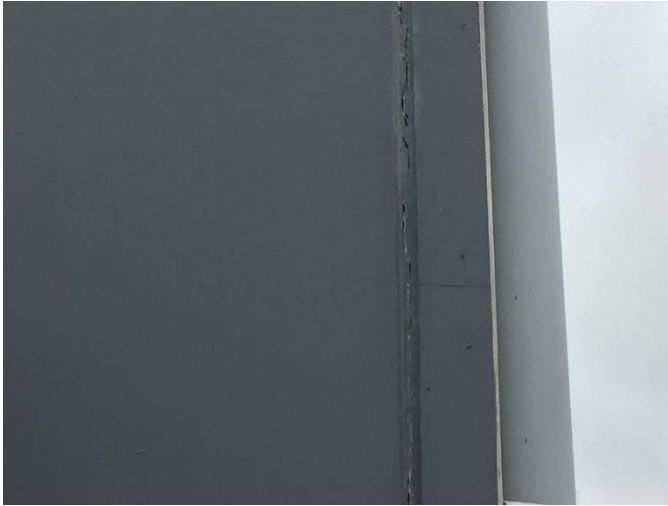
Photograph 9

- 3.4.7 Splitting of the polysulphide mastic sealant was observed to the north-east corner of the Stihl Building. We believe the splitting is due to differential thermal movement between the faces of the concrete, with no major issue suspected. However, we would recommend a structural engineer is engaged to provide comment on the possible causes of the splitting and movement. We assume all structural observations described above will be covered within the structural review being undertaken by Stephen Mitchell Engineers Limited.

Splitting of the polysulphide mastic sealant was observed to the north-east corner of the Stihl Building. We believe the splitting is due to differential thermal movement between the faces of the concrete, with no major issue suspected. However, we would recommend a structural engineer is engaged to provide comment on the possible causes of the splitting and movement.

<p><u>Stihl - Polysulphide Mastic Sealant</u></p> <p>Splitting of the polysulphide mastic sealant was observed to the north-east corner of the Stihl Building. We believe the splitting is due to differential thermal movement between the faces of the concrete, with no major issue suspected.</p> <p><u>Recommendation:</u> However, we would recommend a structural engineer is engaged to provide comment on the possible causes of the splitting and movement.</p> <p>We assume all structural observations described above will be covered within the structural review being undertaken by Stephen Mitchell Engineers Limited.</p> <p><u>Timescale:</u> Immediate.</p> <p><u>Estimate cost:</u> \$5,000</p>

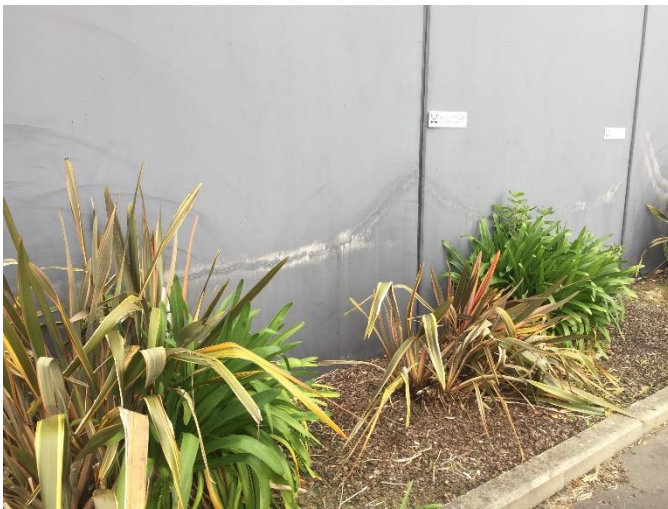
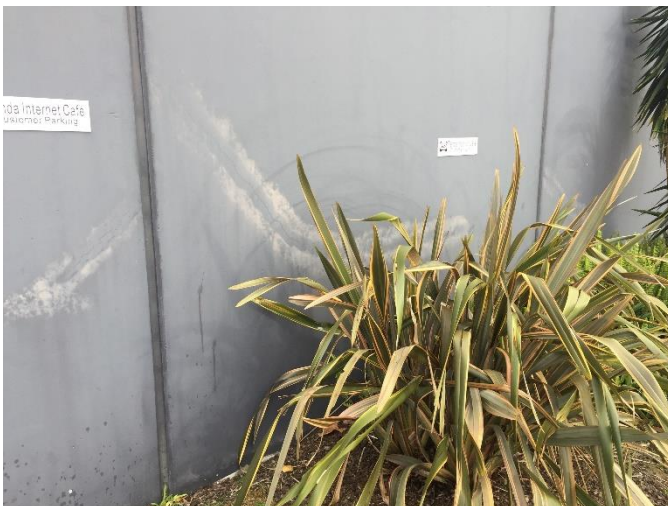
Photograph 11

- 3.4.8 Efflorescence staining and cracking of the concrete tilt slab panels was noted to the east elevation of the Stihl Building. We would recommend a structural engineer is engaged to provide comment on the possible causes of the cracking and movement. We assume all structural observations described above will be covered within the structural review being undertaken by Stephen Mitchell Engineers Limited.

Efflorescence staining and cracking of the concrete tilt slab panels was noted to the east elevation of the Stihl Building. We would recommend a structural engineer is engaged to provide comment on the possible causes of the cracking and movement.

<p><u>Stihl - Tilt Slab Panels</u></p> <p>Efflorescence staining and cracking of the concrete tilt slab panels was noted to the east elevation of the Stihl Building.</p> <p><u>Recommendation:</u> We would recommend a structural engineer is engaged to provide comment and remedial works on the possible causes of the cracking and movement.</p> <p>We assume all structural observations described above will be covered within the structural review being undertaken by Stephen Mitchell Engineers Limited.</p> <p><u>Timescale:</u> Immediate.</p> <p><u>Estimate cost:</u> \$5,000</p>

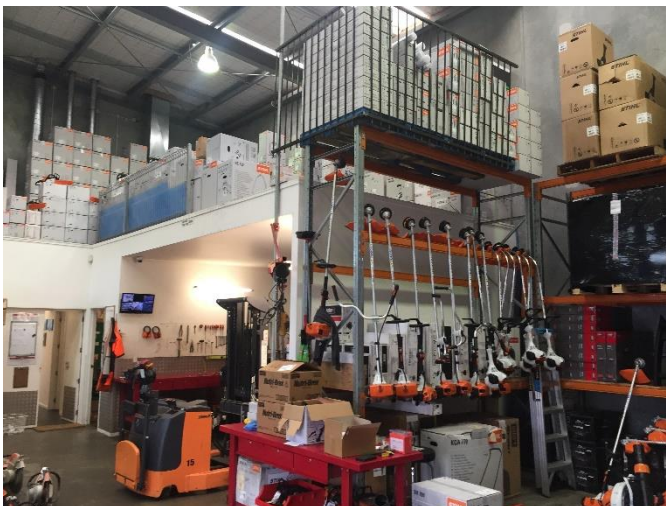
Photograph 15

We note that an unconsented mezzanine storage area has been installed within the warehouse/workshop area of the Stihl building which is unlikely to comply with the NZBC and will require the upgrading of the fire systems. This item should be removed, or a building consent applied for urgently.

Missing sections of edge protection were noted to the mezzanine storage area, with no warning signage on place. This is a Health and Safety risk given the fall height to the ground floor.

■	<p><u>Stihl - Internal Finishes</u></p> <p>We note that an unconsented mezzanine storage area has been installed within the warehouse/workshop area of the Stihl building which is unlikely to comply with the NZBC and will require the upgrading of the fire systems.</p> <p><u>Recommendation:</u> The mezzanine should be removed, or a building consent applied for urgently. We consider this to be a Health and Safety risk given the construction, flammable chemicals stored on site and could result in the voiding of the current insurance policy and/or criminal prosecution.</p> <p><u>Timescale:</u> Immediate.</p> <p><u>Estimate cost:</u> \$5,000</p>
■	<p><u>Stihl - Internal Finishes</u></p> <p>Several partitions have been installed throughout the Stihl Building first floor to form private gaming rooms.</p> <p><u>Recommendation:</u> This item should be removed, or a building consent applied for urgently. This is a Health and Safety risk given the construction, change in escape paths and could result in the voiding of the current insurance policy and/or criminal prosecution.</p> <p><u>Timescale:</u> Immediate.</p> <p><u>Estimate cost:</u> \$7,500</p>

■	<p><u>Stihl - Internal Finishes</u></p> <p>Missing sections of edge protection were noted to the mezzanine storage area, with no warning signage on place.</p> <p><u>Recommendation:</u> This is a Health and Safety risk given the fall height to the ground floor.</p> <p><u>Timescale:</u> Immediate.</p> <p><u>Estimate cost:</u> \$2,000</p>
■	<p><u>Good Health - Skylight</u></p> <p>Evidence of water damage to the plasterboard ceiling linings around the central light well to the Good Health office accommodation. Inspection of the roof covering, and skylight found several temporary repairs in the form of sealant applied to the skylight.</p> <p><u>Recommendation:</u> We recommend a permanent repair is made to the roof penetration flashings.</p> <p><u>Timescale:</u> Immediate.</p> <p><u>Estimate cost:</u> \$2,500</p>

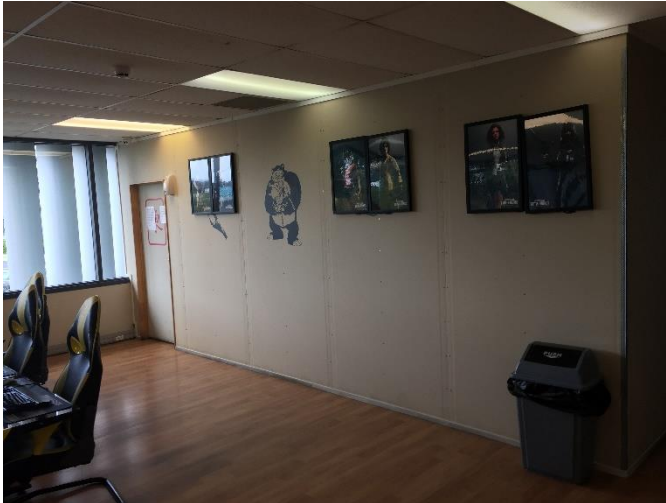
Photograph 16

Several partitions have been installed throughout the Stihl Building first floor to form private gaming rooms. This item should be removed, or a building consent applied for urgently.

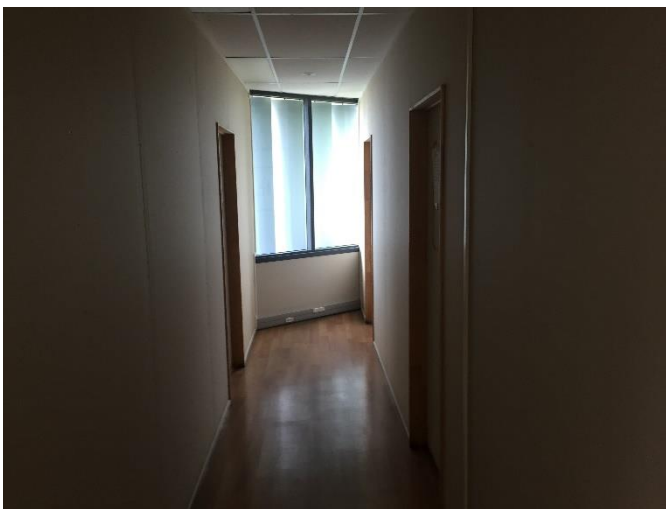
Photograph 17

Several partitions have been installed throughout the Stihl Building first floor to form private gaming rooms. This item should be removed, or a building consent applied for urgently.

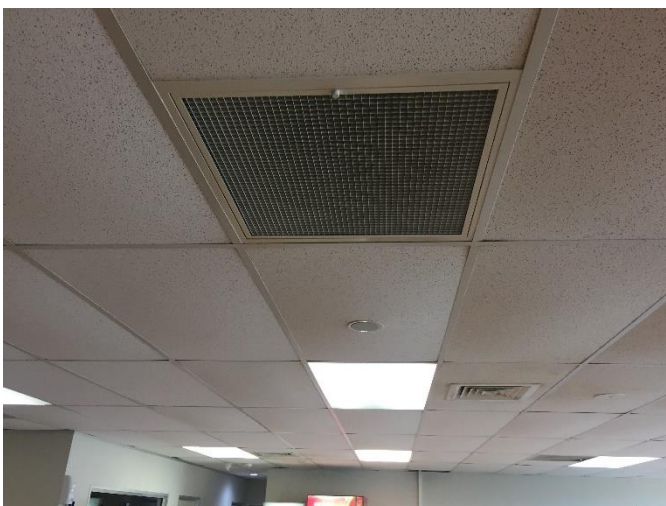
Photograph 18

Sagging and staining of several mineral fibre tiles was noticed within the first-floor space to the Stihl Building.

<p><u>Stihl - Mineral Fibre Tiles</u></p> <p>Sagging and staining of several mineral fibre tiles was noticed within the first-floor space.</p> <p>Recommendation: Investigate the cause of the sagging mineral fibre tiles to the tenancy and replace the damaged ceiling tiles.</p> <p>Time scale: Year 1.</p> <p>Cost: \$1,000</p>
<p><u>Caffe é Cucina - Soaker to cement fibre weatherboard</u></p> <p>There is a damaged soaker to the base of the weatherboard cladding to the left-hand side of the exit door from the kitchen area.</p> <p>Recommendation: Repair/re-fix soaker to prevent water ingress and hazard to passing building users.</p> <p>Timescale: Immediate.</p> <p>Cost: \$250</p>
<p><u>Caffe é Cucina - Timber weatherboard and facings</u></p> <p>The timber weatherboard cladding and facings to the base of the external seating area is showing signs of deterioration of the timber, with splitting and cracking noted.</p> <p>Recommendation: Prepare and re-decorate timber weatherboard and facings to prevent further deterioration.</p> <p>Timescale: Immediate.</p> <p>Cost: \$2,000</p>

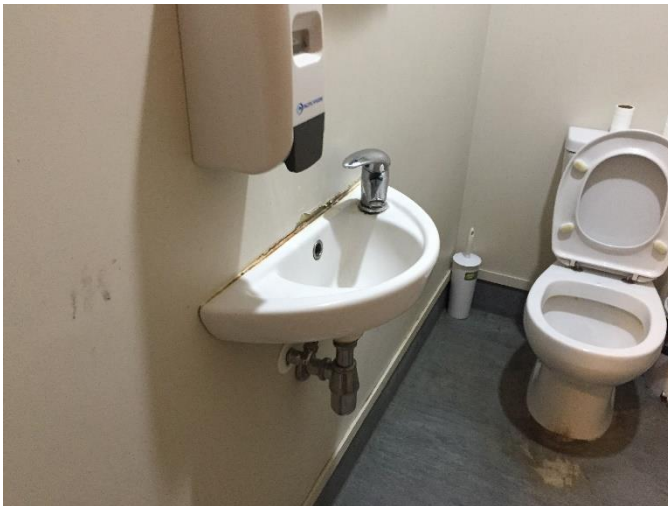
Photograph 19

Staining and water damage were noted to the wall linings behind the wash hand basins to the toilets within the first floor. No splash back has been installed to prevent moisture damage.

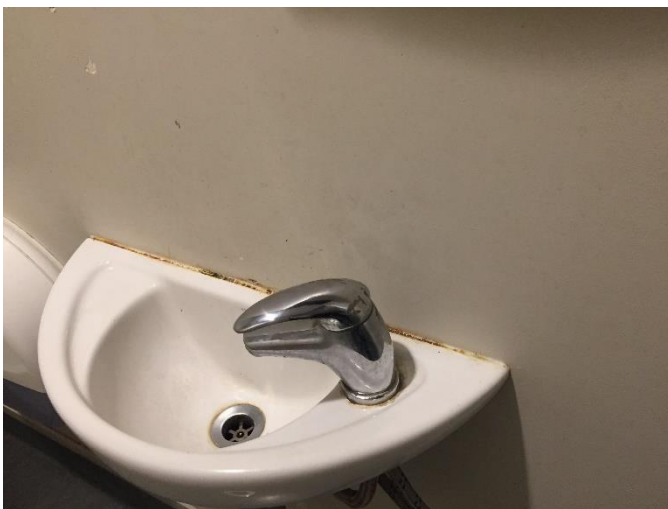
Photograph 20

Staining and water damage were noted to the wall linings behind the wash hand basins to the toilets within the first floor. No splash back has been installed to prevent moisture damage.

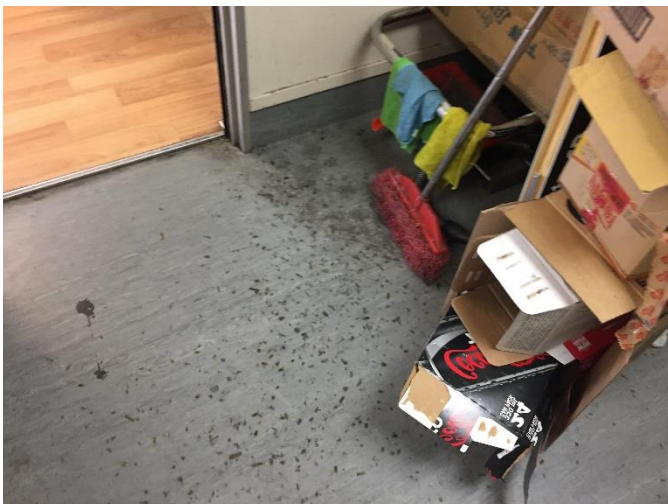
Photograph 21

Staining and damage was noted to the first floor kitchenette vinyl floor covering. The floor covering will require replacement.

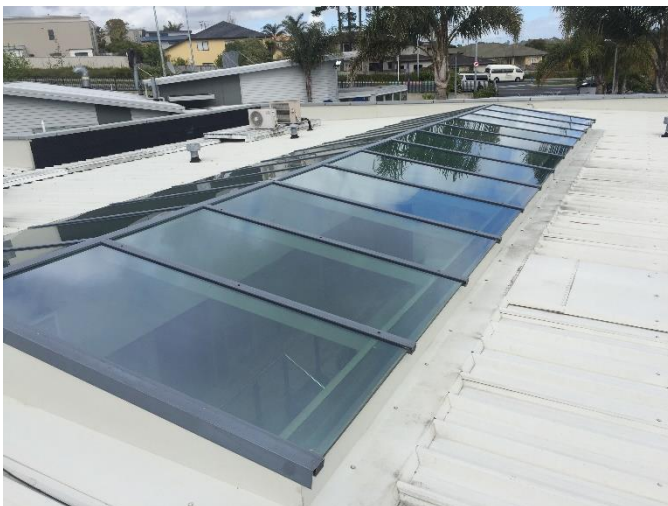
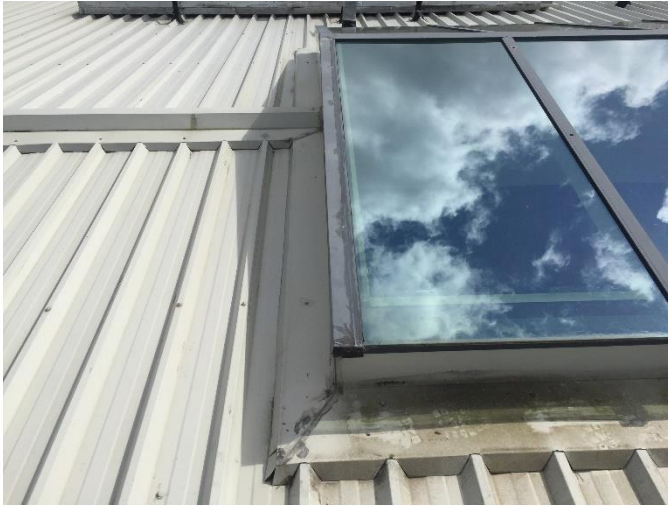
Photograph 27

Inspection of the roof covering, and skylight found several temporary repairs in the form of sealant applied to the skylight.

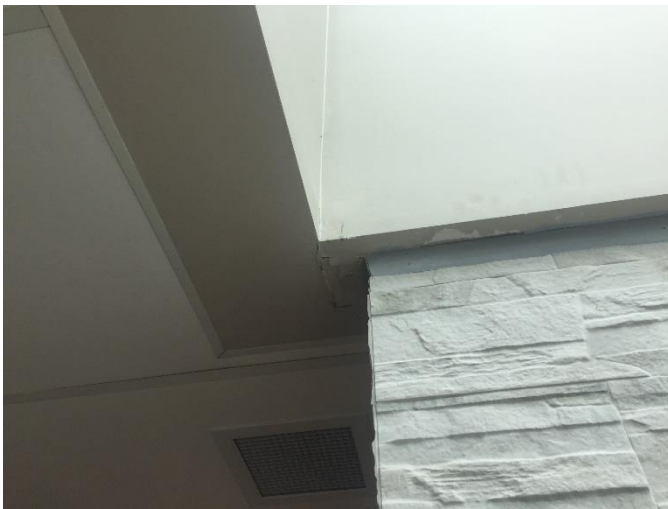
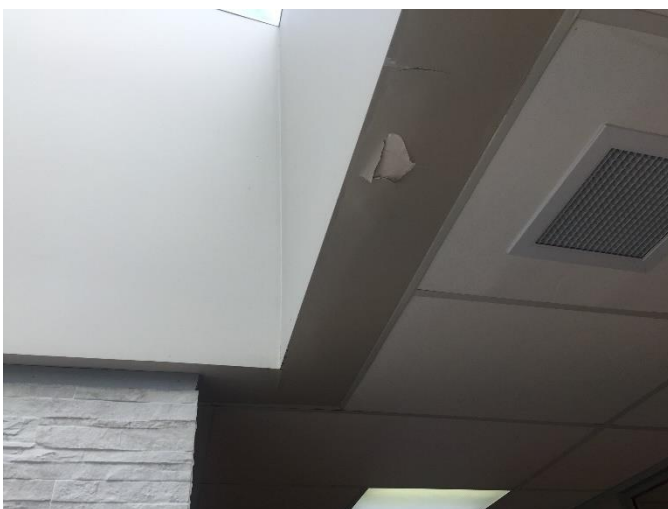
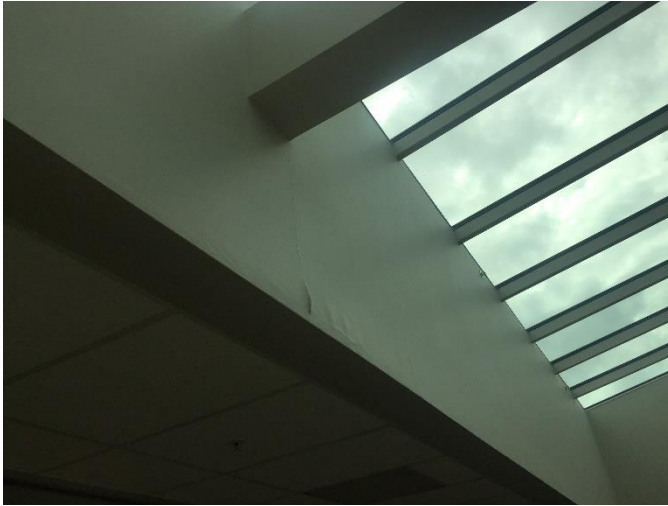
Photograph 29

- 3.2.16 Heavy staining and atmospheric debris build-up was noted to the Good Health warehouse roof around the south elevation ventilation stack.
- 3.2.17 Evidence of water damage to the plasterboard ceiling linings around the central lightwell to the Good Health office accommodation. Inspection of the roof covering and skylight found several temporary repairs in the form of sealant applied to the skylight. We recommend an appropriate permanent repair is made to the roof penetration.

Evidence of water damage to the plasterboard ceiling linings around the central light well to the Good Health office accommodation.

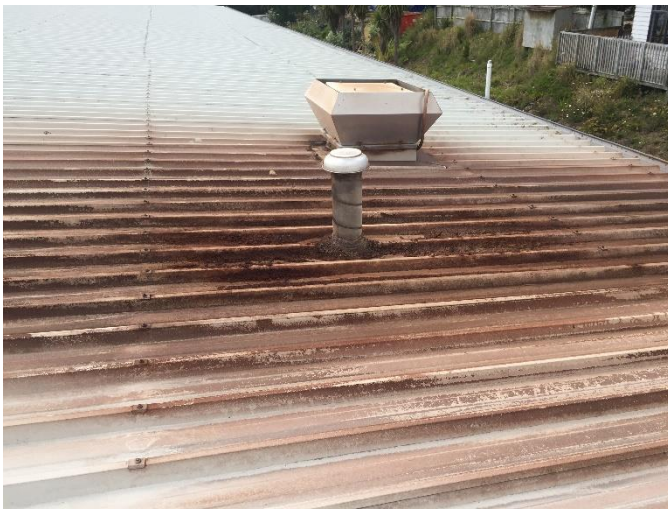
Photograph 32

Heavy staining and atmospheric debris build-up was noted to the Good Health warehouse roof around the south elevation ventilation stack.

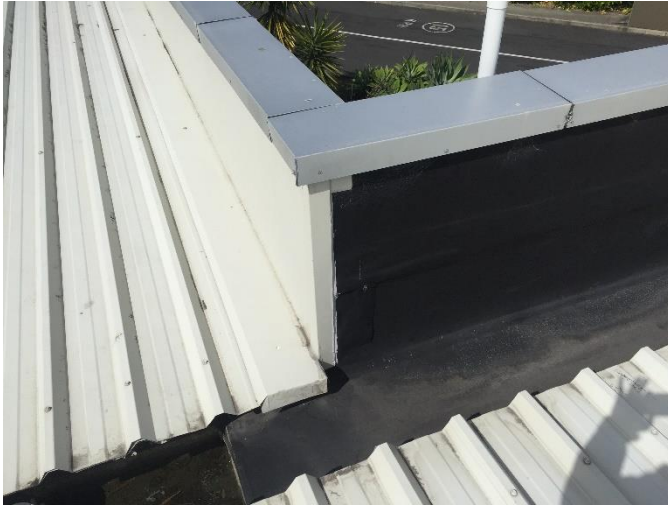
Photograph 34

- 3.2.18 Internal roof leaks were noted within the Good Health Building and focused around the south-west internal corner. Inspection of the internal gutter and parapet found several temporary repairs in the form of sealant applied to the membrane. We recommend an appropriate permanent repair is made to the roof gutter and parapet junction.

Inspection of the internal gutter and parapet found several temporary repairs in the form of sealant applied to the membrane.

<p><u>Good Health - Parapet/Internal Gutter</u></p> <p>Internal roof leaks were noted within the Good Health Building and focused around the south-west internal corner. Inspection of the internal gutter and parapet found several temporary repairs in the form of sealant applied to the membrane.</p> <p><u>Recommendation:</u> We recommend a permanent repair is made to the roof gutter, parapet junction and parapet cladding junction.</p> <p><u>Timescale:</u> Immediate.</p> <p><u>Estimate cost:</u> \$2,000</p>

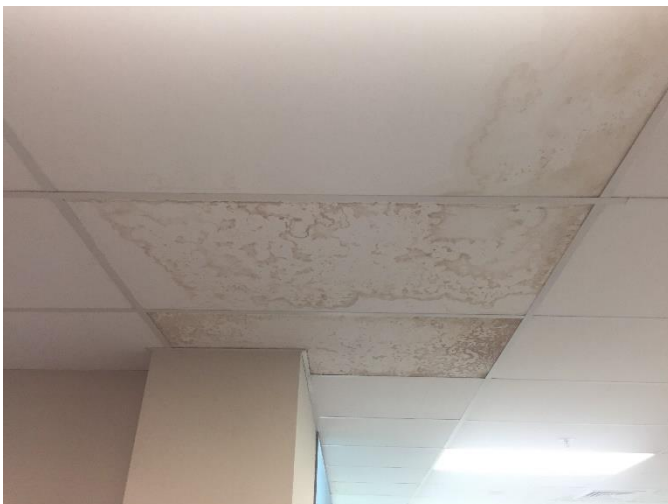
Photograph 36

- 3.3.5 Internal roof leaks were noted within the Good Health Building and focused around the south-west internal corner. Inspection of the internal gutter and parapet found several temporary repairs in the form of sealant applied to the membrane. We recommend a permanent repair is made to the roof gutter and parapet junction.

Internal roof leaks were noted within the Good Health Building and focused around the south-west internal corner.

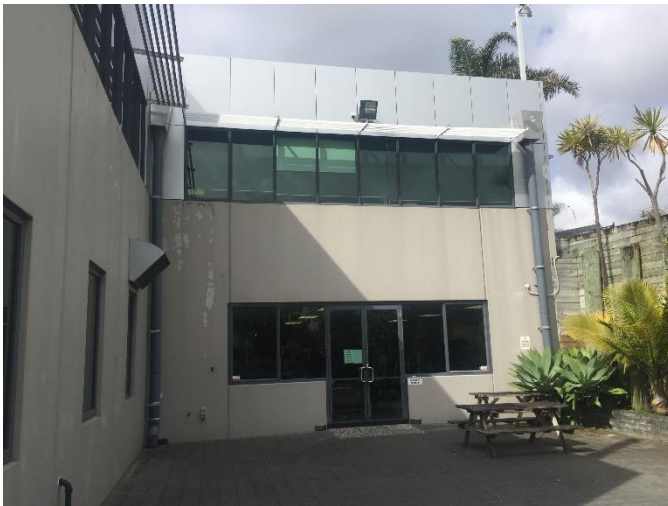
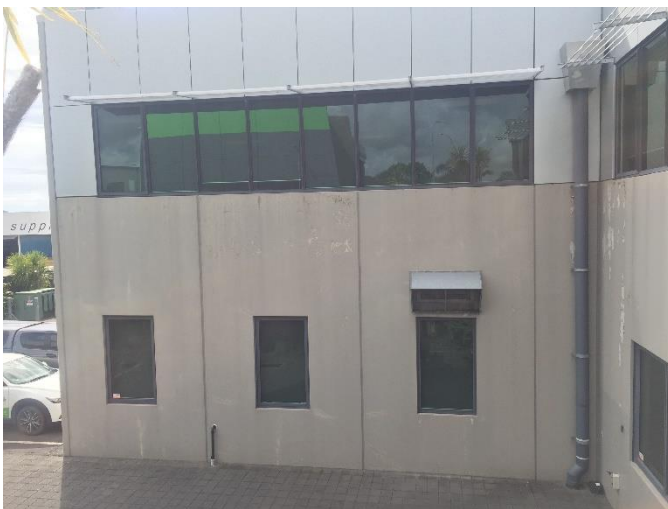
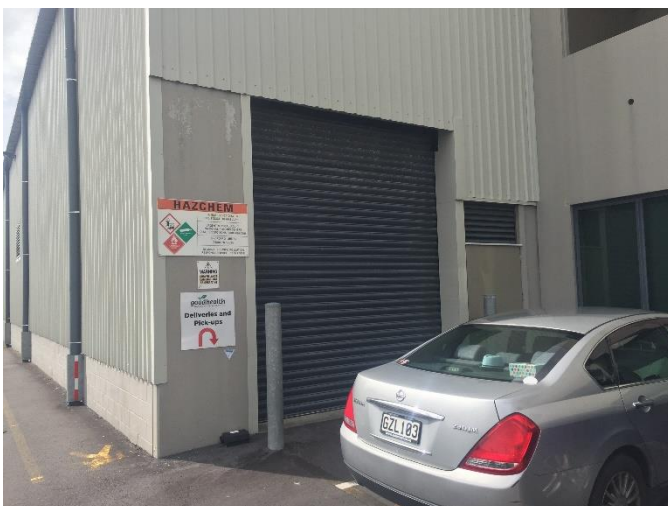
Photograph 37

- 3.4.9 Several areas of flaking paint were noted to the concrete tilt slab panels to the Good Health building on the south and west elevations.

Several areas of flaking paint were noted to the concrete tilt slab panels to the Good Health building on the south and west elevations.

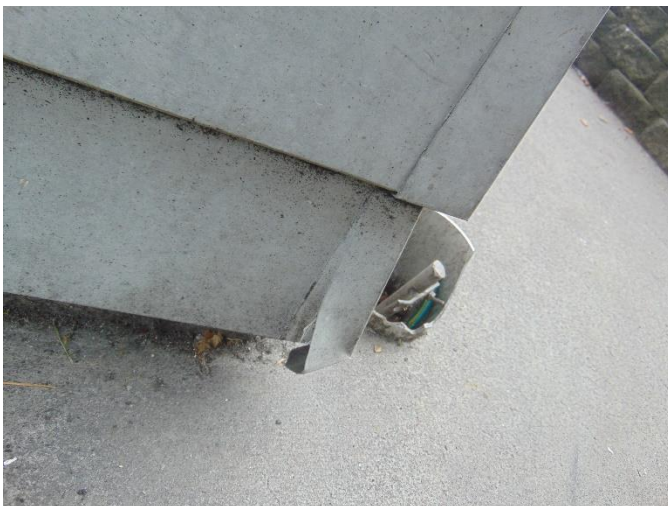
Photograph 48

Caffè é Cucina: Damaged soaker to base of weatherboard.

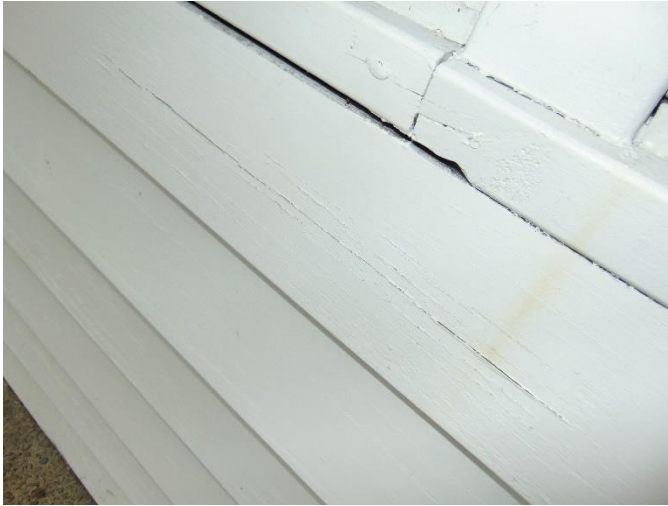
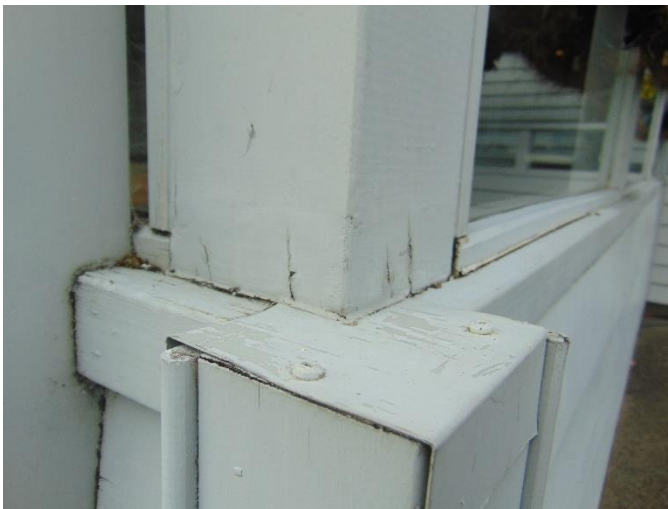
Photograph 49

- 3.4.10 The timber weatherboard cladding and facings to the base of the external seating areas to the Caffe e Cucina building shown signs of deterioration of the timber, with splitting and cracking noted.

Caffe é Cucina: Deterioration to timber cladding and facings to external seating area.

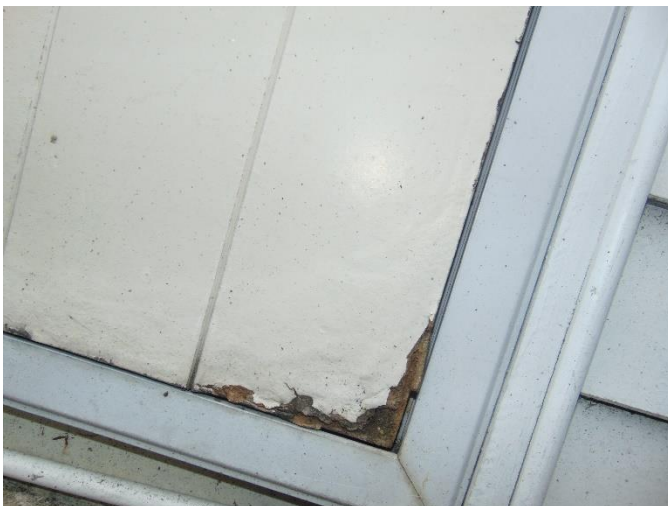
Photograph 51

Caffe é Cucina: Deterioration to base of external doors.

<p><u>Caffe é Cucina - Deterioration of external doors</u></p> <p>The external fire exit doors to the rear of the building have been damaged on the bottom and side edges and material is starting to swell and deteriorate.</p> <p>Recommendation: Replacement of external fire doors will be required within 1-2 years.</p> <p>Timescale: 1 - 2 years.</p> <p>Cost: \$4,000</p>
<p><u>Childcare Centre - Damaged section of weatherboard</u></p> <p>There is a damaged section of weatherboard at low level to the left-hand side of the entrance.</p> <p>Recommendation: Install replacement weatherboard to prevent water ingress damaging timber frame.</p> <p>Timescale: Immediately.</p> <p>Cost: \$1,000</p>
<p><u>Childcare Centre - Floor coverings</u></p> <p>The barrier entrance mat is lifting at the threshold of one of the rear external doors in the Childcare Centre.</p> <p>Recommendation: Supply and fit replacement barrier entrance mat.</p> <p>Timescale: Immediately.</p> <p>Cost: \$500</p>

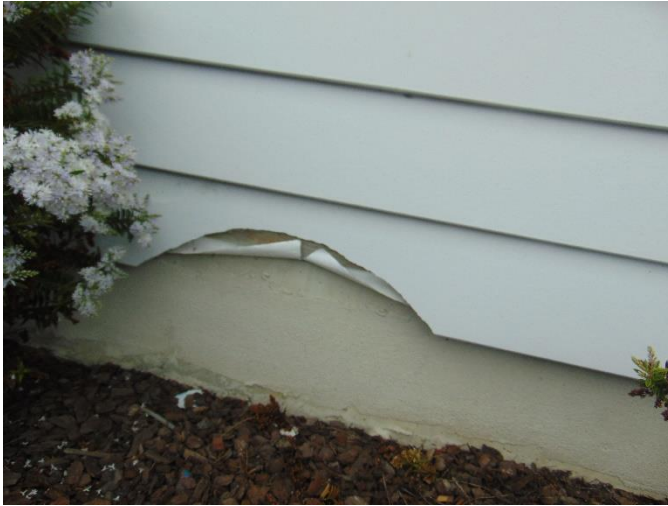
Photograph 55

- 3.4.11 There is a damaged section of weatherboard at low level to the left-hand side of the entrance to the Childcare Centre.

Childcare Centre: Damaged section of weatherboard to left hand side of entrance.

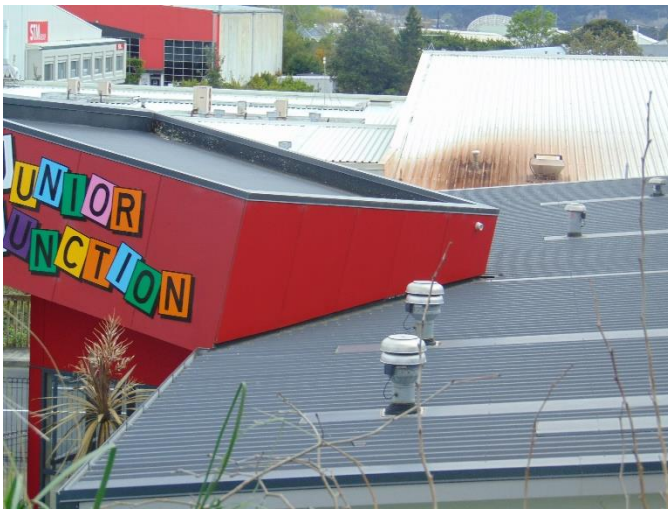
Photograph 56

- 3.2.19 There was evidence of water damage to the decorations to the ceiling in the reception area of the Childcare Centre, the source of the water ingress is reported to have been a blocked rainwater gutter to the rear of the roof upstand above, which has now been cleared. This will require regular maintenance to ensure the blockage does not re-occur.

Childcare Centre: Back gutter detail above reception entrance prone to blockage.

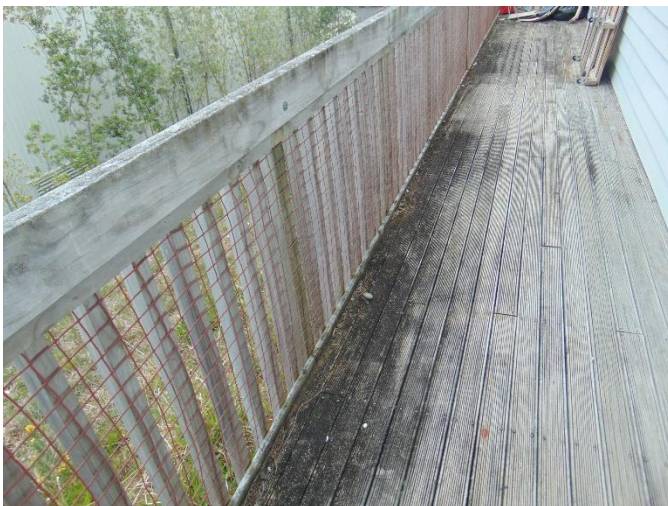
Photograph 57

Childcare Centre: Walkway deck and balustrade requiring cleaning and decoration.

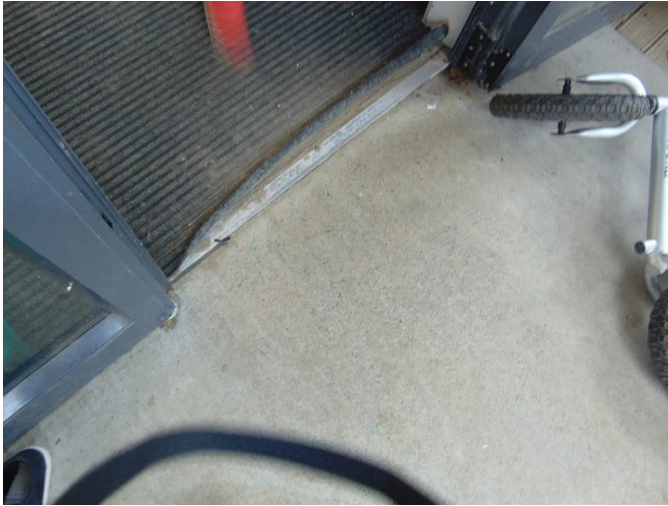
Photograph 58

Childcare Centre: Lifting barrier mat to rear exit doorway.
