TECHNICAL DUE DILIGENCE

67 VICKERYS ROAD

WIGRAM

CHRISTCHURCH

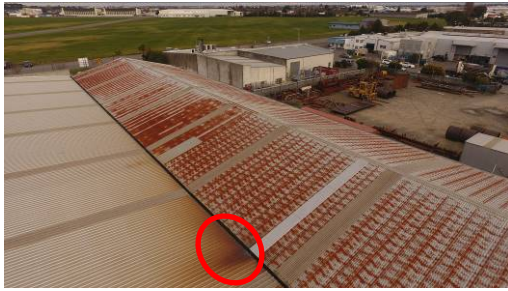
9. The roof coverings to Bays 2, 3 and 4 appear to have been installed circa 2005/6 and are in a serviceable condition, however localised roof sheets to Bay 2, where adjacent to Bay 1, were noted to be heavily corroded, or discoloured, in one location. It is unclear why this has occurred, however it is noted that the discolouration has occurred immediately adjacent to a new back flashing section to Roof Bay 1, which is not currently occupied by any roof penetrations. This indicates that historically, this location of Roof Bay 1 has possessed some form of extraction or vent point, which may have been depositing impurities or other materials onto the surrounding roof sheets. This may be the cause of the heavy corrosion in this location. For additional reference, this has been shown in the photographs below;

1.1. Location of heavy corrosion to Roof Bay 2

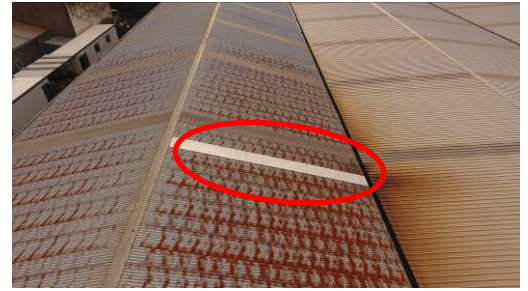
1.2. Back flashing to Roof Bay 1 (with no roof penetrations)

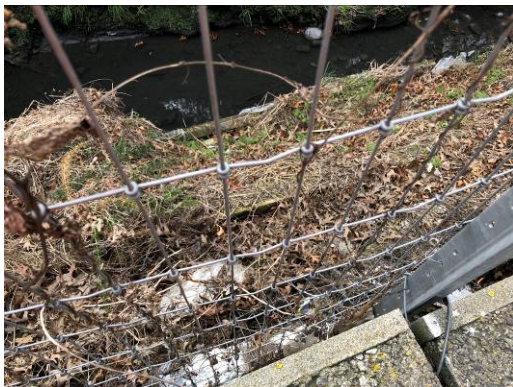
23. Drainage to the site is provided via a number of ground recessed drainage inlets which are in turn served by sub floor pipes.
24. There is a retaining wall built to the north of the site adjacent to the nearby stream – we understand the Tenant built this themselves shortly after taking possession of the site. The construction of retaining walls over 1.5m in height, or with a driveway at the higher section adjoining require Building Consent. It is unknown if any consent was sought for this and the Vendor should be contact for further information. Our CAPEX plan includes a sum for consultancy allowances to potentially allow a party to navigate this process, however it is possible that consent was obtained, or that the council would be able to sign this off quite quickly via a Certificate of Acceptance.

1.3. Retaining wall visible behind fence

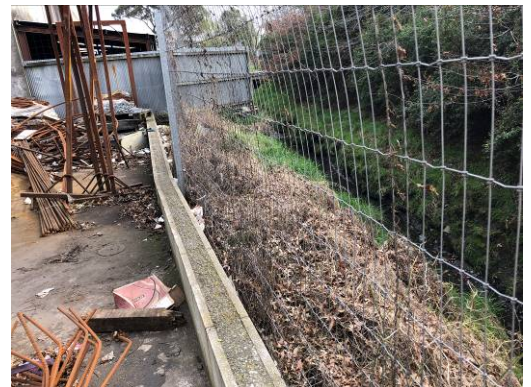
1.4. Boundary of Retaining Wall

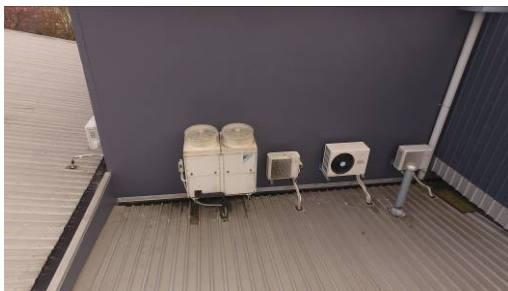
The condition of the condensers to the office roof was difficult to assess as there was no access to the office roofs where the condensers are positioned, however as viewed from drone photographs, they appear to be aged and likely to require renewal over a 10 year period. The building occupier was asked and did not inform of any issues with any of the air conditioning units at the present time, however due to their age, we have allowed to replace the condensers and the Air Handling Unit within 10 years.

The refrigerant utilised could not be determined – however based upon the age of the units it is possible that R22 has been used, which is an ozone depletant and is no longer available. If this is the case, it should be noted that the units would require replacement and that no replacement R22 refrigerant could be easily sourced.

1.5. AC cassettes and AHU

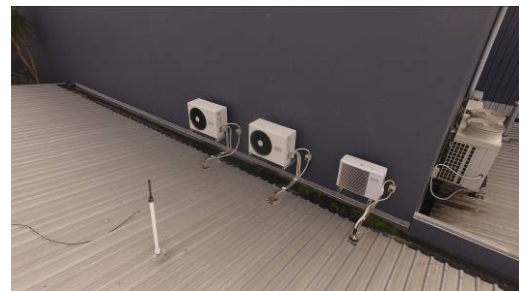
1.6. AC cassettes

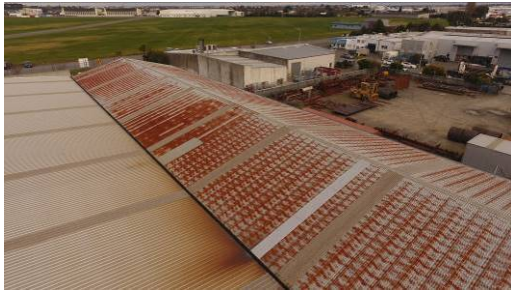
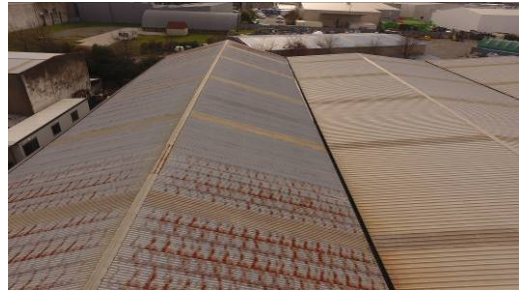
8. Roof coverings to 'Roof Bay 1' are heavily corroded and it is recommended that these sheets be replaced in the near future. The age of the sheets is unknown, however it is not considered possible to repair or maintain the sheets.

1.0	EXTERNAL AREAS															
	Roof Areas															
1.1	Roof Bay 1	Corrugated roof sheets to north west roof areas (Roof Bay 1) were noted to be heavily corroded. It is not believed that the sheets can be repaired or overhauled.	Replace damaged sheets with new. To include skylights. Ensure a roofing material is utilised which will not be affected by bi-metallic corrosion relating to potential impurities coming from Tenant operations. <i>Note: it is understood that this item has already been budgeted for and will be undertaken by the vendor in the short term. No cost included.</i>		\$ -

1.1. View of corroded Roof fixings to Bay 1

1.2. View of corroded Roof fixings to Bay 1

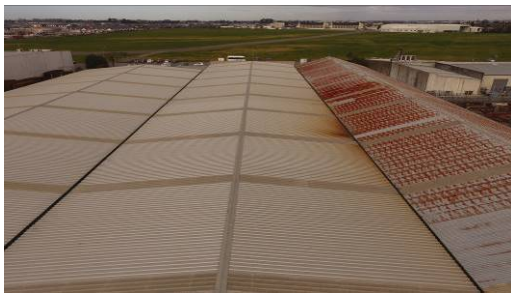
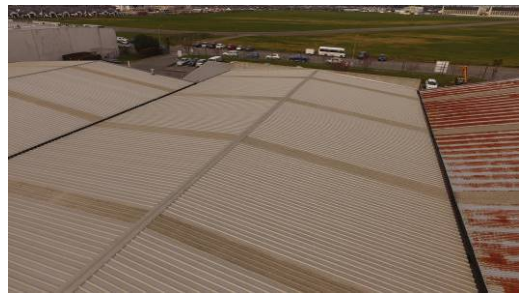
1.3	Roof Bay 2	From a review of the drone photographs, the Roof Bay 2 sheets are heavily stained to the centre of the roof, where adjacent to Roof Bay 1.	It is thought that the corrosion is due to some manner of extraction through the Roof Bay 1 sheets, which appears to have now been removed. In line with Roof Bay 1 renewal, allow to replace affected sheets. <i>No cost - discuss with Vendor to ascertain if these works can come under their planned roofing works.</i>		\$ -	\$ -

1.3. General view of Bay 2 Coverings

1.4. General view of Bay 2 Coverings

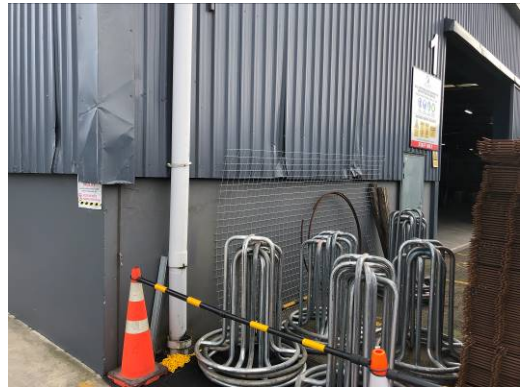
15. Metal profile cladding sheets are heavily impact damaged throughout the site, in line with the Tenant storing steel and other materials and equipment close or in contact with the cladding sheets.

2.2	Cladding	Cladding panels are heavily impact damaged in various locations.	Reconsider operational process in relation to storing materials against cladding sheets - consider installing barriers to prevent impact damage. This cost may be recoverable from the Tenant.		TBC

1.12. Impact damage to cladding sheets

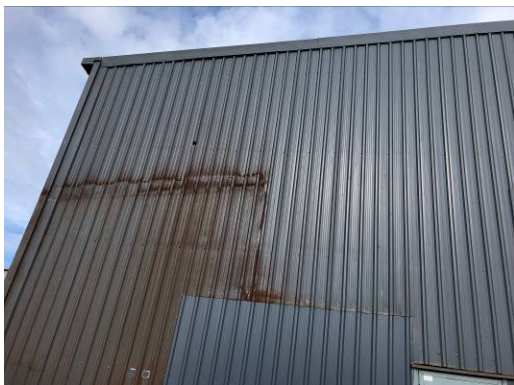
1.13. Damage noted to cladding sheets

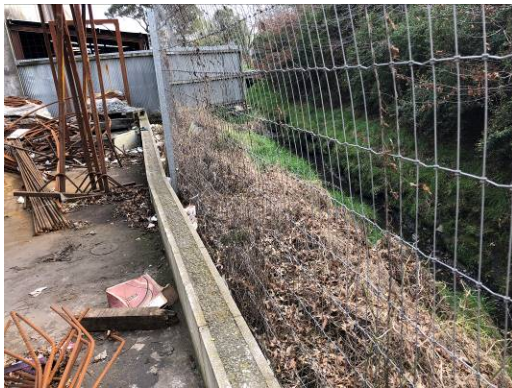
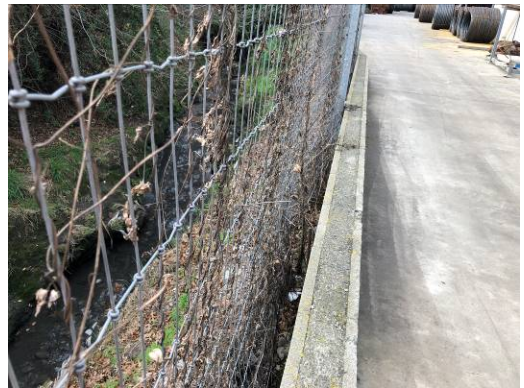
1.17. Retaining wall to rear of site

1.18. Retaining wall to rear of site

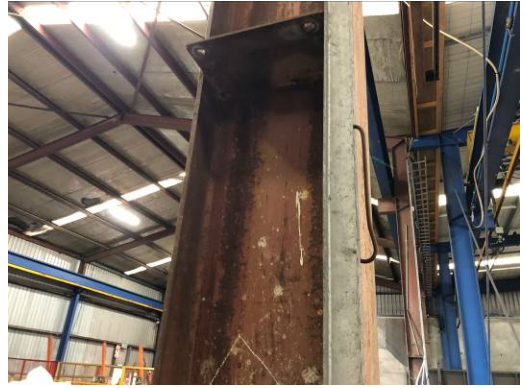
3. The steel portal frame was generally found to be serviceable, however steel columns and beams to the 'Roof Bay 1' area were found to be corroded and do not appear to have been decorated in a significant period of time. It is recommended that the framework in this location be treated and painted.

1.22. Corroded columns noted

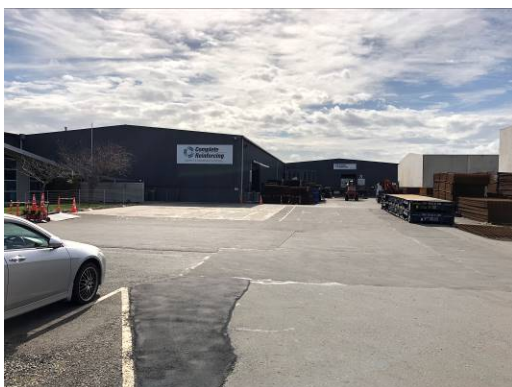
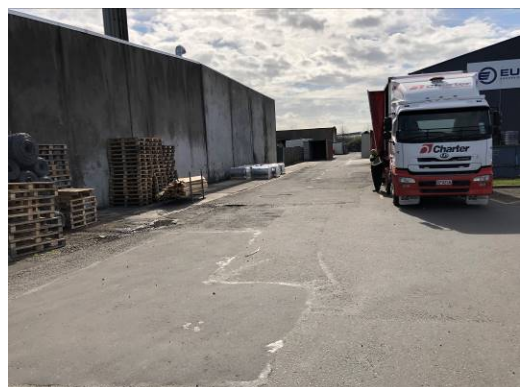
21. Localised areas of the asphalt surfaces of the site car parks and driveways were generally noted to be in a poor condition commensurate with their heavy use and minimal maintenance. An allowance should be made to undertake localised repairs over a 10 year period and to remark car parking bays.

1.25. Cracking and historic repairs to yards

1.26. Cracking and historic repairs to yards

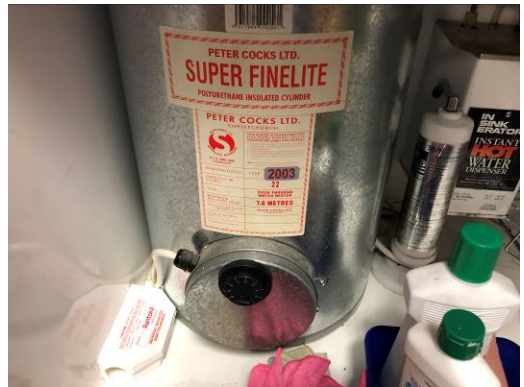
The building's hot water supply is provided via hot water cylinders which are believed to have been manufactured in 2003. 2no. hot water cylinders were noted, with both being located beneath sinks, one in the

An allowance should be made to renew the cylinders as they expire and this has been included in our CAPEX. It should also be noted that these cylinders are required to be seismically restrained under current Building Code, and currently they are not.

1.30. Typical hot water cylinder
