Technical Due Diligence Report

For and on behalf of
**AUGUSTA FUNDS
MANAGEMENT LTD**

5 & 21 Beach Road
Otahuhu
Auckland 2024

OCTOBER 2018
P18-0174

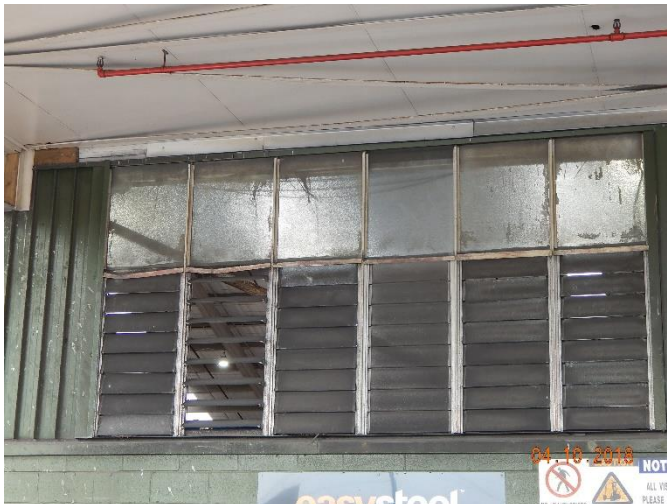
Photograph 2

- 3.5.3 The existing window joinery to all elevations is considered beyond its serviceable life. Externally, the joinery is suffering from a lack of maintenance exhibiting signs of isolated surface corrosion to the painted metal windows. There appear to be a lack of appropriate flashings at the window and cladding junctions, which we consider is likely to be contributing to the water staining evident to the internal timber reveals and sills.

Single glazed metal framed window to the east elevation. The windows were generally found to be beyond their serviceable life.

<p><u>5 Beach Road - Glazing System/Window Joinery:</u></p> <p>The existing window joinery to all elevations is beyond its notional life. Externally, the joinery is suffering from a lack of maintenance and is exhibiting signs of isolated surface corrosion to the painted metal windows. There is an apparent lack of suitable flashings at the window and cladding junctions, which we believe may be contributing to the water ingress that was visible to the internal timber facings around numerous windows. We also note that many of the windows, particularly to the first floor office have been painted in attempt to prevent further deterioration and subsequently many of the windows can no longer be opened.</p> <p><u>Recommendation:</u> Replace window joinery to 5 Beach road in the short term. The budget allowance excludes the costs associated with relocation of tenants. Removal of the cladding and access has also been excluded at this stage, due to the possible variance in costs depending on methodology and approach. It would be advised to coordinate the replacement of the window joinery with the replacement of the external cladding system so that the flashings can appropriately formed at the junctions.</p> <p><u>Timescale:</u> Year 3.</p> <p><u>Approximate Cost:</u> \$400,000 excl. GST.</p>

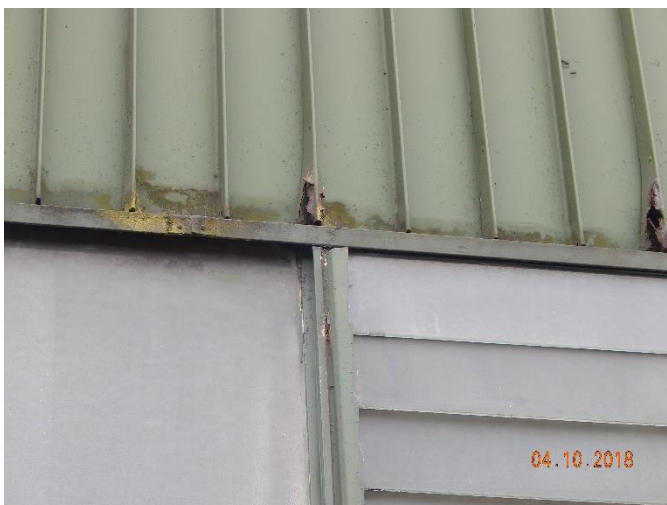
Photograph 3

Cut edge corrosion evident to the bottom edge of the cladding most notably at the junctions with the window head flashings to the south elevation.

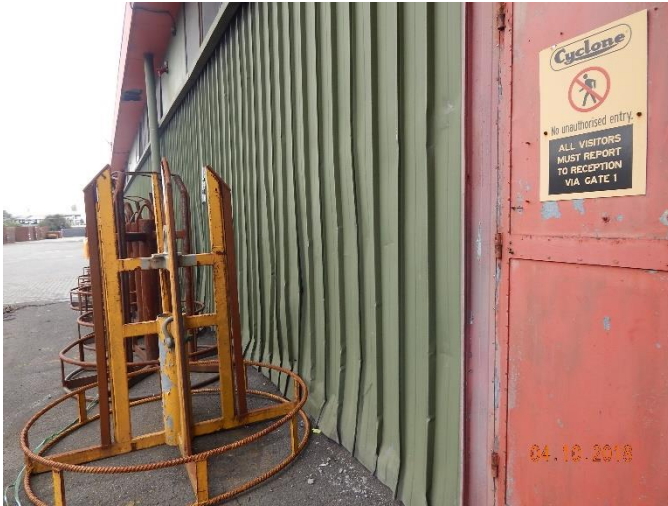
Photograph 4

3.4.5 The profile metal cladding to the warehouse elevations is generally in poor condition, with widespread impact damage and corrosion noted at junctions with windows and veneer cladding.

Impact damage to the metal cladding.

<p><u>5 Beach Road - External Cladding to Warehouse:</u></p> <p>The existing profile metal cladding to the original warehouse elevations has reached the end of its life expectancy. Widespread impact damage and subsequent penetrations are evident predominately at low level to the east elevation caused by the use of machinery and plant on site. This has compromised the weathertightness of the cladding system and it is likely that during heavy periods of rainfall, water is entering the property.</p> <p>We also noted that a number of the flashings around the window joinery and low-level masonry walls are inadequate. Particularly the head flashings which do not appear to be set to sufficient falls, as such water is being retained at the junction of the wall cladding and head flashing expediting the deterioration of the painted finish and subsequently causing corrosion to metal wall cladding. It is likely that water is penetrating at these junctions and where timber framing is present to the south elevation, this could be leading to the onset of decay.</p> <p><u>Recommendation:</u> Undertake further intrusive weathertightness investigations, including inspection, sampling and testing of concealed timber framing where present.</p> <p>Budget for wholesale replacement of exterior profile metal and fibre cement cladding and associated flashings to the warehouses. The budget allowance for replacement excludes the costs associated with testing and replacement of decayed timber framing, relocation of tenants. access has also been excluded at this stage, due to the possible variance in costs depending on methodology and approach.</p> <p><u>Timescale:</u> Year 3.</p> <p><u>Approximate Cost of Further Investigations:</u> \$10,000 exc GST.</p> <p><u>Approximate Cost for Replacement:</u> \$310,000 excl. GST.</p> <p><i>(note: this cost does not allow for additional costs if asbestos is found to be present).</i></p>

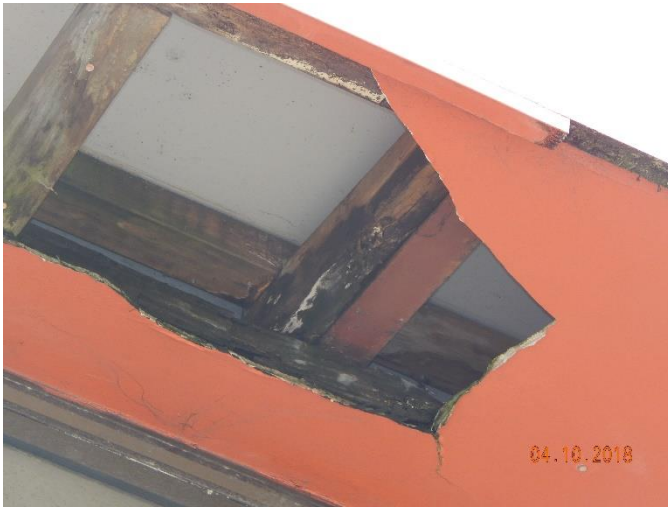
Photograph 5

3.3.5 There is evidence of water ingress and subsequent decay to the timber framing forming the box gutter to numerous locations along the west and north elevations. This has resulted in deterioration and isolated collapse of the fibre cement soffit linings and deterioration of the timber fascia board.

Decay identified to the timber framing serving the eaves box gutters resulting in isolated collapse of the fibre cement soffit.

<p><u>5 Beach Road - Rainwater Goods:</u></p> <p>There is evidence of water ingress and subsequent decay to the timber framing forming the eaves box gutters along the west and north elevations, this has resulted in deterioration and isolated collapse of the fibre cement soffit linings.</p> <p>Pitted corrosion is visible to isolated locations along the length of the metal eaves gutter to the north elevation.</p> <p>Internally the PVC downpipes have been damaged and displaced from the movement of machinery and plant. Adhoc repairs were also apparent in the form of flashing tape in an attempt to prevent water penetration.</p> <p><u>Recommendation:</u> We anticipate that the rainwater system serving the warehouse areas is in need of full replacement. However as access was limited to ground level, we would first recommend a full survey of the rainwater goods by a chartered building surveyor with the necessary access provided.</p> <p><u>Timescale:</u> Immediate.</p> <p><u>Approximate Cost:</u> \$100,000 excl. GST.</p>

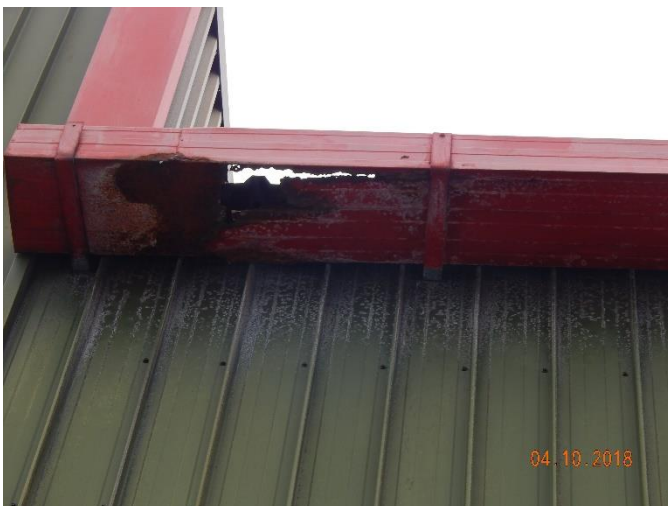
Photograph 6

Corrosion noted to the metal eaves gutters.

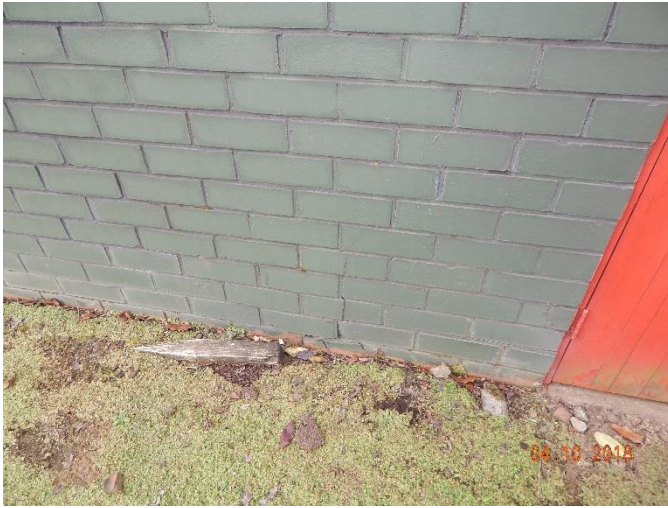
Photograph 7

- 3.4.8 The brickwork veneer cladding to the south elevation appears to be leaning outwards and vertical cracking is evident adjacent to the pedestrian access door. We also noted that the lawn to the external ground slopes towards and directly abuts the brick veneer in this location with no ground clearance, ground drainage or damp proof course evident. Directly above this area, significant moss growth was evident within the brickwork mortar joints. Internally, where accessible adjacent to the pedestrian door, damaged and saturated painted timber boards were present at low level.

Vertical crack evident to the brick veneer to the south west of the warehouse.

<p><u>5 Beach Road - External Brickwork to Warehouse:</u></p> <p>Evidence of water ingress through external brickwork to the south elevation of the warehouse, particularly to the south west side of the warehouse.</p> <p>Poorly detailed overflow penetration through rendered brickwork to the south external wall to the ladies warehouse WC, with evident staining below.</p> <p>An area of brickwork to the south west corner of the warehouse adjacent to the roller shutter and pedestrian door shows signs of distortion, spalling and moss growth within the mortar joints. External lawn slopes towards and directly abuts the low-level brickwork in this location, with no apparent damp proof course or ground clearance. The corresponding internal finishes were mostly obscured by the current tenant's goods stored against the external wall, however adjacent to the pedestrian door the painted timber linings were damp and deteriorating. It is considered likely that unseen damage and decay may be present to the concealed timber frame.</p> <p><u>Recommendation:</u> Undertake further intrusive weathertightness investigations, including inspection, sampling and testing of concealed timber framing where present.</p> <p><u>Timescale:</u> Immediate.</p> <p><u>Approximate Cost of Further Investigations:</u> Cost for weathertightness intrusive survey included within item above (investigation only).</p>

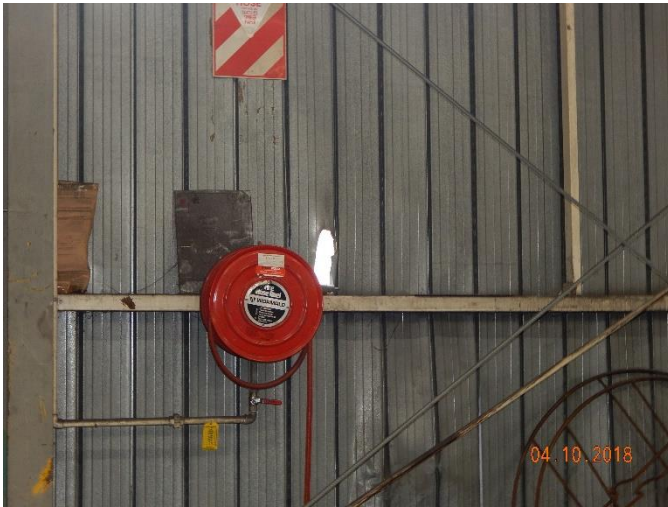
Photograph 8

3.4.6 Widespread impact damage and subsequent penetrations are evident predominately at low level to the north and east elevations caused by the use of machinery and plant on site. This has compromised the weathertightness of the cladding system, enabling water to enter the property.

Widespread Impact damage and penetrations evident to the metal cladding.

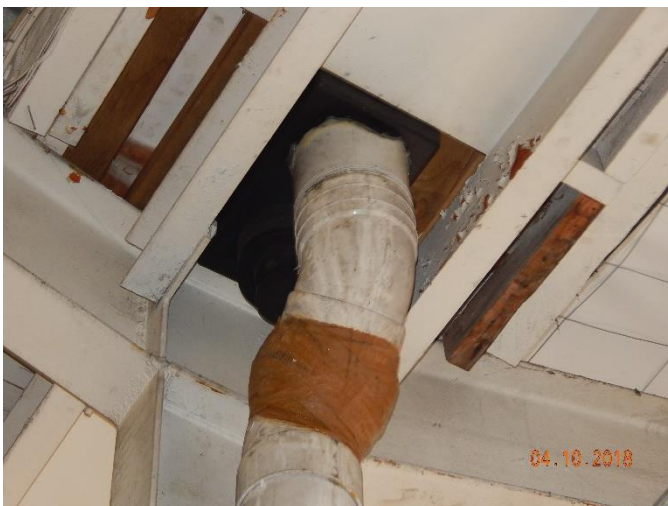
Photograph 9

- iv Inadequate reactive repairs, including the application of flashing tape in several areas, have been undertaken, presumably to address leaks from rainwater goods.
- v Localised pitted corrosion to the metal eaves gutters along the east elevation.

Flaking paintwork and inappropriate repairs in the form of flashing tape to the downpipe, suggesting issues with water ingress.

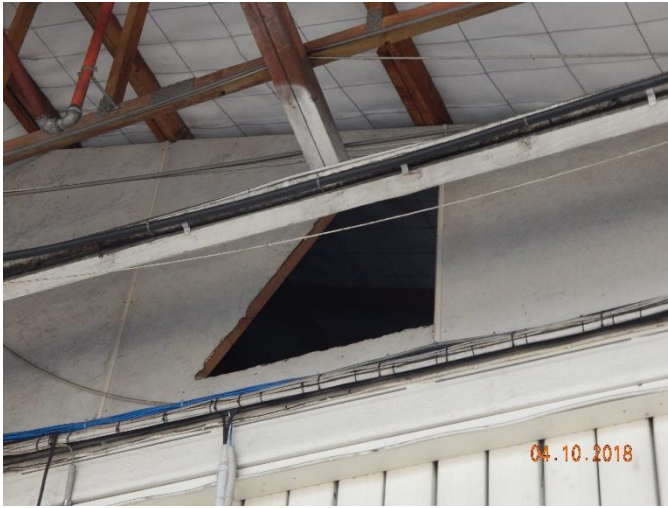
Photograph 10

Damaged fibre cement linings noted as a potential asbestos containing material.

■	<p><u>5 and 21 Beach Road - Site - Hazardous and Deleterious Materials:</u></p> <p>Due to the age and type of construction, it is likely that asbestos containing materials are present within the subject buildings.</p> <p>We visually identified a number of materials within the building fabric which appear to be asbestos containing materials, including fibre cement sheet cladding, fibre cement soffits and fibre cement ceiling tiles. The fibre cement sheet cladding, gutter boxing and soffits appear to be in a damaged condition, should these elements contain asbestos, it is likely that fibre release is/has occurred and the property may be subject to asbestos debris.</p> <p>We have not had sight of any asbestos register, records or asbestos management plans for any of the buildings.</p> <p>Should there be no asbestos registers, asbestos management plans or other asbestos identification records in existence we would recommend that an appropriately qualified asbestos surveyor is instructed to carry out an asbestos survey and prepare an asbestos register in respect of the property. This will ensure that all remedial/removal/encapsulation works required to any asbestos containing materials can be factored into your decision to acquire the properties. It will also ensure your statutory duties and responsibilities as a PCBU under the Health and Safety at Work (Asbestos) Regulations 2016 are fulfilled once you become the Building Owner.</p> <p>We would also like to bring to your attention, under Regulations 13 and 14 of the Health and Safety at Work (Asbestos) Regulations 2016, PCBUs with management or control of a premise, such as Building Owners, are required to ensure that an asbestos management plan is prepared and reviewed.</p> <p><u>Recommendation:</u> If not already in place, instruct a suitably qualified independent asbestos surveyor to conduct an Asbestos Identification survey and prepare an asbestos management plan, identifying any remedial/replacement/encapsulation works required in the immediate and longer term, in accordance with the Health & Safety at Work (Asbestos) Regulations 2016.</p> <p><u>Timescale:</u> Immediate.</p> <p><u>Approximate Cost:</u> \$30,000 excl. GST.</p>

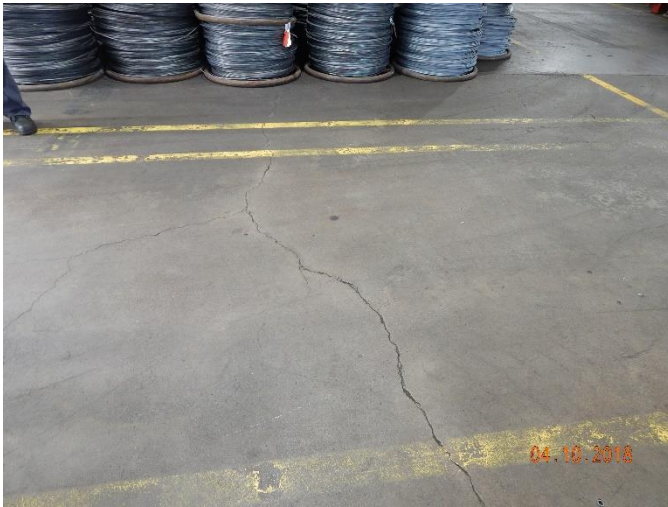
Photograph 11

- 3.1.7 Impact damage and cracking was evident to the concrete floor slab in several locations throughout the warehouse, most notably at the junction of the original warehouse and the various warehouse extensions.

Widespread cracking noted to the concrete slab throughout the warehouse.

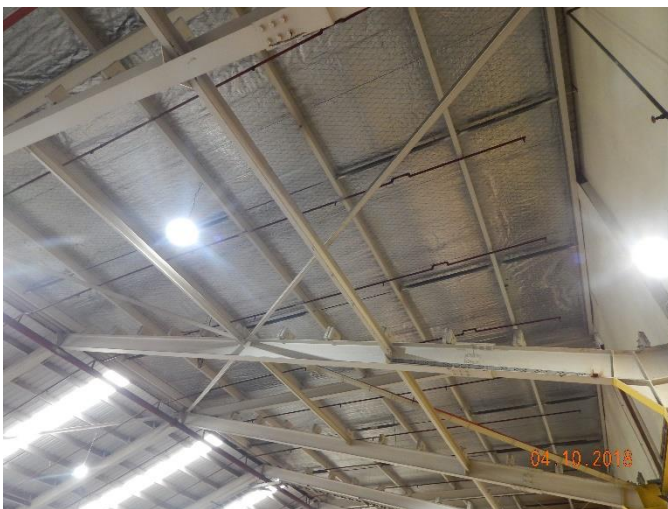
Photograph 12

- 3.1.5 Although outside the scope of our survey, we noted the building appears to have undergone numerous structural alterations over the years. As the various warehouse extensions have been constructed onto the original warehouse structure, the roof structure has been significantly altered to accommodate this. It was also evident that numerous steel columns and internal walls between warehouses have been removed, it is assumed this has been undertaken to allow for movement of traffic between the various warehouses.

Significant structural alterations evident to the warehouses.

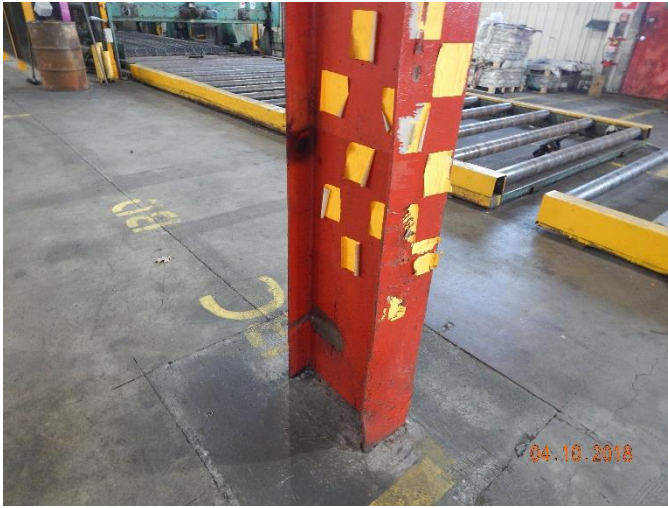
Photograph 13

- 3.1.6 We identified that a number of the structural columns were impact damaged resulting in distortion and deformation at the base. We consider it is likely that this has been caused by movement of machinery and vehicles on site.

Impact damage and deformation to steel columns.

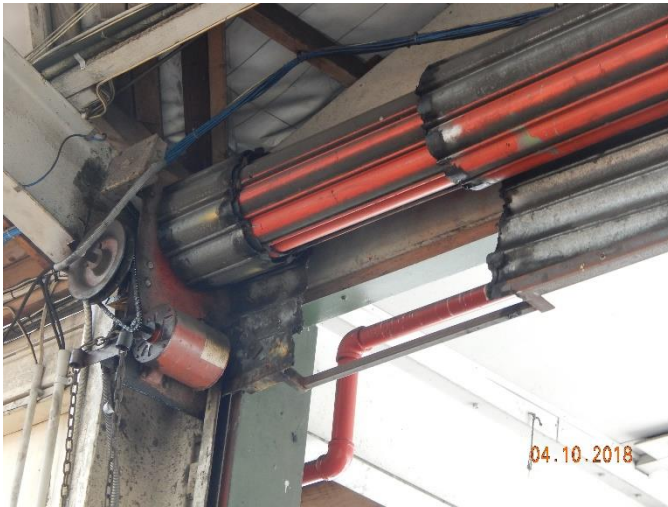
Photograph 14

Alterations made to roller shutter doors have been poorly formed.

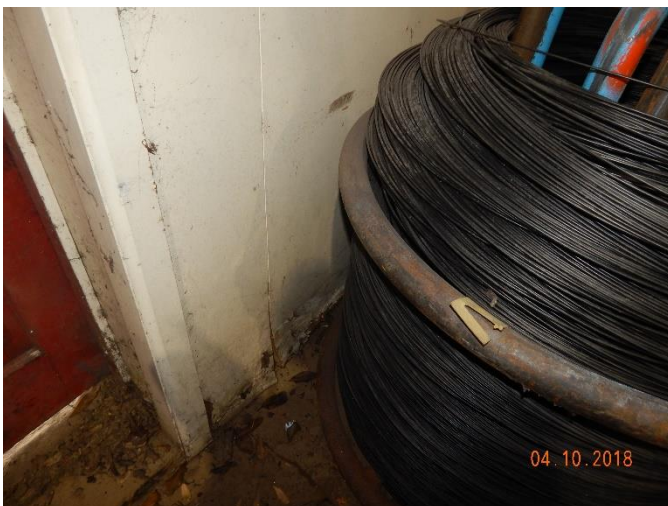
Photograph 15

Signs of water ingress identified at low level to the southwest corner of the warehouse.

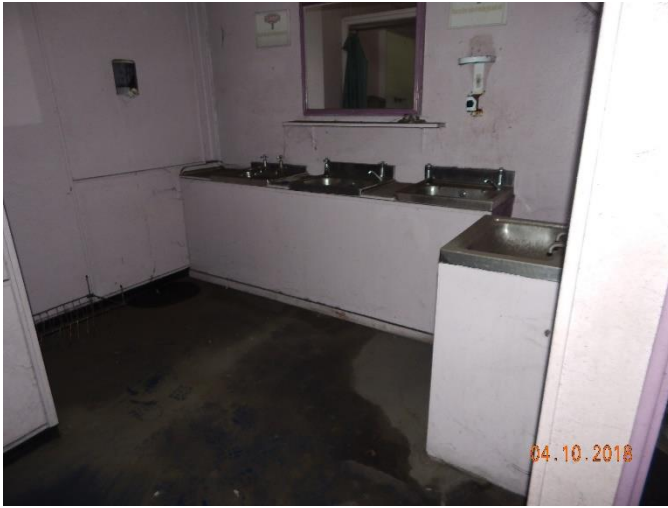
Photograph 16

Finishes to the facilities serving the warehouse are in poor condition and require refurbishment.

<p><u>5 Beach Road - Office Fit-Out</u></p> <p>The base-build office fit out to the south east of the warehouse is generally dated, particularly to the warehouse staff kitchen/canteen and the warehouse male & female changing rooms and WCs, where wall, ceiling and floor finishes were generally noted in poor and deteriorated condition. The office accommodation would benefit from refurbishment on expiry of the current lease in order to improve the office quality to Grade B.</p> <p><u>Recommendation:</u> Renewal of general wall and ceiling finishes, along with the upgrade of the internal doors, internal glazed fixed lights, floor coverings, kitchen and WC facilities is recommended.</p> <p><u>Timescale:</u> Year 4.</p> <p><u>Approximate Cost:</u> \$250,000 excl. GST.</p>

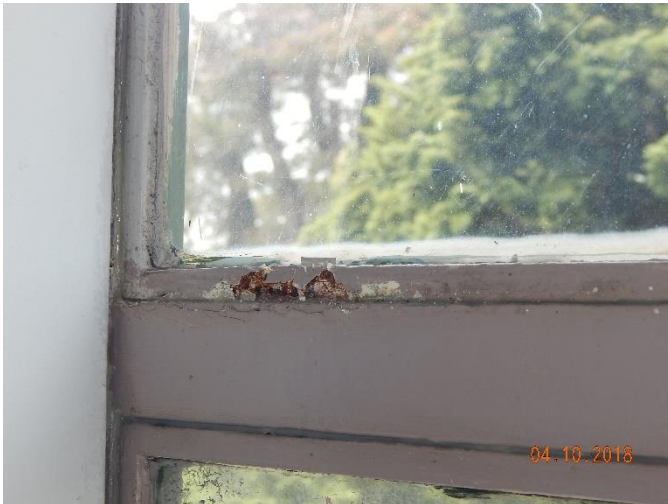
Photograph 17

Isolated corrosion to the window frame, they have been subsequently painted and can no longer be opened.

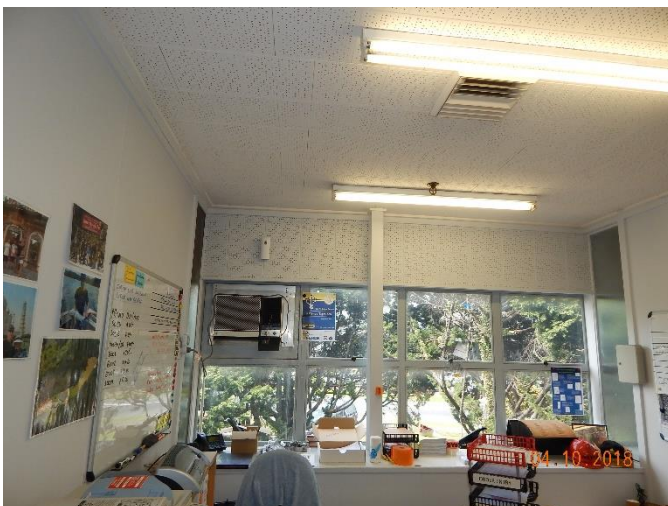
Photograph 18

Office finishes dated and require updating.

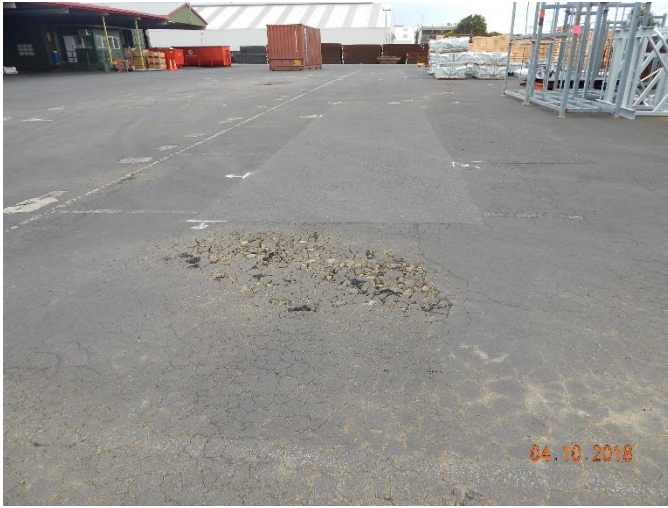
Photograph 19

- 3.7.11 The asphalt surface is uneven and there is widespread cracking and crazing throughout, particularly to service yard to the east of the site. This is likely due to heavy vehicle traffic passing through the site. We recommend wholesale replacement of the asphalt surfacing within the next five years.
- 3.7.12 The site boundaries are demarcated by chain link fencing which appears to be in a reasonable condition.

Crazing to the asphalt surfacing noted throughout the yard areas.

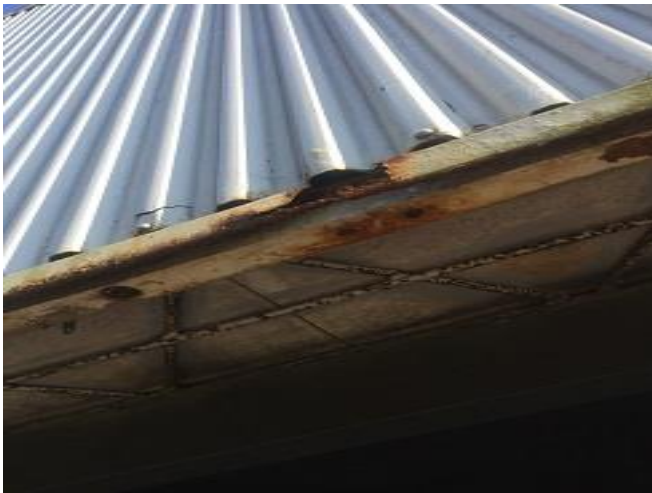
Photograph 21

- 3.4.11 The external wall cladding to the manufacturing facility is painted corrugated steel. The cladding is generally in a fair to poor condition with several sections heavily corroded particularly along the lower edge. The framing along the lower edge is also extensively corroded and we envisage that this will need to be replaced in the short term. It will be necessary to replace a large portion of the cladding system in the next 5 years, and recent repairs to the cladding on the western elevation indicates that a replacement program may be in existence. The steel framing supporting the corrugated cladding is supported in most areas with a painted concrete block wall. This structure is generally in good condition commensurate with its age, save for isolated impact damage and some cracking noted along the northern façade.

Typical section of corroded steel framing. Also note cracking to painted corrugated cladding. Likely due to corrosion.

<p><u>21 Beach Road - Cladding - All Steel Portal Framed Structures</u></p> <p>The corrugated long run metal cladding system to the manufacturing/ dispatch facilities are showing signs of corrosion. This corrosion is particularly extensive along the lower sections of corrugated steel cladding and to the lower steel framing where moisture/rainwater gathers. The decay in the cladding and the framing could result in further moisture ingress and ultimately the failure of the framing. Note this extensive corrosion refers to the cladding system and framing not the structural portal framework, this was not part of our inspection.</p> <p><u>Recommendation:</u> Remove all corroded corrugated steel sheets, fixings and framing showing signs of to the manufacturing and dispatch facilities. We have allowed to replace with similar. Note: It may be more cost effective in the longer term to carry out a more extensive or even full re clad of the manufacturing facility. (save those areas which have recently been repaired in the western façade).</p> <p><u>Timescale:</u> Within the next 6 - 12 months.</p> <p><u>Estimate cost:</u> \$350,000 - \$400,000 (We have allowed for the replacement of approx. 950 sqm of corrugated steel cladding plus c. 390 lm of steel framing. P & G costs may vary due to access etc).</p>

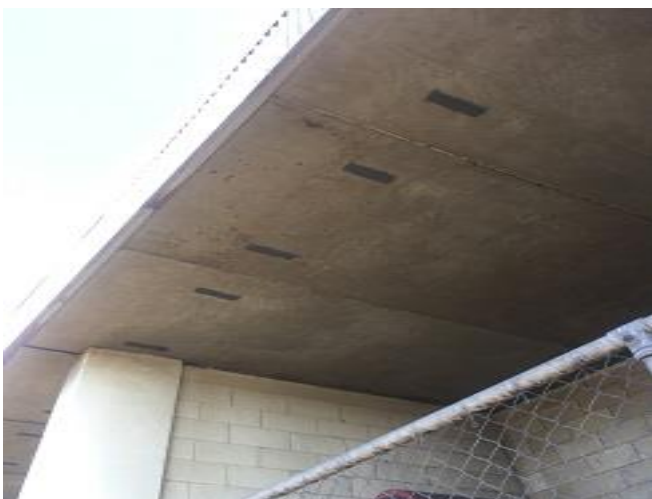
Photograph 22

- 3.4.14 Sections of cladding around the external transformer were identified as being potentially asbestos containing materials. PCBUs with management or control of a premise, such as Building Owners, are required to ensure that an asbestos management plan is prepared and reviewed. If this is not already in place, we would recommend instructing a suitably qualified surveyor to conduct an Asbestos Identification survey and prepare an asbestos management plan.

Cladding to power transformer along southern façade. Possibly contains asbestos.

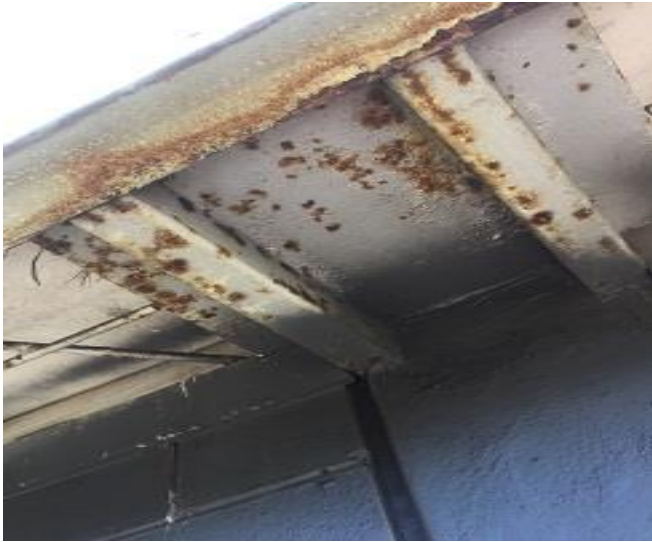
Photograph 23

Further evidence of corrosion to steel cladding system, southern elevation.

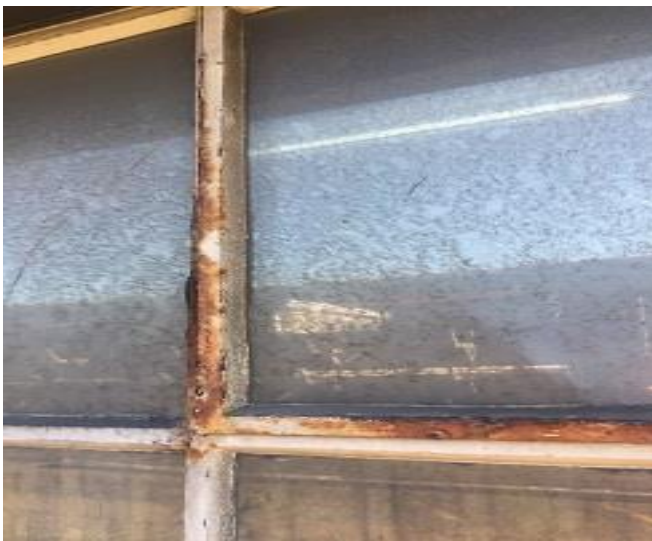
Photograph 24

Extensive corrosion to steel window frames in workshop/ paint storage area.

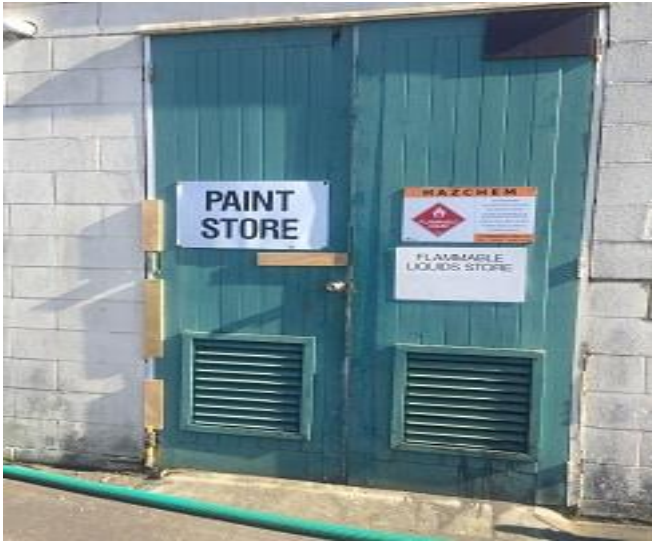
Photograph 26

Patch repairs to wooden doors.

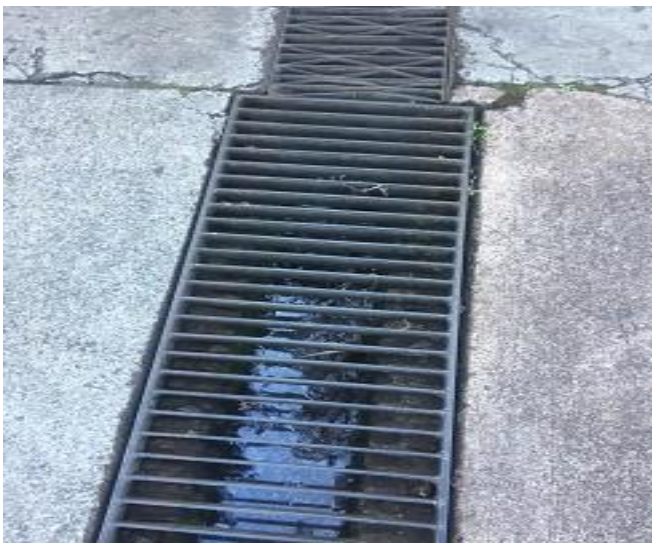
Photograph 27

Drainage grates to external yard. Requires cleaning.

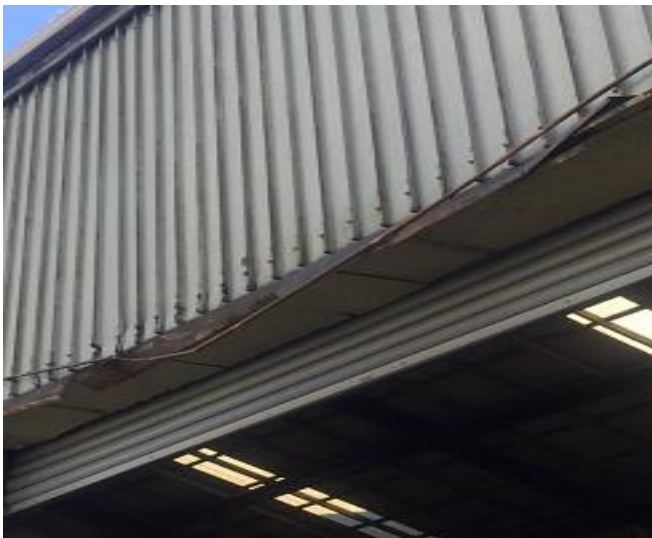
Photograph 28

Damaged cladding and flashing to western façade.

<p><u>21 Beach Road - Cladding - All Steel Portal Framed Structures</u></p> <p>Damaged cladding and flashings were noted to several roller doors around the manufacturing facility.</p> <p><u>Recommendation:</u> Remove all damaged cladding and flashing to door surrounds. We have allowed to replace with similar. Note: It may be more cost effective in the longer term to carry out a more extensive or even full re clad of the manufacturing facility.</p> <p><u>Timescale:</u> 12 - 24 months.</p> <p><u>Cost:</u> \$8,500</p>

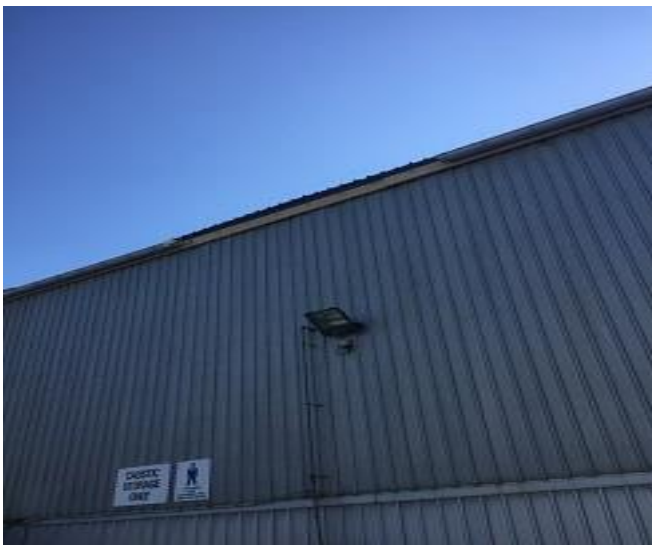
Photograph 30

Section of missing gutter to western elevation.

<p><u>21 Beach Road - Rainwater Goods - All Steel Portal Framed Structures</u></p> <p>Viewed only from the ground level, the rain water system appears to be a mixture of uPVC and galvanized/ painted steel.</p> <p>As noted in our photographic appendices there are several sections of gutter which are damaged or missing, similarly there are several downpipes which require replacement.</p> <p><u>Recommendation:</u> Allow to remove all damaged gutters and downpipes and replace with similar.</p> <p><u>Timescale:</u> 6 - 12 months.</p> <p><u>Approximate Cost:</u> Would form part of any existing roof cladding replacement programme.</p>
	<p><u>21 Beach Road - Window Joinery - Workshop/Paint Storage Building</u></p> <p>The existing window joinery to all elevations is considered beyond its serviceable life. Externally, the joinery is suffering from a lack of maintenance exhibiting signs of isolated surface corrosion to the painted metal windows. There appear to be a lack of appropriate flashings at the window and cladding junctions, which we consider is likely to be contributing to the water staining evident to the internal timber reveals and sills.</p> <p><u>Recommendation:</u> Allow to strip back paint on steel windows to storage / workshop section of manufacturing facility. Ascertain the extent of corrosion of frames. Likely full replacement of frames will be required within the next 2-3 years.</p> <p><u>Timescale:</u> 12 - 24 months.</p> <p><u>Approximate Cost:</u> \$60,000</p>

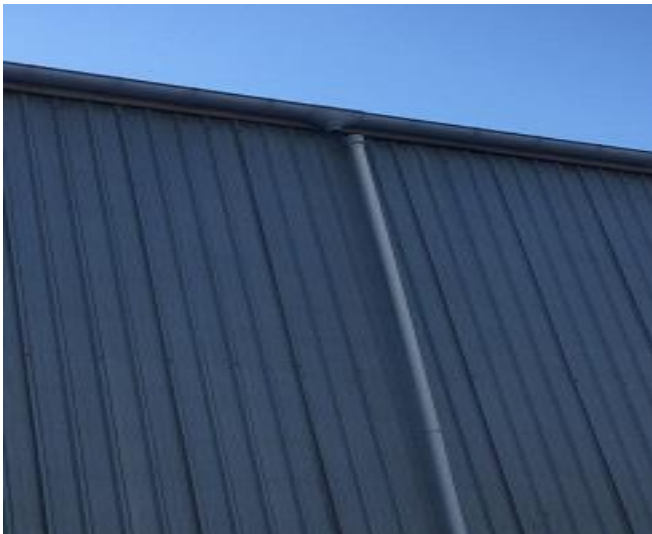
Photograph 31

Downpipe not fixed to gutter, western elevation.

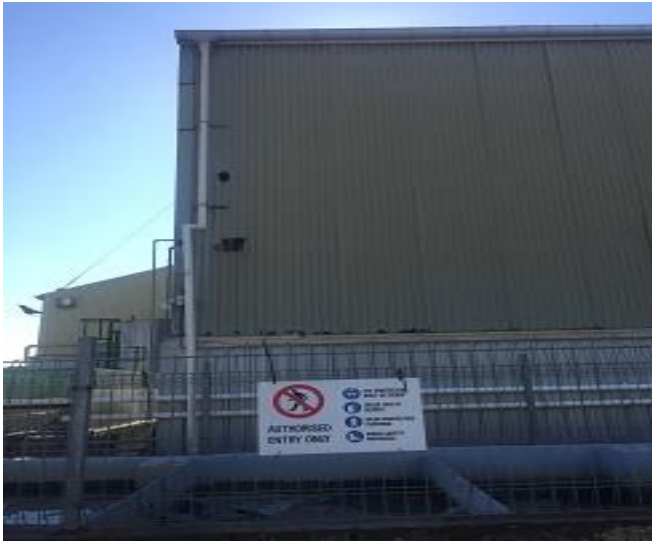
Photograph 32

North west corner of facility, note damaged downpipe and bottom edge of corrugated steel cladding. Evidence of damage and corrosion.

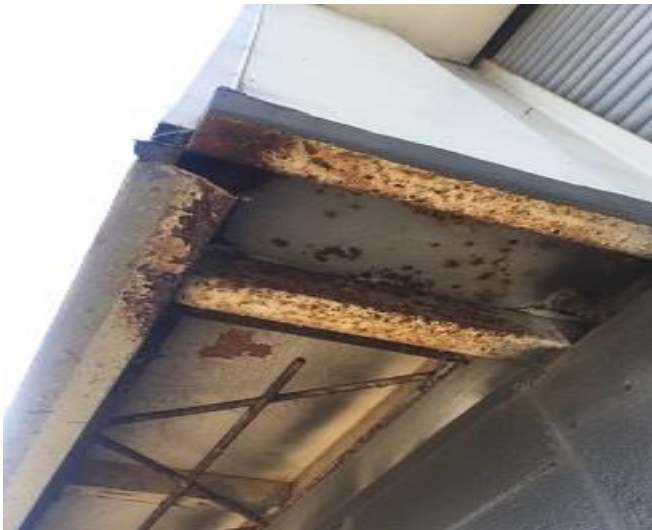
Photograph 34

Corrosion to steel framing, northern elevation.

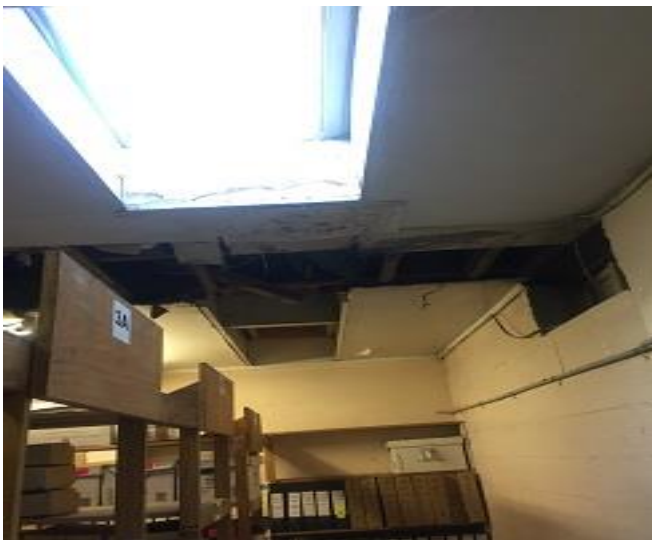
Photograph 36

Store room (within staff changing / canteen area). Note evidence of moisture ingress / staining on ceiling tiles.

<p><u>21 Beach Road - Roof - Amenities Building</u></p> <p>Evidence of moisture ingress thru roof to staff locker rooms/shower area, further inspection required.</p> <p><u>Recommendation:</u> Allow for further investigation of the roof to this structure, however moisture ingress is clearly evident.</p> <p><u>Timescale:</u> 6-12 months.</p> <p><u>Cost:</u> Allow \$ 10,000</p>

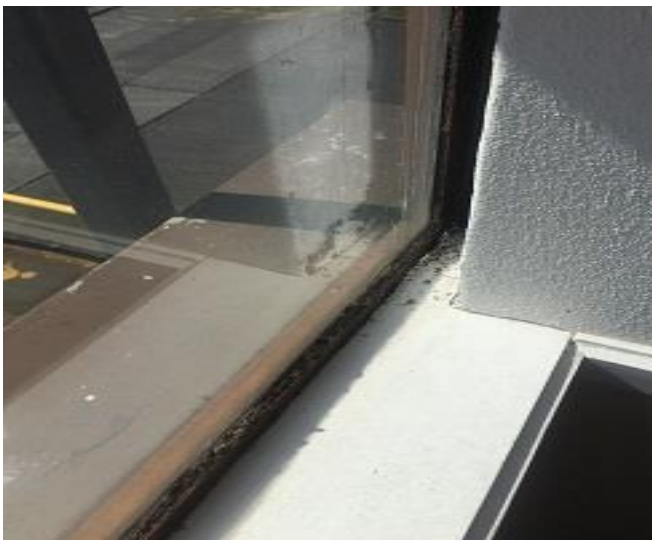
Photograph 39

Extensively perished window seals to office block.

<p><u>21 Beach Road - Window Joinery - Main Office</u></p> <p>Windows to main office are failing.</p> <p><u>Recommendation:</u> Allow for detailed inspection on steel window frame structural integrity. Seals have clearly failed, and moisture ingress is very evident. It may be necessary to replace the entire window infrastructure.</p> <p><u>Timescale:</u> 6 - 12 months.</p> <p><u>Cost:</u> \$285,000</p> <p>Various designs and options would need to be considered however we would allow to remove the existing and replace with similar.</p>

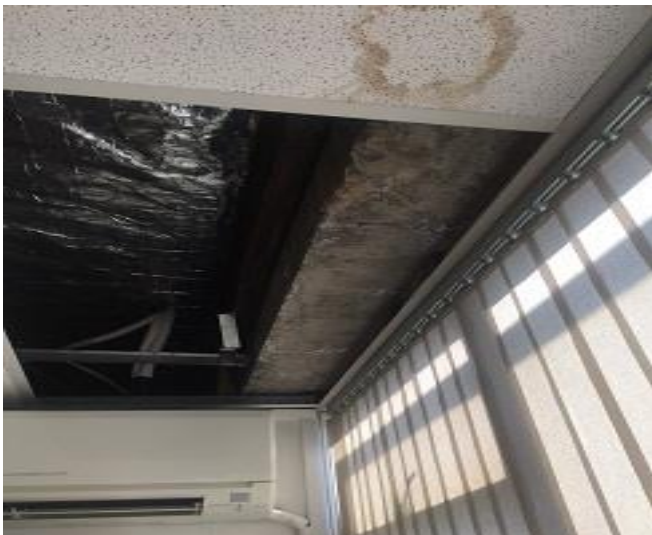
Photograph 40

Evidence of moisture ingress to offices.
