TECHNICAL DUE DILIGENCE REPORT

65B MAIN HIGHWAY

ELLERSLIE

Date: 19 January 2019

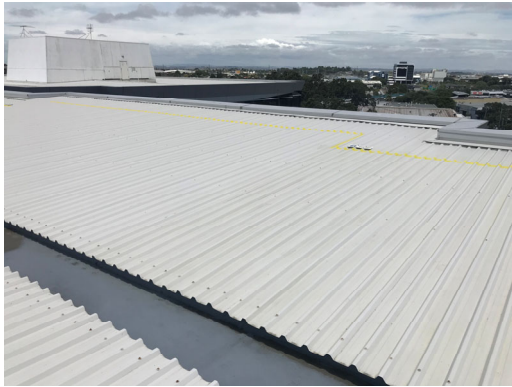
- 1) The roof sheets are believed to be original to the building and have not been recoated since their installation. No corrosion was noted to the roof, however it is considered likely that roof sheets will require painting with localised roof fixings replaced within 10 years.

1.1. General view of roof coverings

1.1	Roof Sheets	The roof sheets are generally in a serviceable condition.	It is recommended that the roof sheets are repainted in year 8.		\$ 34,890										\$ 34,890

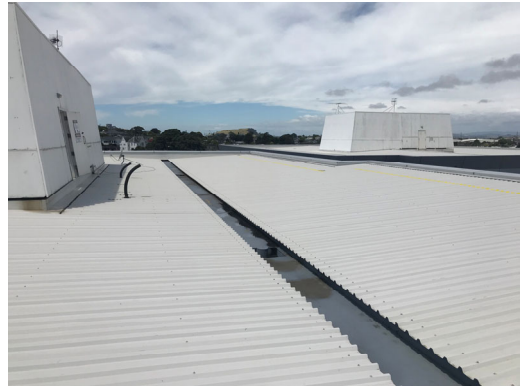
- 2) The membrane to the valley gutters was noted to be deteriorating with areas of corrosion visible to the metal substrate beneath. It is recommended that the gutters be replaced within 5 years.

1.2. View of valley gutters

1.2	Roof Sheets	Roof fixings were noted to be corroding in localised areas.	Allow to replace corroded fixings.		\$ 11,630				\$ 5,815						\$ 5,815		
1.3	Gutters	Membranes noted to be deteriorating with metal substrate visible and noted to be corroding.	Allow to renew gutters.		\$ 14,000			\$ 14,000

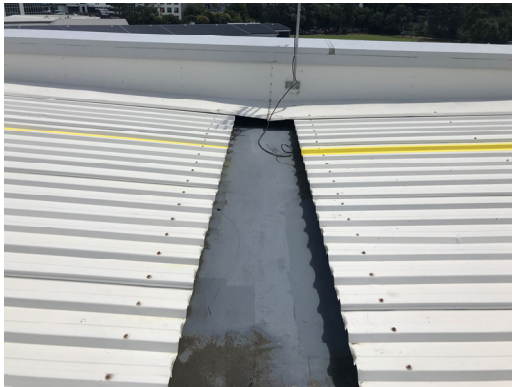
1.3. View of gutter membrane

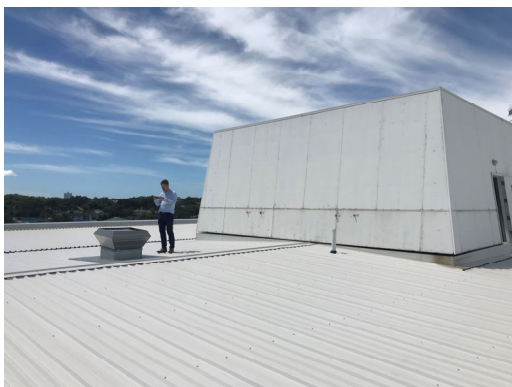
- 3) The fibre cement sheets to the plant screen were noted to be heavily deteriorating and are likely to chip and deteriorate further over the next 5 years.

1.5. View toward plant screen

1.4	Plant Screen	Plant screen assumed to be formed of fibre cement. Heavy deterioration noted.	Take down and replace with new. Note - sheets should be tested for asbestos prior to works being undertaken.		\$ 20,000			\$ 20,000

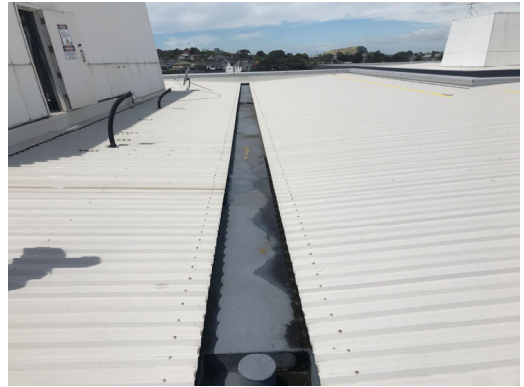
1.8. View of valley gutters

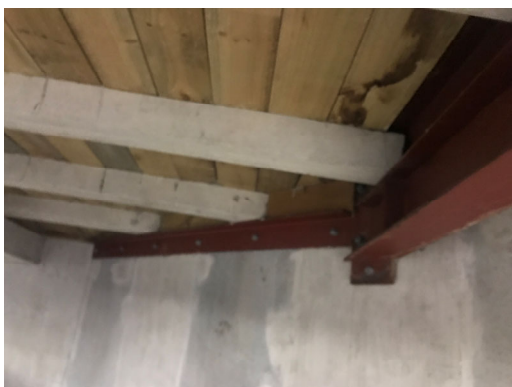
- 12) Steel framework within the basement parking area was noted to be corroding in localised areas. In addition, there is evidence of moisture ingress on the internal walls of the basement as well as to the underside of the timber formwork within Basement 1 areas. We have been provided with a report formulated by Babbage Consultants, in which representatives of Babbage have undertaken destructive testing to the tiles and asphalt above the basement areas and have reviewed the water proofing membrane.

Destructive testing and visual observations revealed waterproofing membranes beneath tiled and tar-sealed surfaces were extensively degraded or were non-existent. Ponding was observed to the bottom of planter boxes indicating inadequate drainage. Visual deterioration to concrete surfaces and elevated moisture content readings to timber formwork throughout areas beneath the podium in the basement carpark were observed. Indications of spalling of concrete beams and corrosion to steel reinforcing were also identified.

1.53. Basement - Timber formwork noted to be stained and displaying evidence of moisture ingress

However, based upon our review of the building drawings, together with observations during our inspection, we do agree that this is the only method of repair which would provide surety that water ingress into the basement will permanently cease. Given the damage that has already occurred to the steel and concrete within the basement, we would recommend that these works

are undertaken in the near future. If no work is undertaken, water will corrode the steel reinforcing within the concrete eventually causing structural concerns. In addition, small pieces of concrete will likely spall from the concrete beams and columns onto cars and possibly onto people within the basement.

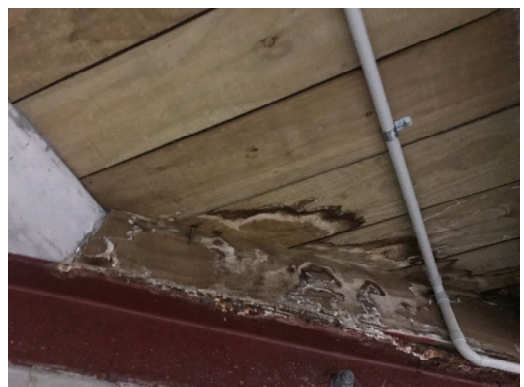
1.54. Basement - Steel noted to be corroding adjacent to stained timber formwork

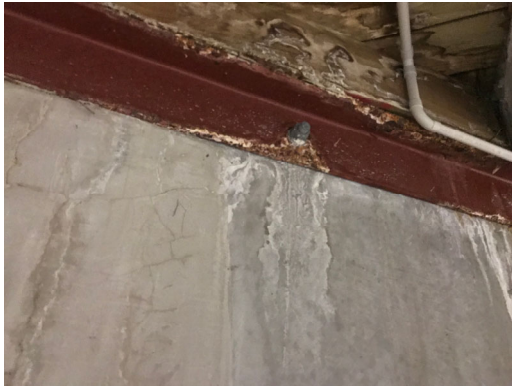
1.55. Basement - Steel noted to be corroding adjacent to stained timber formwork

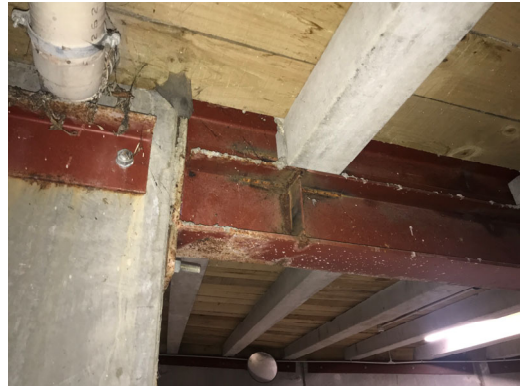
1.56. Basement - Steel noted to be corroding adjacent to stained timber formwork

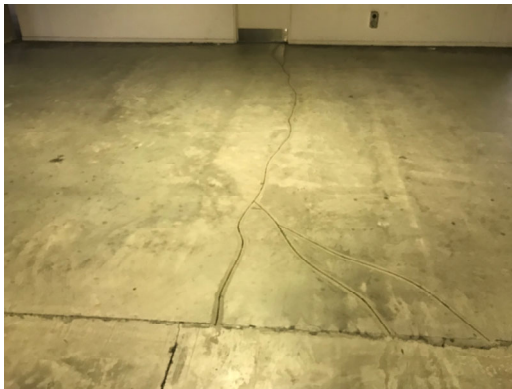
1.57. Basement - Cracking noted to car park surfaces – cracks appear to have been filled in and repaired

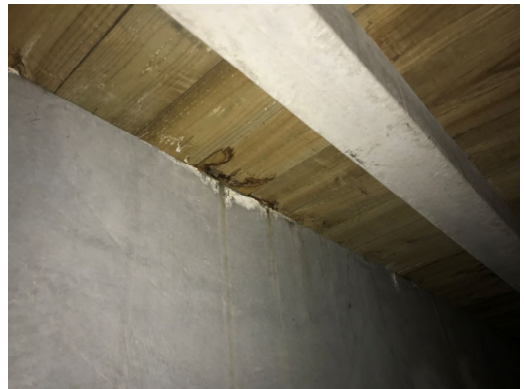
1.58. Basement - Timber formwork noted to be stained and displaying evidence of moisture ingress

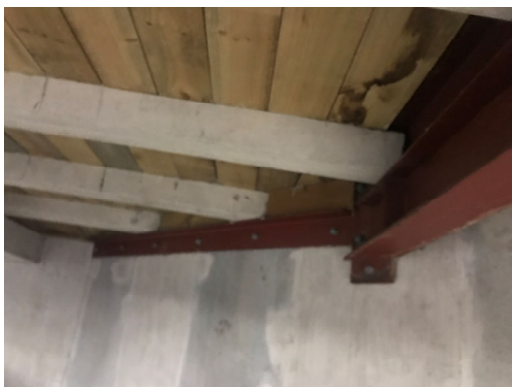
1.59. Basement - Timber formwork noted to be stained and displaying evidence of moisture ingress

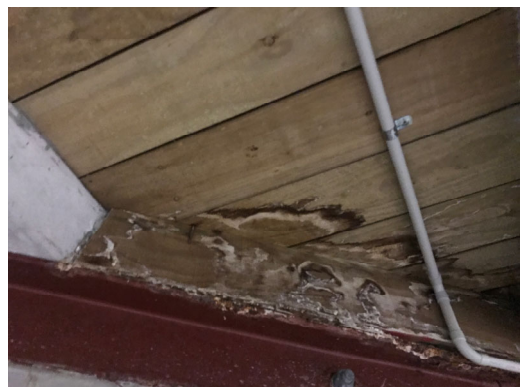
1.60. Basement - Steel noted to be corroding adjacent to stained timber formwork
