TECHNICAL DUE DILIGENCE REPORT

20-28 Sir William Pickering Drive,
Christchurch

Date: 27th November 2017
CBRE Ref: 49211286

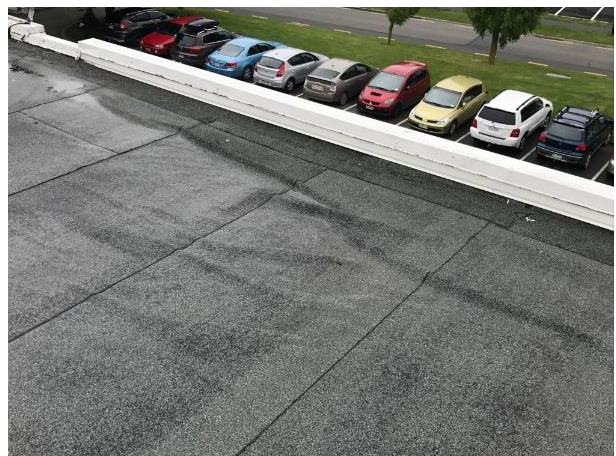
- Joints to felt roofing starting to fail and sheets lifting at edges.
 - Gutters choking, surface water not draining and ponding to surface.
 - A number of areas were noted to be brittle and de-bonding from substrate which has led to bubbling of roof coverings and is likely to be a source of ongoing water ingress as sheet become brittle and cracks appear.

B1 – felt ruffled and de-bonded from substrate

| Item | Element / Description / Location | Suggested Remedy | Work Type | Likelihood | Consequence | RISK | Immediate | Short Term (1-2 Years) | Medium Term (3-5 Years) | Long Term (6-10 Years) | Extended Term (11-25 years) | Total |
|---|--|--|---|---|---|---|---|---|---|---|---|---|
| 2.1.1 | Felt roof to building 1 will require replacement in the long term. | Replace felt roof coverings to building 1. | CAP | Possible | Moderate | Moderate | \$ - | \$ - | \$ - | \$ - | \$ 135,000 | \$ 135,000 |

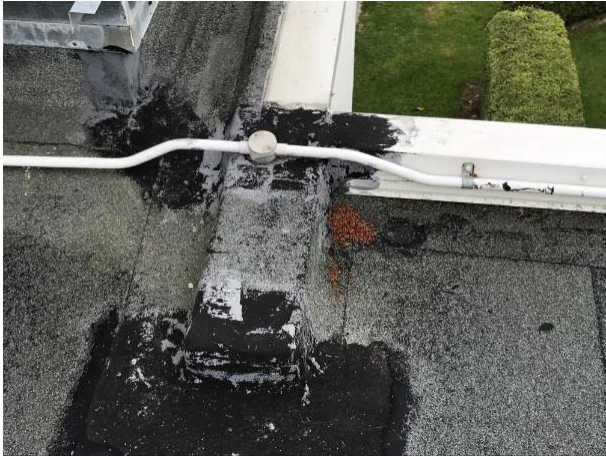
- The Static line system is fitted to roof, although no tags were noted. We are unaware if this system has been de-commissioned.
 - Penetrations have been sealed with a liquid applied coating, this is for the most part cracked and worn and required to be re-coated.

B1 – sealed junctions worn & solar degrading

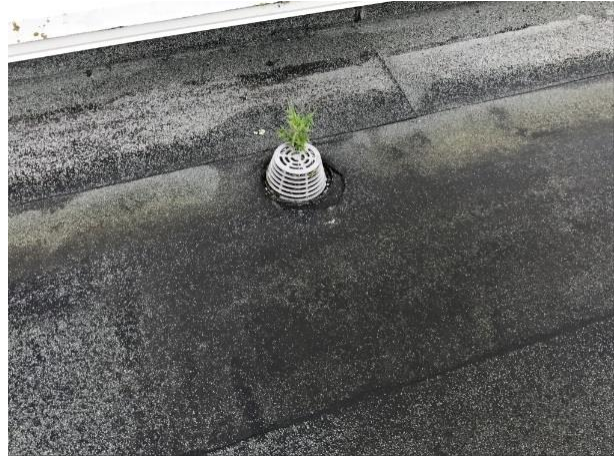
B1 – choked outlet despite grate being fitted.

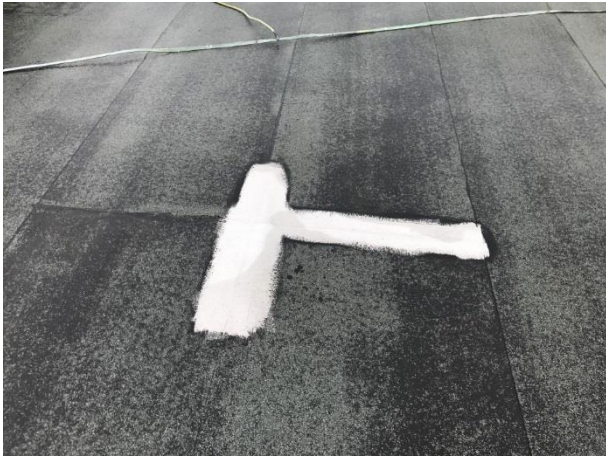
- At the time of replacement roof coverings, a new metal walkway was installed, supported on plinths and housing a large satellite dish.
 - Although generally in fair condition, the roof has been subject to numerous patch repairs and ongoing repairs should be anticipated.

B1 – Liquid applied patch repair.

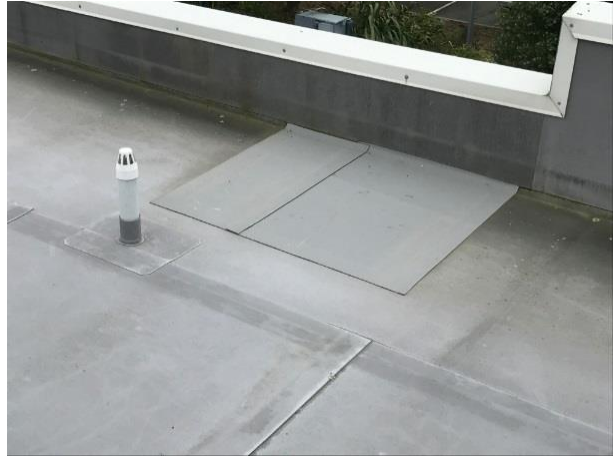
B2 – Patch repairs evident

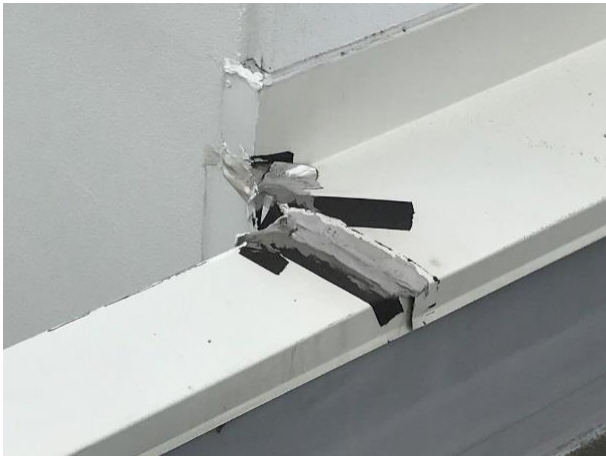
- Repairs/seals at joints to cap flashings have been crudely completed and are likely to fail.
- The façade overall is considered to be in good condition for its age, and we understand it is performing relatively well. No obvious visual defects were noted.

B2 – Poor patch repairs to cap flashing joint

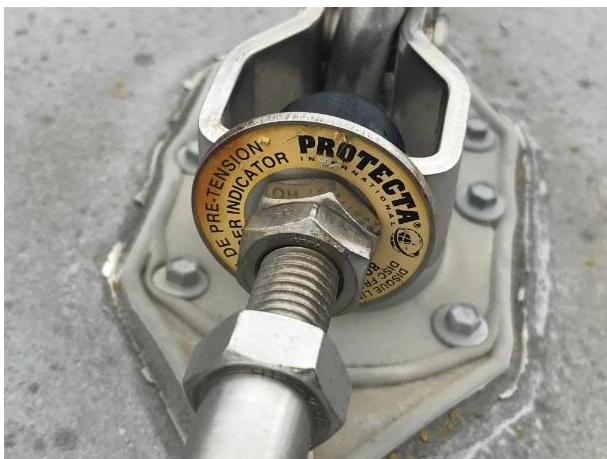
- A metal stair and walkway was installed at time of extension to facilitate access between the two roofs.
 - The Static line system is fitted to roof, although no tags were noted. We are unaware if this system has been de-commissioned.

B2 – static line system.

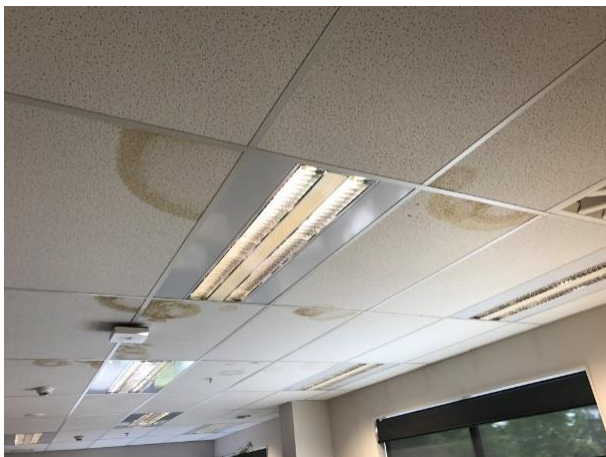
- The level of finish is of a good standard.
 - A number of water damaged ceiling tiles are stained from previous water ingress and should be replaced.

B2 – Stained & damaged ceiling tiles north end

| Item | Element / Description / Location | Suggested Remedy | Work Type | Likelihood | Consequence | RISK | Immediate | Short Term (1-2 Years) | Medium Term (3-5 Years) | Long Term (6-10 Years) | Extended Term (11-25 years) | Total |
|---|--|--|---|---|---|---|---|---|---|---|---|---|
| 2.3.2 | Water damaged ceiling tiles. | Replace all water damaged ceiling tiles. | R&M | Likely | Insignificant | Low | \$ 1,000 | \$ - | \$ - | \$ - | \$ - | \$ 1,000 |

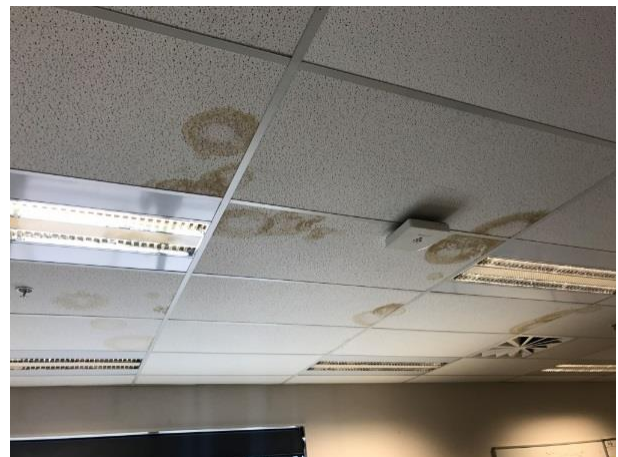
B2 – Stained & damaged ceiling tiles north end

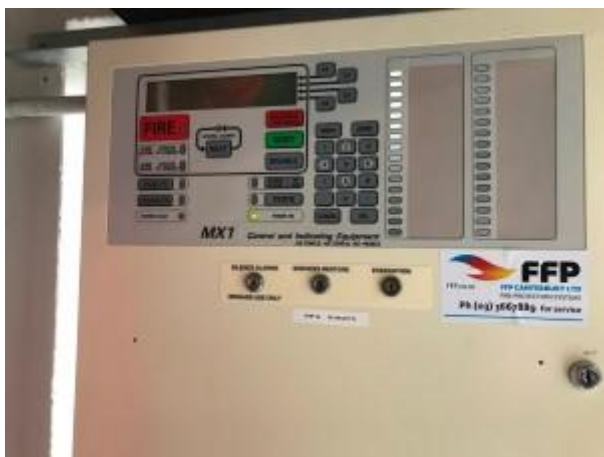
- Fire services comprise:
 - Fire indicator panel (FIP) located in the foyer of building 1. The panel appears to be reasonably old.
 - Sprinklers throughout both buildings with booster connections and valves located at ground level. It was noted that wet sprinklers are also protecting the mission critical areas.
 - A storage tank at ground level for sprinklers in the building 1
 - Smoke detectors throughout the buildings.
 - Equipment rooms (Computers) are protected by VESDA early warning alarms which we understand is property of the Tenant.
 - Hosereels are located throughout the buildings.
 - Hydrants are provided throughout the buildings.

FIP

| Item | Element / Description / Location | Suggested Remedy | Work Type | Likelihood | Consequence | RISK | Immediate | Short Term (1-2 Years) | Medium Term (3-5 Years) | Long Term (6-10 Years) | Extended Term (11-25 years) | Total |
|---|---|---|---|---|---|---|---|---|---|---|---|---|
| 6.01 | FIP | Replace at the end of economic life | R&M | Likely | Moderate | Moderate | \$ - | \$ - | \$ - | \$ 25,000 | \$ 25,000 | \$ 50,000 |

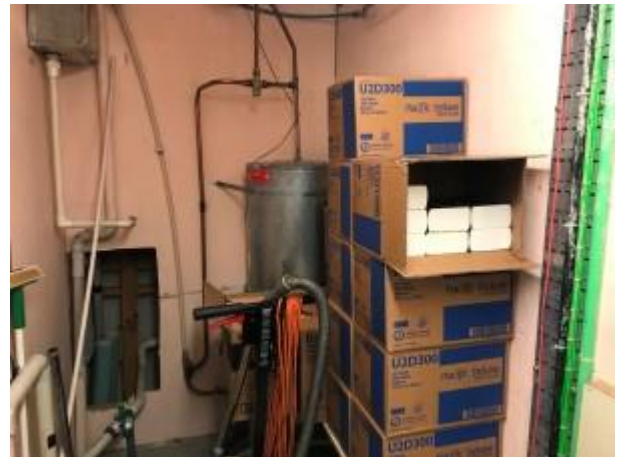
- Hydraulic services appear in reasonable condition with reasonable maintenance.
- The two header tanks on the roof of the building will need to be replaced in the medium term.
- Hot water system will need to be replaced as they fail.

Typical hot water system

| Item | Element / Description / Location | Suggested Remedy | Work Type | Likelihood | Consequence | RISK | Immediate | Short Term (1-2 Years) | Medium Term (3-5 Years) | Long Term (6-10 Years) | Extended Term (11-25 years) | Total |
|---|---|---|---|---|---|---|---|---|---|---|---|---|
| 7.02 | Hot water systems | Replace as they fail | CAP | Likely | Moderate | Moderate | \$ - | \$ - | \$ 10,000 | \$ 10,000 | \$ 20,000 | \$ 40,000 |
