TECHNICAL DUE DILIGENCE REPORT

Bethlehem Shopping Centre

19 Bethlehem Road

Date: 23 April 2021

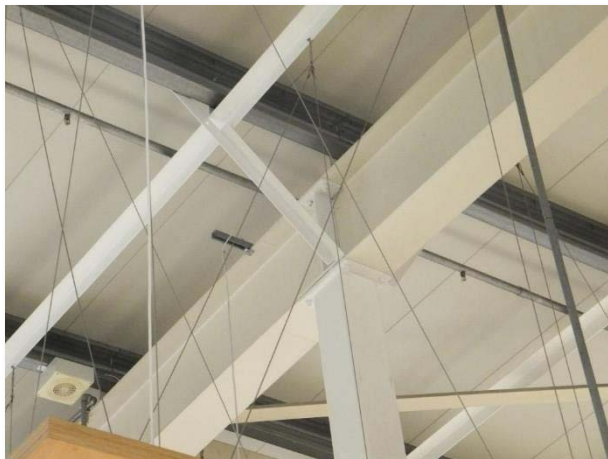
- We understand that works were completed recently to the supermarket tenancy comprising the installation of an intermediate column, to address settlement of one rafter. We have received a Code Compliance Certificate in relation to these works and assume that the Territorial Authority have reviewed documents and are satisfied that the works have been completed satisfactorily. We recommend that your structural consultants engaged for the ISA / DSA work review and comment upon the appropriate documentation in this regard.

New column in supermarket

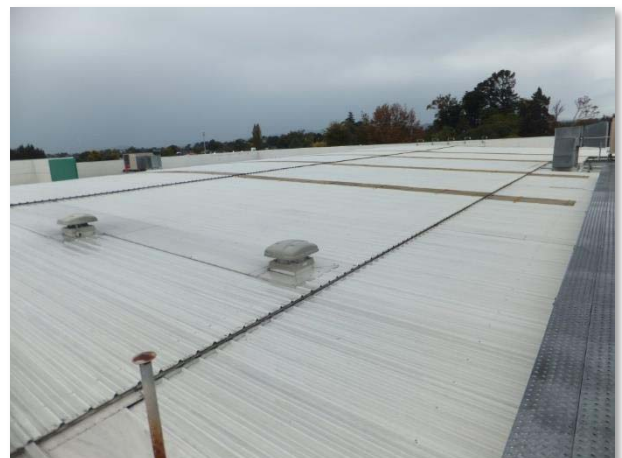
- Roof areas, where inspected, are in fair condition, with maintenance apparently reactive rather than planned. The roof sheeting over the supermarket tenancy was noted to be generally soiled, with early signs of corrosion at sheet ends. Isolated instances of mis-shaped flashings and sheet sections were noted. This roof is around 17 years' old and we recommend that allowance is made for a comprehensive overhaul in the medium term, to include for replacement of flashings, fixings and sealants, re-lining gutters as necessary.

View over supermarket roof

2.1.2	Roof over supermarket tenancy	Allow for periodic repairs through the period and an overhaul in the medium term to include replace flashings, fixings, renew sealants, re-line gutters	R&M	Moderate	\$ -	\$ 10,000	\$ 50,000	\$ 10,000	\$ 70,000

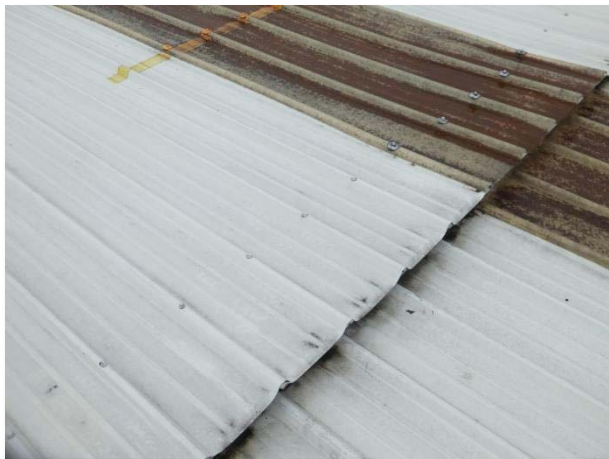
- Glass Reinforced Plastic (GRP) rooflights to the supermarket tenancy are significantly deteriorated and soiled. Deformation of the rooflights is causing them to 'dish' in certain areas, allowing them to hold water. We recommend that the rooflights are replaced in their entirety in the short term. Coloured fixing caps should be used, to help identify the GRP sheets, in the interests of health & safety.

Rooflights to supermarket roof

2.1 ROOF									
2.1.1	Roof over supermarket tenancy	Replace GRP rooflights in the short term. Coloured fixings caps to be used.	CAP	Moderate	\$ -	\$ 60,000	\$ -	\$ -	\$ 60,000

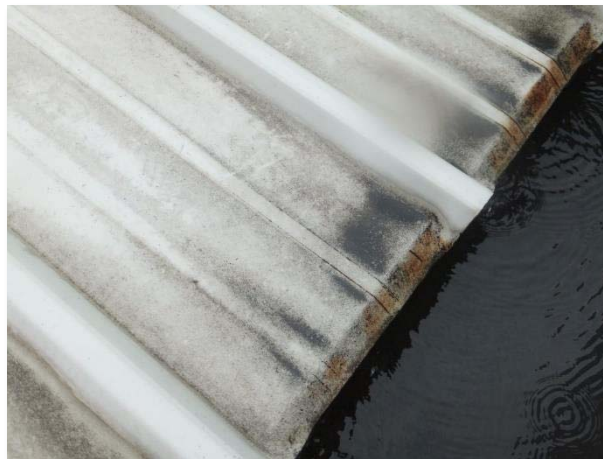
Roof sheet edges, supermarket roof

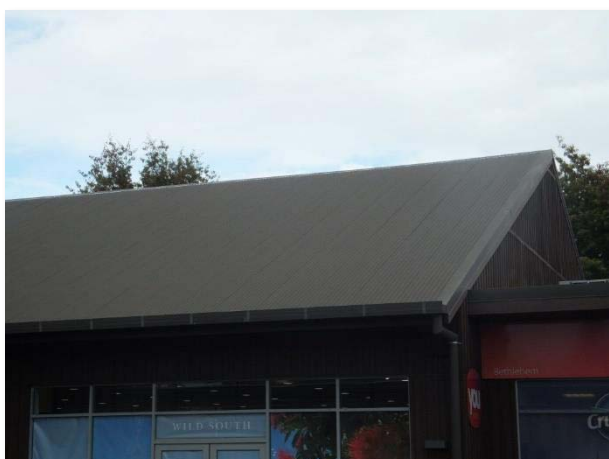
- Our verbal enquiries on site reveal that ongoing isolated roof leaks affect all areas. Allowance should be made for cyclical roof repairs to all retail terrace blocks, to include for renewal of sealant at junctions, replacement of fixings / fixing caps and treatment to isolated corrosion. Allowance has been made in our Capex forecast.

Block B roof

2.1.4	Roofs over retail terraced blocks	Allow for periodic repairs through the period to include replace isolated flashings, fixings, renew sealants etc.	R&M	Low	\$ -	\$ 10,000	\$ 40,000	\$ 50,000	\$ 100,000

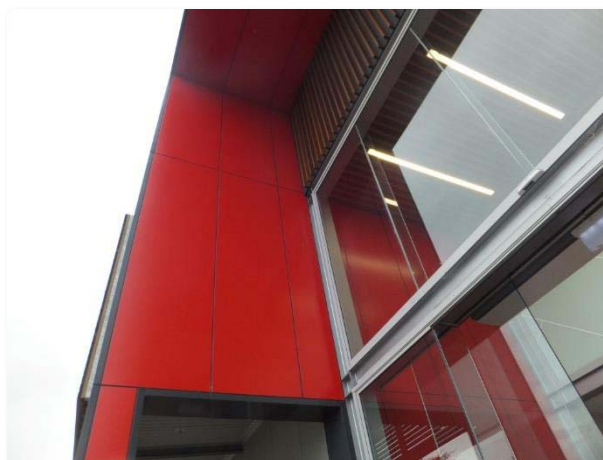
- Aluminium Composite Panels (ACPs) are used as a façade material to the double height space around the entrance to the principal tenancy of E Block (K-Mart). The same material is also used as an internal wall lining in the entrance lobby area. We have requested specification details to determine the fire resistance characteristics of this material. The vendor has been unable to provide this. We recommend that you liaise with your insurers to establish whether the presence of this material would affect your ability to procure property insurance at commercially viable rates.

ACPs to Block E

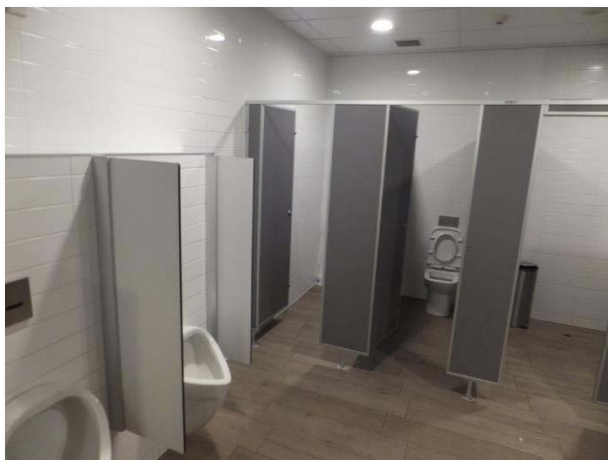
- The public WC facilities within Block A appear to have been recently refurbished. We feel that allowance for redecoration is required through the reporting period, with a light refurbishment in the long term.
- The centre management office and staff WC area is in fair condition. We recommend that allowance is made for a general refurbishment in the medium term.
- The staircase area and vacant tenancy to the first-floor level in Block G are in fair condition. A general refurbishment may be required in the short term, to assist leasing.
- We recommend that a provisional allowance is made for general refurbishments of units as they become vacant, for the purpose of re-leasing.

Public WC facilities

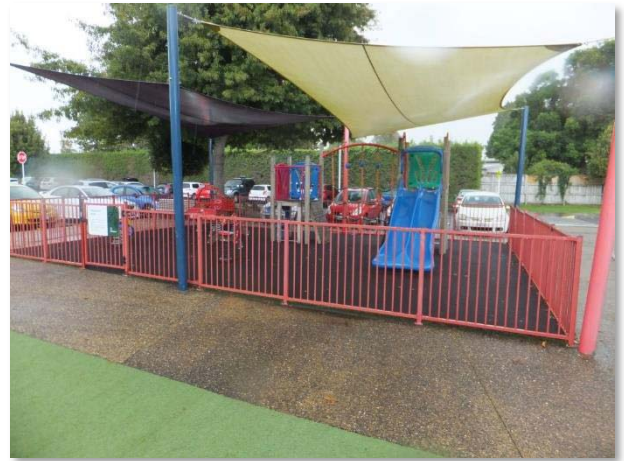
- No defects were noted with street furniture or playground equipment. However, we recommend that allowance is made for overhauls and replacements in the long term.

Children's playground

- We recommend a Provisional Sum allowance for an overhaul of the playground area in the long term.

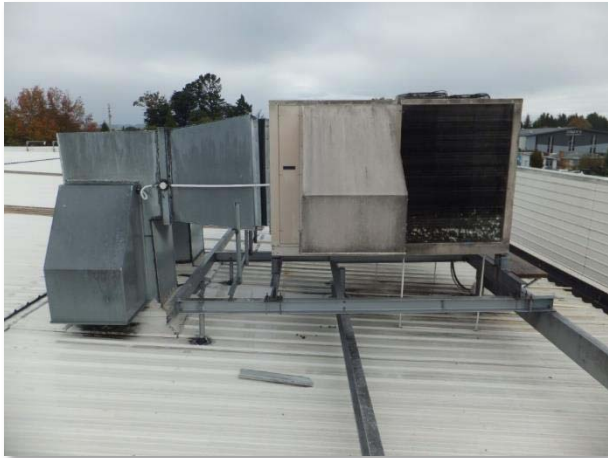
- Maintenance is commissioned by the landlord, with a range of contractors providing compliance certificates for BWoF purposes.
- The Temperzone packaged units serving the supermarket tenancy were noted to be suffering from deterioration to the heat exchange coils and soiling and corrosion to external cabinets. These units date to 2004 and utilise R22 refrigerant. We believe that these units will require replacement in the short term. Corroded mounts should also be replaced.

Packaged unit to supermarket tenancy

4.1	Temperzone PAC units, supermarket tenancy	Allow to replace PAC units, to include corroded mounts	CAP	Moderate	\$ -	\$ 150,000	\$ -	\$ -	\$ 150,000
4.2	Western Temperzone PAC unit, supermarket tenancy	Relocate Soil Vent Pipe (SVP). To be positioned over 6m from fresh air intake	CAP	Moderate	\$ -	\$ 2,500	\$ -	\$ -	\$ 2,500

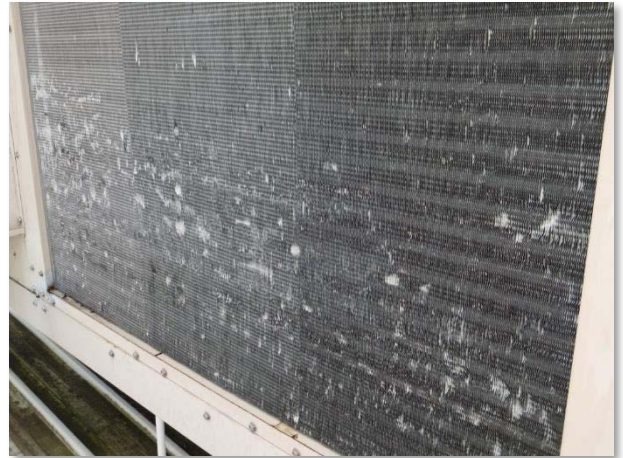
Deteriorated coils to packaged unit.

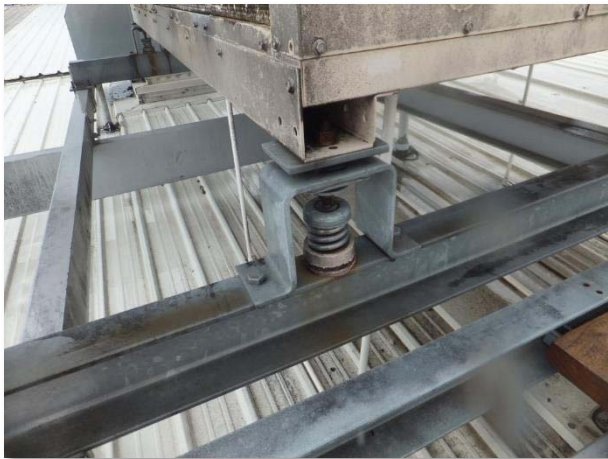
Packaged unit - soiled cabinets and corroded mounts

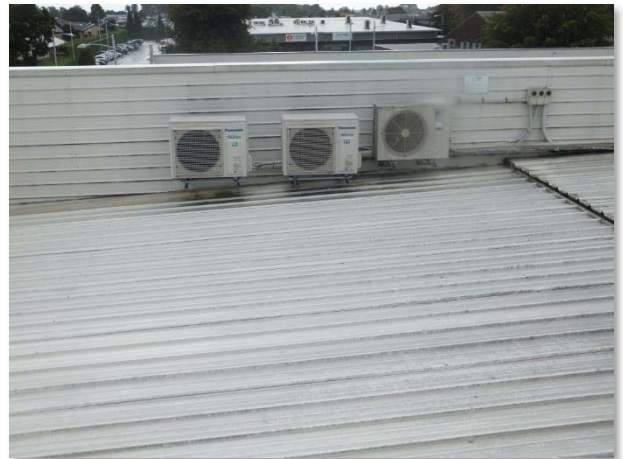
Split system outdoor units, supermarket tenancy

4.3	Split system air conditioning units, supermarket tenancy	Allow to replace outdoor and indoor units in the medium term. Landlord's equipment only	CAP	Moderate	\$ -	\$ -	\$ 50,000	\$ -	\$ 50,000

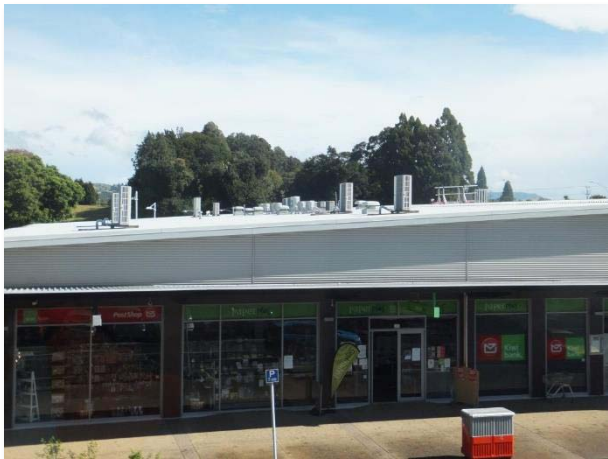
- The split system outdoor and indoor units serving the terraced retail tenancies, and management office, are assumed to primarily date to 2007/8. We recommend that all such equipment is budgeted for replacement across the short and medium term.

Typical split system units on Block C

4.5	Split system air conditioning units & PAC units, retail terraces	Allow to replace outdoor and indoor units throughout the period. Landlord's equipment only	CAP	Moderate	\$ -	\$ 90,000	\$ 500,000	\$ 250,000	\$ 840,000

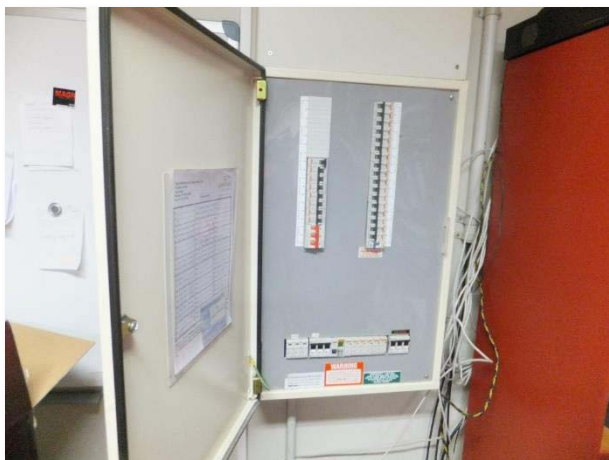
- DBs have a typical life expectancy of around 20 years, subject to adequate maintenance. We recommend that allowance is made for phased replacement as the boards reach this age in the long term. New DBs with RCD protection are recommenced.
- Emergency and exit lighting have a typical life expectancy of around 30 years, subject to adequate maintenance. We do not anticipate widescale replacement in the reporting period, but recommend that an allowance is made for some replacements should failures occur.
- External lighting appears to be primarily via metal halide or mercury type luminaires. Consideration should be given to an LED upgrade for façade mounted lighting and light poles, phased over the medium and long terms.
- We understand that the landlord's CCTV system was replaced in 2017 and therefore do not anticipate any further works during the reporting period.

Typical DB within tenancy

5.1	Distribution boards	Allow for replacement at life expiry. New boards to be fitted with RCD protection.	CAP	Moderate	\$ -	\$ -	\$ -	\$ 250,000	\$ 250,000

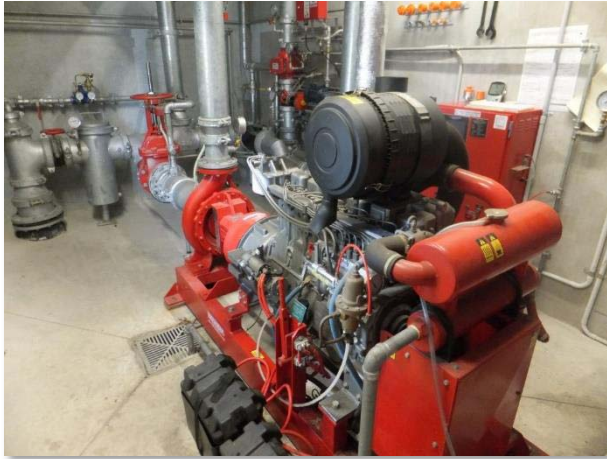
- The booster pump for the Block E sprinkler system is around six years old. We do not anticipate any requirement for replacement during the reporting period but recommend that allowance is made for an overhaul in the long term.

Sprinkler pumpset, Block E

6.4	Sprinkler system, Block E	To be maintained and certified through Opex. No replacement envisaged. Allow for long term overhaul to booster pump and controls.	R&M	Moderate	\$ -	\$ -	\$ -	\$ 20,000	\$ 20,000
7 HYDRAULIC SERVICES

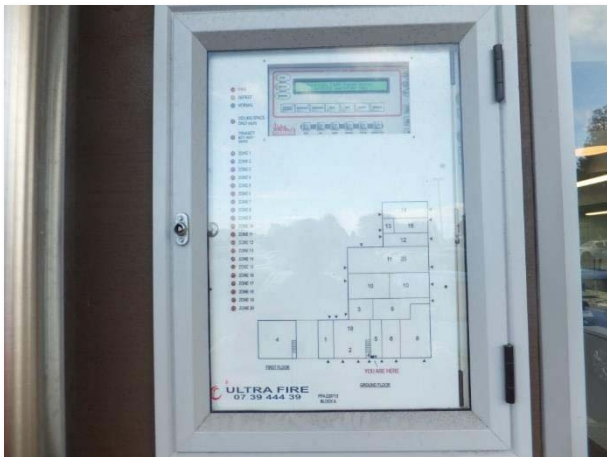
- Maintenance is arranged by the landlord, with compliance certificates for BWoF purposes appearing to be in order.
- The FIPs to the various buildings should be programmed for replacement at life expiry of around 15 years.

Typical FIP, retail terrace block

5.3	CCTV system	Recently replaced. No works envisaged			\$ -	\$ -	\$ -	\$ -	\$ -
6 FIRE SERVICES									
6.1	Fire Indicator Panels	Allow for replacement at life expiry (anticipated at 15 years).	CAP	Moderate	\$ -	\$ 10,000	\$ 80,000	\$ 10,000	\$ 100,000

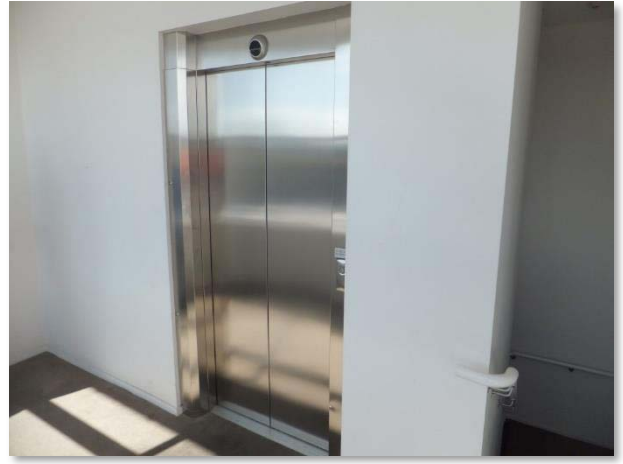
- The Kone passenger lift is currently around 12 years old. With a typical life expectancy of 20 years, we recommend that allowance is made for replacement in the long term.

Passenger lift, Block G

7.3	Sewer drainage system	Allowance for periodic repairs.	R&M	Low	\$ -	\$ 5,000	\$ 20,000	\$ 30,000	\$ 55,000
8 VERTICAL TRANSPORTATION									
8.1	Kone passenger lift, Block G	Allow for life cycle replacement in long term	CAP	Moderate	\$ -	\$ -	\$ -	\$ 130,000	\$ 130,000
9 ENVIRONMENTAL & HAZ MATS
