Technical Due Diligence Report For and on behalf of AUGUSTA FUNDS **MANAGEMENT** Anglesea Medical Centre, Corner of Anglesea and Thackeray Streets Hamilton JUNE 2020 P19-0406

REPORT TITLE	Technical Due Diligence Report
JOB NUMBER	P19-0406
CLIENT	Augusta Funds Management
CLIENT CONTACT	Joel Lindsey

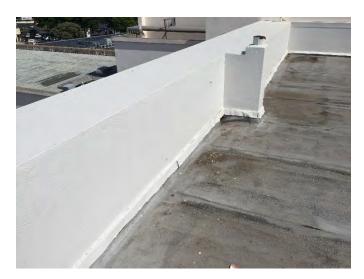
Photograph 9.

No barriers or fall restraint/arrest system have been installed to the south portion of the roof.

Access to the south portion of the roof covering should be limited until the barriers to the perimeter have been installed.

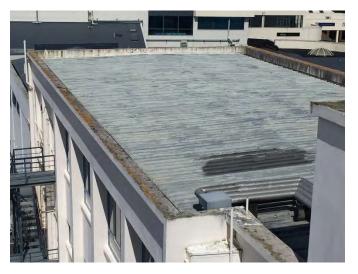
Photograph 10.

No barriers or fall restraint/arrest system have been installed to the roof.

Access to the south portion of the roof covering should be limited until the barriers to the perimeter have been installed.

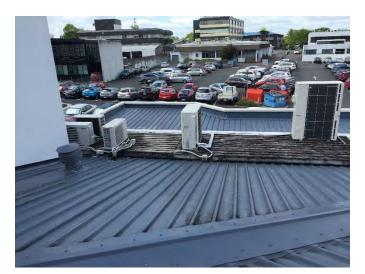
Photograph 11.

No barriers or fall restraint/arrest system have been installed to the roof.

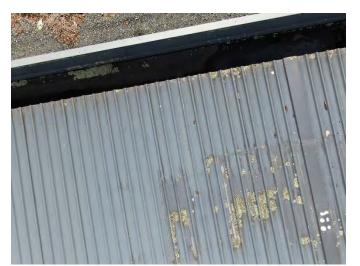
Photograph 14.

Heavy lichen growth was noted to sections of the roof where the plant was previously located.

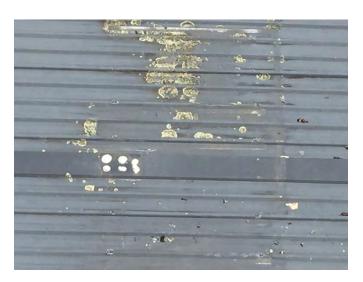
Photograph 15.

Several redundant roof fixings were noted to the roof covering from previously removed extractor fans. The open holes have been filled with a sealant or polystyrene type material and left exposed.

<u>Recommendation:</u> Permanent repairs of the penetrations through the roof covering will be required to prevent moisture ingress through the unprotected repairs.

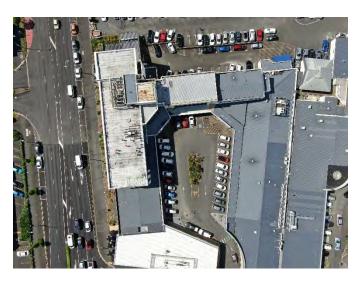
Photograph 16.

Roof B, building 2 comprises a membrane roof with a concrete substrate draining to perimeter gutters.

The roof covering has a concrete substrate and a solar reflective coating. The coating to the roof covering is faded with exposed sections of membrane noted.

<u>Recommendation:</u> We were advised by representatives of Anglesea Clinic that the roof coverings are due to be replaced in January 2020.

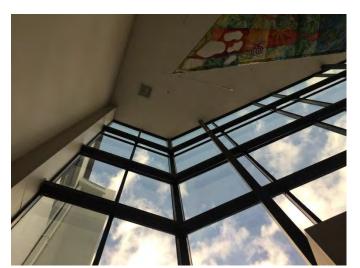
Photograph 17.

Internal historic leaks were noted to the ceiling lining within the entry foyer to building 2.

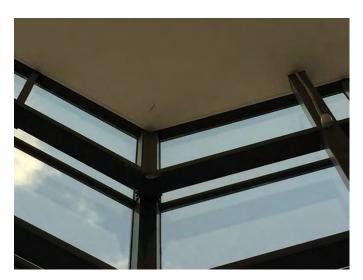
Photograph 18.

Internal historic leaks were noted to the ceiling lining within the entry foyer to building 2.

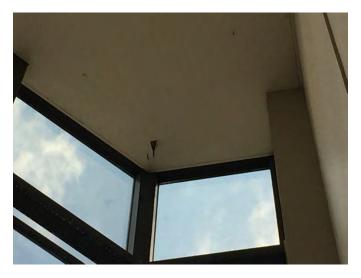
Photograph 19.

Internal historic leaks were noted to the ceiling lining within the entry foyer to building 2.

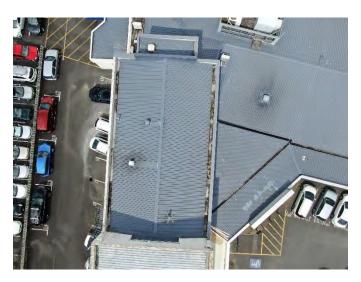
Photograph 21.

Widespread roof dents were noted throughout the roof covering. Flashings have been installed to the roof covering at rain water sump locations to prevent rain water running directly into the outlets and the underside of the roof covering.

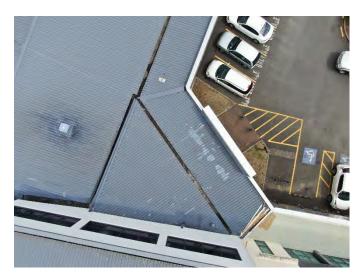
Photograph 23.

Widespread roof dents were noted throughout the roof covering. Flashings have been installed to the roof covering at rain water sump locations to prevent rain water running directly into the outlets and the underside of the roof covering.

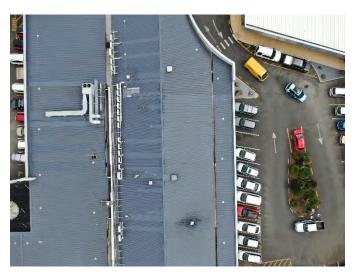
Photograph 24.

Widespread roof dents were noted throughout the roof covering. Flashings have been installed to the roof covering at rain water sump locations to prevent rain water running directly into the outlets and the underside of the roof covering.

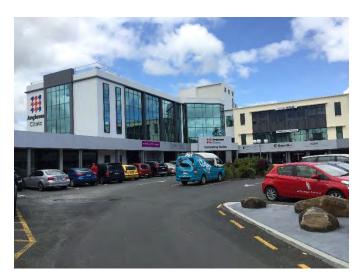
Photograph 32.

The curtain wall cladding appears to be in a reasonable condition with general atmospheric build-up noted.

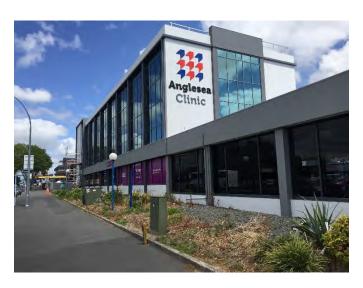
Photograph 33.

The curtain wall cladding appears to be in a reasonable condition with general atmospheric build-up noted.

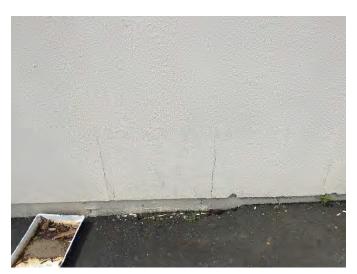
Photograph 38.

Direct fixed fibre cement cladding has been installed to the south and west elevations of the main building and all elevations of the lift plant room.

Cracking and broken sections of cladding were noted to the fibre cement sheet cladding and will be allowing moisture past the cladding and onto the frame.

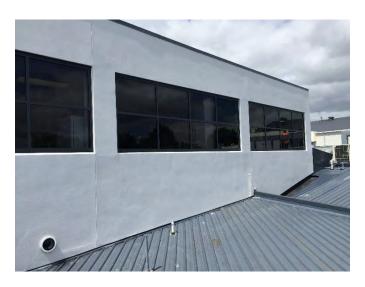
Photograph 39.

Sections of fibre cement sheet cladding have recently been replaced to the south west corner of the building with and EIFS cladding system over a drained cavity. We have not sighted a Code Compliance Certificate for the installation of the new cladding system.

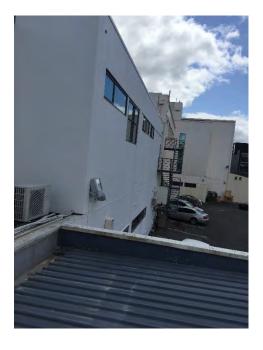
Photograph 40.

Sections of fibre cement sheet cladding have recently been replaced to the south west corner of the building with and EIFS cladding system over a drained cavity. We have not sighted a Code Compliance Certificate for the installation of the new cladding system.

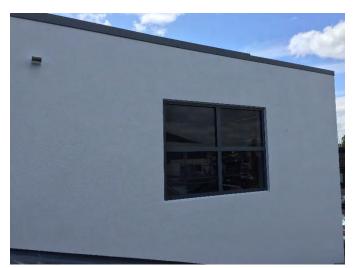
Photograph 41.

Sections of fibre cement sheet cladding have recently been replaced to the south west corner of the building with and EIFS cladding system over a drained cavity. We have not sighted a Code Compliance Certificate for the installation of the new cladding system.

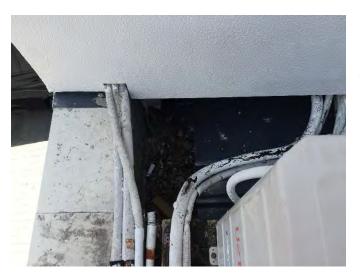
Photograph 44.

Inspection of the concrete to EIFS cladding junction is required. No evidence of back flashing was noted during our inspection. Open unsealed pipe penetrations through the cavity were noted to the west elevation. Conformation the cavity has been adequately closed and ventilated in this area is required.

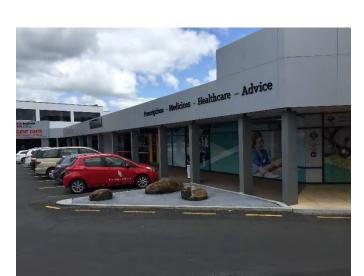
Photograph 48.

Sections of aluminium cladding have been installed to the fascia sections of the north, east and west elevations. Some aluminium composite cladding pose a fire risk with a polyethylene (PE) core.

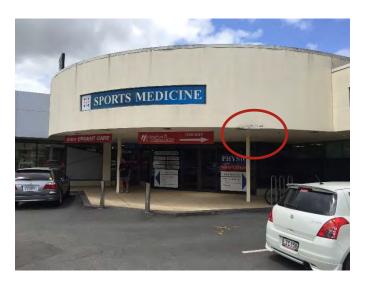
Photograph 65.

General view of the north elevation. Impact damage was noted to the EIFS cladding.

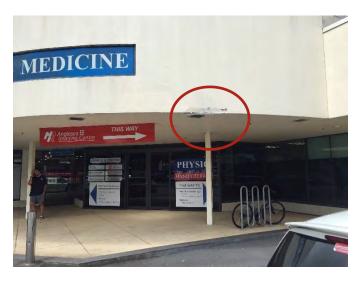
Photograph 66.

Impact damage was noted to the EIFS cladding.

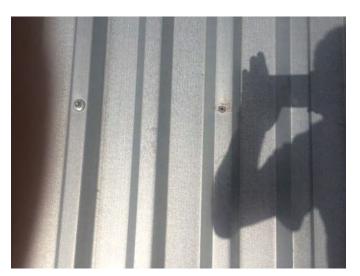
Photograph 89.

Numerous metal roof fixings have been over tightened, resulting in deflection of the roof covering. As a result a number of roof fixings are loose and proud of the roof surface.
