TECHNICAL DUE DILIGENCE REPORT

213-221 TUAM STREET
CHRISTCHURCH

PMG Direct Office
Fund

Date:
24 January
2020

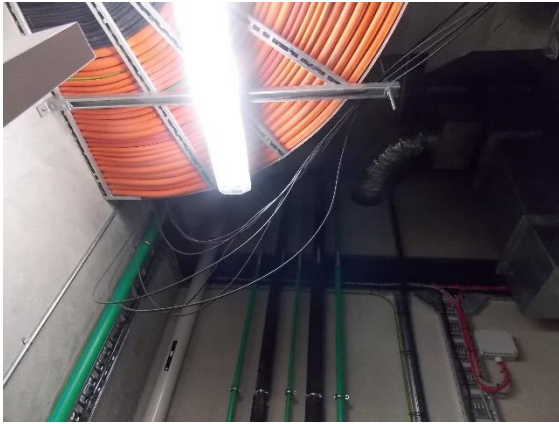
6. Generally, all electrical services are in good operating order and condition.
7. Loose runs of cables in MSB room and risers are to be made good.
8. Mains cabling, and earth connections are recommended to be tested for functionality. This should be carried out every 3 years.
9. The aluminium lining to the generator room wall and ceilings are to be made good with appropriate fixings/clips.
10. Confirmation with the incumbent electrical contractor that fluorescent fittings at ground floor stairs are battery backed up emergency fittings as per specifications.
11. An exit/emergency lighting test logbook should be provided on site in accordance with AS/NZS 2293.1.

E1 – Unsupported cabling in MSB Room

- a) Provision of a single line diagram drawing of the MSB at the switchboard.
- b) We recommend yearly thermal scans of the main switchboard and distribution boards as part of preventative maintenance.
- c) Making good to loose runs of cables in MSB room and risers.
- d) Mains cabling, and earth connections are recommended to be tested for functionality. This should be carried out every 3 years.
- e) The aluminium lining to the generator room wall and ceilings be made good with appropriate fixings/clips.
- f) Confirmation with the incumbent electrical contractor that fluorescent fittings at ground floor stairs are battery backed up emergency fittings as per specifications.
- g) An exit/emergency lighting test logbook should be provided on site in accordance with AS/NZS 2293.1.
- h) Verify compliance with NZS 4219 for seismic restraints of mechanical systems.

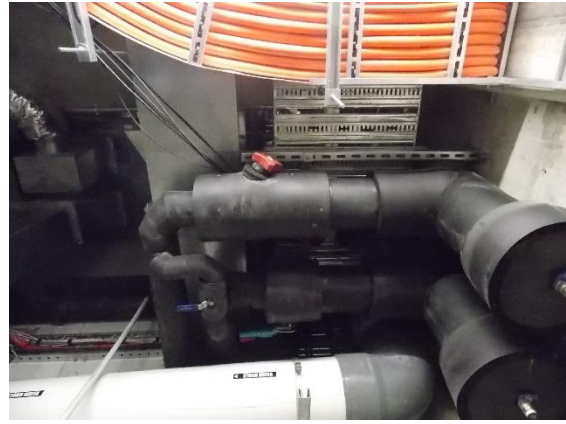
E2 – Unsupported cabling in MSB Room

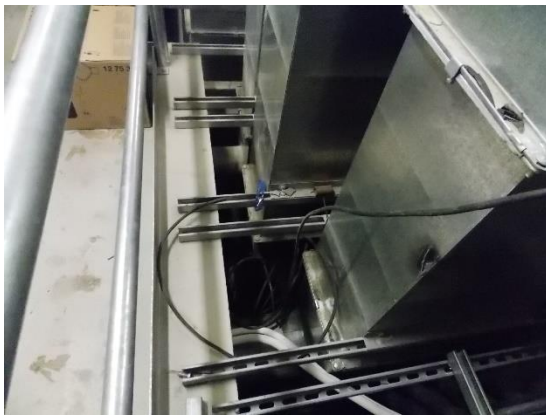
E3 – Unsupported cabling in riser

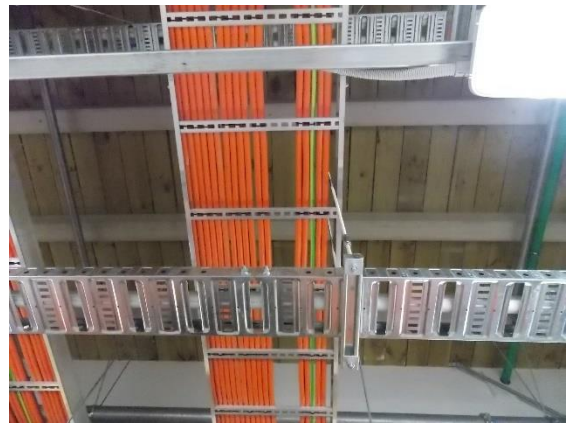
E4 – Non-compliant spacing between hanger and cable ladder

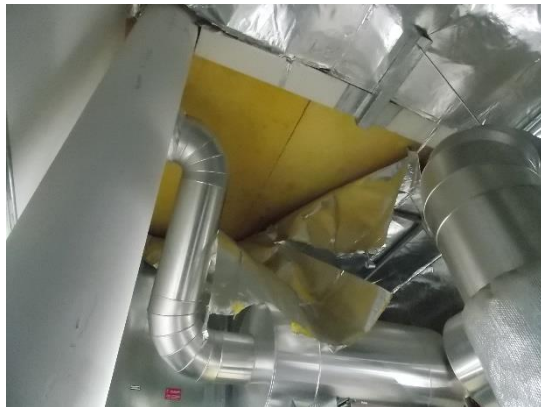
E5 – Aluminium lining above generator coming off

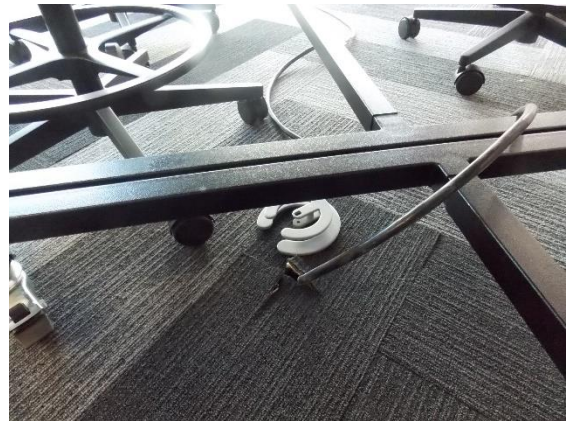
E6 – No grommet to cable from raised floor

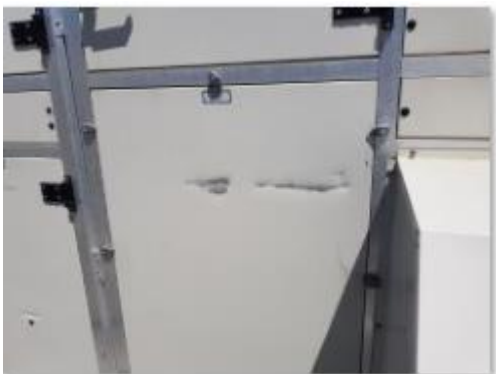
M13 – Damaged AHU Panel

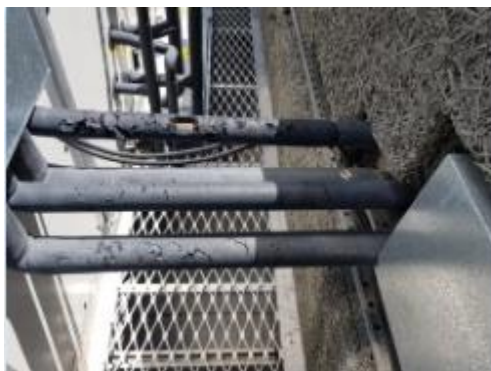
20. Generally, all mechanical services are generally in good operating order and condition.
21. Exposed refrigerant pipework insulation requires replacement and protection from UV damage.
22. We consider that mainly minor plant items would require replacement within the next 10 years, including controls and electric heaters and condensate pumps.
23. A damaged roof mounted AHU panel requires repair.
24. Continue routine maintenance, testing and cleaning of plant, ducts and grilles as required.
25. Confirm purpose for dry cooler condenser units located on top of AHUs (not indicated on design drawings reviewed)
26. We recommend that passive requirements to services penetrations at walls, ceiling and floor are reviewed against the fire engineer's report and are provided if required.
27. All new air conditioning systems as part of tenant fit out should include appropriate seismic restraints.

M20 –DX refrigerant pipework on Roof in need of repair and UV protection.

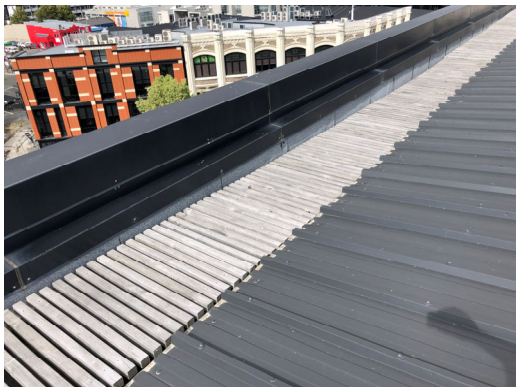
2. Timber walking boards to the perimeter of the roof are in a serviceable condition – an allowance should be made to replace or maintain the boards within 10 years.

1.5. Timber walking boards to perimeter of roof

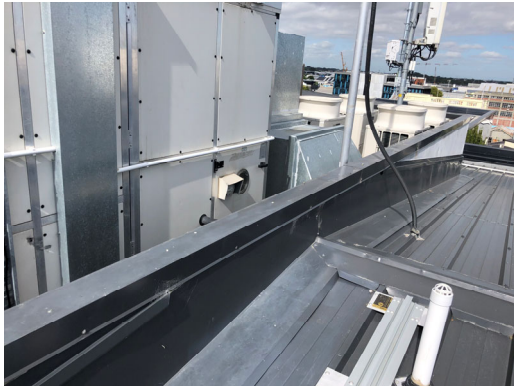
8. Access to the ridge is gained in part by placing a foot onto a metal cap flashing over the precast walls of the plant room area – over time, this will cause the cap flashings to deteriorate. It is recommended that a protective plate is installed over the flashing to protect it from damage.

1.7. View of cap flashing

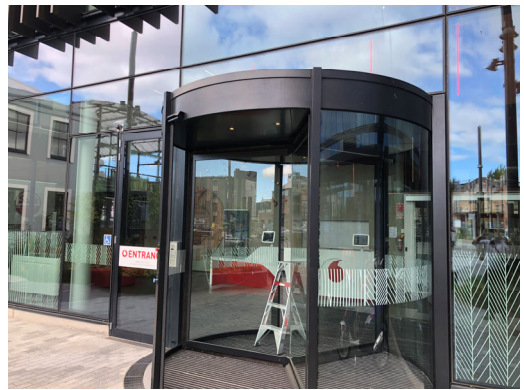
13. The main staff entrance consists of a revolving door on the north western elevation – the door was in the process of being repaired at the time of inspection and was not in use. Doors of this type are expensive to install and it is recommended that clarification is sought prior to proceeding with the purchase of the building to ensure the door will be left functional.

1.18. Main entrance under repair

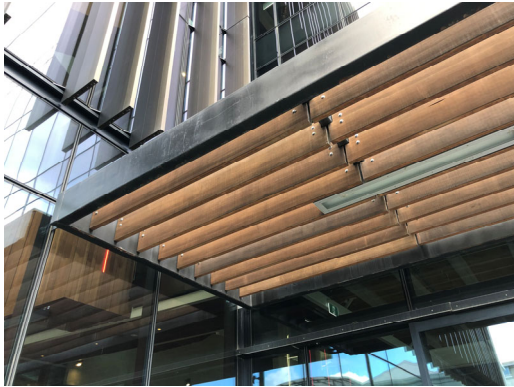
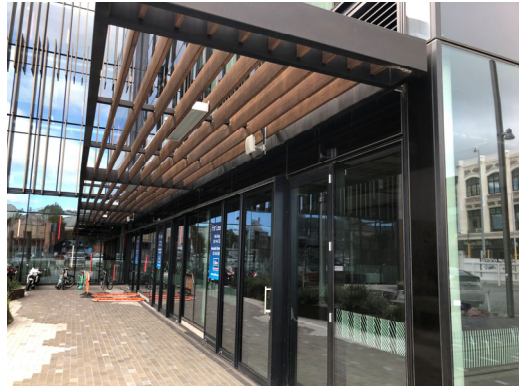
15. The steel frame to the canopy to the northwest elevation is noted to be corroding in localised areas.

1.19. View of canopy

1.20. View of canopy

The corrosion should be treated and the steel frame painted to extend its serviceable life.

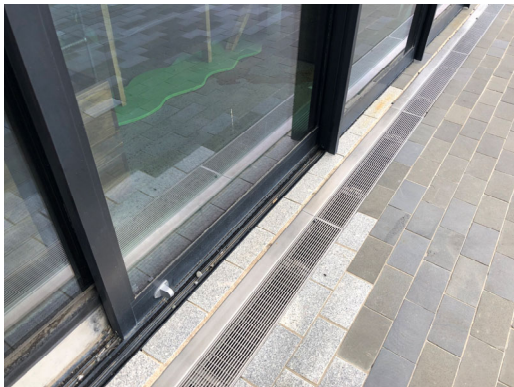
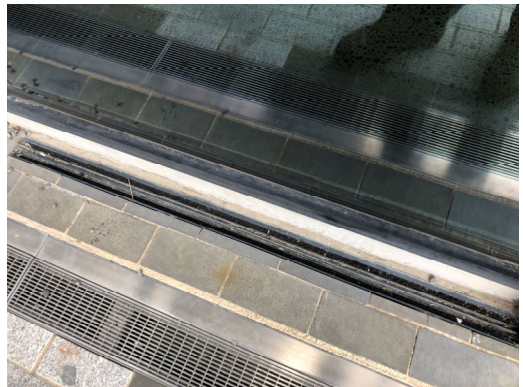
14. There are large sliding entrance doors to the north west of the building – small stones and pebbles were noted in the sliding door tracks and it is recommended that these tracks are monitored to ensure stones are kept free – if the doors are opened over the stones, the doors could be damaged.

1.21. View of sliding door track and Aco Drain

1.22. View of sliding door track and Aco Drain

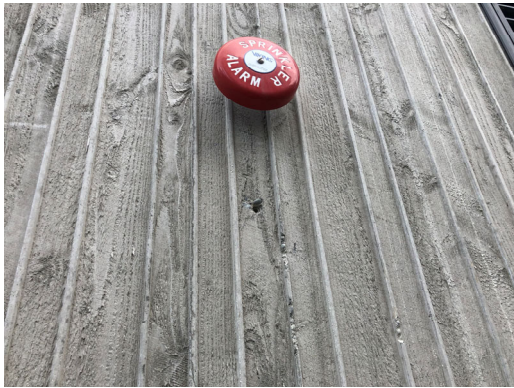
11. The textured coating to the south east of the building is noted to have come free in localised areas – it is unknown if this is a deliberate aesthetic appearance, or if the concrete has been impacted with pieces of concrete knocked free in the past. The ground was checked in the vicinity of the concrete and there was no evidence of render recently falling free. Given the very light weight nature of the render that could come free, together with the render being on the ground floor of the building, we are not concerned about this issue from a health and safety perspective.

1.35. Textured Concrete Walls

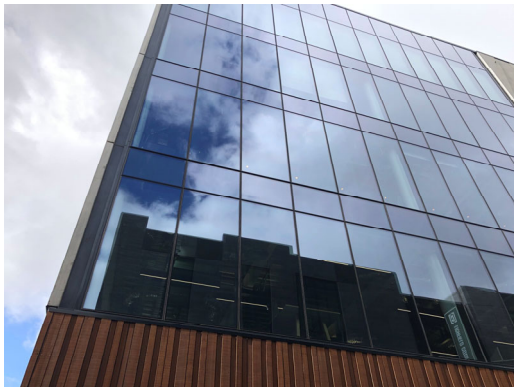
10. The glazed curtain walling is noted to be in a serviceable condition and appears well specified and installed. No evidence of moisture ingress was noted internally. Given the young age and high value of this element we have reviewed the warranty and recommend that the steps called for are implemented, to prevent the warranty being voided. The maintenance steps are as follows;

1.39. General view of glazed curtain walling
