TECHNICAL DUE DILIGENCE REPORT

Castle Rock Business Park

Mary Muller Drive

Date: 14th September 2018

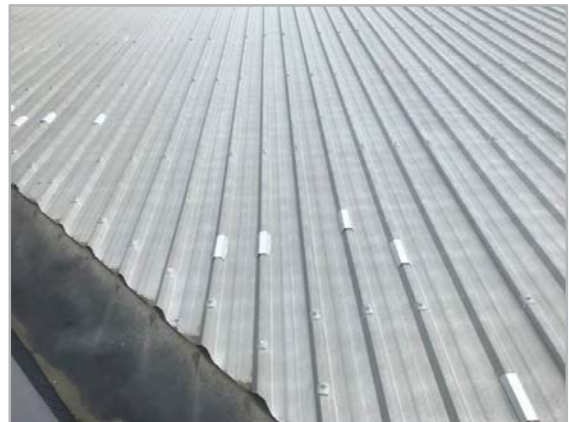
22. Unit 11 Roof Sheetting with Evidence of Repairs

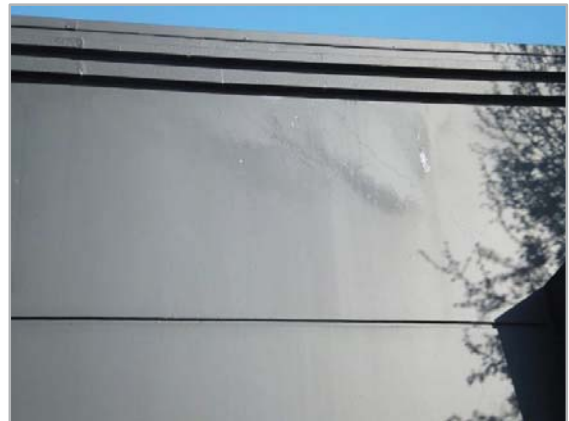
- We noted evidence of water penetration through the copings at the head of pre-cast walls to Unit 4 (see photograph 24). We recommend that the flashing is checked and that fixings and sealants are renewed as necessary prior to remediation of the affected surfaces, to be undertaken in conjunction with cyclical redecoration.

24. Deteriorated Finish to Parapet Walls, Unit 4

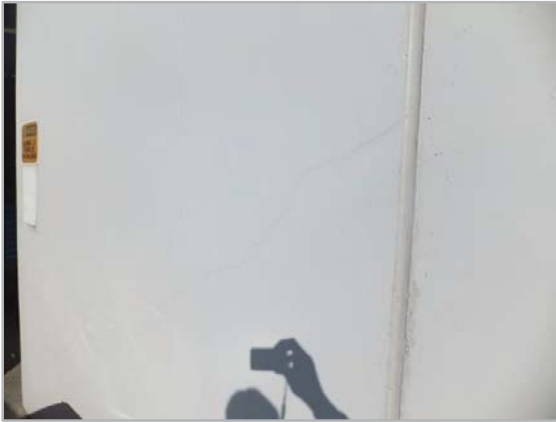
25. Diagonal Cracking to Pre-Cast Walls, Unit 4

- Repairs are required to be undertaken to Unit 4 to prevent water ingress through the panels. These repairs should be similar to those undertaken in Unit 12, which are reported as successful.

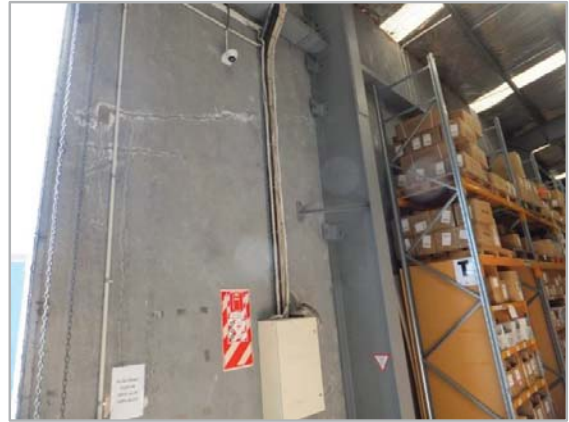
- Hairline cracking was noted to several units, particularly the older buildings, with the most significant cracking seen at Units 2, 4, 6, 12 & 15 (refer to photographs 26, 27 & 30). At Unit 12, the occupier reported that rain water had been penetrating through the cracks in the pre-cast panels, but that this defect had been resolved by the landlord through sealing the internal cracks (refer to photograph 29). We also noted that the external face of the front elevation of Unit 2 has been sheeted over with profile steel cladding. We suspect that this may have been to prevent water ingress through the cracking and also to conceal the cracking from view. Given the presence of

efflorescence within Units 2 & 4, we suspect that water is penetrating through the pre-cast panels. Most cracking noted on either internal or external faces of pre-cast panels is unlikely to penetrate through the full thickness of the panels.

26. Diagonal Cracking to Pre-Cast Walls, Unit 4

- Cracking to pre-cast panels in all units should be monitored over time for deterioration. We recommend that allowance is made for a quantity of resin crack repairs, particularly for the older buildings at the site.

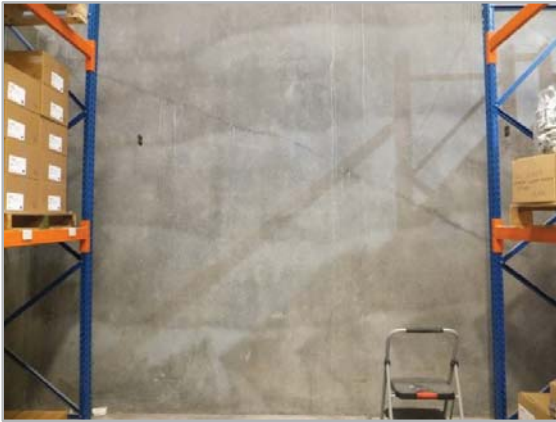
27. Diagonal Cracking to Pre-Cast Walls, Unit 6

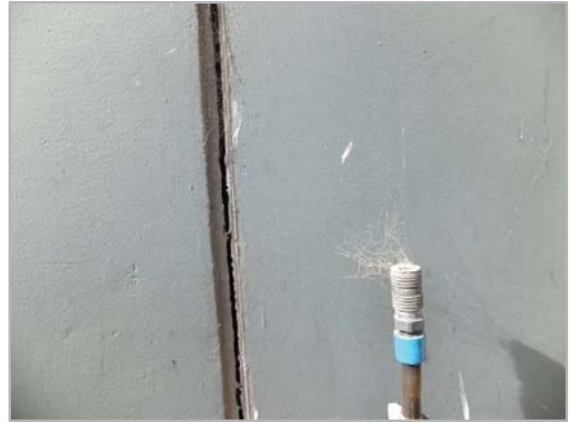
28. Failed Sealant to Pre-Cast Panels, Unit 9

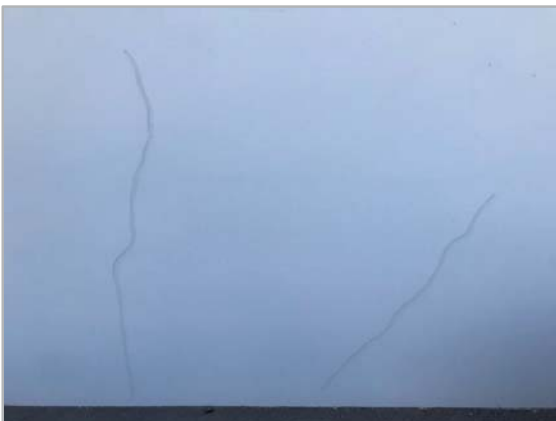
29. Repaired Cracking to Pre-Cast Panels, Unit 12

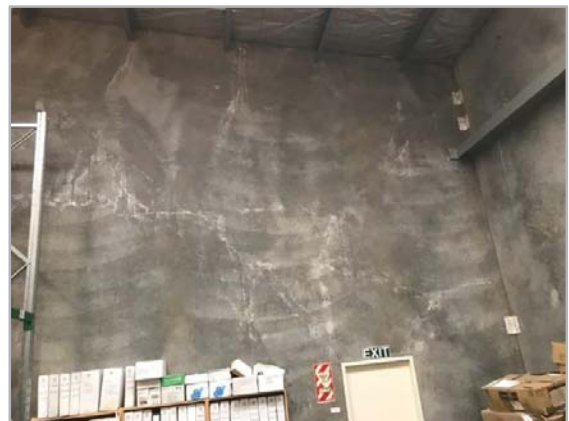
30. Cracking to Internal Face of Pre-Cast, Unit 9

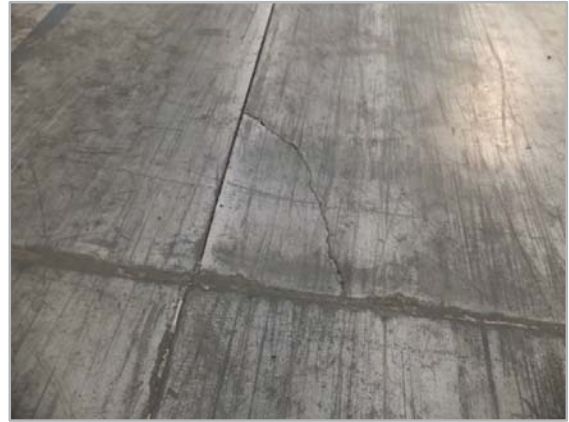
- The warehouse floor slabs in each building exhibit a typical degree of minor cracking, impact damage at slab edges and general wear and tear. None of the cracking is considered to be structural significance. We recommend that allowance is made to undertake periodic repairs over and above any repairs that tenants may be responsible for through their lease provisions. Allowance should also be made to renew sealant to construction joints between the slabs.
- The internal faces of warehouse walls and also floor slabs are painted in some areas. It is assumed that redecoration of these items is a tenant responsibility, and this is therefore excluded from our capex forecast.
- The standard of finishes and fixtures in office areas varies from fair to good in the various buildings on site. We assume that tenants have redecoration obligations for

32. Typical Wear & Tear to Slab, Unit 15

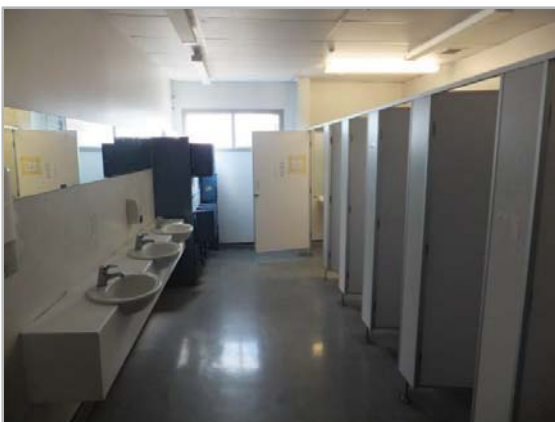
- The standard of finishes and fixtures within amenity areas varies from fair to good in the various buildings on site. Again, we assume that tenants have redecoration obligations for these areas and we have excluded this from our capex forecast. We do recommend that allowance is made for renewal of vinyl floor finishes for a number of the units. We anticipate that a full refurbishment of WC areas will be needed during the reporting period in Units 4 & 15.

41. Dated WC Area, Unit 15

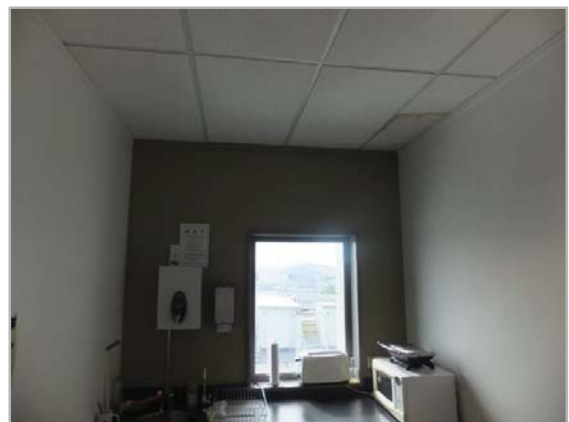
42. Evidence of Roof Leak, Unit 9

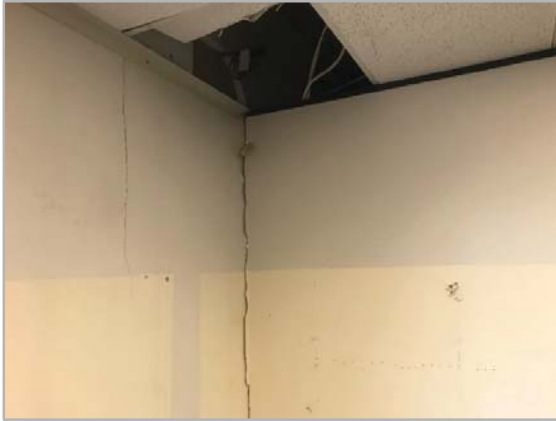
- We note minor cracking to a number of internal wall junctions with the southern elevation of Unit 10A (in the vacant portion of this building). Refer to photograph 43. It appears that there may have been rotational movement of the external wall. Refurbishment works are required in this vacant suite and we recommend that enquiries are raised with the vendor as to whether they are to implement any refurbishment works and whether repairs are to be undertaken to address the minor structural movement.

43. Cracking at Wall Junction, Unit 10A
Chapmans Road

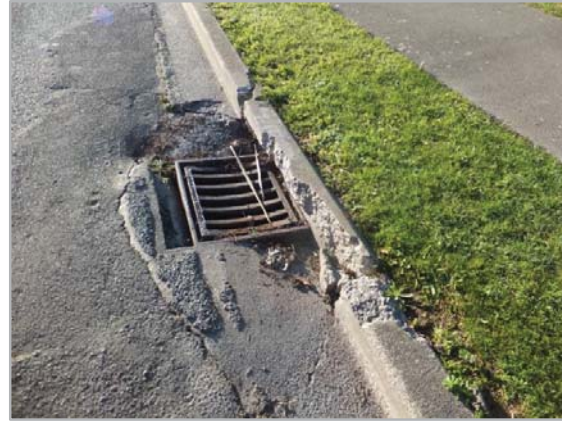
- We noted a number of cracked and broken concrete kerbs (refer to photograph 44), particularly adjacent to vehicle entrances around the site. We recommend a sum is allowed for targeted repairs for these defects.

44. Example of Damaged Kerb at Drainage
Gully

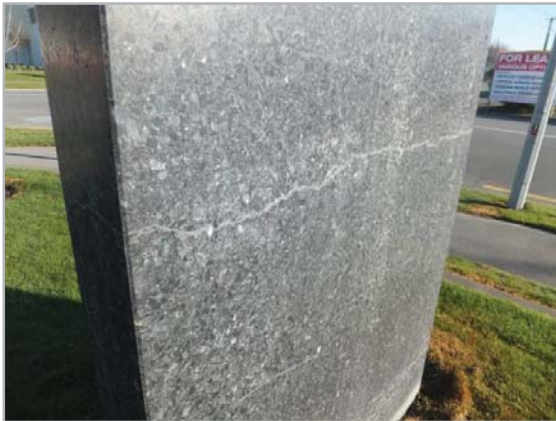
- We noted that the polished stone totem/tenancy directory signage exhibits horizontal cracking (refer to photograph 45). We recommend that this is monitored for any deterioration. We have allowed a sum for resin repairs to the cracks, should these become necessary.

45. Horizontal Cracking to Tenant Directory
Sign

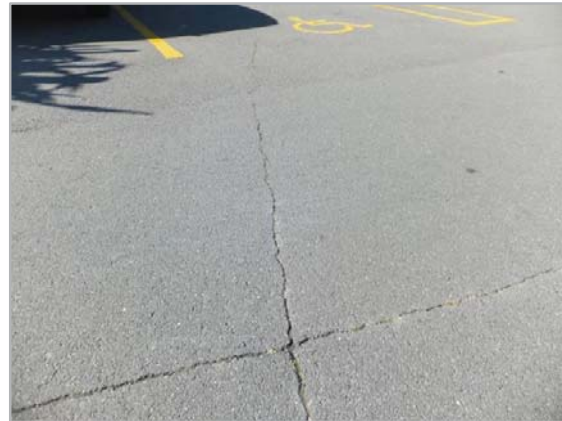
- Externals**
- We noted minor cracking to car park and service yards to a number of the units around the site (see photograph 46). We also noted areas of unevenness and settlement in the

46. Cracking to Asphalt Car Park, Unit 15

footpath and car park areas (see photograph 47). We recommend that a sum is allowed for targeted cyclical repairs to these defects.

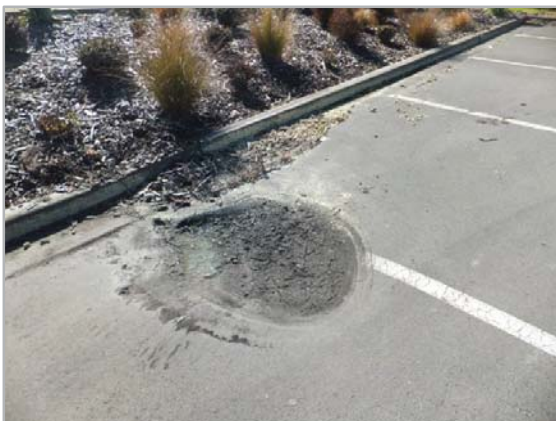
47. Settlement to Car Park, Unit 15
