# TECHNICAL DUE DILIGENCE REPORT

255-257 GYMPIE ROAD  
KEDRON QLD 4031

Reliant Party: Augusta Funds Management

Date: December 2018

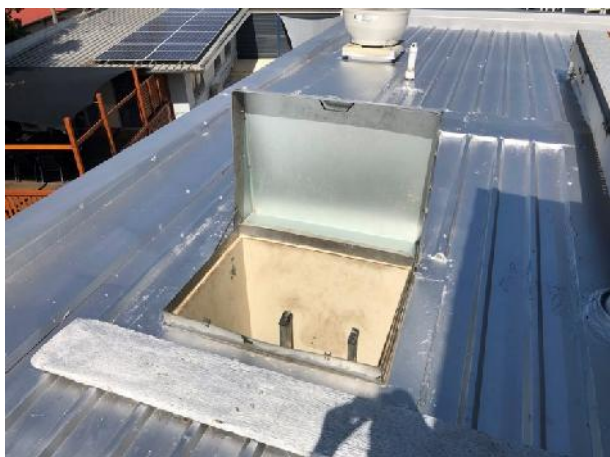
- There are a number of isolated roof leaks which require investigation and repair.
- Note: roof access is near the roof edge and is highly unsafe. There are also areas of plant and equipment adjacent to the roof edge without any side protection. It is recommended that roof access be upgraded including the installation of walkways to air conditioning units.

Building A1/3 Unsafe roof access

2.1.1	Roof Access - C&K Building.	Upgrade unsafe roof access with adequate ladder, side protection, etc.	CAP	High	\$ 25,000	\$ -	\$ -	\$ -	\$ 25,000
2.1.2	Roof Access - C&K Building.	Treat corrosion to access walkways & platforms.	R&M	Moderate	\$ -	\$ 10,000	\$ -	\$ -	\$ 10,000

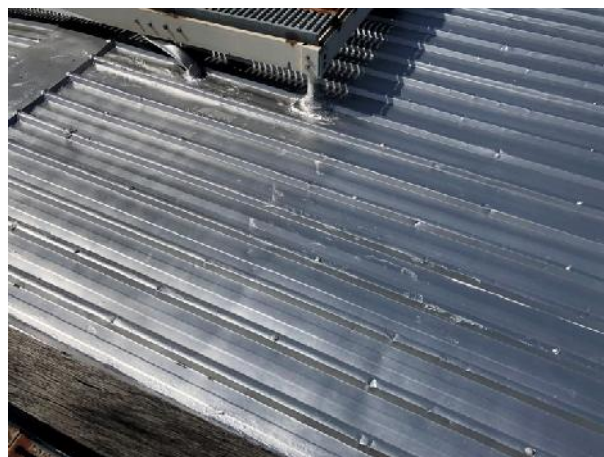
- The roof over the main Building A1/3 (C&K) is in poor condition:
  - The roof has recently been covered with a liquid applied paint product acting as a membrane. It is understood the product is Dulux Metalshield.

- There has evidently been a history of water ingress and rust is clearly visible from Nearmap imagery prior to the application; previous repairs have been carried out.

- There are numerous dents and other imperfections and no walkways are present which would increase damage from foot traffic.
  - The paint application is considered to be a very short-term temporary solution and will likely lead to further problems. This is particularly true for the ridge scribe break which has now been sealed and will prevent moisture from escaping. Corrosion to this area will now accelerate.

Building A1/3 Poor condition of roof

- Lifecycle replacement is recommended to be budgeted for the short term.
  - The plant platforms are in poor condition with significant corrosion noted. Treatment and repairs are recommended.

2.1.3	C&K Building - main upper roof (dated 1990).	Poor condition and application of paint system will lead to further problems. Recommend lifecycle replacement.	CAP	Moderate	\$ -	\$ 285,000	\$ -	\$ -	\$ 285,000

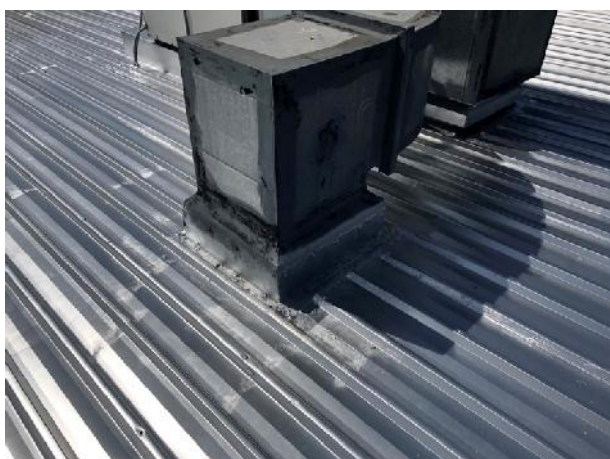
- Poor flashing details are noted throughout where service penetrations do not have a drypan flashing as required; they are relying completely on the sealant around the penetration.

Building A1/3 Inadequate flashings

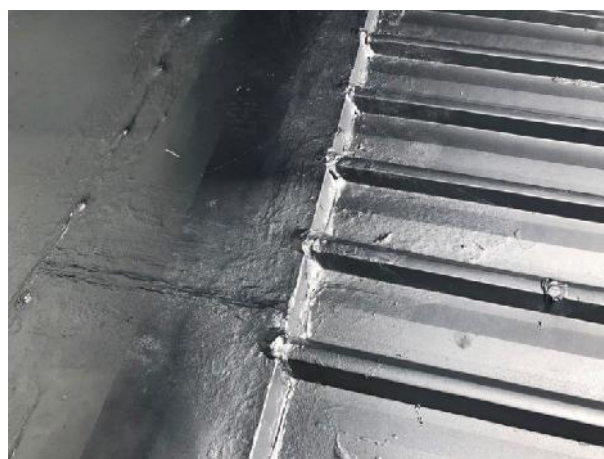
Building A1/3 Capping scribe break sealed

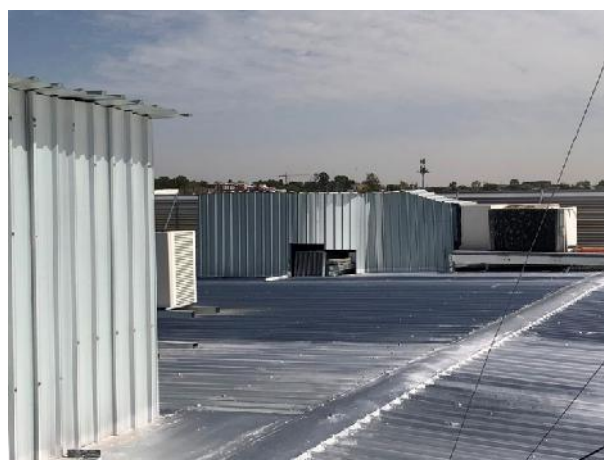
- The roof mounted AC units have had a metal clad enclosure constructed around the ductwork. It is understood to have been constructed to manage leaking ductwork, however this only hides a ductwork issue which is continuing to worsen. It is recommended these be removed as part of the AC replacement works (refer to the Mechanical section below).

Building A1/3 roof – AC enclosure

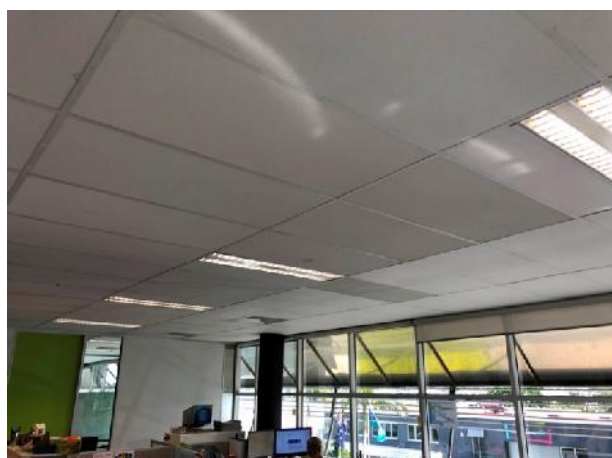
C&K tenancy – ceiling tiles have been replaced.

2.1.6	C&K Building - lower roof areas.	Fair condition; recommend increased R&M.	R&M	Moderate	\$ -	\$ 4,000	\$ 6,000	\$ 6,000	\$ 16,000
2.1.7	C&K Building Traning Centre - northeast corner, ground floor.	Investigate and repair water ingress visible through ceiling tiles.	R&M	Low	\$ -	\$ 10,000	\$ -	\$ -	\$ 10,000

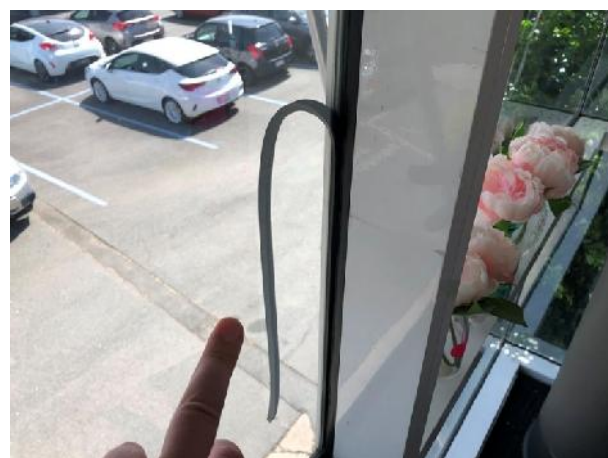
- Façade elements generally appear in fair condition throughout with no major concerns noted.
- Gaskets are typically dislodging from the window frames to Building A1/3. These should be reinstated to ensure the integrity of the glazing is intact and prevent water entry.

Typical window gasket dislodgement

2.2.1	C&K Building.	Gaskets are typically dislodging from window frames. Allow to reinstate/replace.	R&M	Low	\$ -	\$ 10,000	\$ -	\$ -	\$ 10,000
2.2.2	Tenant signage fixed to fascia's throughout.	Appears to be polyethylene Aluminium Composite Panel material, however low risk as signage could be considered to be exempt from recent legislation changes.			\$ -	\$ -	\$ -	\$ -	\$ -

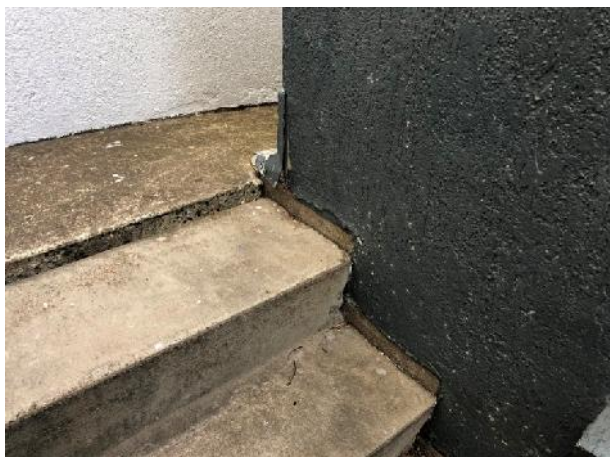
Minor subsidence to concrete path

3.3	Concrete path between C&K office and training buildings.	Further investigate subsidence to concrete steps. Allow provisional sum for repairs incl removing trip hazards.	R&M	Low	\$ -	\$ 10,000	\$ -	\$ -	\$ 10,000

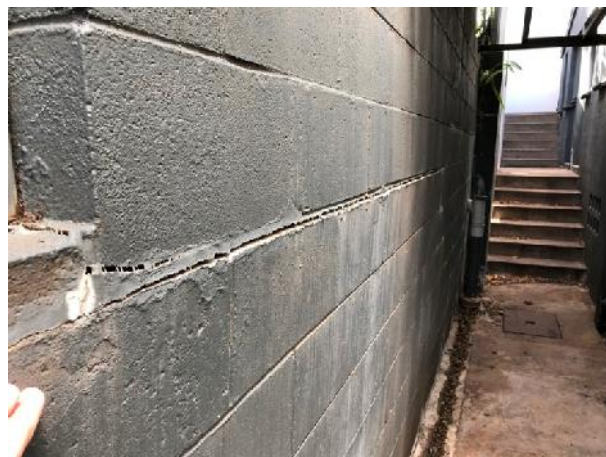
- External areas were noted to be generally in good condition throughout.
- Ongoing maintenance of finishes and landscaped areas will be required as part of OPEX.
- The retaining wall to the east of the C&K training centre has lateral movement which has occurred. The wall is bulging and should be stabilised; it cannot be confirmed from the inspection that the movement has ceased.
- Adjacent to the above, the concrete path has subsided creating a trip hazard. The trip hazard should be eliminated and the subsidence repaired.
- It is recommended to allow for repairs to the asphalt surfacing as the areas age over the term.

Bulge to retaining wall

3.2	Retaining wall to the east of C&K training centre.	Lateral movement noted. Stabilising works would be required if movement is dormant. Monitor movement and allow a provisional sum for repair.	R&M	Moderate	\$ -	\$ 20,000	\$ -	\$ -	\$ 20,000

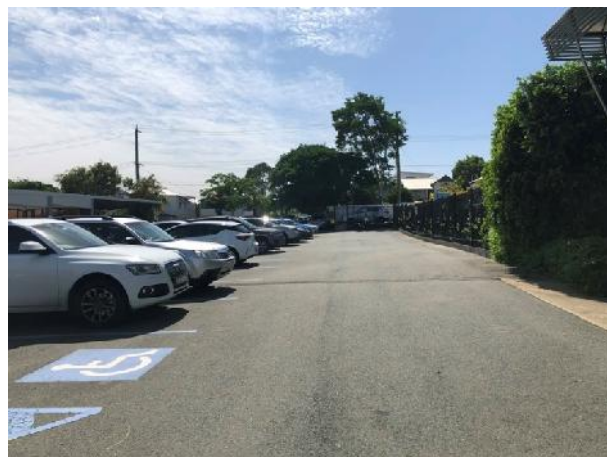
Asphalt driveways

3.7	Asphalt driveways/carparking.	Fair condition; allow for future repairs/partial replacement.	R&M	Moderate	\$ -	\$ 10,000	\$ 10,000	\$ 10,000	\$ 30,000

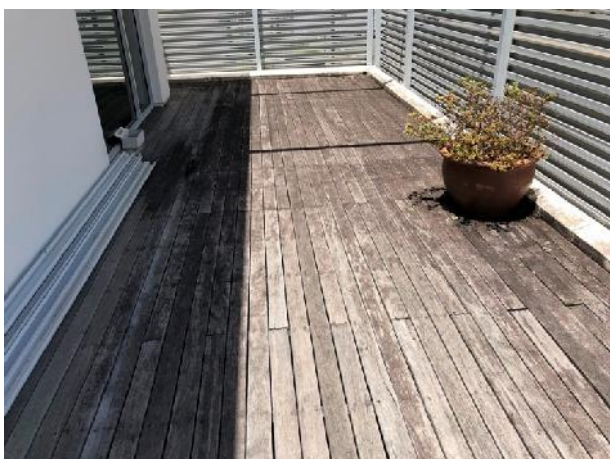
Timber decking to Building A2

2.2.3	Childcare Centre - under croft parking.	Monitor very minor water seepage through blockwork walls. Incl at Item 1.1			\$ -	\$ -	\$ -	\$ -	\$ -
2.2.4	255 Gympie Road - upper floor timber decking.	Fair condition. Allow for overhauling timber and treatment of decking.	R&M	Low	\$ -	\$ 8,000	\$ -	\$ -	\$ 8,000

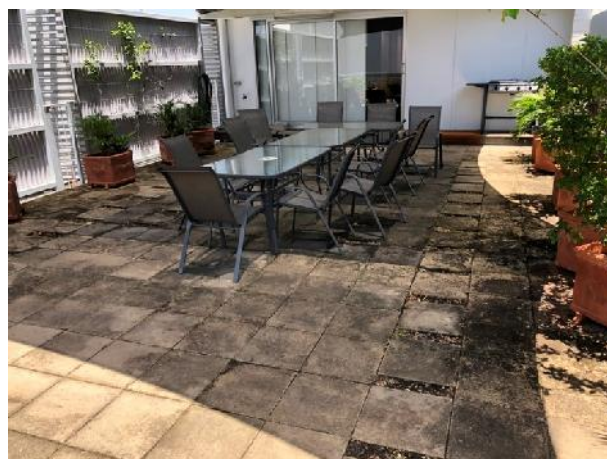
- Building A2 (Planbuild) is recommended to be budgeted for lifecycle replacement in the long term.
- The rear patio to Building A2 appears in poor condition, however there is no evidence of major water ingress into the office space below. Repairs have also been carried out as there is a section of roof which has been secured off from access. It is recommended that this area be monitored and an allowance for lifecycle replacement has been made in the CAPEX.

Building A2 – rear patio roof

2.1.9	255 Gympie Rd - rear sunshade over deck.	Lifecycle replacement	CAP	Low	\$ -	\$ -	\$ -	\$ 9,000	\$ 9,000
2.1.10	255 Gympie Rd - rear paved BBQ Area.	No major water ingress or issues reported/identified. The areas are aged; long term lifecycle replacement of membrane & pavers should be budgeted for.	CAP	Moderate	\$ -	\$ -	\$ -	\$ 45,000	\$ 45,000

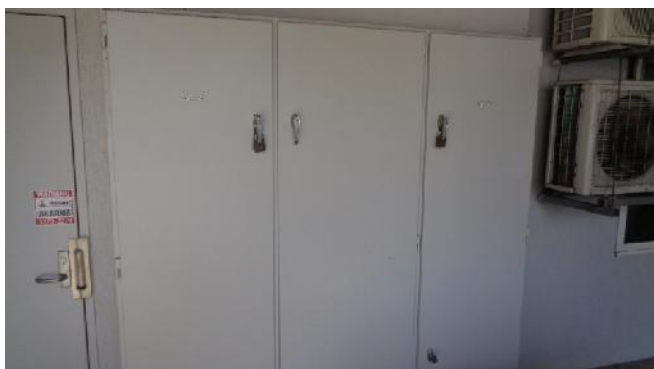
Main Switch board

4.4	Rooftop spilt ducted system.	Lifecycle replacement for unit 19.	CAP	Low	\$ -	\$ 16,200	\$ -	\$ -	\$ 16,200
<b>5 ELECTRICAL SERVICES</b>									
5.1	Main Electrical switchboard	Allow for a technology upgrade in the medium term.	CAP	Moderate	\$ -	\$ -	\$ 24,000	\$ -	\$ 24,000

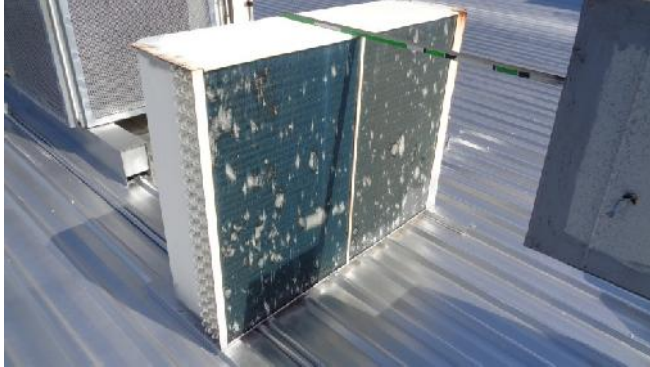
- Mechanical:**
- There are hail-damaged rooftop package AC units serving Building A1/3 (C&K) which are in poor condition and recommended for lifecycle replacement.

Hail damaged condenser

3.10	Blue exterior storage shed.	No access.			\$ -	\$ -	\$ -	\$ -	\$ -
<b>4 MECHANICAL SERVICES</b>									
4.1	C&K - main AC systems.	Lifecycle replacement for units 6 and 9-12.	CAP	Moderate	\$ -	\$ 168,000	\$ -	\$ -	\$ 168,000

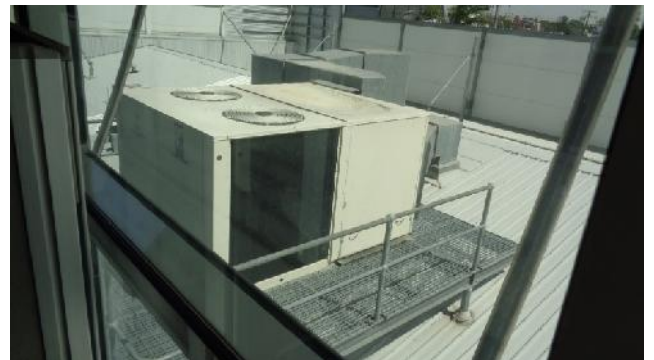
Hail damaged condenser

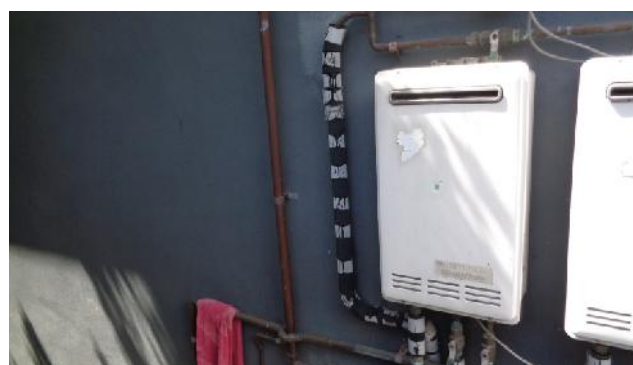
Gas fired water heaters

6.1	AS1851	No major capex anticipated - continue with statutory maintenance.			\$ -	\$ -	\$ -	\$ -	\$ -
<b>7 HYDRAULICS SERVICES</b>									
7.1	Hot Water units	Allow for replacement of Gas fired and electrical Hot water units in the medium and long term	CAP	Low	\$ -	\$ -	\$ 10,000	\$ 20,000	\$ 30,000
<b>8 VERTICAL TRANSPORTION</b>
