Red Flag Report

For and on behalf of
**CENTURIA FUNDS
MANAGEMENT (NZ) LIMITED**

6-14 Chappie Place
Hornby
Christchurch
New Zealand

FEBRUARY 2026
P25-0161

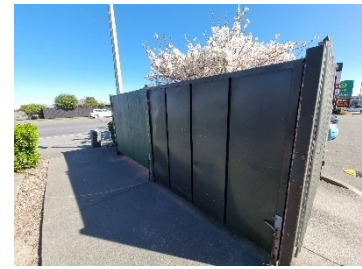
17. Impact damage to the bin storage panels.

Code	Defect	Recommendation	Timescale (yrs)	Approximate Cost
●	<p>Impact damage and general deterioration of the panels to enclosure.</p> <p>Bin enclosure to the west of the site (facing retail unit 3) blocks visibility of pedestrians waiting at the designated crossing.</p>	<p>Replace the freestanding bin structures in the long term.</p> <p>Consider relocating the bin enclosure towards the west of the site, adjacent to the crossing.</p>	10	\$15,000

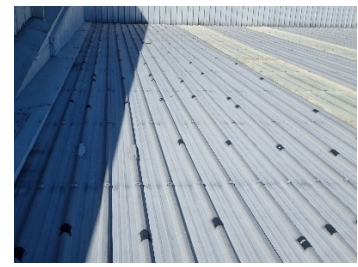
20. Block C - Multiple repairs to the roof cladding.

Code	Defect	Recommendation	Timescale (Yrs)	Approximate Cost
●	Block C – Repairs as recorded in FHS Roofing report.	See FHS Roofing report in Appendix C.	1	\$289,000
●	Block C - Several areas of impact damage to the crests of the roof sheets. Building tape and sealant applied as temporary measures. Internal moisture ingress reported by several tenants and evidenced by damage and staining to ceiling tiles.	Allow to replace roof sheets to entirety of Block C roof. Scaffolding and wrapping may be required should tenancies remain operational.	5-10 Years *Subject to recommended repairs being undertaken as outlined within the attached FHS report.	\$700,000 (estimate supplied by client)
●	Block B & C – Several areas of moisture ingress/ staining adjacent to membrane gutters. Limited width and depth of gutters in areas resulting in what appears to be backflow/ overflowing of gutters.	During roof replacement works, allow to improve gutter design/ capacity where possible to both blocks.	5-10 Years *Subject to recommended repairs being undertaken as outlined within the attached FHS report.	Included in roof replacement above.

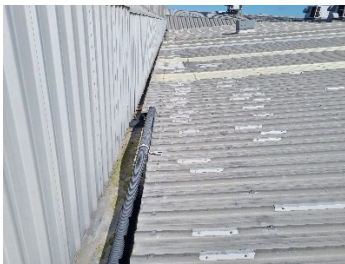
21. Block C - Multiple repairs to the roof cladding.

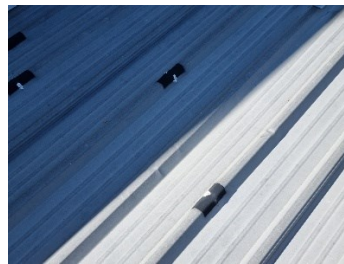
22. Block C - Multiple repairs to the roof cladding.

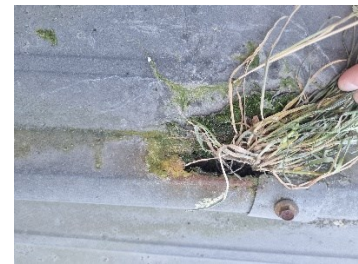
23. Block C - Roof sheets have corroded through. Vegetation growth in hole.

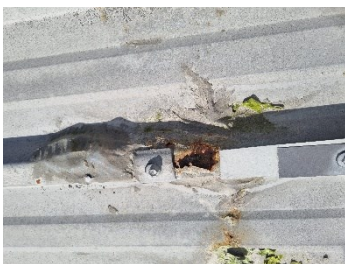
24. Block C - Roof sheets have corroded through.

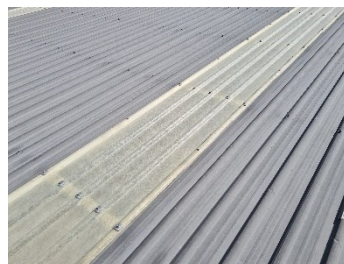
25. Block C - Brittle transparent clear light sheets spanning the length of the roof.

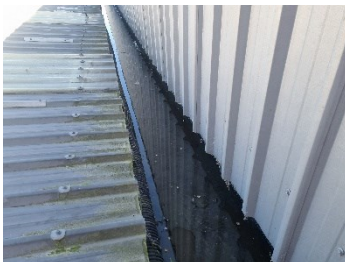
36. Block C - Ponding observed within the guttering.

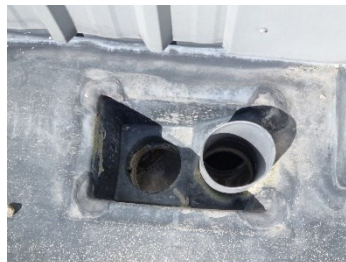
37. Block C - Lack of covers to downpipe outlets. No debris observed.

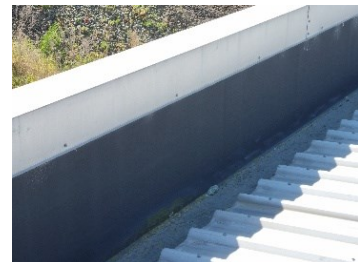
38. Block A - Vegetation growth within internal gutter.

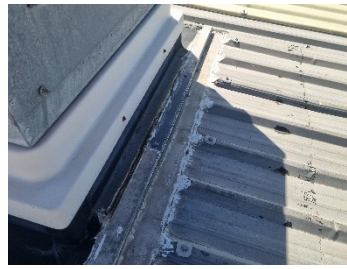
40. Block C - Sealant utilised to flashings to perimeter of service penetrations. Moisture ingress reported internally.

●	All Blocks - Sealant applied at various flashing junctions around service penetrations. Sealant is not a long-term solution and will allow moisture ingress over time.	Block A & B – Replace all sealant finishes on an annual basis. Block C - Replace all flashings during roof replacement works.	5-10 Years *Subject to recommended repairs being undertaken as outlined within the attached FHS report.	Included in roof replacement above.
●	All Blocks - Confirm whether design/ composition of composite panels poses a fire risk. Drawings and specification documents reference 'Alucobond' 6mm panelling but do not specify the exact type.	Allow for further investigation to confirm type and flammability of panelling.	1	\$4,500
●	Block B – Reports of historic and intermittent moisture internal moisture ingress around penetrations. No access available to Block B roof.	Further investigation required. Undertake additional roof investigation to confirm source of moisture ingress and acceptable repair solution.	1	\$2,500

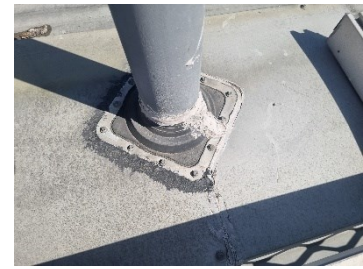
41. Block C - Sealant applied around boot flashings to service penetrations.

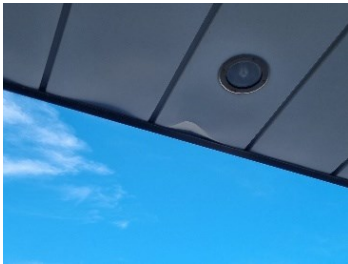
42. Block C - Localised areas of impact damaged to the profiled metal canopy soffit.

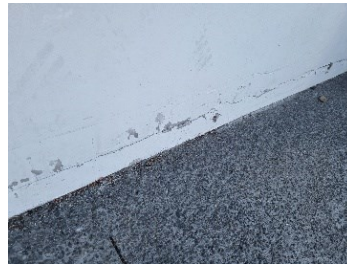
43. Block A - Peeling of painted finish and cracking to the panels.

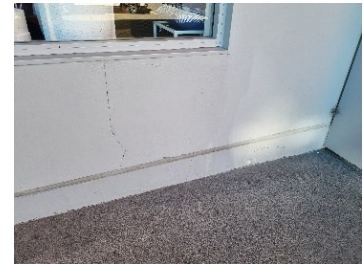
44. Block A - Cracking to the concrete panels below the windows.

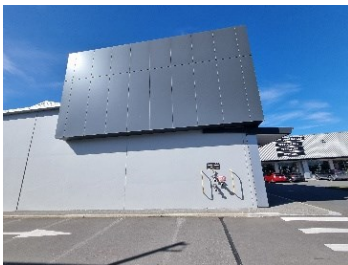
45. Block A - Aluminium composite panels utilised to localised areas.

- 4.3.5 As previously noted, there is concern that aluminium composite panelling, installed to the face of all blocks, may contain flammable cores or other fire defects. Documentation within the council file did not specify the exact panels used, only noting 'Alucobond 6mm' panels. A detailed breakdown of the composition of panels and their fire safety performance was not sighted. This should be investigated further by a qualified professional.

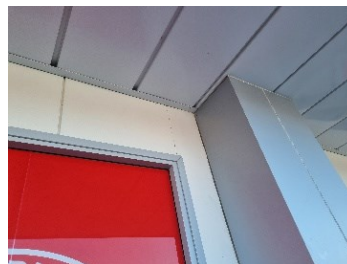
49. Block C - Hairline cracking to face of panels in localised areas.

●	Block C - General degradation and wear and tear to boot flashings.	Replace all flashings during roof sheet replacement works.	1	Included in roof replacement above.
●	Block C - Large number of open penetrations noted within the trapezoidal metal cladding adjacent to signage boards. May allow moisture ingress over time.	Replace panels where several open penetrations are noted.	1	\$25,000
●	All Blocks - Hairline cracking through concrete pre-cast panels. Increases the rate of degradation of concrete surrounding cracks.	Allow to fill cracks in concrete with epoxy solution.	1	\$4,000

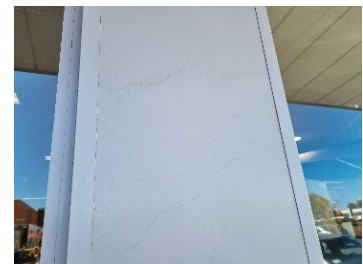
50. Block C - Hairline cracking adjacent to the windows.

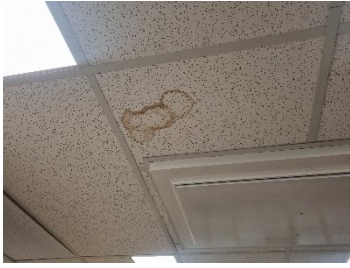
51. Block A - Moisture staining to ceiling tiles adjacent to roof access hatch.

●	All Blocks - Moisture staining to ceiling tiles throughout several tenancies as a result of water penetrations roofing.	Allow to replace all moisture damaged ceiling tiles throughout tenancies.	3	\$5,000
●	All Blocks – Cabinetry within kitchens is worn and has been damaged to some units.	Consider replacement of cabinetry in the medium to long term.	5	\$80,000

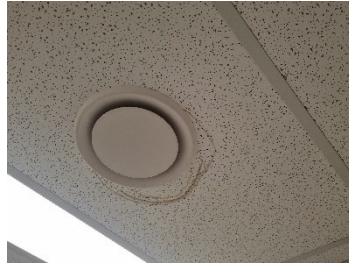
52. Block A - Moisture staining to ceiling tile adjacent to extractor fan in first level toilet.

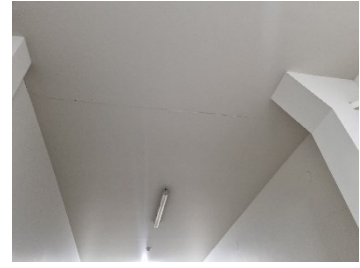
53. Block A - Hairline crack across plasterboard ceiling lining to toilet corridor.

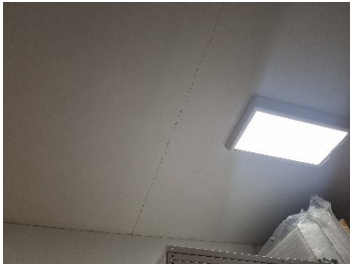
54. Block A - Hairline cracking across ceiling lining to warehouse corridor.

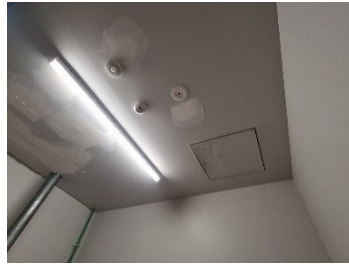
55. Block A - No access to roof from ceiling hatch to west exit.

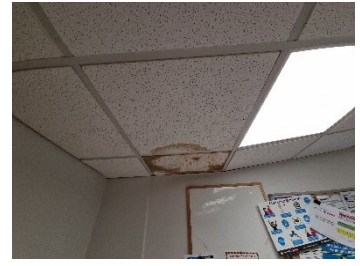
56. Block C - Moisture staining to the ceiling tiles to 'Carpet Court', mezzanine level.

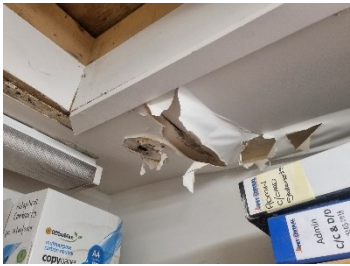
57. Block C - Moisture damage to plasterboard ceiling to 'Pet Central' mezzanine level.

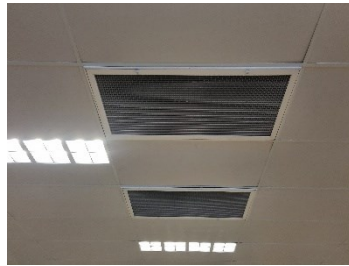
58. Block A - Reported area of moisture ingress between ventilation grilles.

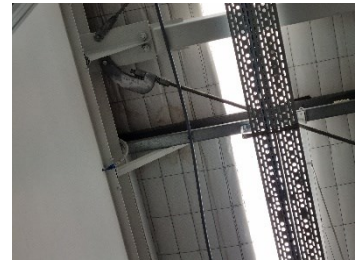
59. Block C - Moisture staining to the underside of roofing underlay to some units (photograph, Carpet Court).

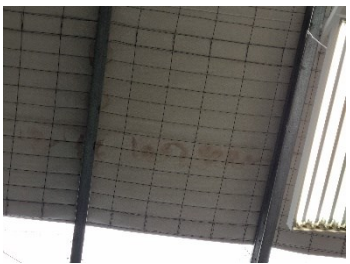
60. Block C - Moisture staining to the underside of roofing underlay to some units (photograph, 99 Bikes).

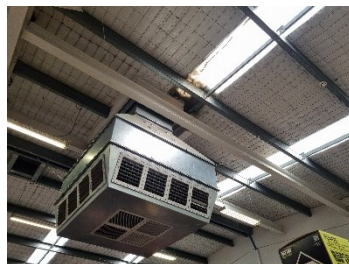
61. Block C - Leaking from the roof penetration. Noted reported in all units with the exception of retail unit 7. (Photograph, retail space 3).

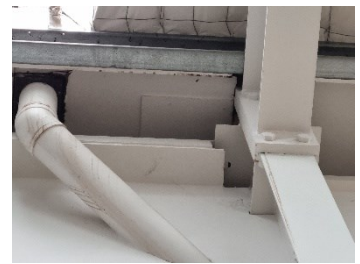
62. Block C - Moisture spotting to the underside of the internal gutter to west (Photograph, retail space 3).

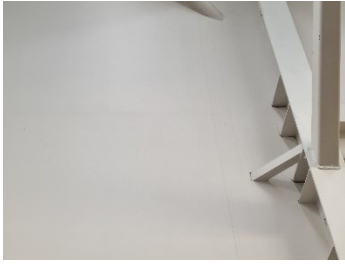
63. Block C - Moisture from the guttering tracks down the internal wall face (Photograph, retail space 3).

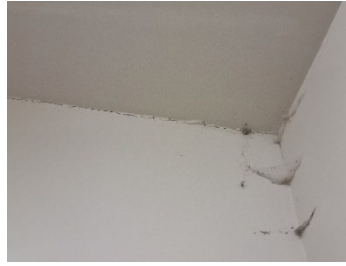
64. Block A - Cracking to the wall and ceiling junction in the rear service corridor.

Code	Defect	Recommendation	Timescale (Yrs)	Approximate Cost
●	Block A – Cracking to concrete and plasterboard walls around junction between warehouse extension to north and internal corridors.	Monitor cracking for any movement. Fill cracks and redecorate in the short term.	1	\$1,500
●	Block A & B - Efflorescence and moisture blistering to the base of concrete walls to the west of the building. Raised pavement has been created adjacent to external wall to west.	Consider installation of channel drain between kerb and exterior wall to partial west elevation.	3	\$3,500
●	All Blocks – Cracking in concrete slab floors. Depressions along concrete slabs of Blocks A & B (potentially control joints) damaging floor coverings and causing potential trip hazards in some areas.	Monitor cracking for any movement to exposed concrete slabs. Allow to uplift floor coverings in localised areas of Block A & B and inspect depressions across slabs prior to further recommendation.	1	TBC

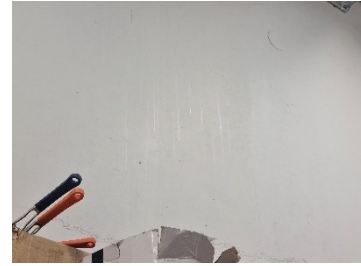
65. Block A - Moisture staining along interior face of east wall to warehouse corridor.

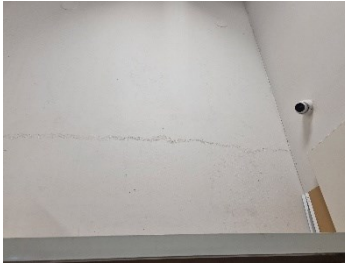
66. Block A - Cracking across interior face of east wall to warehouse corridor.

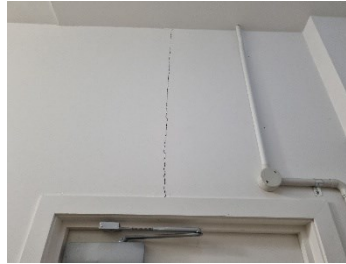
67. Block A - Vertical cracking above doorway to rear hallway.

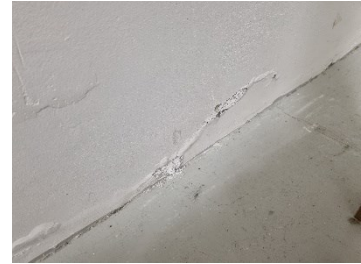
68. Block A - Moisture blistering and efflorescence to the base of the concrete wall to warehouse corridor to east.

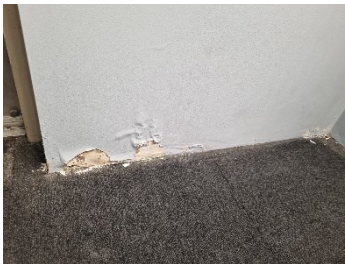
69. Block A - Moisture blistering to base of wall to west fire exit.

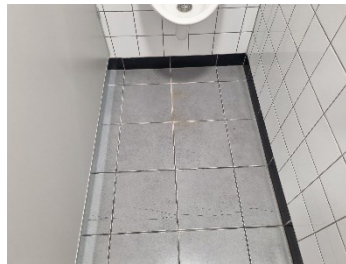
73. Block A - Cracking across tiled flooring within men's toilets towards north.

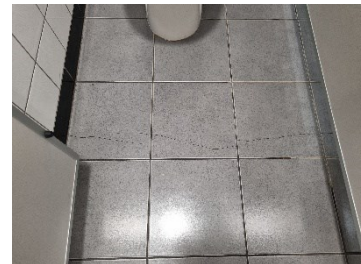
74. Block A - Cracking across tiled flooring within men's toilets towards north.

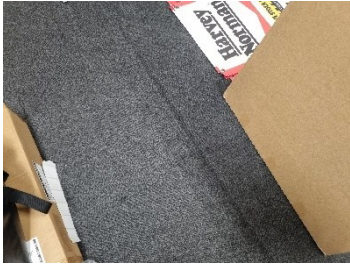
75. Block A & B - Crevices between concrete slabs to blocks are detectable beneath floor coverings, resulting in expediated wear.

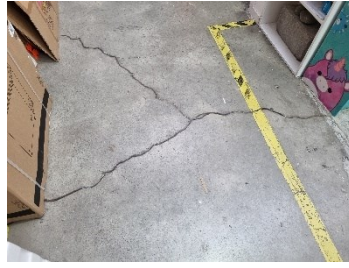
76. Block C - Cracking in concrete slabs noted to several units.

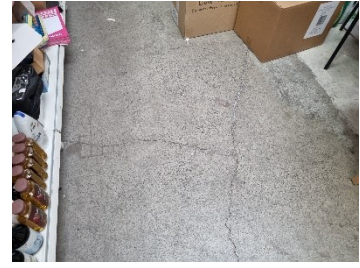
77. Block C - Cracking in concrete slabs noted to several units.

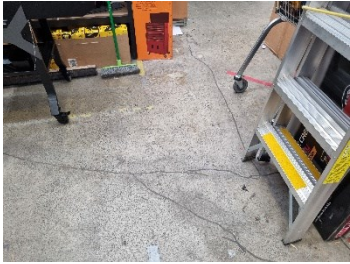
78. Block C - Cracking in concrete slabs noted to several units.

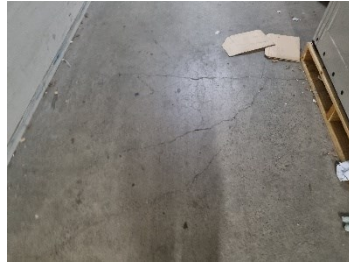
79. Block C - Cracking in concrete slabs noted to several units.

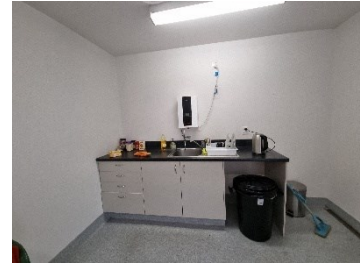
80. Block C - Typical view of kitchenette cabinetry. General wear and tear.

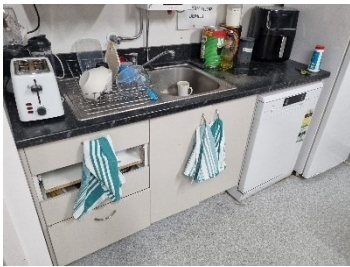
81. Block C - Typical view of kitchenette cabinetry. General wear and tear. Some cabinets damaged and reaching end of serviceable life.

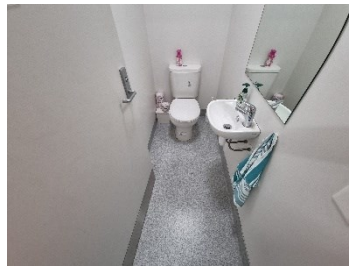
82. Block C - Typical view of toilet facilities. General wear and tear.

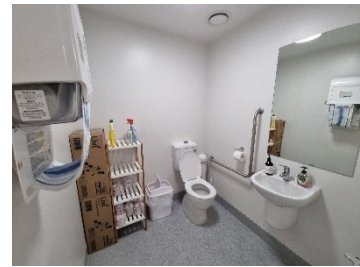
83. Block C - Typical view of accessible toilet facilities. General wear and tear.

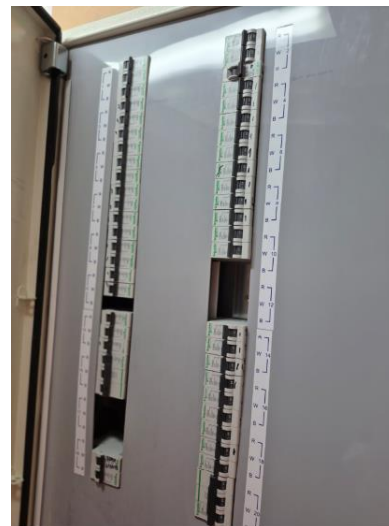
E4 – Pole fillers missing in DB

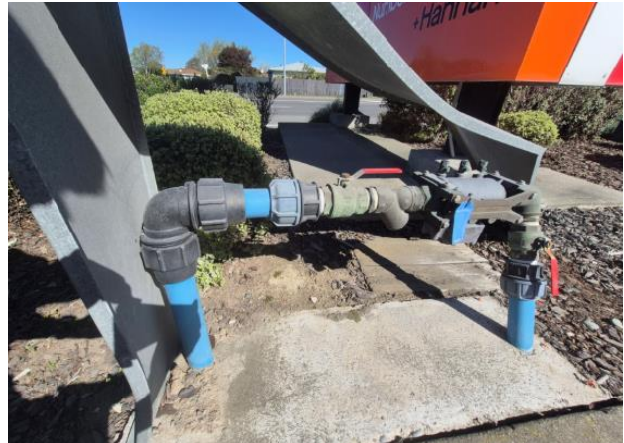
H2– Block C mains incoming water complete with high hazard backflow prevention unit. Note damaged vandal proof enclosure

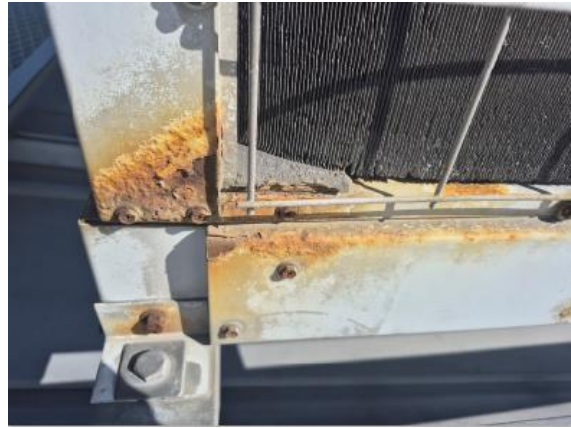
M2 – Block C PAC unit with moderate corrosion on chassis rails

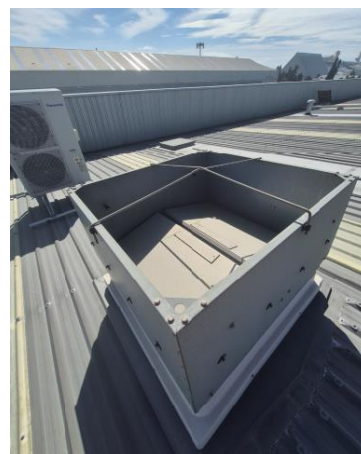
M6 – Smoke extract fan missing bird/vermin mesh

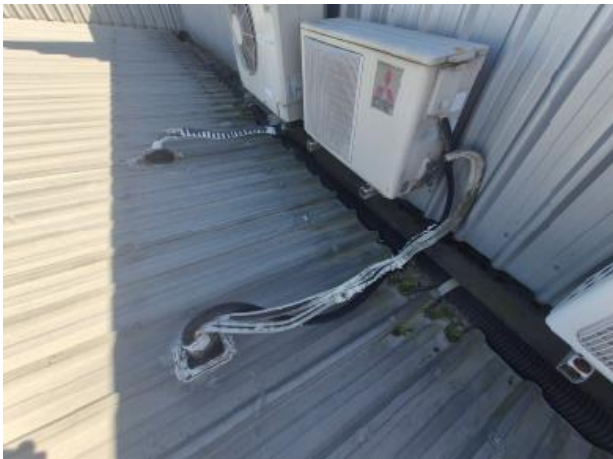
M7 – AC outdoor units with split insulation at seam leaving refrigerant. exposed
