Building Condition Assessment Report

230 Great South Road, Penrose, Auckland 1061

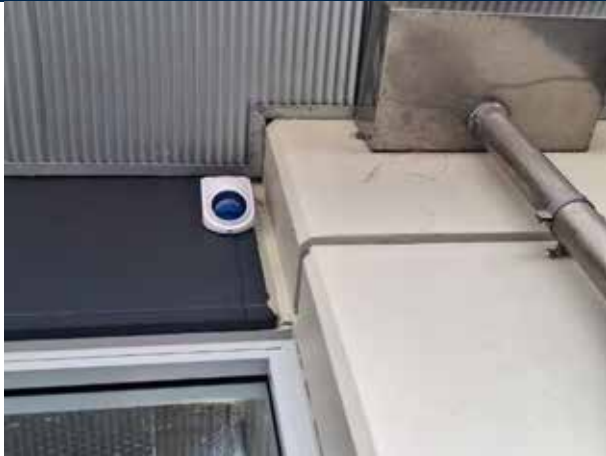
1. Localised moisture run-mark to the concrete wall panel as a result of a leak from the security alarm.

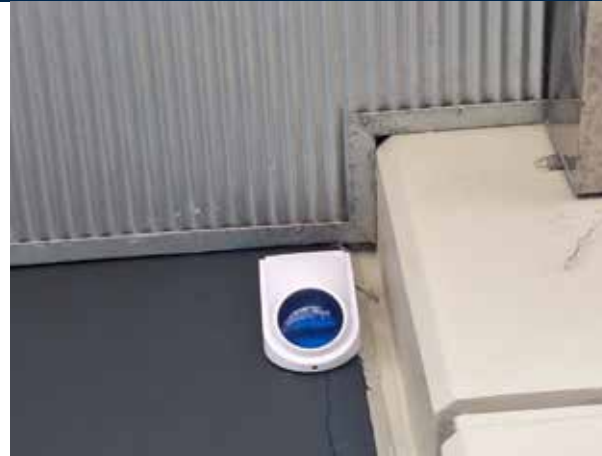
2. Localised moisture run-mark to the concrete wall panel as a result of a leak from the security alarm.

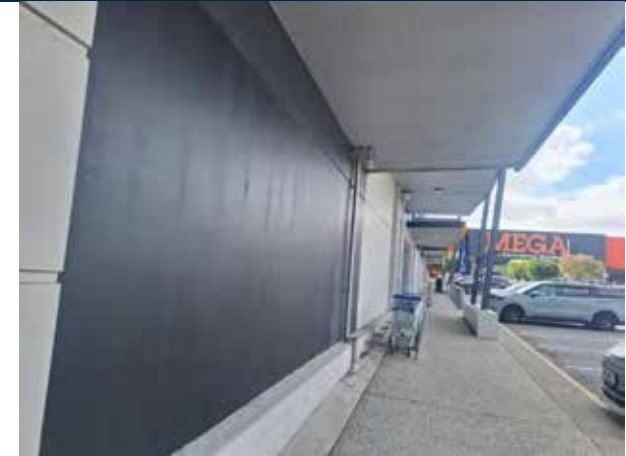
3. Sporadic areas of popping or recessed fixings to the fibre-cement cladding sheets.

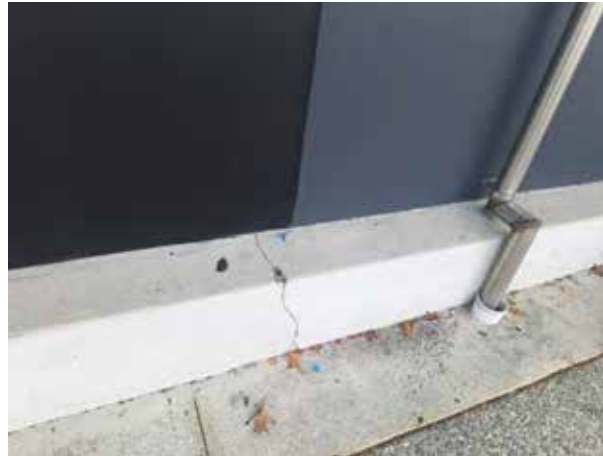
8. Localised cracking to the concrete nib walls.

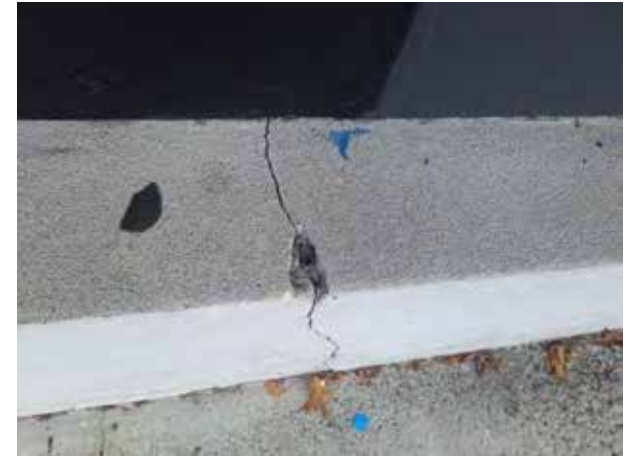
9. Localised cracking to the concrete nib walls.

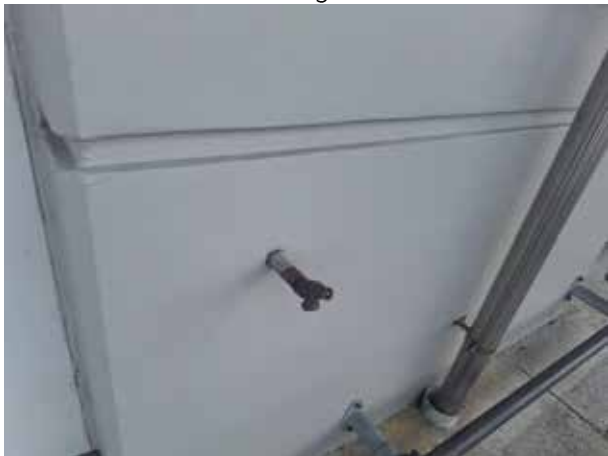
10. Sporadic areas of unsealed tap outlets to the concrete wall panels.

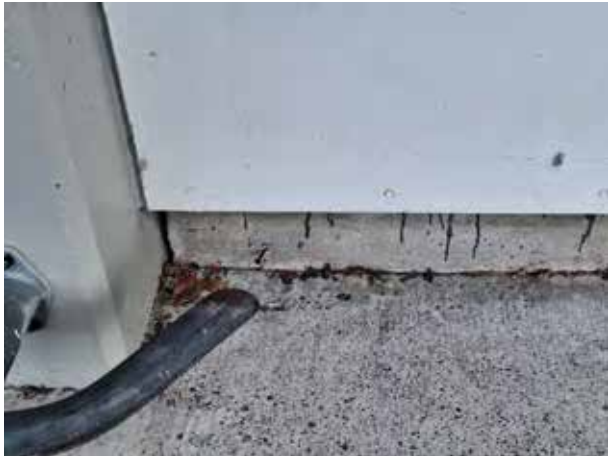
13. Localised area of residue staining to the external face of the concrete base and behind the fibre-cement cladding sheets.

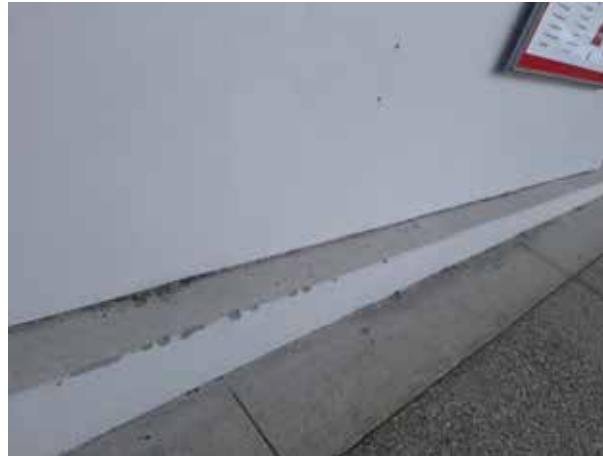
14. Sporadic areas of abrasions and impact damage to the concrete nib walls.

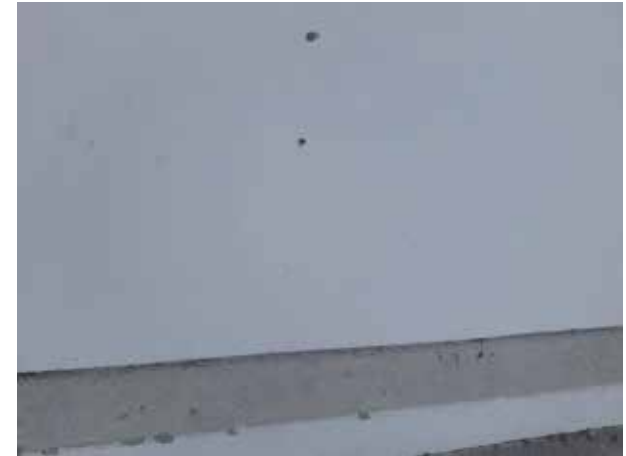
15. Sporadic areas of abrasions and impact damage to the concrete nib walls.

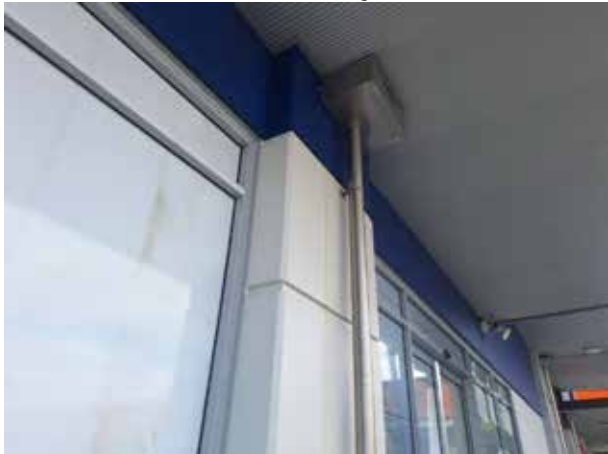
16. Localised corrosion run-off staining to the concrete wall panels emitting from the adjacent stainless-steel downpipe.

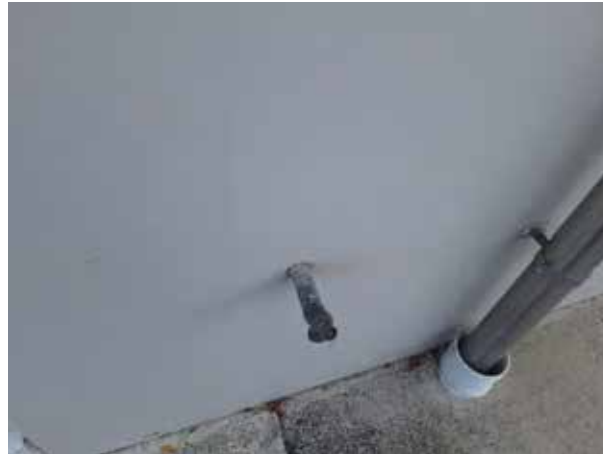
17. Sporadic areas of unsealed tap outlets to the concrete wall panels.

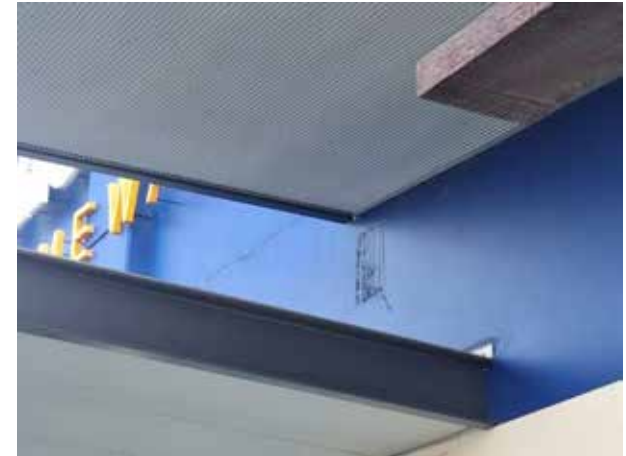
21. Localised residue staining to the upper-level horizontal concrete wall panels from a removed fixture.

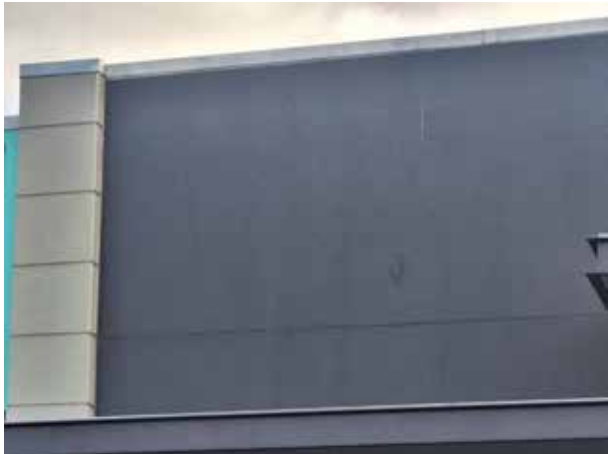
22. Localised blistering of the paint finish to the upper-level horizontal concrete wall panels.

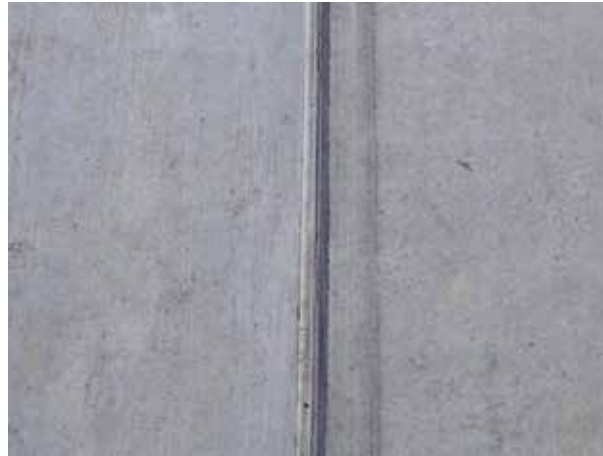
26. Sporadic areas of debonding and cracking to the sealant at the control joints of the concrete wall panels.

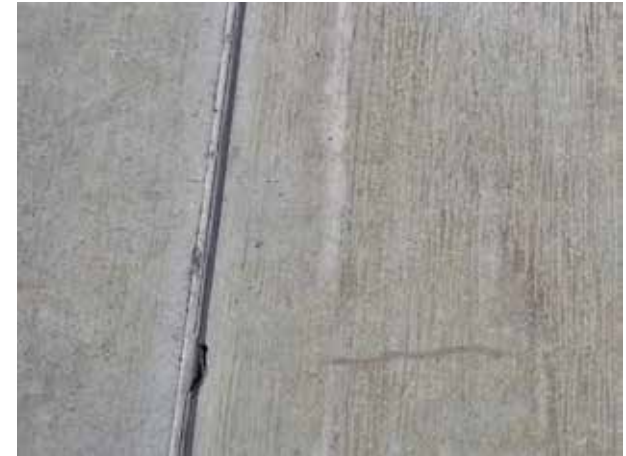
27. Sporadic areas of debonding and cracking to the sealant at the control joints of the concrete wall panels.

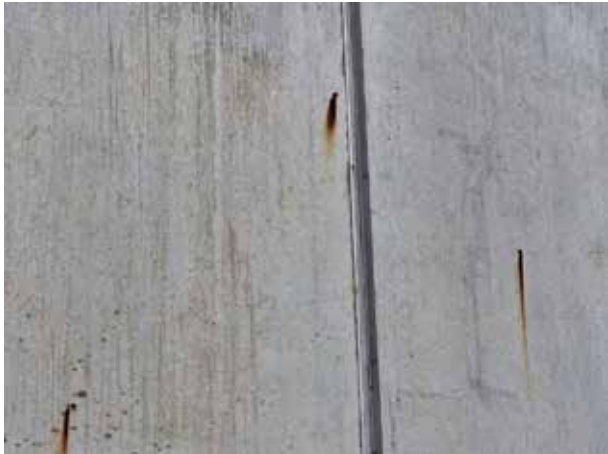
28. Sporadic areas of corrosion staining to the concrete wall panels. The corrosion staining appears to be leaching from the reinforcement bars of the concrete wall panels.

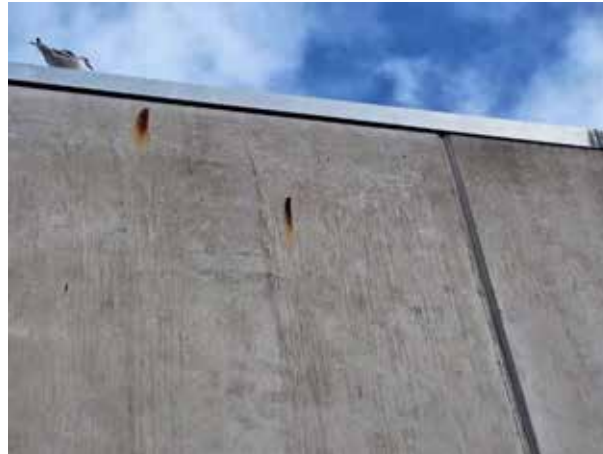
29. Sporadic areas of corrosion staining to the concrete wall panels. The corrosion staining appears to be leaching from the reinforcement bars of the concrete wall panels.

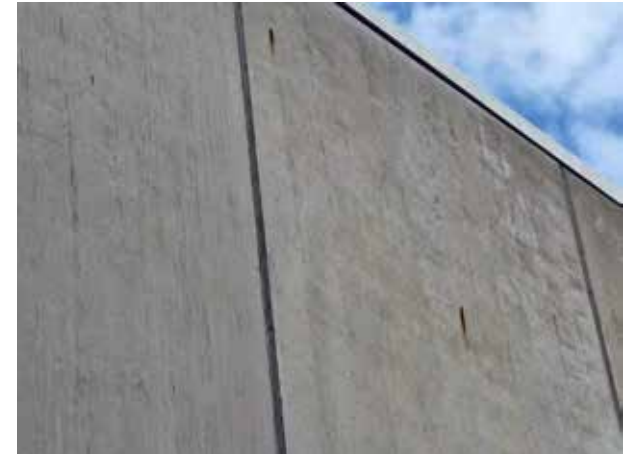
30. Sporadic areas of corrosion staining to the concrete wall panels. The corrosion staining appears to be leaching from the reinforcement bars of the concrete wall panels.

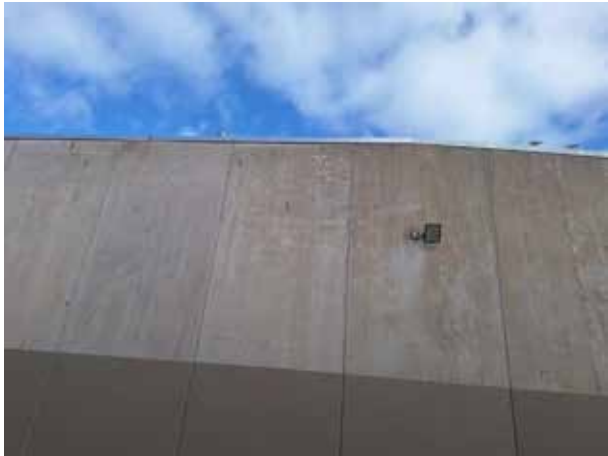
31. Widespread discoloration and staining to the concrete wall panels.

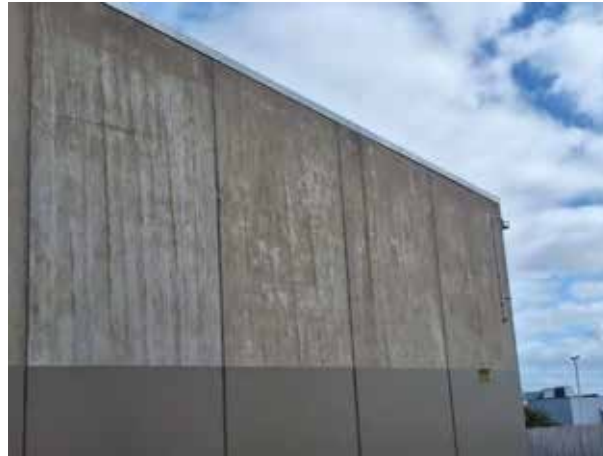
32. Widespread discoloration and staining to the concrete wall panels.

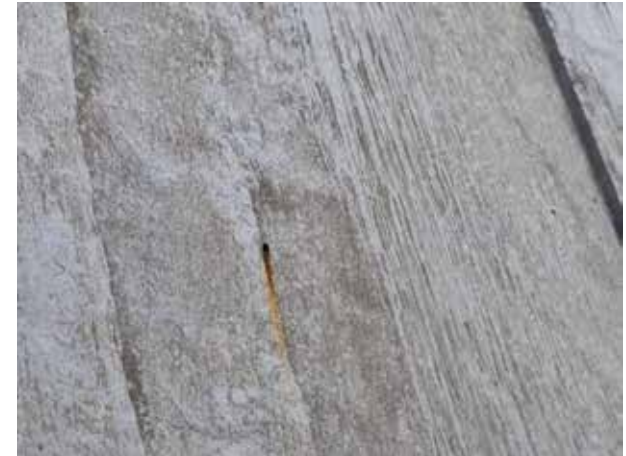
33. Sporadic areas of corrosion staining to the concrete wall panels. The corrosion staining appears to be leaching from the reinforcement bars of the concrete wall panels.

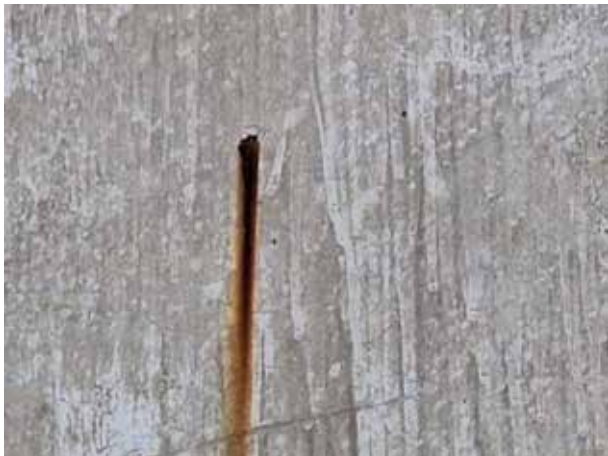
34. Sporadic areas of corrosion staining to the concrete wall panels. The corrosion staining appears to be leaching from the reinforcement bars of the concrete wall panels.

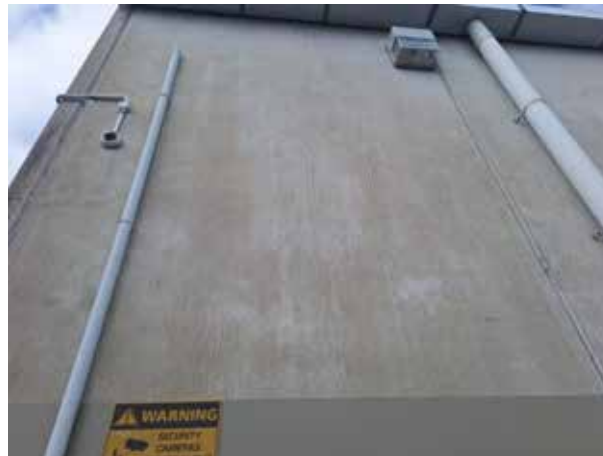
35. Widespread discoloration and staining to the concrete wall panels.

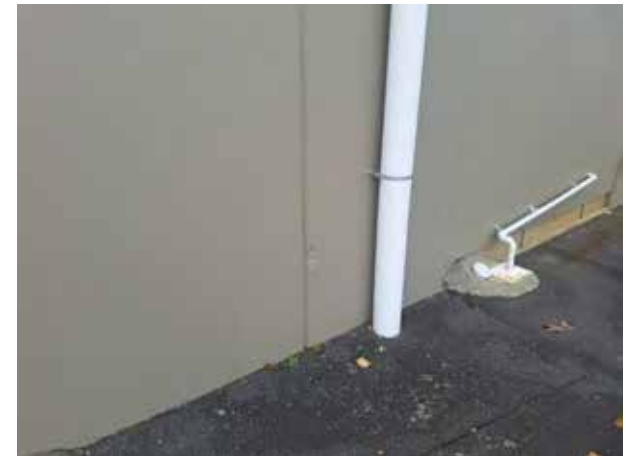
36. Sporadic areas of deterioration and spalling to the concrete wall panels.

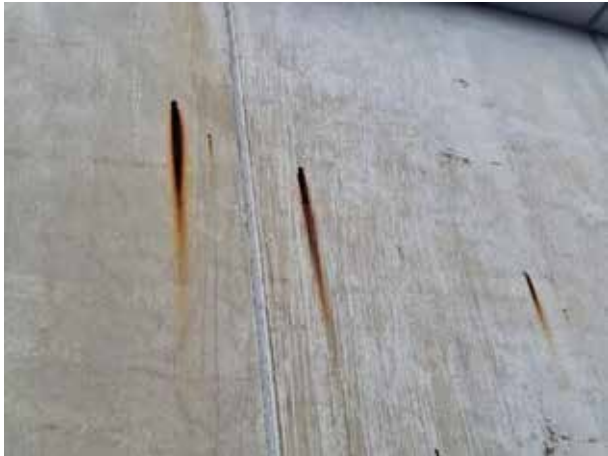
37. Sporadic areas of corrosion staining to the concrete wall panels. The corrosion staining appears to be leaching from the reinforcement bars of the concrete wall panels.

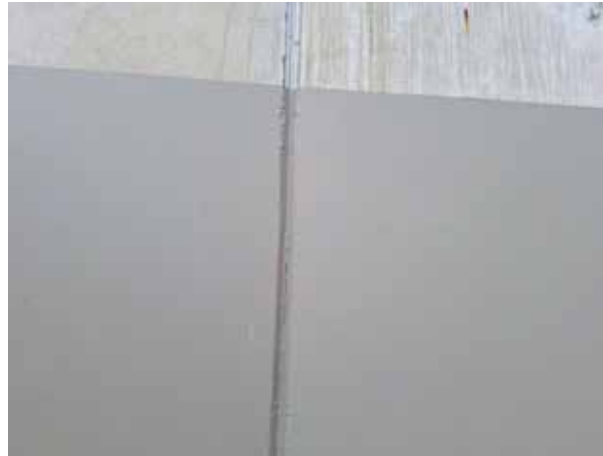
38. Sporadic areas of debonding and cracking to the sealant at the control joints of the concrete wall panels.

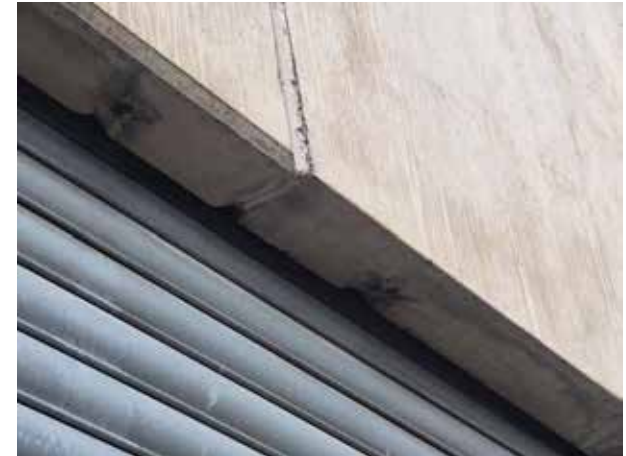
39. Localised spalling and exposed corroded reinforcement bars to the concrete wall panels above an opening.

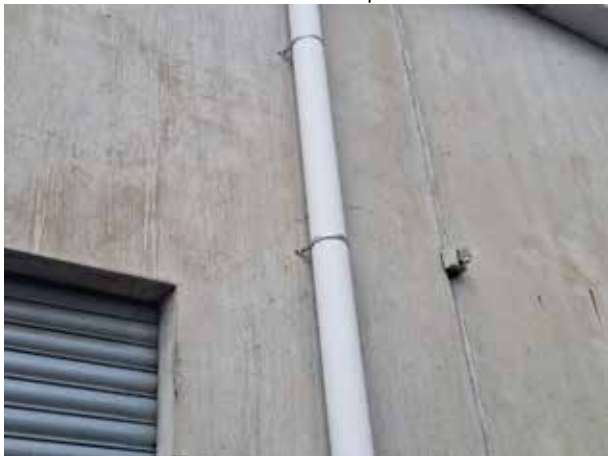
40. Widespread discolouration and staining to the concrete wall panels.

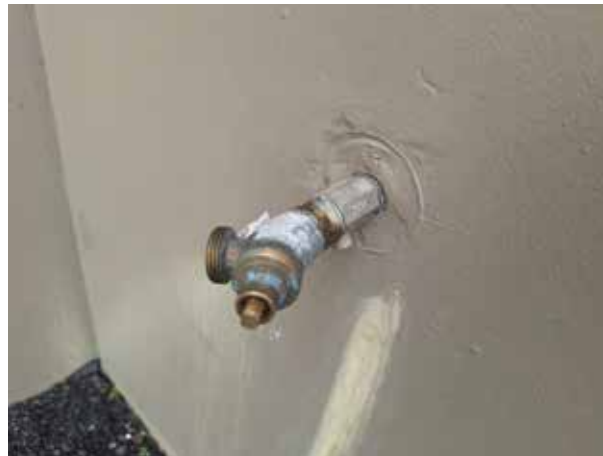
41. Localised minor deterioration to the sealant of the tap outlet.

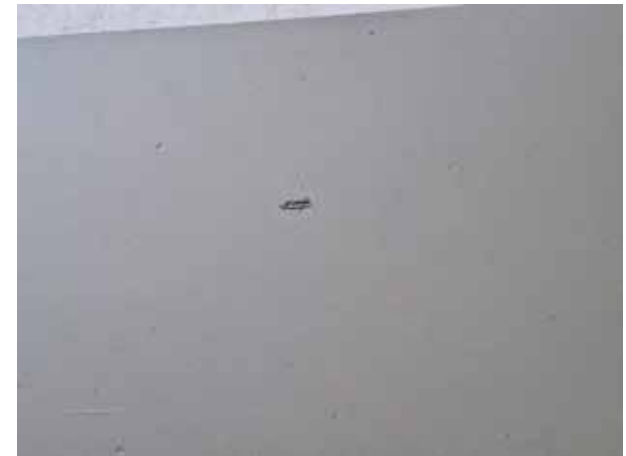
42. Localised exposed reinforcement bars to the concrete wall panels.

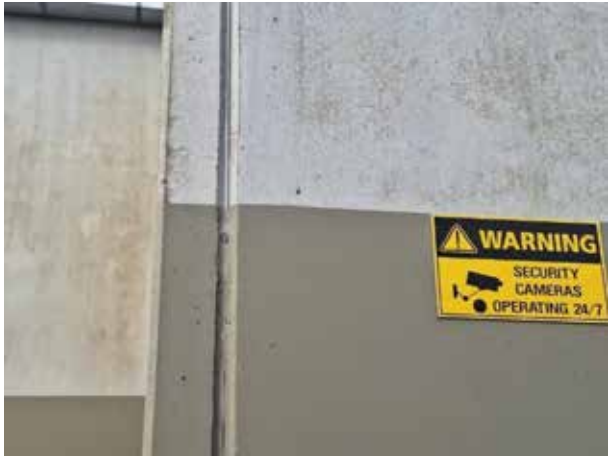
43. Sporadic areas of debonding and cracking to the sealant at the control joints of the concrete wall panels.

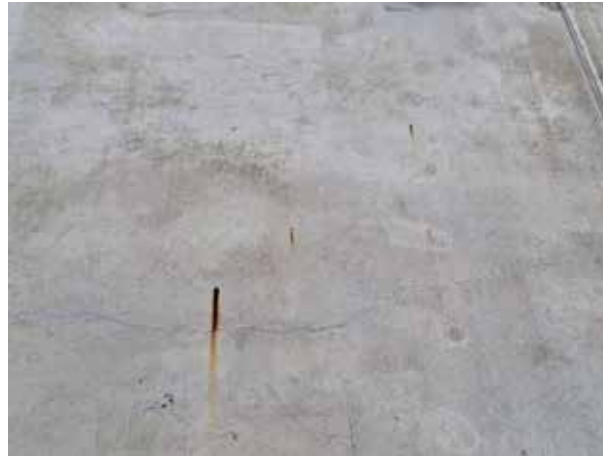
44. Sporadic areas of corrosion staining to the concrete wall panels. The corrosion staining appears to be leaching from the reinforcement bars of the concrete wall panels.

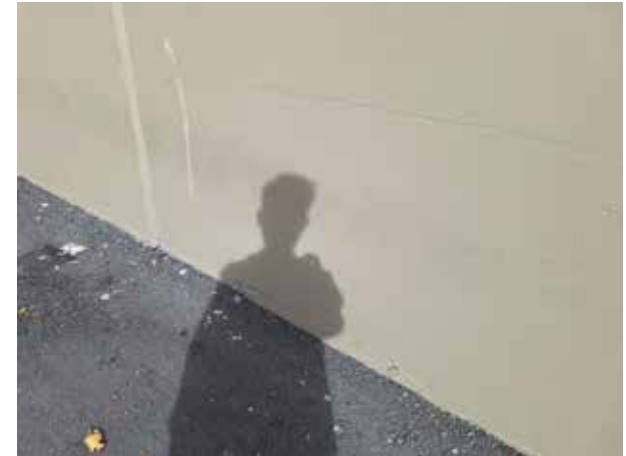
45. Sporadic areas of deterioration and spalling to the concrete wall panels.

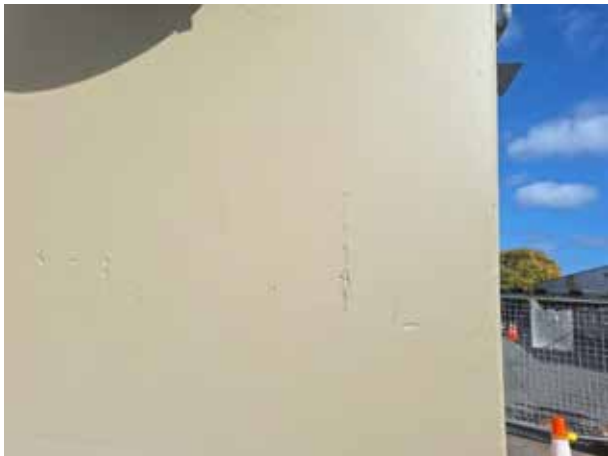
46. Sporadic areas of deterioration and spalling to the concrete wall panels.

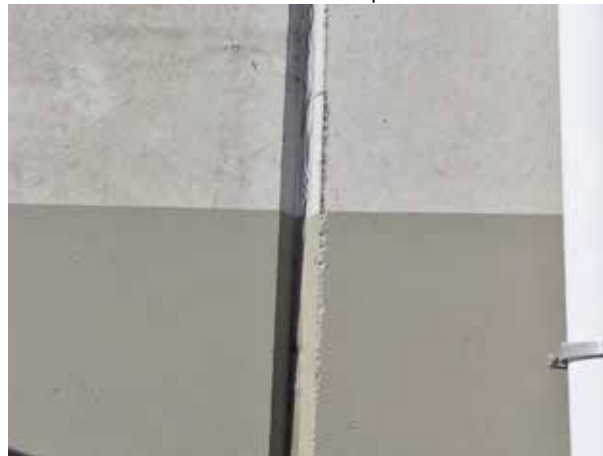
47. Sporadic areas of debonding and cracking to the sealant at the control joints of the concrete wall panels.

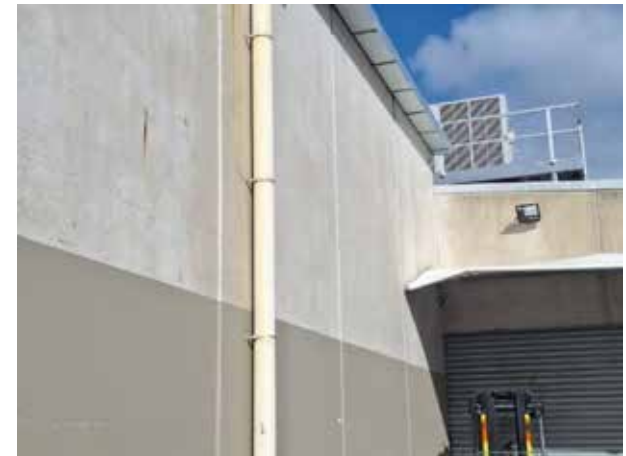
48. Widespread discoloration and staining to the concrete wall panels.

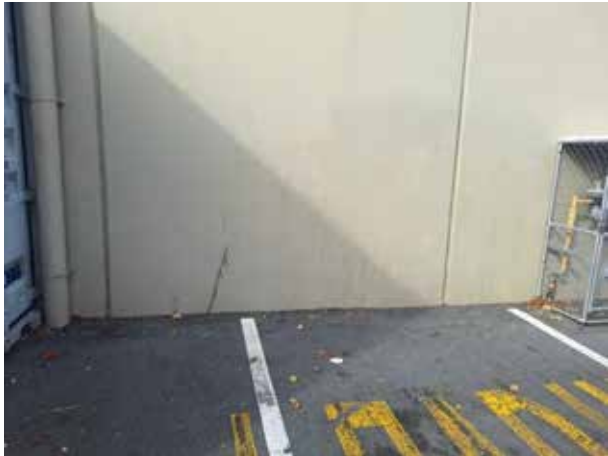
49. Localised surface corner cracking to the base of the concrete wall panels at the western elevation.

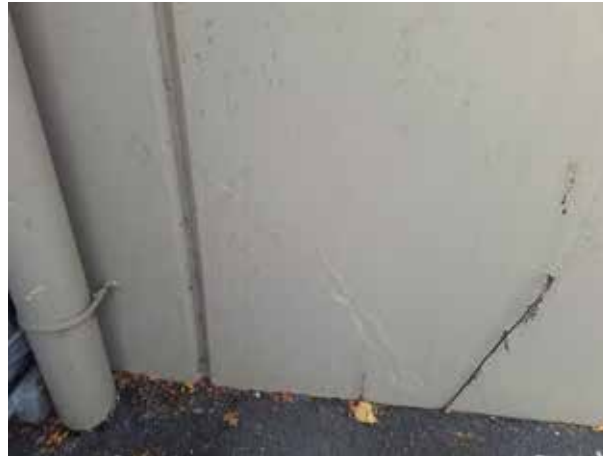
50. Localised surface corner cracking to the base of the concrete wall panels at the western elevation.

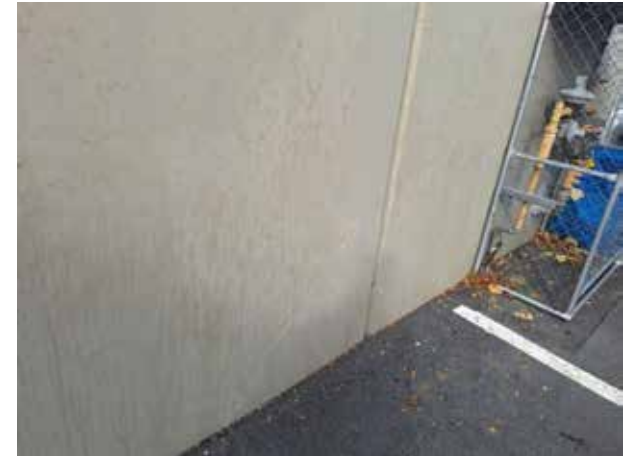
51. Localised surface corner cracking to the base of the concrete wall panels at the western elevation.

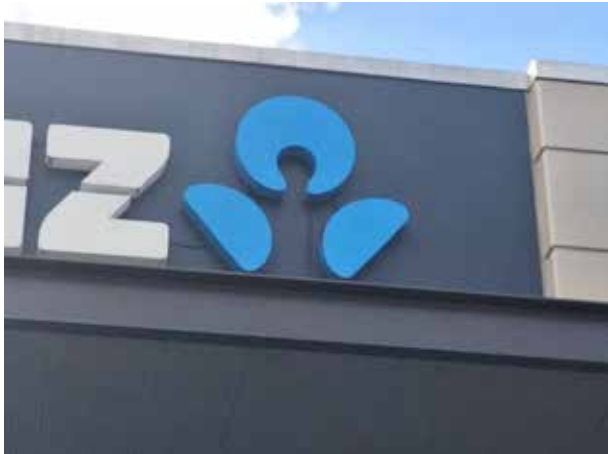
52. Localised discolouration to the upper-level horizontal concrete wall panels at the southern elevation.

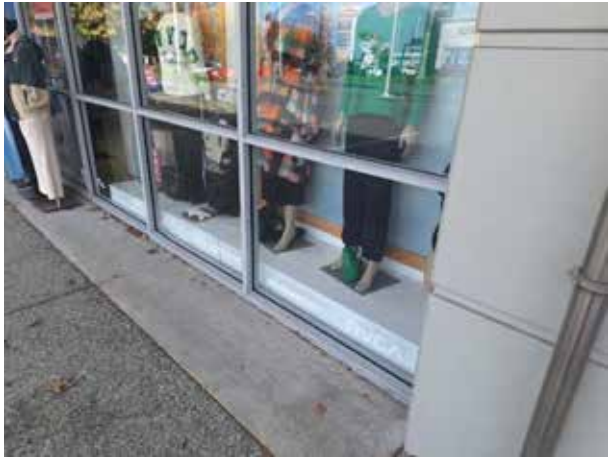
55. Sporadic areas of environmental staining to the aluminium shop front units.

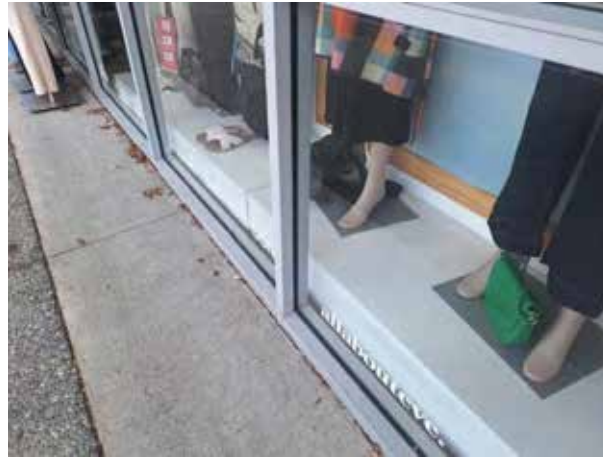
56. Sporadic areas of environmental staining to the aluminium shop front units.

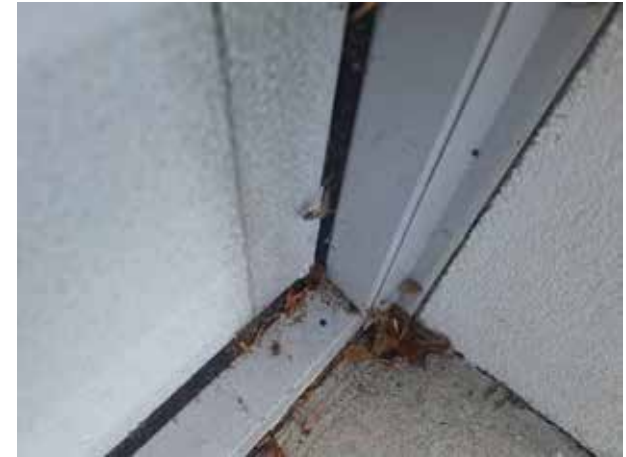
57. Sporadic areas of minor shrinkage of the glazing seals to the aluminium shop front units.

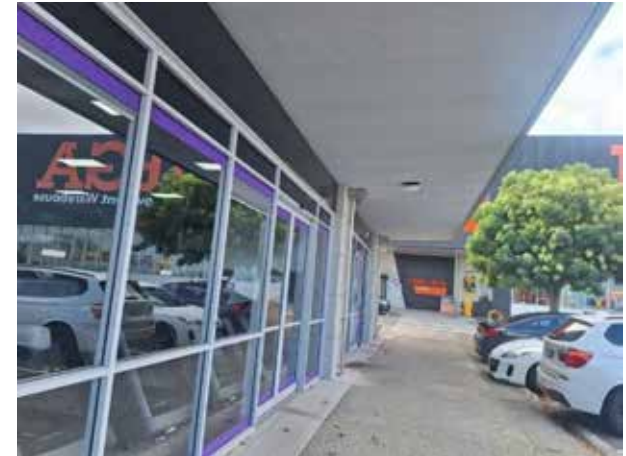
60. Sporadic areas of environmental staining to the aluminium shop front units.

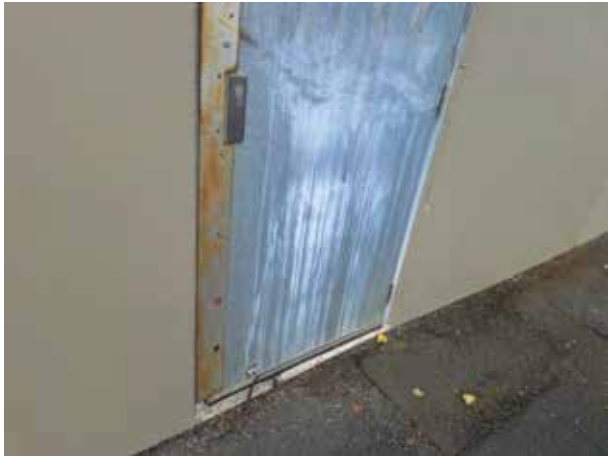
61. Sporadic areas of corrosion and discoloration to the galvanised steel hinged doors.

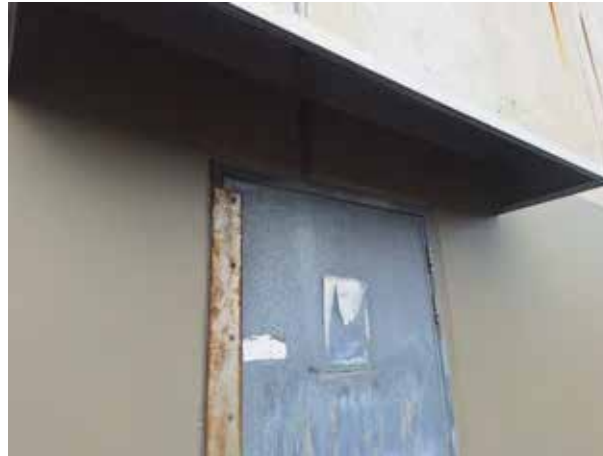
62. Sporadic areas of corrosion and discoloration to the galvanised steel hinged doors.

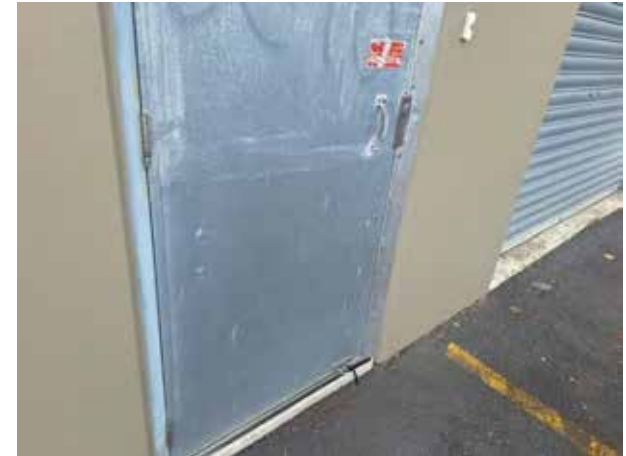
63. Sporadic areas of corrosion and discoloration to the galvanised steel hinged doors.

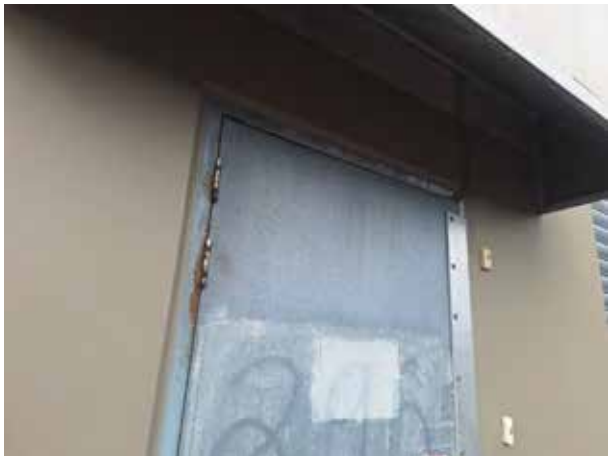
64. Sporadic areas of corrosion and discoloration to the galvanised steel hinged doors.

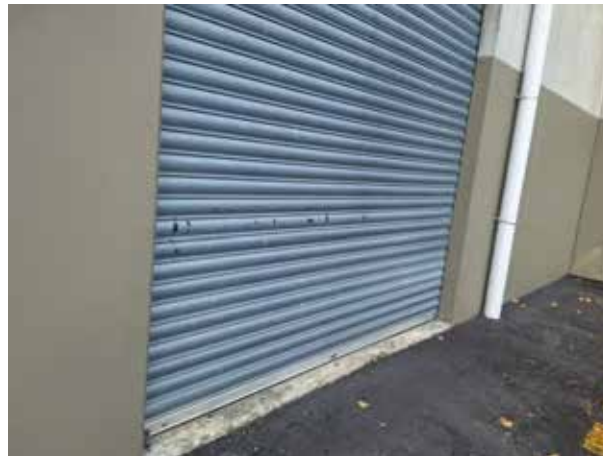
65. Sporadic areas of discoloration to the metal roller doors.

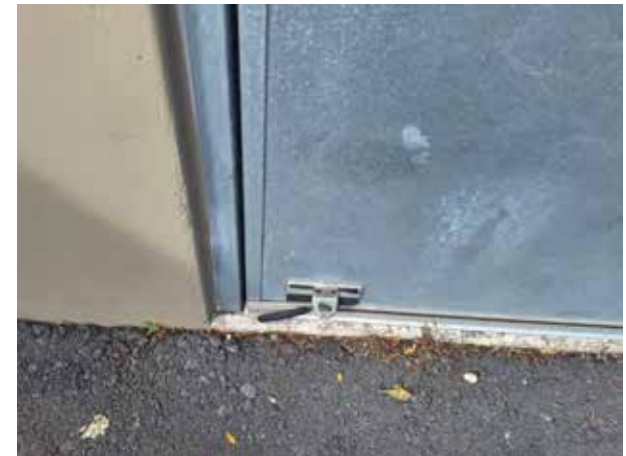
66. Sporadic areas of corrosion and discoloration to the galvanised steel hinged doors.

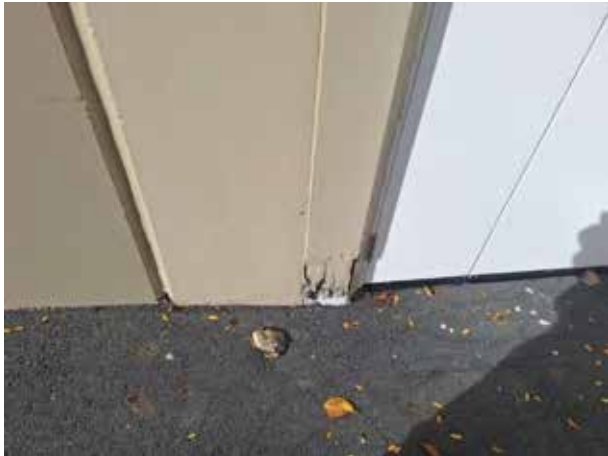
67. Localised swelling and damage to the timber liners at the western elevation.

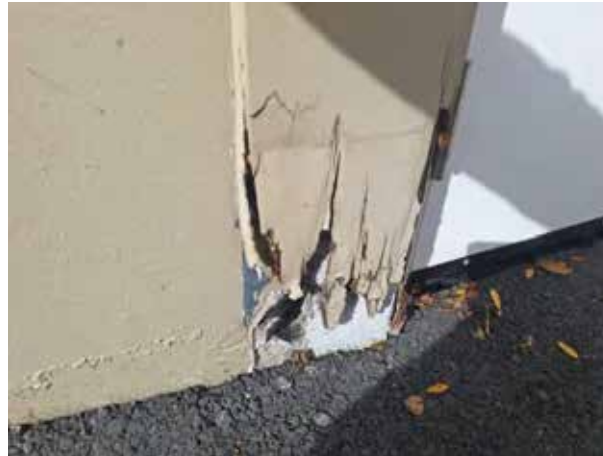
68. Localised swelling and damage to the timber liners at the western elevation.

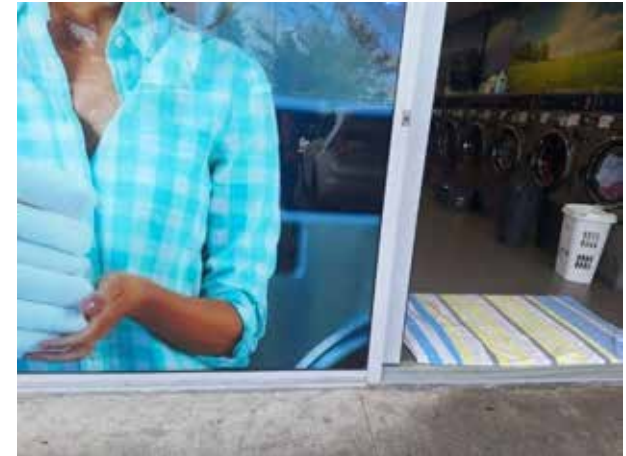
69. Sporadic areas of environmental staining to the aluminium shop front units.

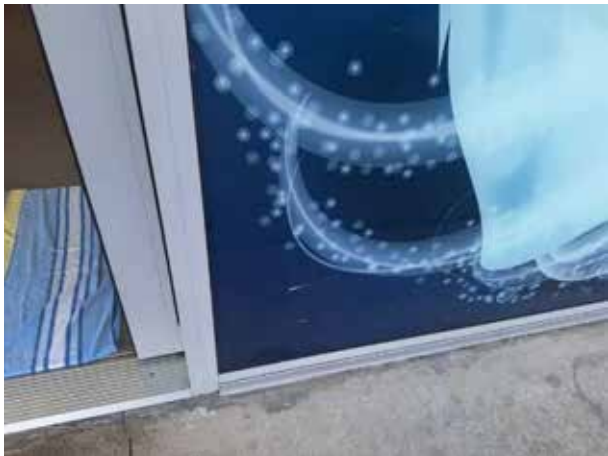
70. Sporadic areas of environmental staining to the aluminium shop front units.

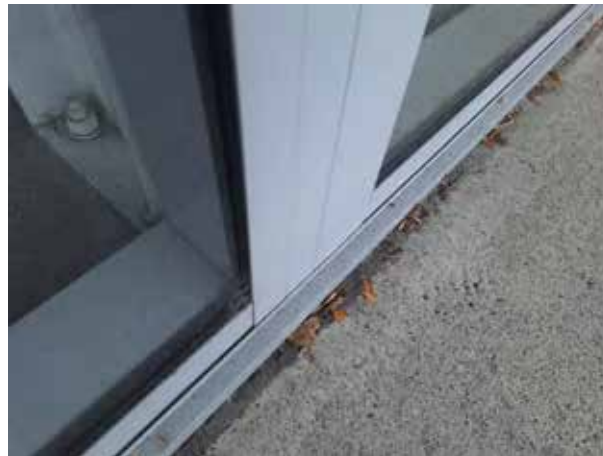
71. Sporadic areas of minor shrinkage of the glazing seals to the aluminium shop front units.

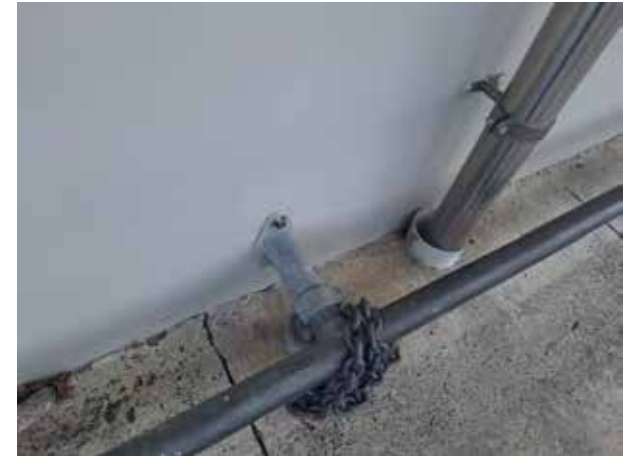
75. Sporadic areas of corrosion to the fixings of the metal bumper rails.

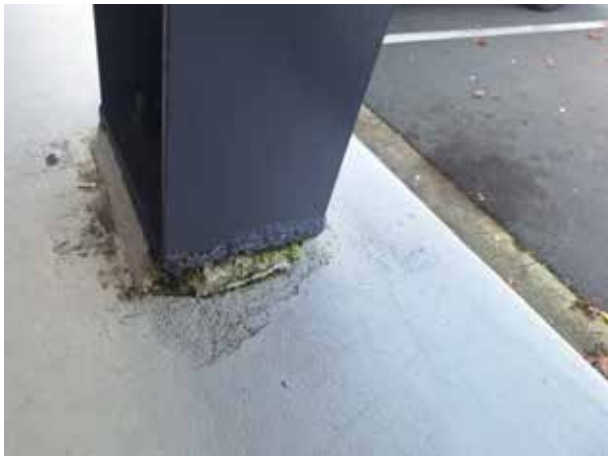
76. Sporadic areas of corrosion and deterioration of the finish to the base of the steel frame of the store signage.

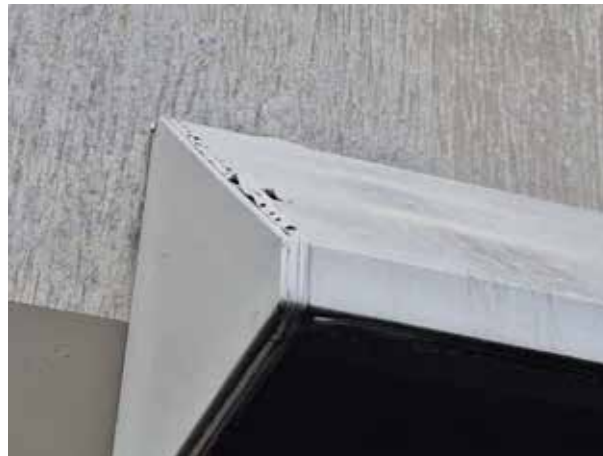
77. Sporadic areas of distortion to the metal door awning.

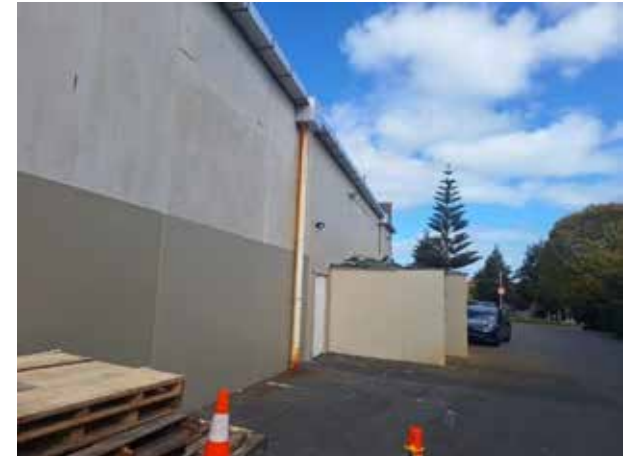
81. Localised extensive staining to the external metal gutter and to the downpipe.

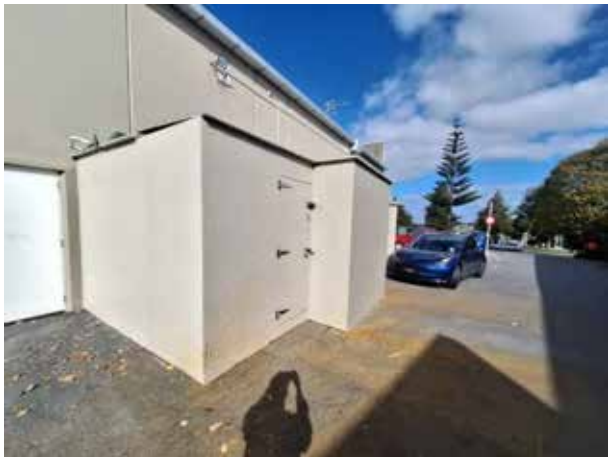
82. Sporadic areas of environmental staining to the plant shed.

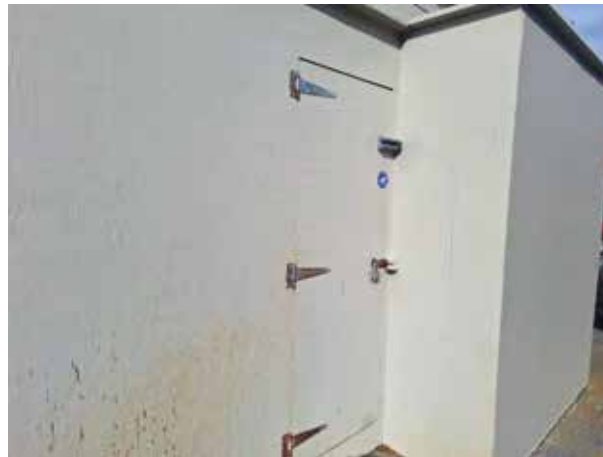
83. Widespread corrosion to the door brackets.

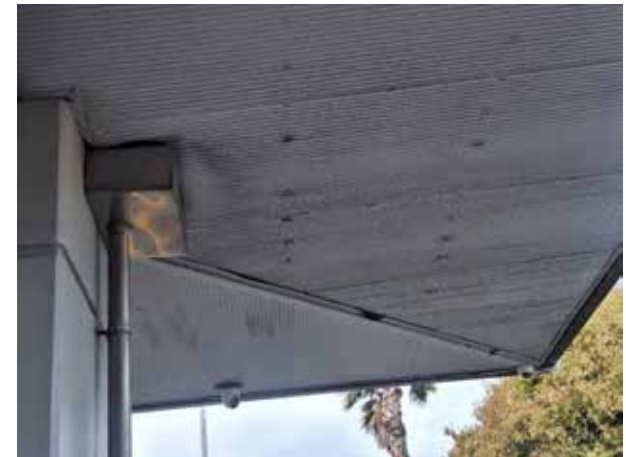
84. Localised corrosion to the underside of the canopy.

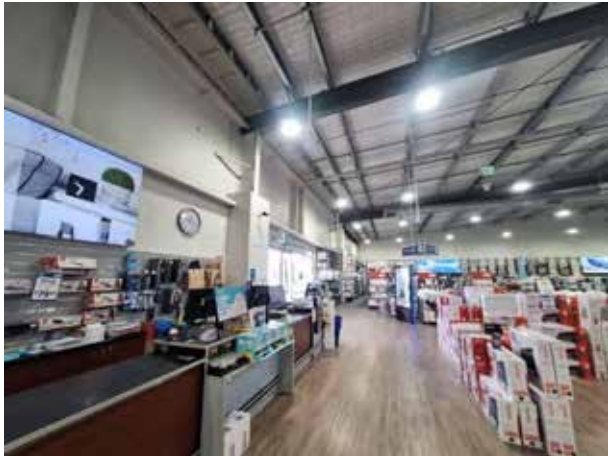
85. Example of the internal condition.

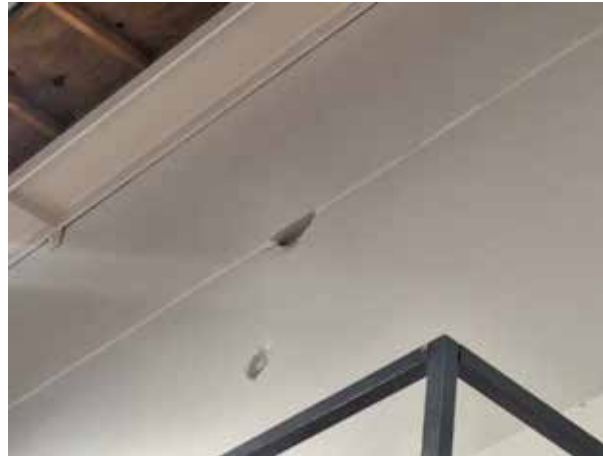
86. Localised deterioration of the edge to the upper-level horizontal concrete wall panels.

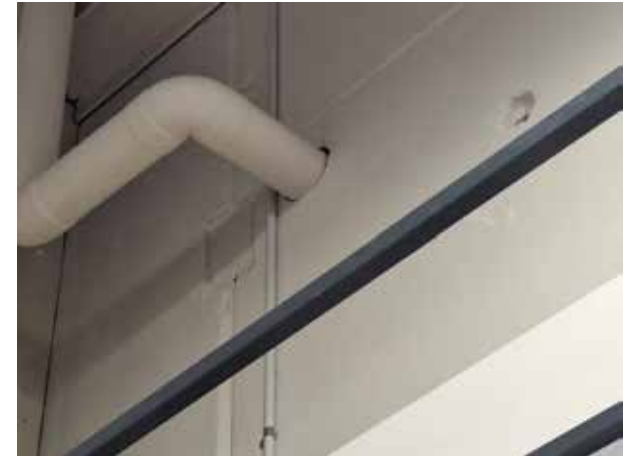
87. Widespread corrosion to the steel embedded plates of the concrete wall panels.

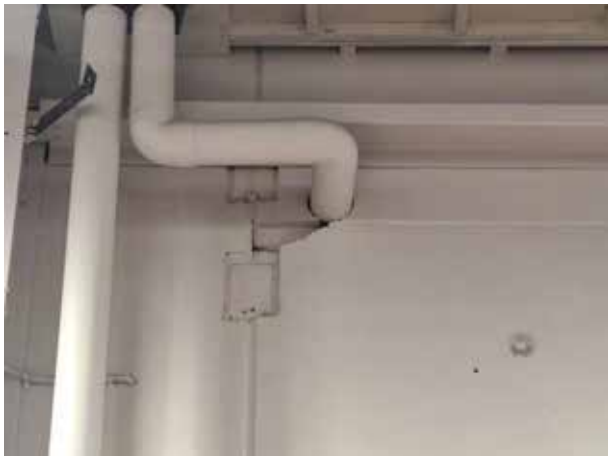
88. Widespread corrosion to the steel embedded plates of the concrete wall panels.

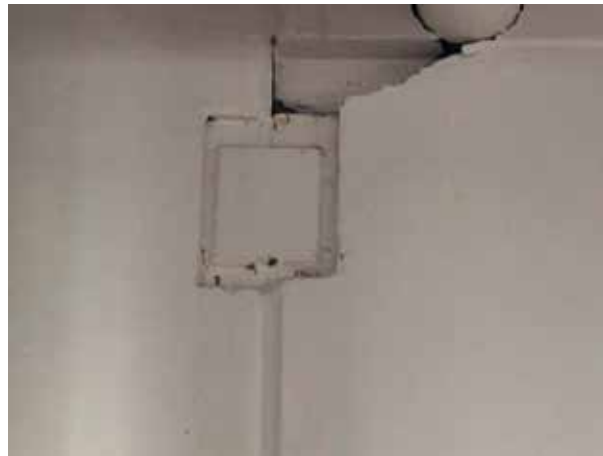
89. Widespread corrosion to the steel embedded plates of the concrete wall panels.

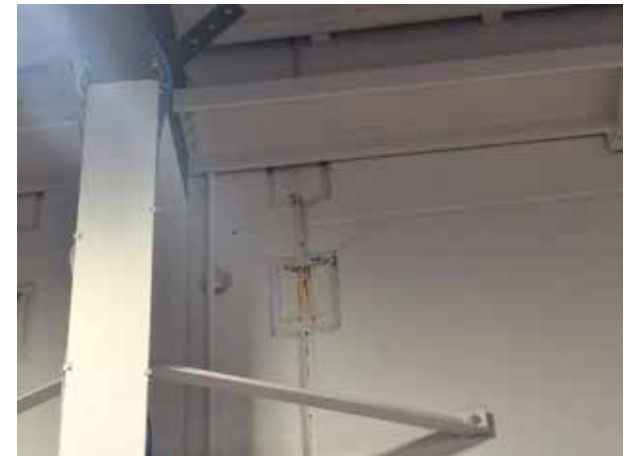
90. Widespread corrosion to the steel embedded plates of the concrete wall panels.

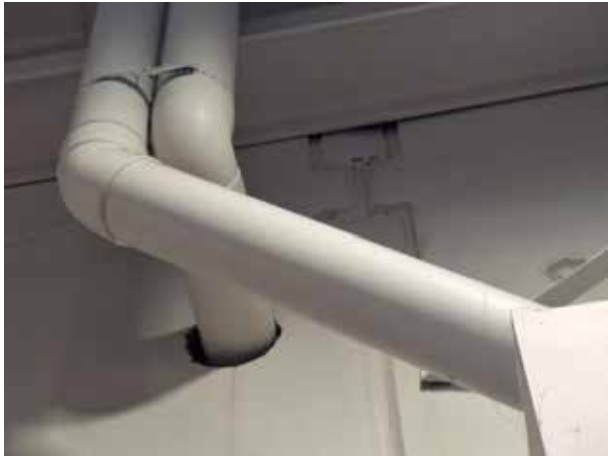
91. Localised unsealed pipe penetration to the concrete wall panels.

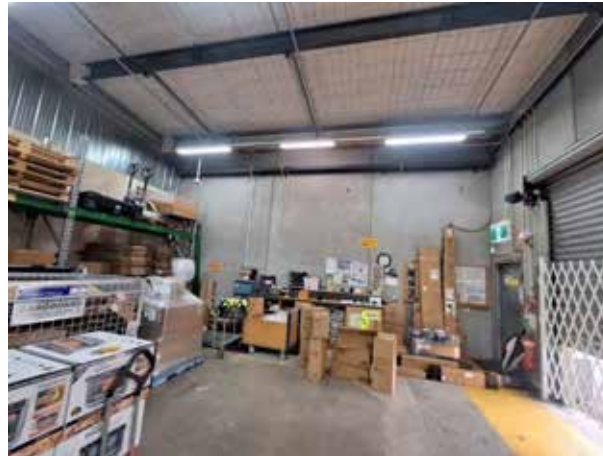
92. Example of the internal condition.

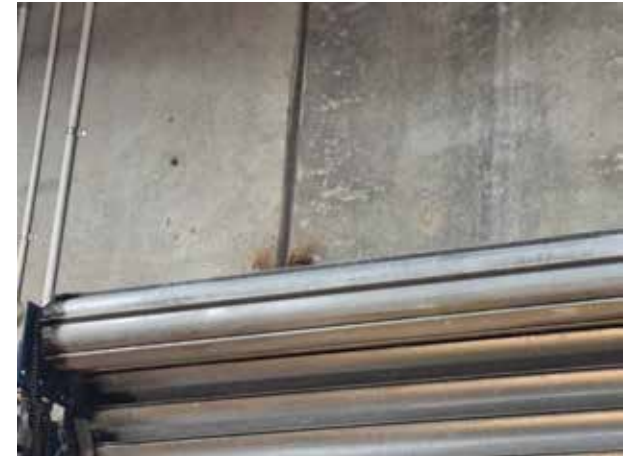
93. Widespread corrosion to the steel embedded plates of the concrete wall panels.

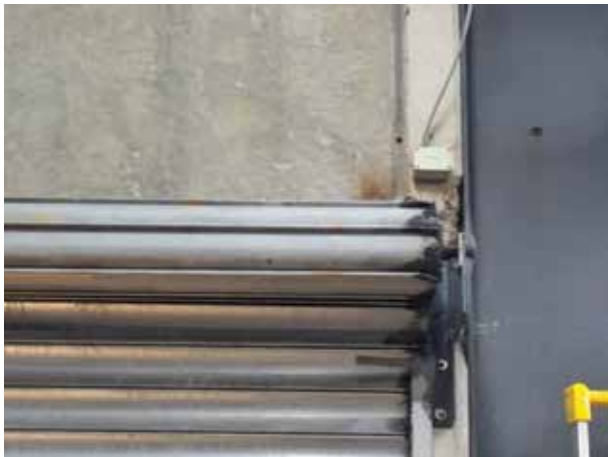
94. Widespread corrosion to the steel embedded plates of the concrete wall panels.

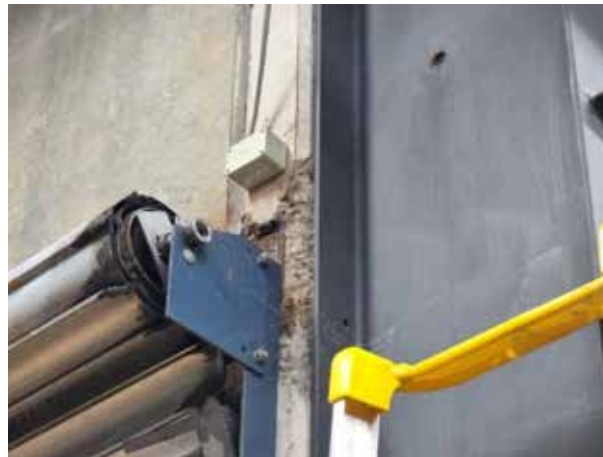
95. Localised corrosion and extensive abrasions to the concrete wall panel within a tenancy which is adjacent to a metal roller shutter door.

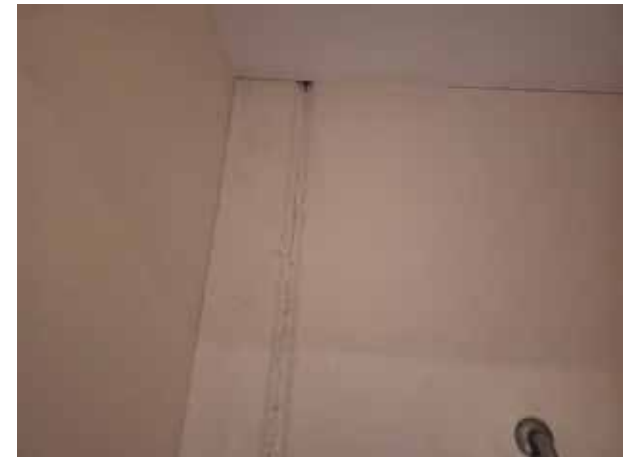
96. Sporadic areas of debonding to the sealed at the control joints of the concrete wall panels.

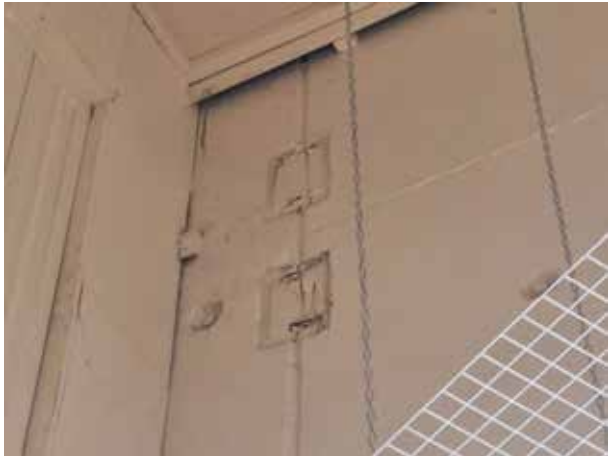
97. Widespread corrosion to the steel embedded plates of the concrete wall panels.

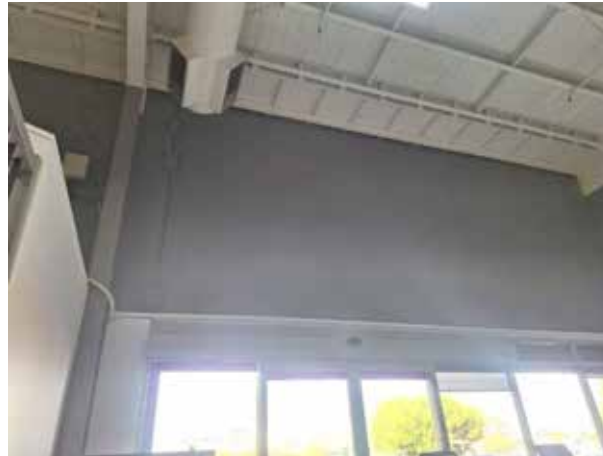
98. Example of the internal condition.
