Building Condition Assessment Report

230 Great South Road, Penrose, Auckland 1061

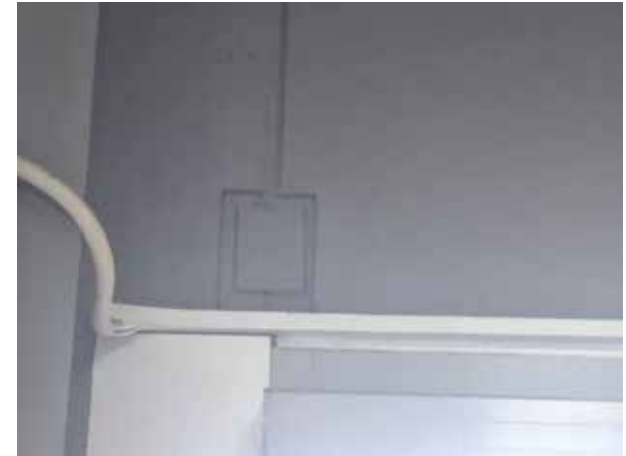
99. No corrosion was observed to the steel embedded plates. It is understood that this tenancy had been painted within the last year.

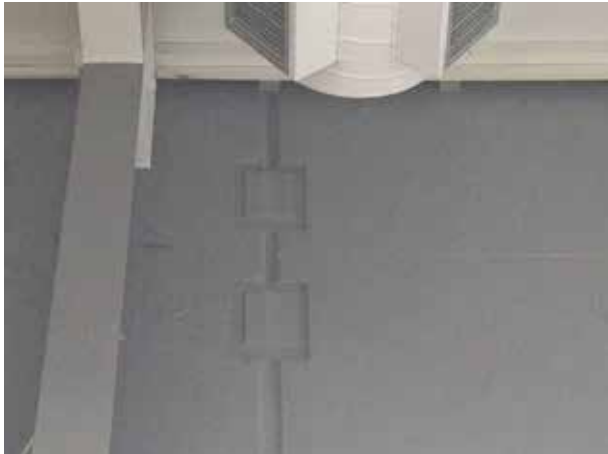
100. No corrosion was observed to the steel embedded plates. It is understood that this tenancy had been painted within the last year.

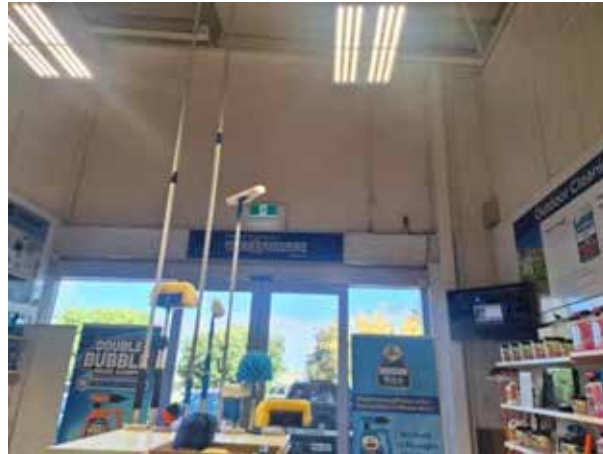
101. Example of the internal condition.

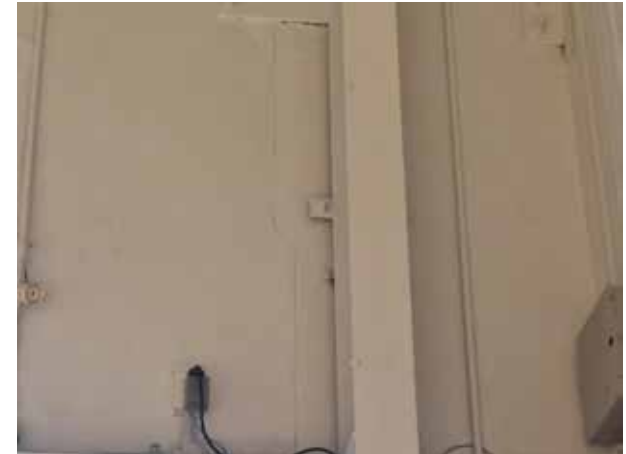
102. Localised vertical hairline cracking to the upper-level horizontal concrete wall panel.

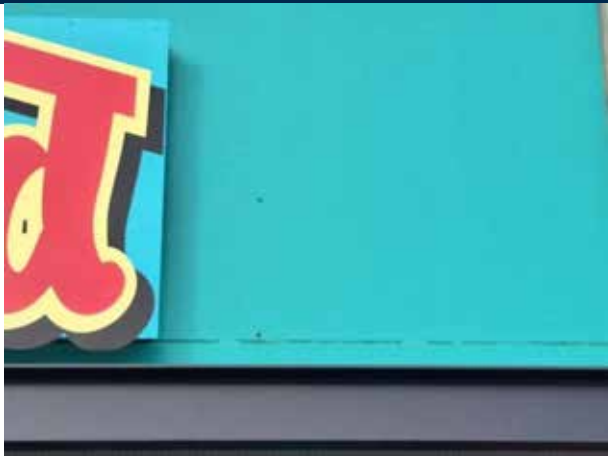
1. Sporadic areas of redundant fixing centres to the upper-level horizontal concrete wall panels.

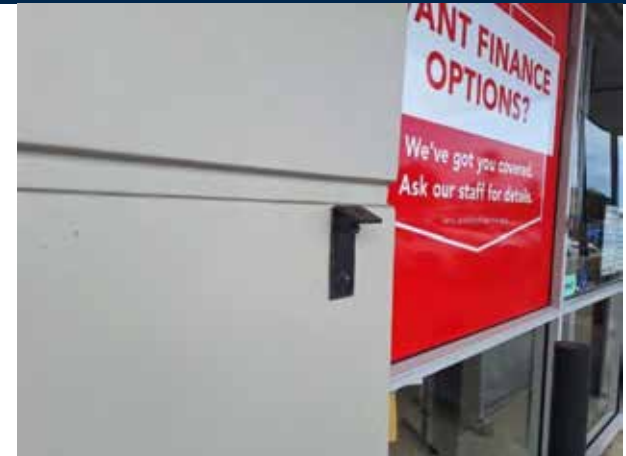
3. Localised corrosion of the fixings to the metal attachment trim of the concrete wall panels.

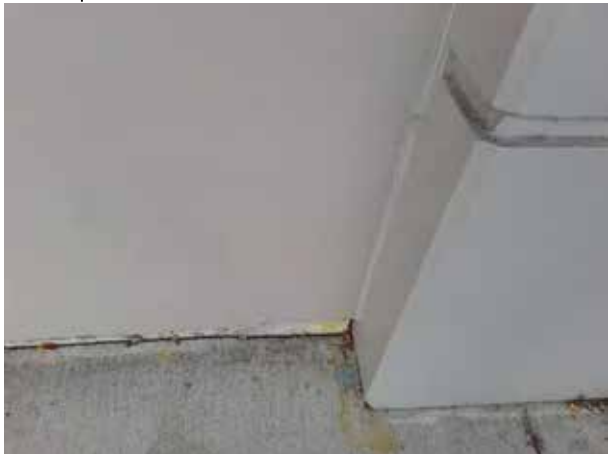
4. Sporadic areas of deterioration of the paint finish to the elevations.

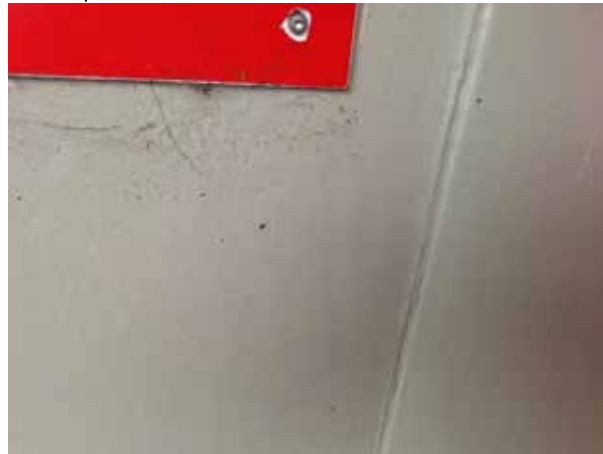
5. Sporadic areas of redundant fixing centres to the fibre-cement cladding sheets.

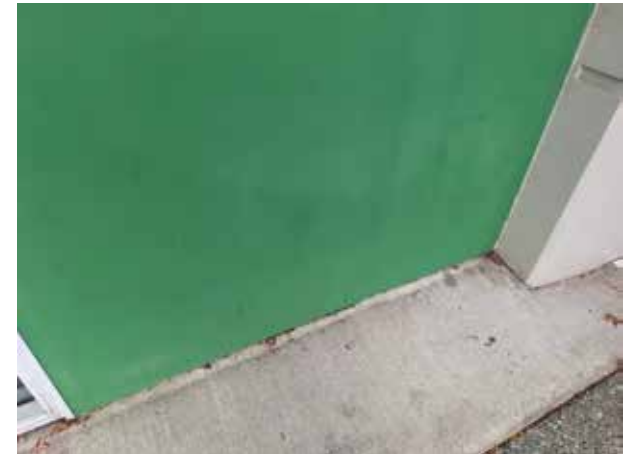
6. Sporadic areas of deterioration of the paint finish to the elevations.

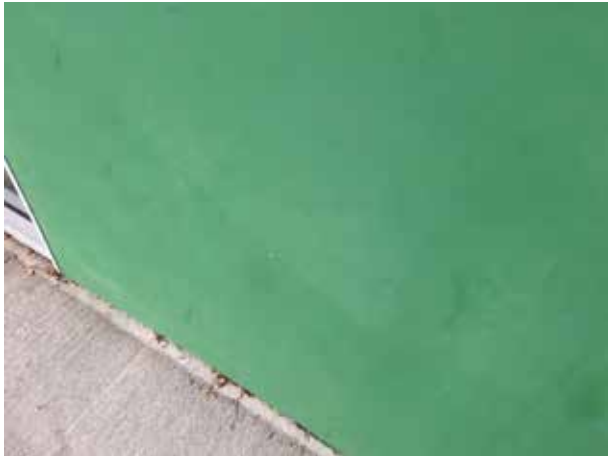
7. Sporadic areas of deterioration of the paint finish to the elevations.

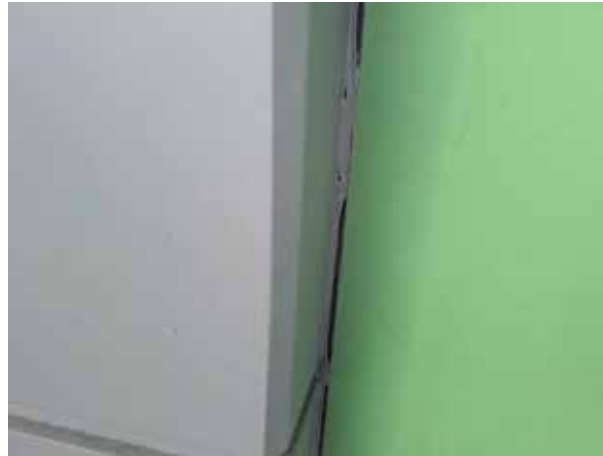
8. Localised separation and debonding of the sealant between the concrete wall panels.

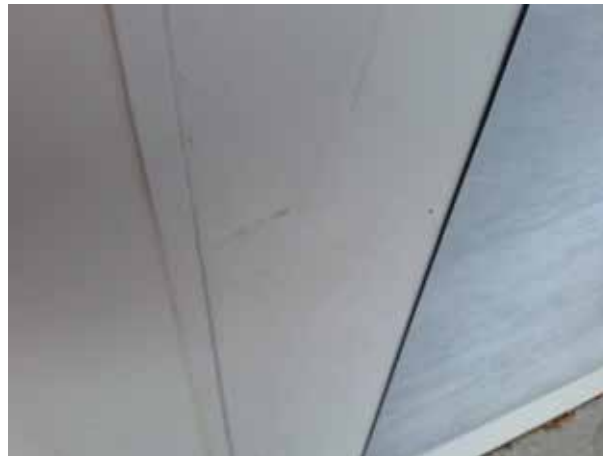
11. Sporadic areas of deterioration of the paint finish to the elevations.

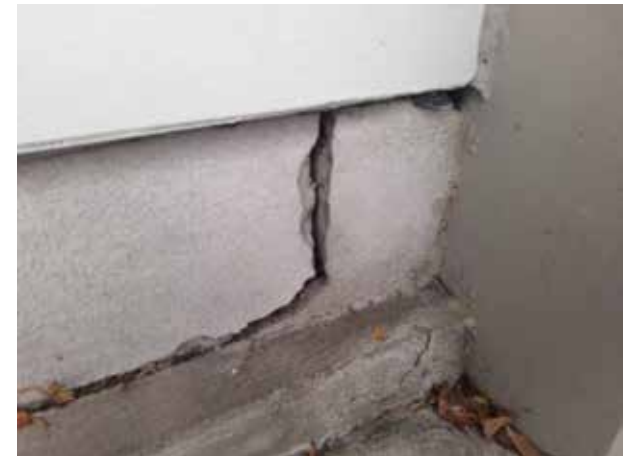
12. Localised cracking to the external face of the concrete base.

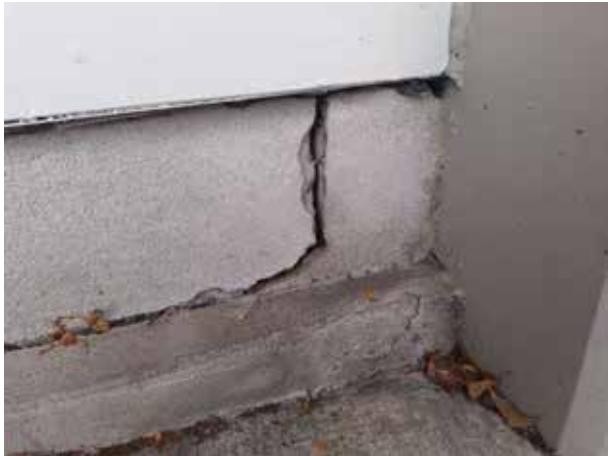
13. Localised cracking to the external face of the concrete base.

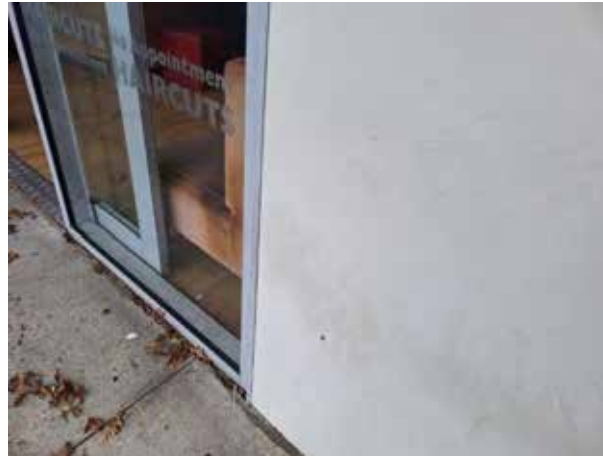
14. Sporadic areas of deterioration of the paint finish to the elevations.

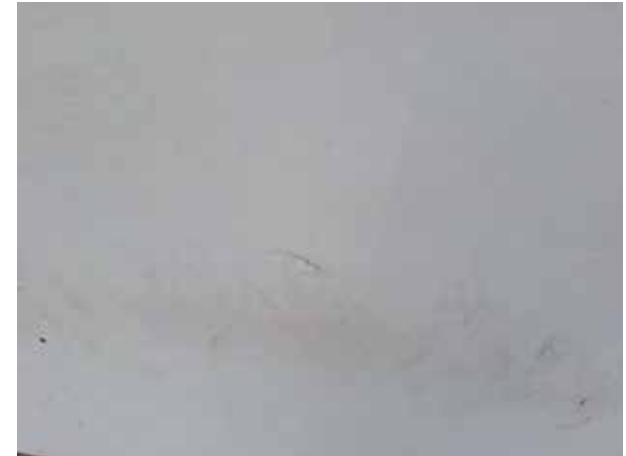
15. Localised impact damage to the fibre-cement cladding sheets.

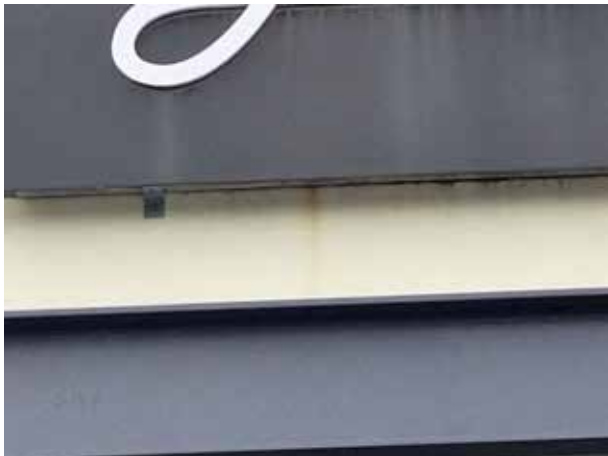
16. Localised corrosion run-off staining to the upper-level horizontal concrete wall panels emitting from the store signage .

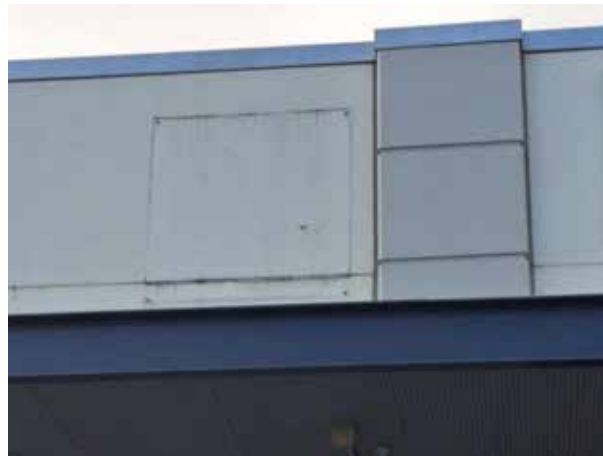
17. Localised removed fixture to the upper-level horizontal concrete wall panels.

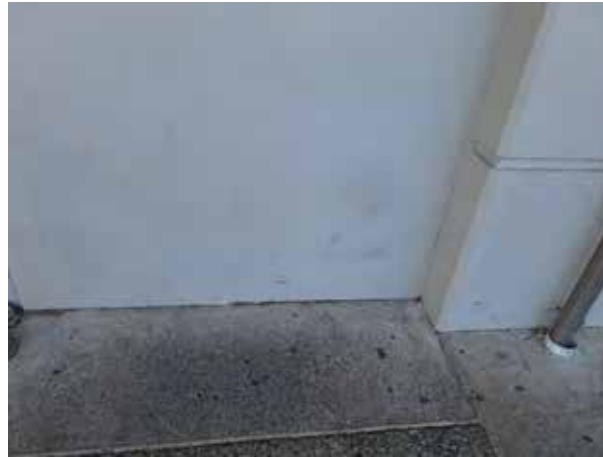
20. Sporadic areas of deterioration of the paint finish to the elevations.

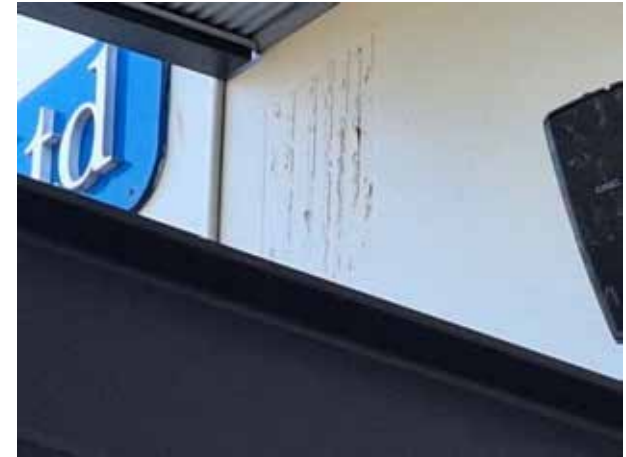
21. Localised residue staining to the upper-level concrete wall panels.

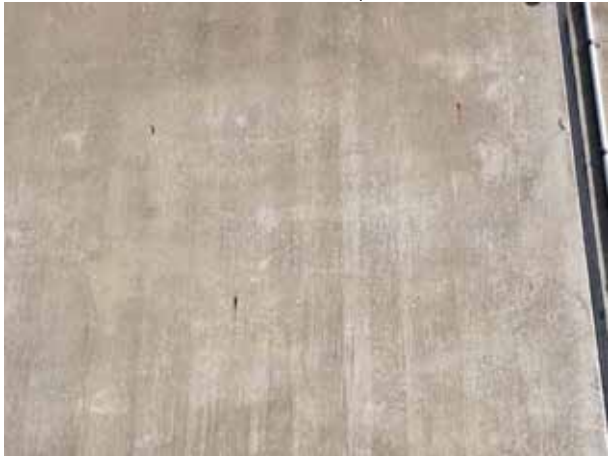
22. Sporadic areas of corrosion staining to the concrete wall panels. The corrosion staining appears to be leaching from the reinforcement bars of the concrete wall panels.

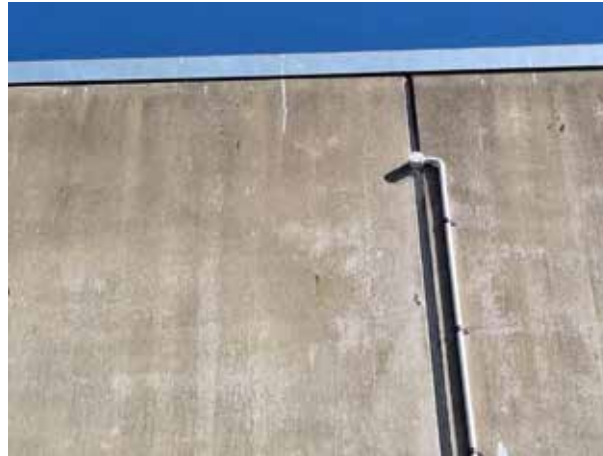
23. Sporadic areas of corrosion staining to the concrete wall panels. The corrosion staining appears to be leaching from the reinforcement bars of the concrete wall panels.

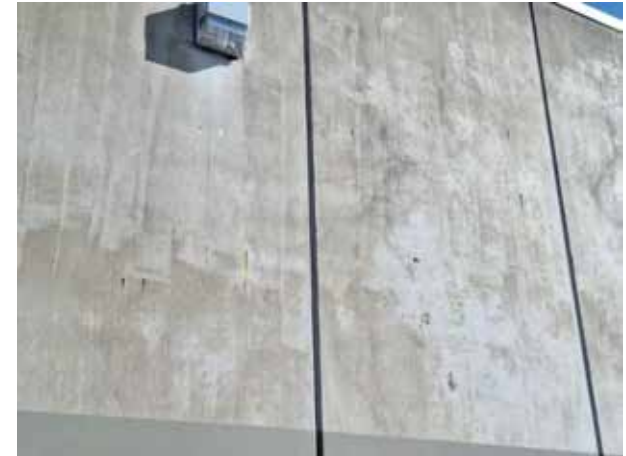
24. Widespread staining and discolouration to the concrete wall panels.

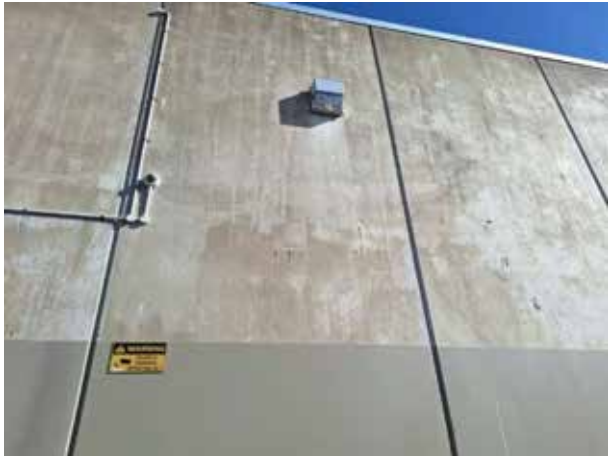
25. Widespread staining and discolouration to the concrete wall panels.

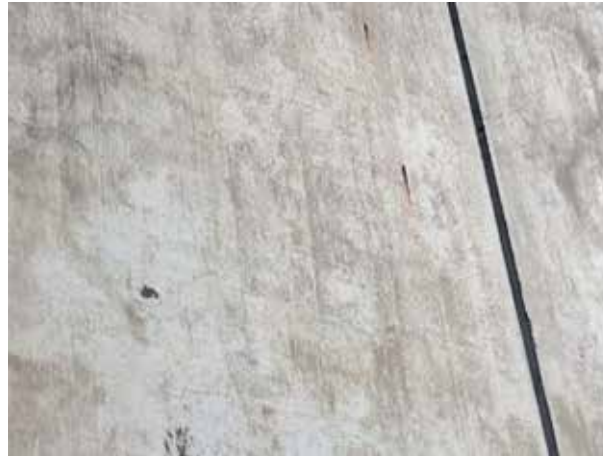
26. Sporadic areas of corrosion staining to the concrete wall panels. The corrosion staining appears to be leaching from the reinforcement bars of the concrete wall panels.

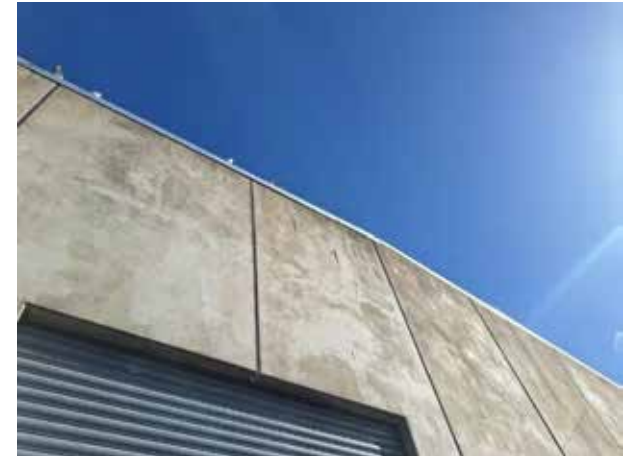
27. Sporadic areas of corrosion staining to the concrete wall panels. The corrosion staining appears to be leaching from the reinforcement bars of the concrete wall panels.

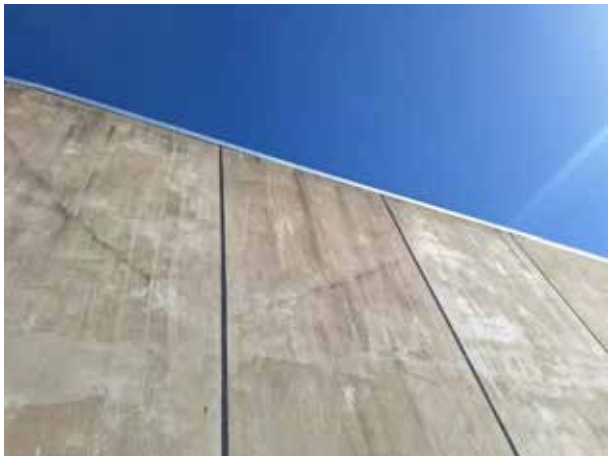
28. Localised area of diagonal surface cracking to the concrete wall panels.

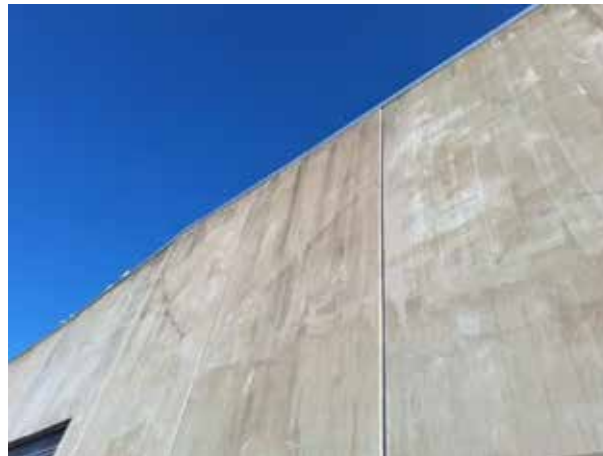
29. Localised area of diagonal surface cracking to the concrete wall panels.

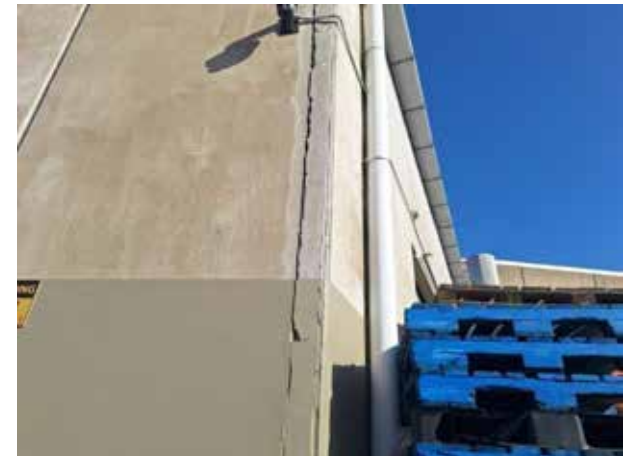
30. Localised vertical extensive cracking to the concrete wall panels.

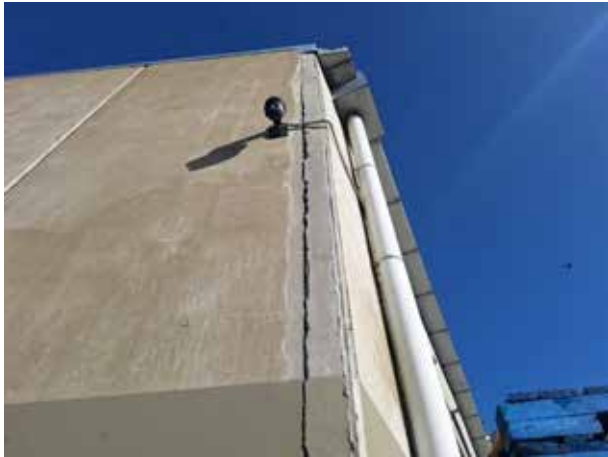
31. Localised vertical cracking to a joint to the concrete wall panels.

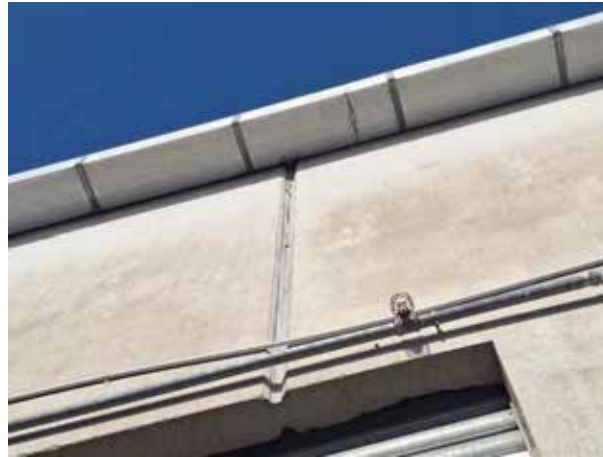
32. Sporadic areas of debonding of the sealant to the control joints of the concrete wall panels.

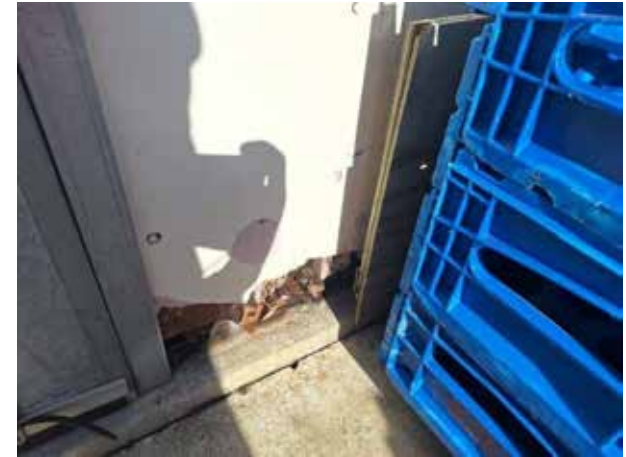
33. Localised area of extensive damage to the fibre-cement cladding sheets.

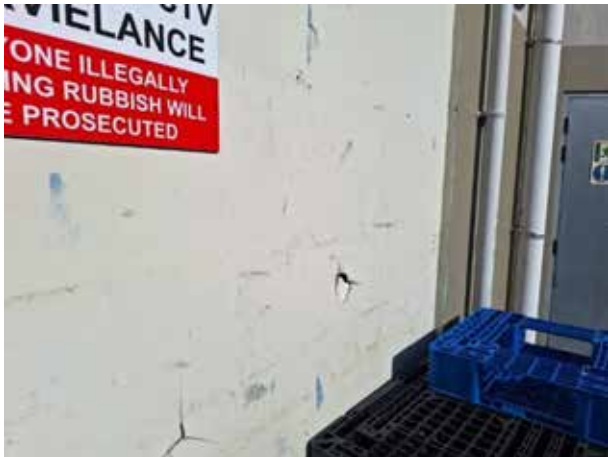
34. Localised area of extensive damage to the fibre-cement cladding sheets.

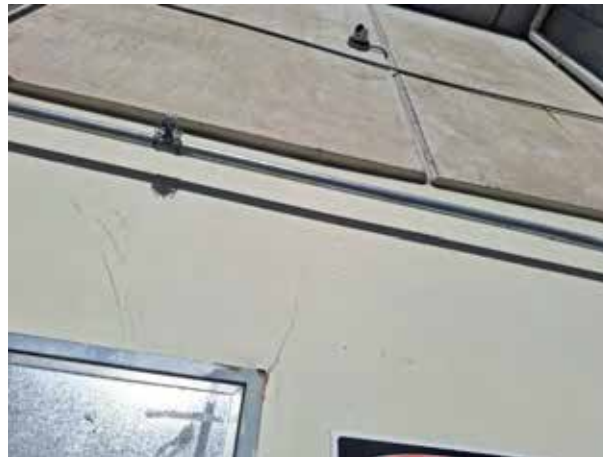
35. Localised area of cracking to the fibre-cement cladding sheets.

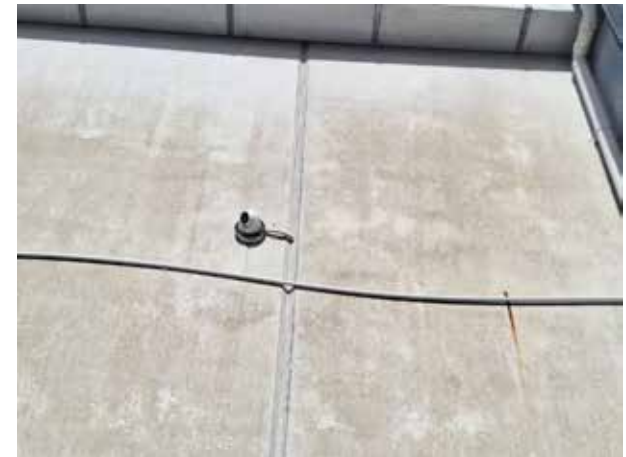
36. Sporadic areas of debonding of the sealant to the control joints of the concrete wall panels.

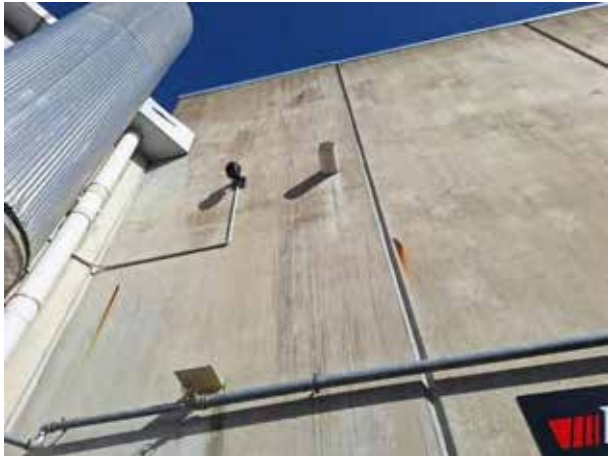
37. Widespread staining and discolouration to the concrete wall panels.

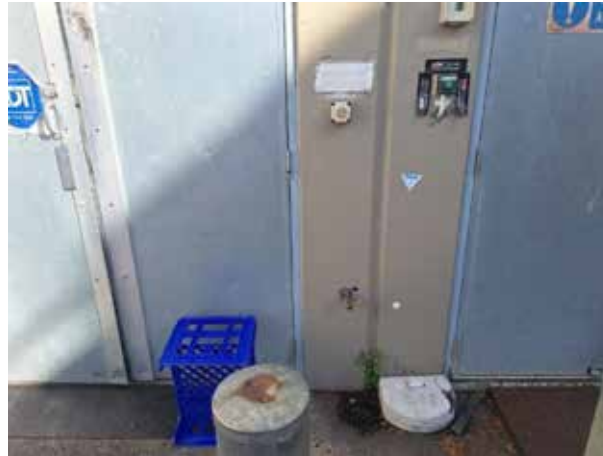
38. Sporadic areas of minor abrasion and deterioration to the concrete wall panels.

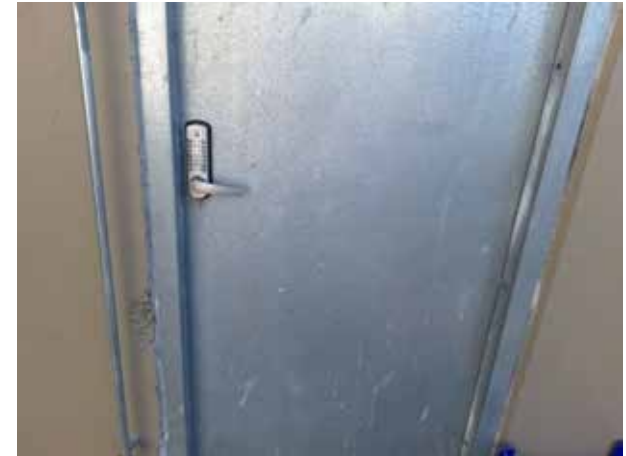
39. Sporadic areas of minor abrasion and deterioration to the concrete wall panels.

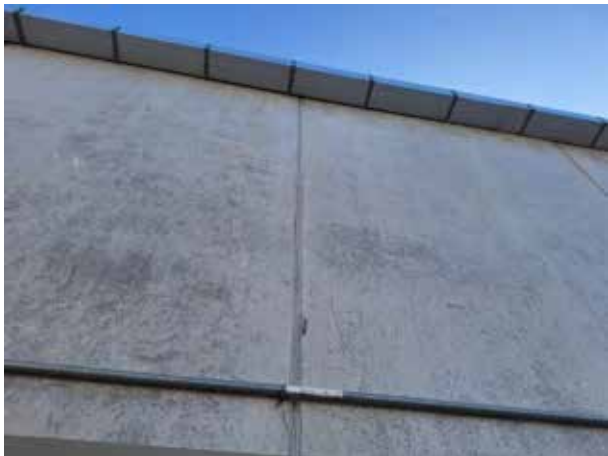
40. Widespread staining and discolouration to the concrete wall panels.

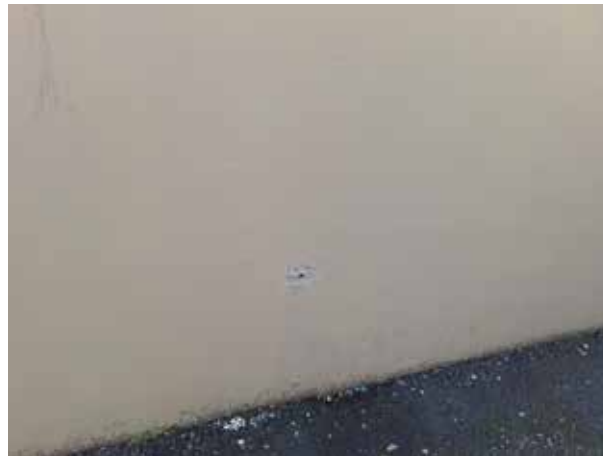
41. Localised unsealed penetration to the concrete wall panels.

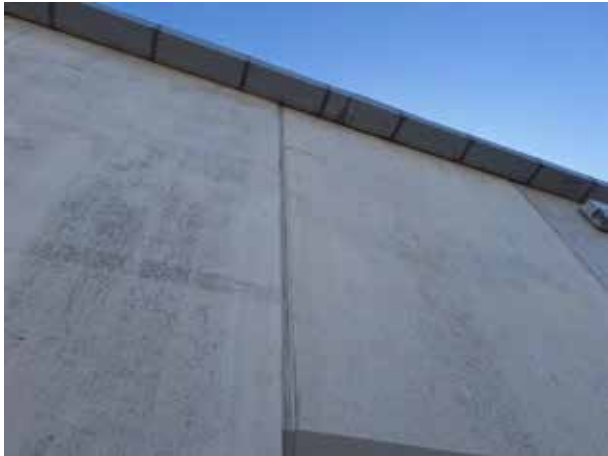
43. Widespread staining and discolouration to the concrete wall panels.

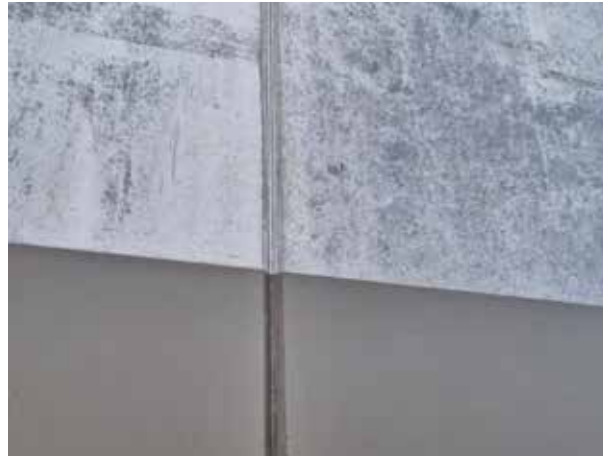
44. Sporadic areas of debonding of the sealant to the control joints of the concrete wall panels.

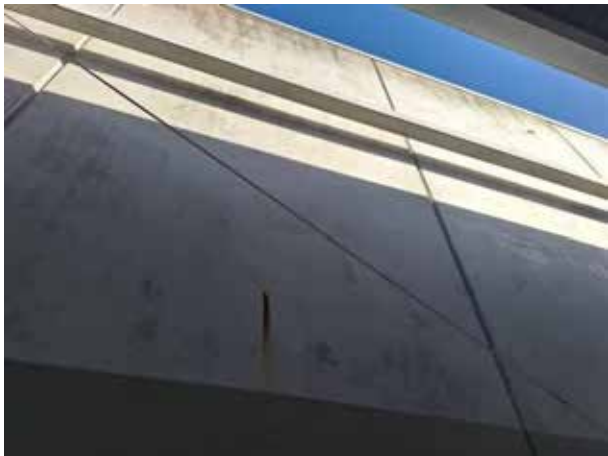
46. Widespread staining and discolouration to the concrete wall panels.

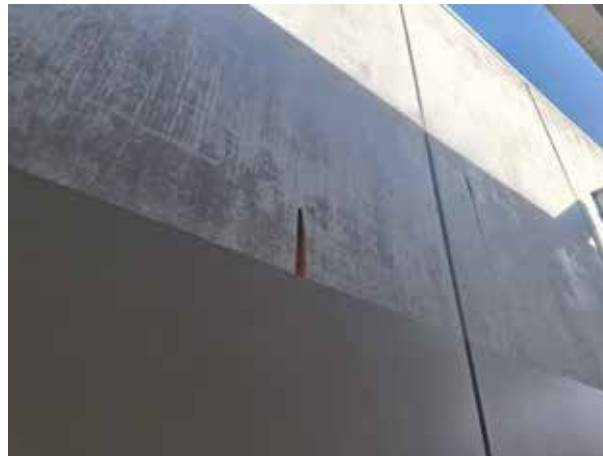
47. Sporadic areas of corrosion staining to the concrete wall panels. The corrosion staining appears to be leaching from the reinforcement bars of the concrete wall panels.

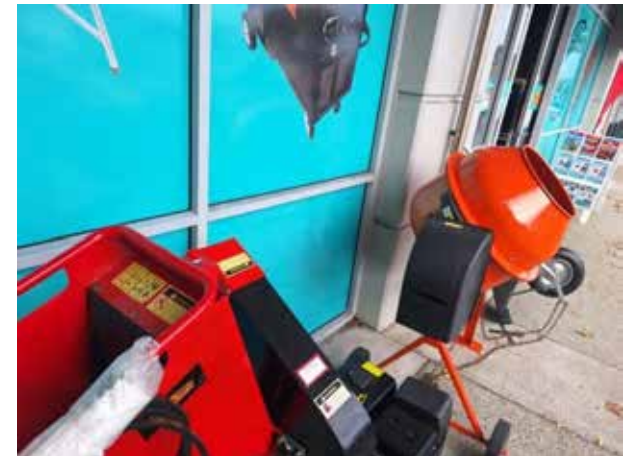
48. Sporadic areas of environmental staining to the aluminium shop front units.

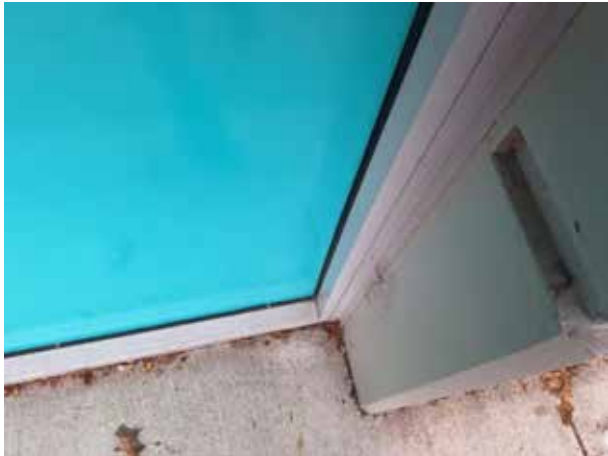
49. Sporadic areas of environmental staining to the aluminium shop front units.

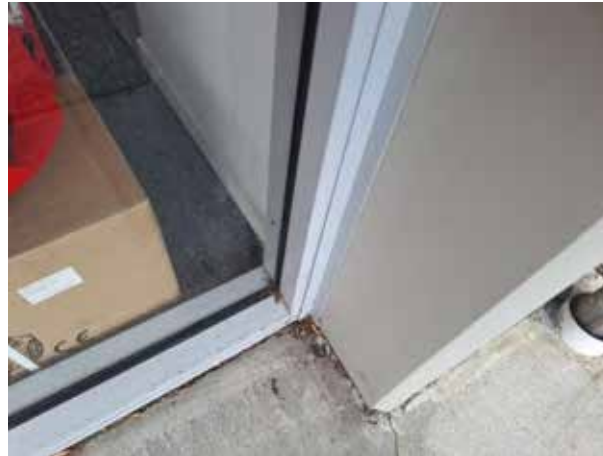
50. Sporadic areas of minor shrinkage to the glazing seals of the aluminium shop front units.

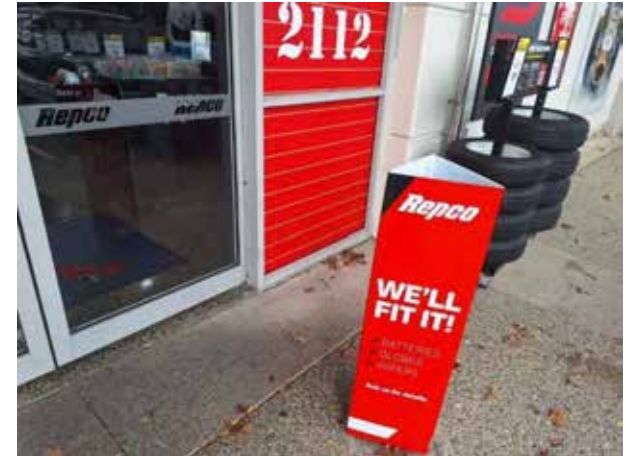
51. Sporadic areas of environmental staining to the aluminium shop front units.

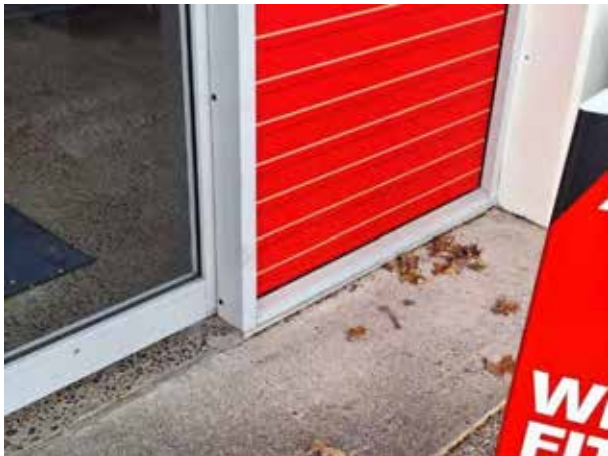
52. Sporadic areas of scuff marks and abrasions to the aluminium shop front units.

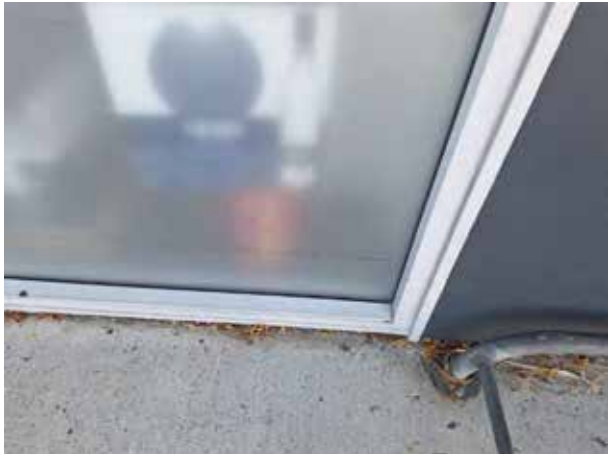
58. Localised deterioration of the glazing film to the aluminium shop front units.

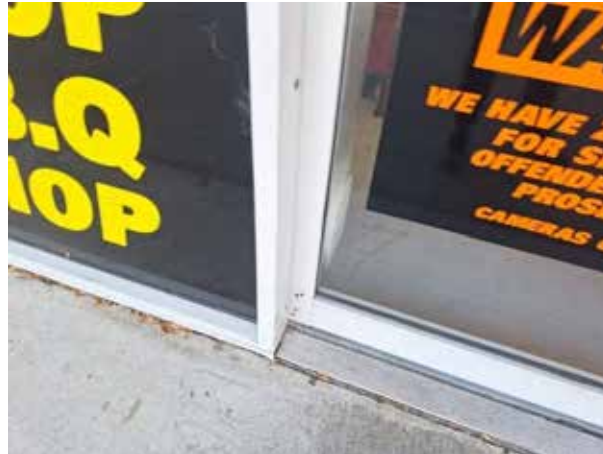
59. Sporadic areas of scuff marks and abrasions to the aluminium shop front units.

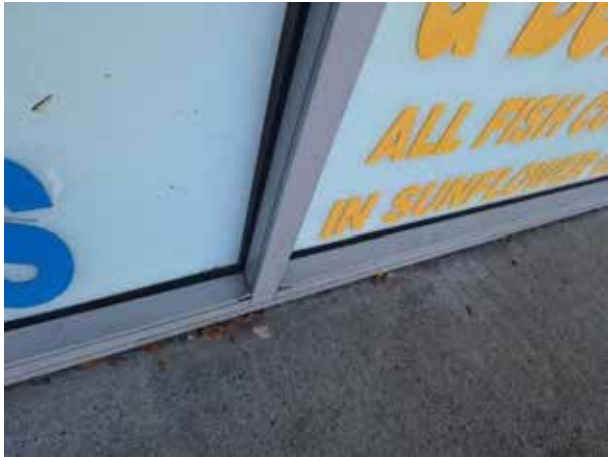
61. Sporadic areas of environmental staining to the aluminium shop front units.

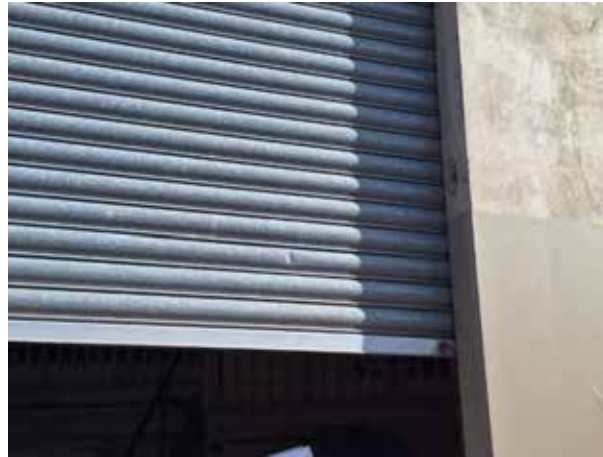
62. Sporadic areas of indentations to the galvanised steel roller shutter door.

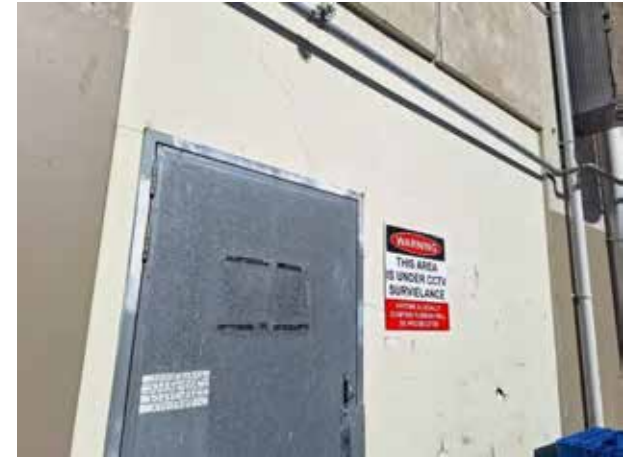
63. Sporadic areas of discolouration and corrosion to the galvanised steel hinged doors.

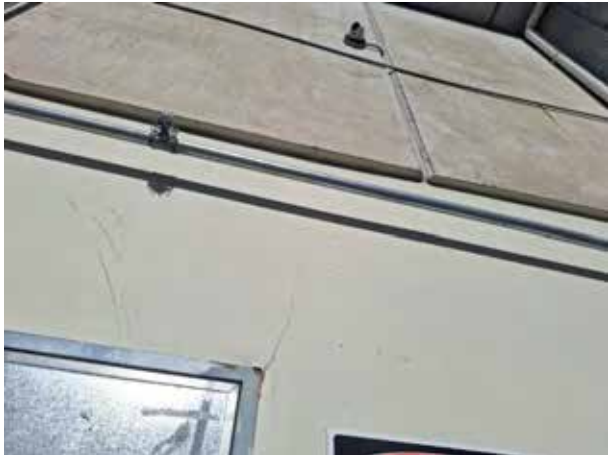
64. Sporadic areas of discolouration and corrosion to the galvanised steel hinged doors.

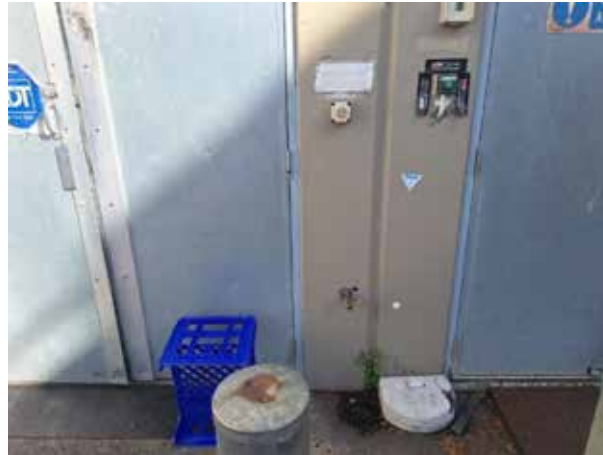
65. Sporadic areas of indentations to the galvanised steel hinged doors.

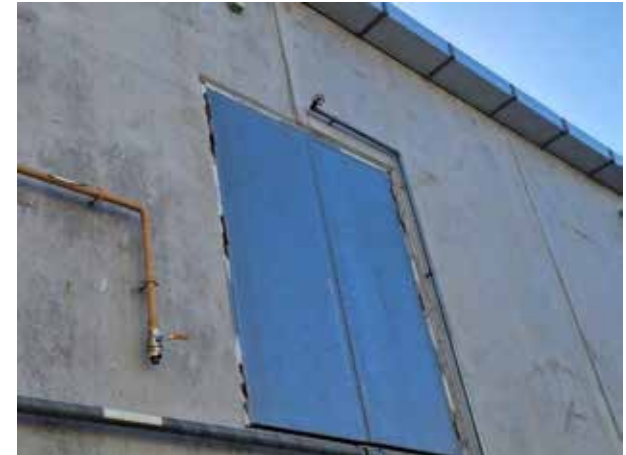
66. Sporadic areas of discolouration and corrosion to the galvanised steel hinged doors.

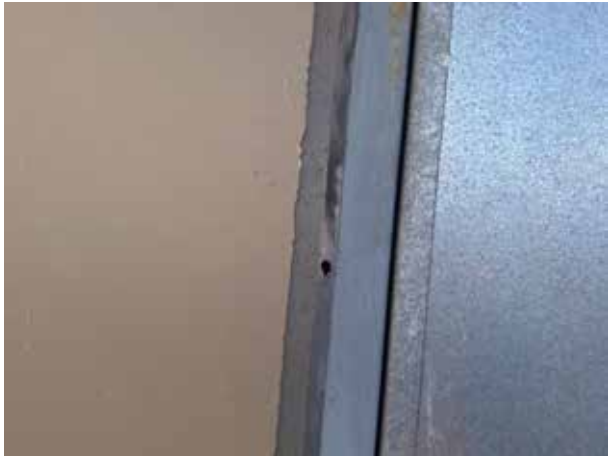
67. Localised debonding to the sealant to the perimeter of the galvanised steel hinged doors.

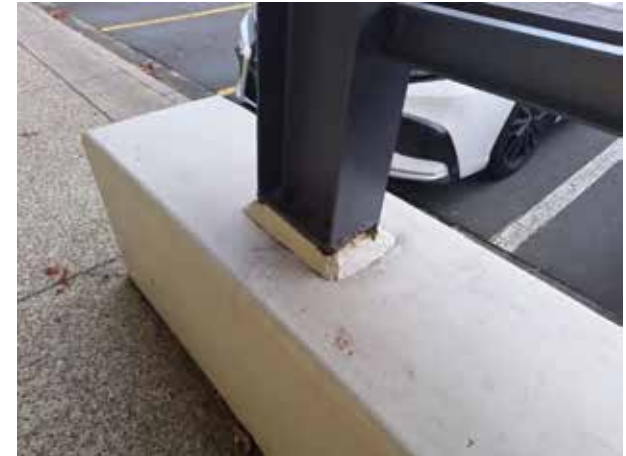
69. Sporadic areas of corrosion and deterioration of the finish to the base of the steel frame of the store signage.

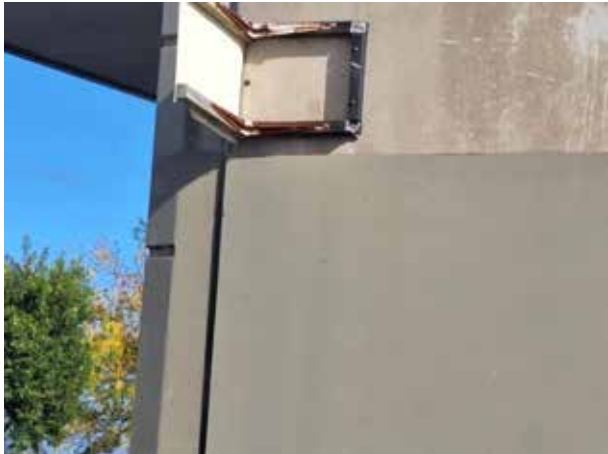
70. Widespread corrosion to the steel frame of the signage to the concrete wall panels.

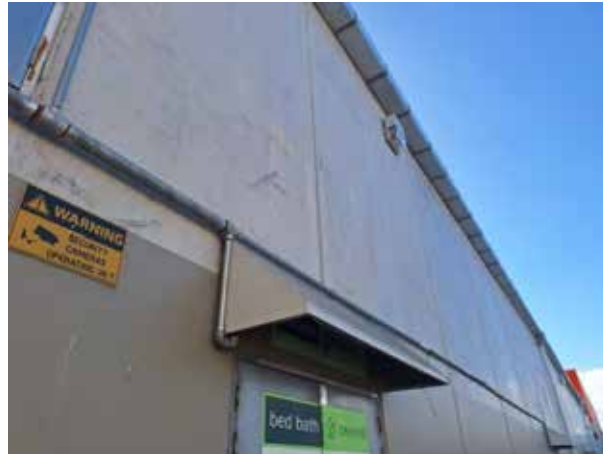
71. Sporadic areas of distortion to the metal door awnings.

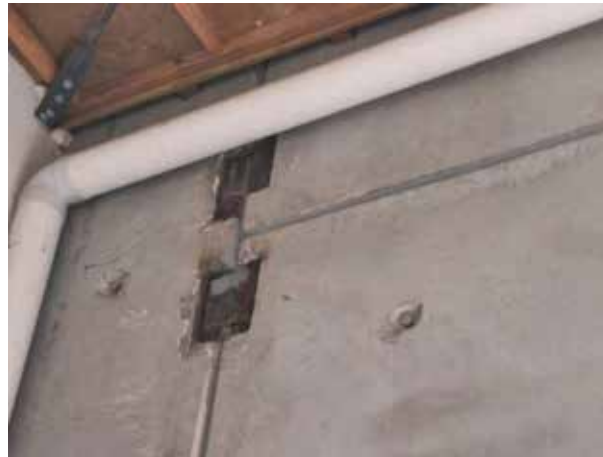
74. Widespread corrosion to the steel embedded plates of the concrete wall panels.

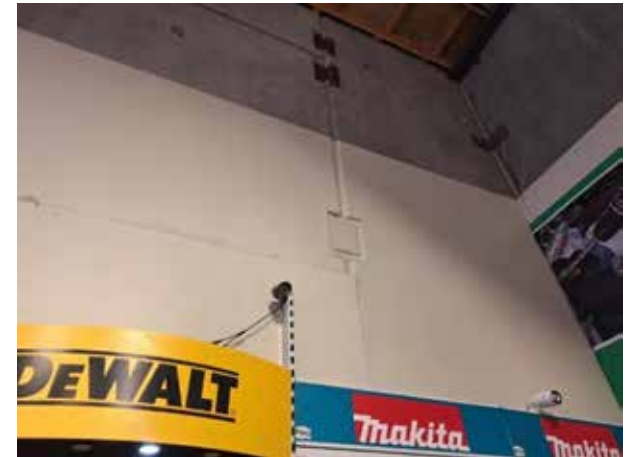
75. Localised diagonal cracking to the concrete wall panels emitting from the steel embedded plate.

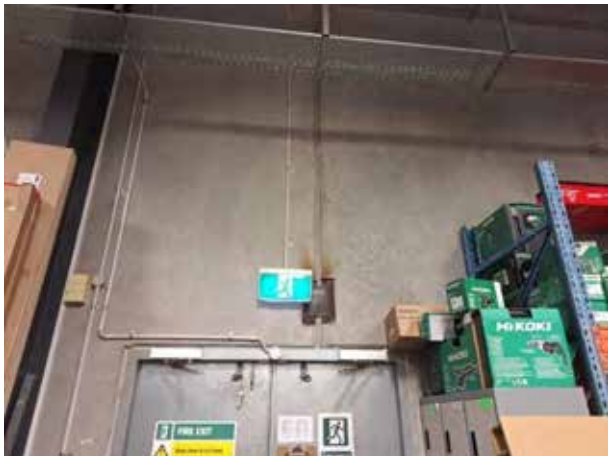
76. Widespread corrosion to the steel embedded plates of the concrete wall panels.

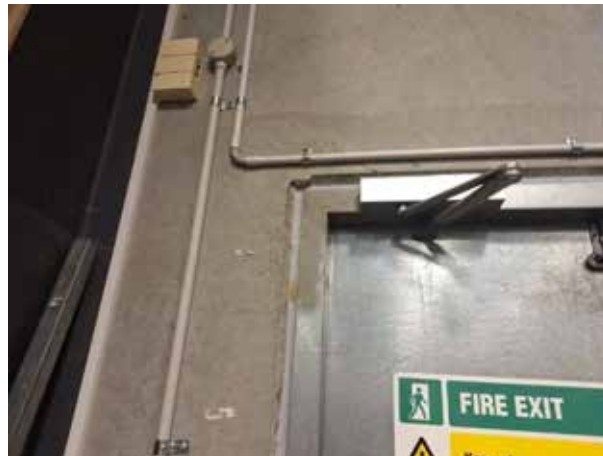
77. The internal sealant applied to the perimeter of the timber hinged doors were in a good condition.

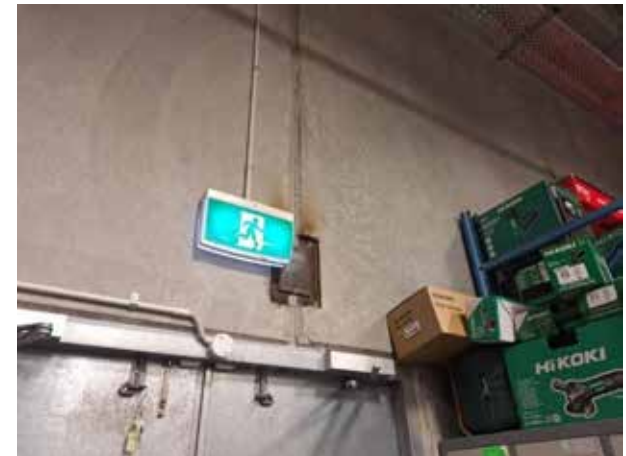
78. Widespread corrosion to the steel embedded plates of the concrete wall panels.

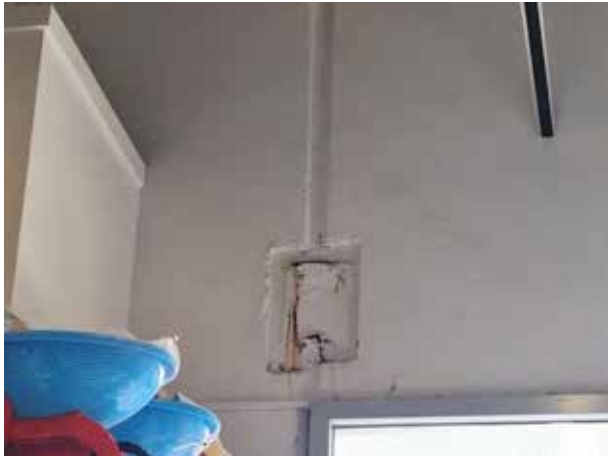
79. Widespread corrosion to the steel embedded plates of the concrete wall panels.

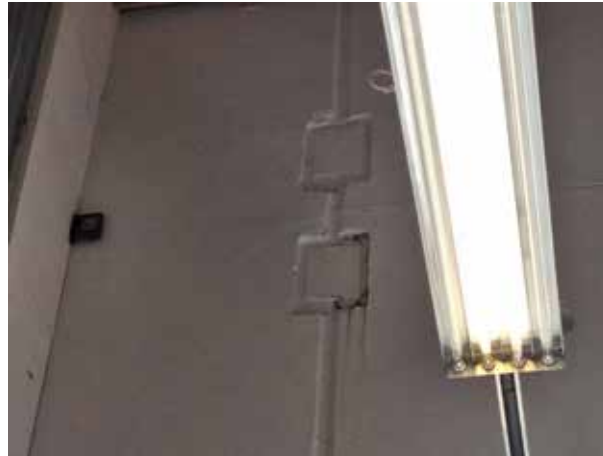
80. Widespread corrosion to the steel embedded plates of the concrete wall panels.

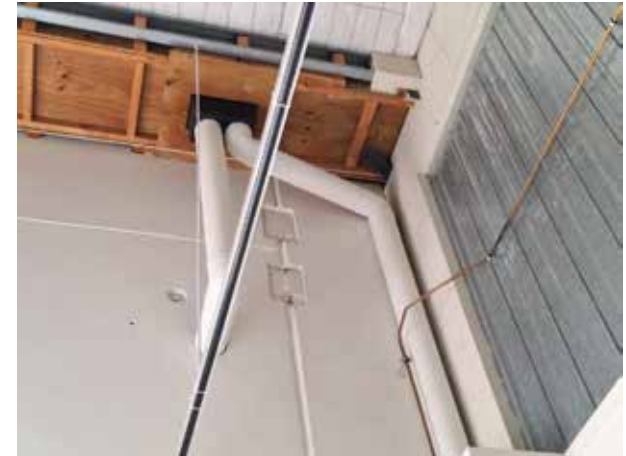
81. Widespread corrosion to the steel embedded plates of the concrete wall panels.

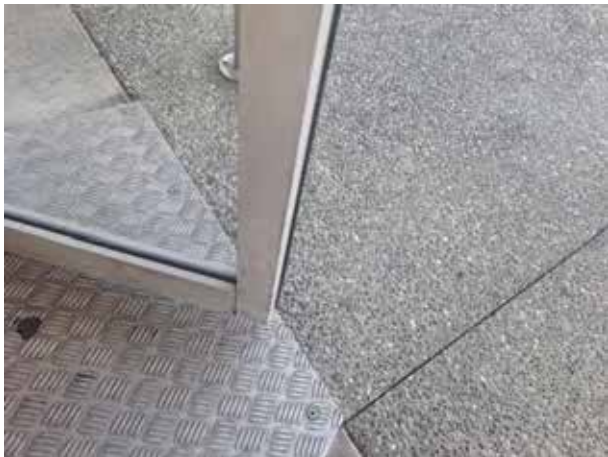
82. Sporadic areas of scuff marks and abrasions to the aluminium shop front units.

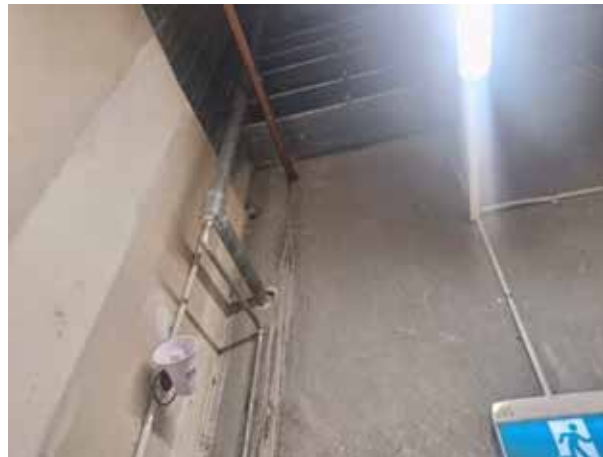
83. Localised moisture run-marks staining to the concrete wall panels emitting from the pipe penetration.

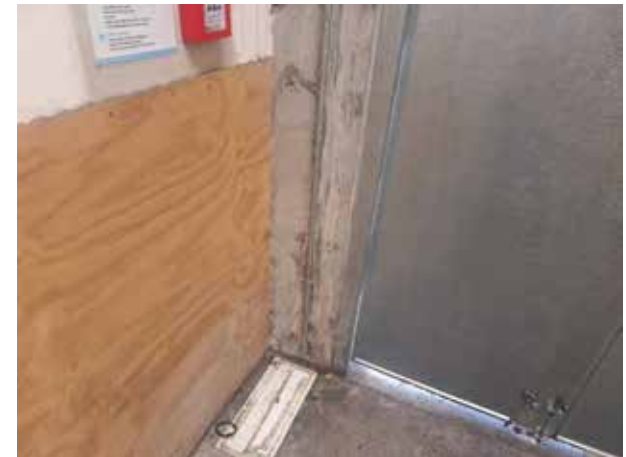
84. Localised moisture run-marks staining to the concrete wall panels emitting from the pipe penetration.

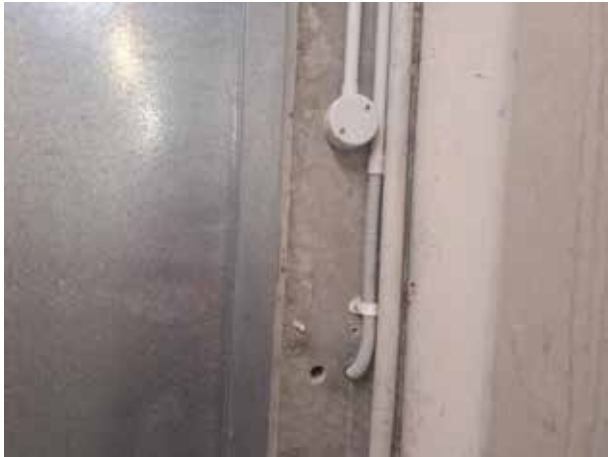
85. Sporadic areas of redundant penetration centres to the concrete wall panels.

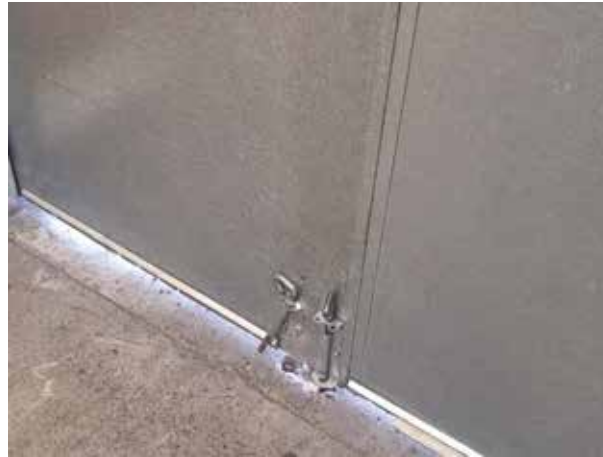
86. Sporadic areas of damage to the door bolt of the galvanised steel hinged doors.

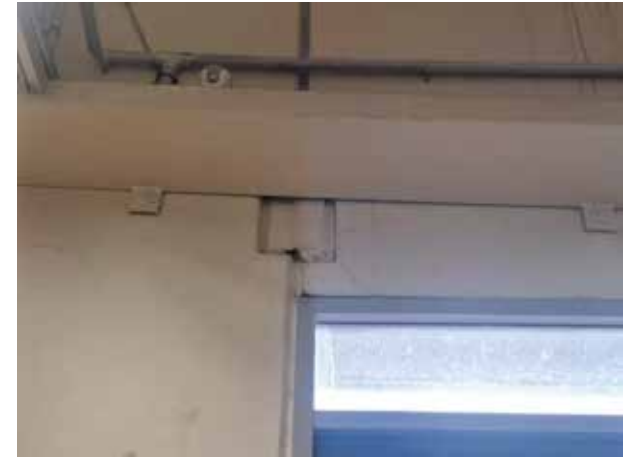
87. Widespread corrosion to the steel embedded plates of the concrete wall panels.

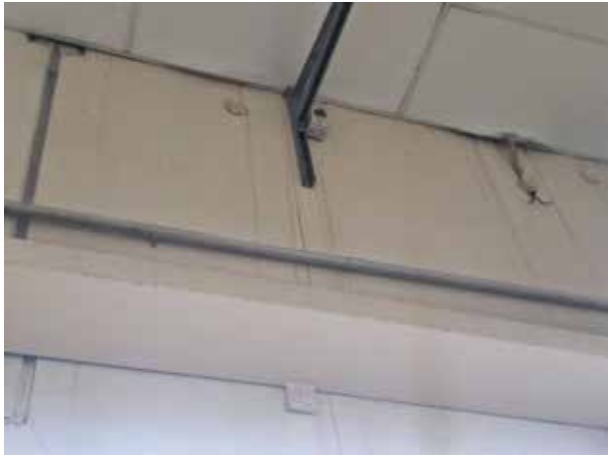
88. Widespread moisture run-marks staining to the concrete wall panels within a tenancy. There was plant equipment installed within the ceiling void.
