Building Condition Assessment Report

230 Great South Road, Penrose, Auckland 1061

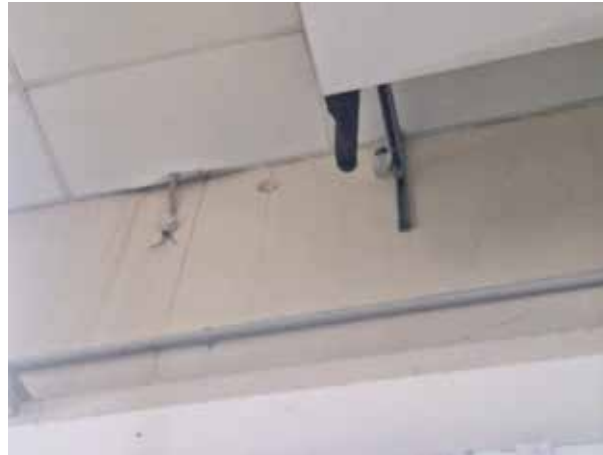
89. Widespread moisture run-marks staining to the concrete wall panels within a tenancy. There was plant equipment installed within the ceiling void.

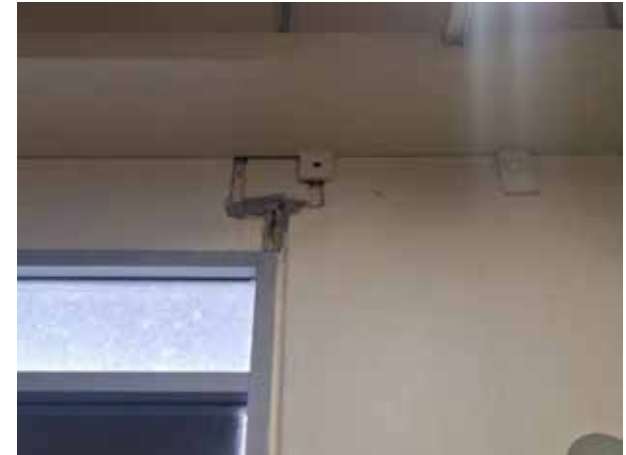
90. Sporadic areas of previous repairs to the control joints and steel embedded plates within the concrete wall panels.

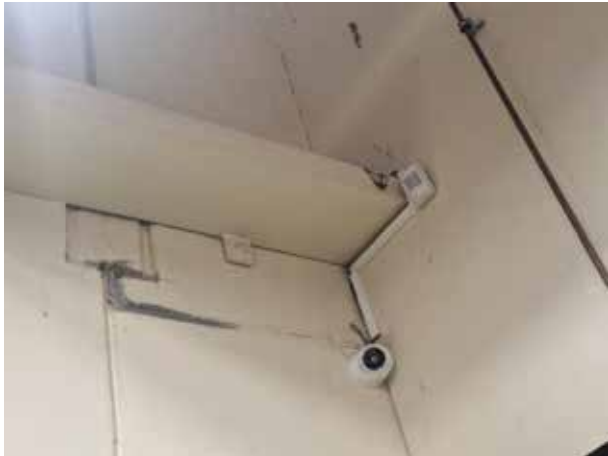
91. Sporadic areas of previous repairs to the control joints and steel embedded plates within the concrete wall panels.

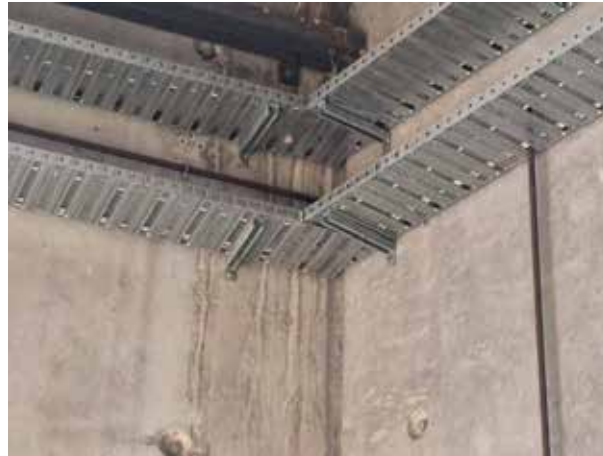
92. Localised moisture run-marks staining to the concrete wall panels and corrosion to the steel beam. This is emitting from the steel beam or internal gutters.

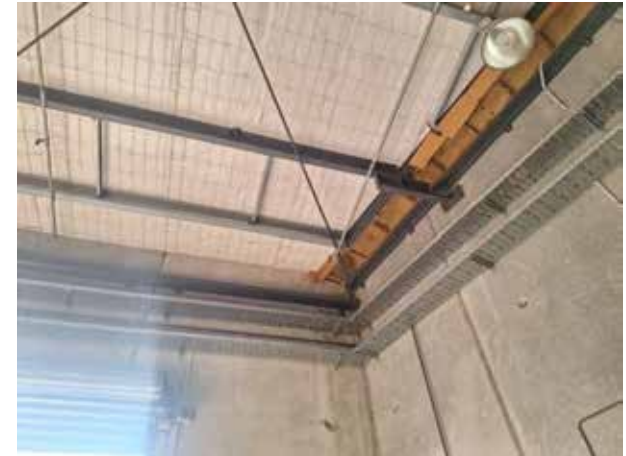
93. Localised moisture run-marks staining to the concrete wall panels and corrosion to the steel beam. This is emitting from the steel beam or internal gutters.

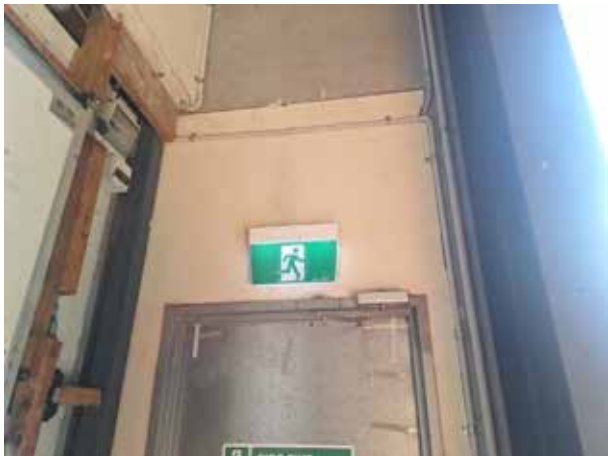
94. Localised removed door hardware with redundant fixing centres to the galvanised steel hinged door.

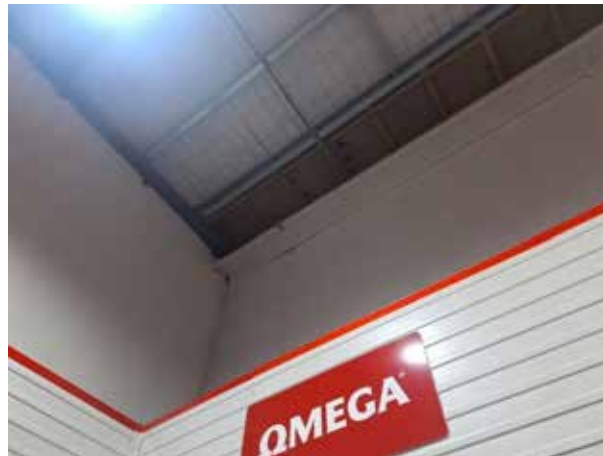
95. Widespread corrosion to the steel embedded plates of the concrete wall panels.

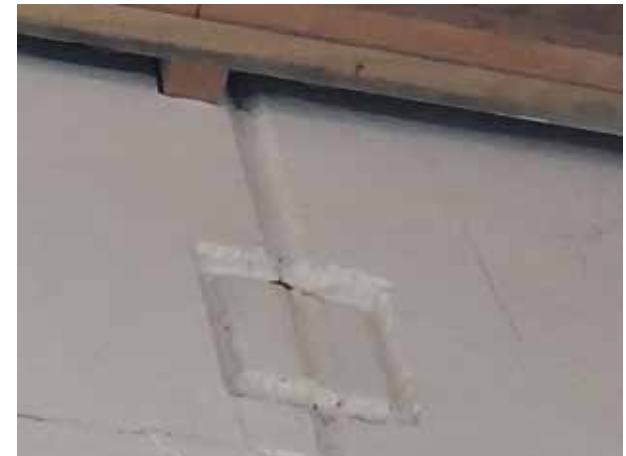
96. Widespread corrosion to the steel embedded plates of the concrete wall panels.

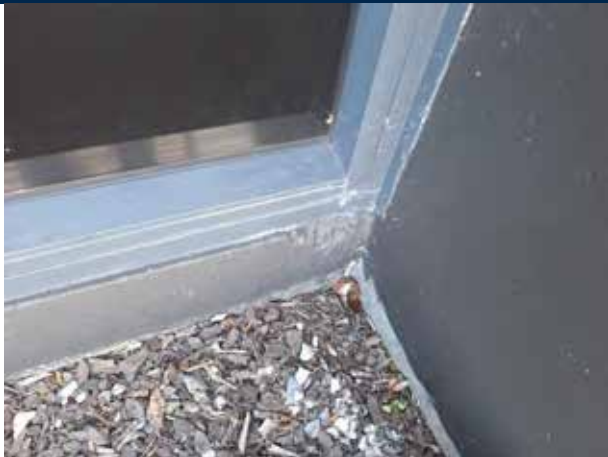
1. Sporadic areas of minor deterioration and spalling to the external face of the concrete base.

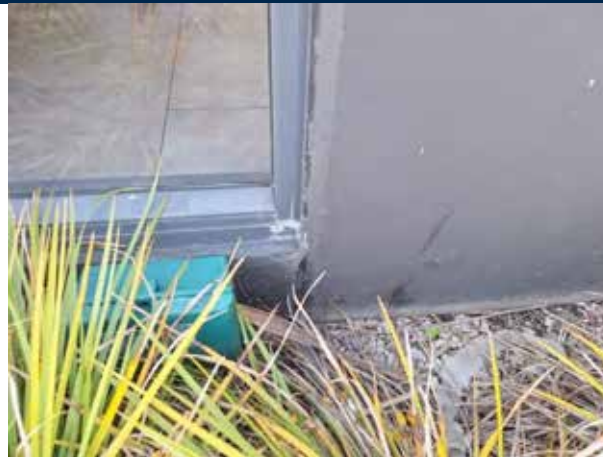
2. Sporadic areas of minor deterioration and spalling to the external face of the concrete base.

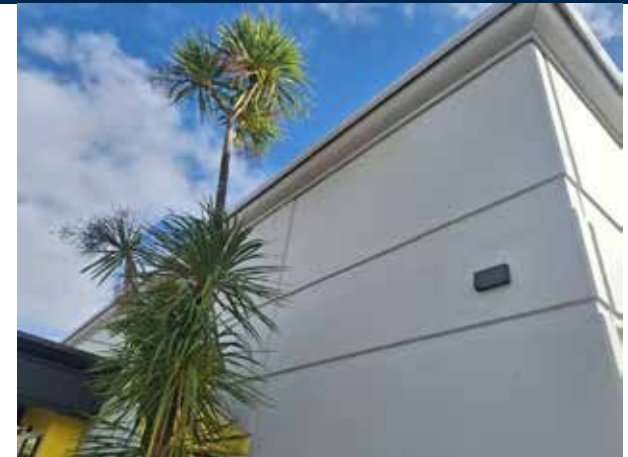
3. The paint condition was generally in a good condition to the elevations.

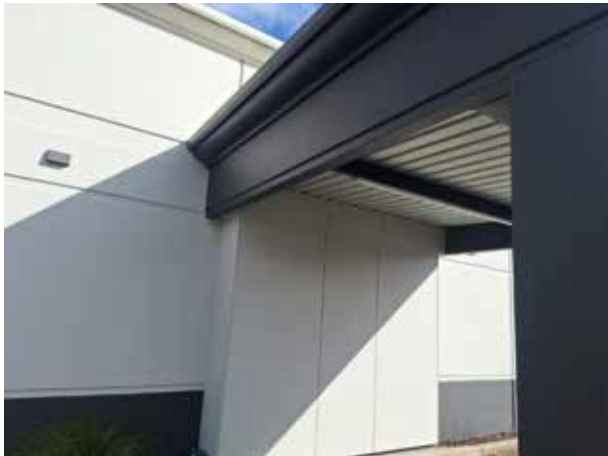
4. The paint condition was generally in a good condition to the elevations.

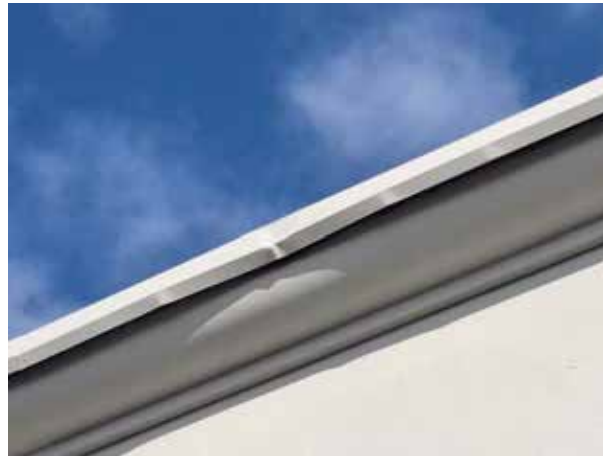
5. Localised distortion to the metal barge cappings.

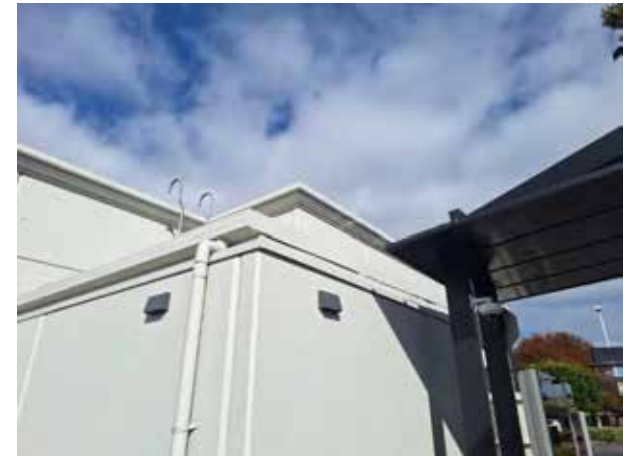
6. The paint condition was generally in a good condition to the elevations.

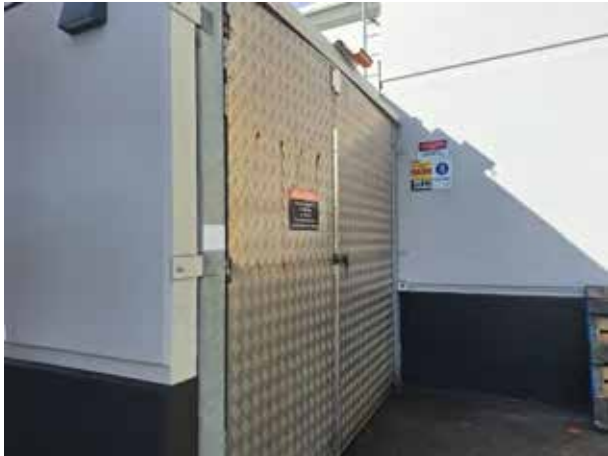
7. Sporadic areas of minor scuff marks and deterioration of the finish to the concrete wall panels.

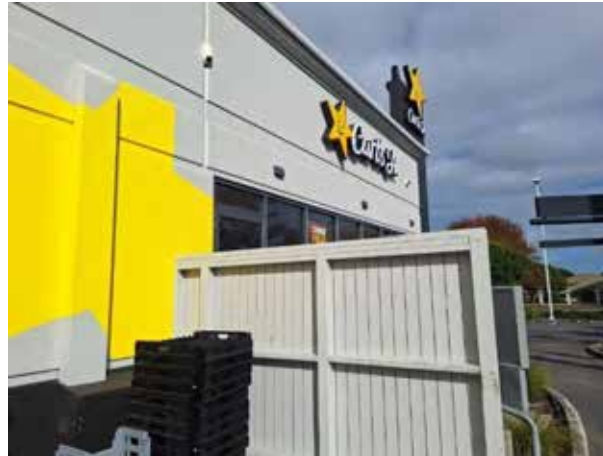
8. The paint condition was generally in a good condition to the elevations.

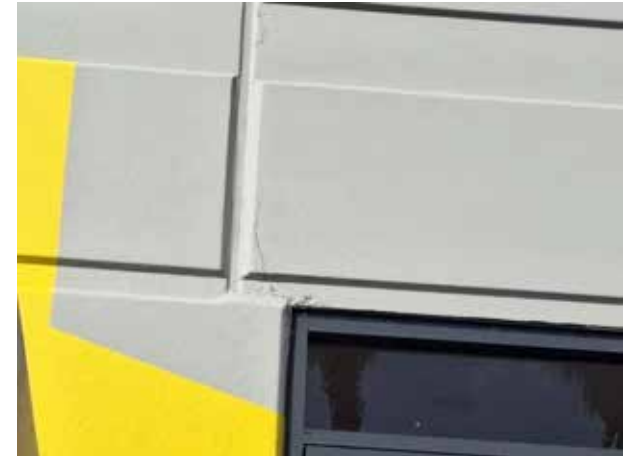
9. Localised minor surface cracking to the concrete wall panels emitting from the corner of the aluminium shop front units.

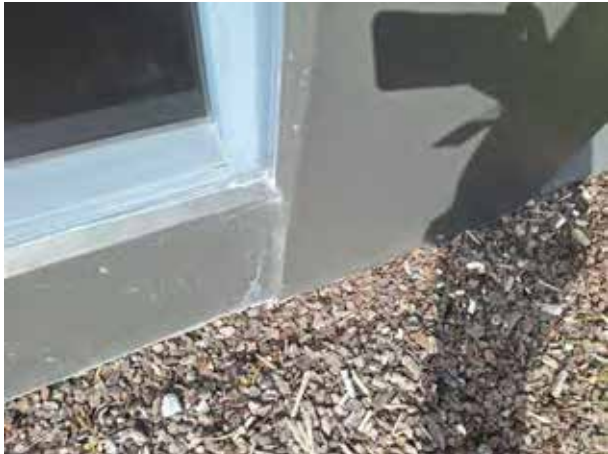
10. Sporadic areas of moisture run-marks to the external face of the concrete base emitting from the aluminium shop front units.

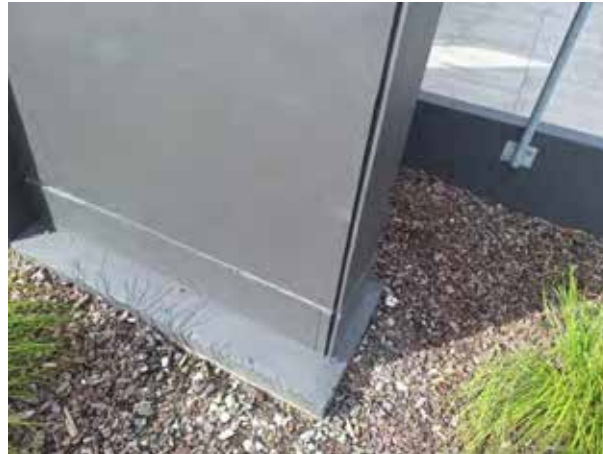
11. Sporadic areas of deterioration of the finish to the fibre-cement cladding sheets.

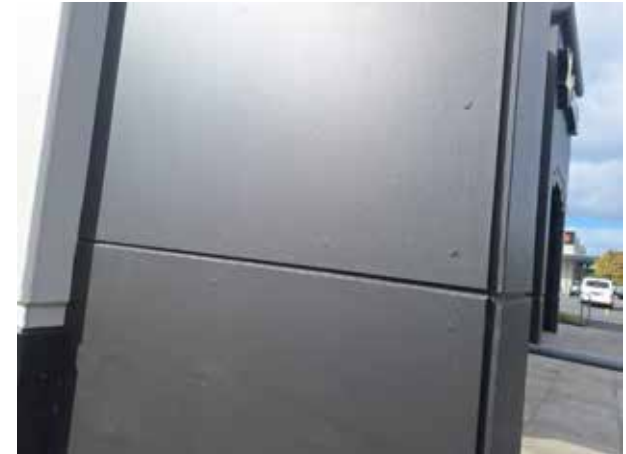
12. Sporadic areas of popping fixings to the fibre-cement cladding sheets.

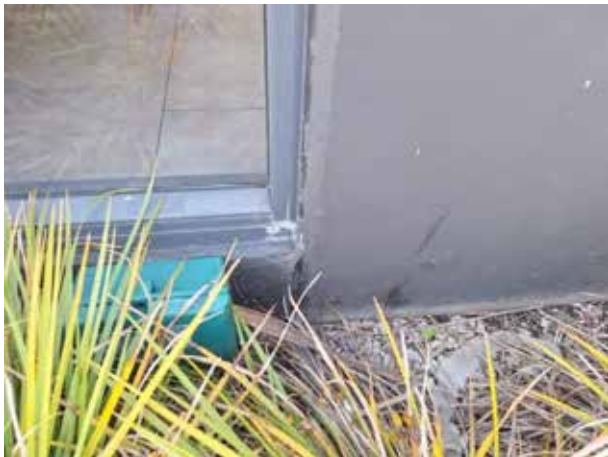
16. Sporadic areas of moisture run-marks to the external face of the concrete base emitting from the aluminium shop front units.

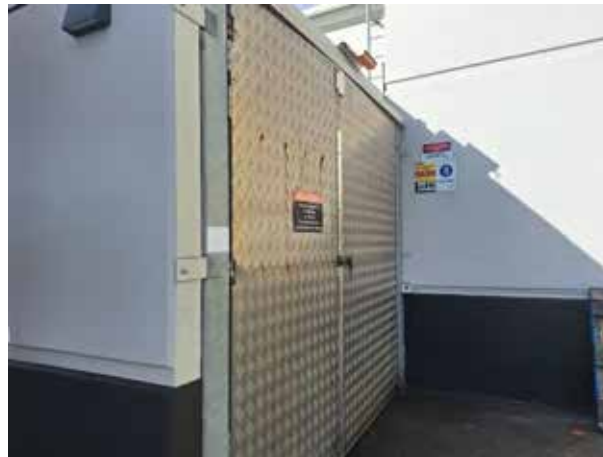
17. Sporadic areas of corrosion to the diamond checker plates of the hinged doors.

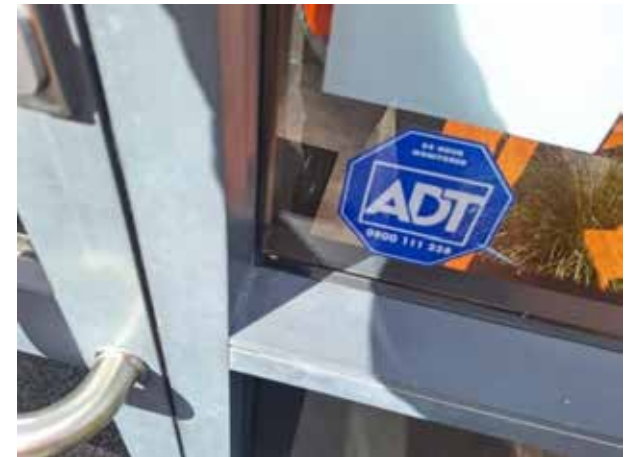
18. Sporadic areas of minor shrinkage to the glazing seals of the aluminium shop front units.

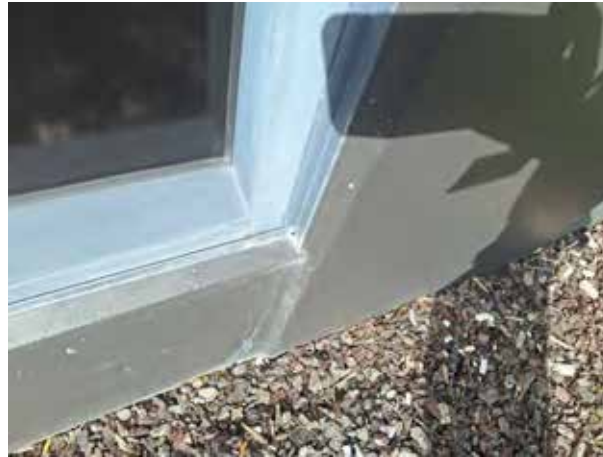
20. Sporadic areas of moisture run-marks to the external face of the concrete base emitting from the aluminium shop front units.

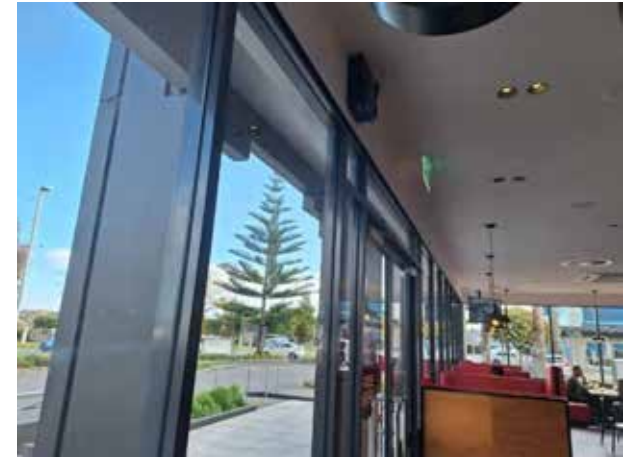
21. Internal view of the elevations.

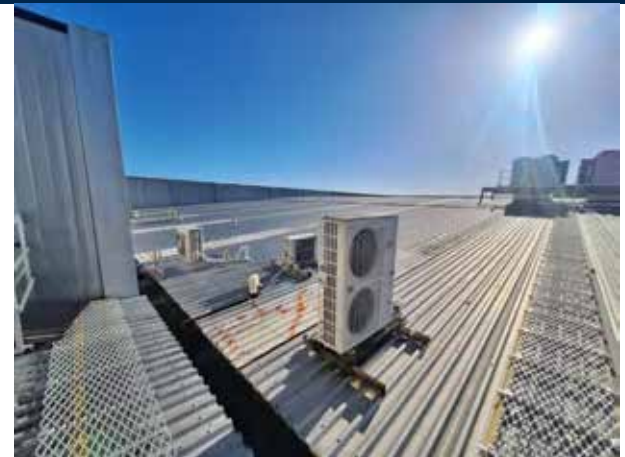
3. The profiled metal roof sheets were typically in good condition.

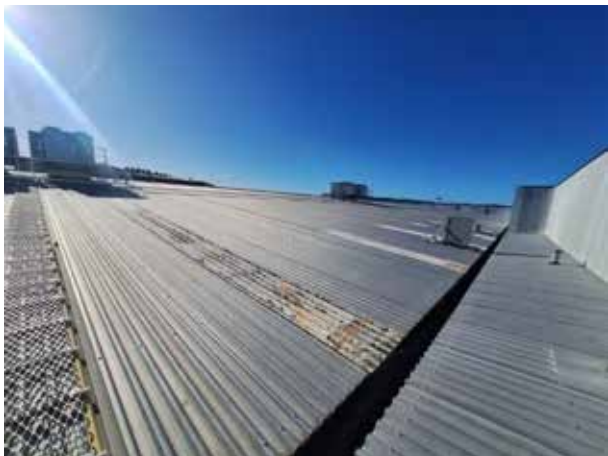
4. The profiled metal roof sheets were typically in good condition.

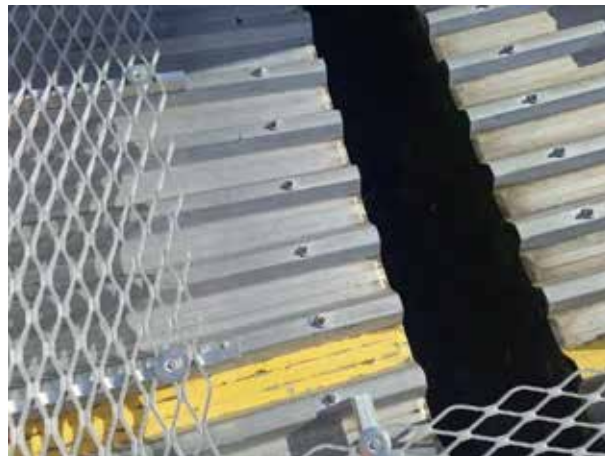
5. Widespread corrosion to the fixings of the profiled metal roof sheets.

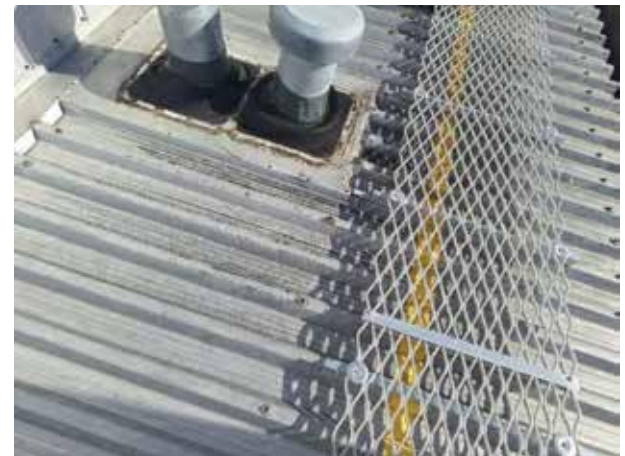
6. Widespread corrosion to the fixings of the profiled metal roof sheets.

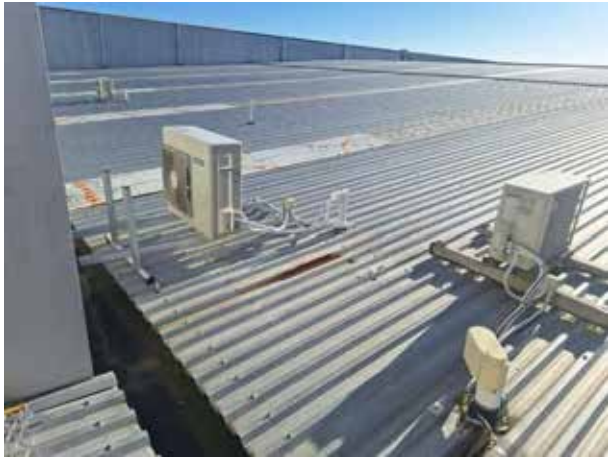
7. Localised corrosion to the profiled metal roof sheets.

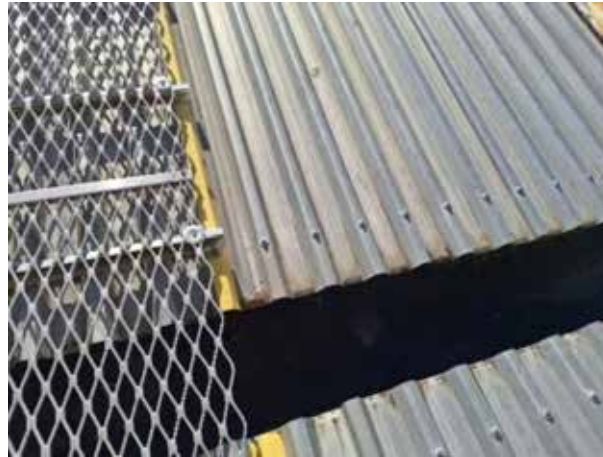
8. Localised corrosion to the sheet edge of the profiled metal roof sheets.

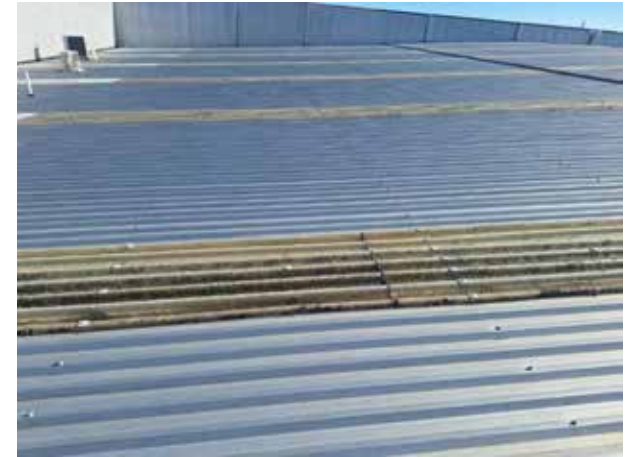
9. The fibreglass sheets were in an aged condition.

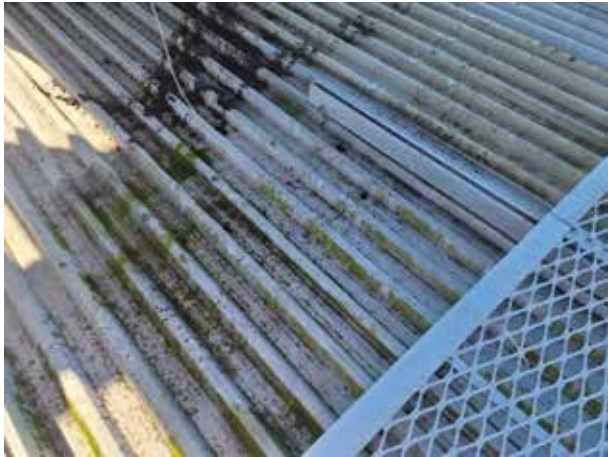
10. Sporadic areas of environmental staining to the roof.

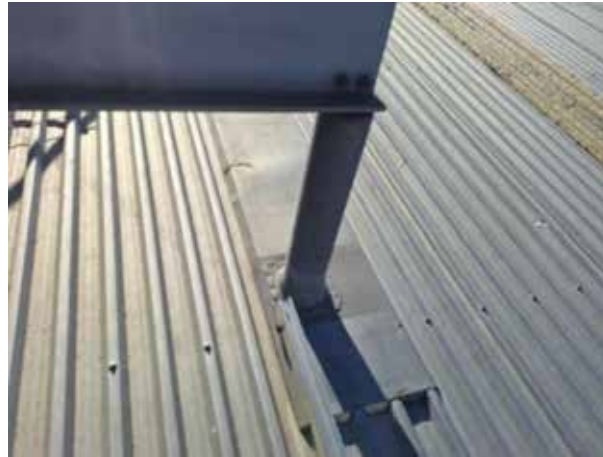
11. Sporadic areas of distortion to the fit-over flashings.

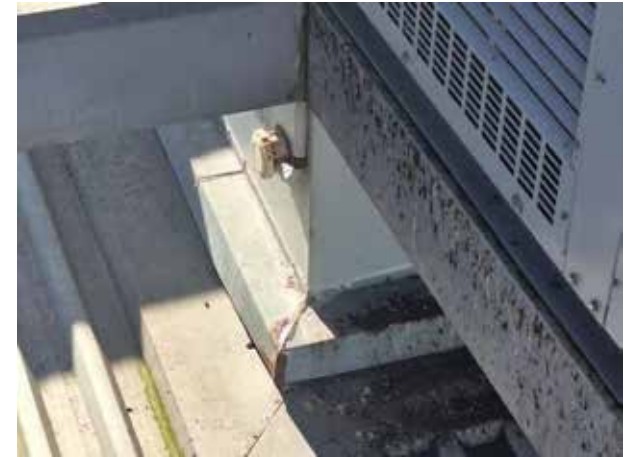
12. Localised corrosion to the ventilation ducting.

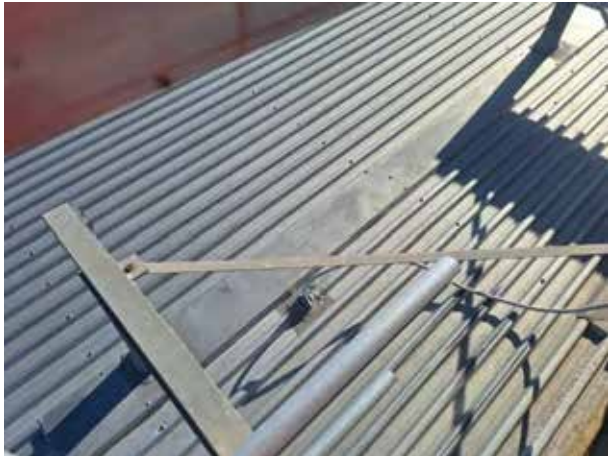
13. The spiral conduit pipe was well sealed.

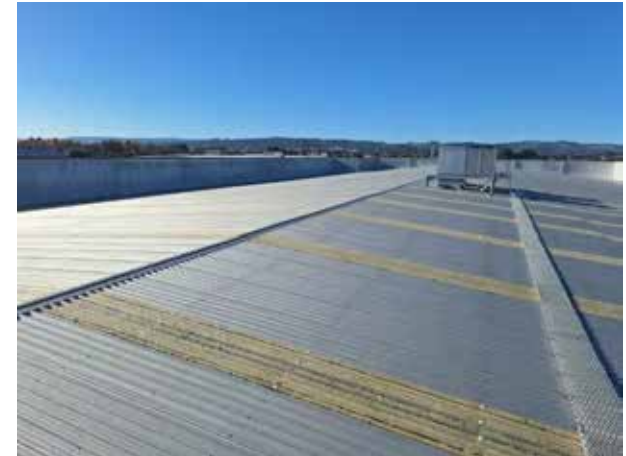
15. The fibreglass sheets were in an aged condition.

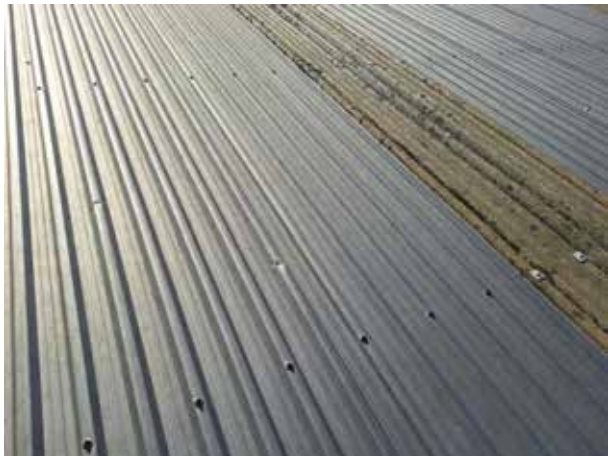
16. Sporadic areas of indentations to the profiled metal roof sheets.

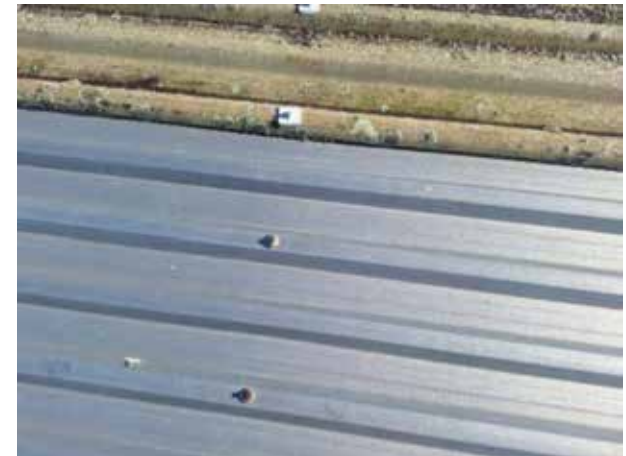
18. Widespread corrosion to the fixings of the profiled metal roof sheets.

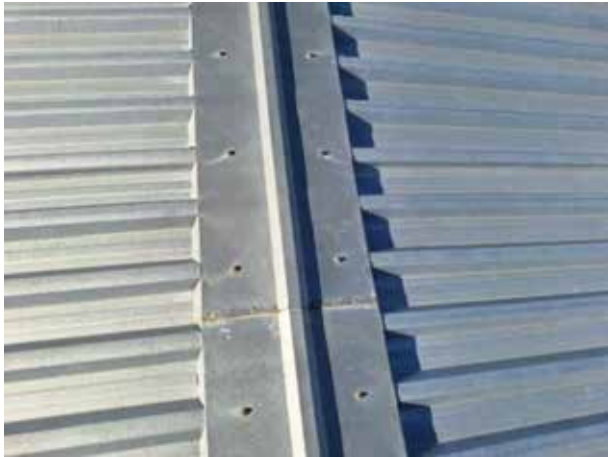
19. Widespread corrosion to the fixings of the metal ridge cappings.

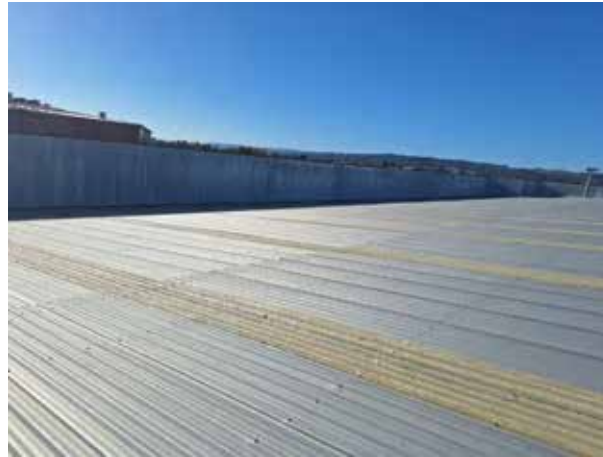
20. The fiberglass sheets were in an aged condition.

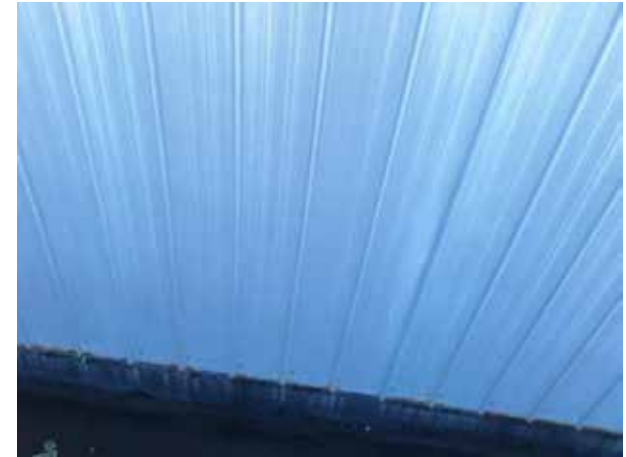
21. Sporadic areas of corrosion to the base of the profiled metal internal parapet sheets. The base of the sheets was in close proximity to the upstand of the internal gutter.

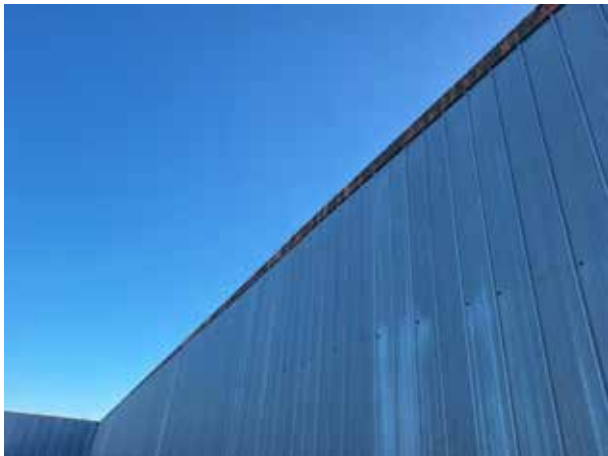
22. Sporadic areas of discolouration to the profiled metal internal parapet sheets.

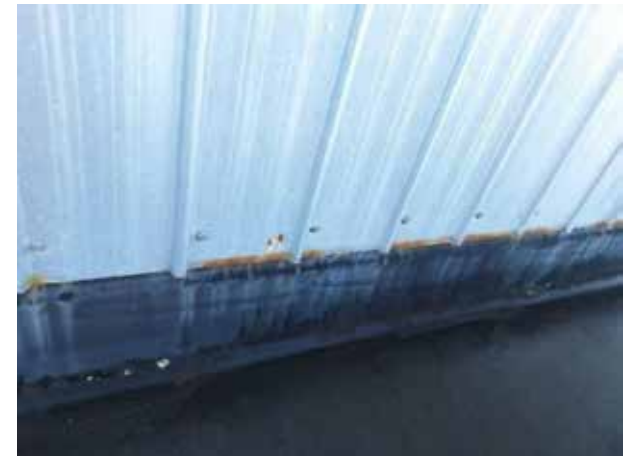
24. Sporadic areas of corrosion to the base of the profiled metal internal parapet sheets. The base of the sheets was in close proximity to the upstand of the internal gutter.

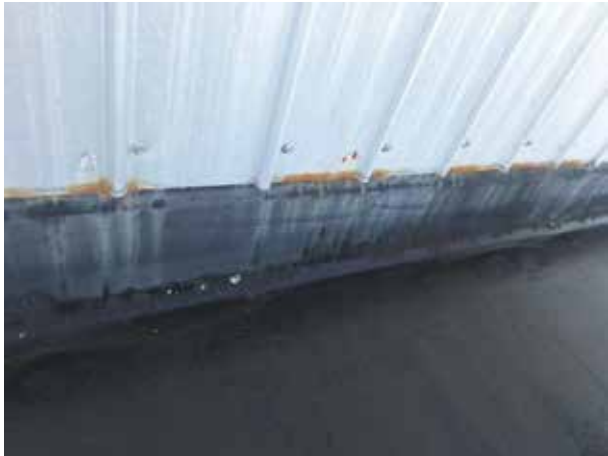
25. Sporadic areas of corrosion to the base of the profiled metal internal parapet sheets. The base of the sheets was in close proximity to the upstand of the internal gutter.

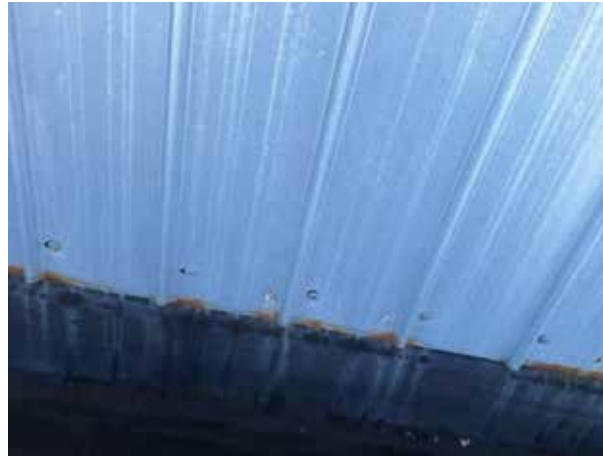
26. Sporadic areas of corrosion to the base of the profiled metal internal parapet sheets. The base of the sheets was in close proximity to the upstand of the internal gutter.

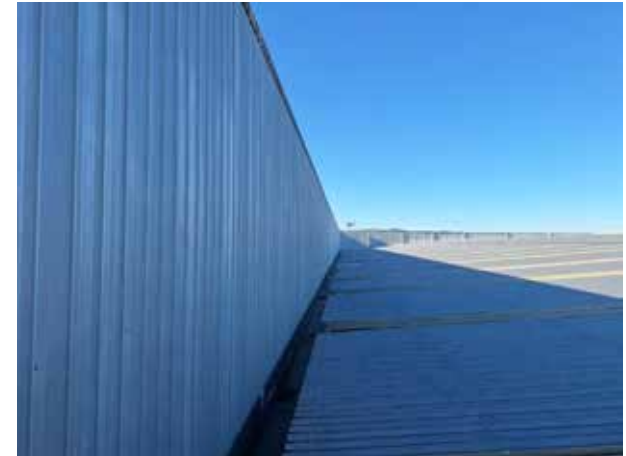
27. Sporadic areas of discolouration to the profiled metal internal parapet sheets.

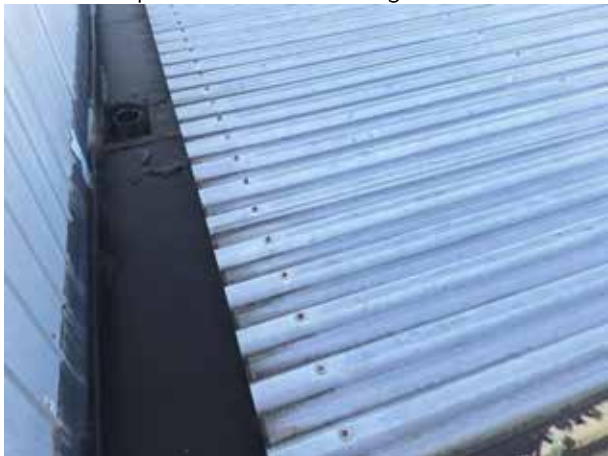
28. Widespread corrosion to the fixings of the profiled metal roof sheets.

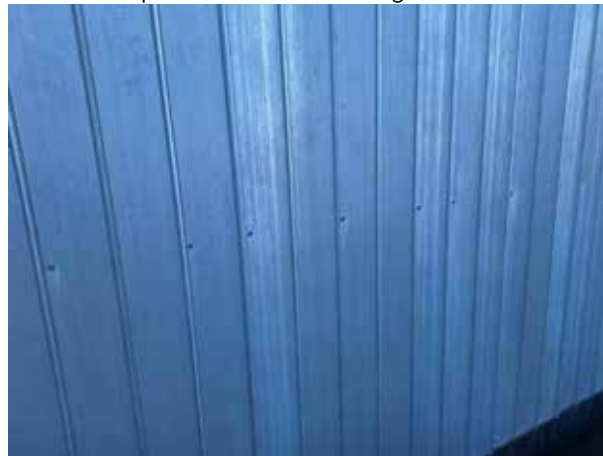
29. Sporadic areas of discolouration to the profiled metal internal parapet sheets.

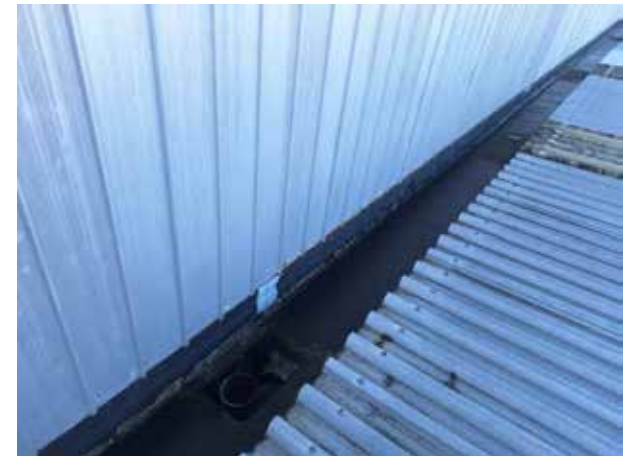
30. Sporadic areas of corrosion to the base of the profiled metal internal parapet sheets.

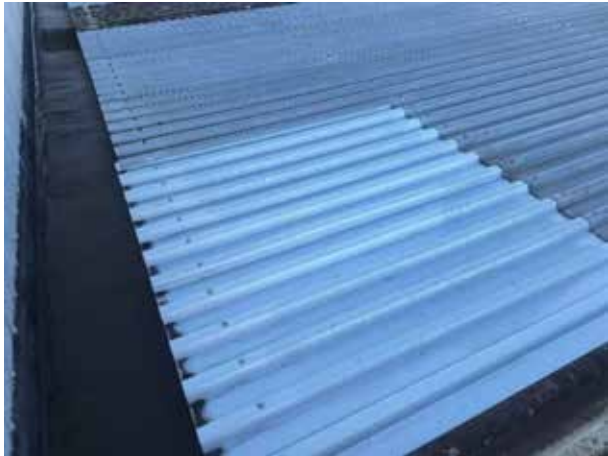
31. Localised targeted roof sheet replacement to the roof.

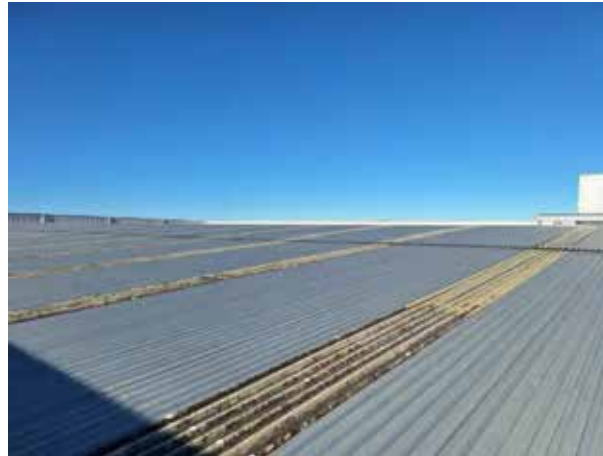
32. The fibreglass sheets were in an aged condition.

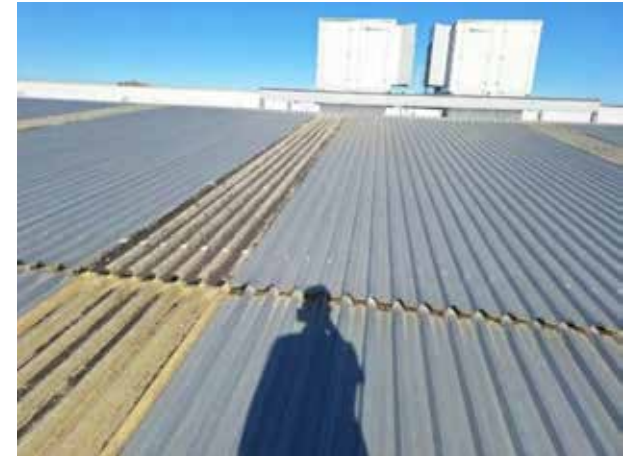
33. Widespread dirt build-up to the stepped junction of the profiled metal roof sheets.

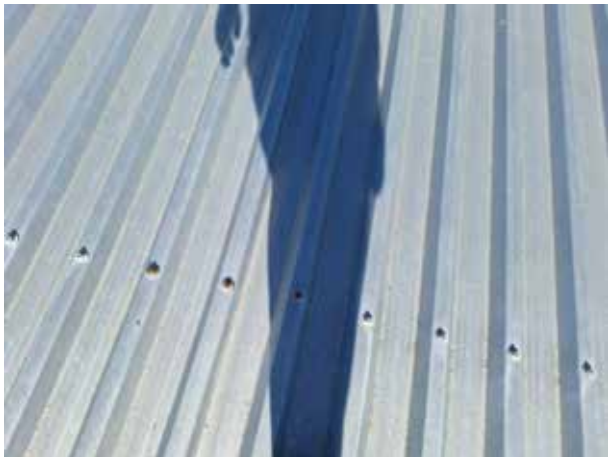
34. Widespread corrosion to the fixings of the profiled metal roof sheets.

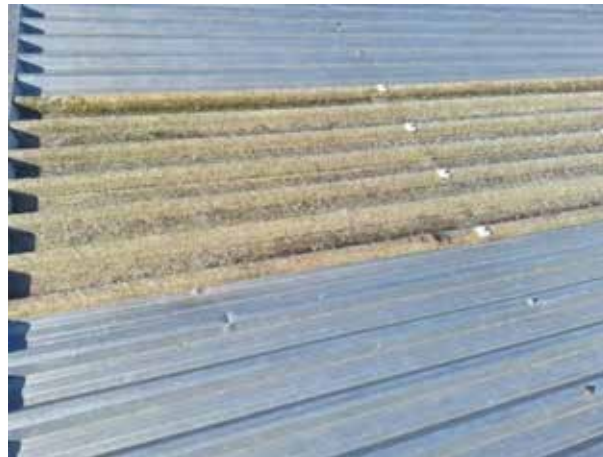
35. Sporadic areas of indentations to the profiled metal roof sheets.

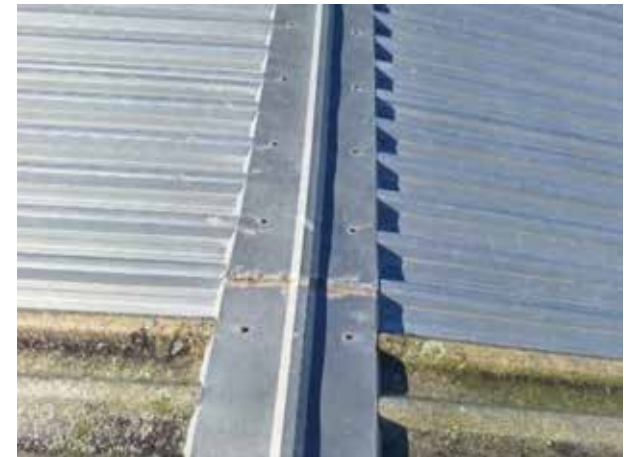
36. Localised corrosion to the joint of the metal ridge cappings.

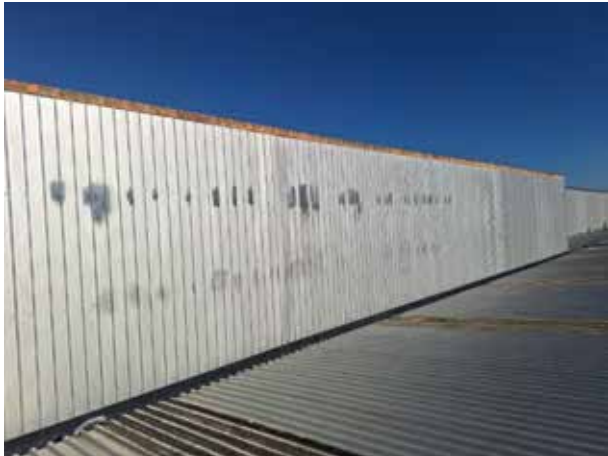
37. Localised area of discolouration to the profiled metal internal parapet sheets.

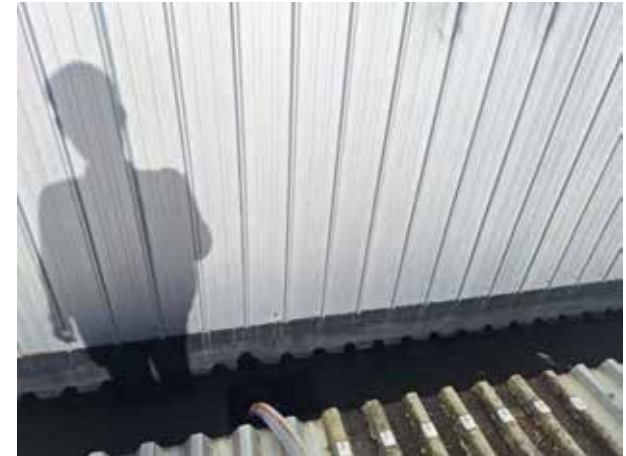
39. Localised extensive corrosion to the profiled metal internal parapet sheets adjacent to a fixing centre.

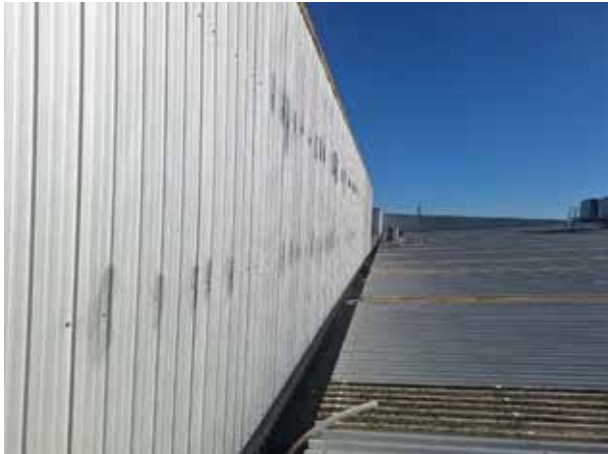
40. Localised area of discolouration to the profiled metal internal parapet sheets.

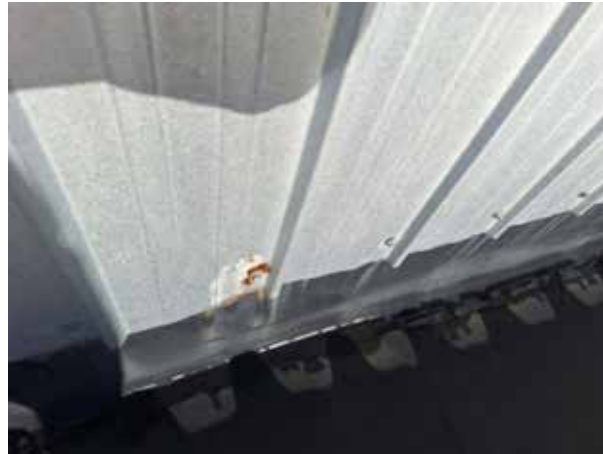
41. Localised extensive corrosion to the profiled metal internal parapet sheets adjacent to a fixing centre.

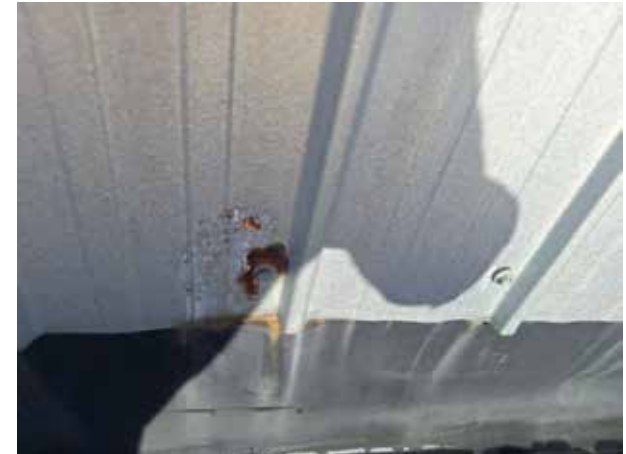
42. Localised extensive corrosion to the profiled metal internal parapet sheets adjacent to a fixing centre.

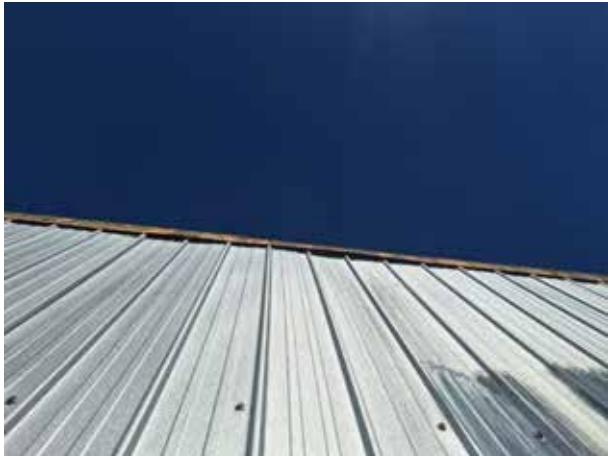
43. Localised area of discoloration to the profiled metal internal parapet sheets.

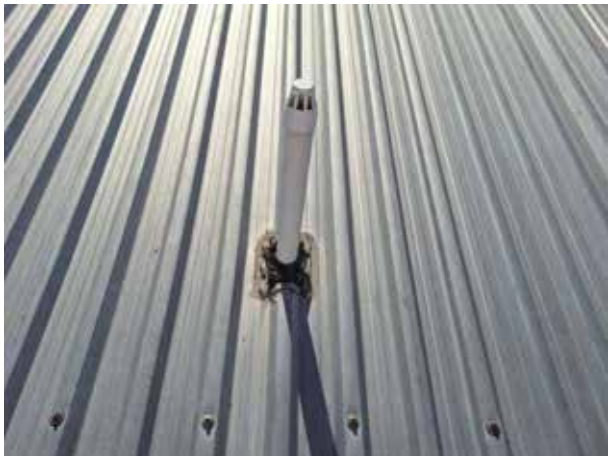
46. The sealant to the vent penetrations was in an aged condition.

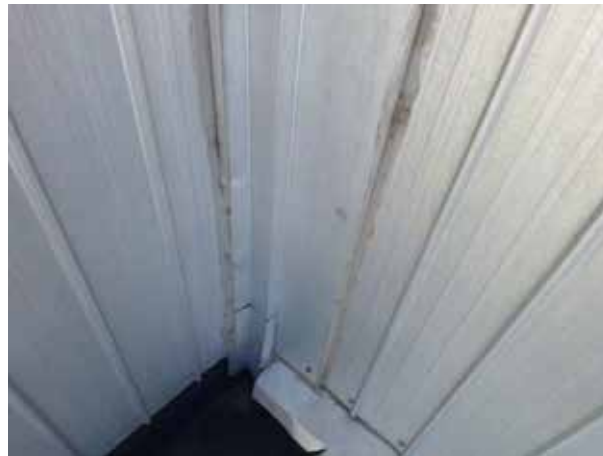
47. Localised debonding to the internal corner cappings of the profiled metal internal parapet sheets.

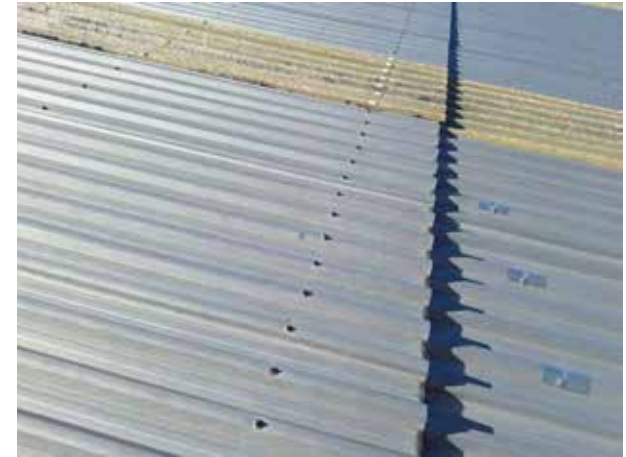
51. Widespread corrosion to the fixings of the profiled metal roof sheets.

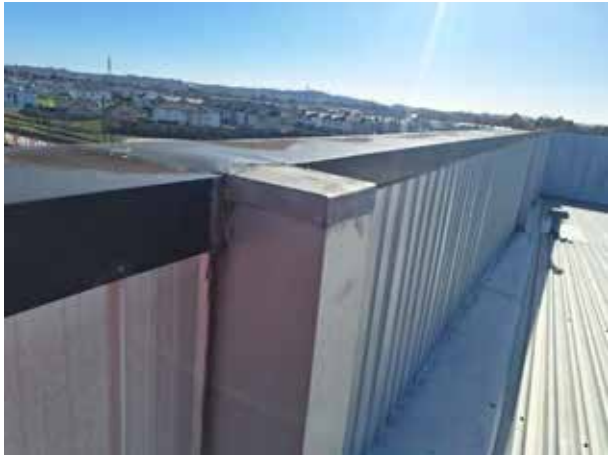
52. Sporadic areas of distortion and discolouration to the metal cappings to the parapet walls.

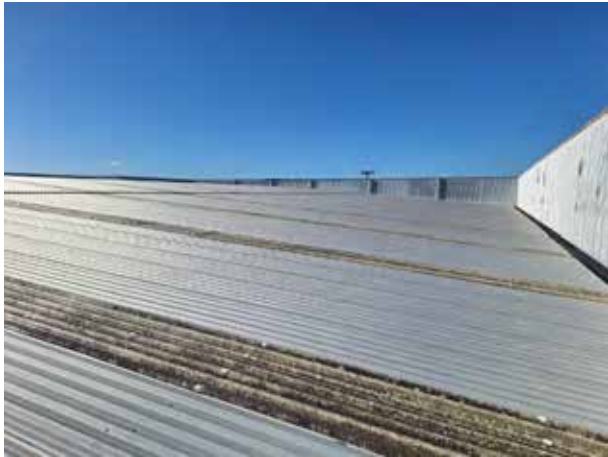
58. The fibreglass sheets were in aged an condition.

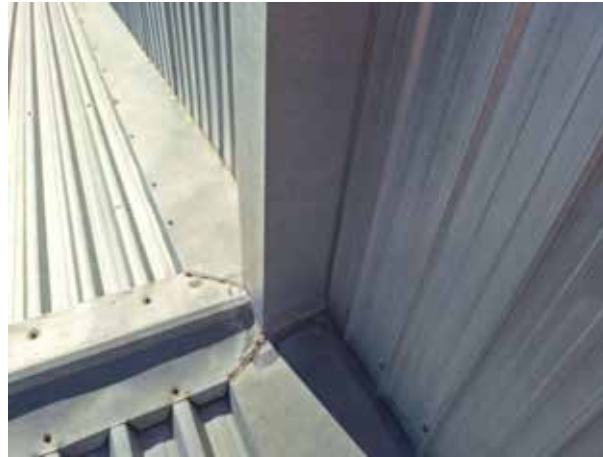
59. Widespread sealant applied to the joints of the apron flashings to metal ridge cappings.

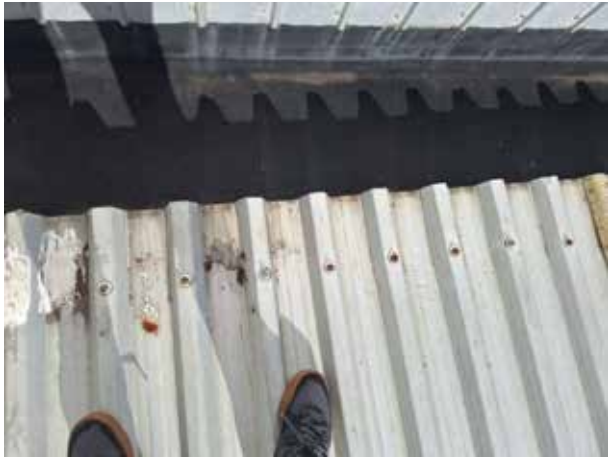
61. Widespread corrosion to the fixings of the profiled metal roof sheets.

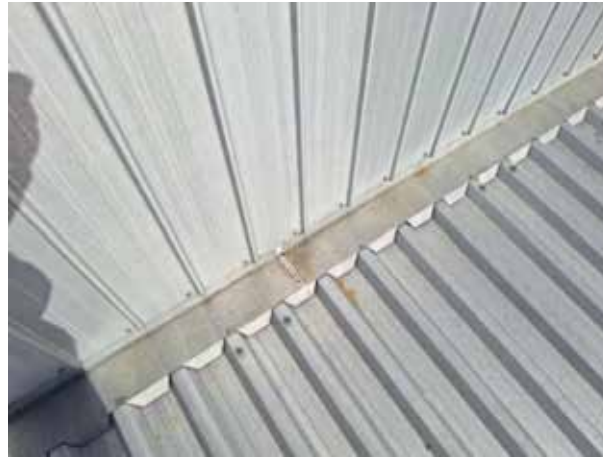
62. Widespread sealant applied to the joints of the apron flashings.

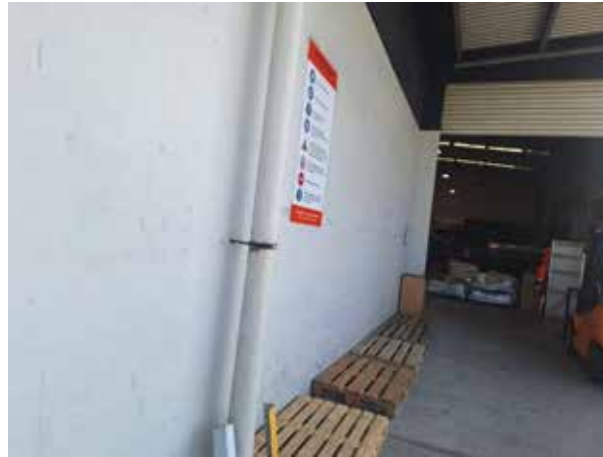
65. Sporadic areas of corrosion to the downpipe brackets of the plastic downpipes.

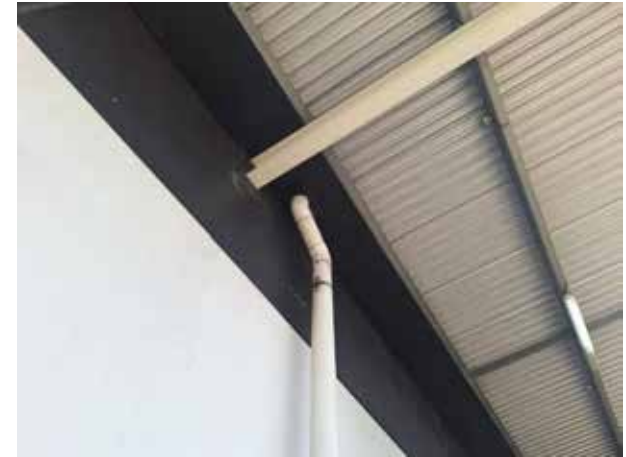
66. Sporadic areas of corrosion to the downpipe brackets of the plastic downpipes.

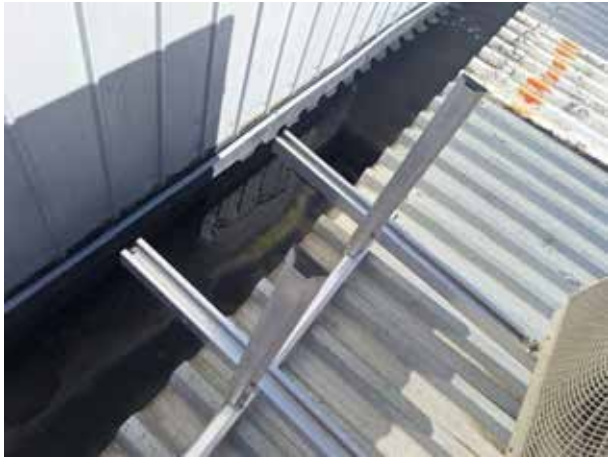
67. Localised ponding surface moisture to the internal gutters.

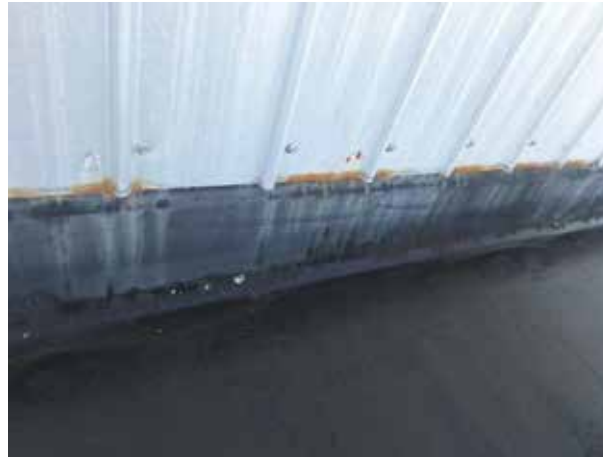
68. Widespread moisture run-marks and discoloration to the upstand of the synthetic rubber sheets.

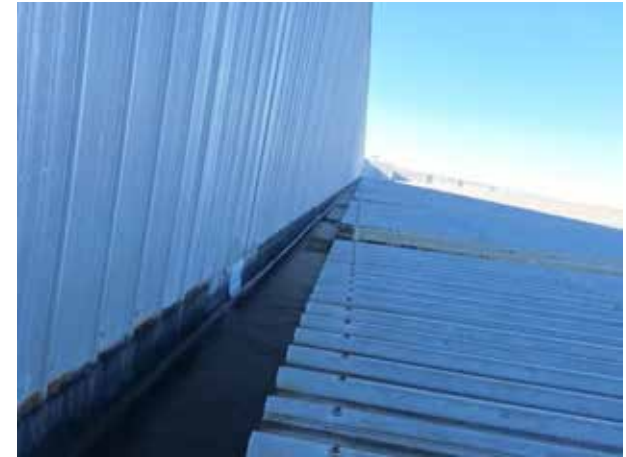
69. Widespread moisture run-marks and discoloration to the upstand of the synthetic rubber sheets.

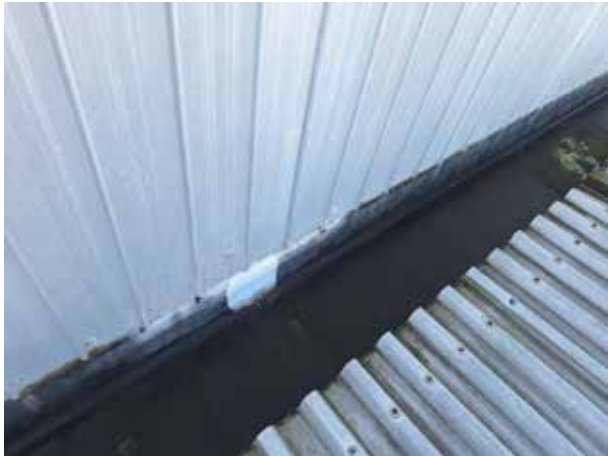
70. Sporadic areas of targeted repair sealing works to the joints of the synthetic membrane sheets.
