Building Condition Assessment Report

230 Great South Road, Penrose, Auckland 1061

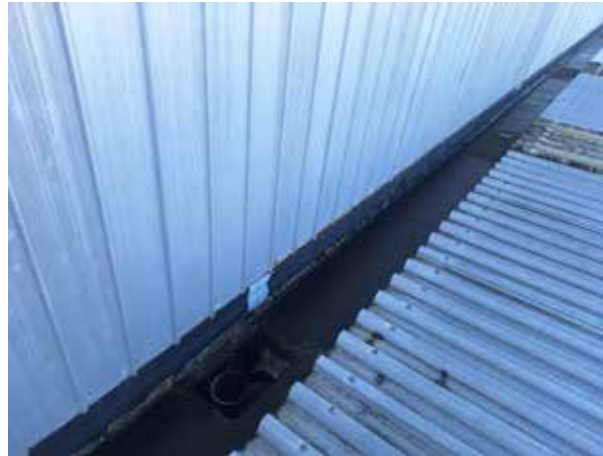
71. Sporadic areas of targeted repair sealing works to the joints of the synthetic membrane sheets.

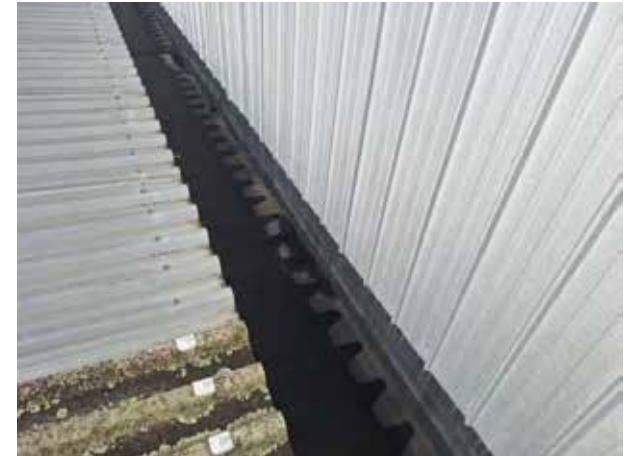
72. Widespread staining and dirt build-up to the internal gutters.

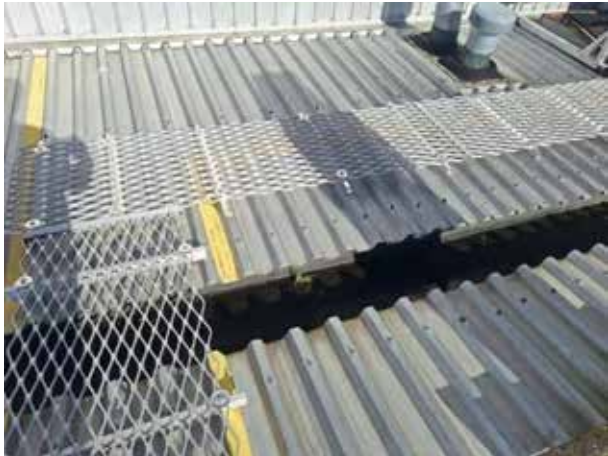
73. Localised vegetation growth to the internal gutters.

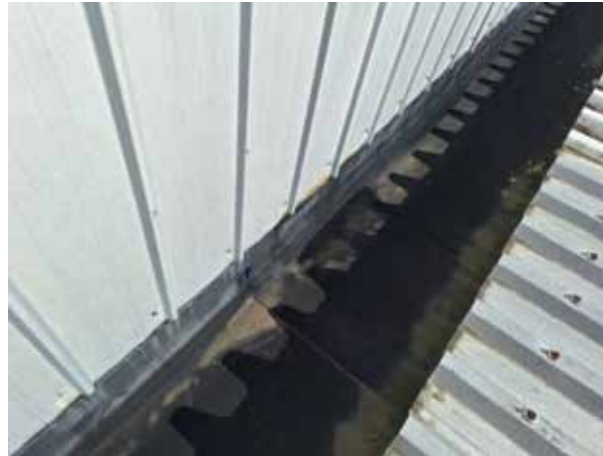
74. Widespread staining and dirt build-up to the internal gutters.

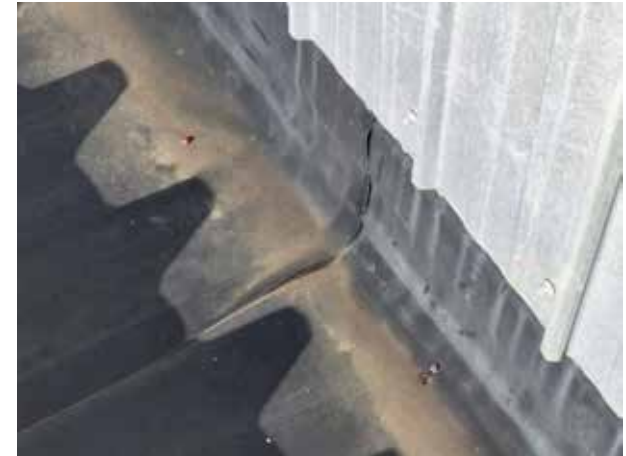
75. Localised minor deboning to the synthetic rubber membrane sheets.

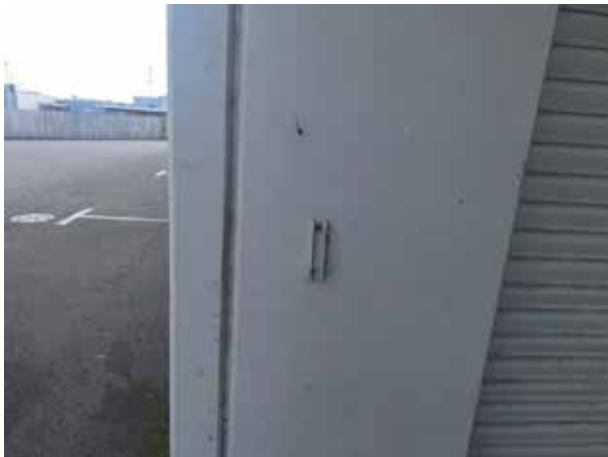
76. Localised corrosion to the fixings of the metal bracket.

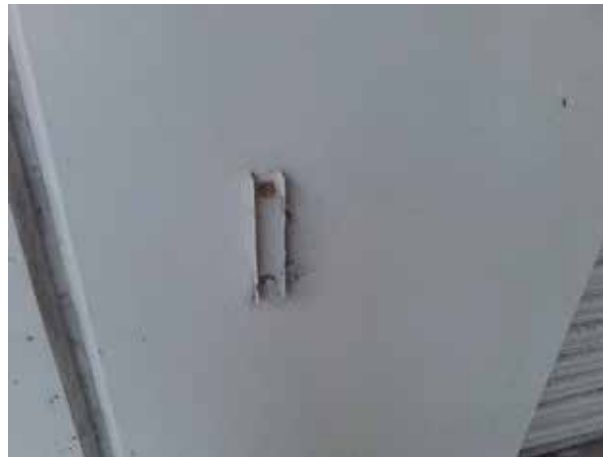
77. Localised corrosion to the fixings of the metal bracket.

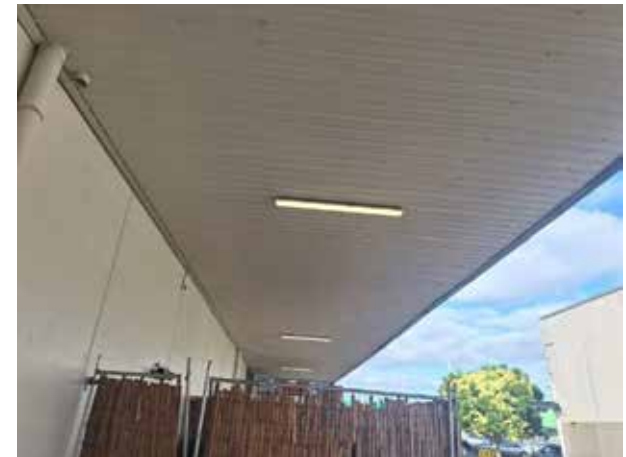
78. Widespread deterioration of the finish to the lower half of the concrete wall panels.

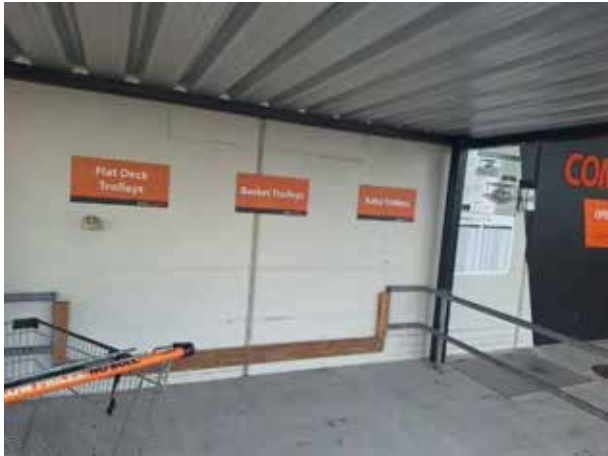
79. Widespread deterioration of the finish to the lower half of the concrete wall panels.

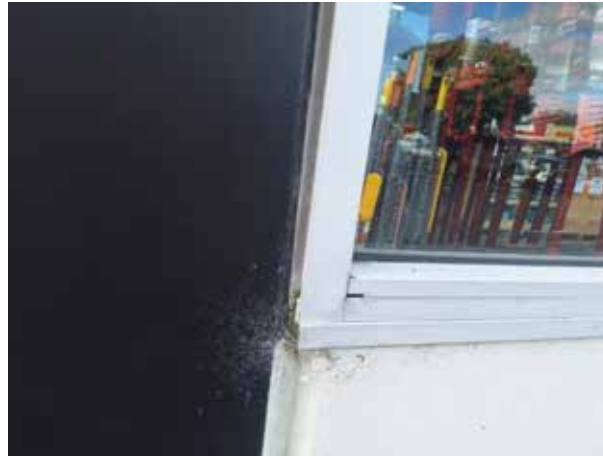
80. Localised mould growth and minor deterioration of the sealant between the concrete wall panel and aluminium shop front units.

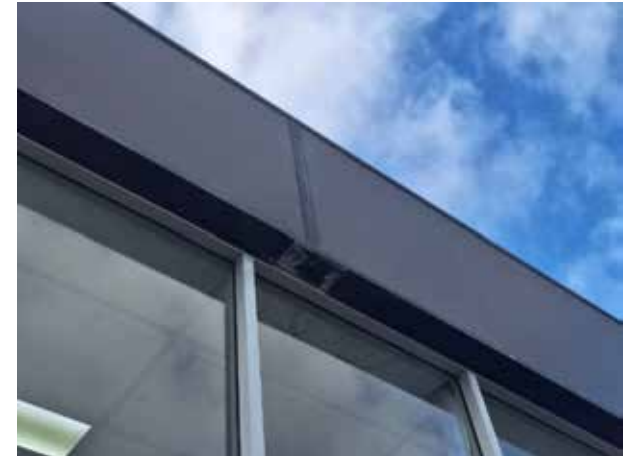
81. Sporadic areas of deterioration of the finish to the metal fascia sheets.

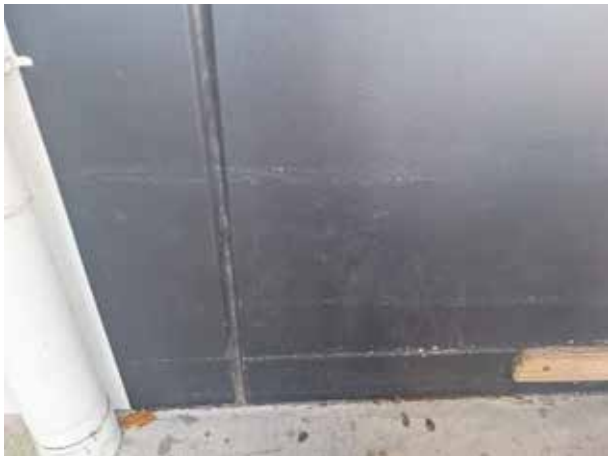
82. Widespread deterioration of the finish to the lower half of the concrete wall panels.

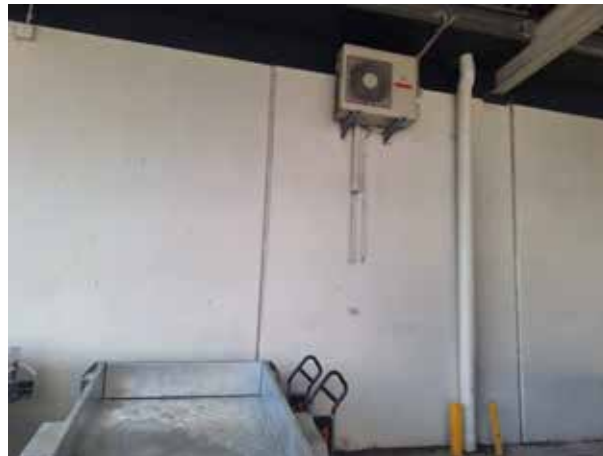
83. Widespread debonding of the sealant to the control joints of the concrete wall panels.

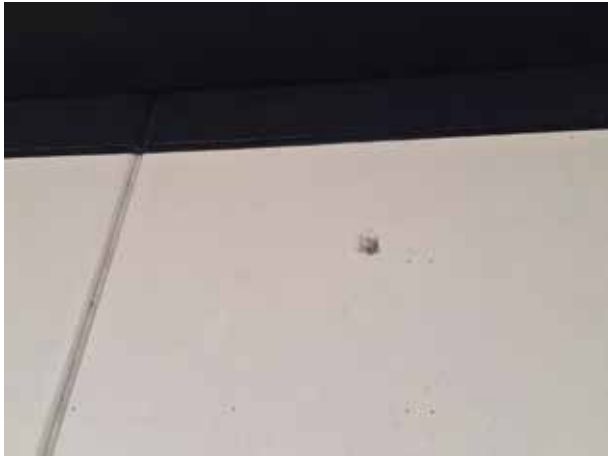
85. Sporadic areas of abrasions, deterioration and spalling to the concrete wall panels.

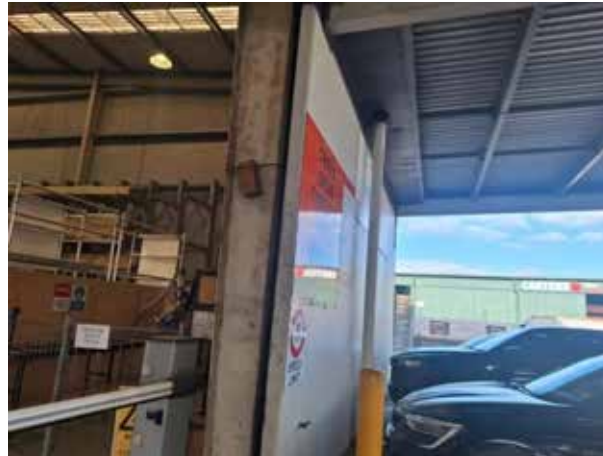
86. Sporadic areas of abrasions, deterioration and spalling to the concrete wall panels.

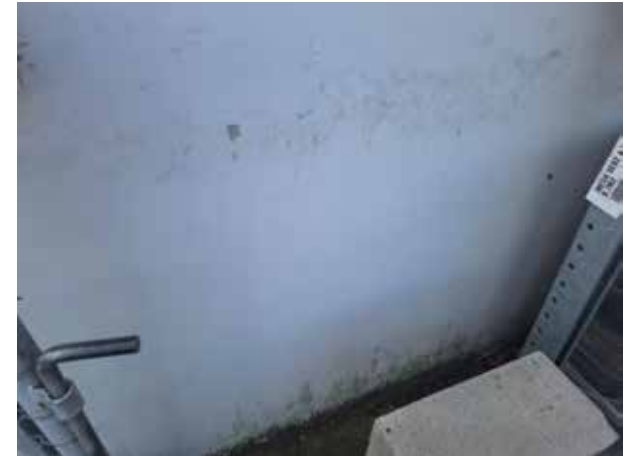
87. Widespread deterioration of the finish to the lower half of the concrete wall panels.

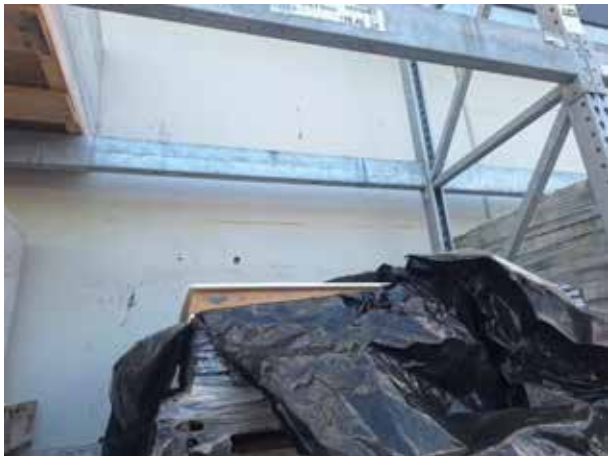
88. Widespread deterioration of the finish to the lower half of the concrete wall panels.

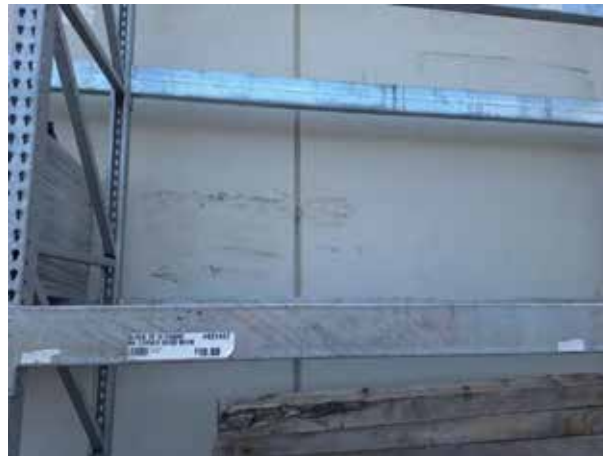
89. Widespread deterioration of the finish to the lower half of the concrete wall panels.

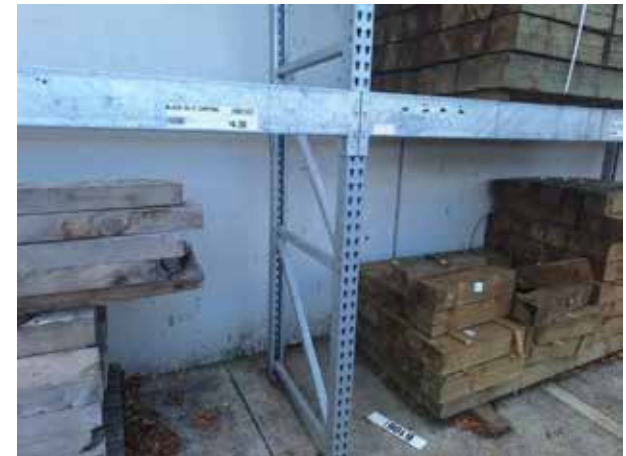
90. Sporadic areas of lichen and vegetation growth to the concrete wall panels at the eastern elevation. The Tenant's racking was installed at this location.

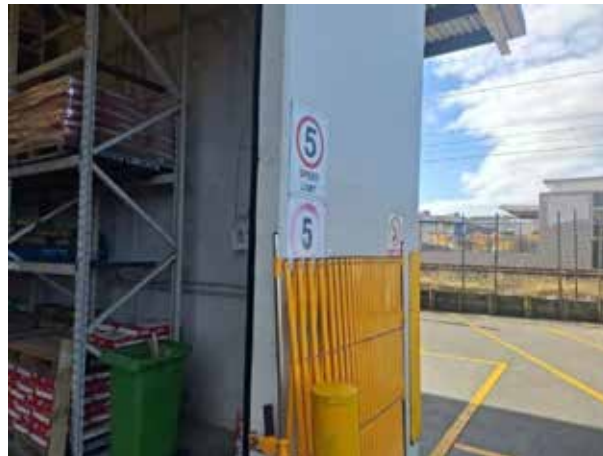
95. Sporadic areas of abrasions, deterioration and spalling to the concrete wall panels.

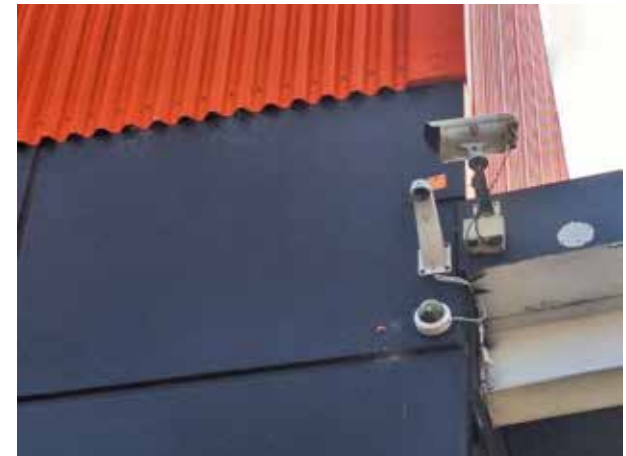
96. Localised redundant fixing centres to the concrete wall panels.

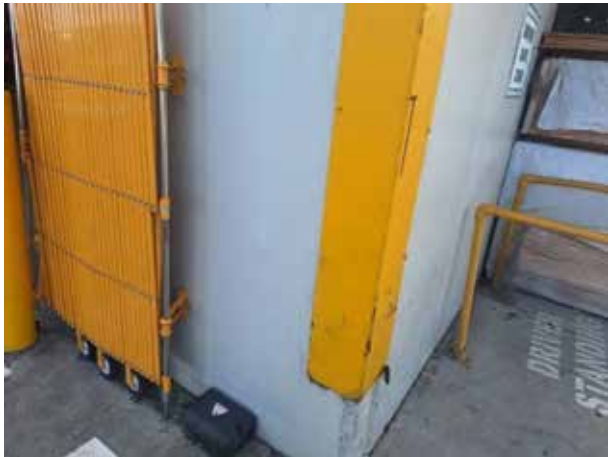
97. Sporadic areas of abrasions and deterioration of the finish to the metal corner cappings of the concrete wall panels.

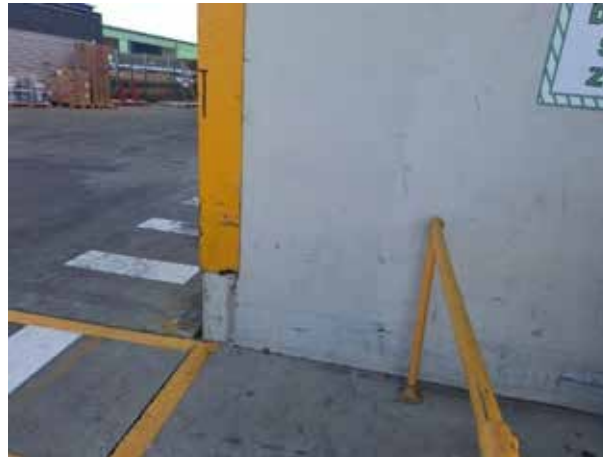
98. Widespread deterioration of the finish to the lower half of the concrete wall panels.

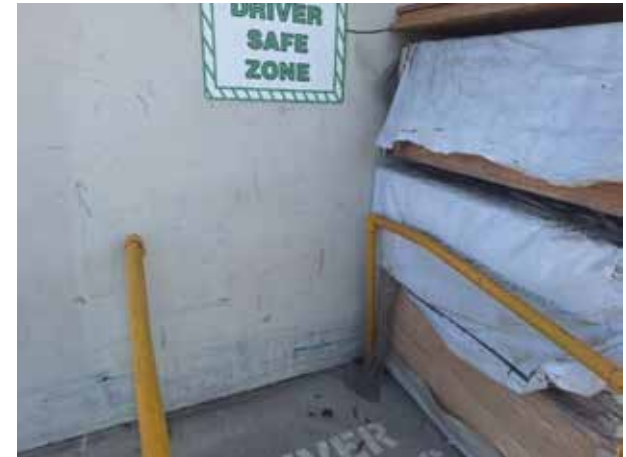
99. Widespread deterioration of the finish to the lower half of the concrete wall panels.

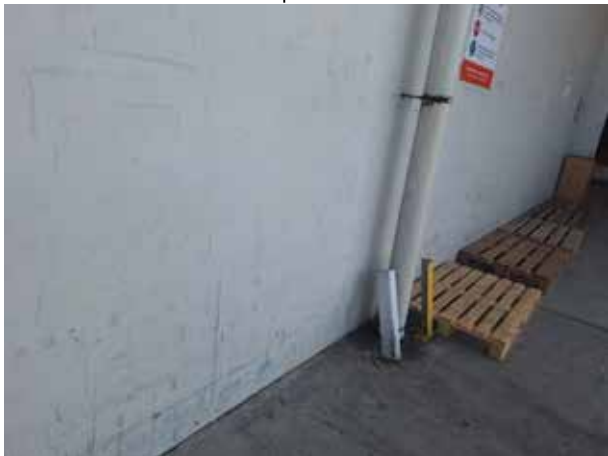
100. Widespread deterioration of the finish to the lower half of the concrete wall panels.

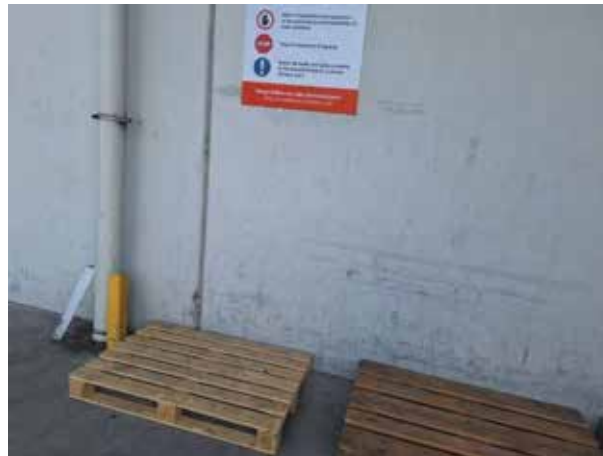
101. Sporadic areas of abrasions, deterioration and spalling to the concrete wall panels.

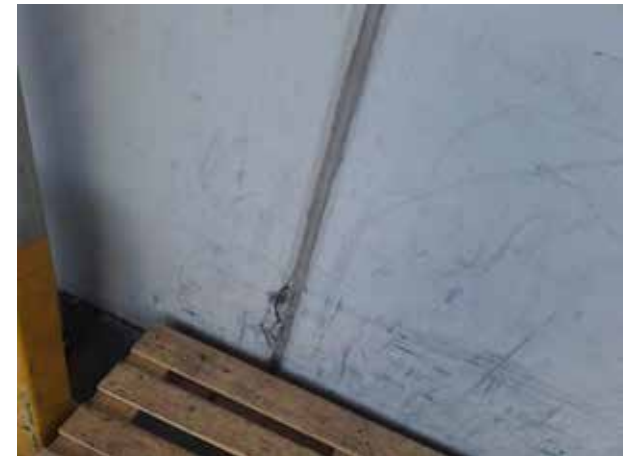
102. Sporadic areas of abrasions, deterioration and spalling to the concrete wall panels.

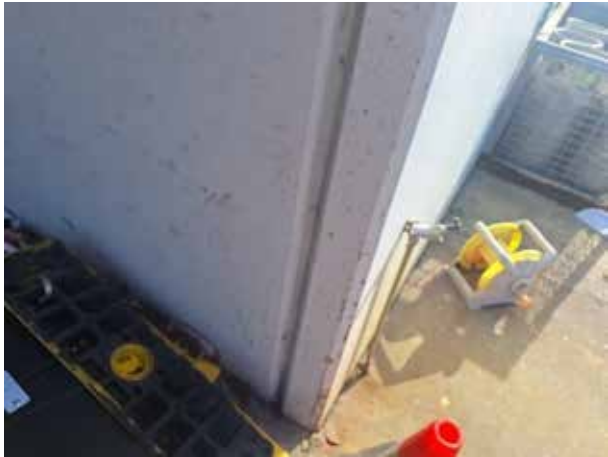
103. Sporadic areas of abrasions, deterioration and spalling to the concrete wall panels.

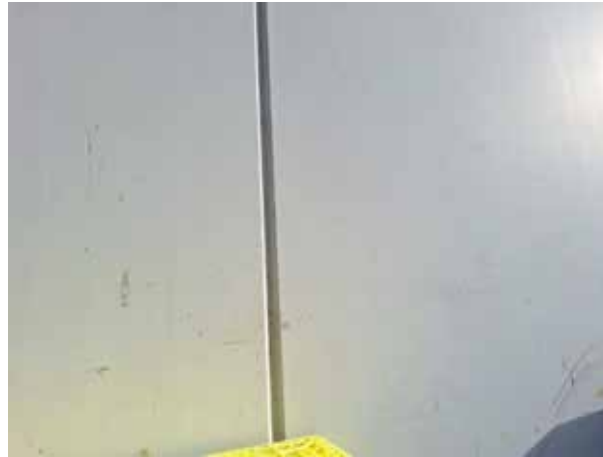
104. Widespread debonding of the sealant to the control joints of the concrete wall panels.

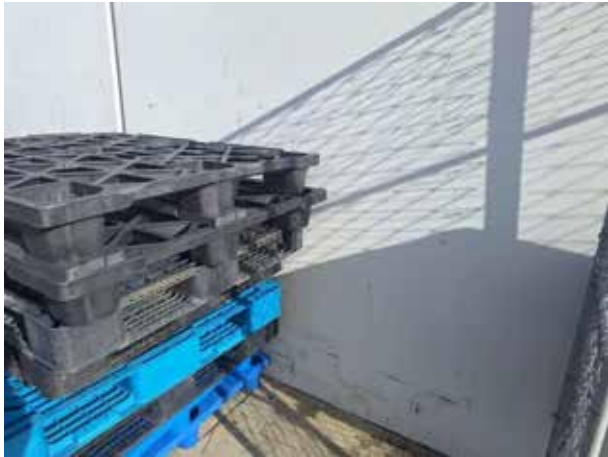
106. Widespread deterioration of the finish to the lower half of the concrete wall panels.

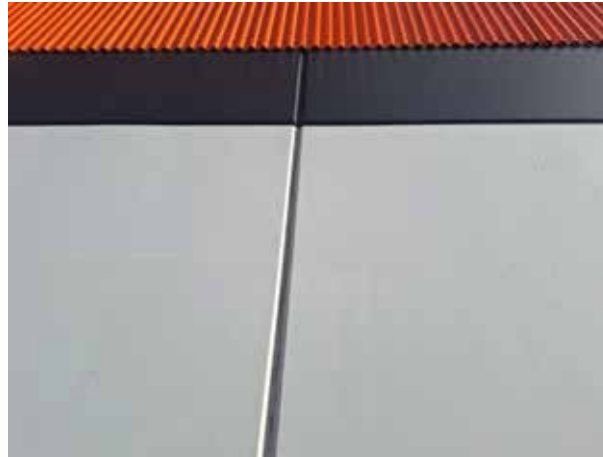
107. Widespread debonding of the sealant to the control joints of the concrete wall panels.

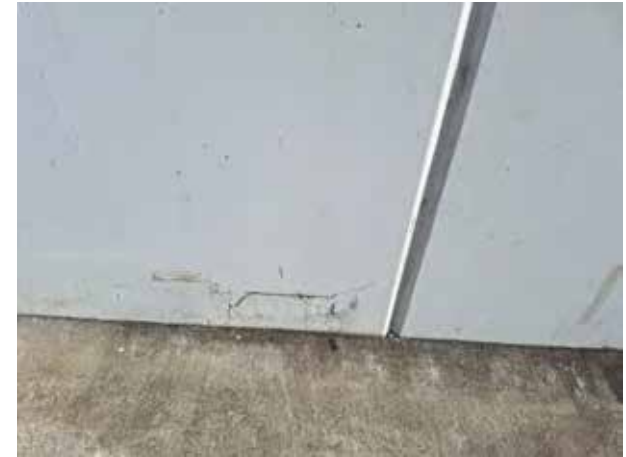
108. Sporadic areas of horizontal surface cracking to the base of the concrete wall panels at the northern elevation.

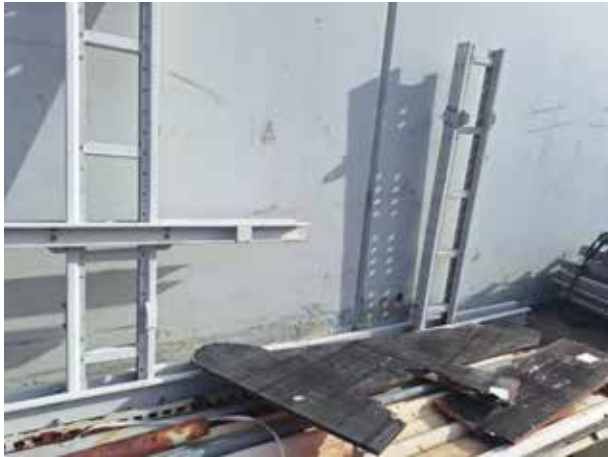
109. Widespread deterioration of the finish to the lower half of the concrete wall panels.

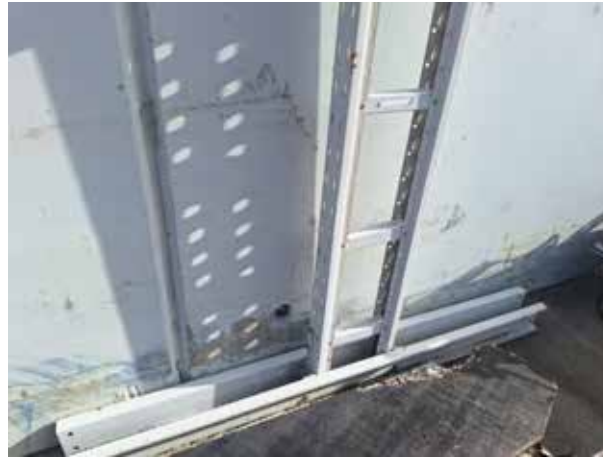
110. Sporadic areas of unsealed penetration centre to the concrete wall panels.

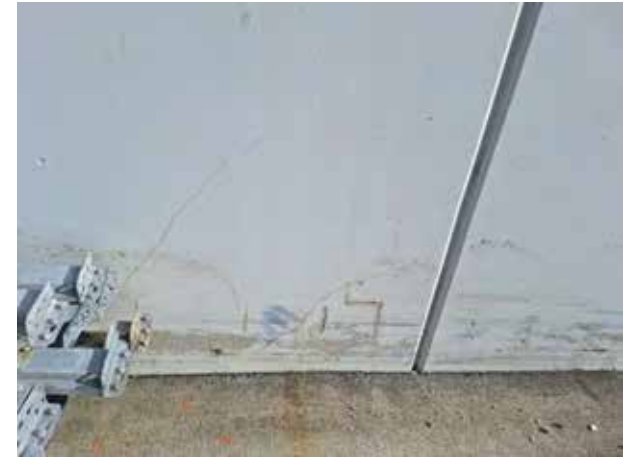
111. Sporadic areas of diagonal surface cracking to the base of the concrete wall panels at the northern elevation.

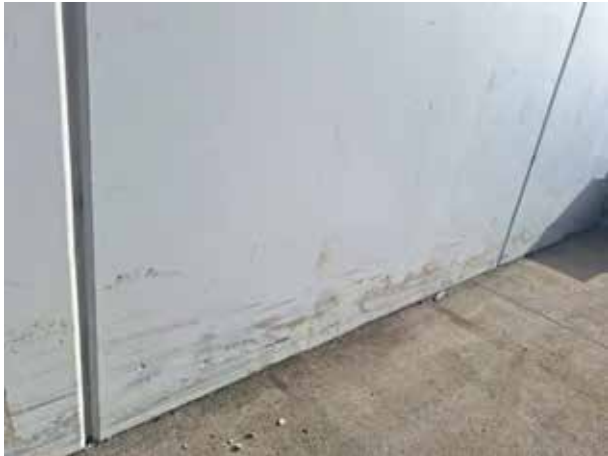
112. Widespread deterioration of the finish to the lower half of the concrete wall panels.

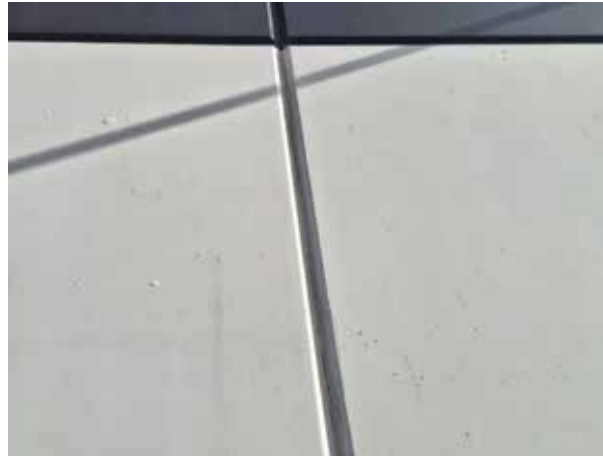
113. Widespread debonding of the sealant to the control joints of the concrete wall panels.

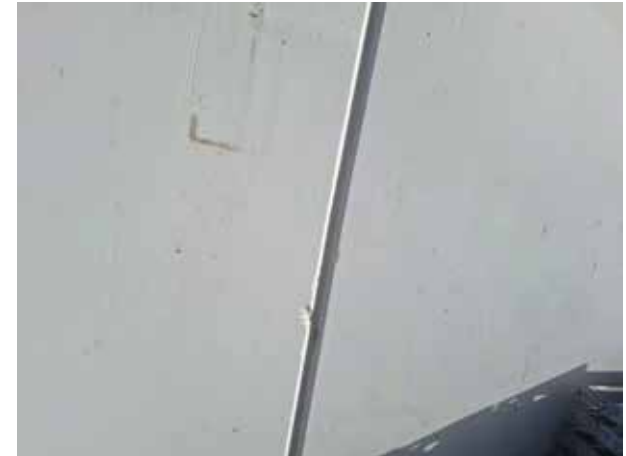
117. Sporadic areas of abrasions, deterioration and spalling to the concrete wall panels.

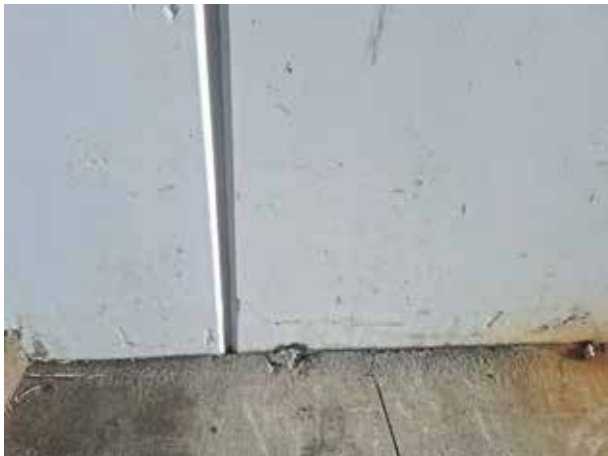
118. Sporadic areas of horizontal surface cracking to the base of the concrete wall panels at the northern elevation.

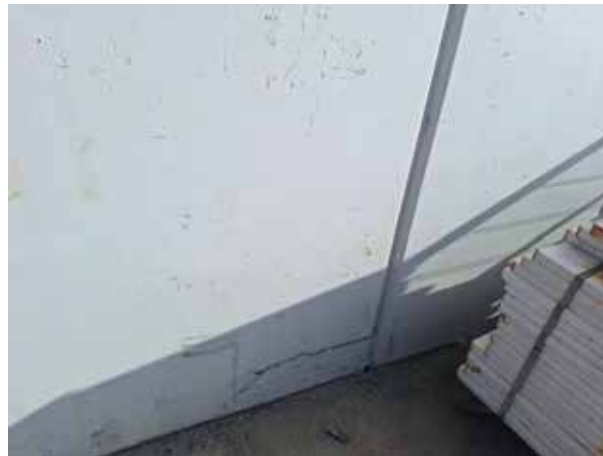
119. Sporadic areas of horizontal surface cracking to the base of the concrete wall panels at the northern elevation.

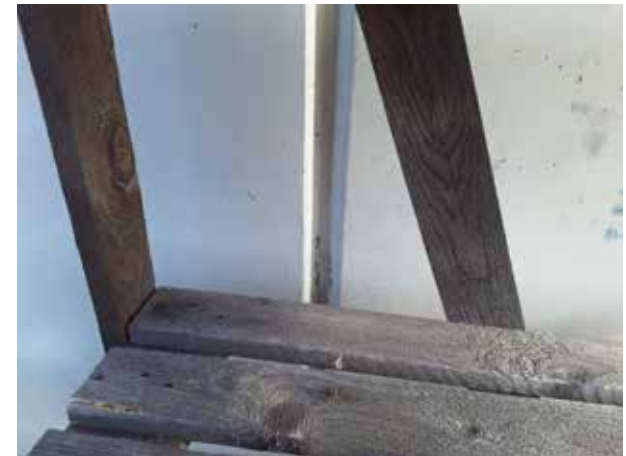
120. Widespread debonding of the sealant to the control joints of the concrete wall panels.

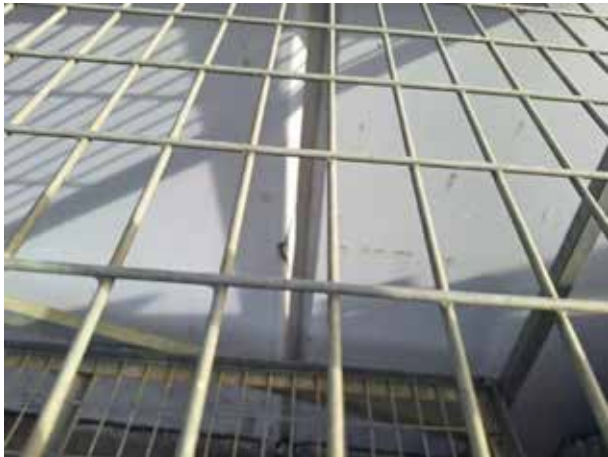
121. Sporadic areas of abrasions, deterioration and spalling to the concrete wall panels.

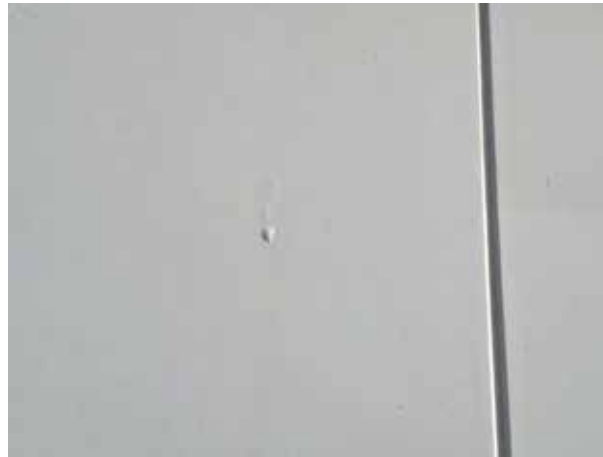
122. Widespread deterioration of the finish to the lower half of the concrete wall panels.

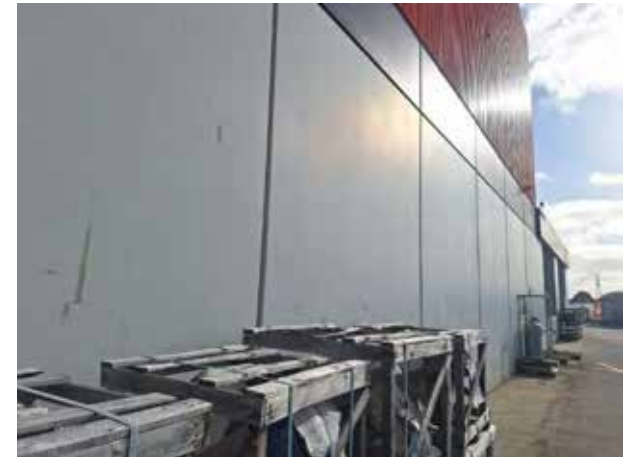
123. Widespread deterioration of the finish to the lower half of the concrete wall panels.

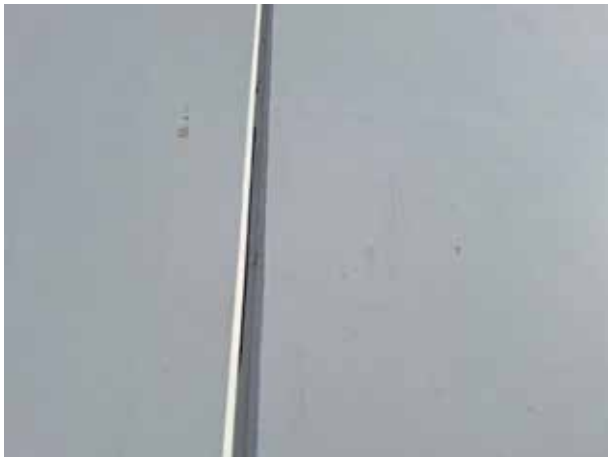
124. Widespread debonding of the sealant to the control joints of the concrete wall panels.

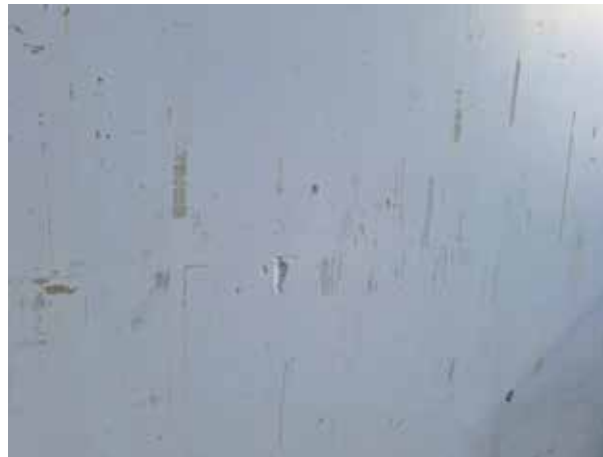
125. Sporadic areas of abrasions, deterioration and spalling to the concrete wall panels.

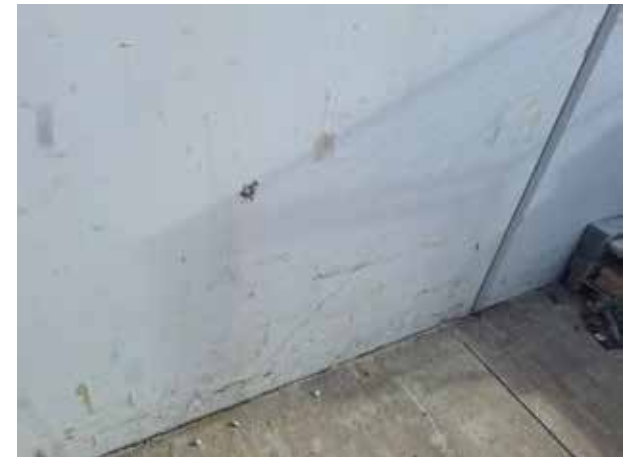
126. Sporadic areas of diagonal surface cracking to the base of the concrete wall panels at the northern elevation.

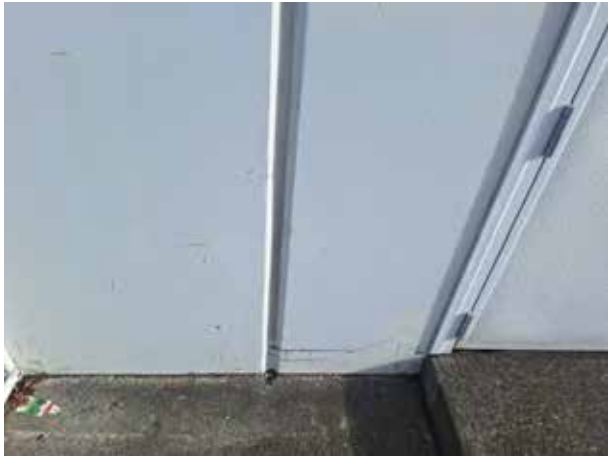
127. Sporadic areas of horizontal surface cracking to the base of the concrete wall panels at the northern elevation.

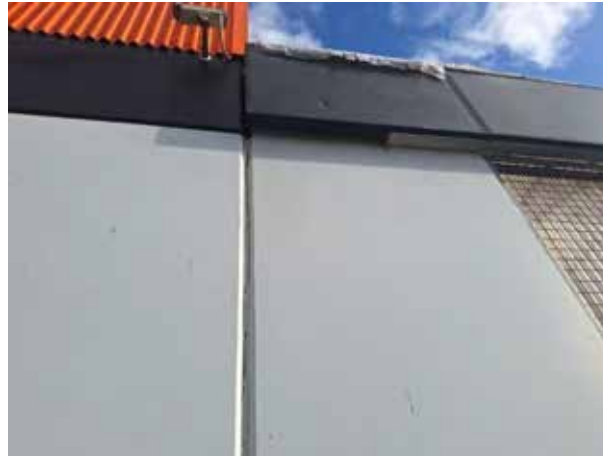
128. Widespread debonding of the sealant to the control joints of the concrete wall panels.

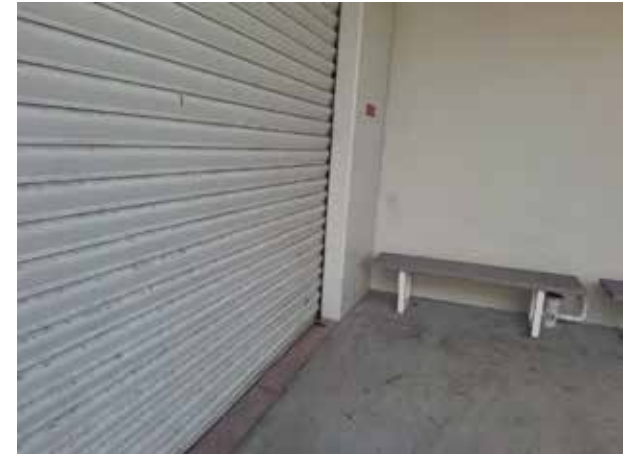
132. Sporadic areas of environmental staining to the metal roller shutter door.

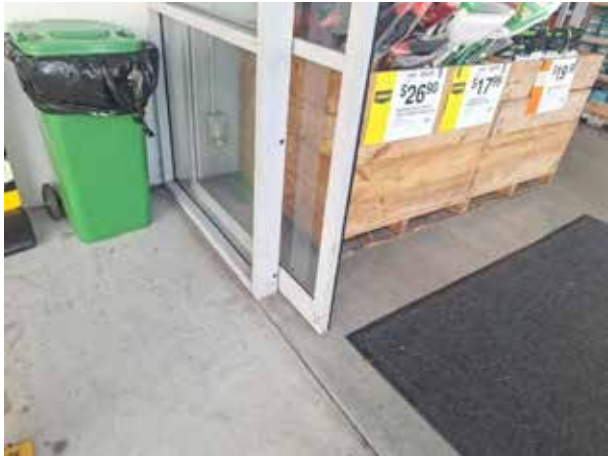
133. Localised abrasions to the automatic sliding doors.

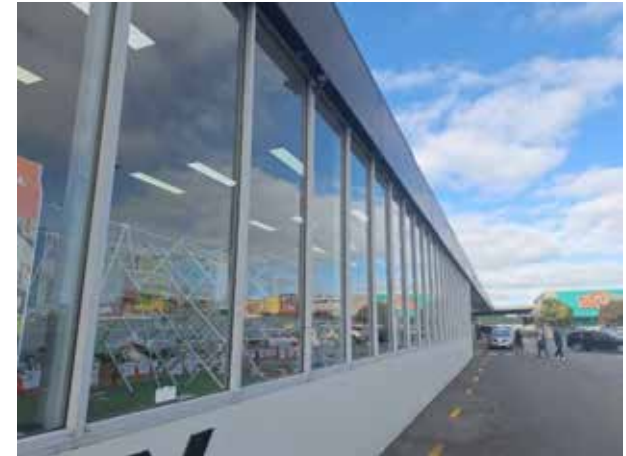
135. Sporadic areas of environmental staining to the aluminium shop front units.

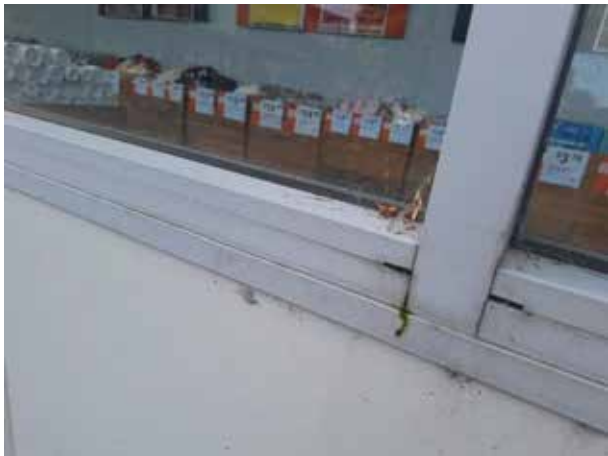
136. Localised mould staining to the aluminium shop front units.

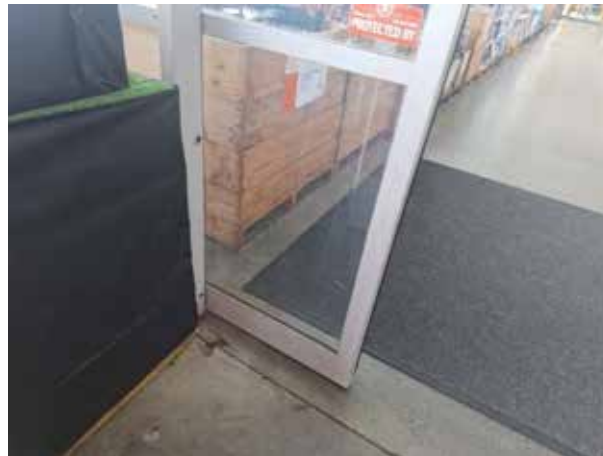
137. Sporadic areas of environmental staining to the aluminium shop front units.

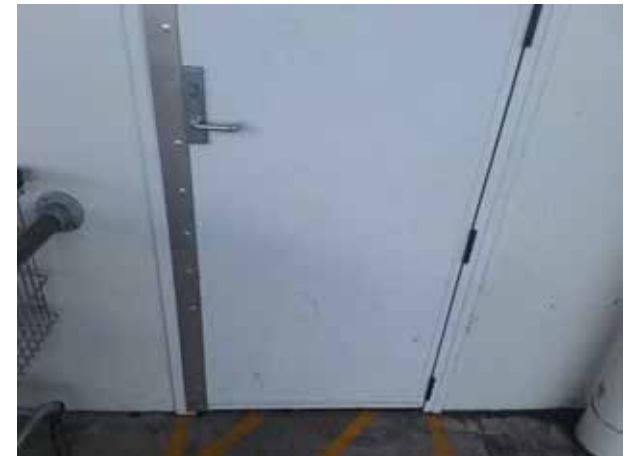
138. Sporadic areas of indentations to the metal panelled hinged doors.

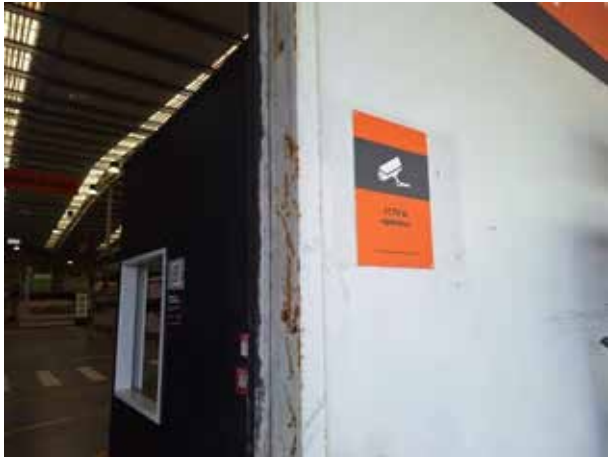
139. Widespread corrosion to the metal opening cappings.

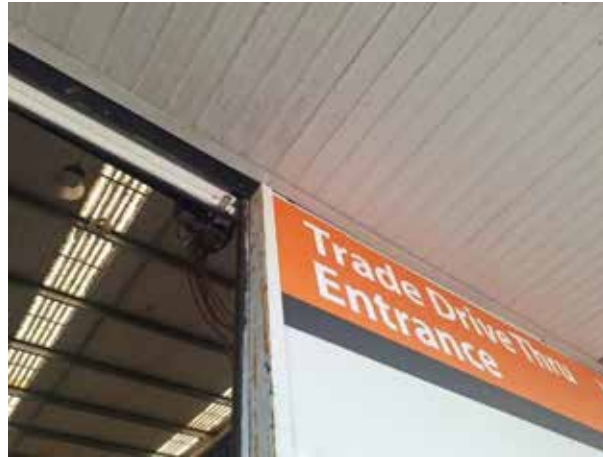
140. Widespread corrosion to the metal opening cappings.

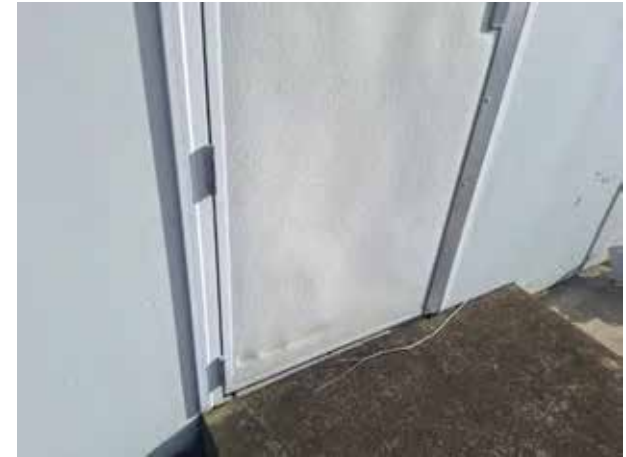
141. Sporadic areas of indentations to the metal panelled hinged doors.

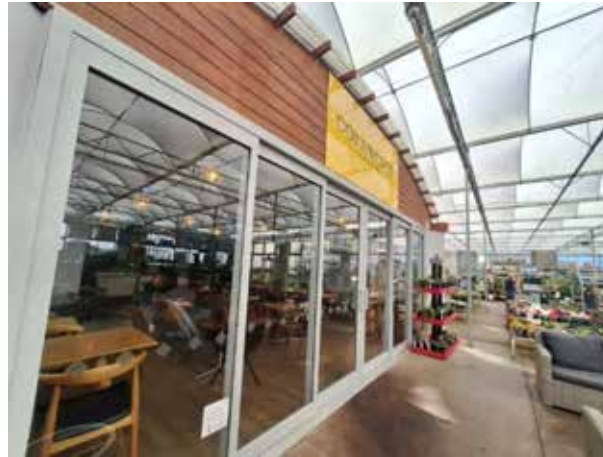
143. Sporadic areas of environmental staining to the aluminium shop front units.

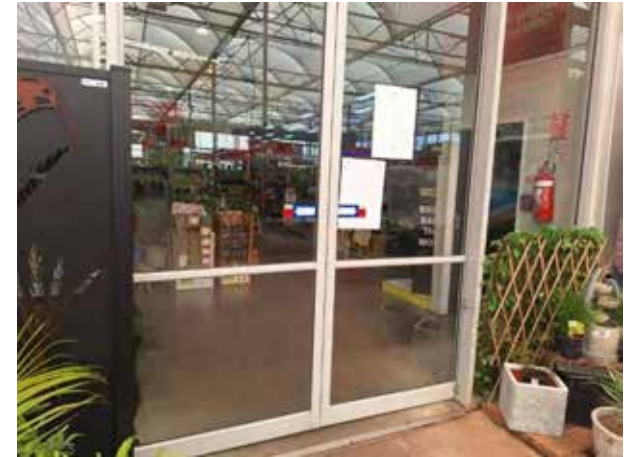
144. Sporadic areas of environmental staining to the aluminium shop front units.

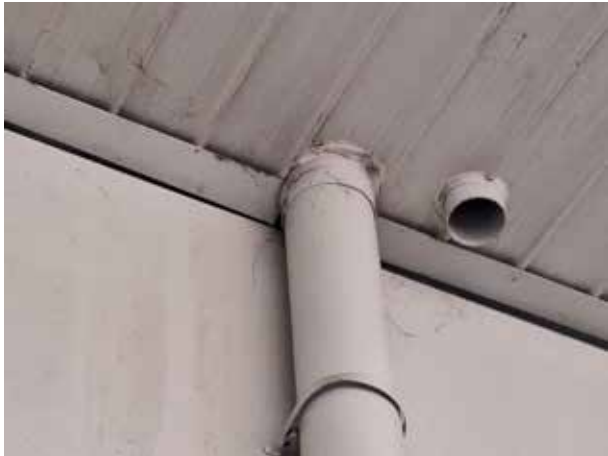
145. Localised debonding to the sealant applied between the underside of the canopy and the downpipe.

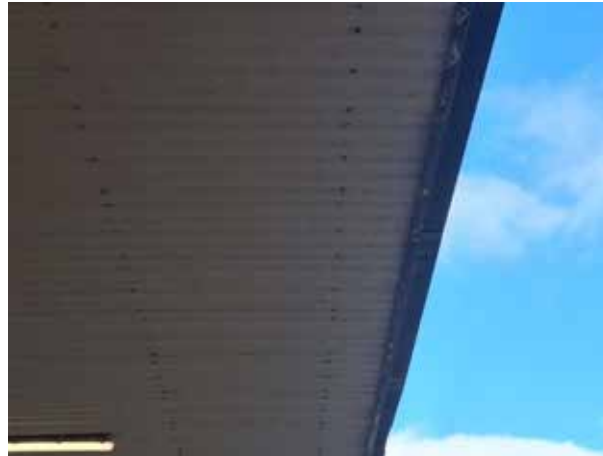
146. Widespread environmental staining to the underside profiled metal canopy sheets.

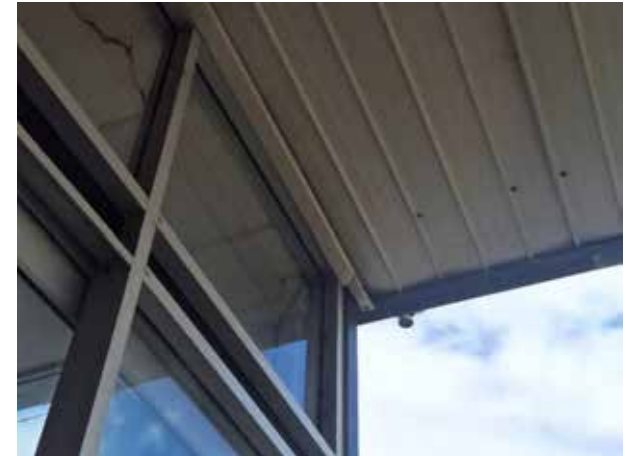
147. Localised distortion of the metal trim to the underside of the canopy.

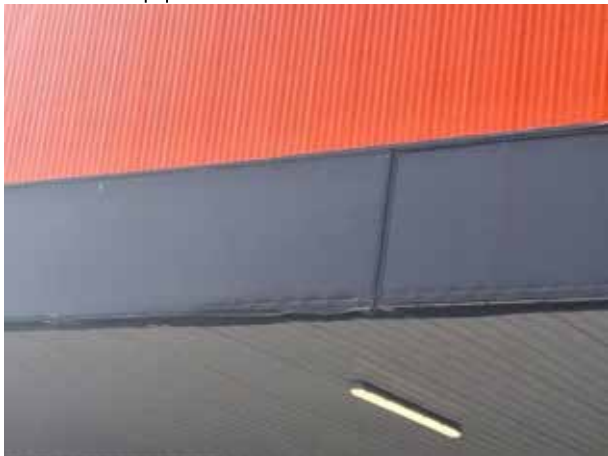
148. Sporadic areas of impact damage and distortion to the metal fascia canopy sheets.

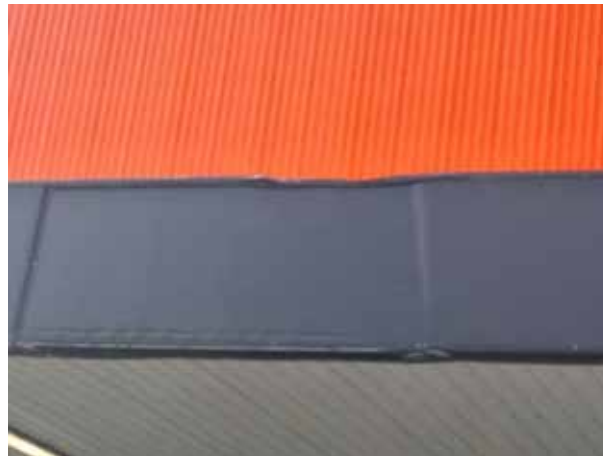
149. Sporadic areas of impact damage and distortion to the metal fascia canopy sheets.

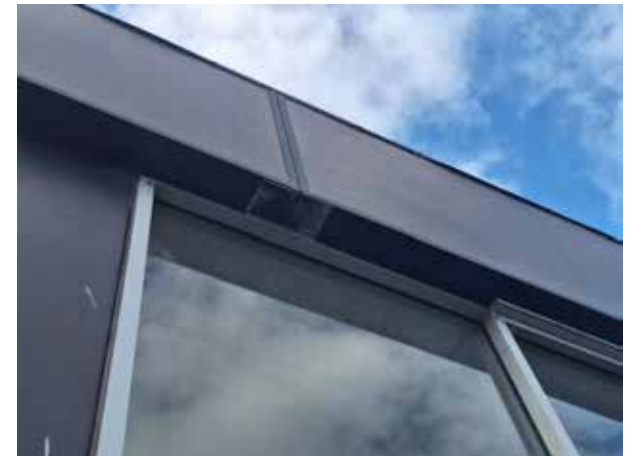
150. Sporadic areas of deterioration of the finish to the metal fascia sheets.

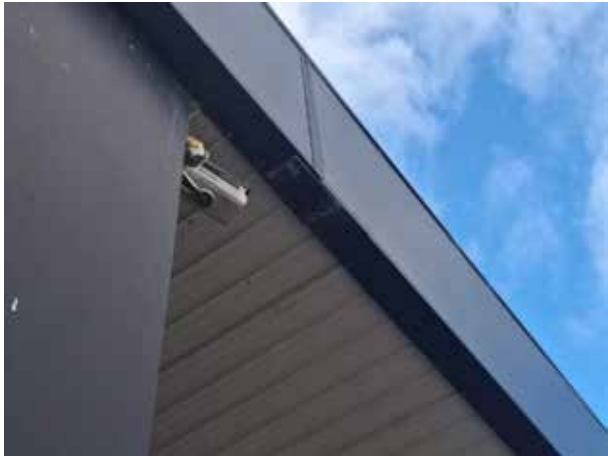
151. Sporadic areas of deterioration of the finish to the metal fascia sheets.

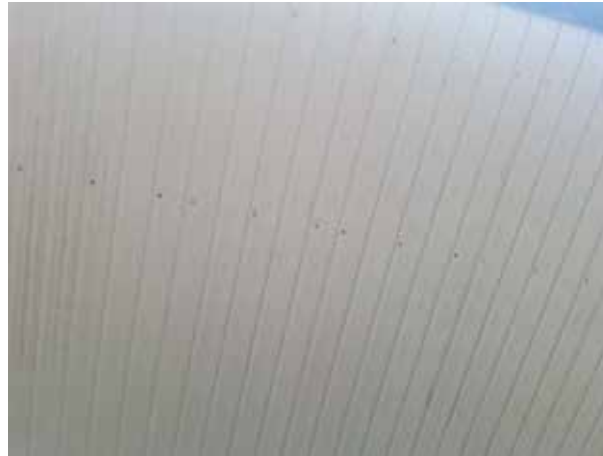
152. Widespread environmental staining to the underside profiled metal canopy sheets.

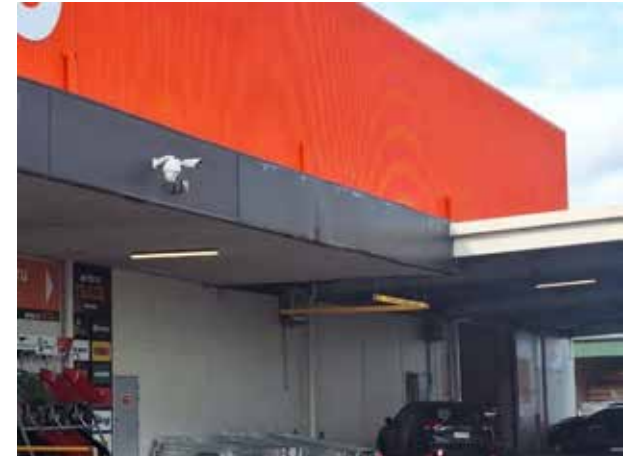
153. Sporadic areas of impact damage and distortion to the metal fascia canopy sheets.

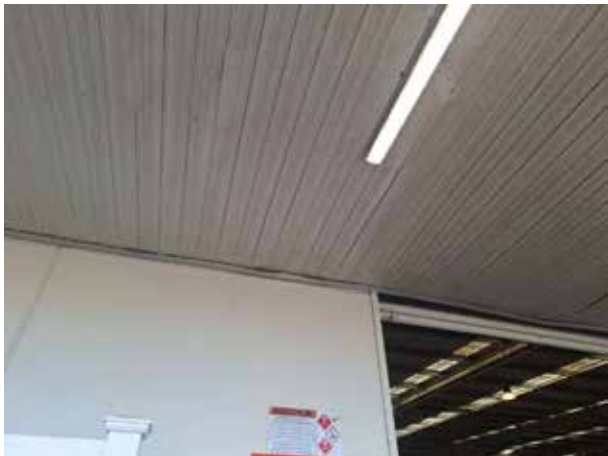
154. Sporadic areas of distortion of the metal trim to the underside of the canopy.

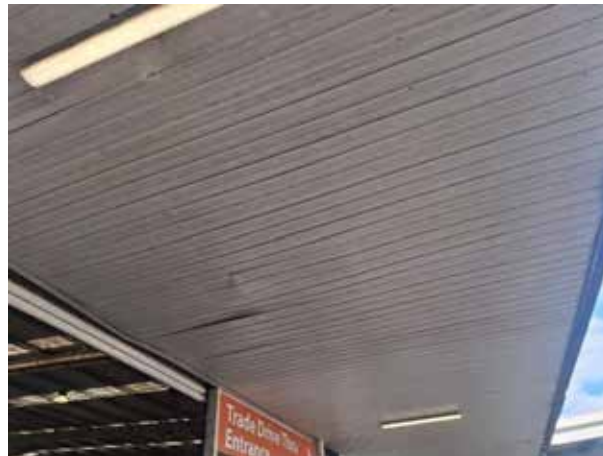
155. Localised impact damage and partial detachment to the underside profiled metal canopy sheets.

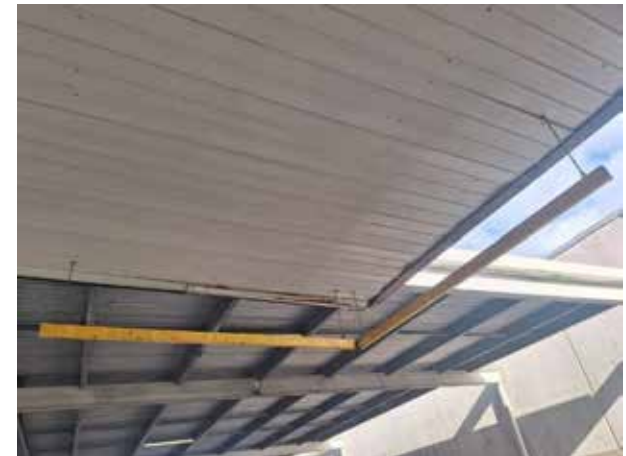
156. Localised corrosion to the metal perimeter trim of the underside of the canopy.

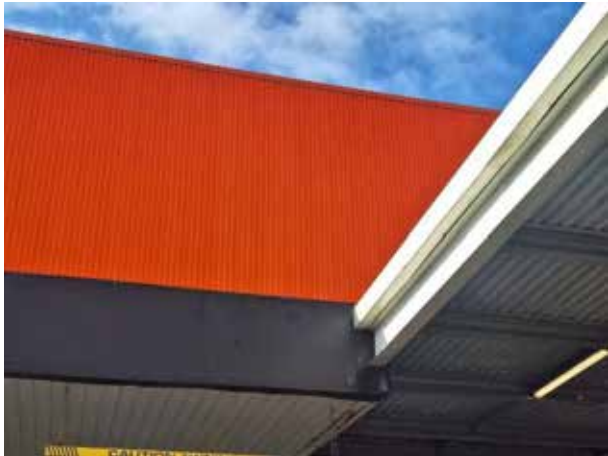
157. Sporadic areas of impact damage and distortion to the metal fascia canopy sheets.

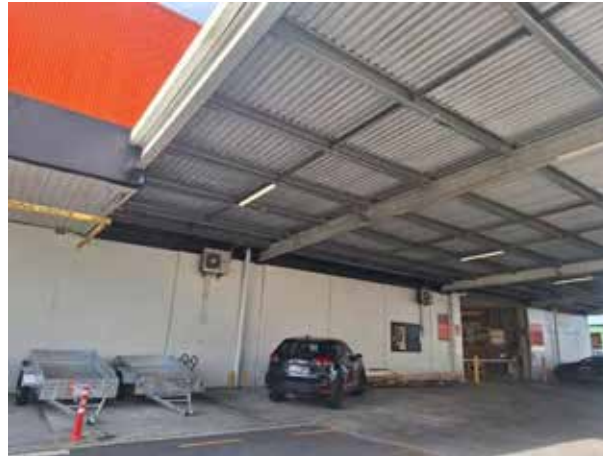
158. Sporadic areas of discolouration and corrosion to the steel canopy frame.

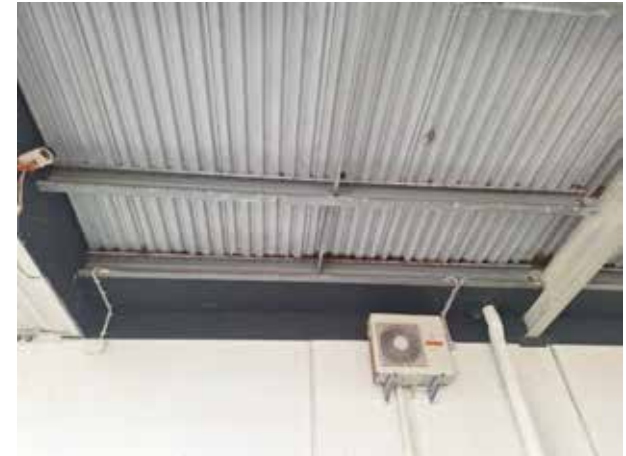
159. Widespread corrosion to the underside of the profiled metal canopy sheets.

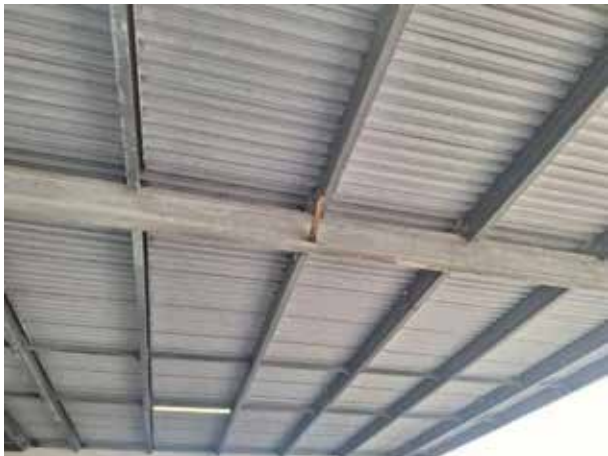
160. Sporadic areas of discolouration and corrosion to the steel canopy frame.
