Building Condition Assessment Report

230 Great South Road, Penrose, Auckland 1061

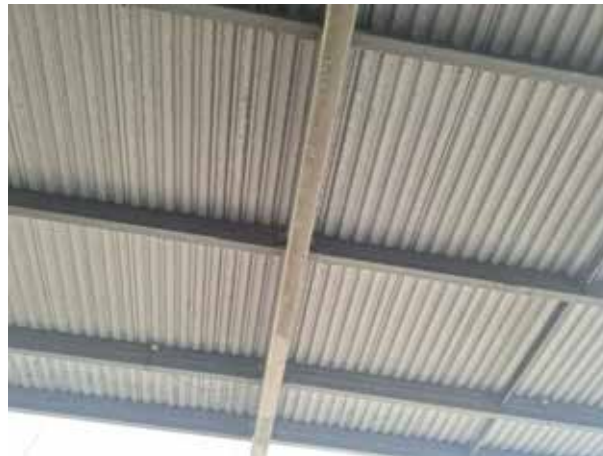
161. Sporadic areas of discolouration and corrosion to the steel canopy frame.

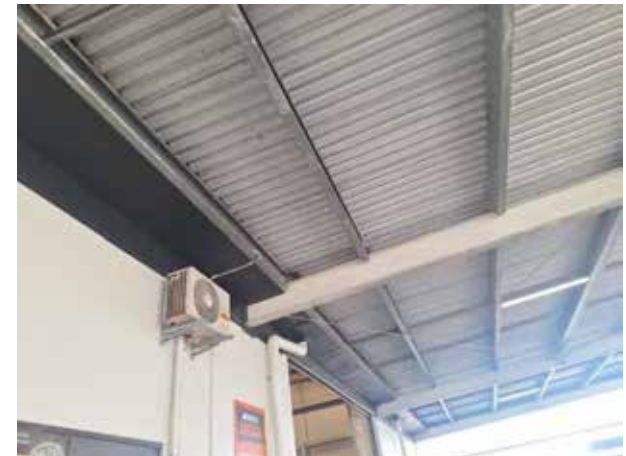
162. Widespread corrosion to the underside of the profiled metal canopy sheets.

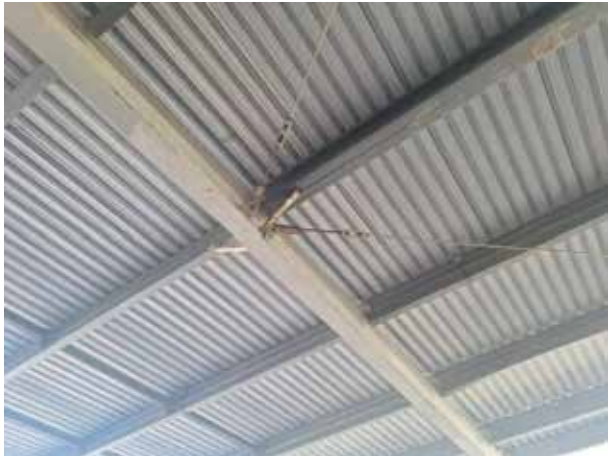
163. Sporadic areas of discolouration and corrosion to the steel canopy frame.

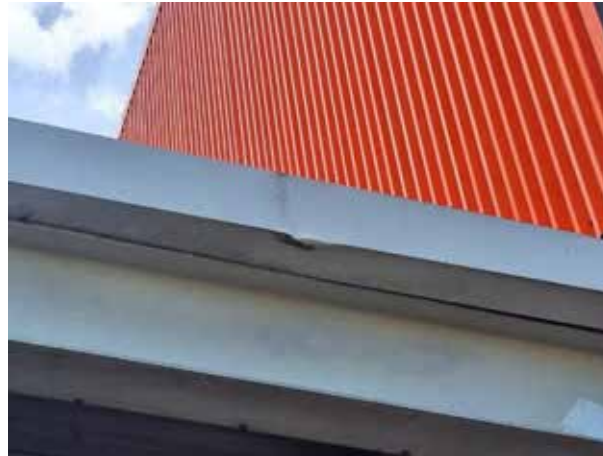
164. Sporadic areas of distortion to the metal barge cappings of the canopy.

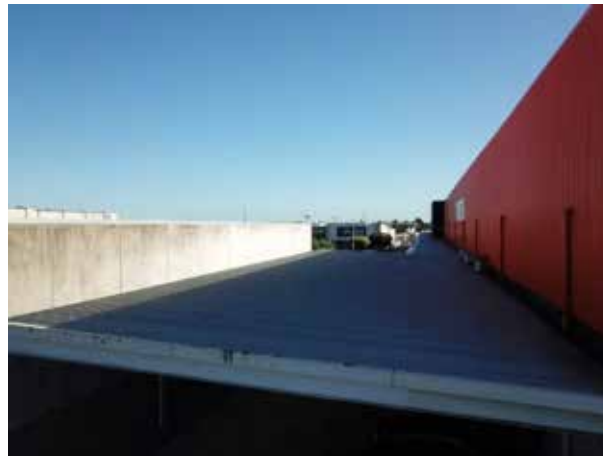
167. Widespread environmental staining to the canopies.

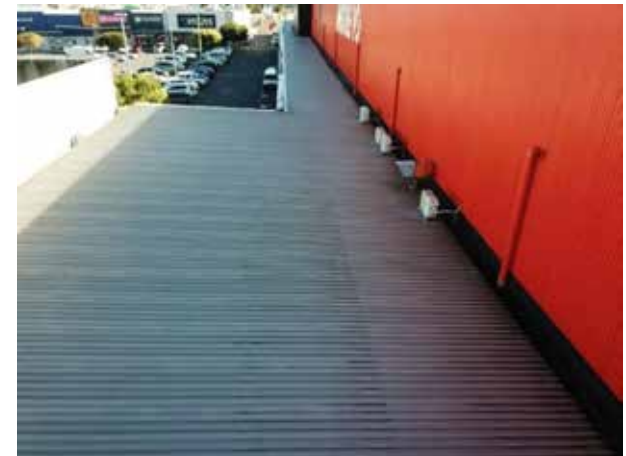
168. Widespread environmental staining to the canopies.

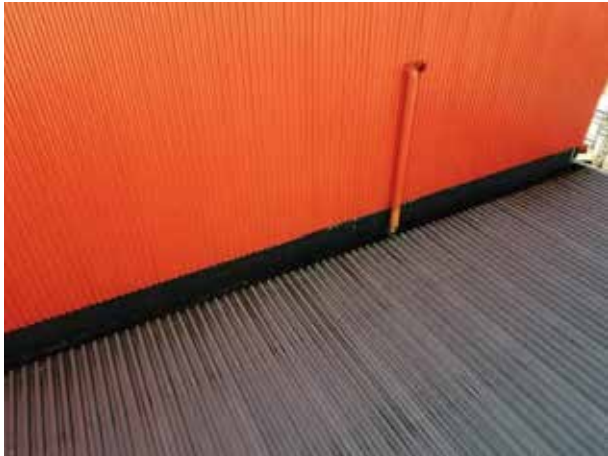
169. Widespread environmental staining to the internal gutter of the canopies.

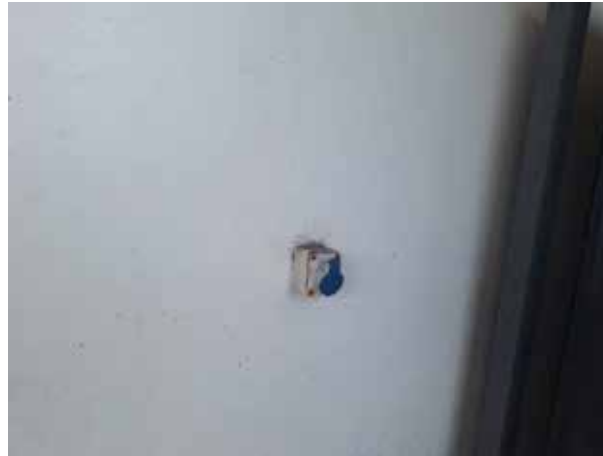
170. Widespread corrosion to the fixings of a wall-mounted power outlet.

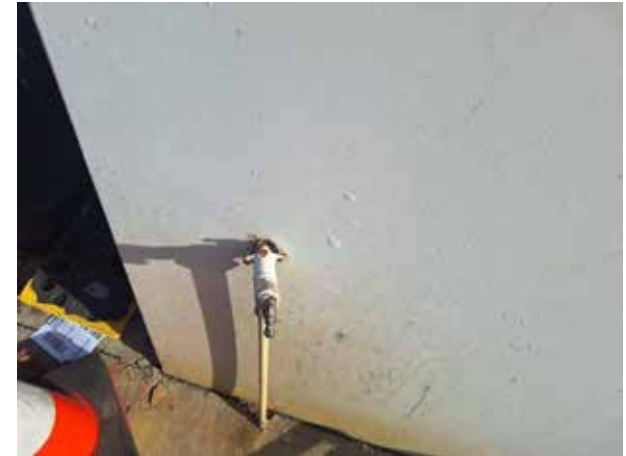
171. Localised partial detachment and corroded fixings to the tap outlet.

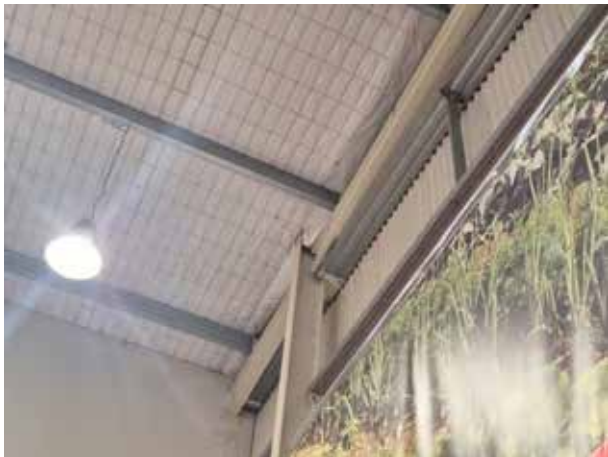
172. Sporadic areas of wrinkling to the building paper underlay.

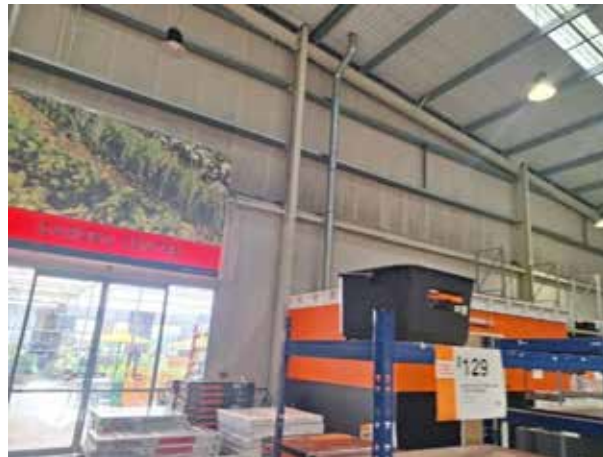
173. Widespread soil staining to the internal side of the elevations.

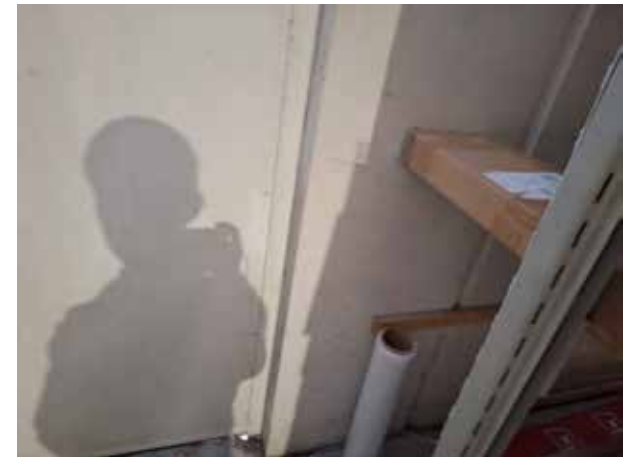
174. Localised hairline cracking to the concrete wall panel adjacent to a metal panelled hinged door.

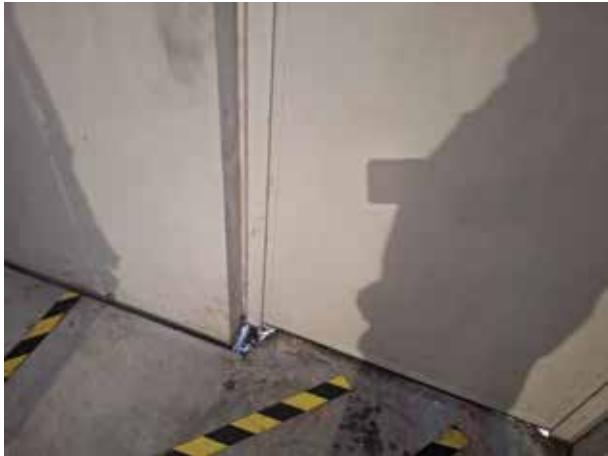
175. Sporadic areas of separation between the concrete floor slabs and concrete wall panels at the metal panelled hinged doors.

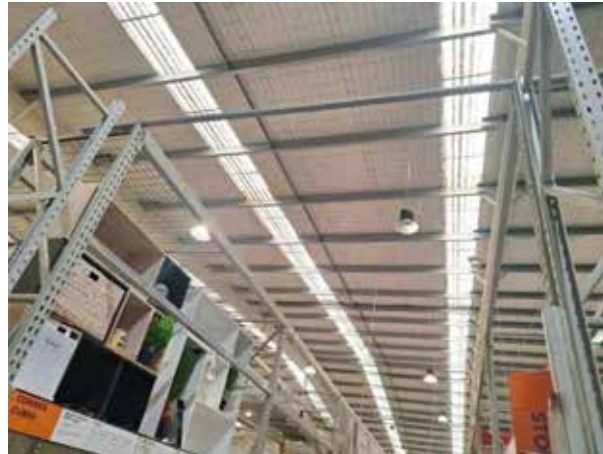
179. The underside of the roof was in a good condition with no leaks observed at the time of the inspection.

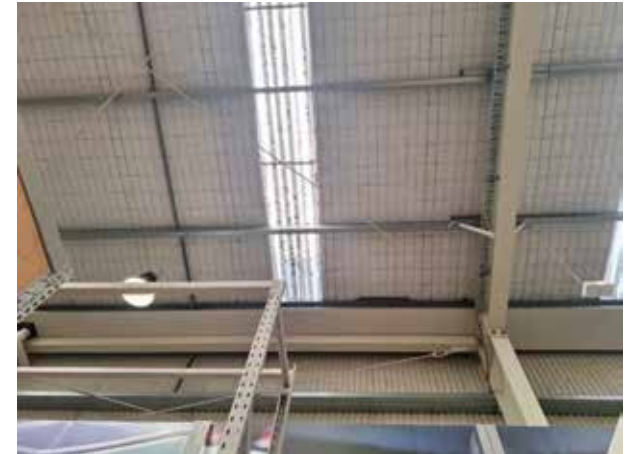
180. The underside of the roof was in a good condition with no leaks observed at the time of the inspection.

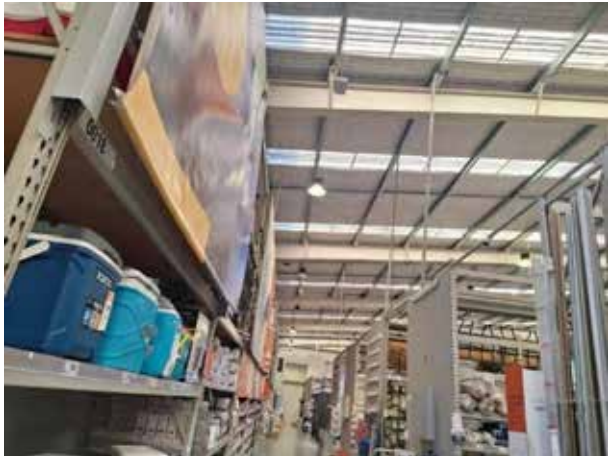
181. The underside of the roof was in a good condition with no leaks observed at the time of the inspection.

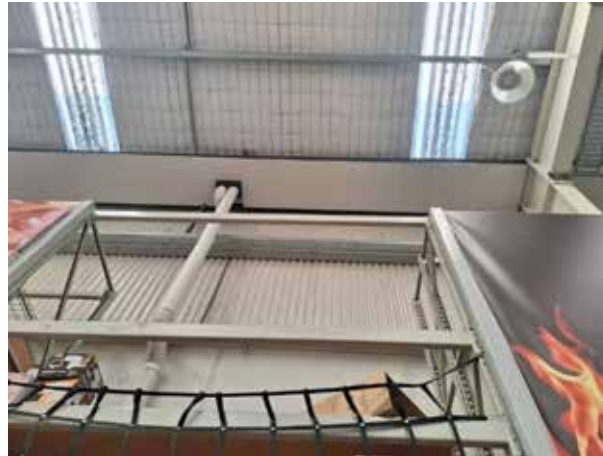
182. The underside of the internal gutters were in a good condition with no leaks observed at the time of the inspection.

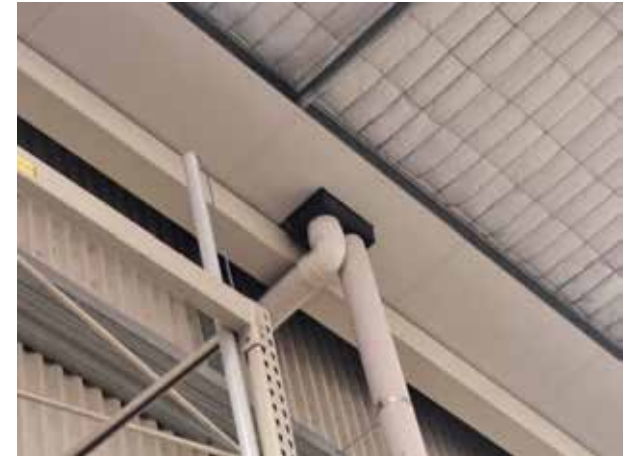
183. The underside of the internal gutters were in a good condition with no leaks observed at the time of the inspection.

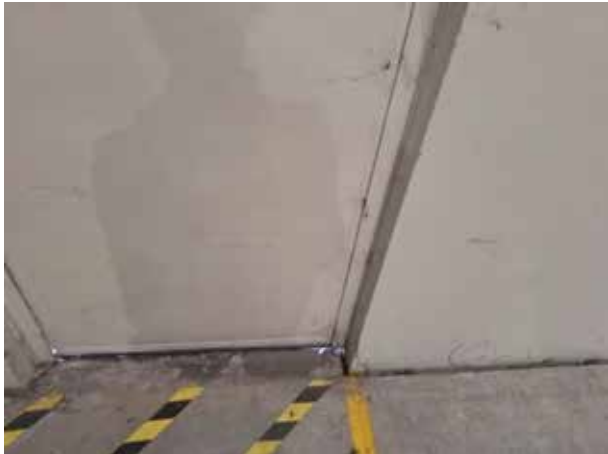
184. Sporadic areas of separation between the concrete floor slabs and concrete wall panels at the metal panelled hinged doors.

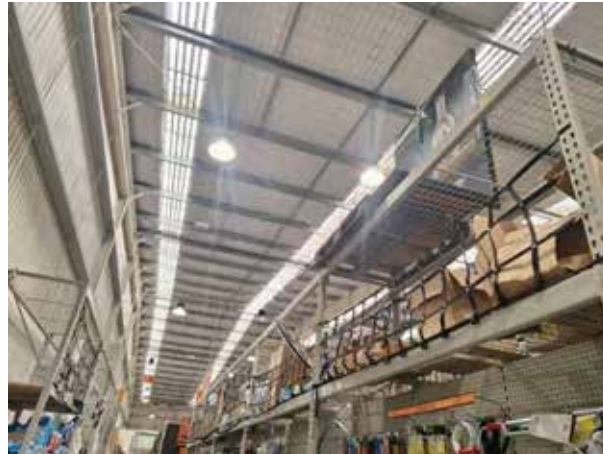
185. The underside of the roof was in a good condition with no leaks observed at the time of the inspection.

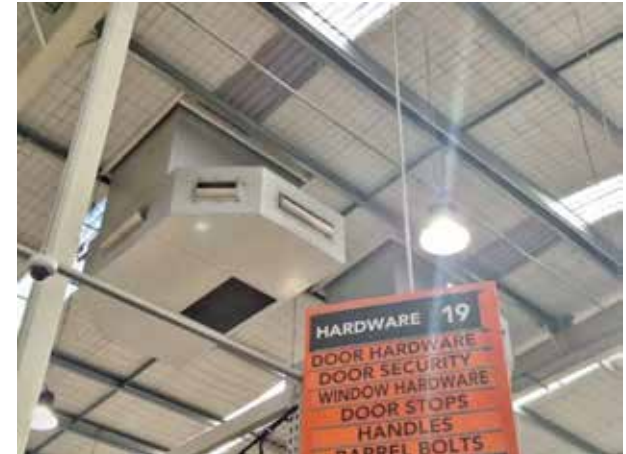
186. The underside of the roof was in a good condition with no leaks observed at the time of the inspection.

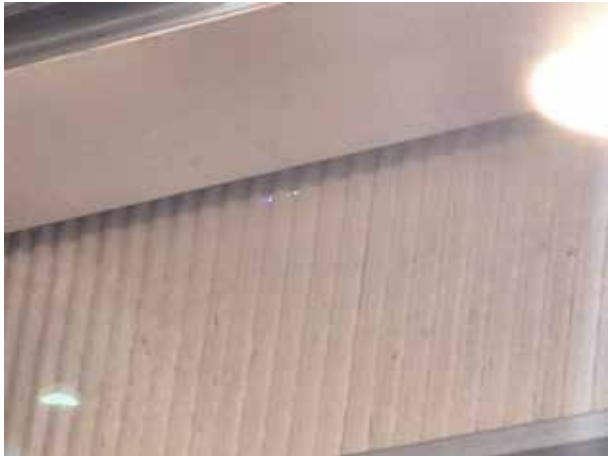
187. Sporadic areas of unsealed fixing or penetration centres to the profiled metal cladding sheets.

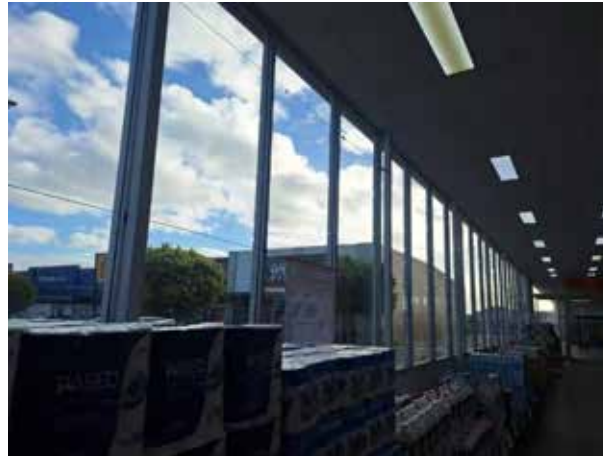
188. Sporadic areas of soil staining to the internal face of the aluminium shop front units.

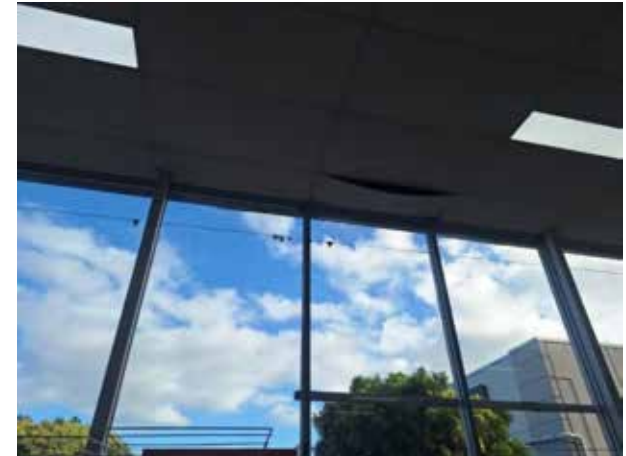
189. Localised bowing to the ceiling grid tiles below the entrance canopy.

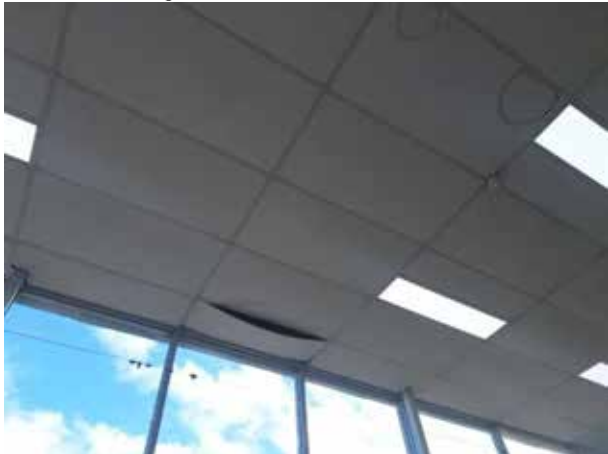
190. Sporadic areas of moisture staining to the ceiling grid tiles below the entrance canopy.

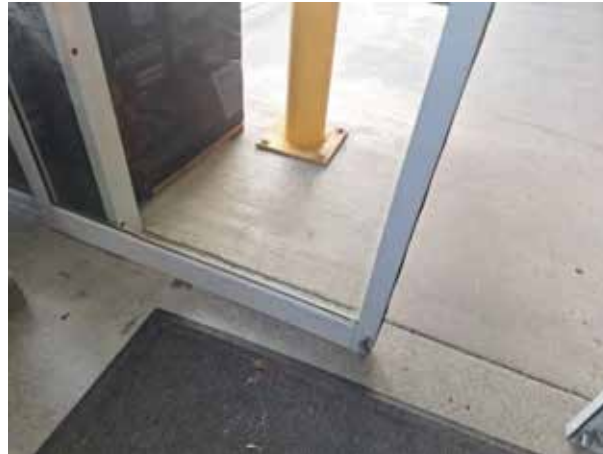
191. Localised abrasions to the internal face of the automatic sliding doors.

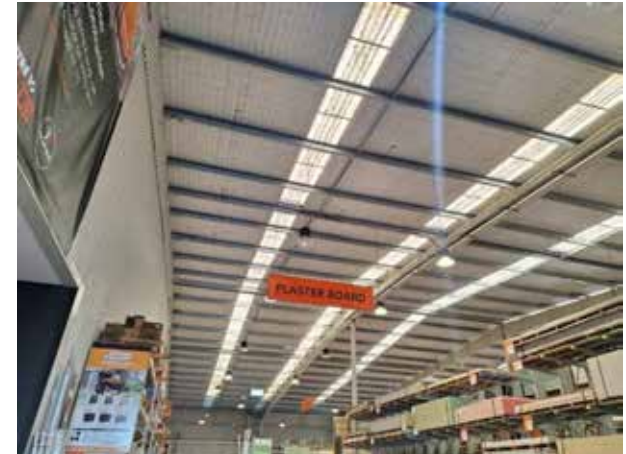
192. The underside of the roof was in a good condition with no leaks observed at the time of the inspection.

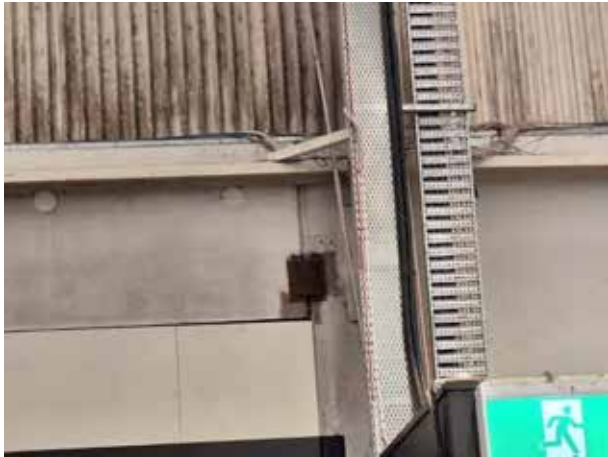
193. Localised corrosion to the steel embedded plates within the concrete wall panels.

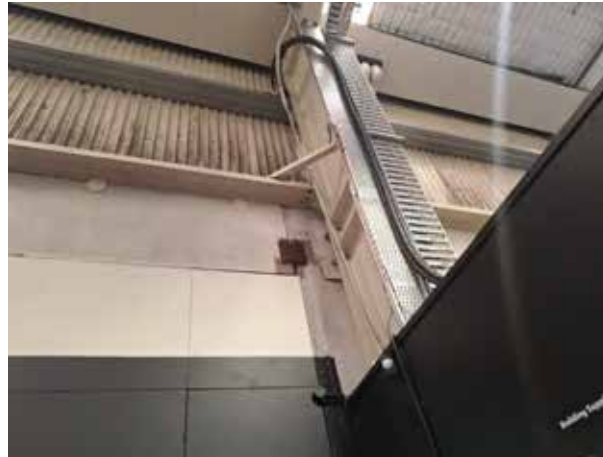
194. Localised corrosion to the steel embedded plates within the concrete wall panels.

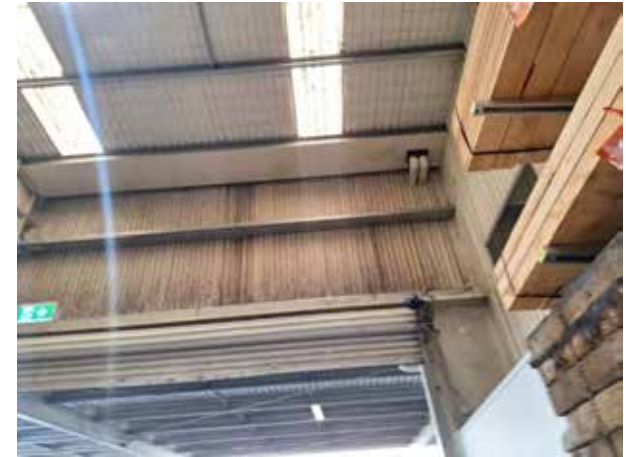
195. Widespread soil staining to the internal side of the elevations.

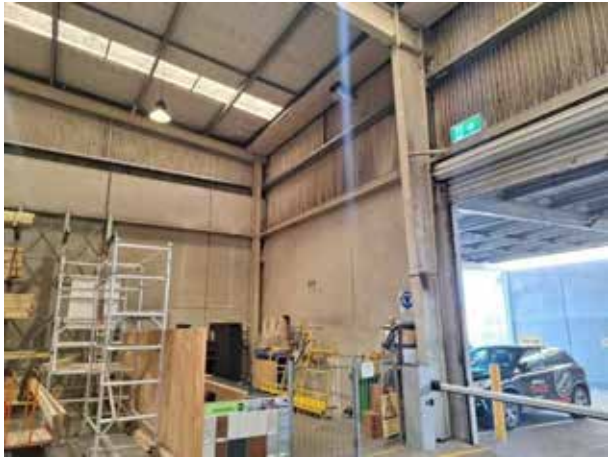
196. Widespread soil staining to the internal side of the elevations.

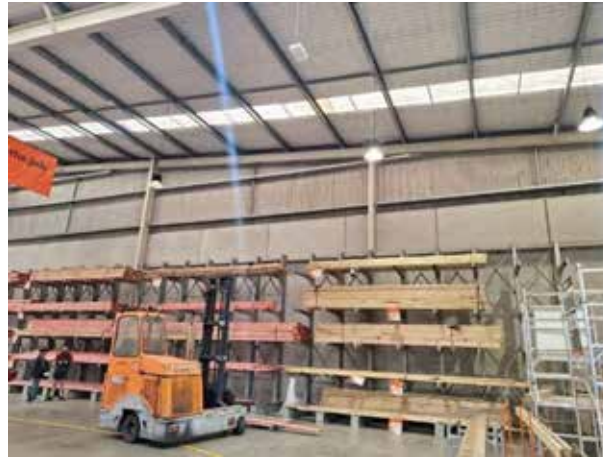
197. Widespread soil staining to the internal side of the elevations.

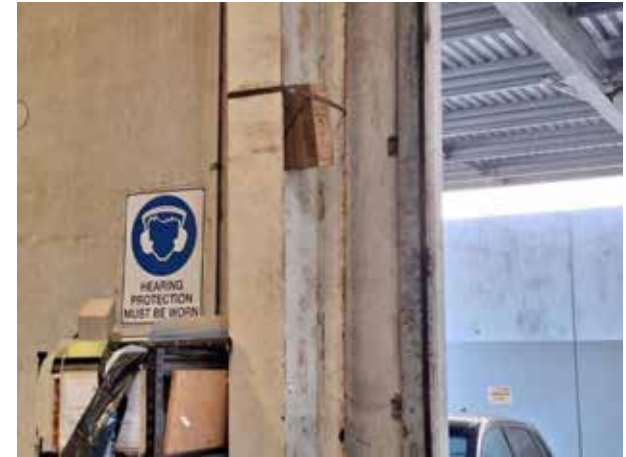
198. Localised area of corrosion to the painted steel column adjacent to an opening.

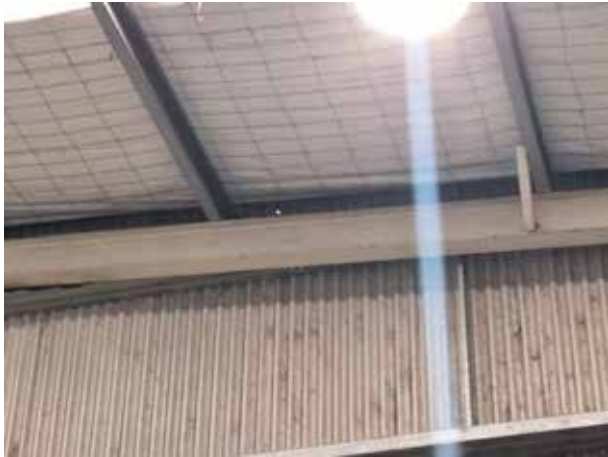
199. Sporadic areas of unsealed fixing or penetration centres to the profiled metal cladding sheets.

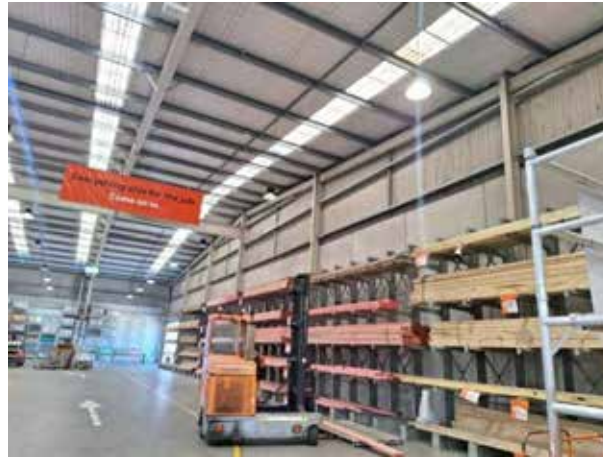
200. Widespread soil staining to the internal side of the elevations.

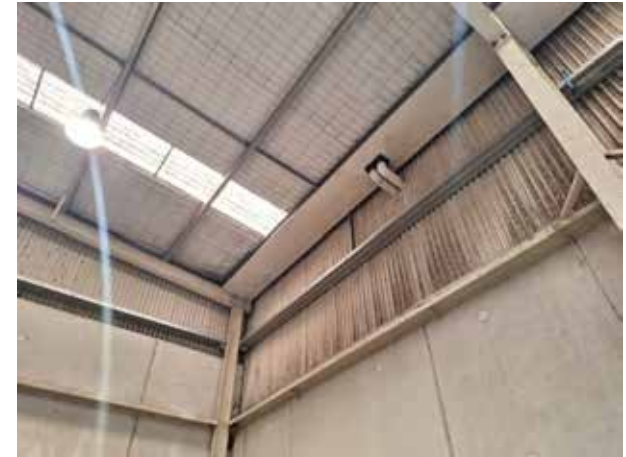
201. Widespread soil staining to the internal side of the elevations.

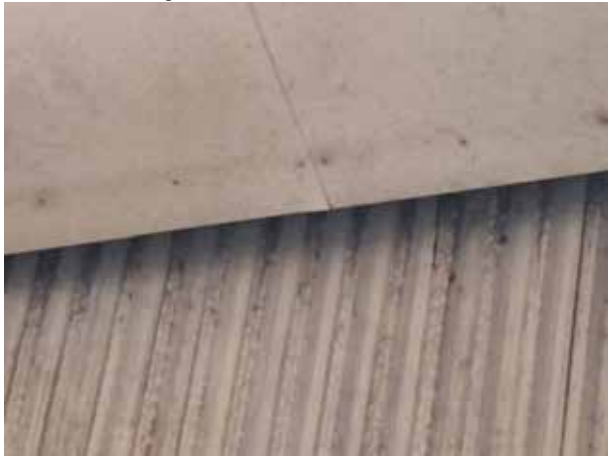
202. Widespread soil staining to the internal side of the elevations.

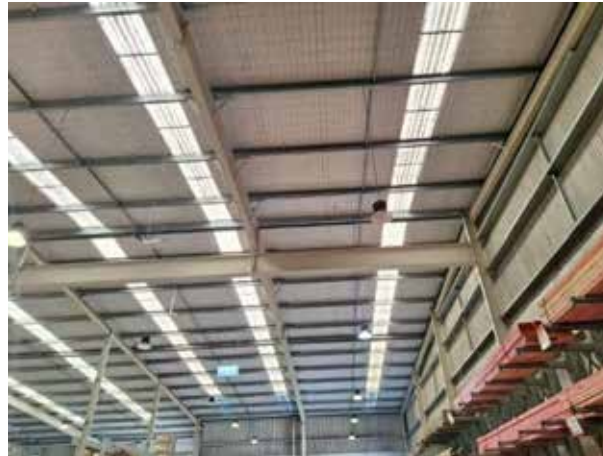
203. The underside of the roof was in a good condition with no leaks observed at the time of the inspection.

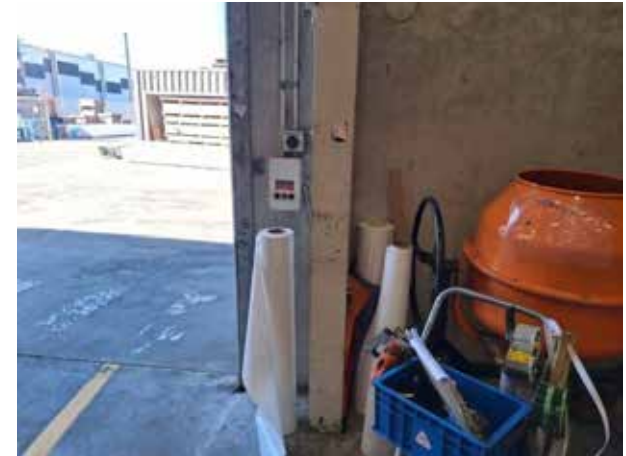
204. Sporadic areas of scuff marks and deterioration of the finish to the steel portal frame.

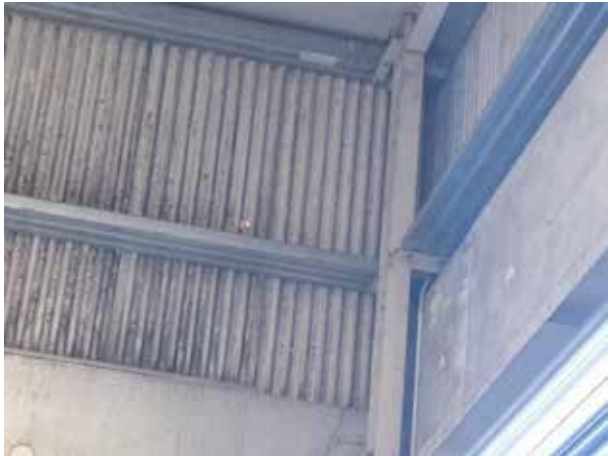
205. Sporadic areas of unsealed fixing or penetration centres to the profiled metal cladding sheets.

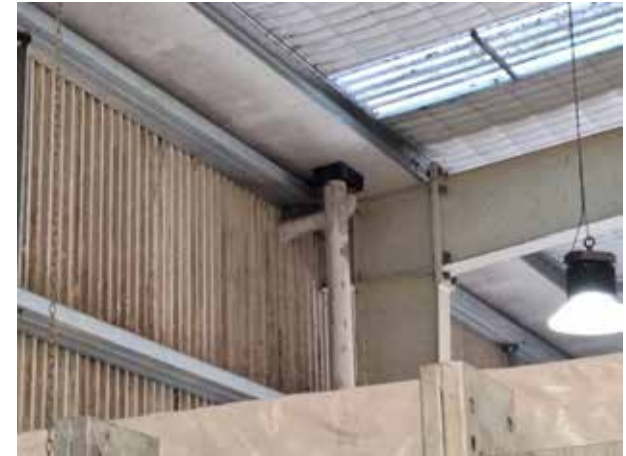
207. The underside of the rainwater goods were in a good condition with no leaks observed at the time of the inspection.

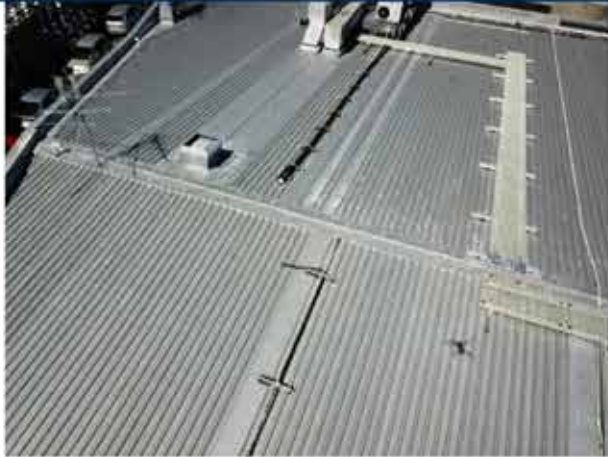
1. Areas of staining on the profiled metal roof sheets.

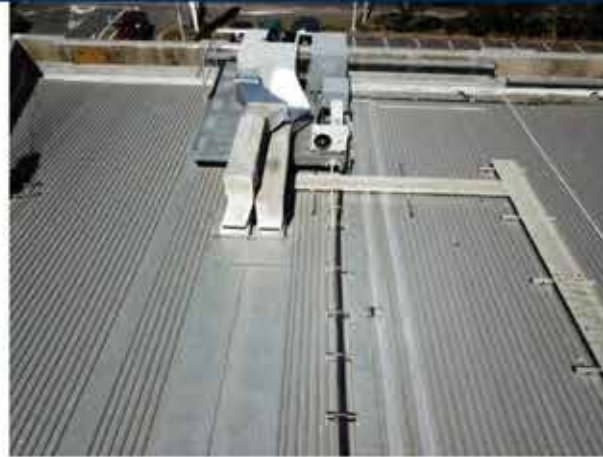
2. Areas of staining on the fit-over flashings.

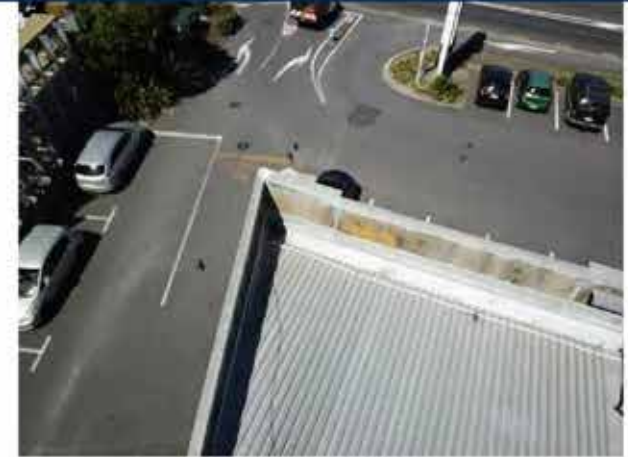
3. Staining on the metal parapet cappings.

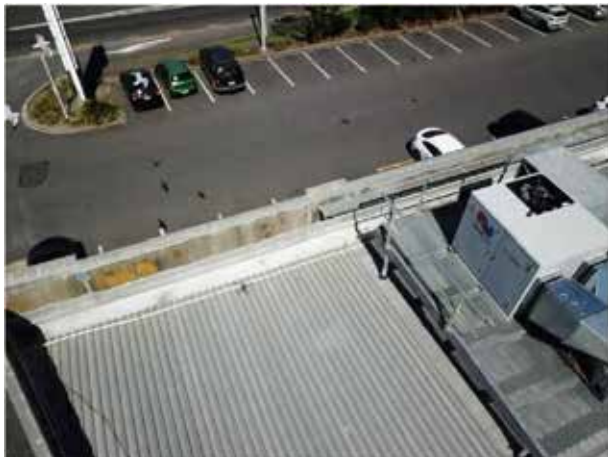
4. Staining and darkening on the internal face of the concrete parapet walls.

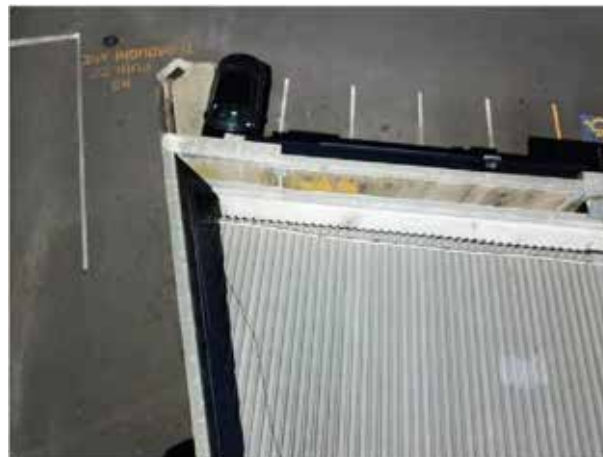
5. Staining on the single-plywood membranes at the internal gutters.

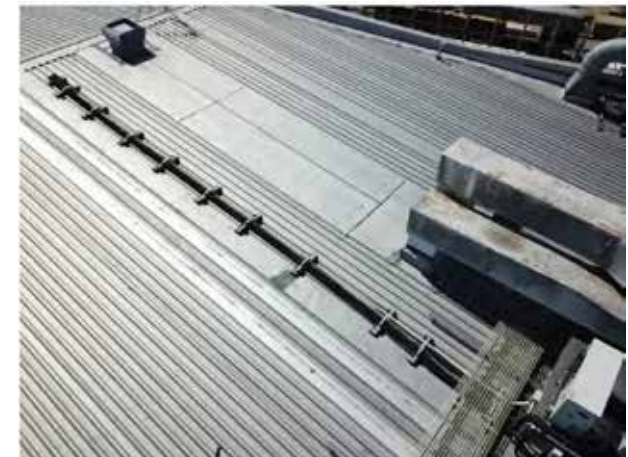
6. Extensive sealant applied to the fit-over flashings and kerb penetrations.

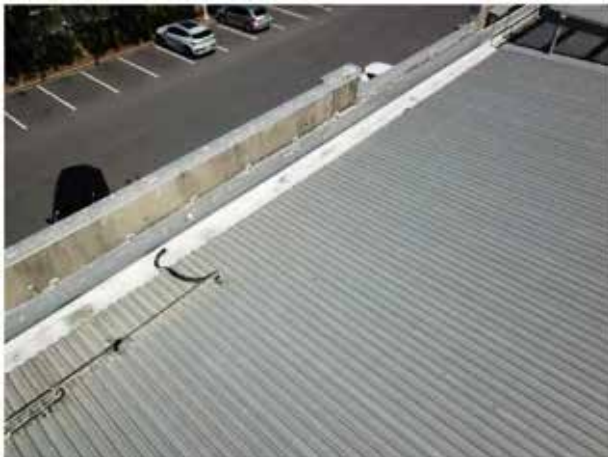
10. Staining on the single-plywood membranes at the internal gutters.

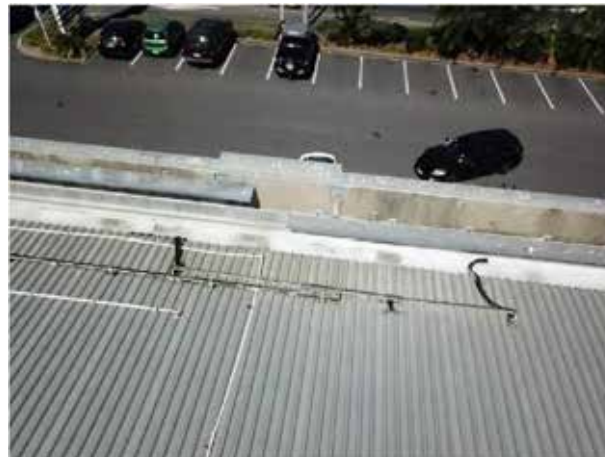
11. Deterioration of the sealant at the apron flashing.

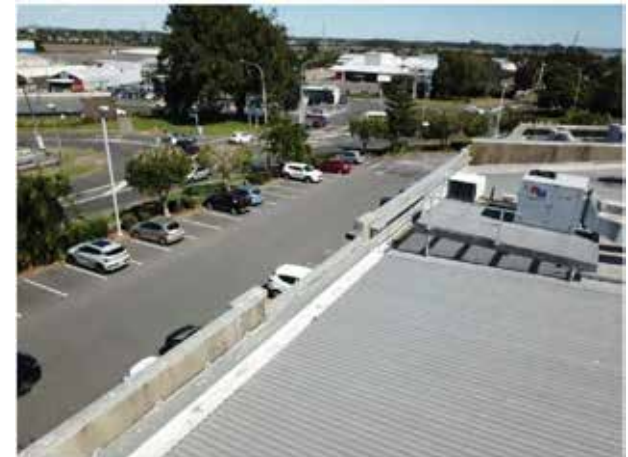
12. Staining on the metal capping and the internal face of the concrete wall.

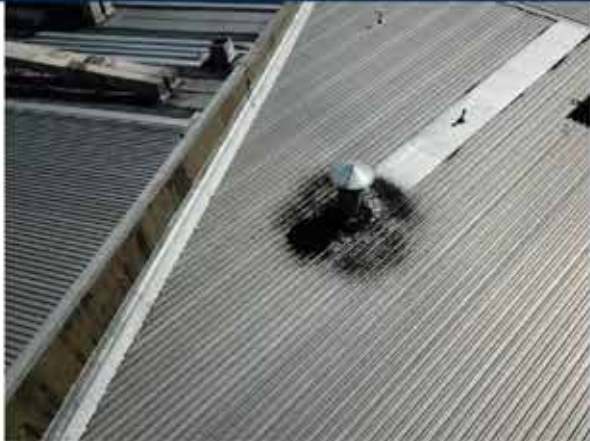
13. Extensive staining and discoloration on the sheets adjacent to a vent penetration.

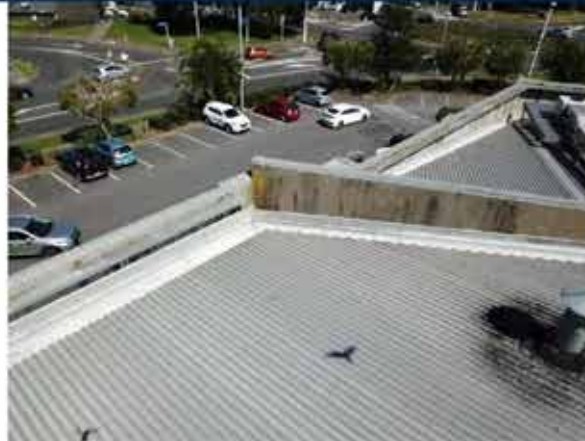
14. Staining on the metal capping and the internal face of the concrete wall.

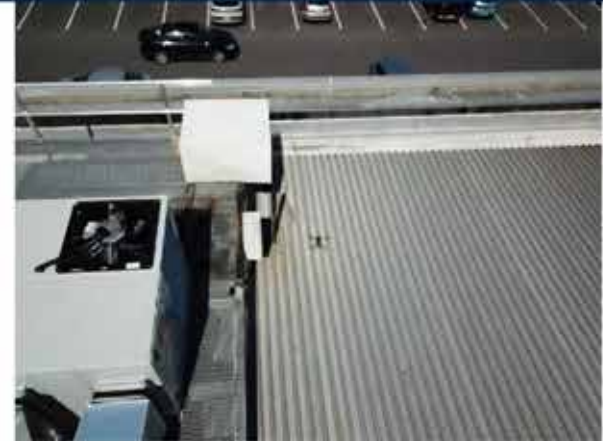
15. Extensive staining and discoloration on the metal walkway.

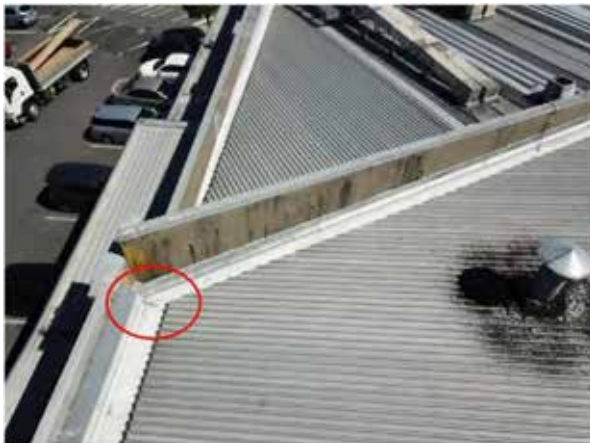
16. Discolouration and residue to the mitre joint of the internal gutters.

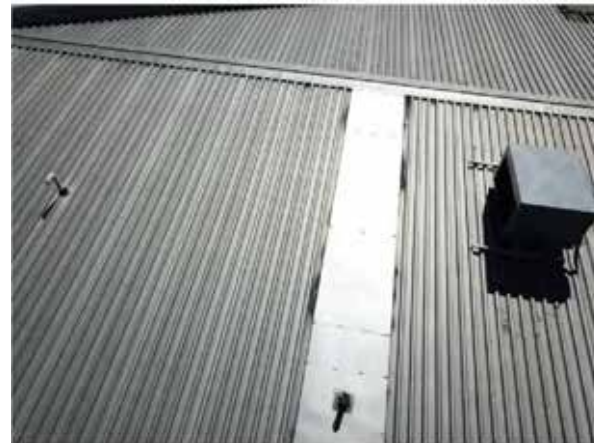
17. Extensive staining and discoloration adjacent to the fit-over flashings.

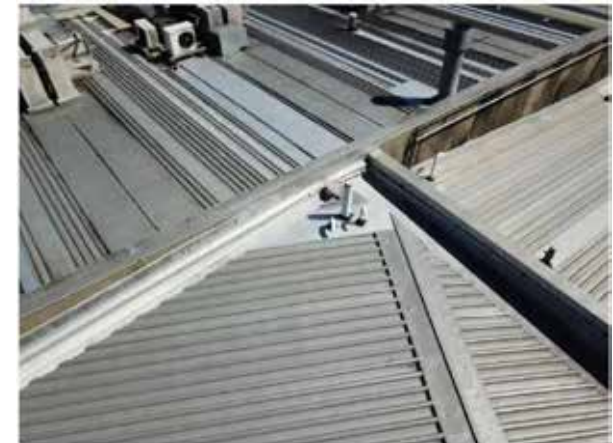
18. Deterioration of the sealant at the chased-in apron flashing.

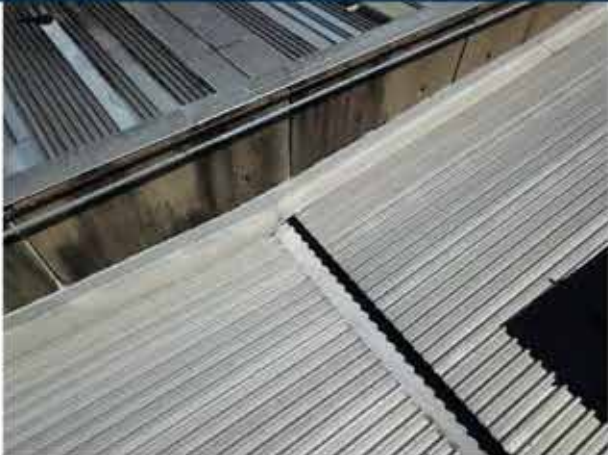
19. Undulation to the single-plywood membrane sheets and distortion to the apron flashings.

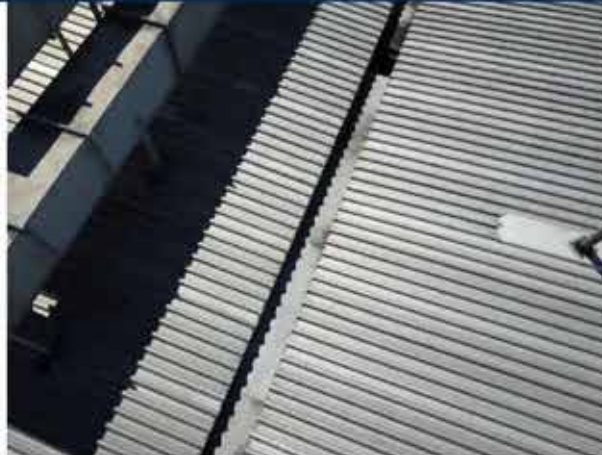
20. Staining and uplift at the sheet joints of the single-plywood membranes.

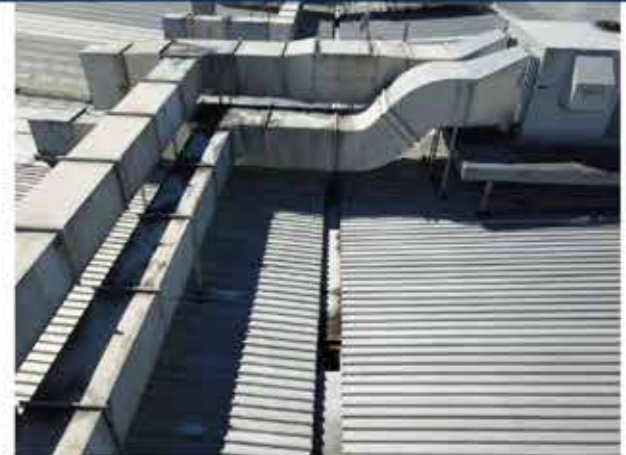
21. Extensive staining on the single-plywood membrane sheets.

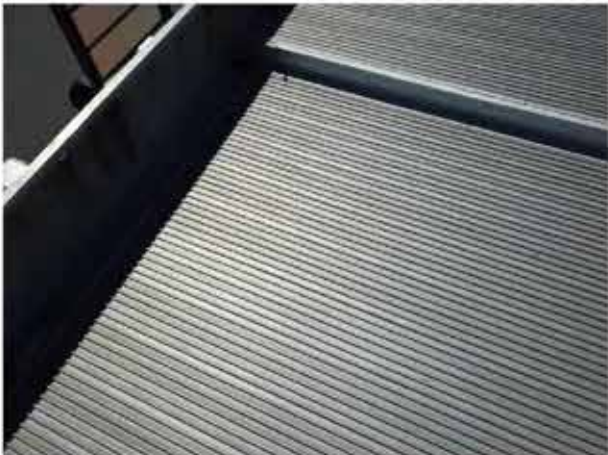
22. Profiled metal roof sheets.

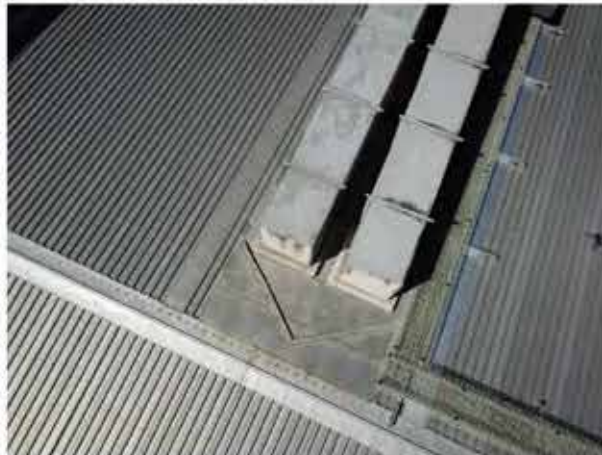
23. Deterioration of the finish and staining to the HVAC trunking.

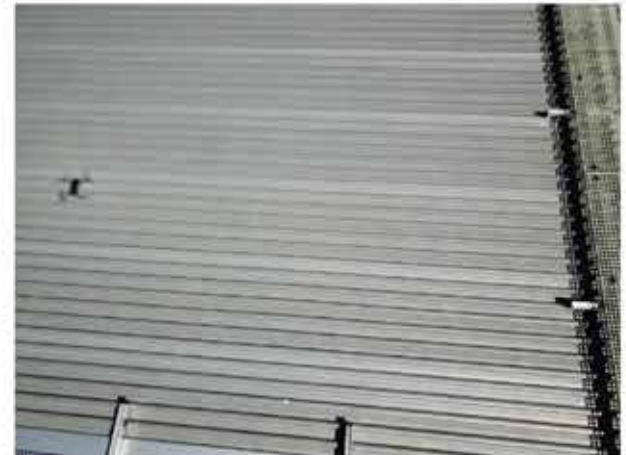
24. Corrosion to the roof sheets' fixings and washers.

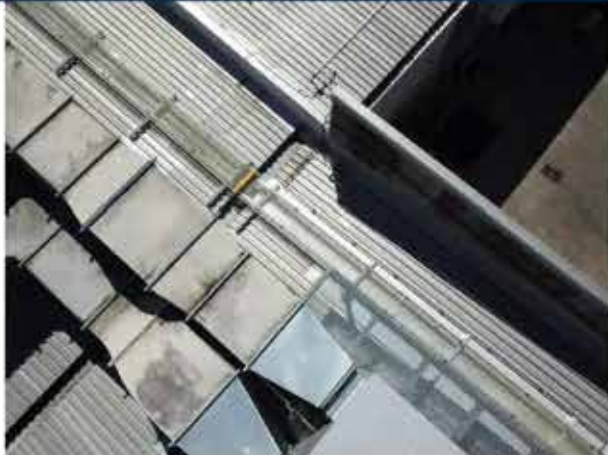
25. Staining and deterioration of the single-plywood membranes.

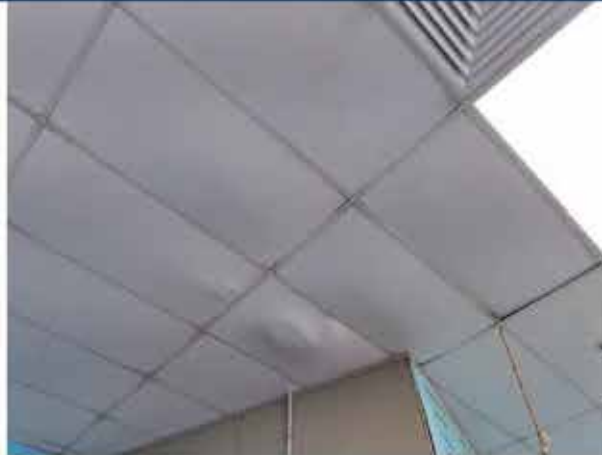
26. Moisture-related damage to the ceiling gird tiles (Takanini Fish Mart).

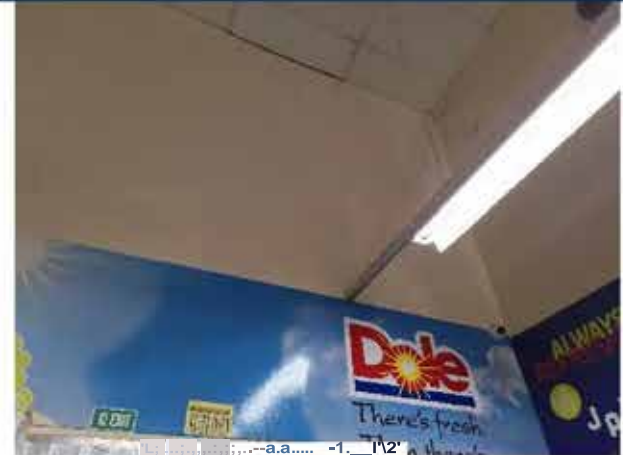
27. Moisture run-marks on the painted plasterboard wall linings (Fruit World).

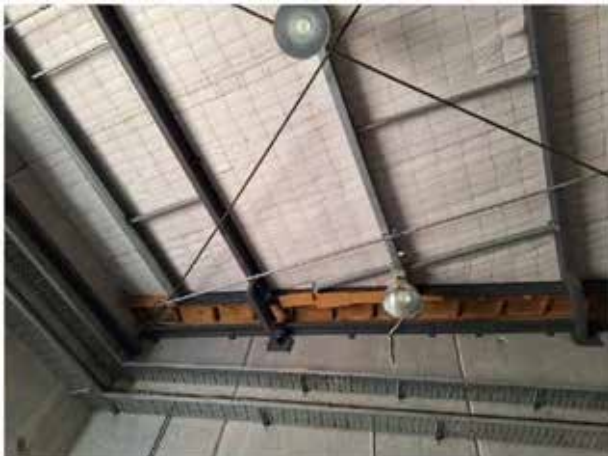
28. View of the underside of the roof (Fruit World).

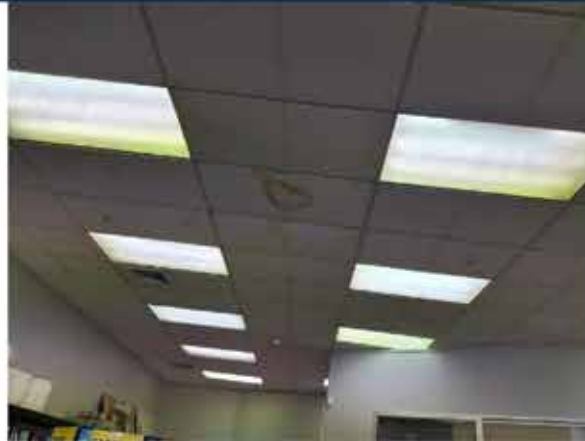
38. Moisture-related staining to the ceiling grid tiles (Western Union).

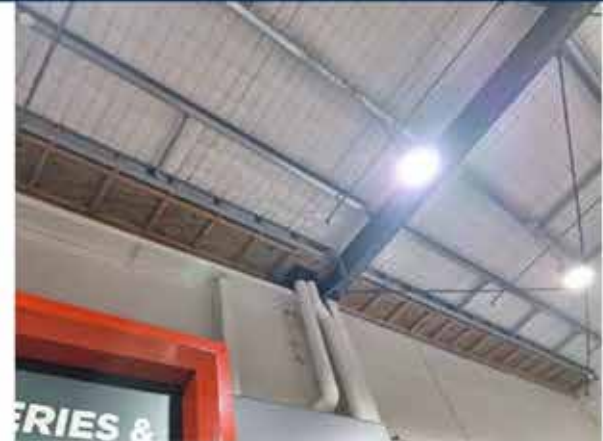
39. View of the underside of the roof (RepcO).

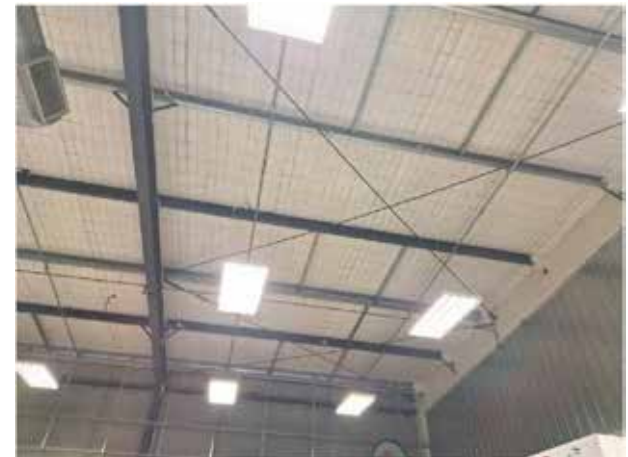
54. View of the underside of the roof (Tool Shed).

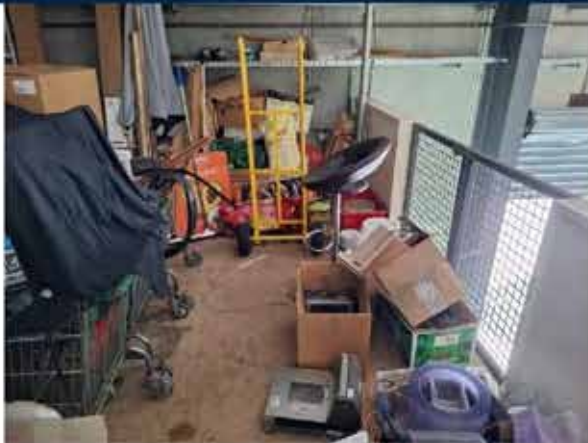
55. Staining on the plywood flooring below a penetration (Fruit World).

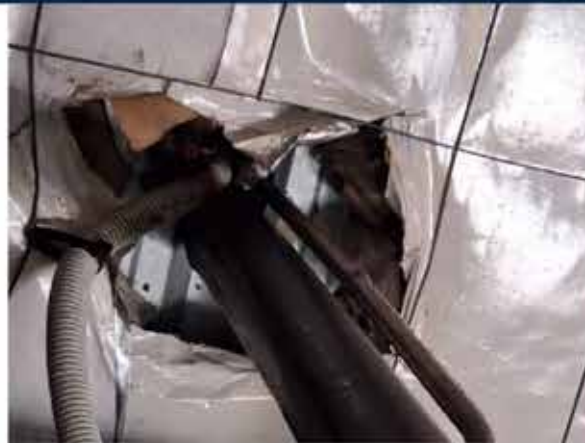
56. Services penetration through the profiled metal roof sheets.

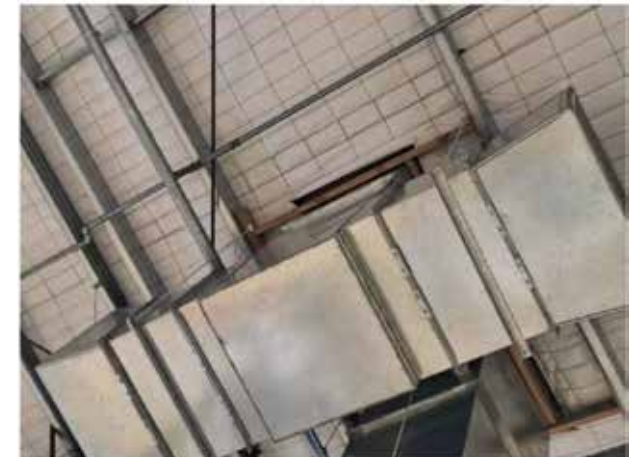
60. View of the underside of the roof (Bed Bath and Beyond).

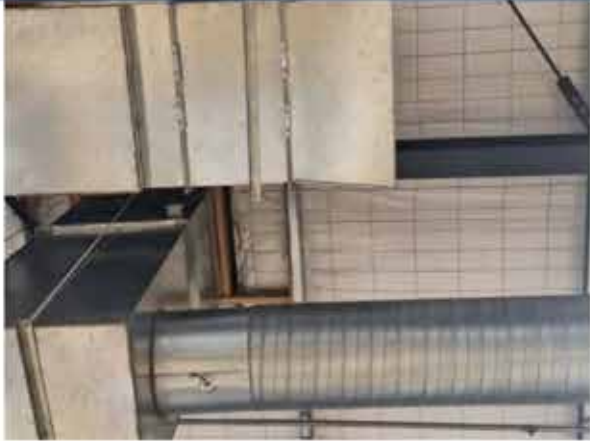
61. Minor wrinkling of the roof underlay adjacent to a large penetration (Bed Bath and Beyond).

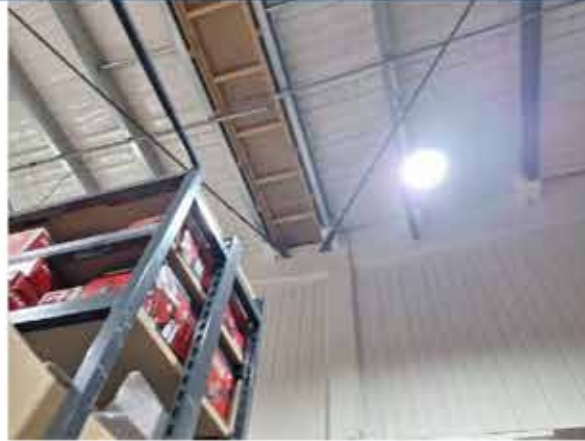
62. Localised staining to the plywood substrate (RepcO).

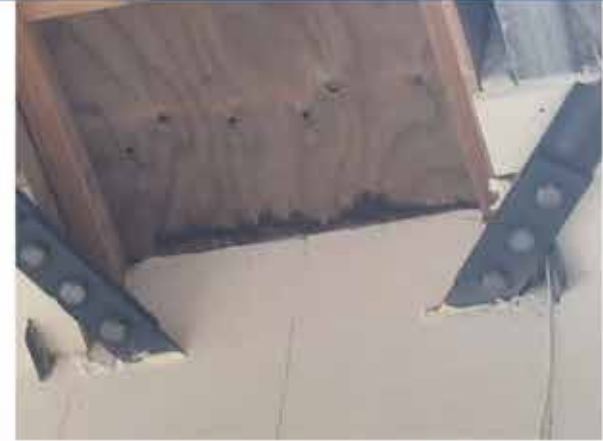
63. Localised staining to the plywood substrate (RepcO).

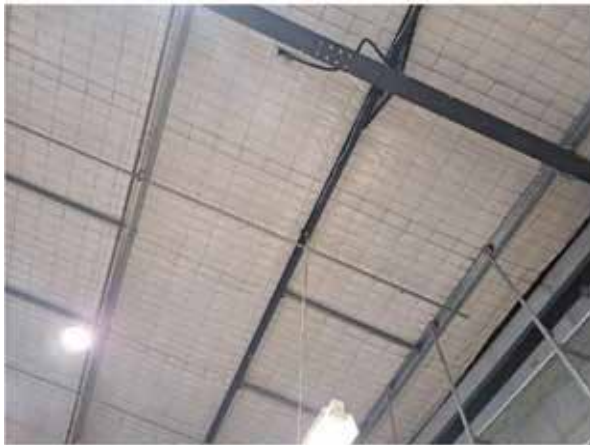
64. View of the underside of the roof (Harvey Norman).

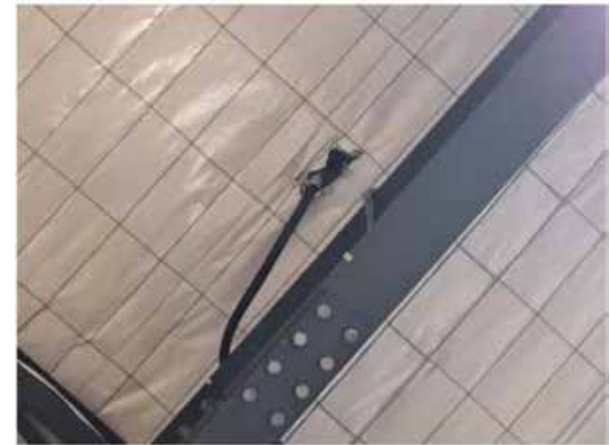
66. Minor tears to the roof underlay adjacent to a penetration (Harvey Norman).
