Building Condition Assessment Report

230 Great South Road, Penrose, Auckland 1061

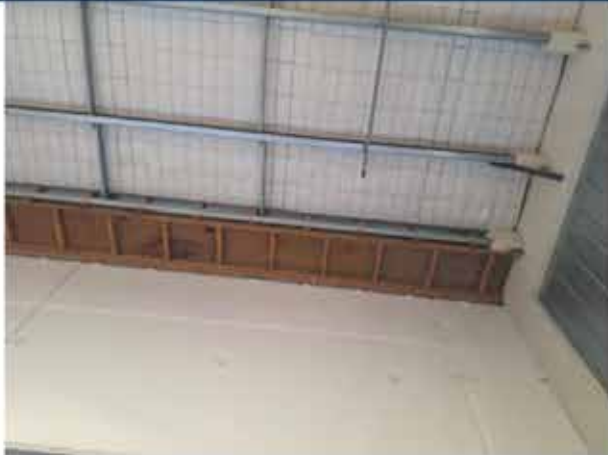
67. View of the underside of the roof (Harvey Norman).

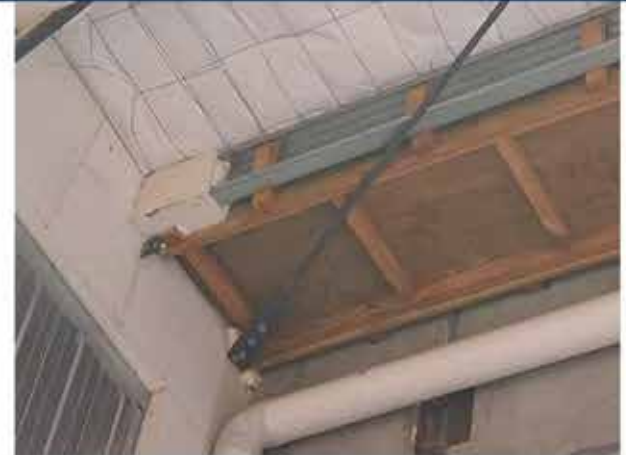
69. No evidence of staining to the plywood substrate (Tool Shed).

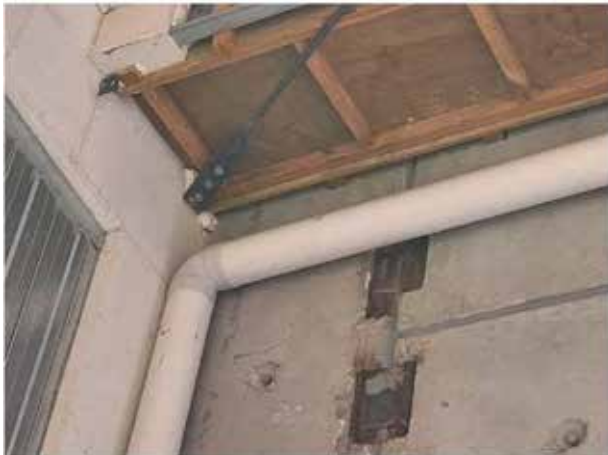
70. Minor staining on the concrete wall panels (Tool Shed).

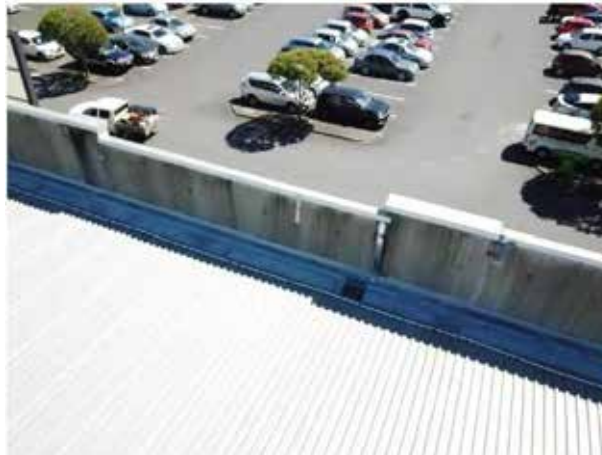
71. Deterioration of the sealant at the control joints of the concrete parapet walls. Flashing tape and extensive sealant applied to the metal capping and concrete parapet walls.

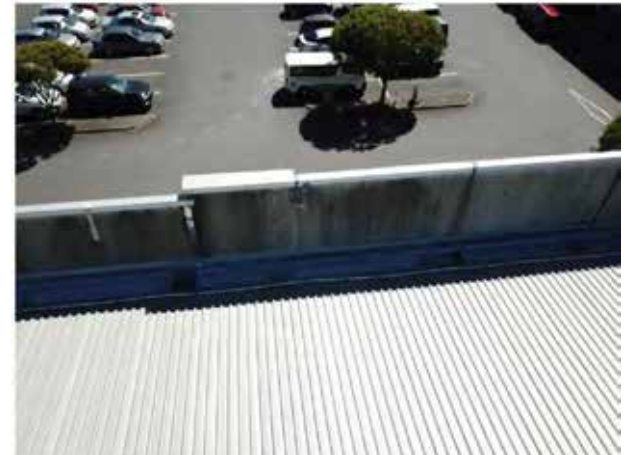
72. Corrosion to the steel anchor plates for the tension rods of the canopy roofs.

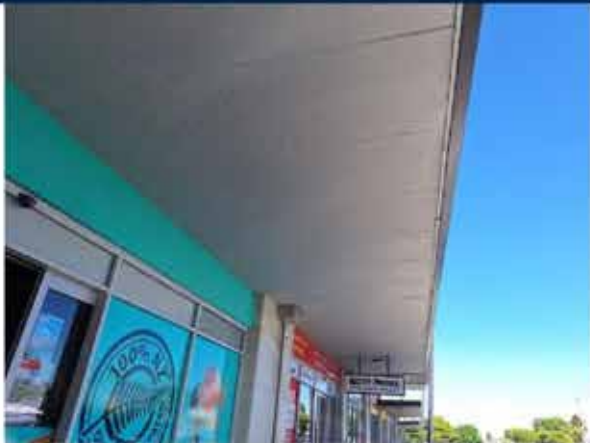
73. View of the underside of the canopy roofs.

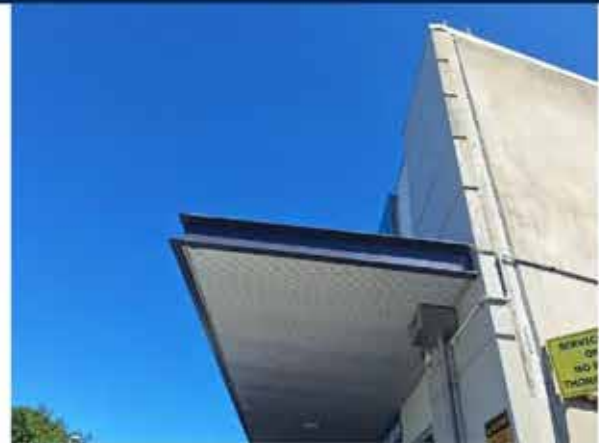
75. Minor deterioration of the finish to the steel perimeter frame.

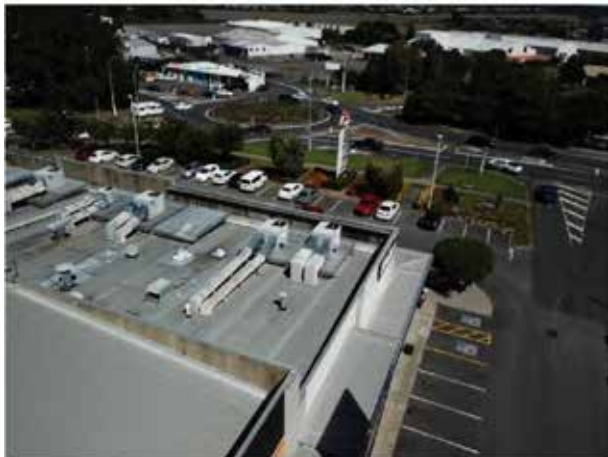
76. View of the upper side of the canopy roofs.

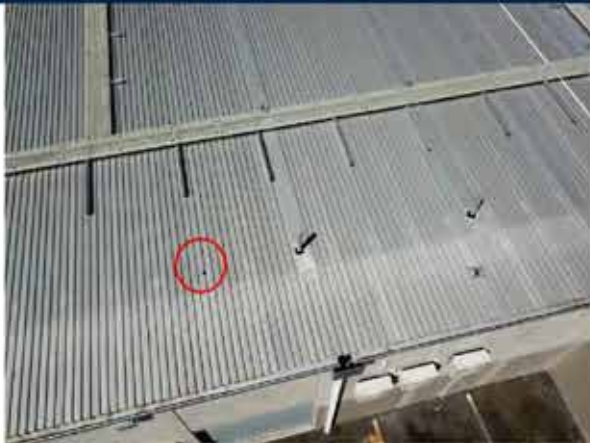
82. Previous repairs which appear to be carried out with sealant to the roof sheets.

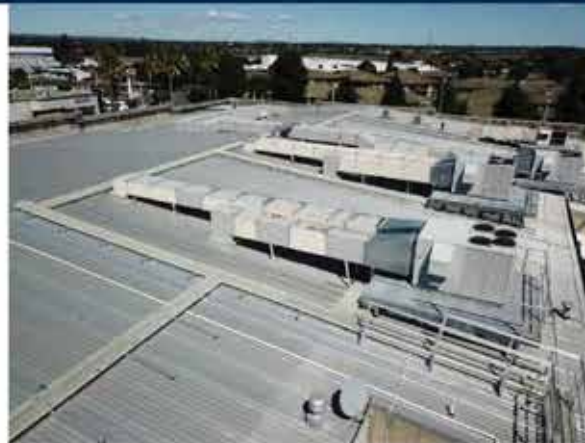
83. Corrosion and staining to the HVAC ducting.

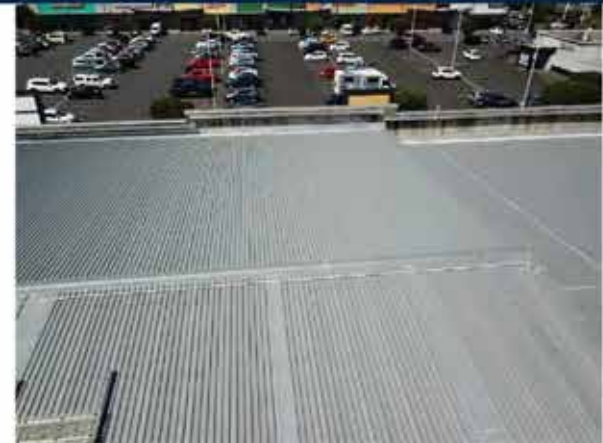
84. Extensive sealant applied to the ridge cappings and fit-over flashings.

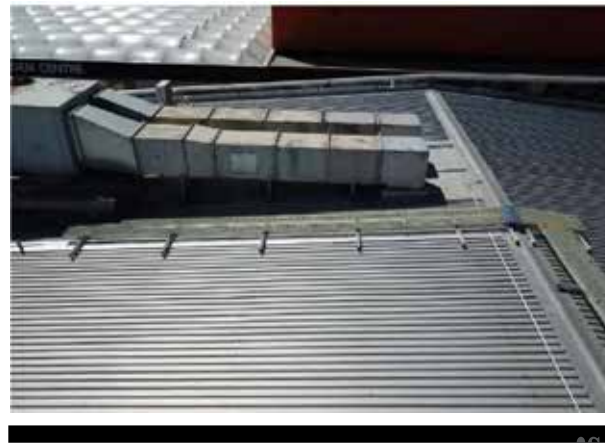
86. Environmental staining on the profiled metal roof sheets.

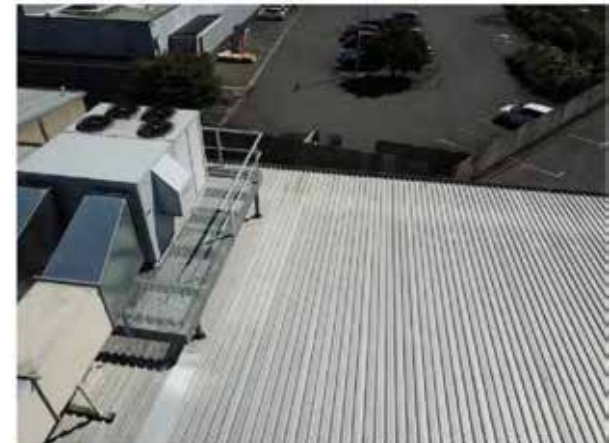
87. Environmental staining on the profiled metal roof sheets.

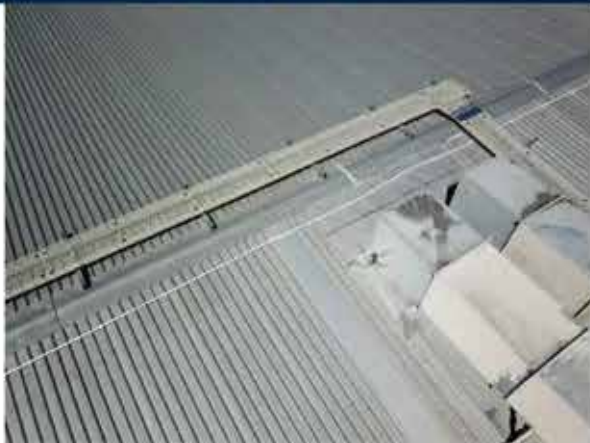
88. Corrosion to the kerb penetrations and sealant applied to the fit-over flashings and the ridge cappings.

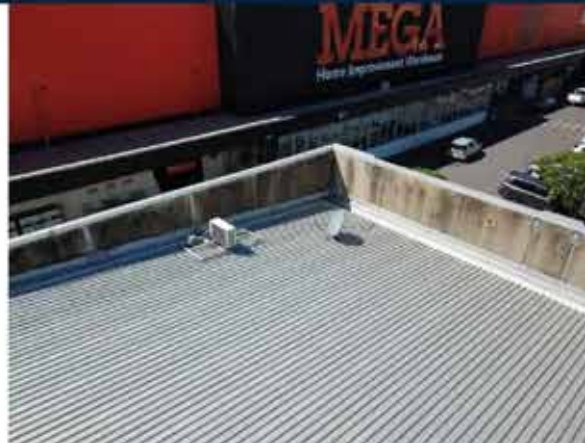
89. Extensive staining on the internal face of the concrete wall panels.

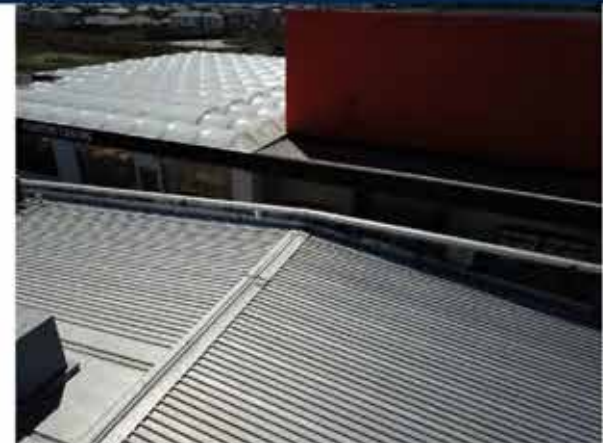
90. Extensive staining on the internal face of the concrete wall panels.

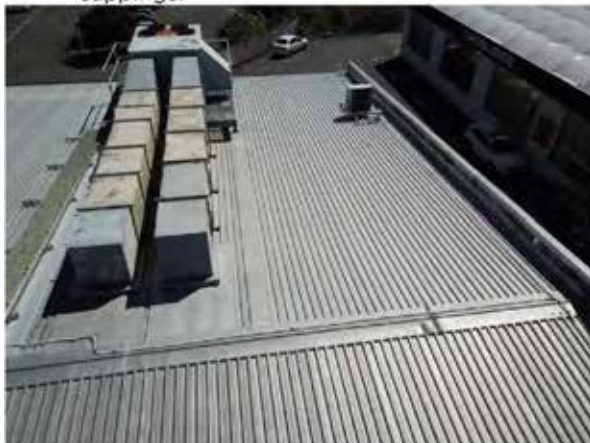
91. Extensive sealant applied to the ridge cappings and fit-over flashings.

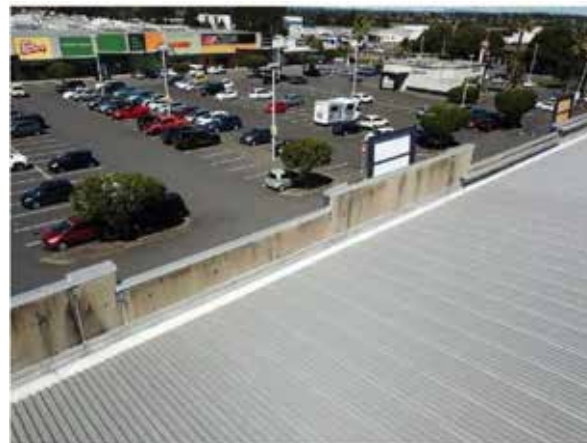
92. Corrosion on the metal anchor plates and extensive staining on the internal face of the concrete wall panels.

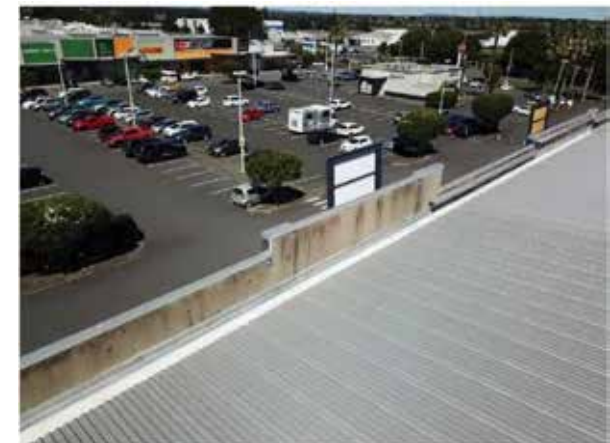
93. Extensive staining on the internal face of the concrete wall panels.

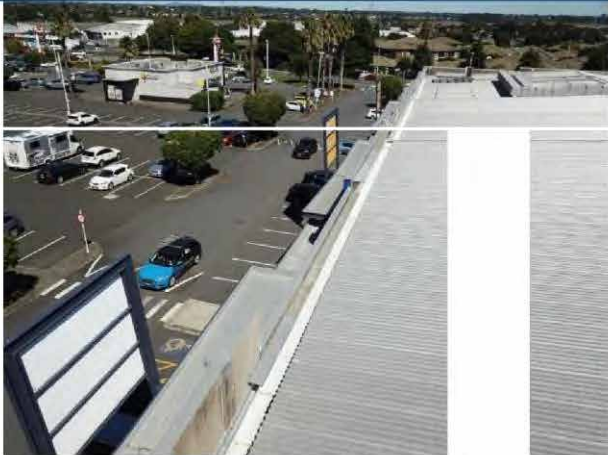
94. Staining and minor uplift to the single-plywood membrane sheets.

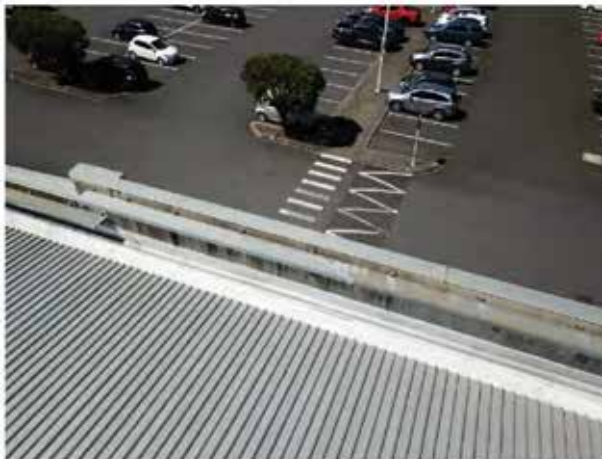
98. Staining and minor uplift to the single-plywood membrane sheets.

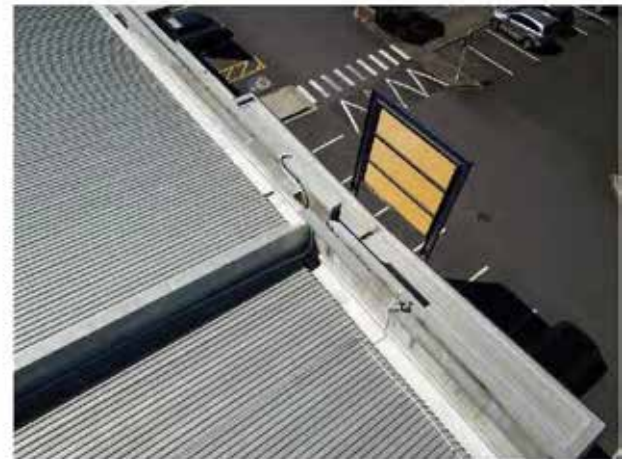
99. Sealant applied to the

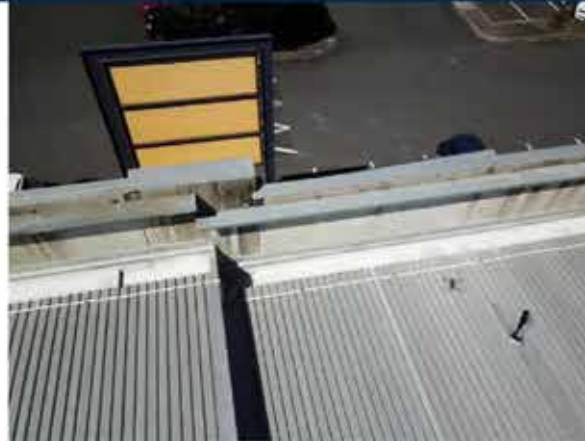
101. Staining and minor uplift to the single-plywood membrane sheets.

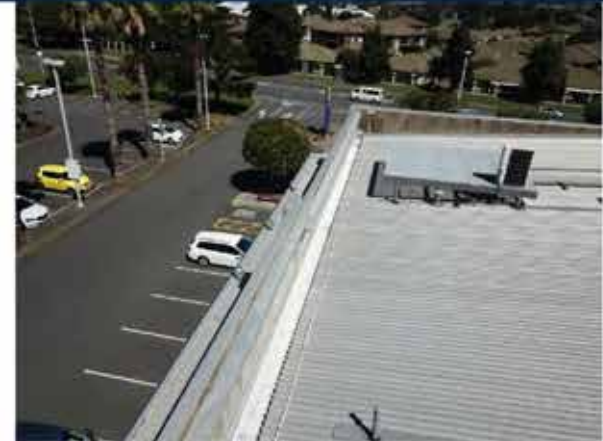
102. Staining and minor uplift to the single-plywood membrane sheets.

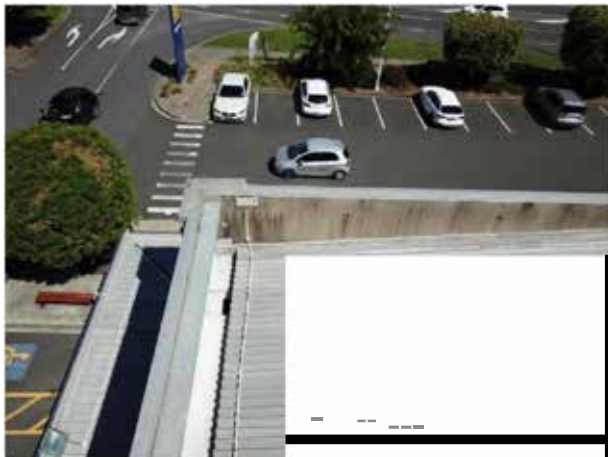
103. Staining and minor uplift to the single-plywood membrane sheets.

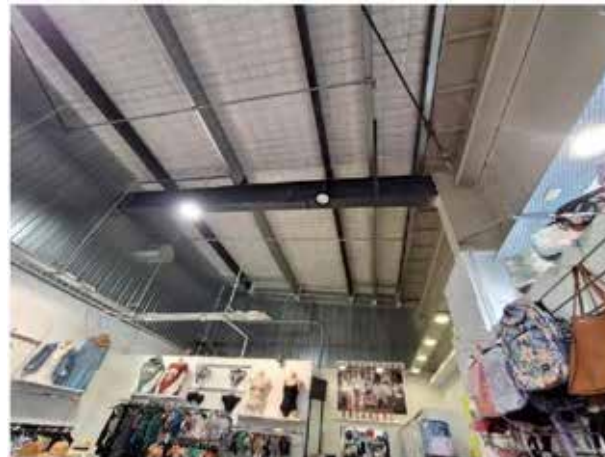
104. View of the underside of the roof (Chances Surf New Zealand).

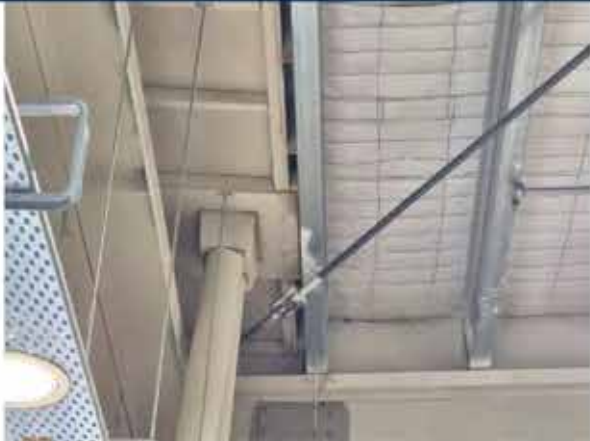
106. Staining on discolouration to the painted external cutters.

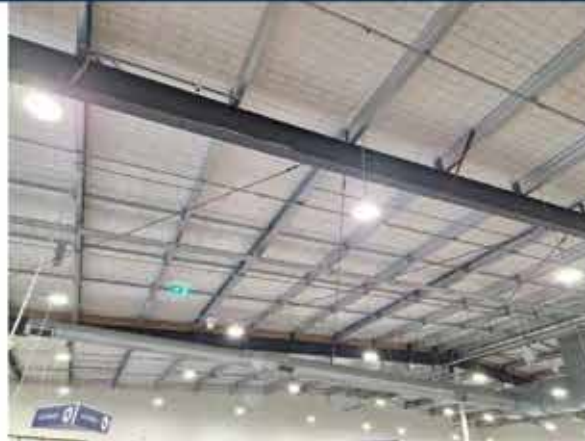
107. View of the underside of the roof (Briscoes).

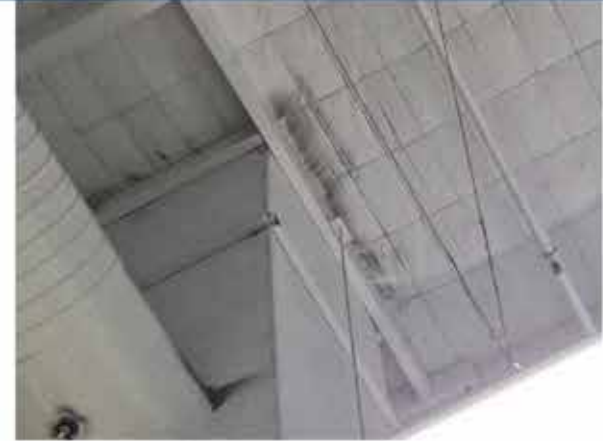
114. Environmental staining on the roof underlay.

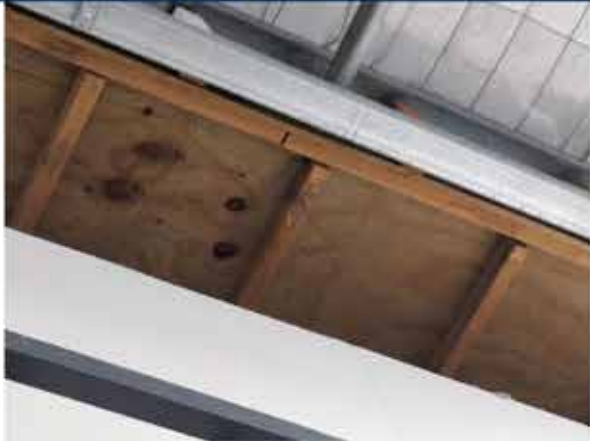
115. Minor discolouration to the timber box frame of the plywood substrate.

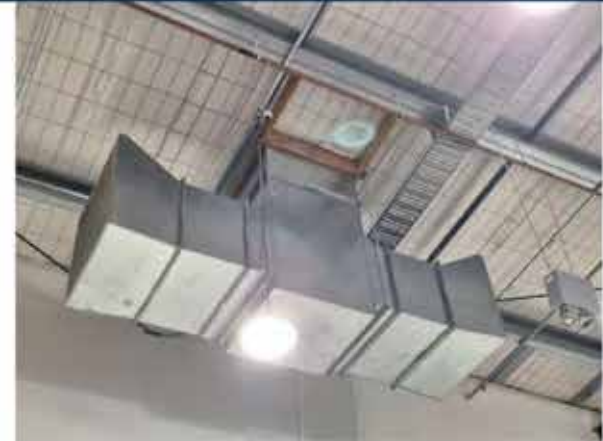
117. Localised staining on the timber framing for the large penetration.

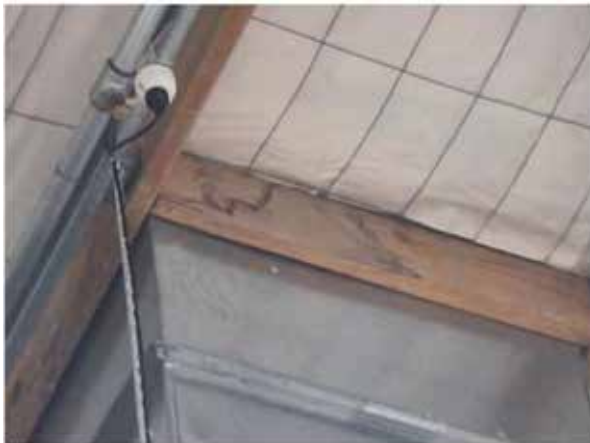
118. Localised staining on the timber framing for the large penetration.

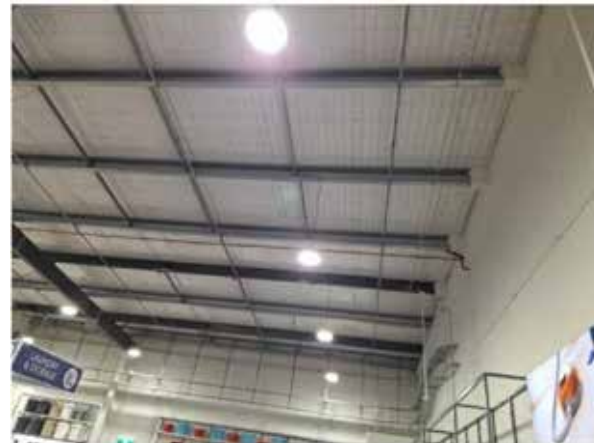
119. View of the underside of the roof.

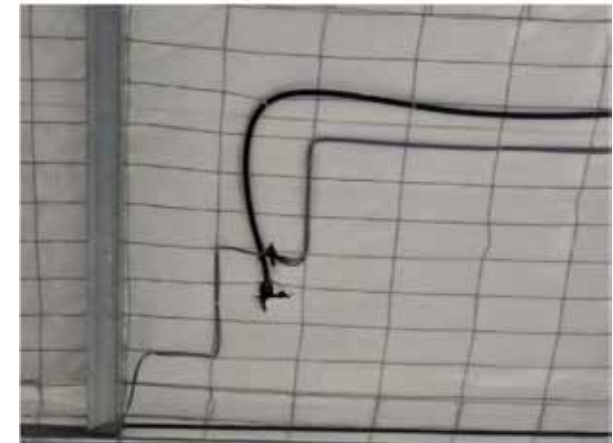
120. A cable penetration was observed within this area.

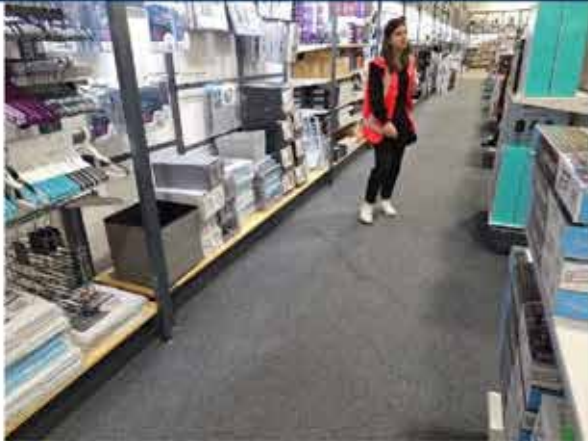
121. Minor staining on the carpet finish.

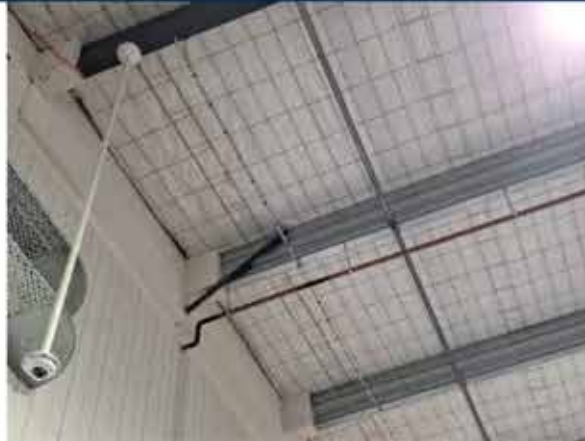
122. Staining observed below a copper pipe, sprinkler and the exposed roof structure. No obvious visual signs of water ingress were present to the roof structure.

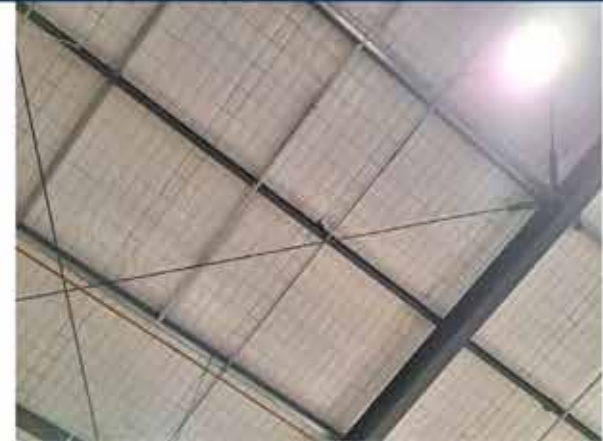
123. A localised tear was observed roof underlay adjacent which appears to be a post for the services platform. Fire sprinklers were also noted within the area.

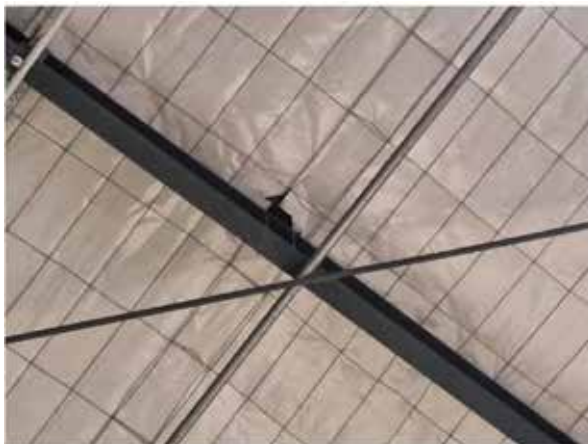
124. A localised tear was observed roof underlay adjacent to a post for the services platform. Fire sprinklers were also noted within the area.

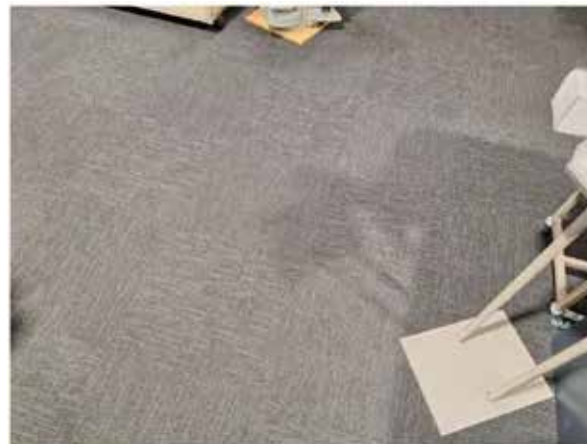
125. Staining on the carpet.

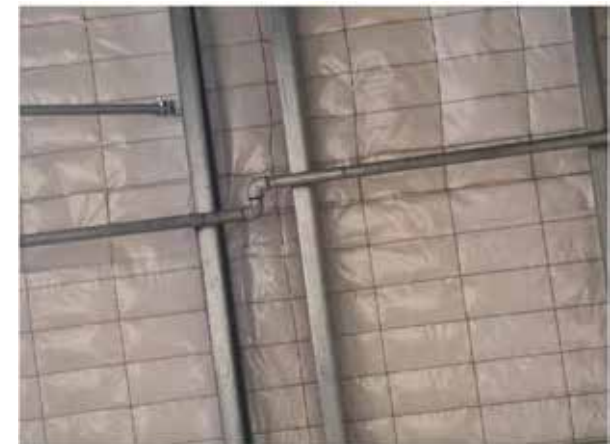
126. Underside of the roof with minor wrinkling to the underlay and a service pipe.
