BUILDING REPORT 025093003

2-4 Fred Thomas Drive, Takapuna

Photo Section 1

2 Fred Thomas Drive (The Doctors and
Property Partners)

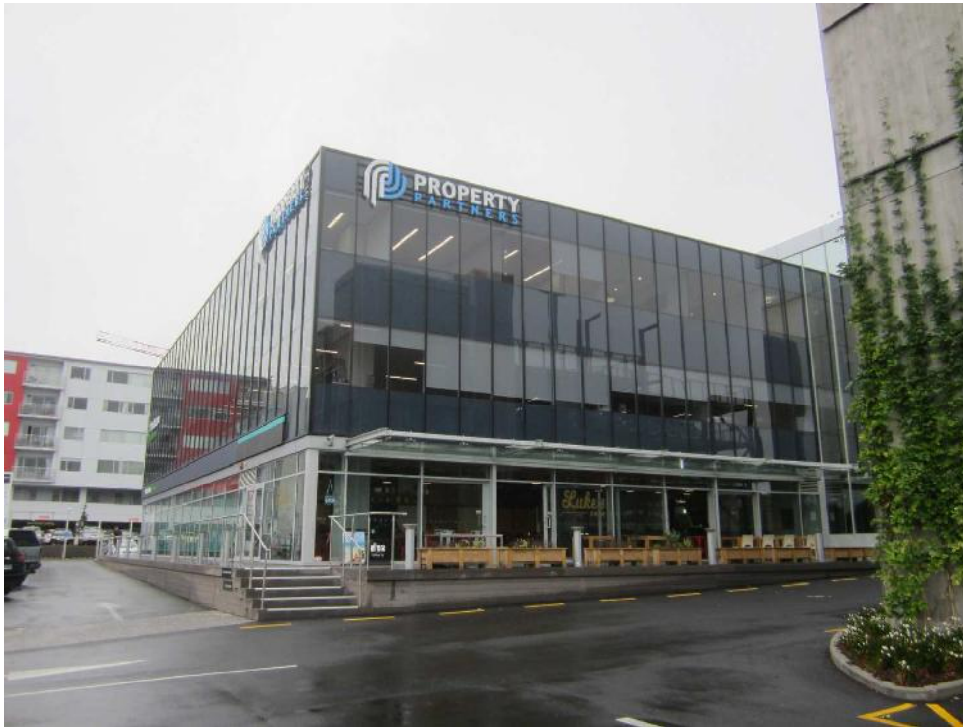
Photo 1: General view of the south elevation.

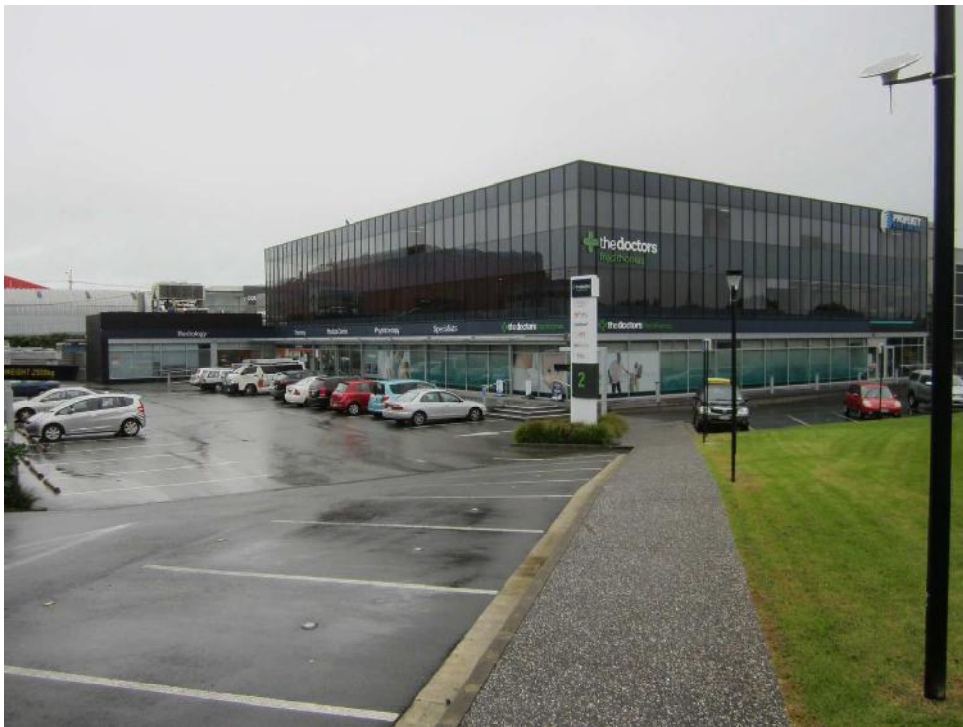
Photo 2: General view of the north and west elevations.

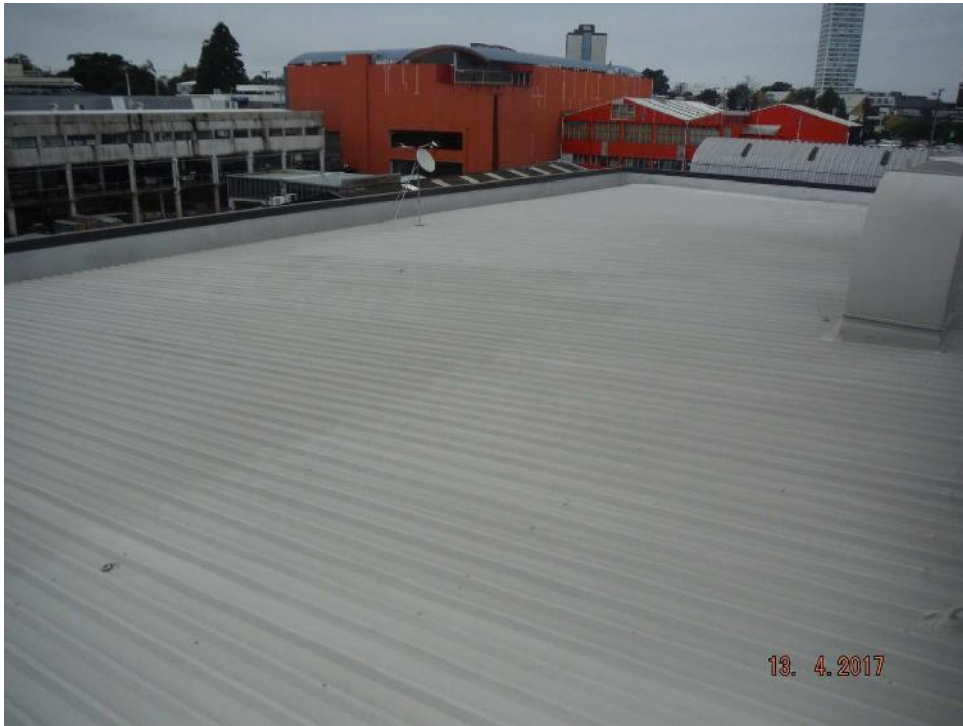
Photo 3: General view of the metal roof covering. The roof has been sprayed with an elastomeric coating to prolong its service life.

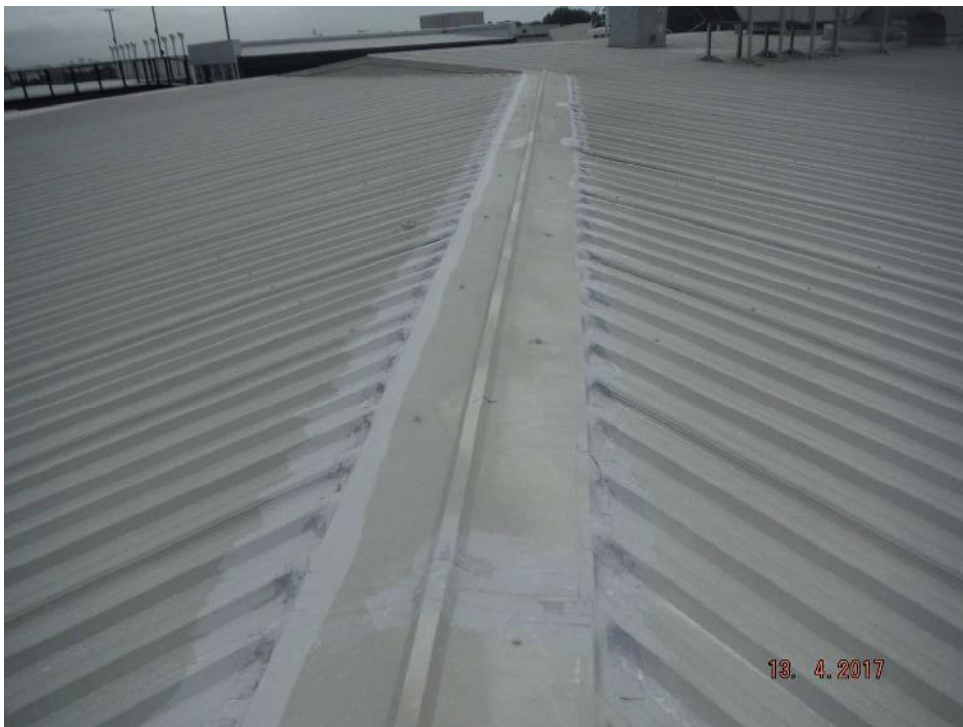
Photo 4: More recent repairs were also noted, such as brush applied elastomeric coatings to the hip capping.

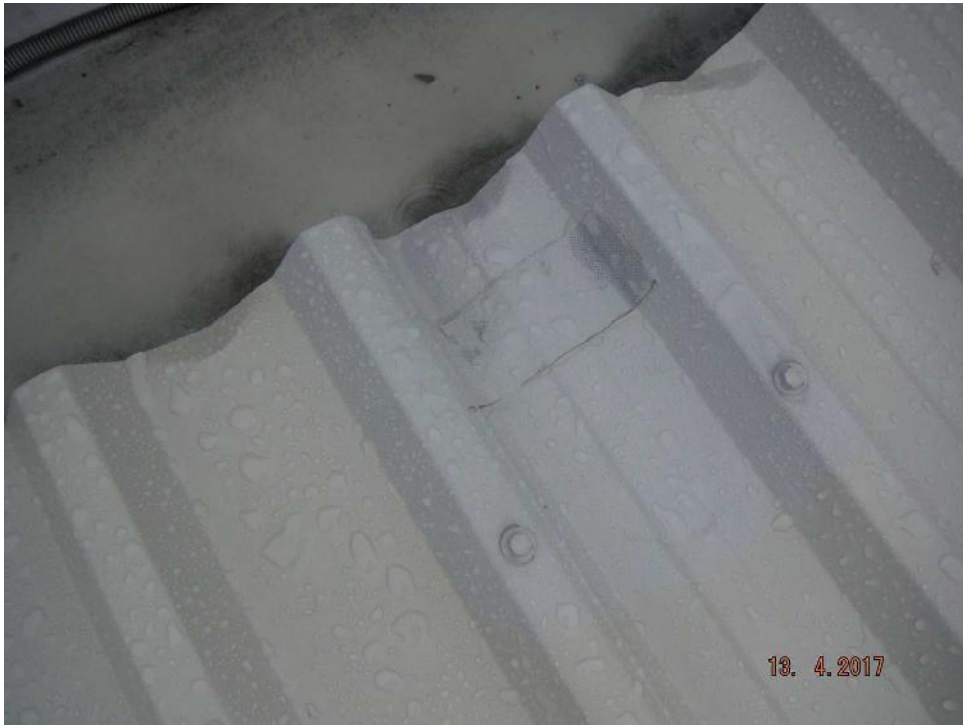
Photo 5: Flashing tape has been applied in numerous locations.

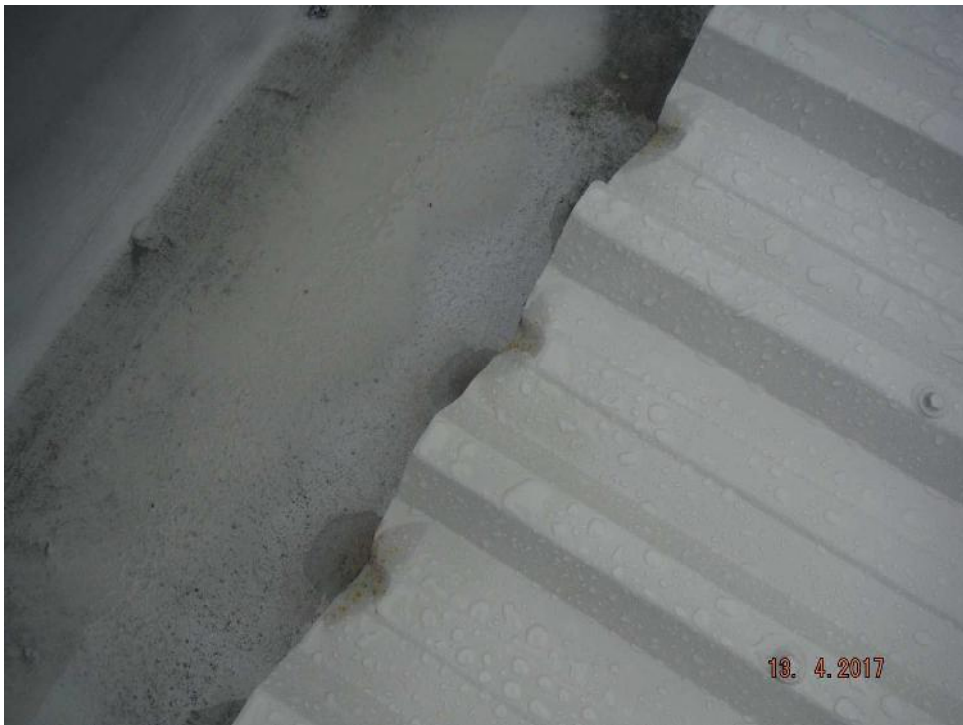
Photo 6: Surface corrosion to roof sheets is apparent through the coating.

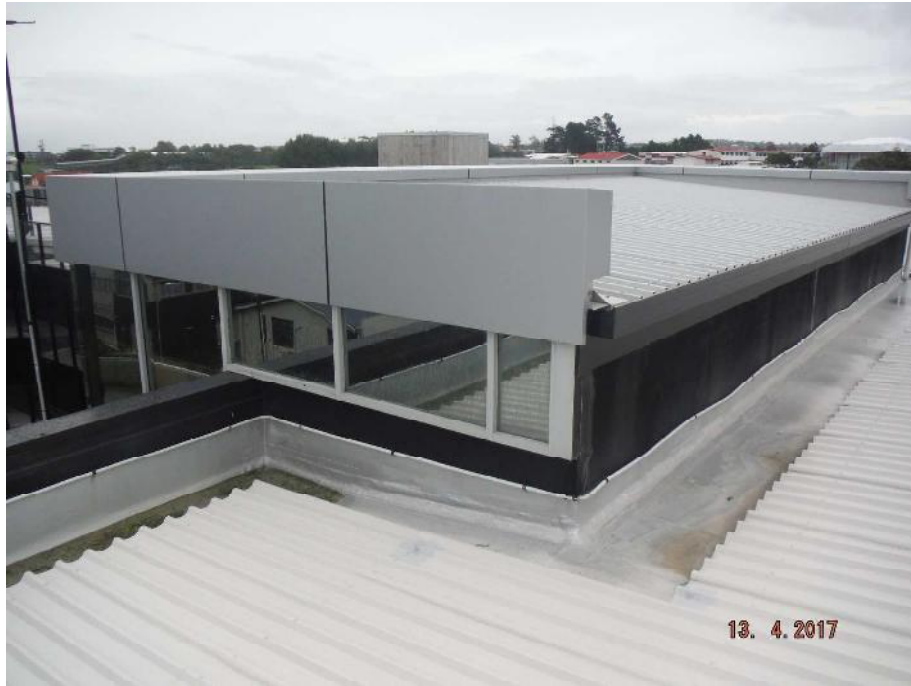
Photo 7: The metal roof covering over the main stair core appears is in good condition, although cyclone washers have not been installed to fixings. The junction between the parapet wall and window lacks adequate flashing cover and is high-risk from a weather-tightness perspective.

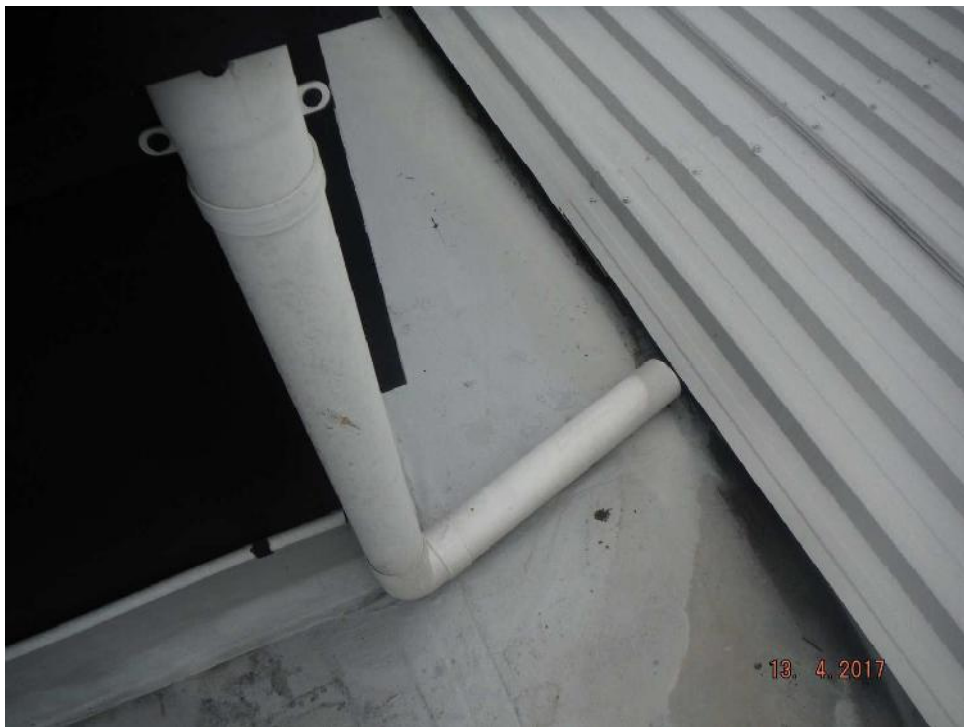
Photo 8: A downpipe from the stair core roof currently discharges against an unsealed roof edge; this should be reviewed.

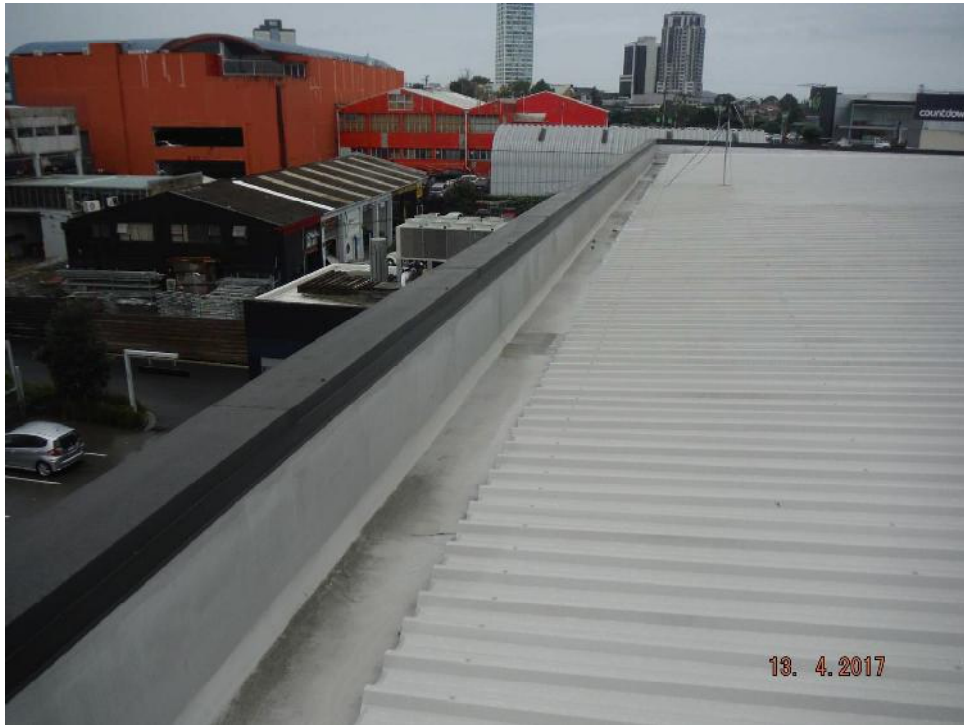
Photo 9: An elastomeric coating has been applied to membrane gutters.

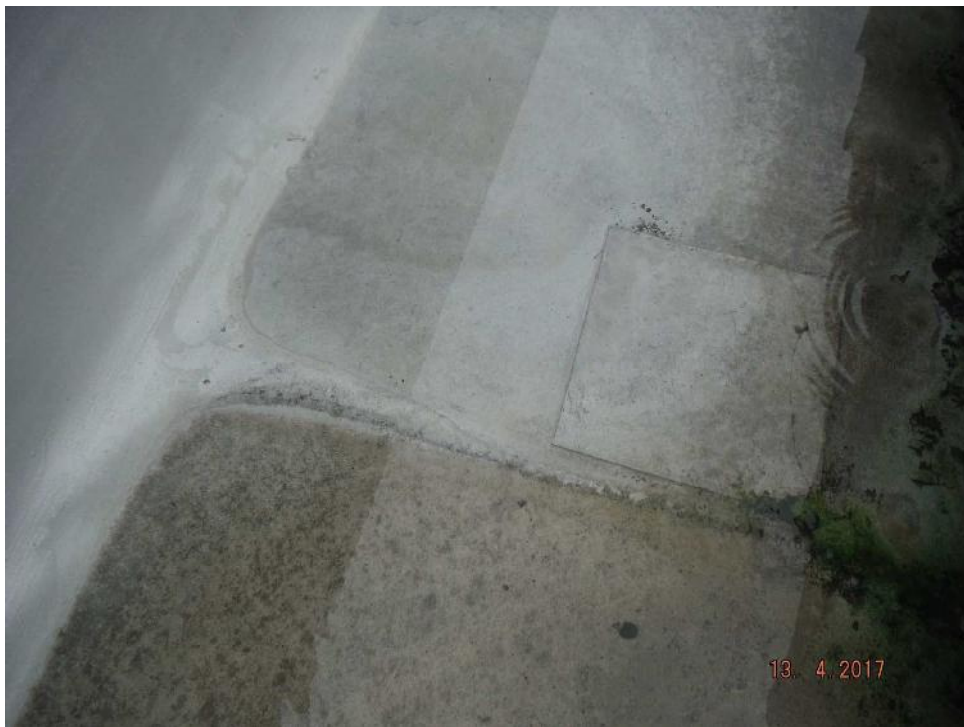
Photo 10: Ponding water noted to membrane gutters. Bubbling and evidence of previous patch repairs were also apparent.

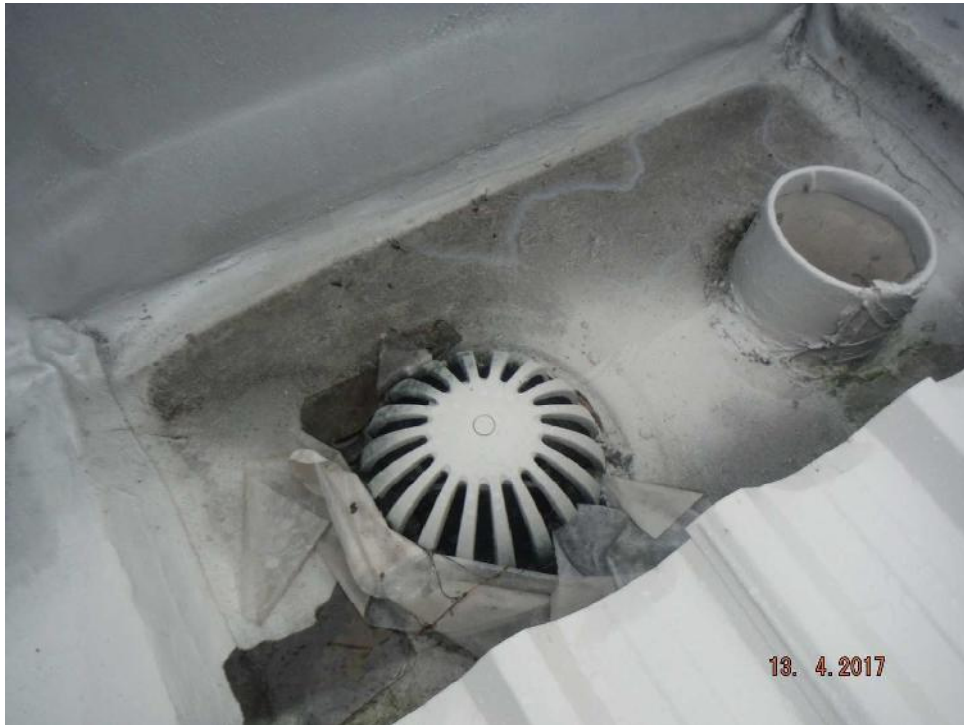
Photo 11: Gutter baskets and overflow pipes are installed throughout.

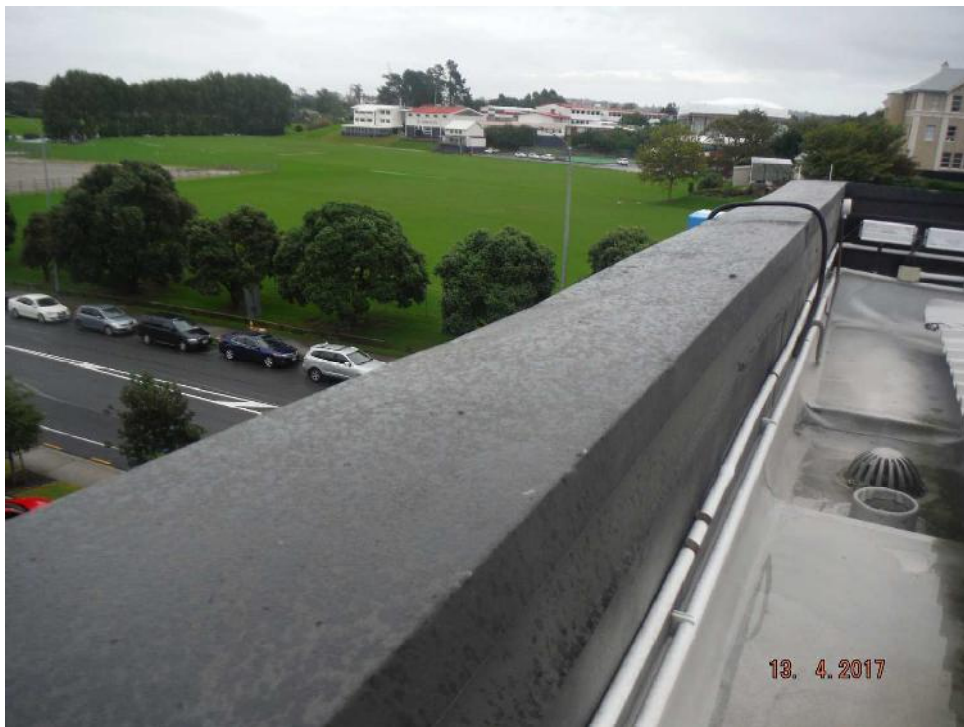
Photo 12: Parapet cappings include minimal falls and top fixings in some locations.

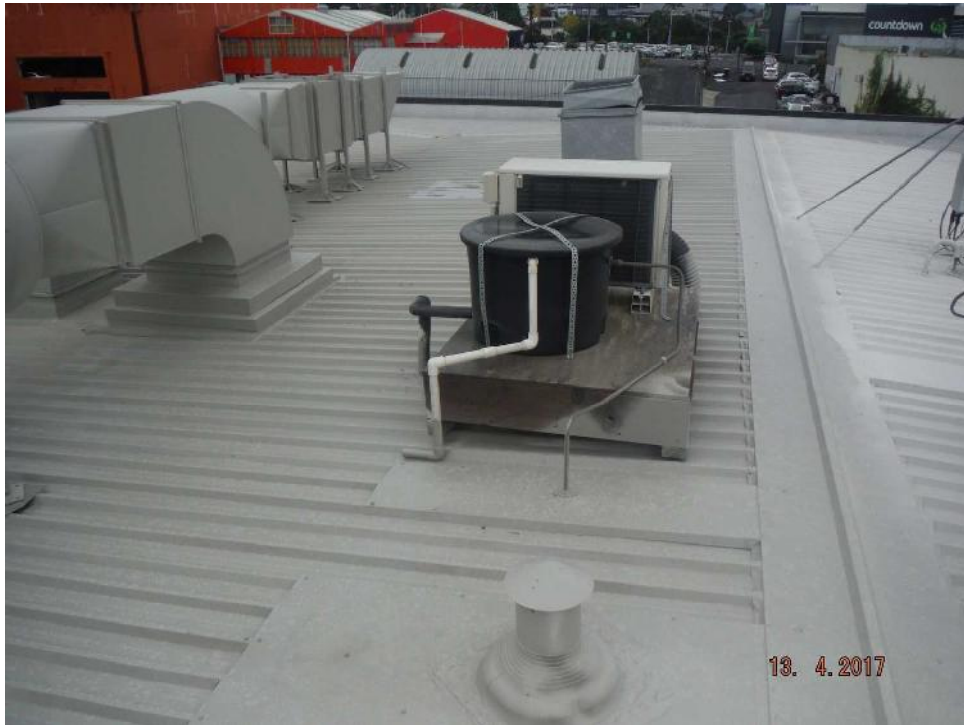
Photo 13: Numerous plant and equipment is installed to the roof.

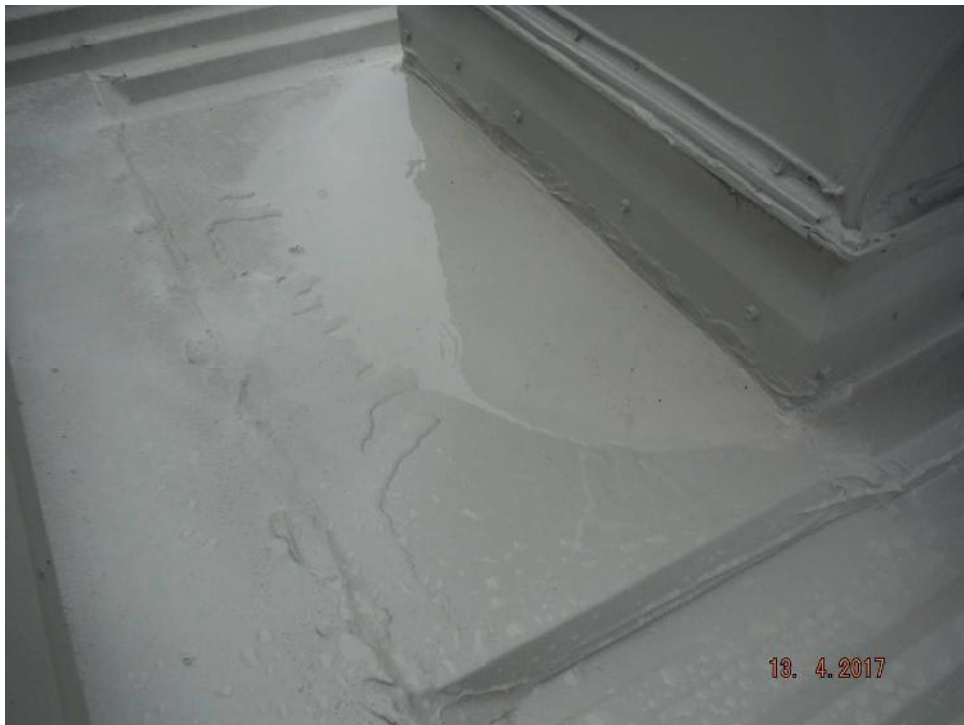
Photo 14: Historic repairs using sealant to roof penetrations.

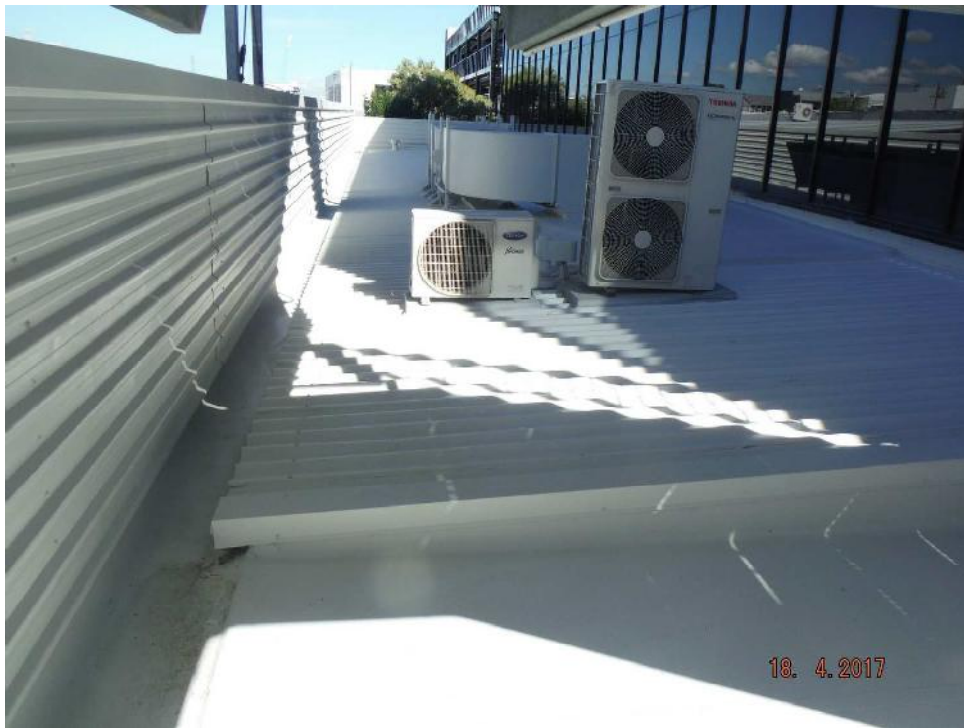
Photo 15: General view of the lower roof covered in trapezoidal metal sheets. A spray applied elastomeric coating has been used across the roof.

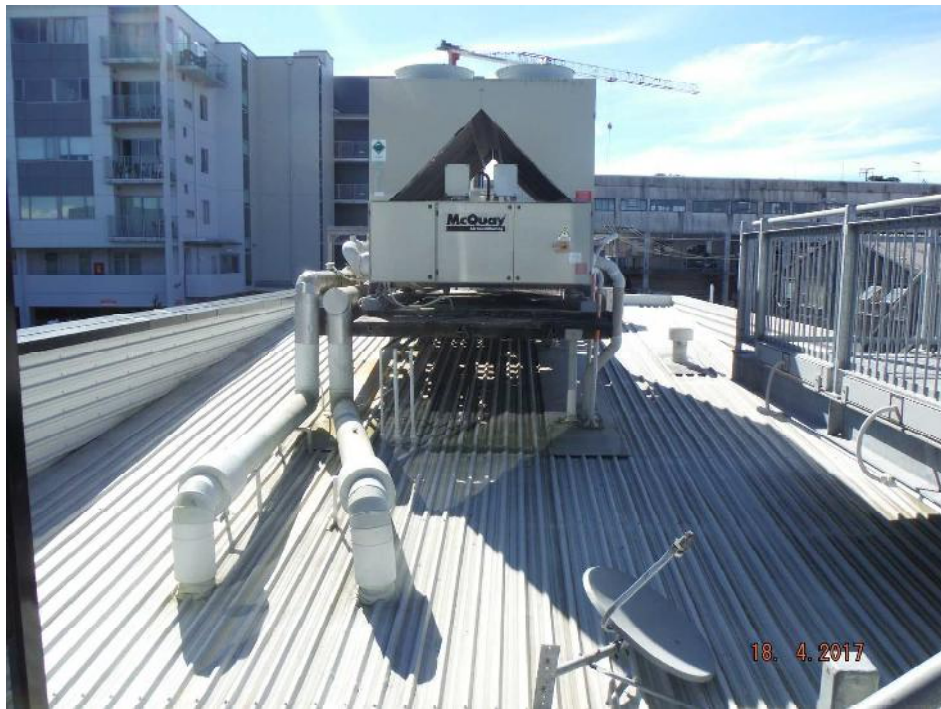
Photo 16: Air conditioning plant installed to the lower roof. Poorly detailed penetrations through roof sheets.

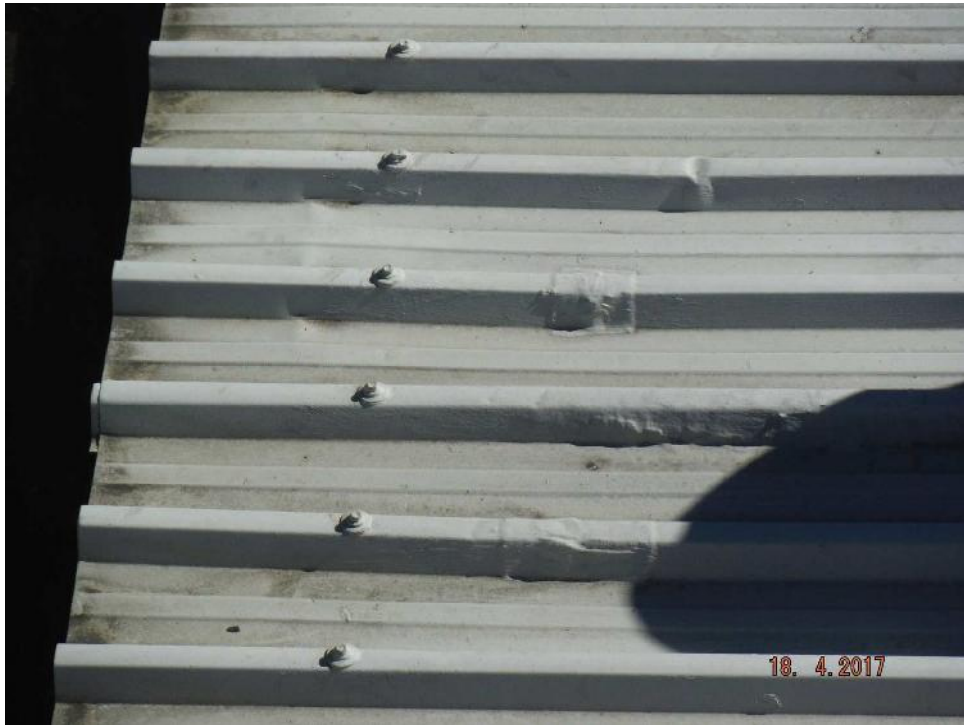
Photo 17: Patch repairs present to the lower roof.

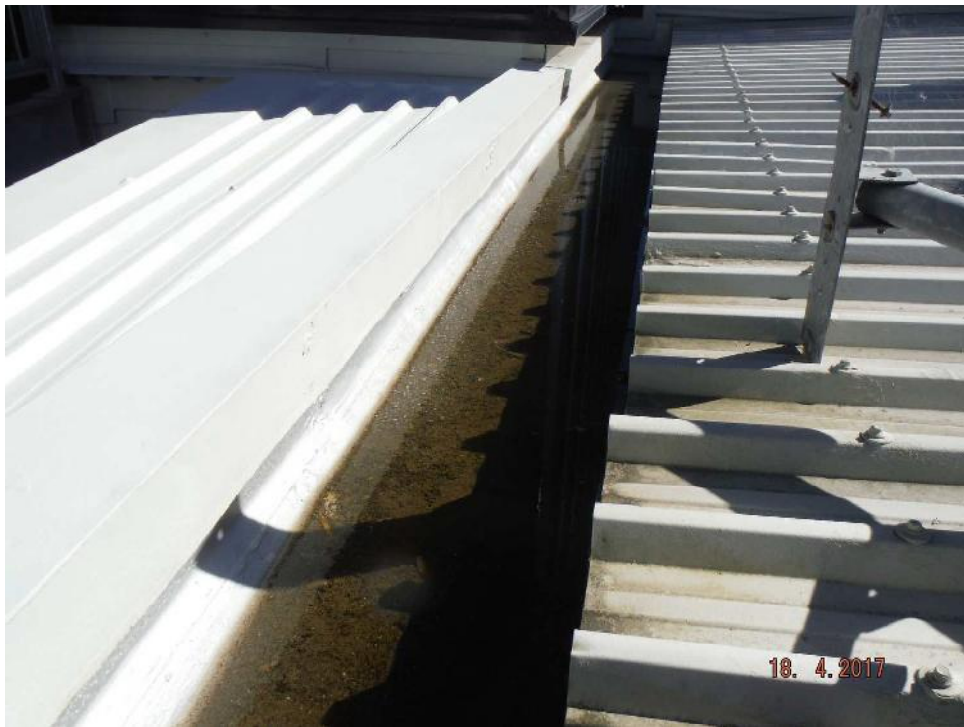
Photo 18: Ponding water to the membrane gutter.

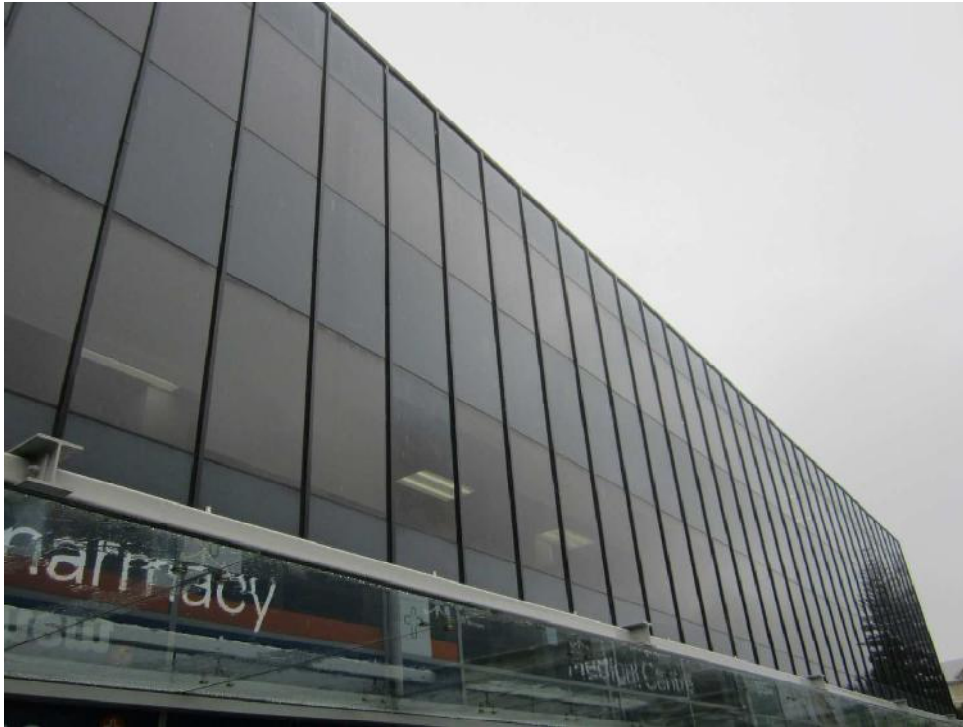
Photo 19: The cladding system to the upper level comprises glazed panels within aluminium mullion channels.

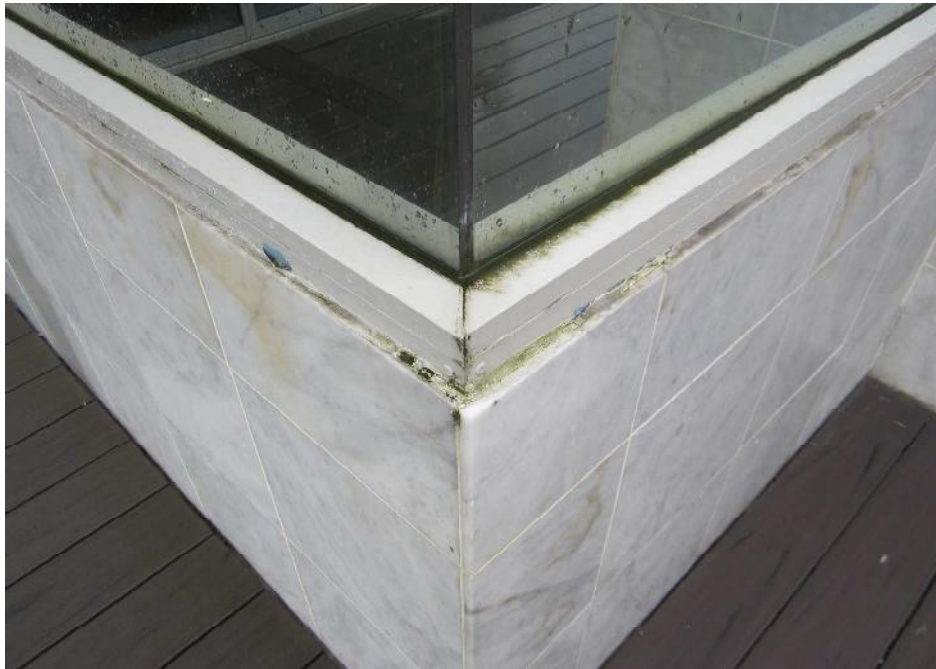
Photo 20: The age of the cladding system and the effects of UV degradation has resulted in hardened and shrunk seals. Sealant repairs have been applied to the stone veneer cladding joints, which are marked with algae and degrading.

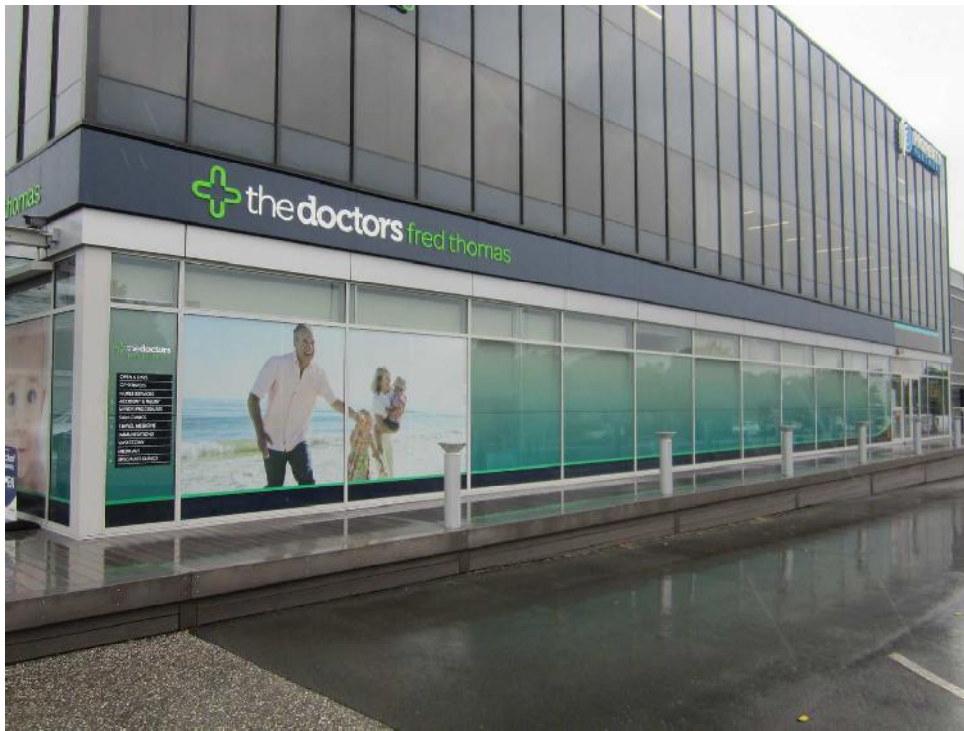
Photo 21: The glazing system to the ground floor appears to be of more recent construction.

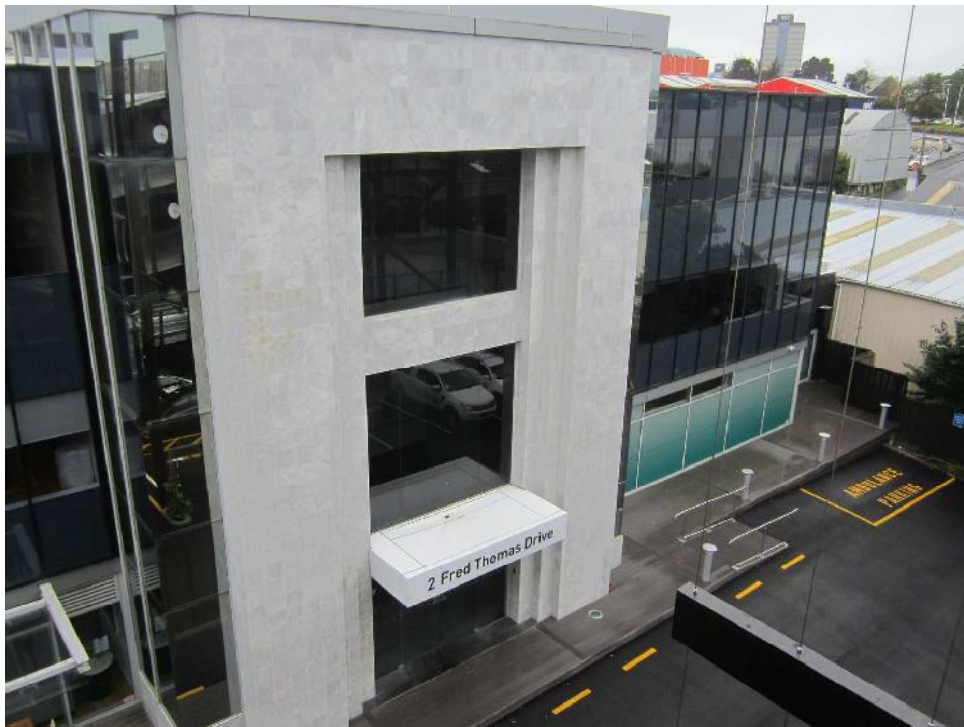
Photo 22: General view of the main stair core tower.

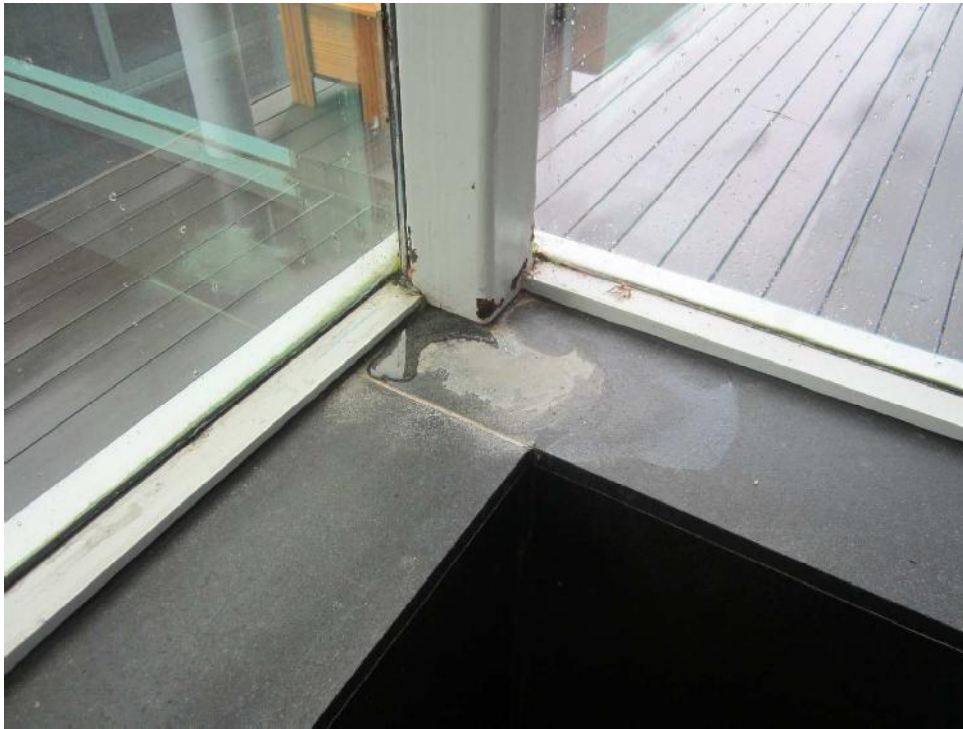
Photo 23: Water ingress noted within the main stair core. The water is likely entering at high level and tracking down.

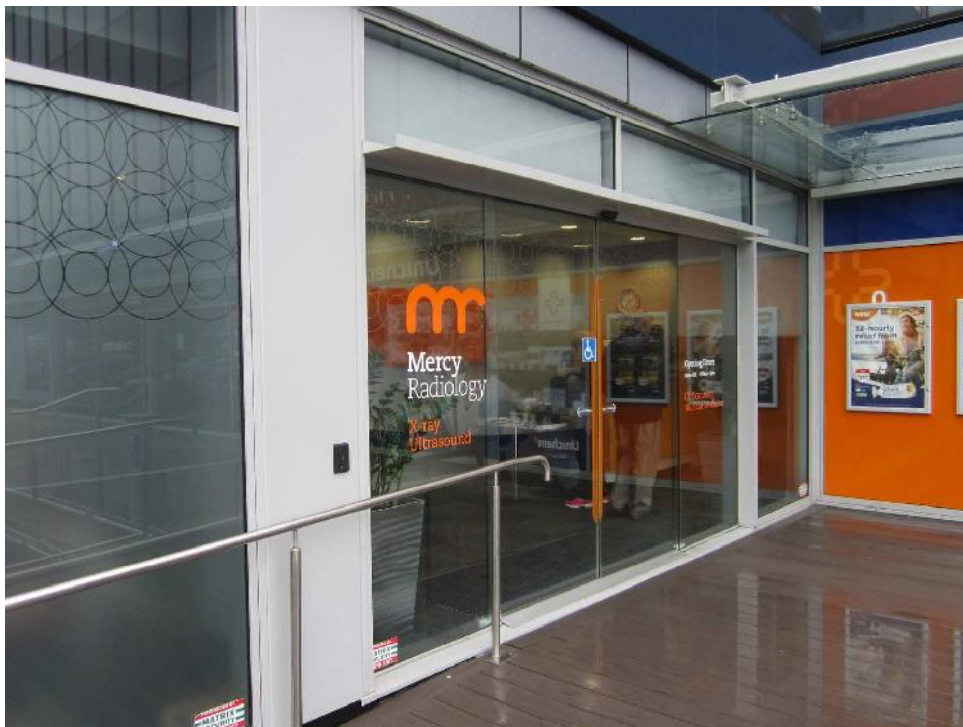
Photo 24: A gutter installed above the radiology department entrance door collects water off the canopy, which discharges against the glazed cladding.

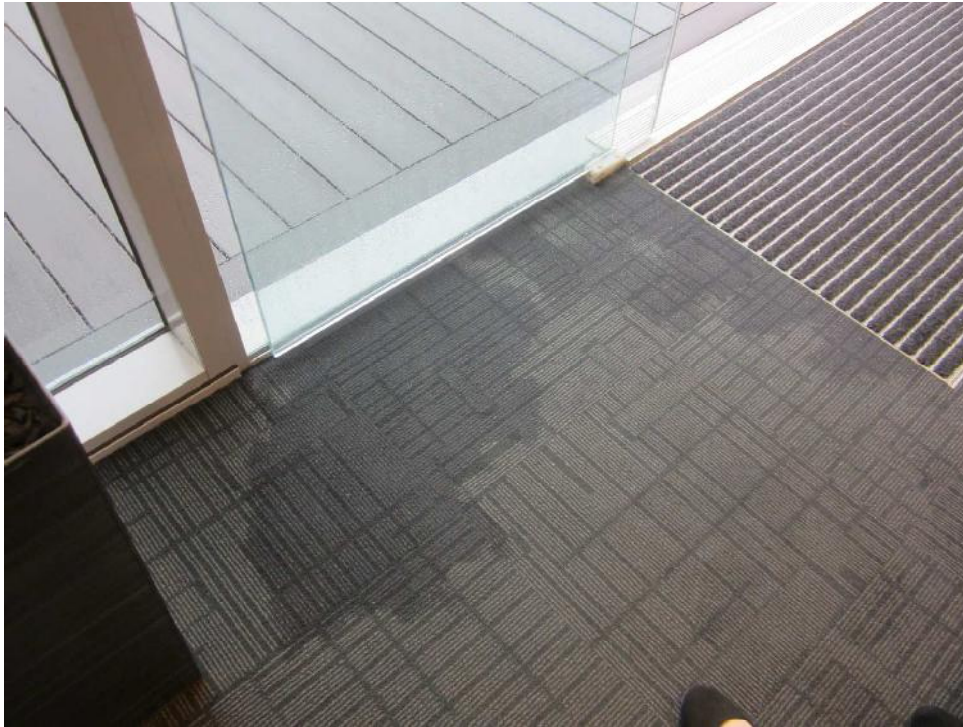
Photo 25: Water is entering the building adjacent to the radiology department doorway as a result of the poorly designed gutter.

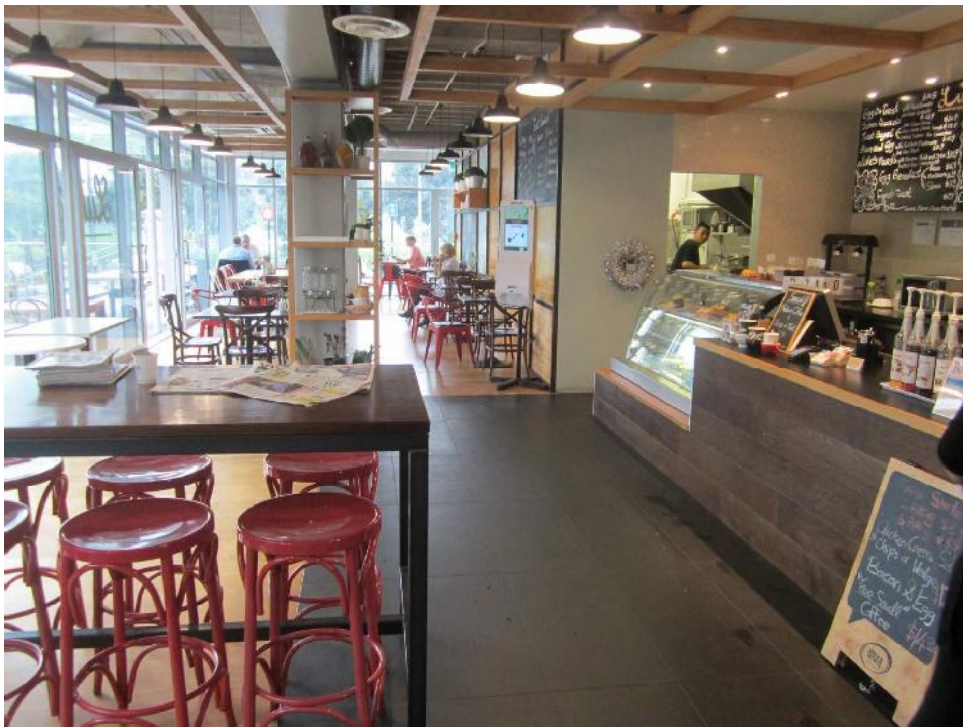
Photo 26: General view of the cafe to the ground floor.

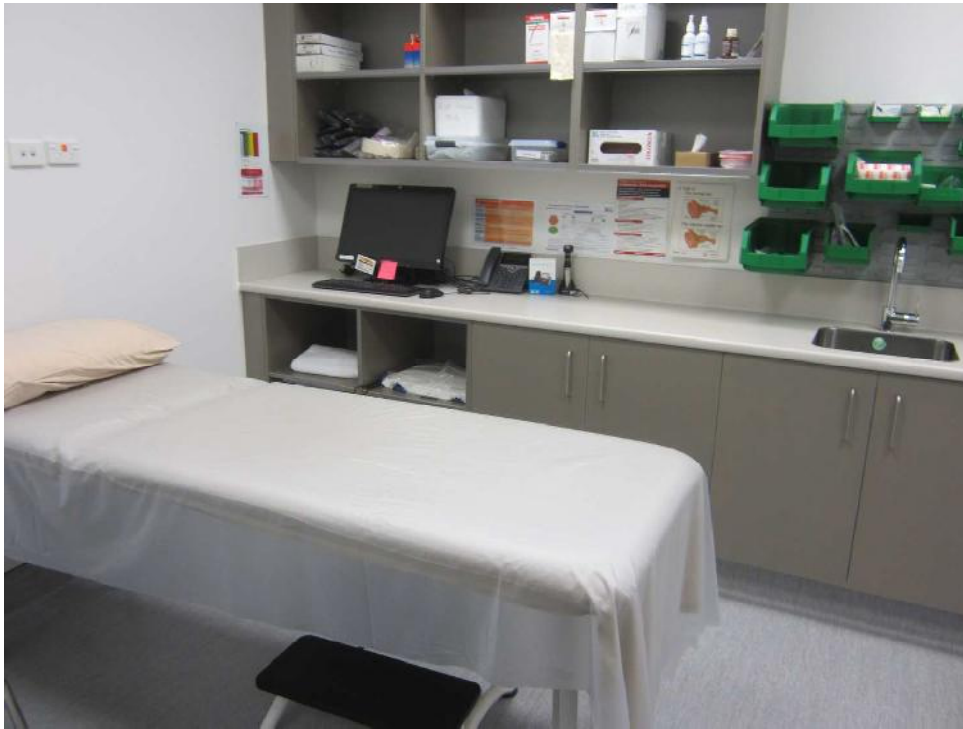
Photo 27: The medical centre has been fitted out to a high standard and includes treatment, consulting and recovery areas.

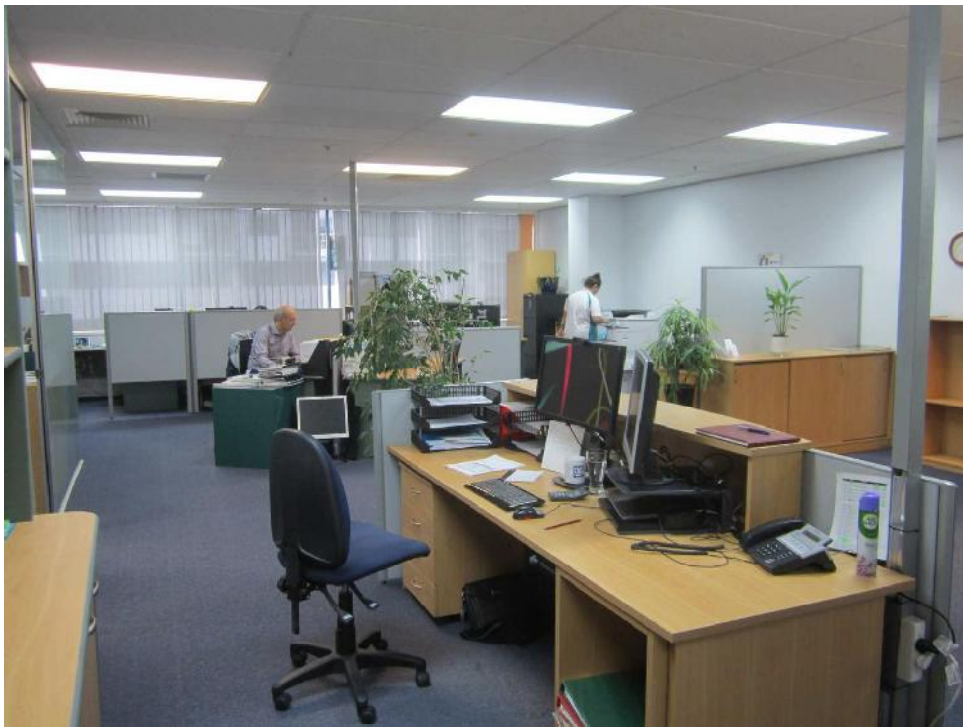
Photo 28: Office accommodation is provided to the upper levels.

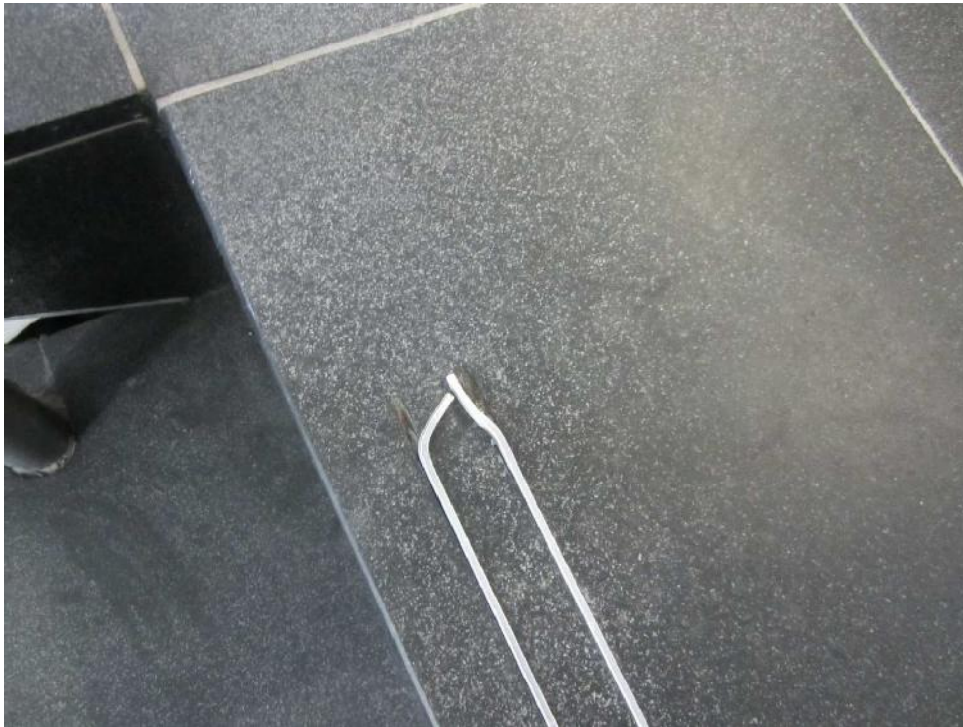
Photo 29: Metal tread strips to the main stair core are damaged.

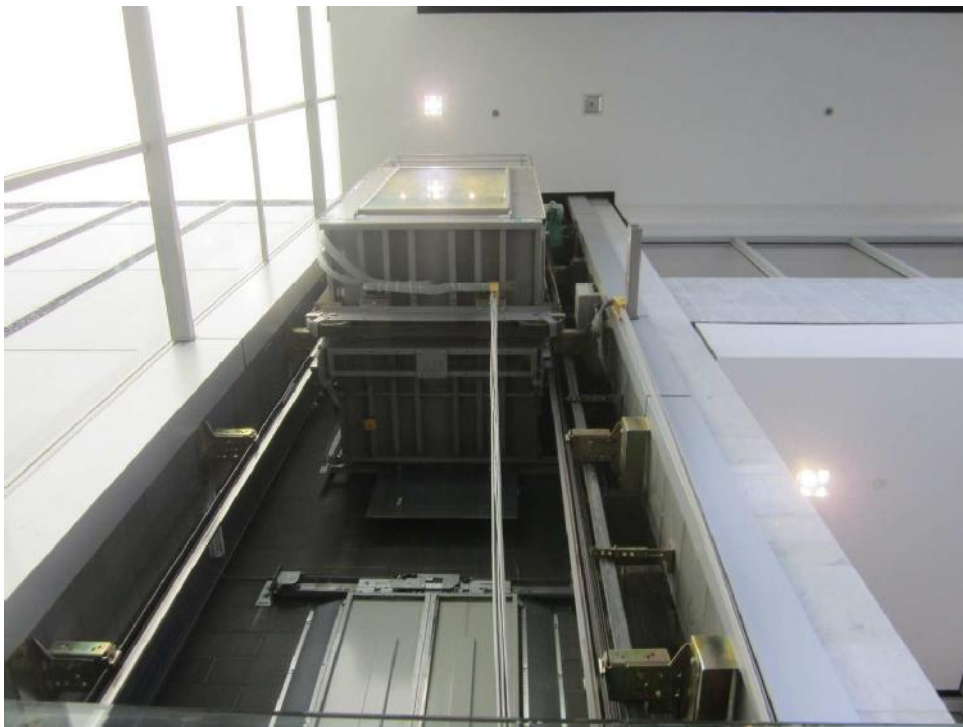
Photo 30: Passenger lift to the upper floors of the office accommodation. The lift car appears to be original.

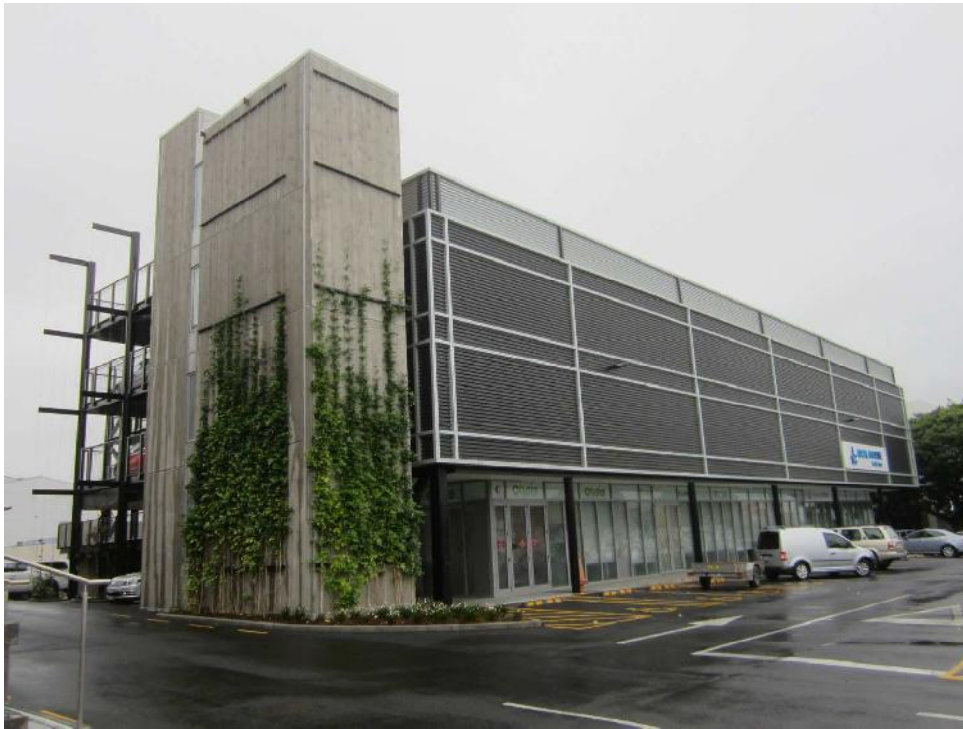
Photo 1: General view of the west elevation. Auckland Eye occupies the ground floor. Multi-storey car parking is provided above.

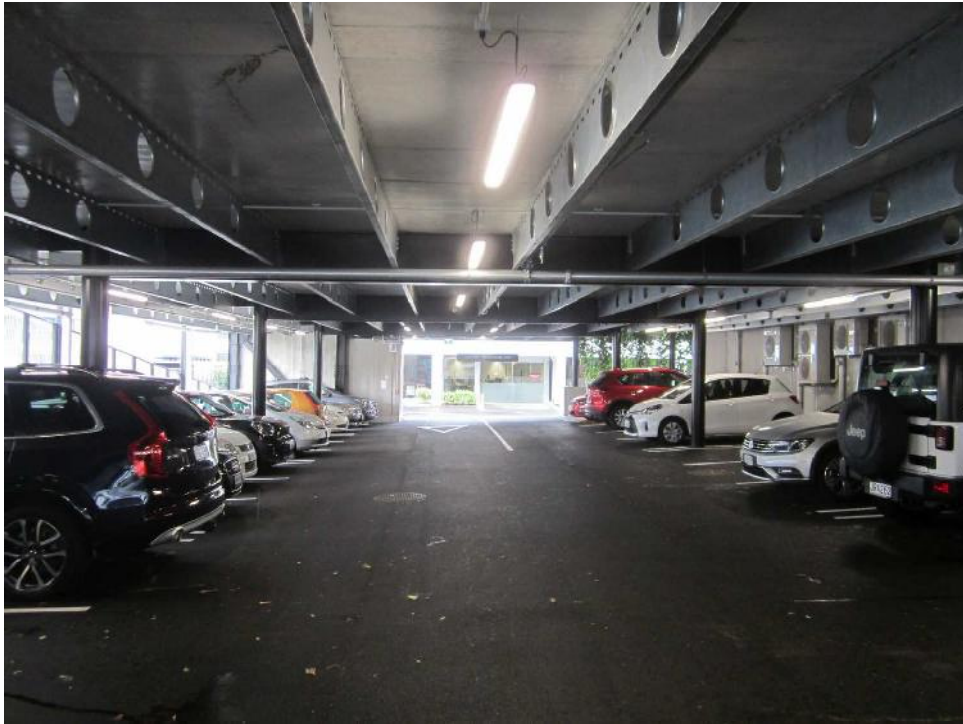
Photo 2: General view of the ground floor car park level.
