BUILDING REPORT 025093003

2-4 Fred Thomas Drive, Takapuna

Photo Section 1

2 Fred Thomas Drive (The Doctors and
Property Partners)

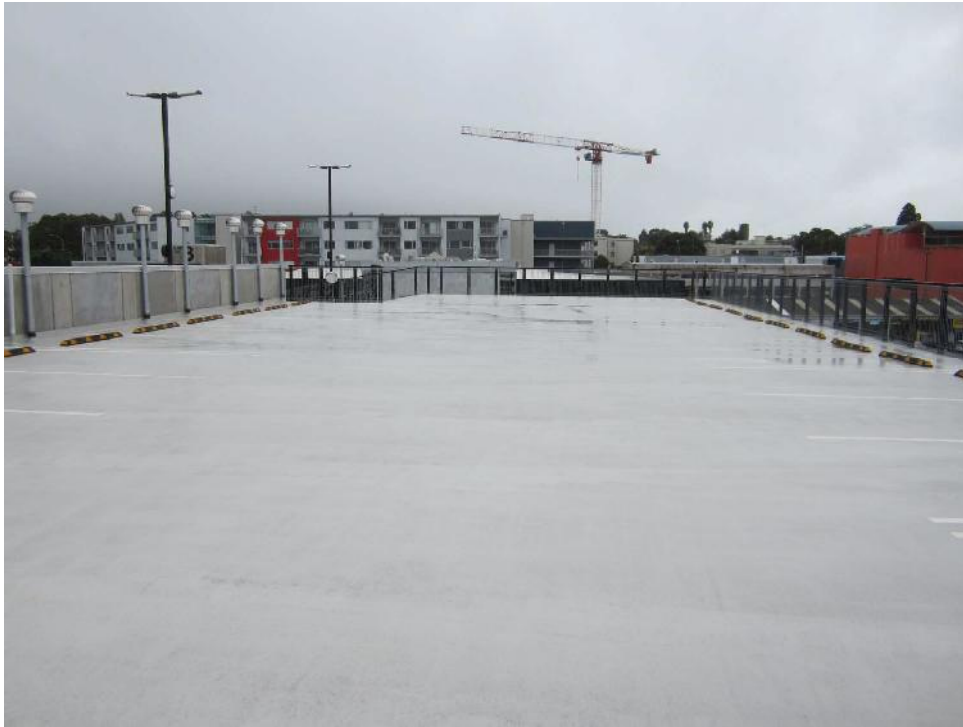
Photo 3: The upper deck to the carpark is coated with a flexible polyurethane waterproofing system.

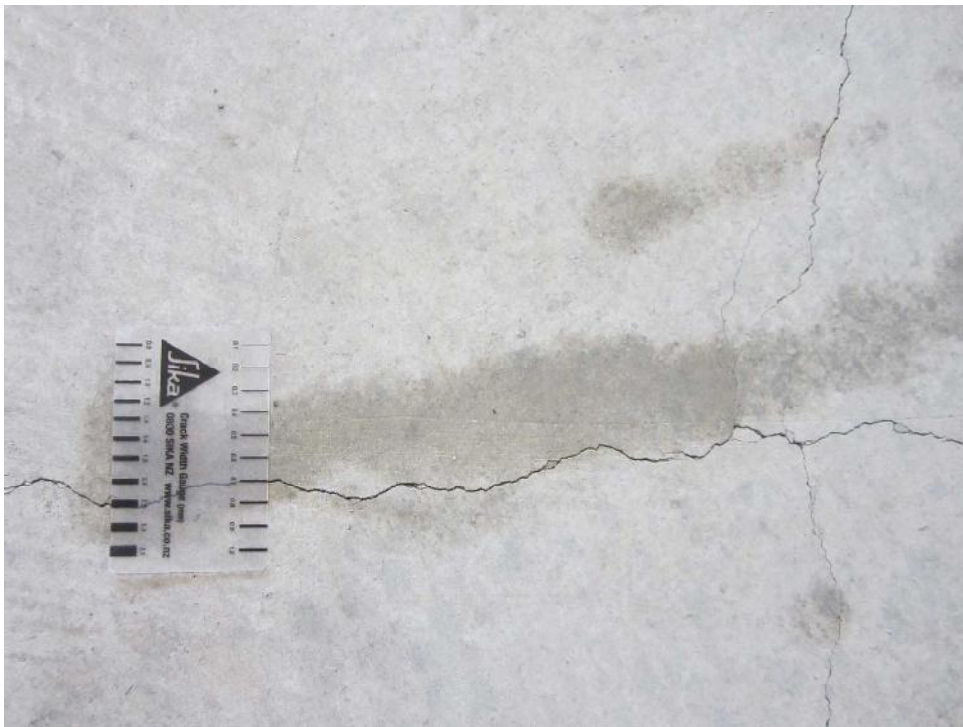
Photo 4: Numerous cracks are present to the concrete car park decks.

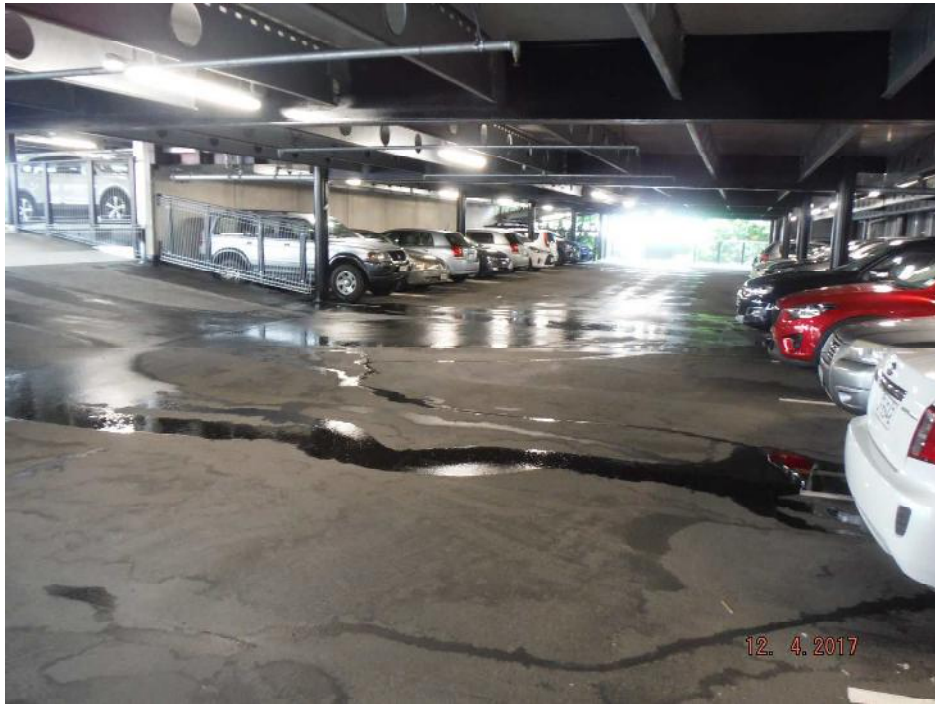
Photo 5: Water staining is present to the car park decks. Water management from the upper car park levels should be reviewed.

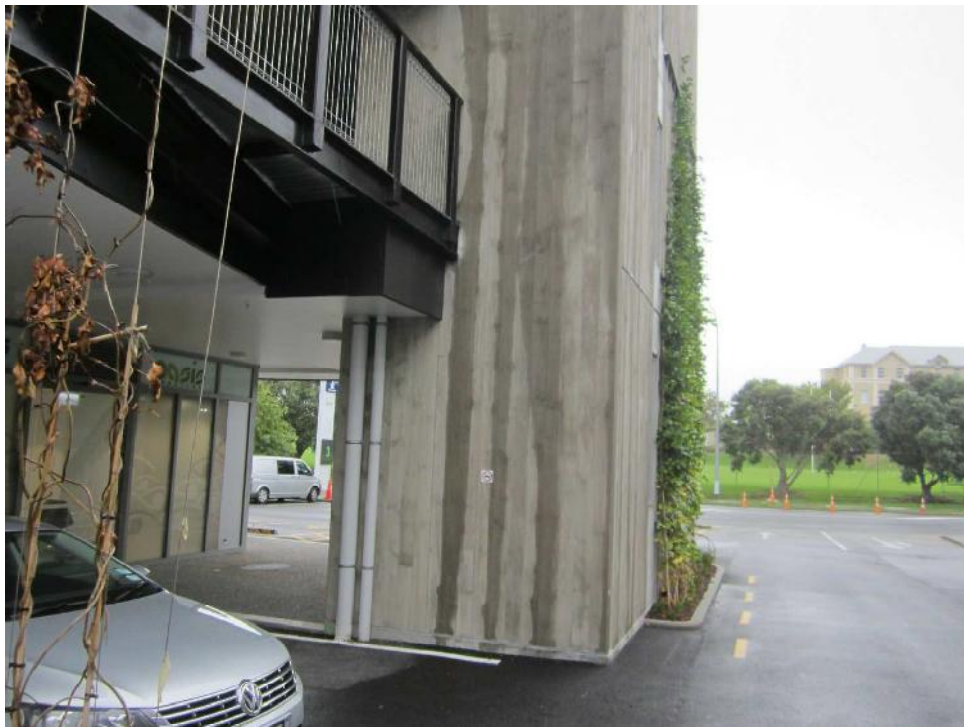
Photo 6: Water staining to the south stair tower.

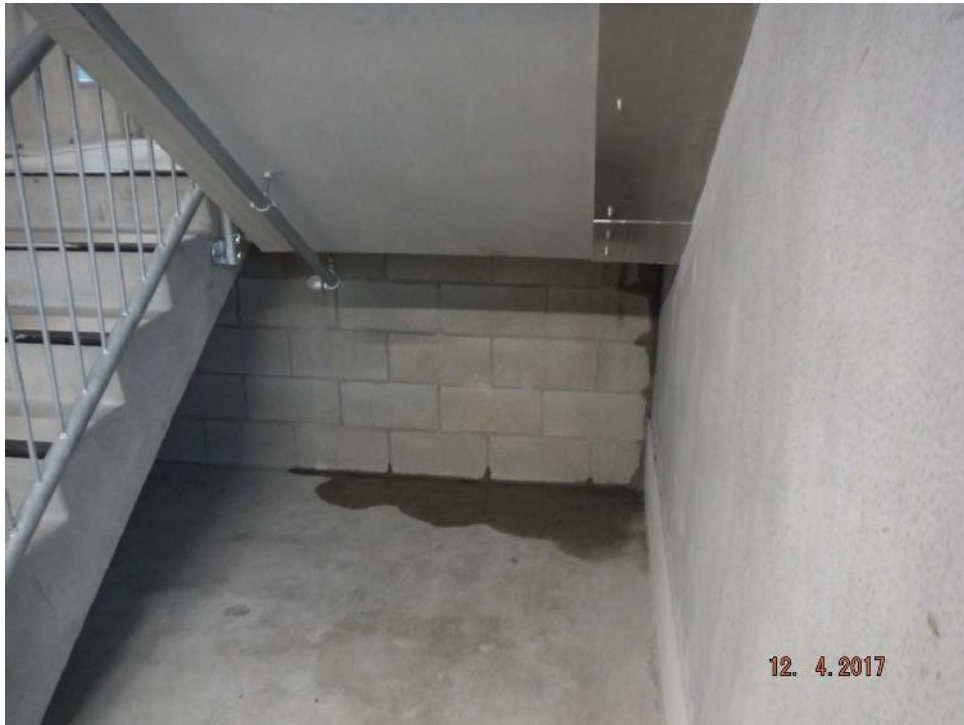
Photo 7: Water is entering the northern stair tower at ground level.

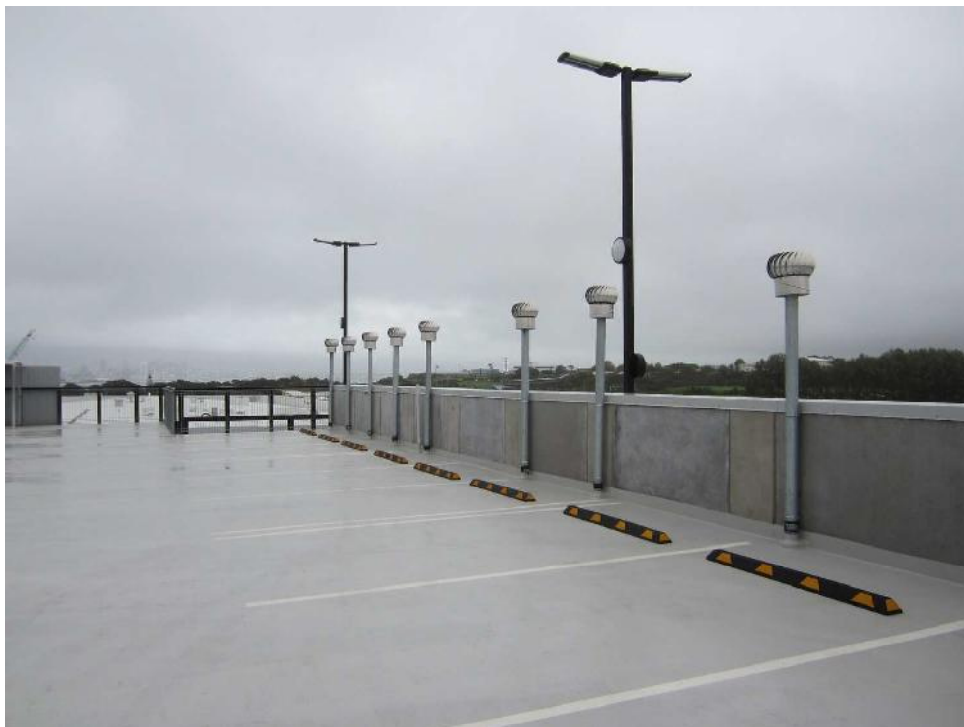
Photo 8: Wind driven cowls are installed at roof level as part of gas protection measures.

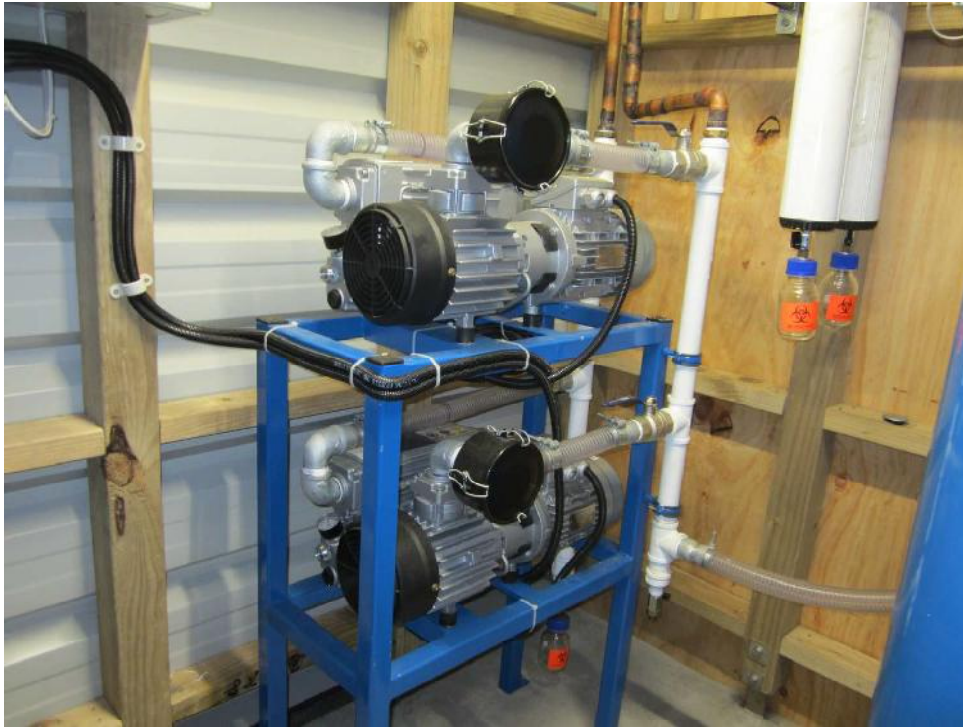
Photo 9: A medical gas store has been installed to the ground floor of the car park, removing several car park spaces.

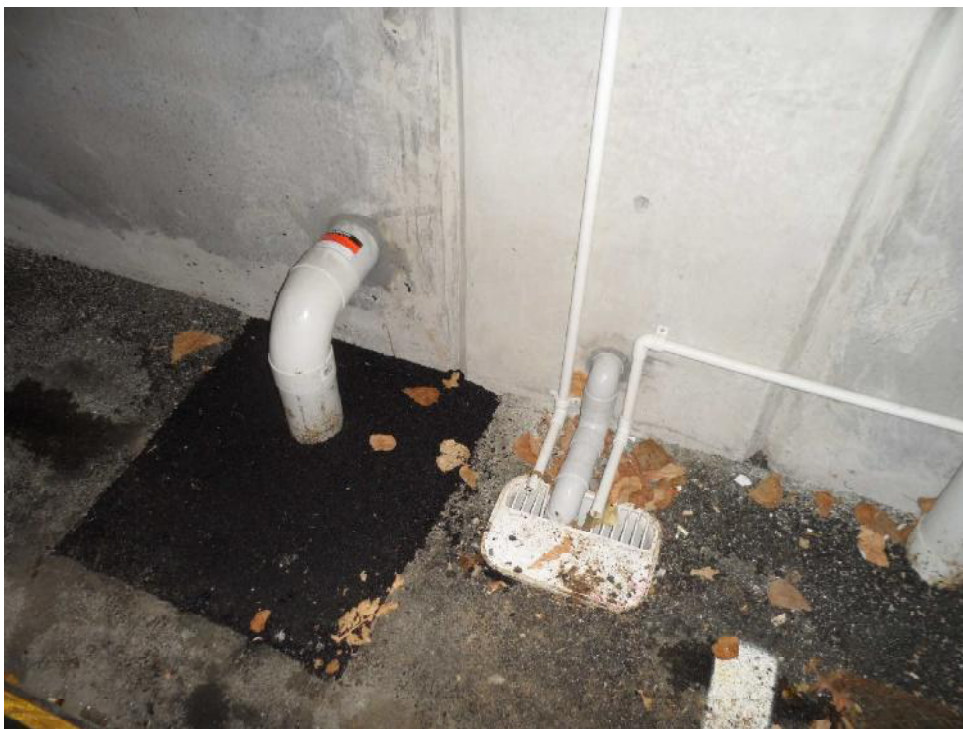
Photo 10: Service penetrations through a fire rated wall. The large penetration is labelled, but the smaller penetration is not and the fire stopping system is unknown.

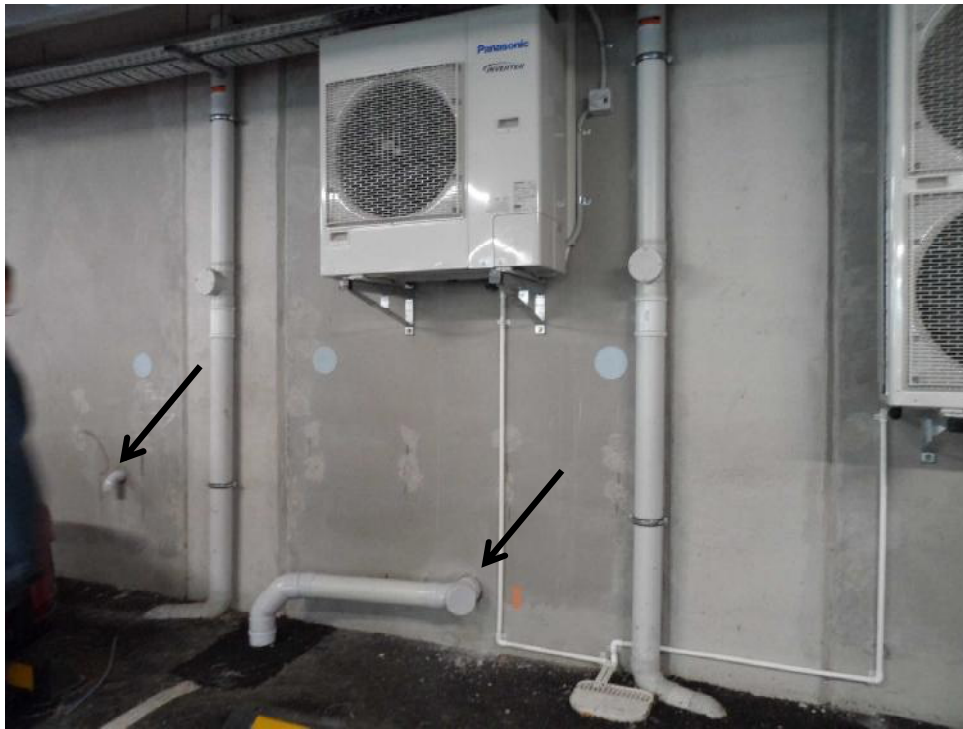
Photo 11: Typical example of service penetrations through a fire rated wall without fire stopping system labels.

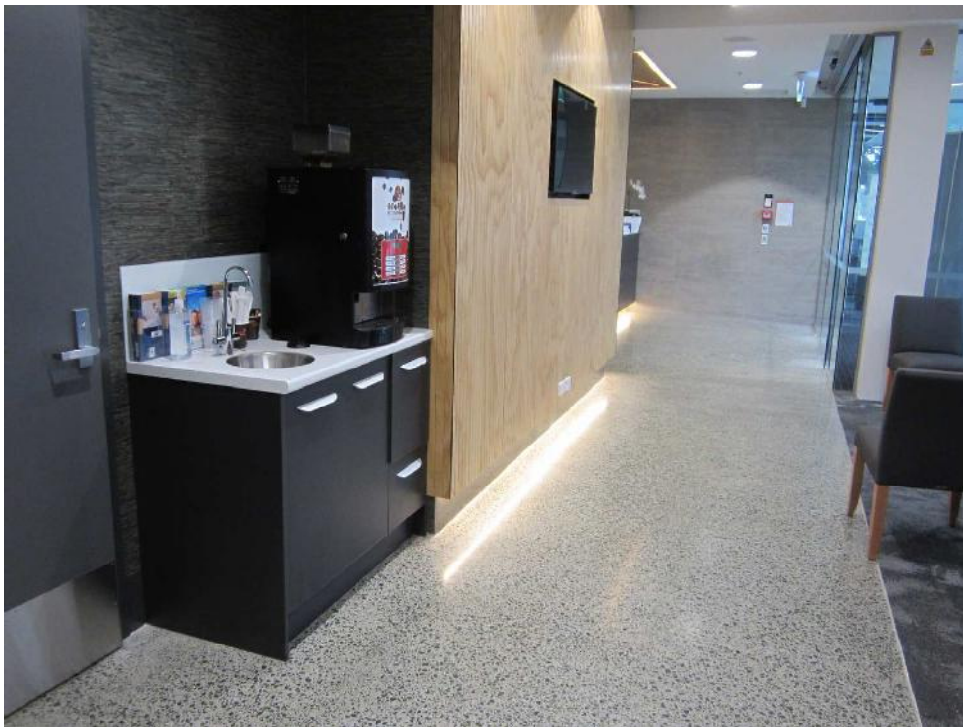
Photo 12: The internal fit-out is highly customised. Internal finishes are in a good condition.

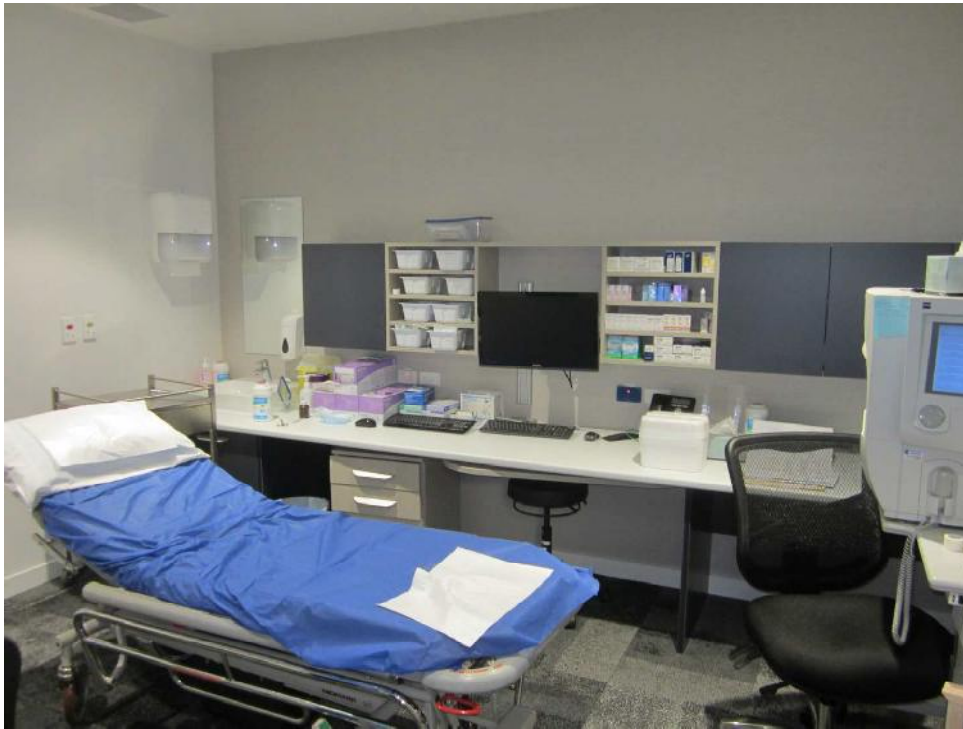
Photo 13: Numerous specialised equipment has been installed by the tenant.

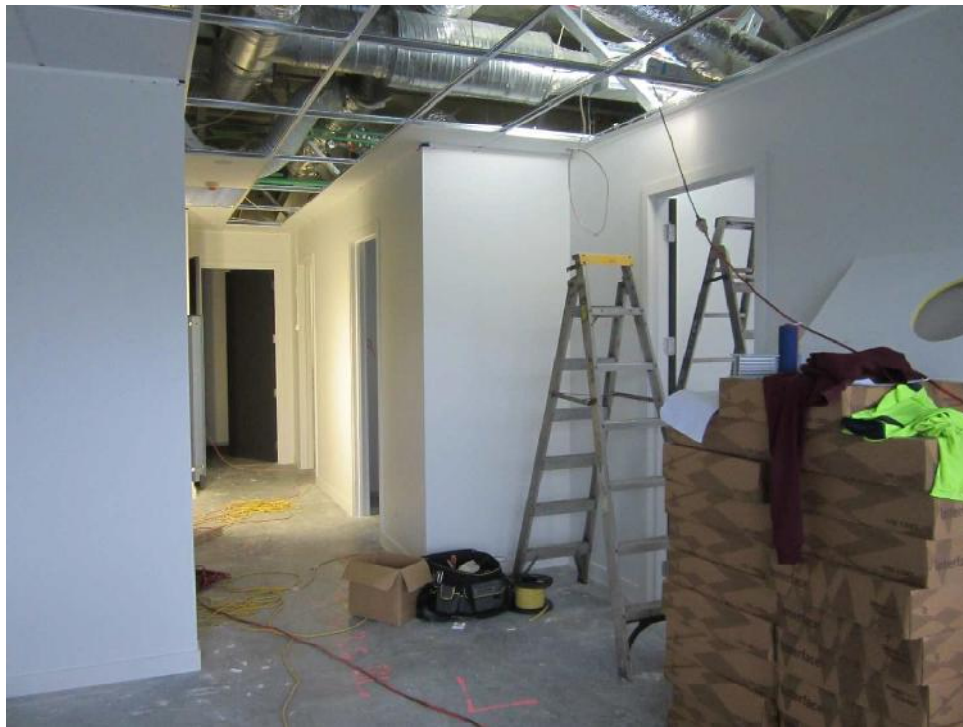
Photo 14: The adjacent unit to the southern end was being fitted out at the time of inspection.

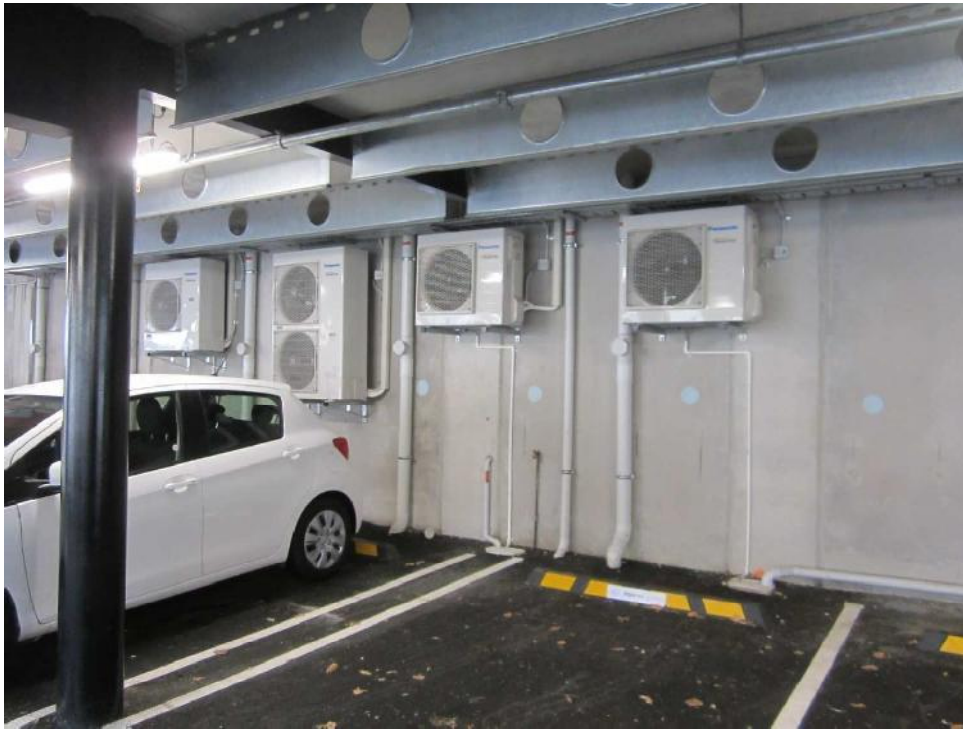
Photo 15: External condenser units located in the wall to the car park provide heating and cooling to internal areas.

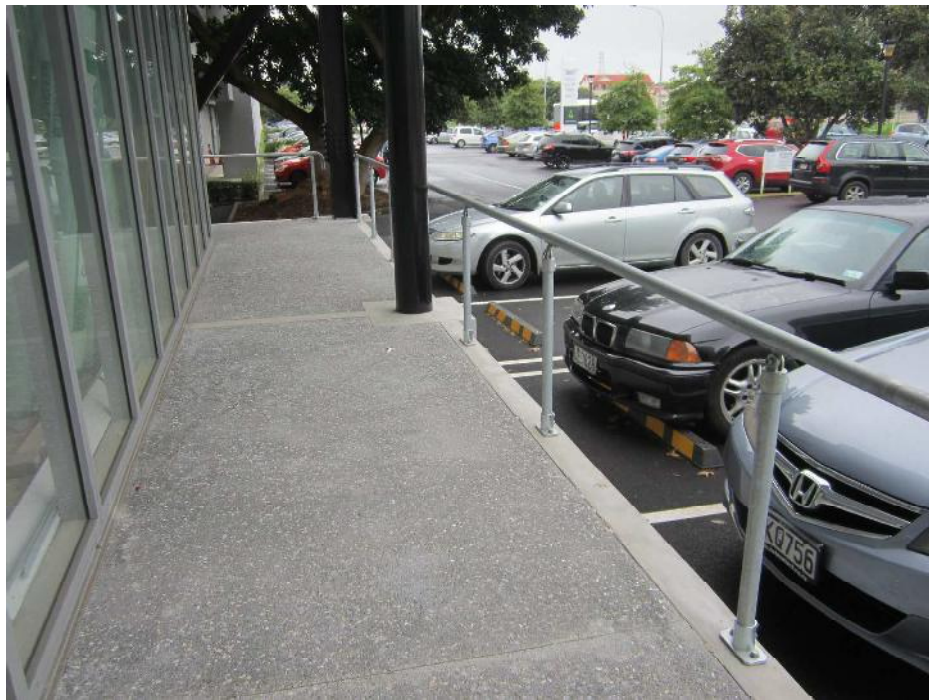
Photo 16: The handrail outside the building does not provide a barrier to children and should be reviewed. An upstand should also be installed to the edge of the ramp for disabled users.

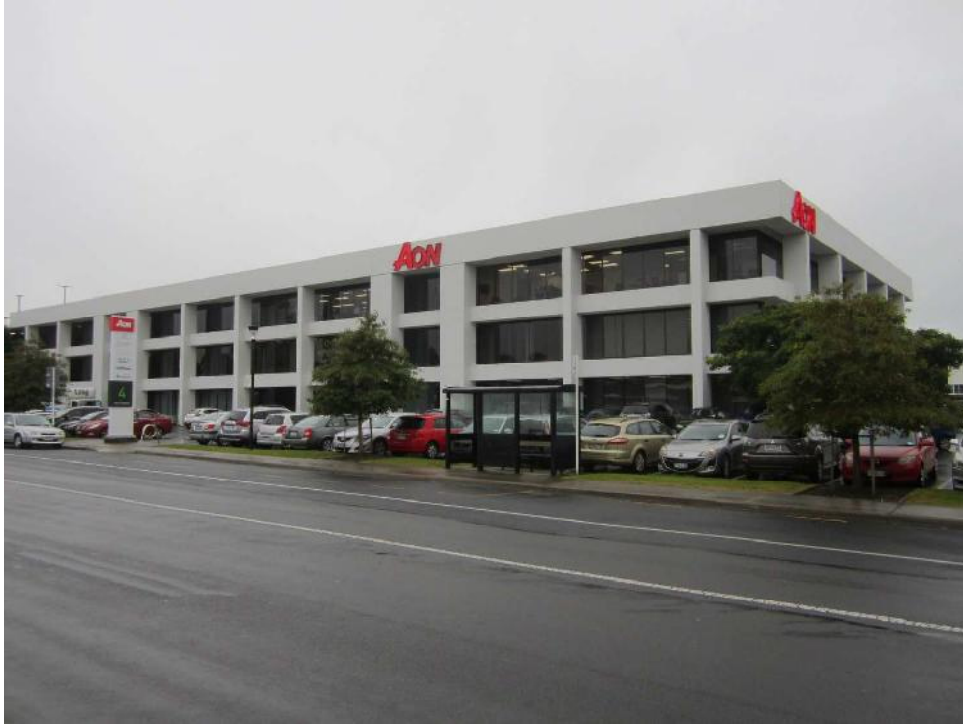
Photo 1: General view of the west elevation.

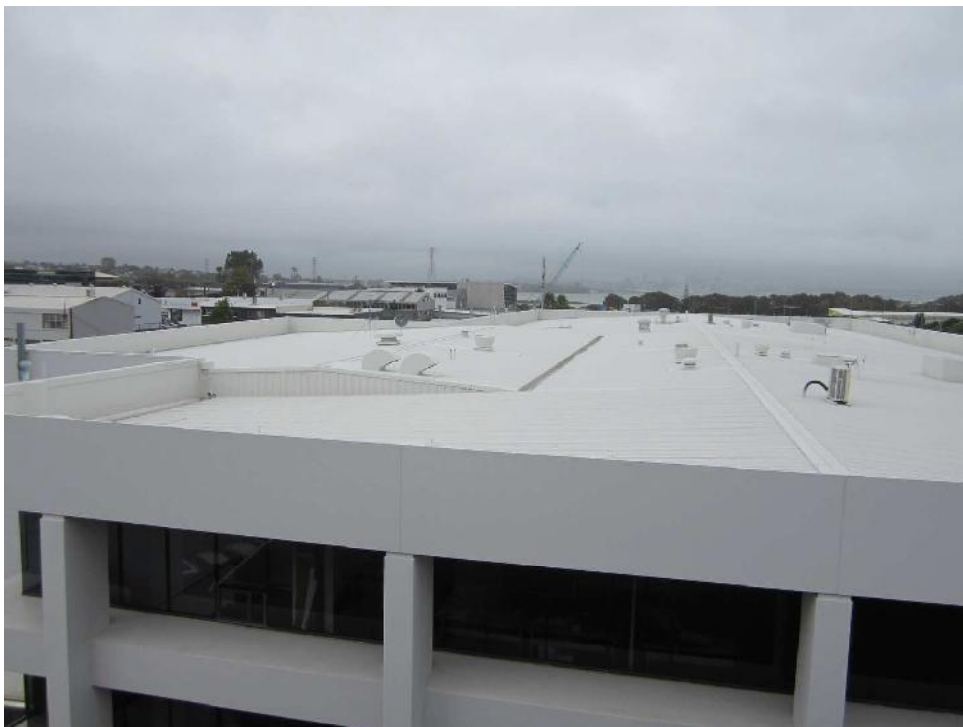
Photo 2: General view of the metal roof covering. The roof has been coated with a spray applied elastomeric coating.

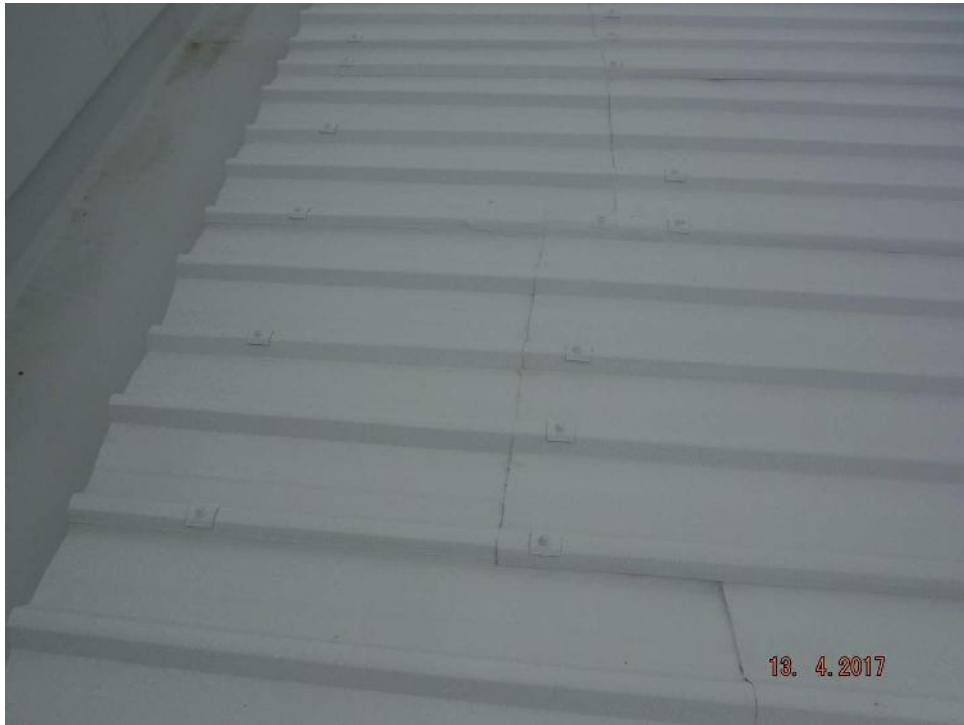
Photo 3: Evidence of previous patch repairs to roof sheets.

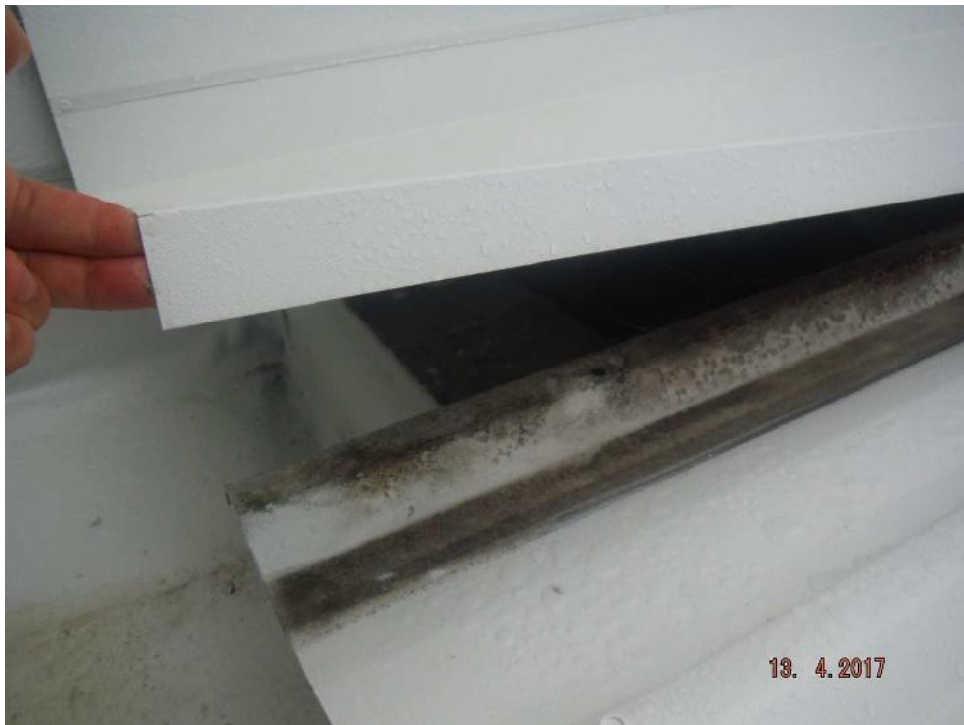
Photo 4: Several loose roof sheets and fixings were noted.

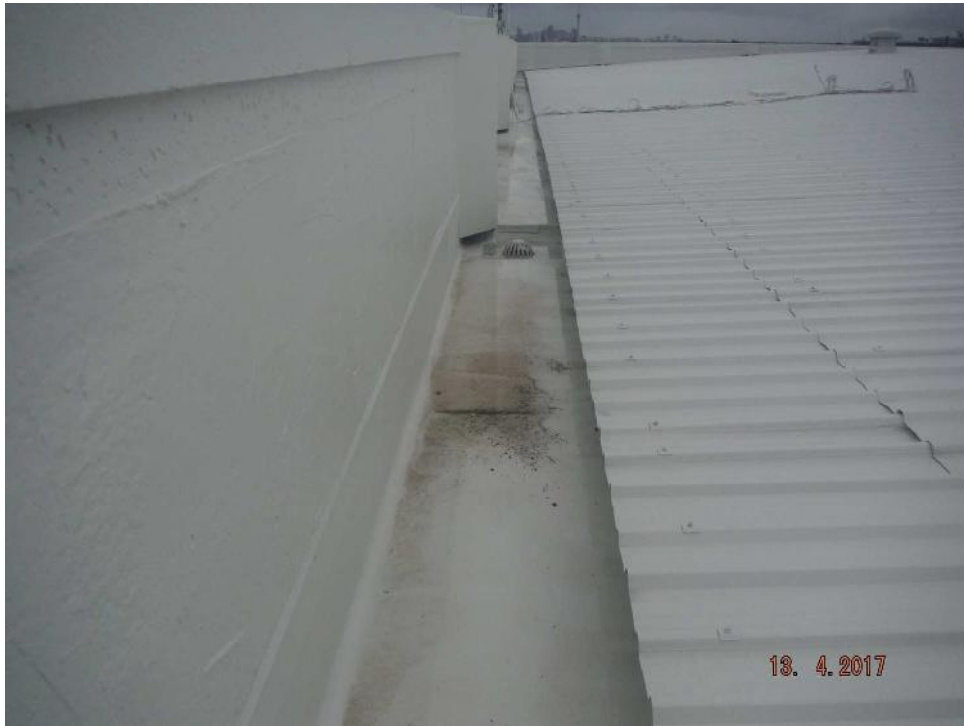
Photo 5: Gutters are formed from timber behind parapet walls and lined with butyl membrane.

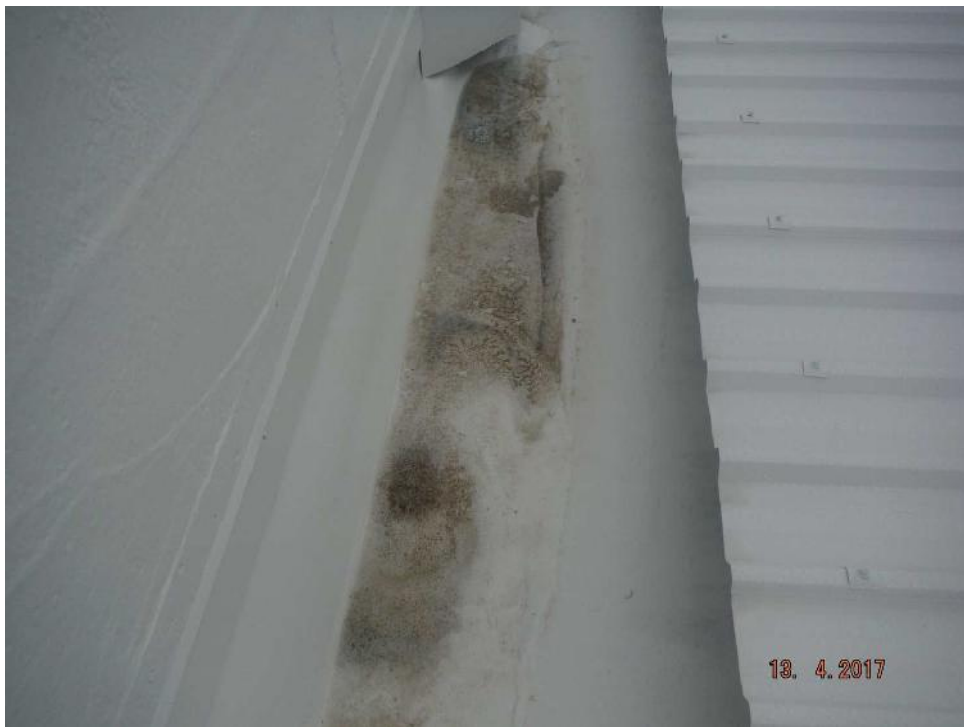
Photo 6: Ponding water evident to the membrane gutter. Bubbling and splits to the membrane were also noted.

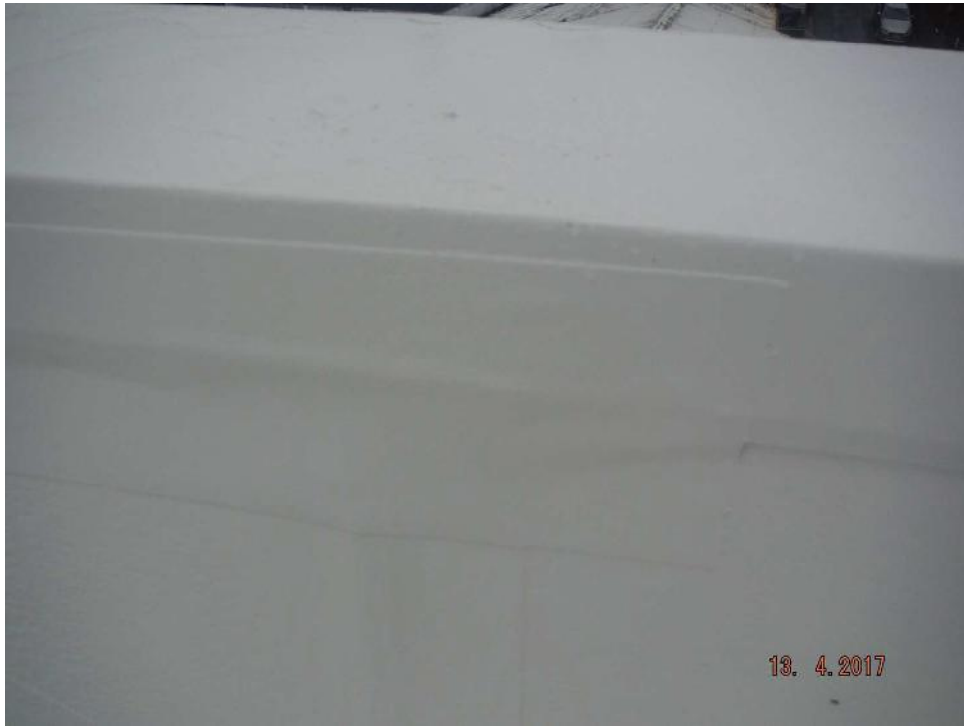
Photo 7: An elastomeric coating has been applied to parapet cappings. Evidence of previous patch repairs using flashing tape.

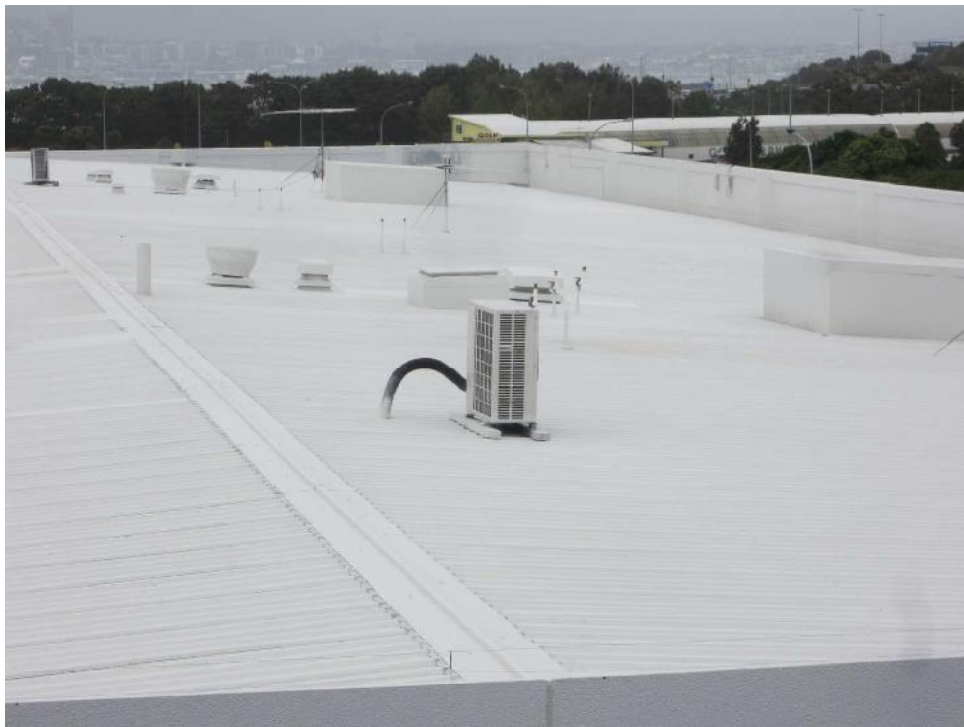
Photo 8: A variety of plant equipment is installed to the roof.

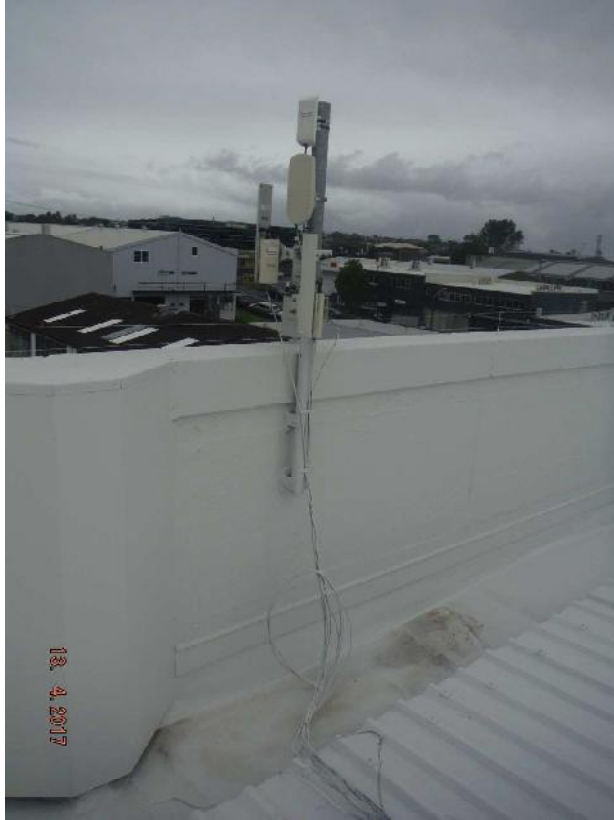
Photo 9: Cabling present to the roof. Any redundant roof items or cabling should be removed.

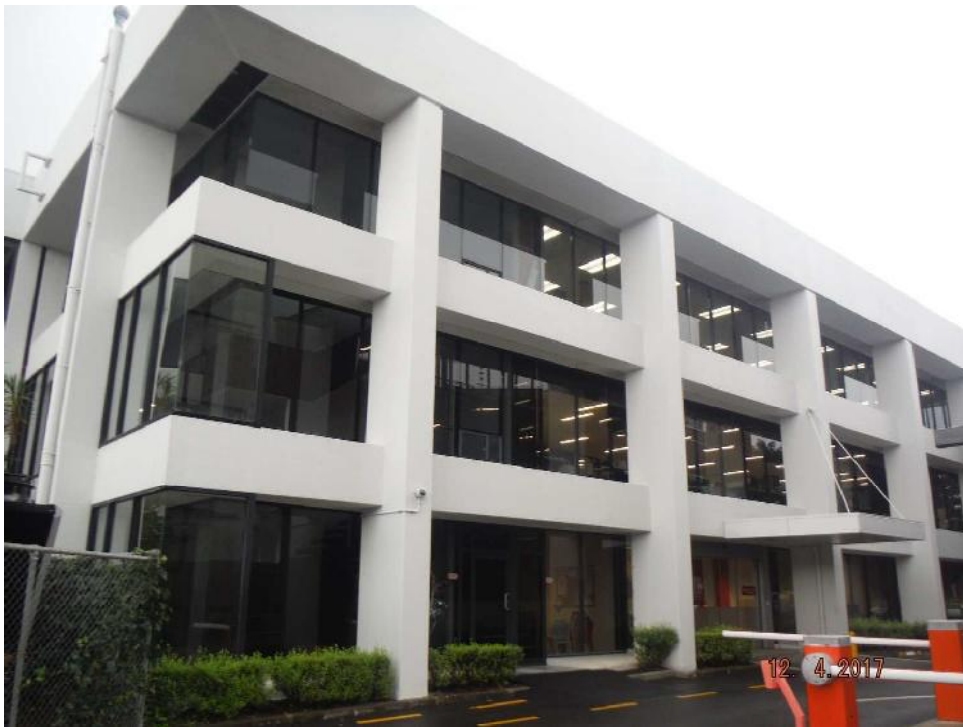
Photo 10: Elevations are finished with brush applied paint.

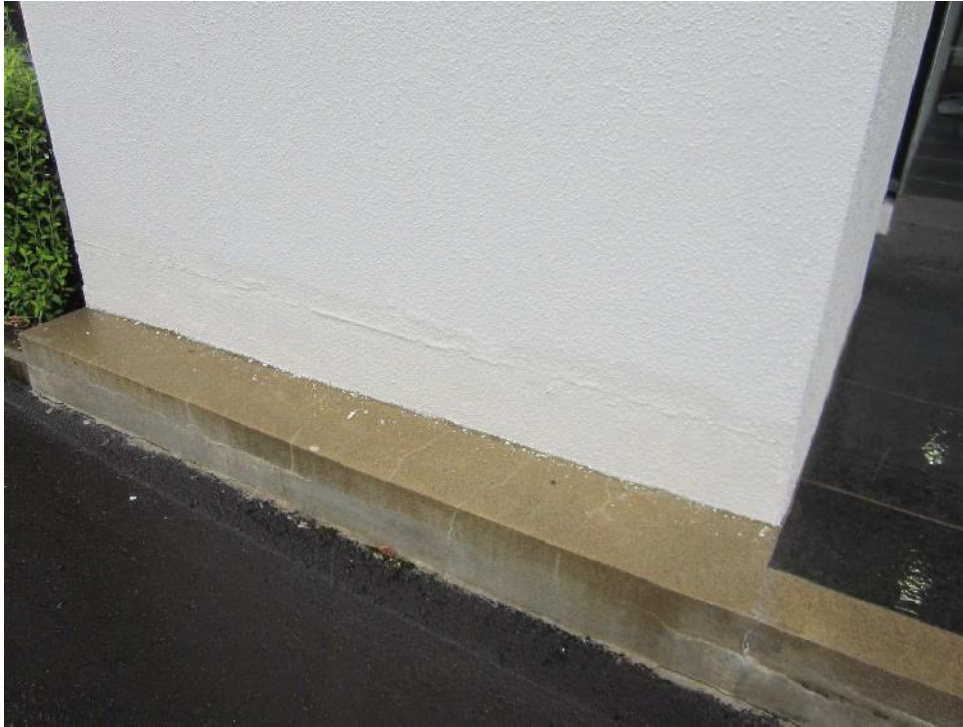
Photo 11: Previous damage to the render has been covered by the latest paint coat.

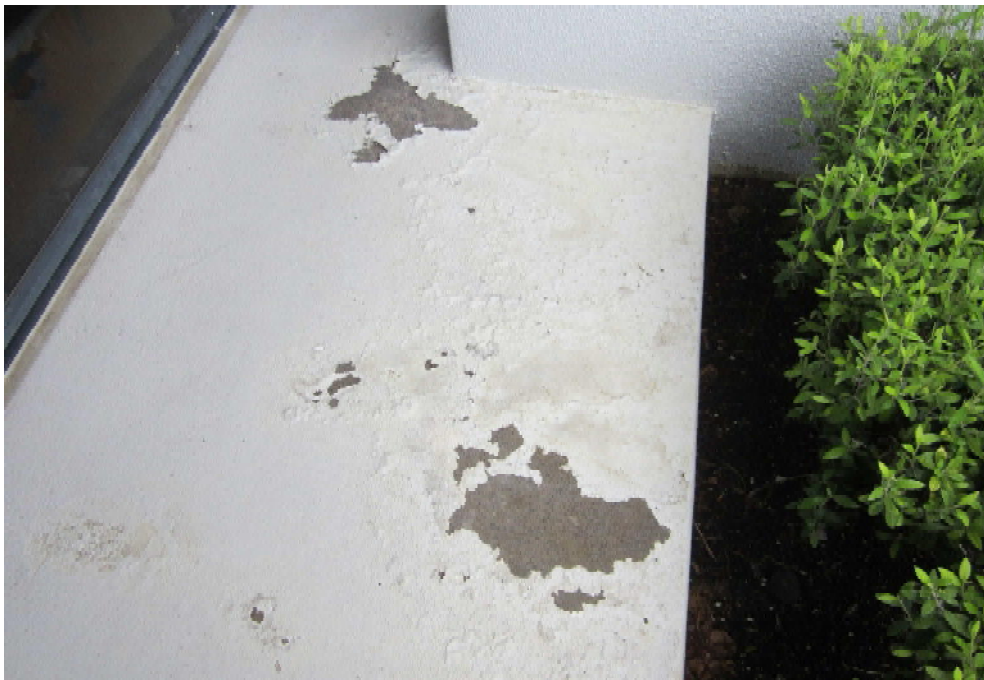
Photo 12: Window ledges are stained from water runoff and the paint surface is flaking. On going redecoration of the paint finish is required.

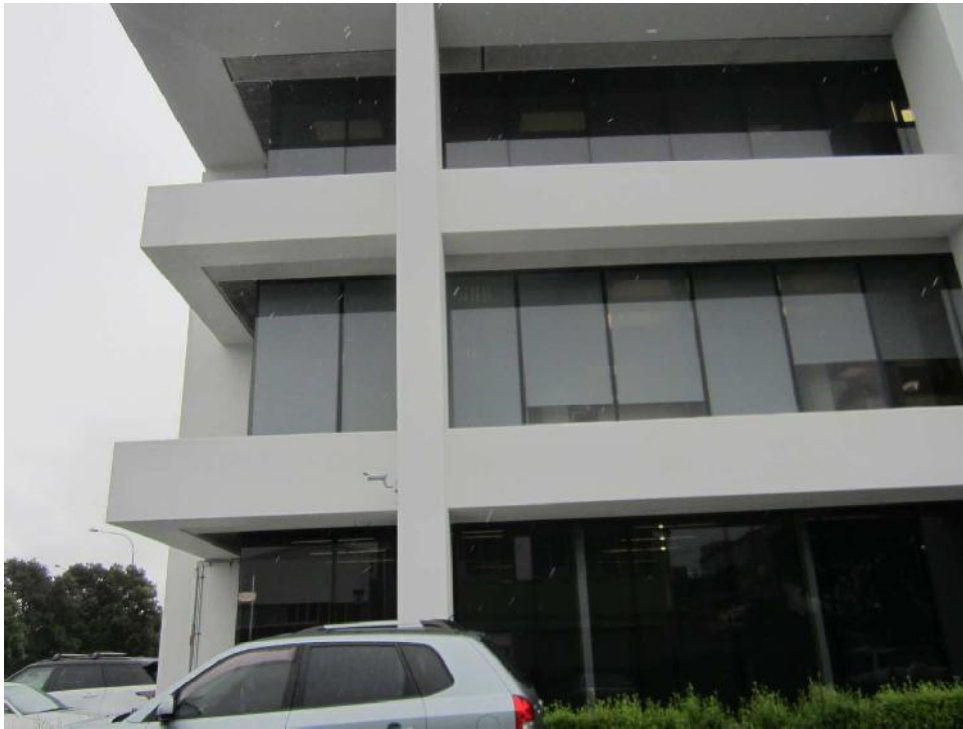
Photo 13: Aluminium framed windows installed throughout are recessed in to the elevation. Shrinkage and hardening of rubber seals was noted.

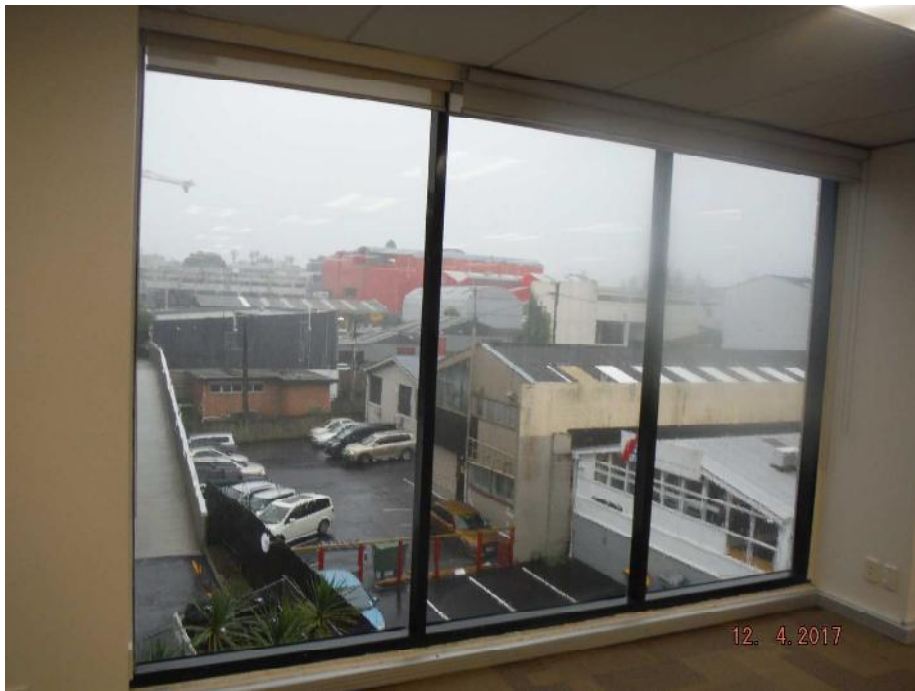
Photo 14: The specification of the full height glazing to the side and rear has not been confirmed. Non-compliant glass should be replaced with safety glass, or barriers should be installed.

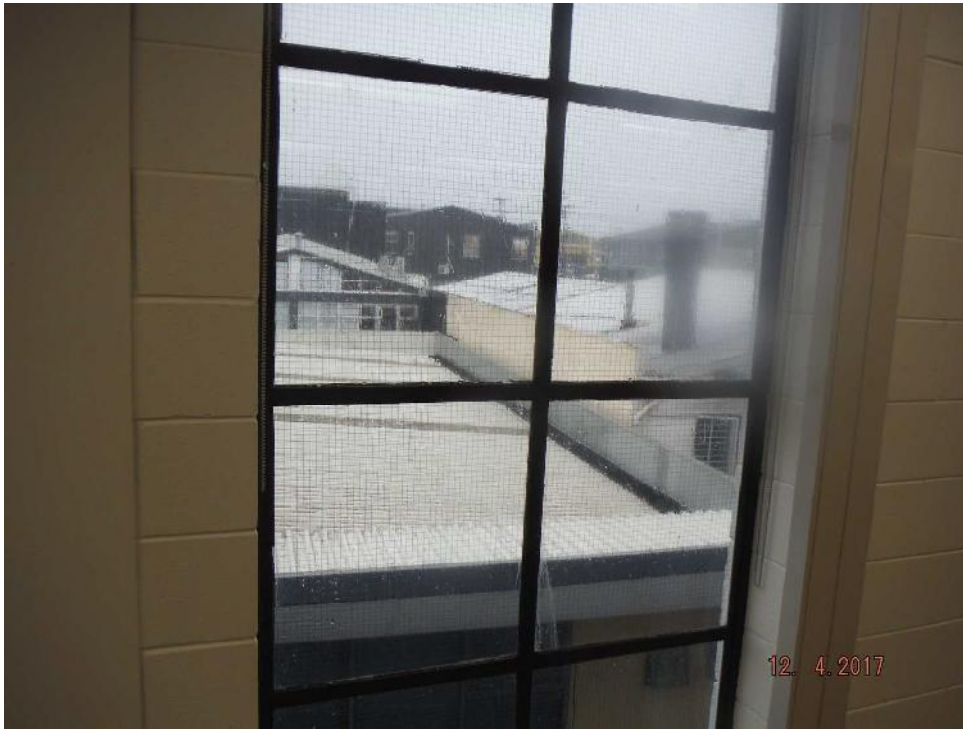
Photo 15: Steel framed windows to the rear elevation of level two are in a poor condition.

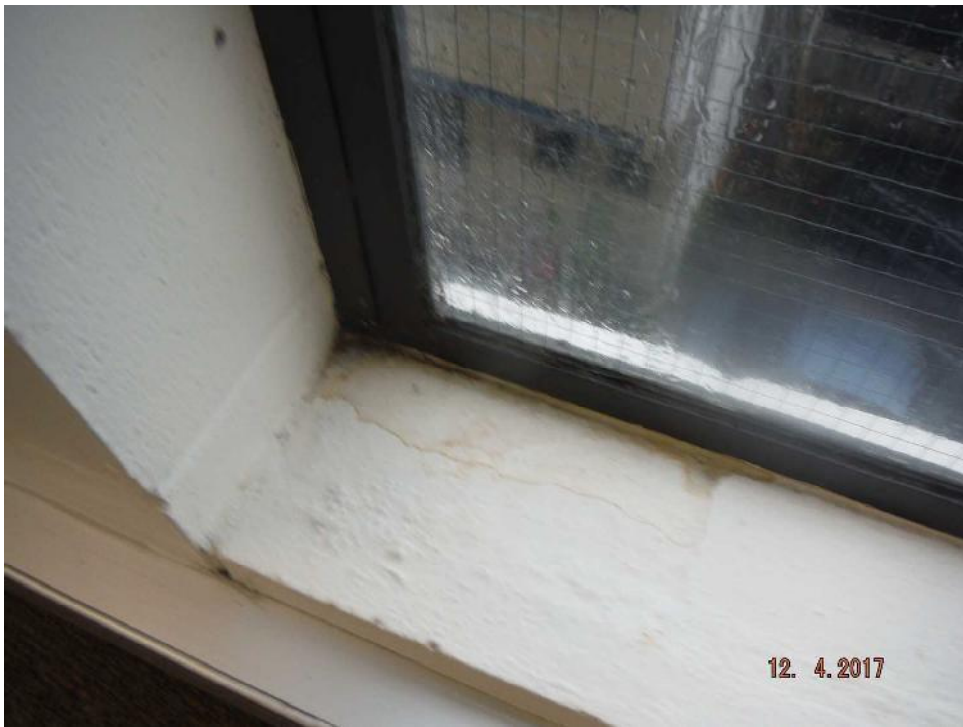
Photo 16: Water staining present to sills internally.

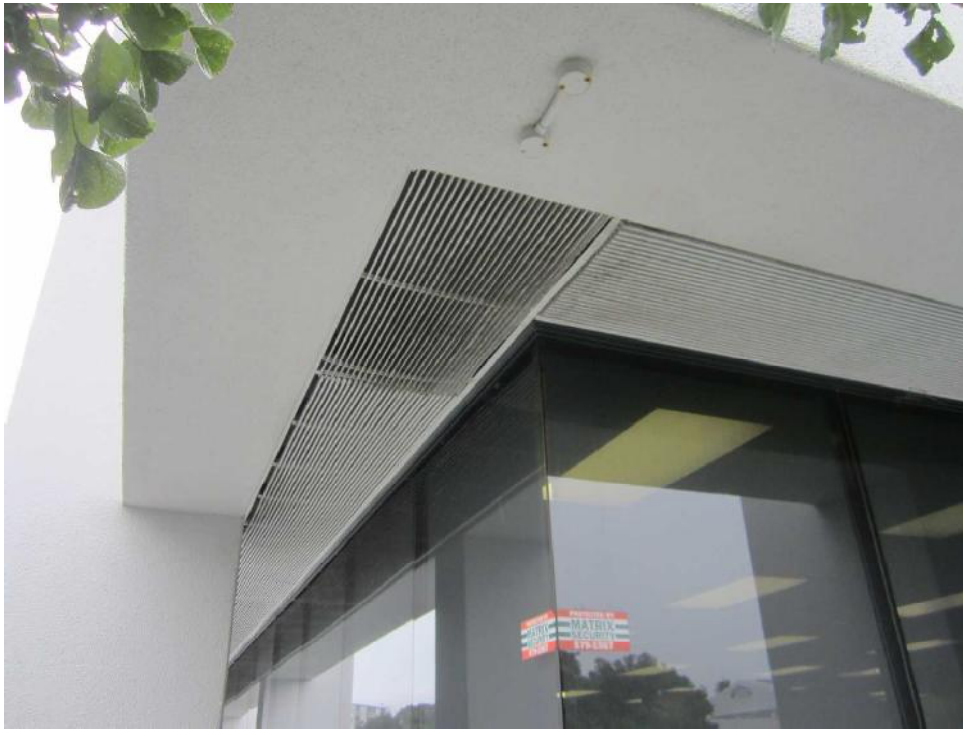
Photo 17: Soffit vents are installed to the perimeter of the building at each level. Grilles protecting the vents are missing in several locations.

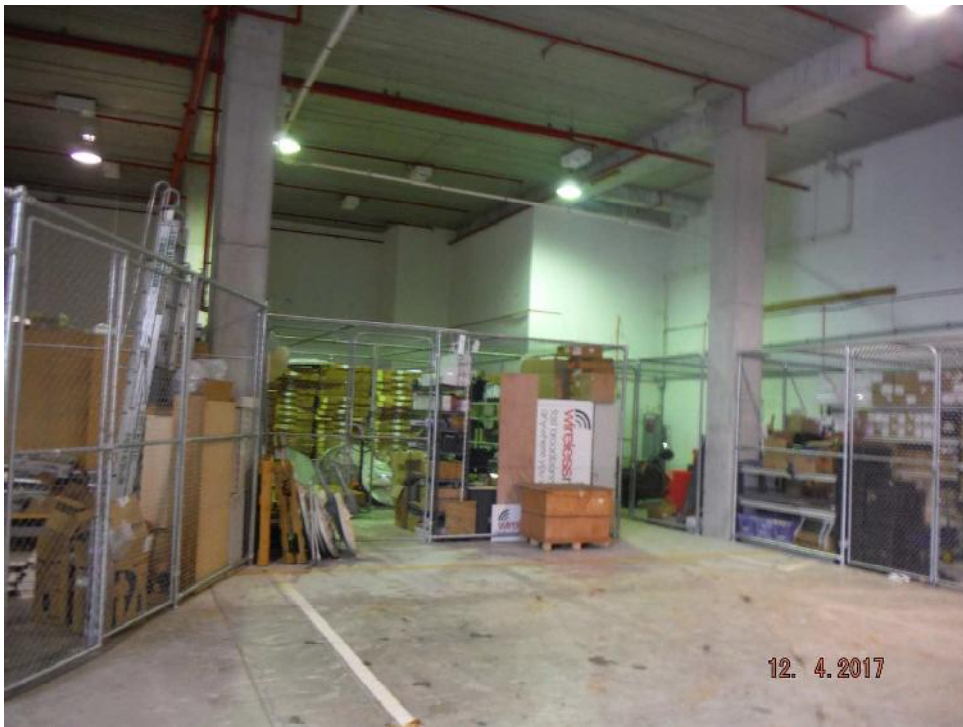
Photo 18: General view of the warehouse storage area.
