# Technical Due Diligence Report

For and on behalf of  
**CENTURIA FUNDS  
MANAGEMENT (NZ) LIMITED**

196 Roydale Avenue  
Christchurch

**MAY 2021**  
**P21-0103**

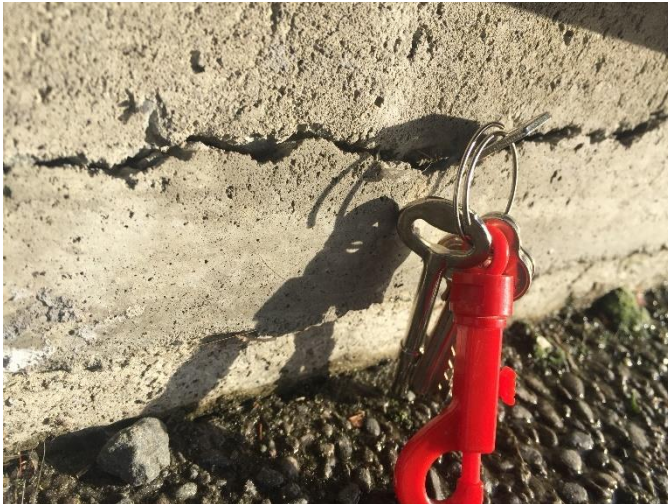
Photograph 2

6.3.1 The building structure is generally in good condition and no adverse observations were made. We would, however, reiterate that there is a slight concern over the ground floor concrete slab cracking to the right-hand side of the south elevation. There are no defects noted in any other area, either internally or externally, however at the time of our site inspection there was some fairly heavy equipment undertaking some deep bore holes to the adjacent site on the south side of the site.

Suspect crack within the concrete floor slab to the right-hand side of the southern elevation, externally.

5.13.1 It is recommended that further investigation is carried out to the below ground drainage system and a review of the ground conditions generally, given the cracking noted to the floor slab to the south / east corner of the building.

6.4.1 We would recommend further investigation to the above area is undertaken in conjunction with the review of the separate Geotech / ground condition report prepared by others.

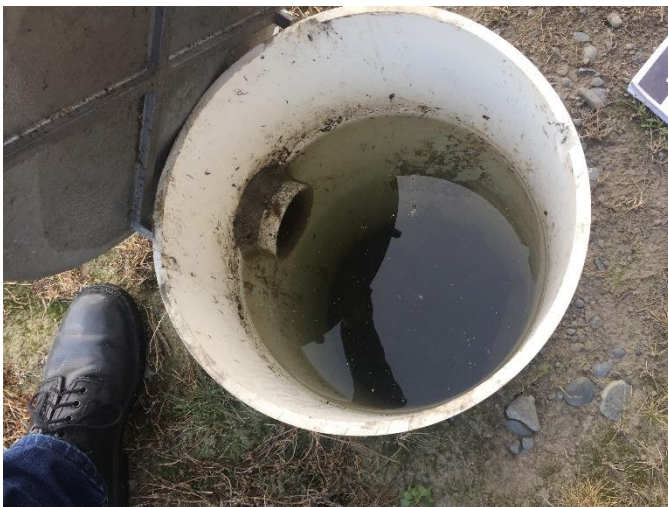
Photograph 3

7.1.1 A non-intrusive visual inspection was undertaken from a building surveyor's perspective. There were no issues encountered other than the potential backing up of the surface drainage system and given the suspected cause of this, construction material build up, the below ground plumbing drainage as well.

Drainage system appear block and is backing up.

7.2.1 We would recommend that the entire drainage system is inspected and reviewed by a specialist, to confirm whether there are any issues present.

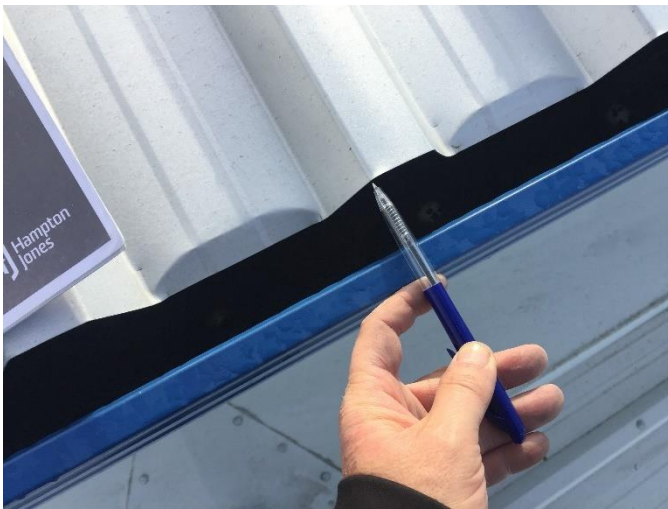
Photograph 8

Limited access to clear out gutter.

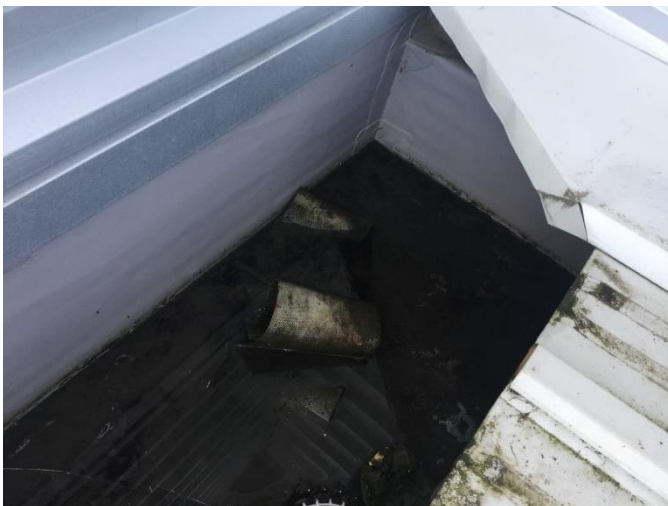
Photograph 9

Debris and ponding water within the main roof gutters

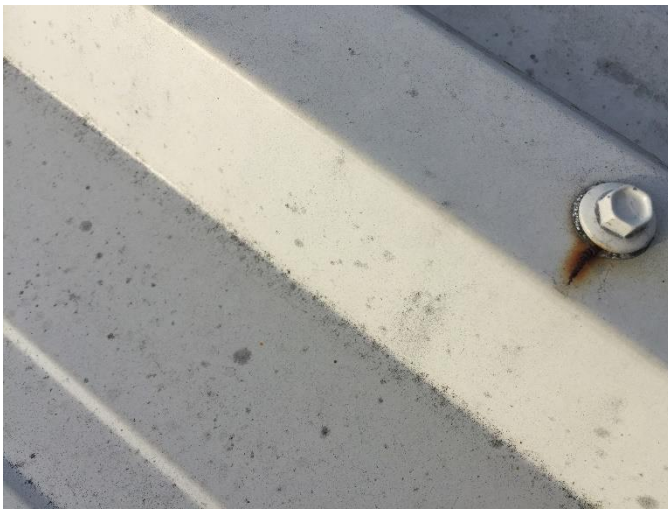
**Photograph 11**

The commencement of corrosion around a roof sheet fixing

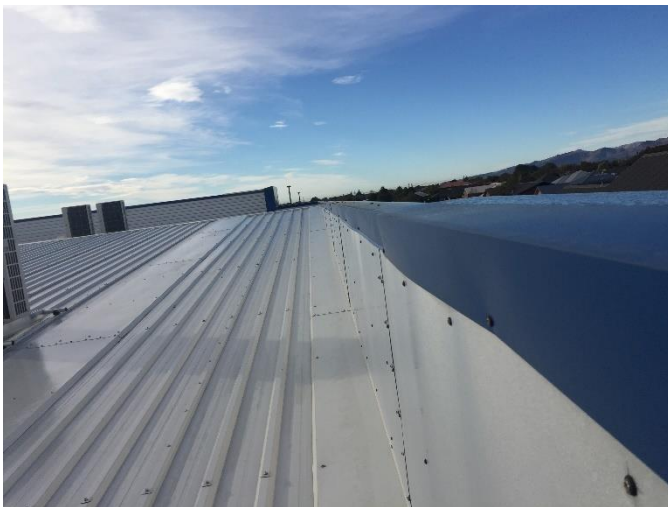
Photograph 14

The colorsteel parapet cap flashing was designed to sit at a fall, but in some instances the constructed fall is incorrect

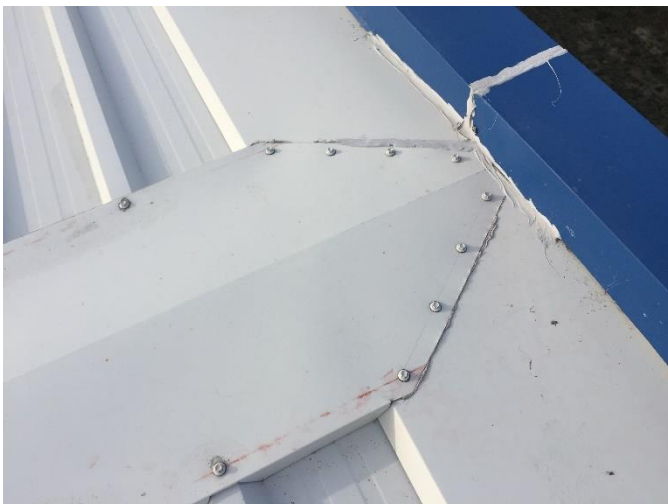
Photograph 15

Apparent retrospective mastic repairs to roof sheet / flashing joints. Should only be deemed as a temporary repair though. No evidence to the underside of any issues

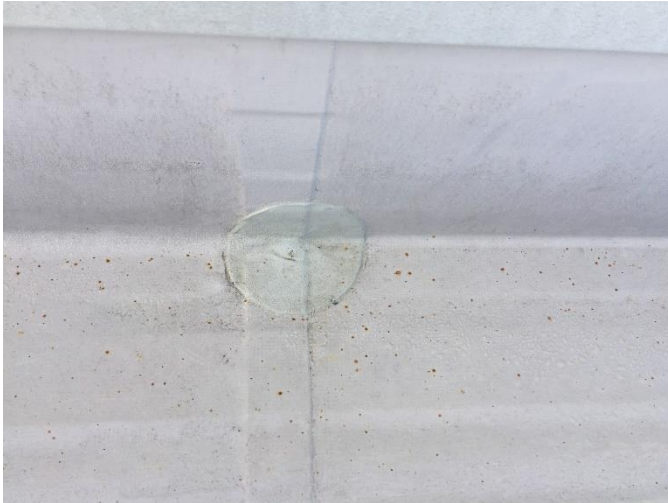
**Photograph 16**

Apparent retrospective repair to the TPO within the gutter. Repair is acceptable and no evidence internally was noted

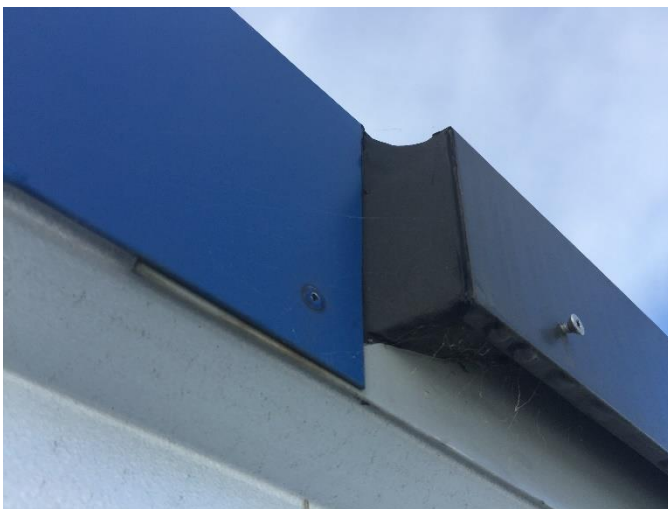
**Photograph 17**

A rather large gasket / mastic infill joint, between differing cladding members. This will have a limited life expectancy

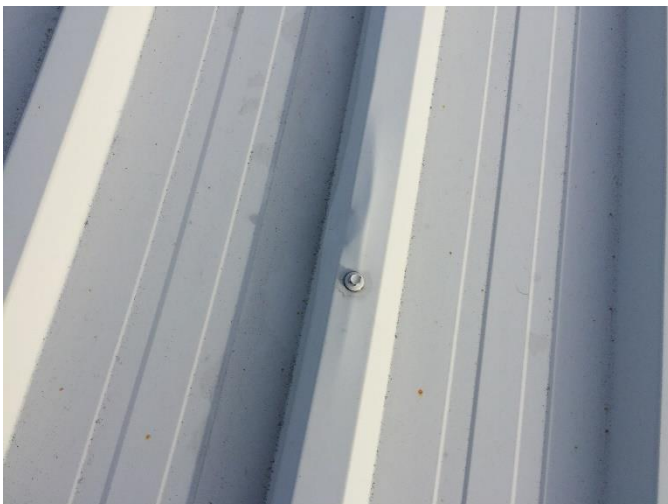
**Photograph 18**

Impact damage, presumed from foot traffic to the roof sheets

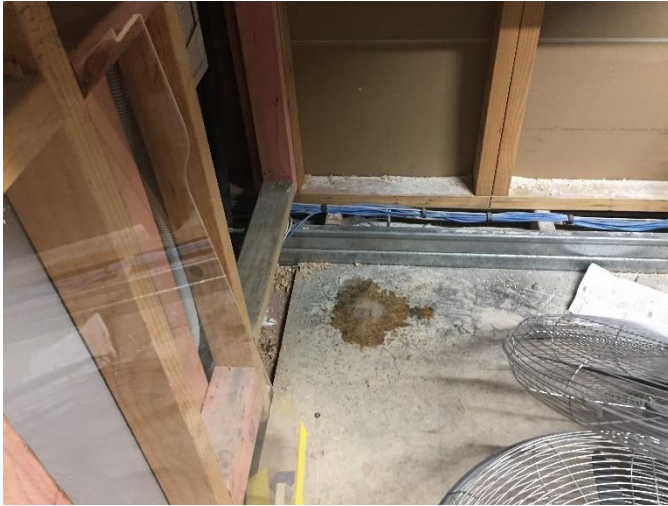
Photograph 25

The above air conditioning duct is leaking

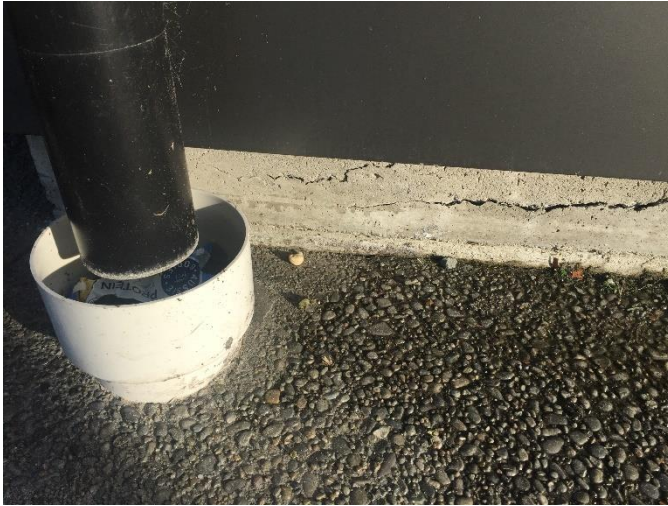
Photograph 40

Location of the suspect crack to the concrete floor slab on the south elevation

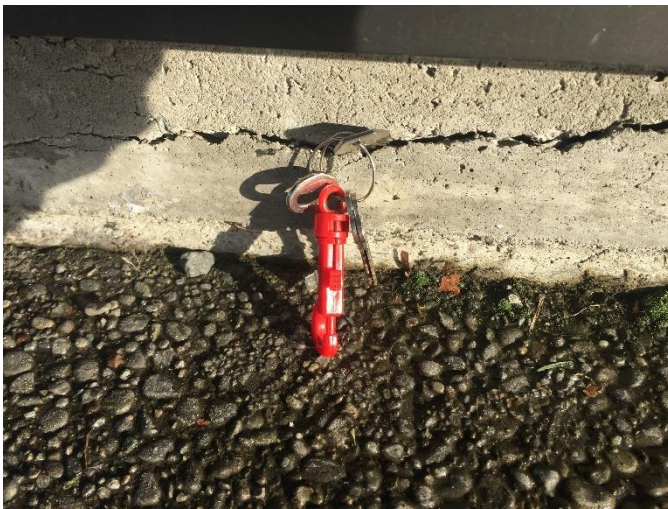
Photograph 41

Representation of the crack in terms of depth

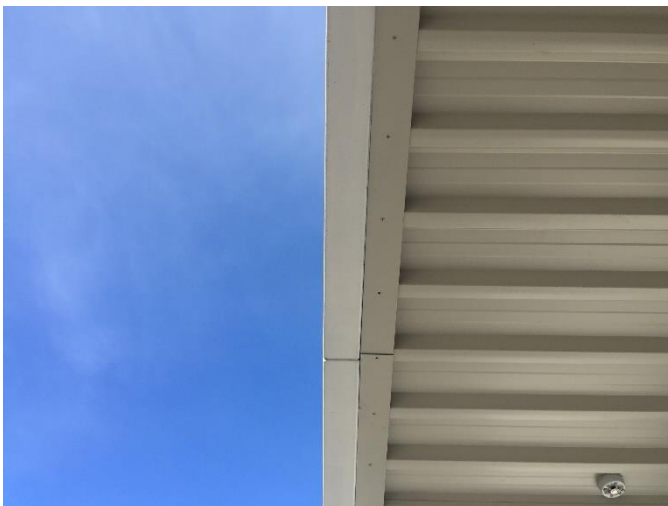
Photograph 42

Minor corrosion spotting beginning to painted metal soffit

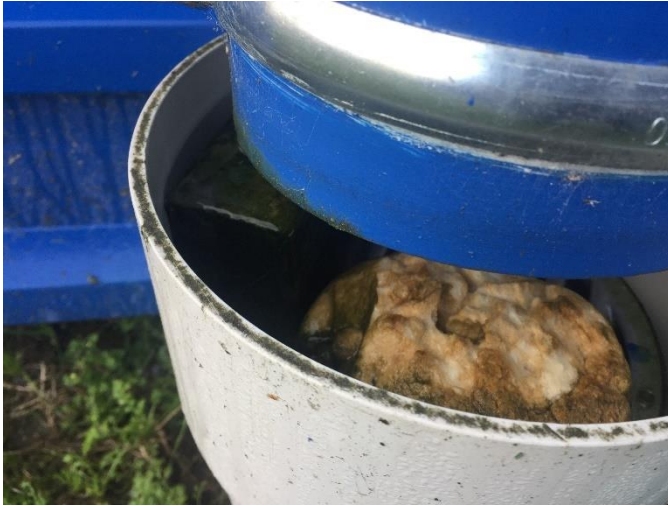
Photograph 46

Example of debris found within the drainage system. Apparent foam core cut out, potentially left over from original construction

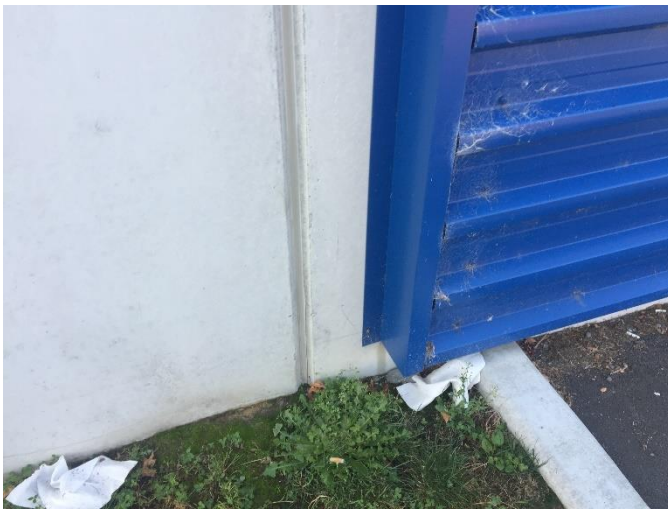
Photograph 47

Interaction of metal cladding and concrete panel

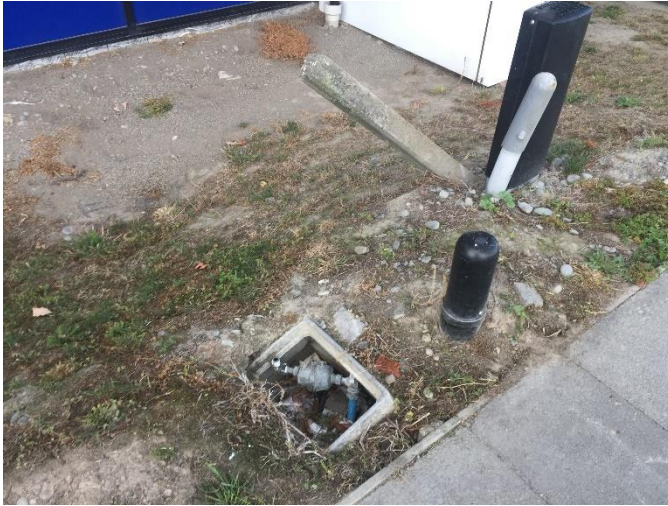
Photograph 52

Potential vehicle damage

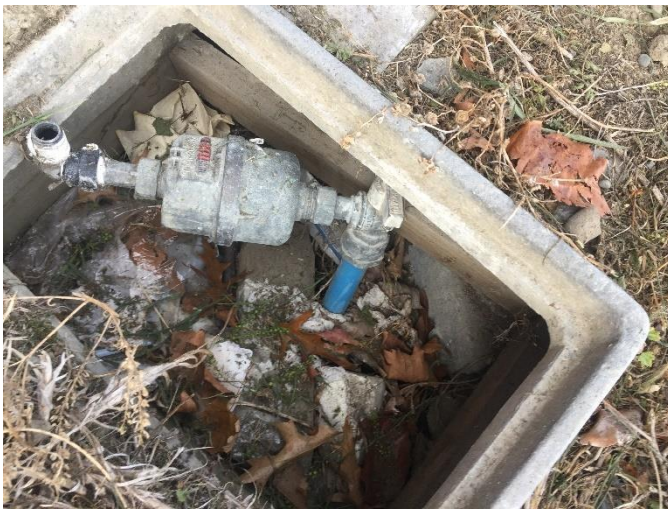
Photograph 53

Water meter and housing potentially damage by a vehicle

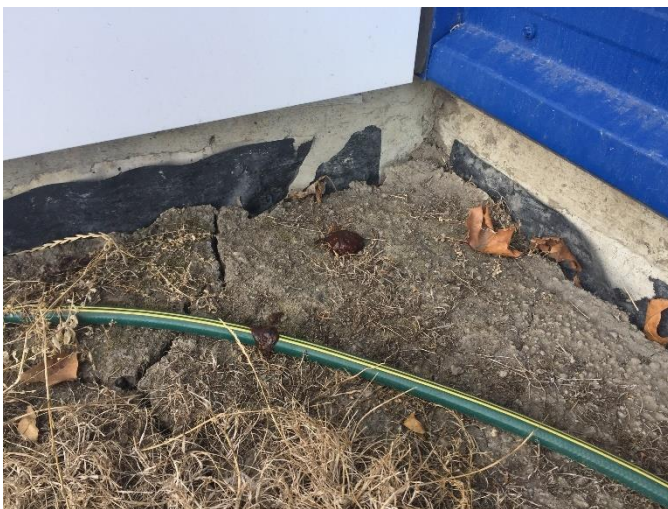
Photograph 59

Section of deteriorating waterproofing membrane, as above

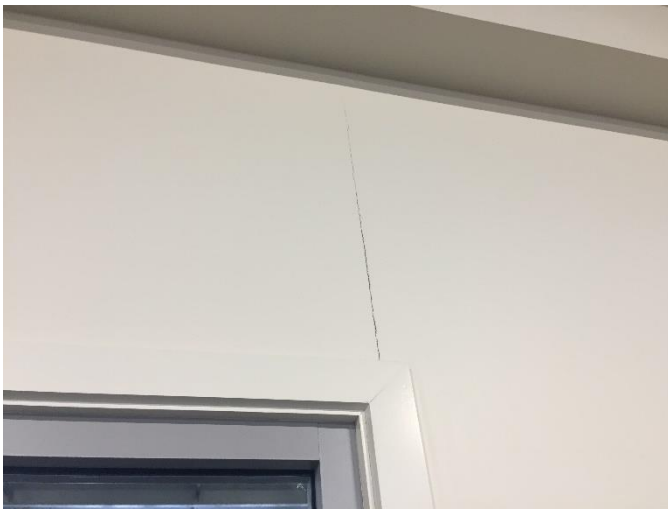
Photograph 77

Minor crack to plasterboard lining of internal partition
