Land Information Memorandum

Property address:
1/347 Moorhouse Avenue

Moorhouse Central Seismic Capacity and Earthquake Damage Assessment

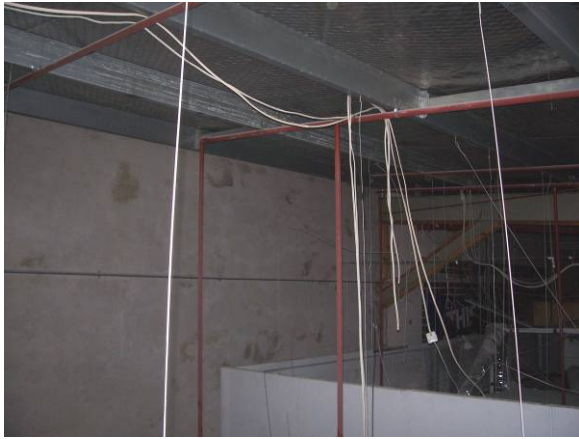
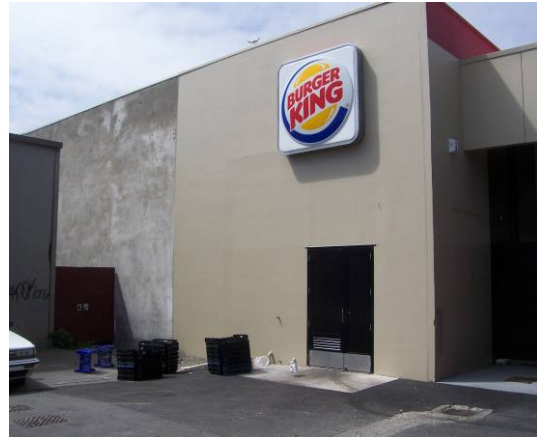
We have not obtained structural drawings for this building. But from limited observation in the attic area (left photo above), it appears to be an extension of the main building structure, with north-south lateral loads supported by the same steel frames. The canopy façade is supported by steel trusses on concrete columns. The concrete panel north wall is shared with Countdown (again left photo above), the west wall is concrete panel, and the south and east walls are framed and partially glazed.

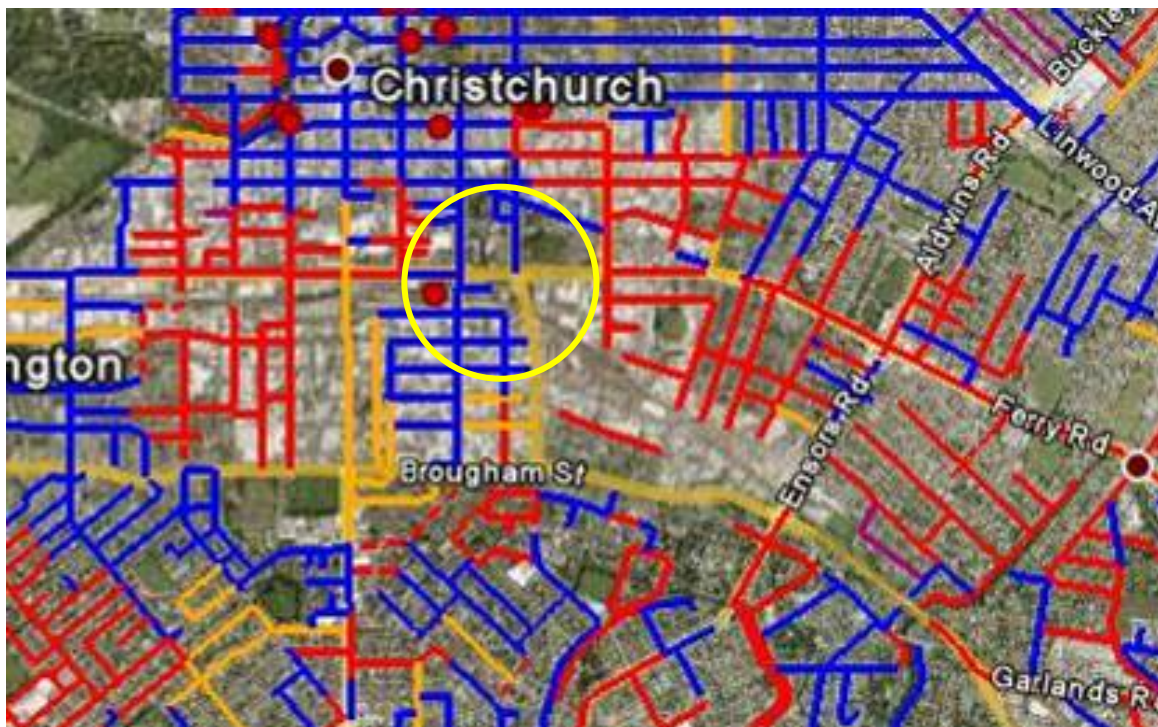
There appears to have been very little liquefaction at this site, consistent with the University of Canterbury record reproduced below.

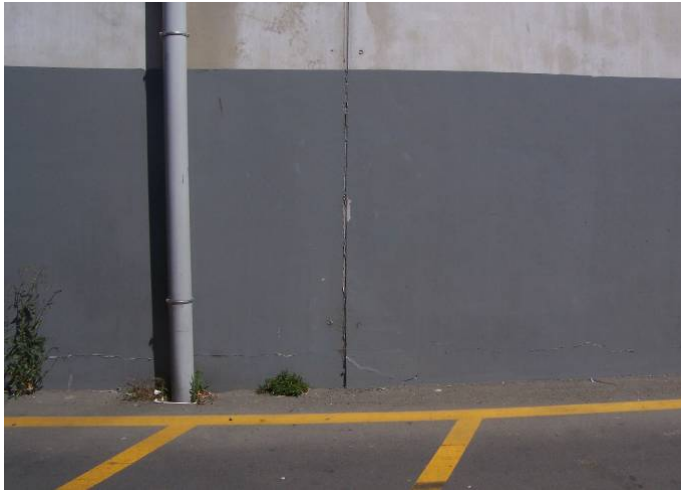
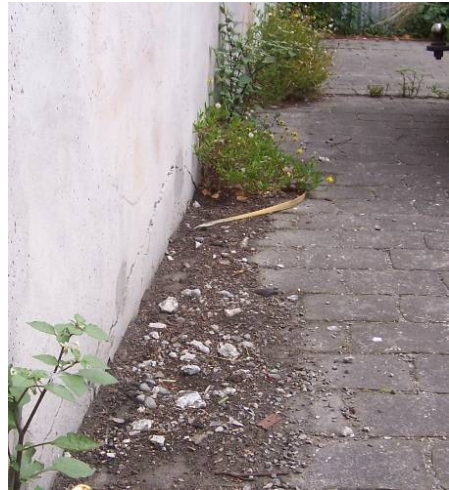
Countdown: The exterior of the precast concrete wall panels appear largely unaffected by all events. On the north wall there is some minor opening of joints, and a fine crack, apparently along the line of the floor slab surface. On the west wall there is one small crack at the bottom of one panel.

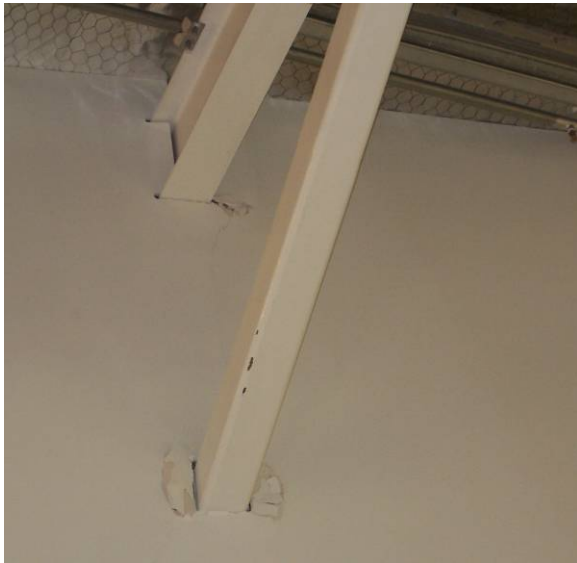
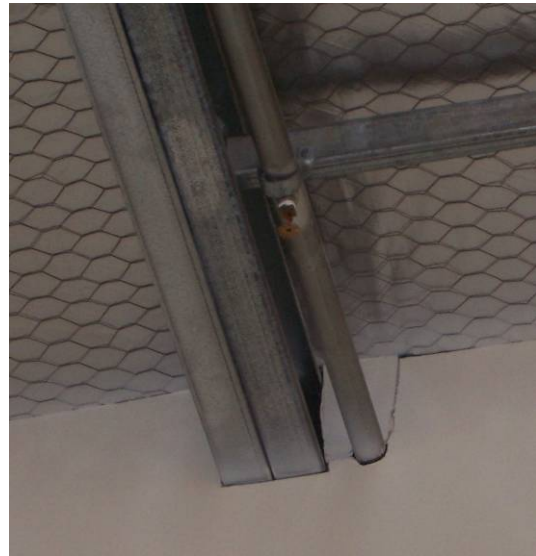
Around the interior walls of the supermarket there are a number of cracks and crushings of the gib-board lining where structure or services penetrate the walls.

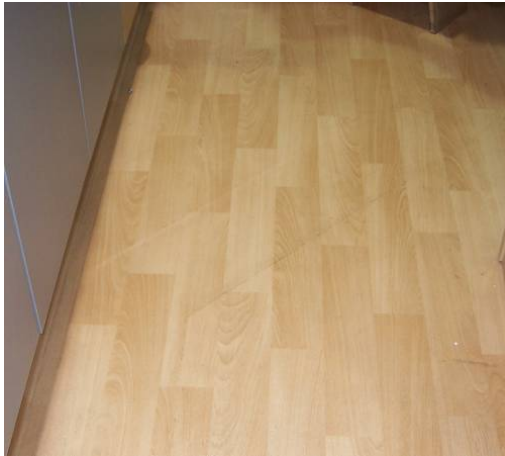
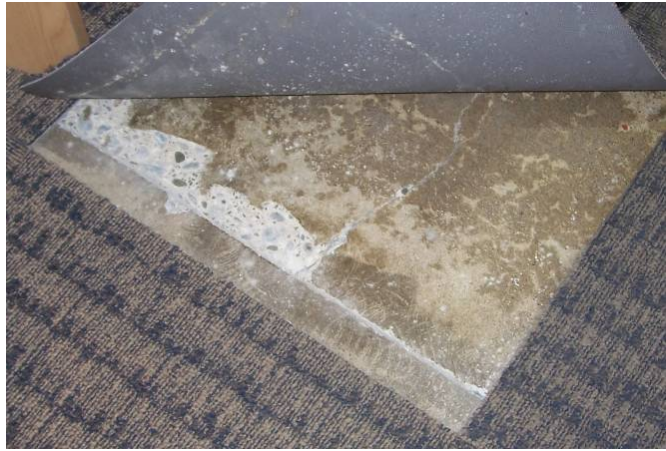
Food Court (& Pharmacy): The floor slab has undergone some movement, particularly at service duct locations, and apparently at construction/control joints – both in the pharmacy and along the

shop frontage line of the food court. Generally floor coverings conceal the extent, but the damages appear to be minor.
