Red Flag Condition Report

For and on behalf of
**CENTURIA FUNDS
MANAGEMENT LIMITED**

146 Shands Road
Hornby
Christchurch

**NOVEMBER 2024
P24-0230**

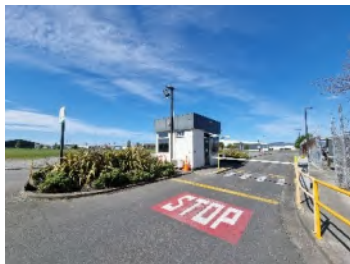
1. View towards security entrance showing vehicle barrier arm and painted markings to hardstanding.

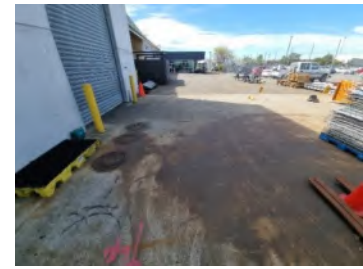
6. Area of staining to the hardstanding to the southwest.

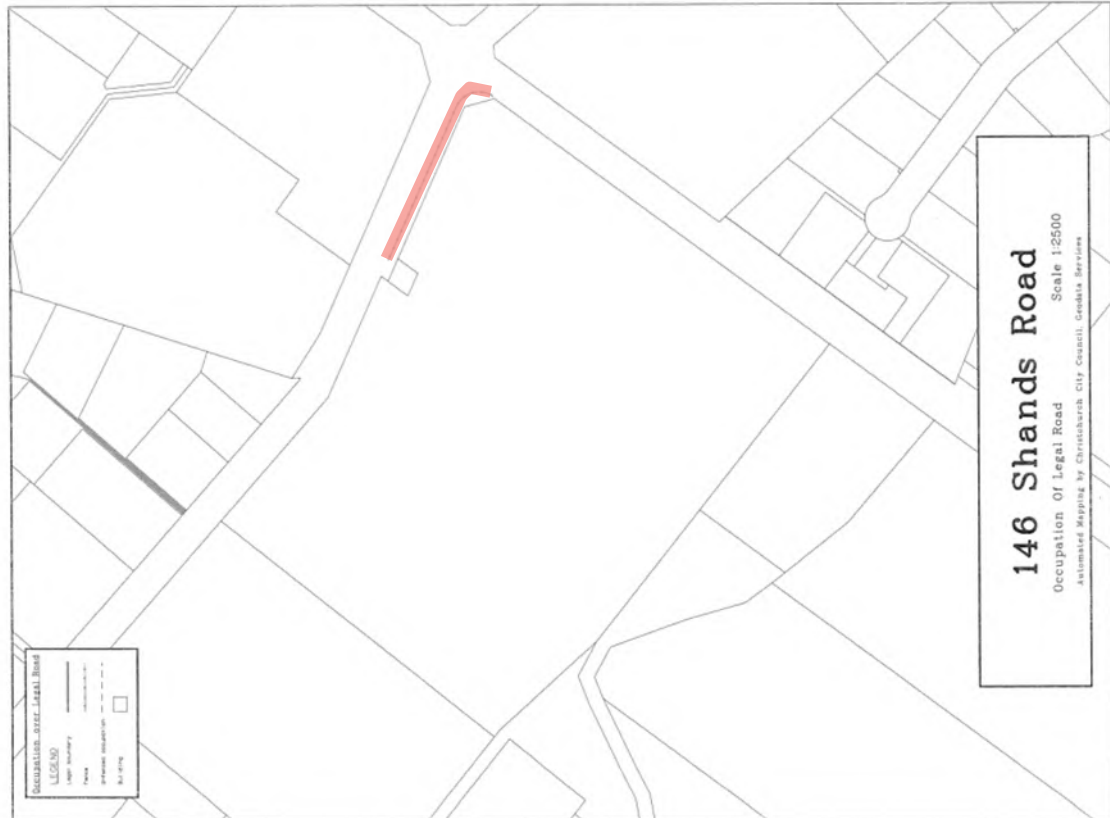
7. The area highlighted in red denotes fencing which, in 2009, was reportedly located on council owned land. Image is an extract from LIM70104302.

Code	Ref	Defect	Recommendation	Timescale (yrs)	Approximate Cost
●	2.3.2	The LIM report dated 05/03/2009 notes that fencing was reportedly located on council-owned land (to the east of the site, along Halswell Junction Road) and it was therefore requested that the fencing be relocated.	Confirm whether this work has been undertaken. Allow for relocation of fencing should works not have been completed as requested.	1	\$15,000

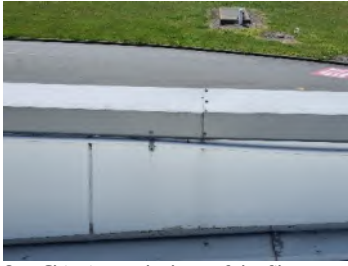
8. Chipping to the base of the fibre cement cladding to the parapet walls.

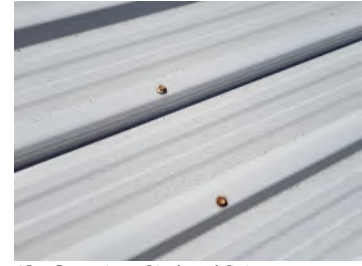
10. Corrosion of isolated fixings.

- 4.1.4 Isolated fixings to the office roof are corroding and require replacement.
- 4.1.5 The flashings to the perimeter of the roof have been poorly detailed and are sealed against the building using sealant. This is not a long-term solution, and, over time, moisture can penetrate the building at these junctions as the sealant deteriorates.

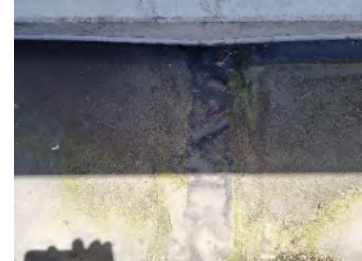
13. The butyl membrane to the internal gutter appears to have been patch repaired at laps. Staining indicates ponding may be occurring and that run off is not always directed towards outlets.

●	2.5.6	Hairline cracking through concrete pre-cast panels.	Allow to fill cracks in concrete with epoxy solution.	3	\$2,500
●	2.5.7	Typical deterioration and patch repairs to the internal membrane guttering of the lower office roof.	Allow to uplift membrane covering and replace in the medium to long term. Rectification of the fall to the substrate may be required in the long term (10+ yrs).	8	\$5,500

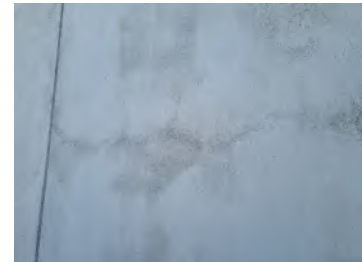
16. Hairline cracking to the exterior of panels observed to the southeast and southwest panels.

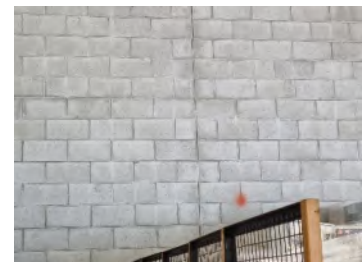
19. Splitting to the flexible seal along the control joint within the northwest fire wall (internal view).

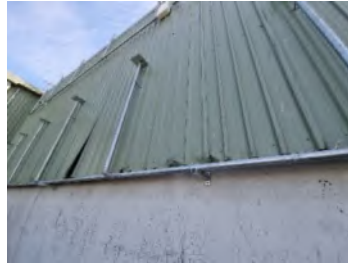
21. Detaching panel and impact damage to the base of panels to the partial southeast panels and length of the northeast panels.

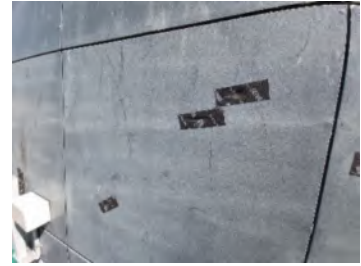
22. Impact damage to the fibre cement panels to the southeast elevation of office.

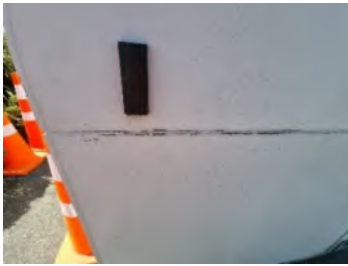
23. Deterioration of the cladding and painted finish at the horizontal expressed joint of the cladding.

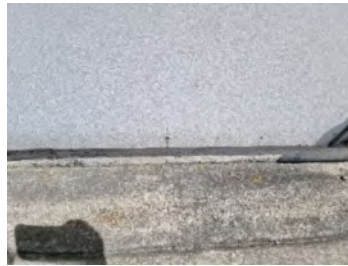
24. Cracking to the fibre cement panels of the security office, adjacent to fixings.

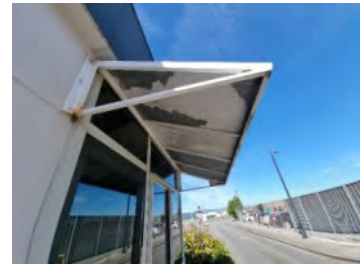
25. Corrosion of the metal framing and deterioration of the painted finish.

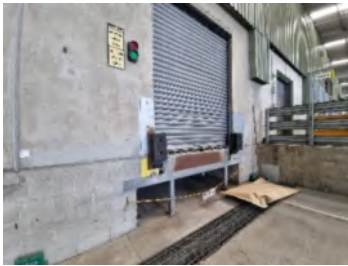
26. Example of dock roller shutter door and barriers.

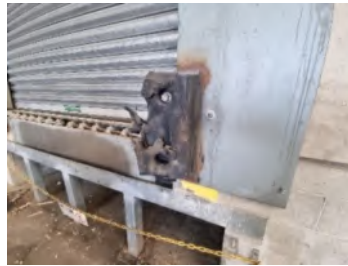
27. Deterioration of the rubber buffers.

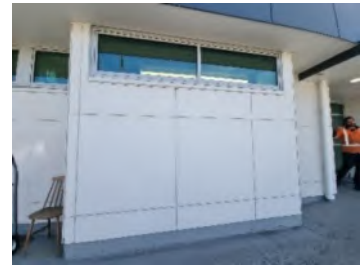
28. Example of single glazed window joinery.

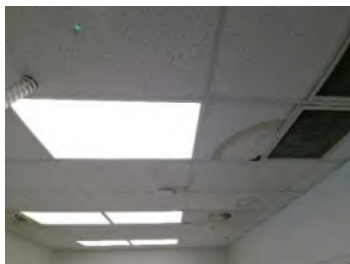
29. Moisture staining to the ceiling tiles of the ground floor office.

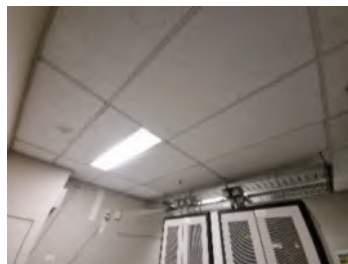
30. Ceiling tiles within server room are in a reasonable condition.

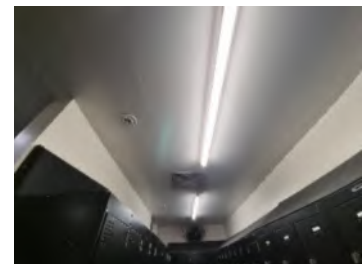
31. Plasterboard ceilings to locker room, corridor and toilet areas are in good condition.

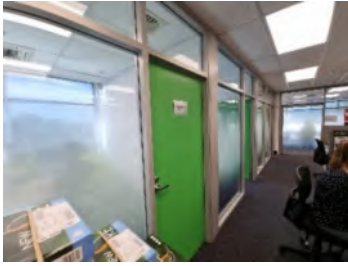
32. View of glazed partition walls.

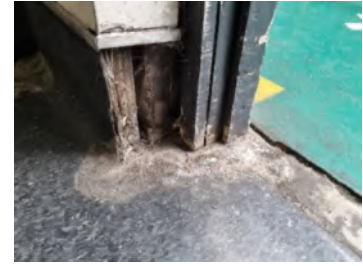
34. Isolated area of damage wall framing and lining adjacent to warehouse door between toilet corridor and warehouse.

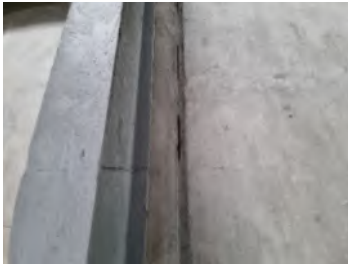
35. Openings within the flexible sealant between panels.

Code	Ref	Defect	Recommendation	Timescale (yrs)	Approximate Cost
●	2.7.2	Openings within the flexible seals between concrete pre-cast panels.	As noted in exterior.	1	\$0
●	2.7.3	Hairline cracking through the concrete pre-cast panels.	As noted in the exterior.	3	\$0
●	2.7.4	Cracking and chipping to the concrete slab, adjacent to the armoured movement junctions.	Further input is required from a structural engineer to establish the cause of the cracking to the slab within the extension and severity of cracking along the movement junctions within the original warehouse area.	1	\$2,000

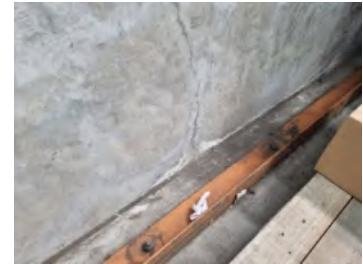
37. Hairline cracking and efflorescence surrounding cracks within pre-cast concrete panels.

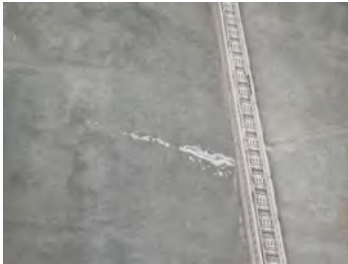
38. Hairline cracking and efflorescence surrounding cracks within pre-cast concrete panels.

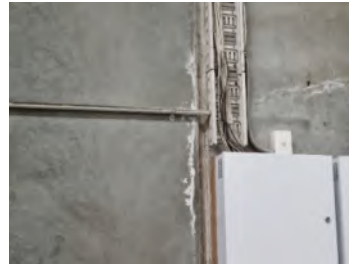
39. Hairline cracking and efflorescence surrounding cracks within pre-cast concrete panels.

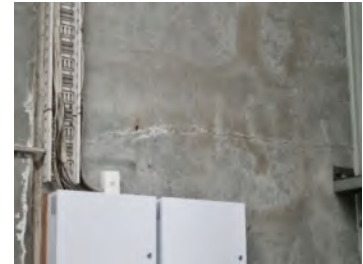
40. Hairline cracking and efflorescence surrounding cracks within pre-cast concrete panels.

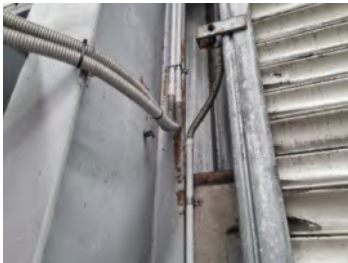
41. Isolated area of surface corrosion to the steel structure.

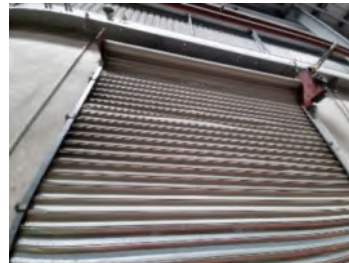
42. Typical view of roller shutter doors from interior. Doors are in a reasonable condition.

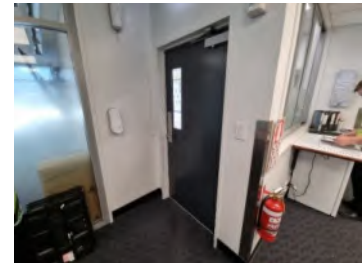
43. View of internal timber door. Internal timber doors are in a reasonable condition.

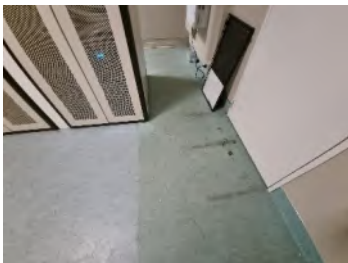
44. Sheet vinyl within the server room is worn.

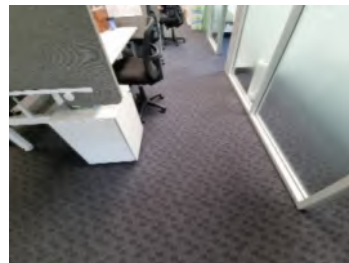
45. Carpets are worn but in a reasonable condition.

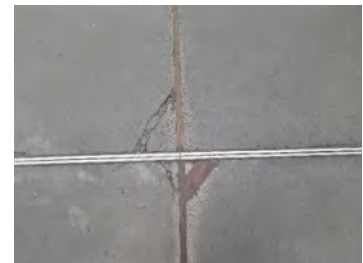
46. Cracking observed to the concrete slab flooring of the warehouse, adjacent to movement joints within extended section of warehouse.

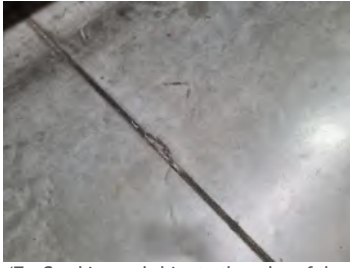
47. Cracking and chips to the edge of the concrete floor adjacent to the control joint.

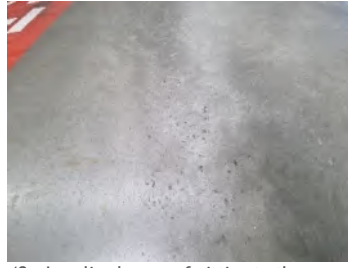
48. Localised areas of pitting to the surface of the concrete slabs within the warehouse (both the original and extended areas of the warehouse).

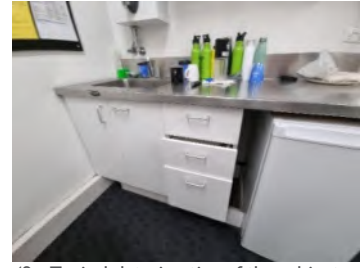
49. Typical deterioration of the cabinetry to the office kitchen.

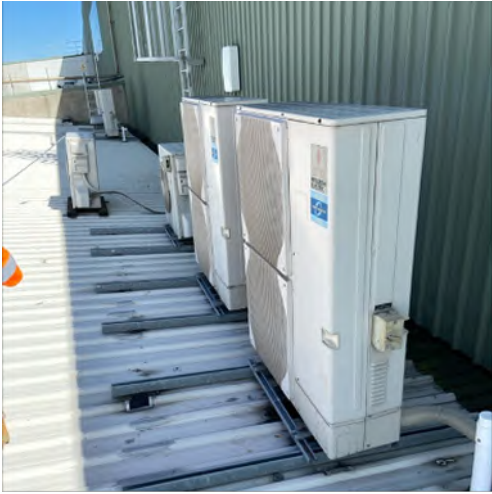
<p>Typical split system outdoor units.</p>

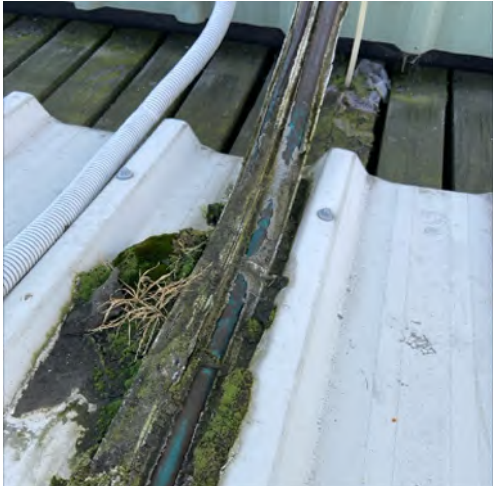
<p>Refrigerant pipe insulation perished.</p>
5	  <p>Outdoor unit condenser fins.</p>

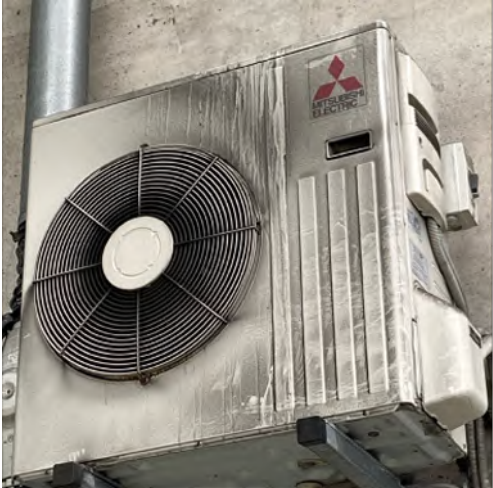
<p>Air conditioning split system serving warehouse offices.</p>
<p>7</p>

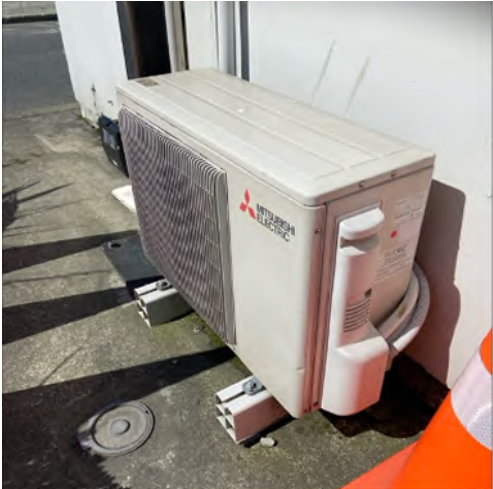
<p>Air conditioning split system serving the security office cabin.</p>
<p>8</p>

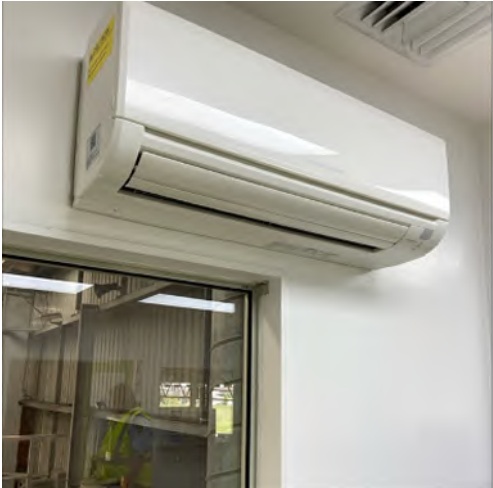
<p>Typical air condition hi-wall unit.</p>

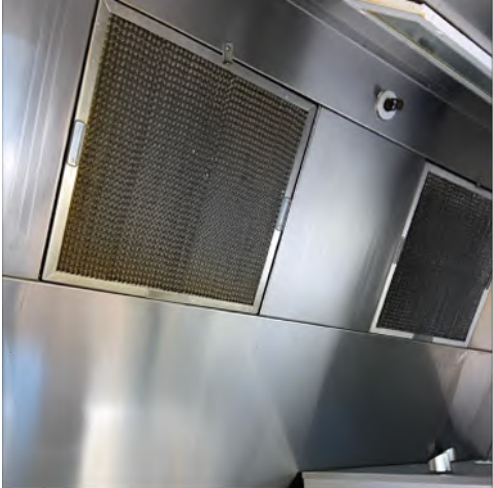
<p>Kitchen exhaust canopy.</p>
<p>10</p>

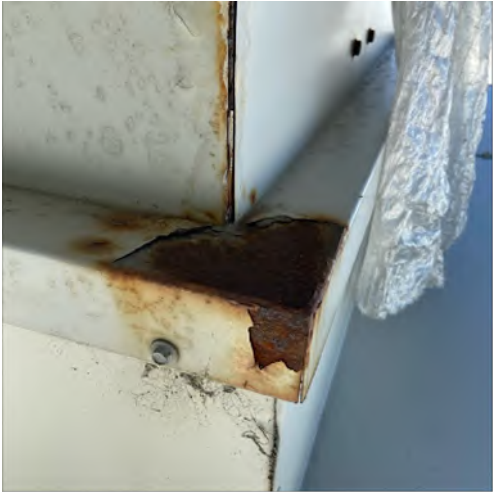
<p>Supply air fan corrosion</p>

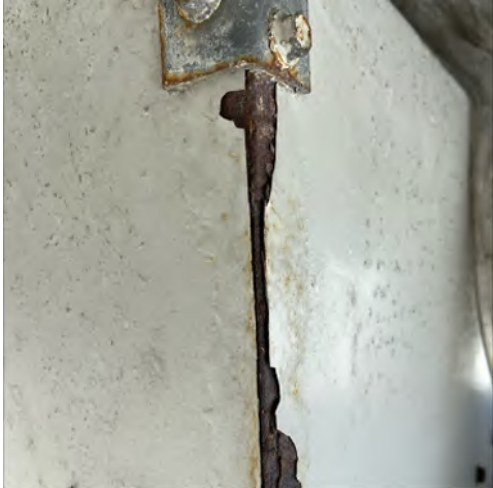
<p data-bbox="794 360 1038 394">Supply air fan corrosion</p>
13

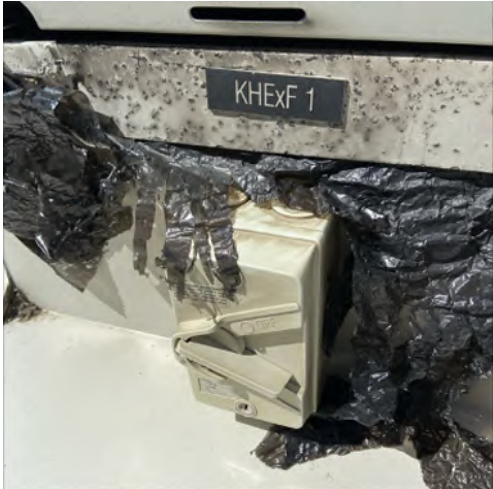
<p data-bbox="794 875 1251 909">Trapped plastic sheet needs to be removed.</p>
14	  <p data-bbox="794 1391 1401 1424">Mitsubishi AS cassette units. Dirty build up around louvres.</p>

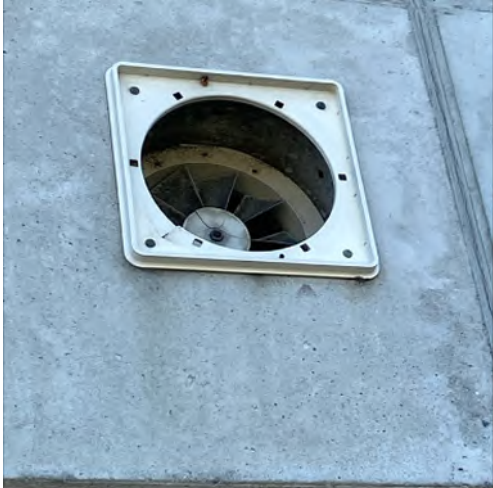
<p data-bbox="791 360 1289 392">Missing Louvre on main switchroom extract fan.</p>
19

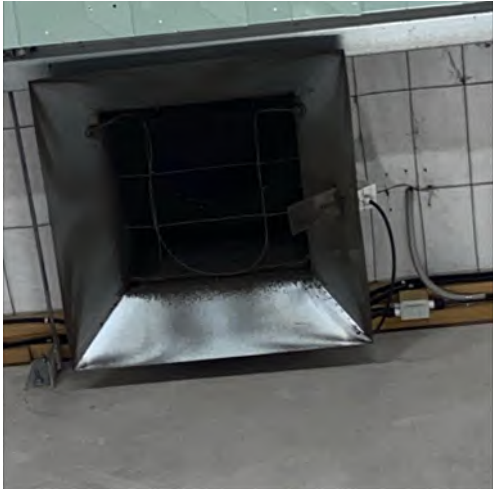
<p data-bbox="791 875 1404 940">Exhaust fans in the charging battery store. We recommend full service.</p>
20

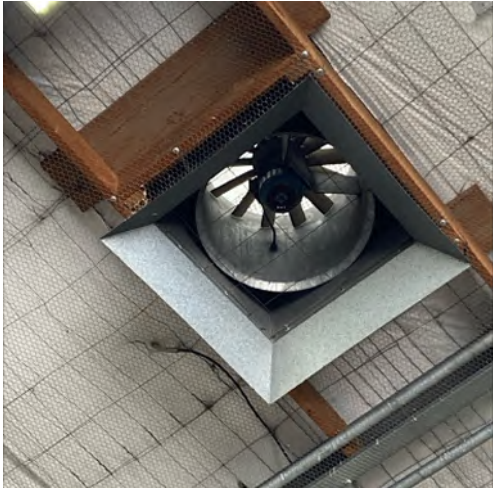
<p data-bbox="791 1391 1370 1456">Canopy fans inward/outward goods area. We could not confirm if the fans are still in use.</p> <p data-bbox="791 1494 1401 1559">The fans may function as both supply and exhaust units to improve air circulation in this busy area.</p> <p data-bbox="791 1597 1426 1868">Due to the constant movement of vehicles like trucks in the goods inward/outward section, there is a risk of excessive exhaust fumes accumulating. Effective ventilation is essential to reduce the buildup of harmful gases such as carbon monoxide, nitrogen oxides, and particulate matter, which can threaten the health of personnel and compromise air quality. From low level inspection the fans look to be in satisfactory condition.</p>

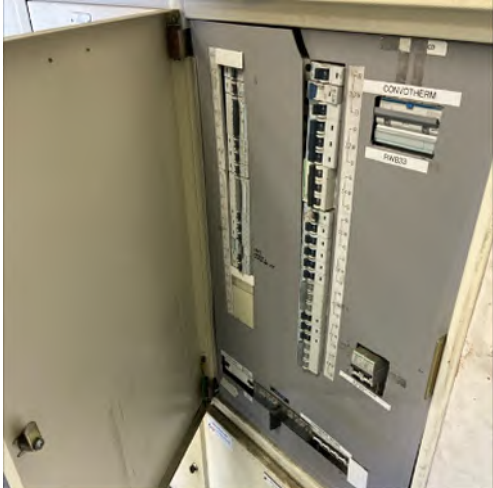
<p>DB escutcheon plate damaged.</p>
28	  <p>DB escutcheon plate damaged. Dirt build up in and around MCBs.</p>
29

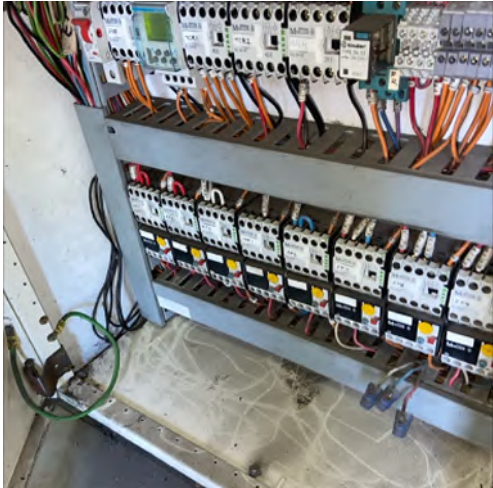
<p>Mechanical services control panel. Contactors dirty and excessive chattering.</p>

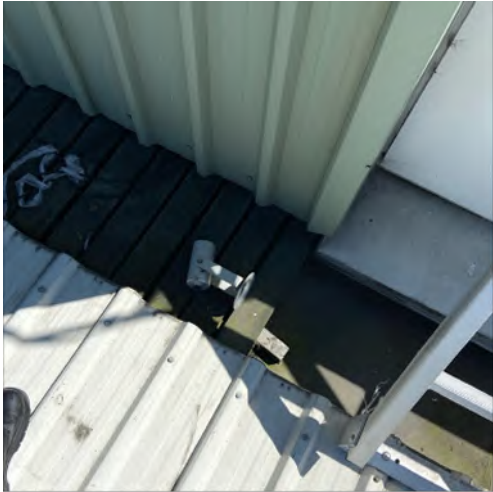
<p>External lighting damaged on roof above offices.</p>

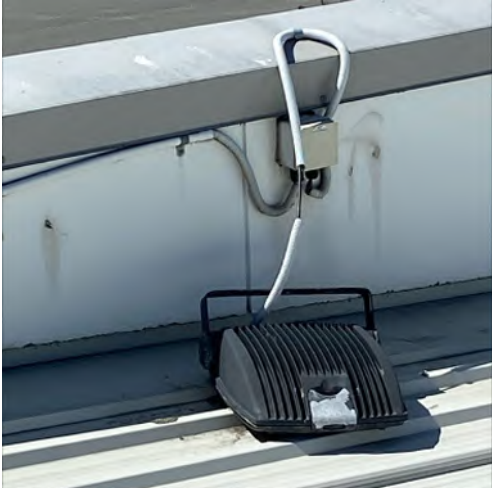
<p data-bbox="794 360 1294 394">External lighting damaged on roof above offices.</p>
37

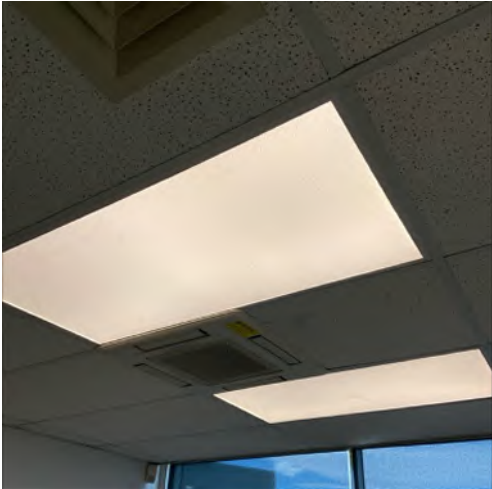
<p data-bbox="794 875 1366 943">Office LED lighting. Some diffusers are dirty and require cleaning.</p>
38

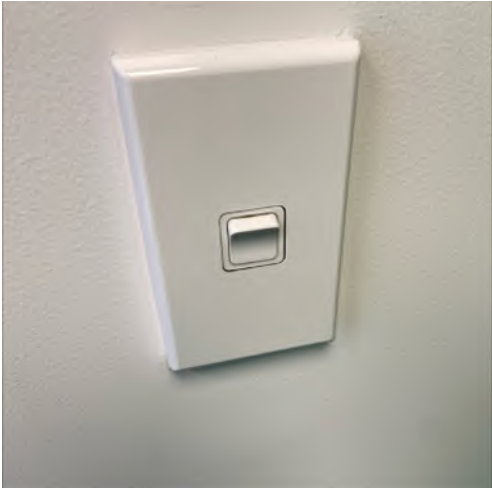
<p data-bbox="794 1391 1321 1424">Office typical light switching showing signs of wear.</p>

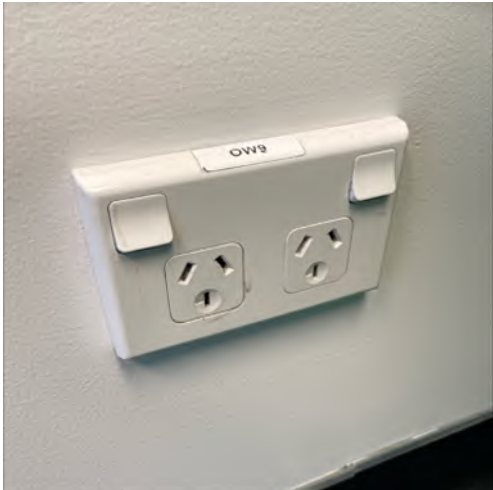
<p>Office typical socket outlets showing signs of wear.</p>
40

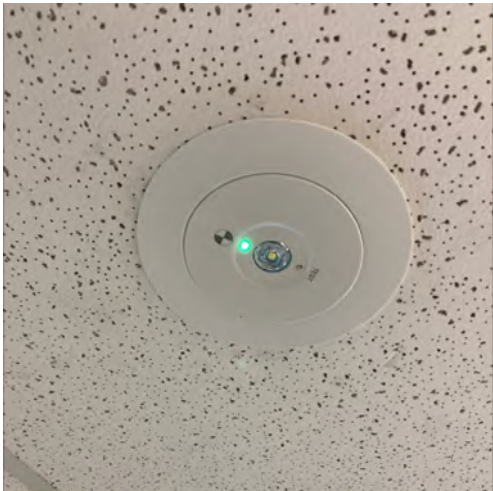
<p>Office emergency lighting in satisfactory condition. We note that emergency lights do not include a identification label.</p>
41

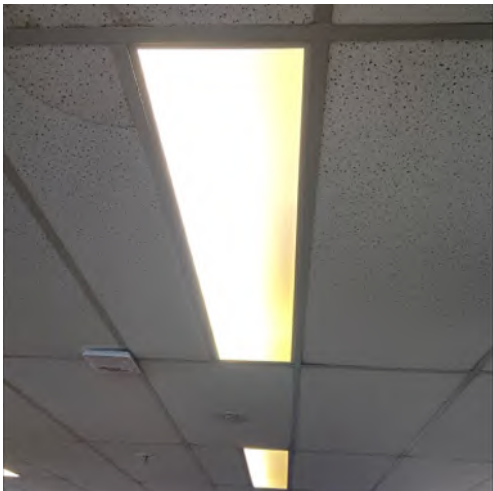
<p>Canteen lighting. Diffusers having signs of discolouration.</p>

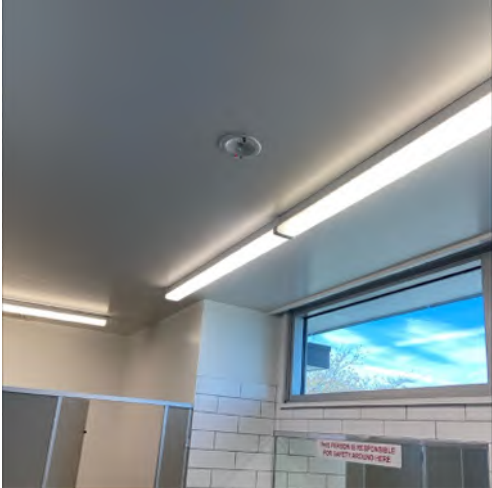
<p>Toilet LED lighting in satisfactory condition.</p>
43

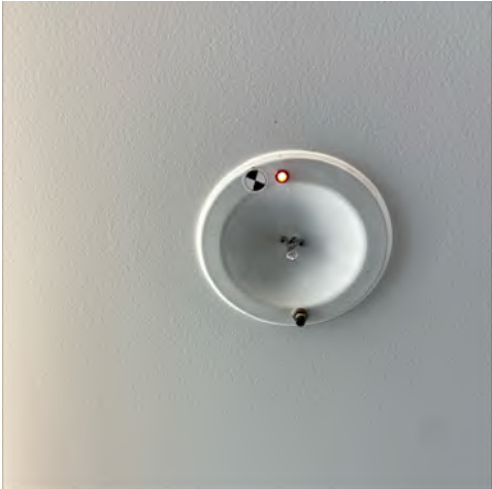
<p>Some older tungsten halogen emergency lights which we recommend replacing.</p>
44

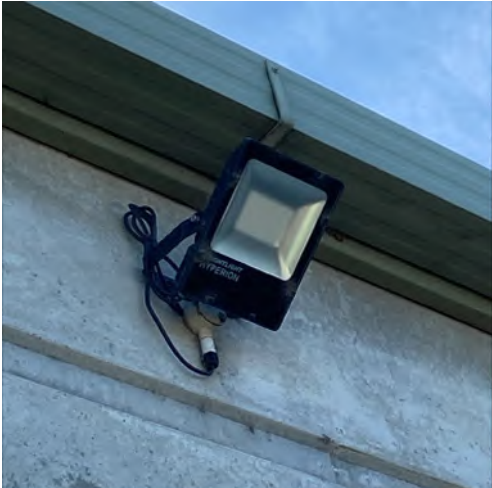
<p>External flood lights in satisfactory condition.</p>

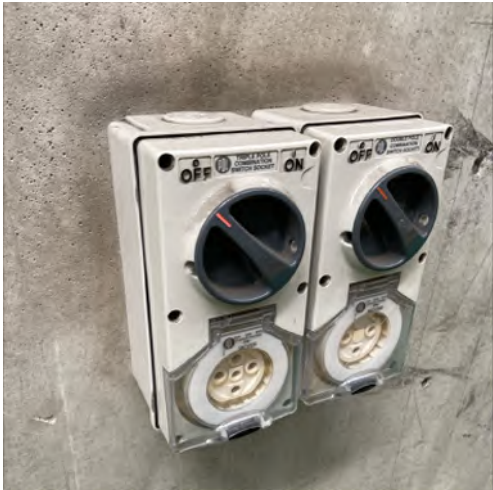
<p data-bbox="794 358 1394 392">Warehouse contains some IP rated general power outlets.</p>
46

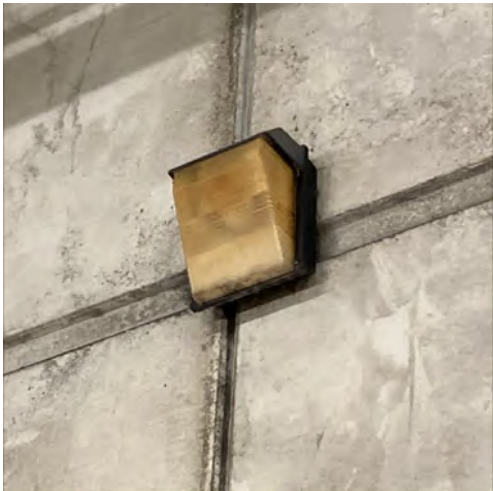
<p data-bbox="794 873 1406 940">Older lighting in the charging battery store. We recommend replacing and/or full service.</p>
47

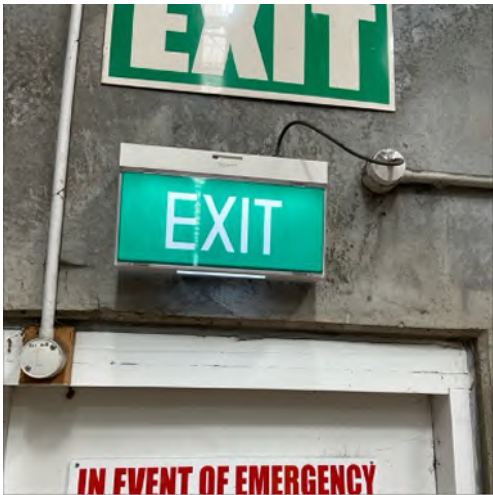
<p data-bbox="794 1388 1158 1422">Illuminated exit signs in warehouse.</p>

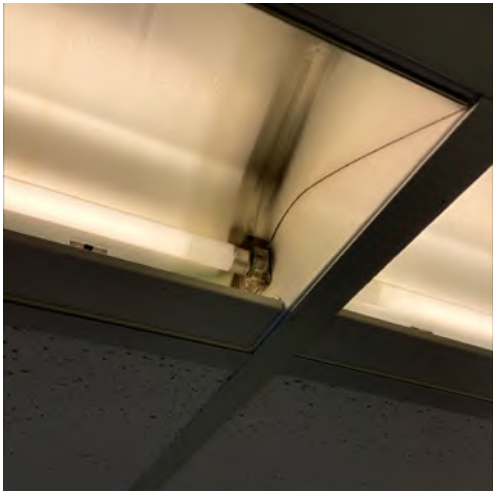
<p data-bbox="794 873 1372 940">Training room wall wash lighting should be inspected and serviced. We recommend replacing.</p>
53

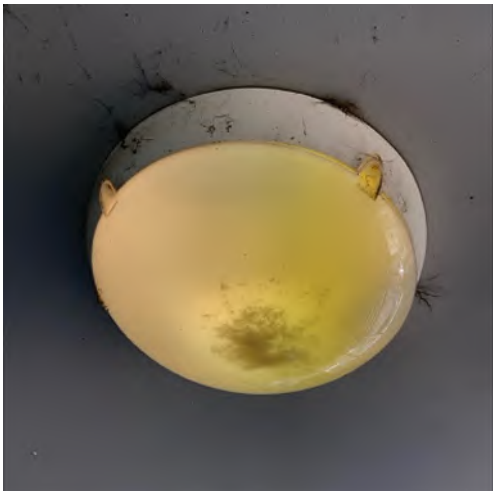
<p data-bbox="794 1388 1372 1456">Several external canopy lights are dirty and require cleaning and likely re-lamping.</p> <p data-bbox="794 1489 1372 1556">Lights should not be operational in day time for energy saving. Electrical to clean and inspect.</p>

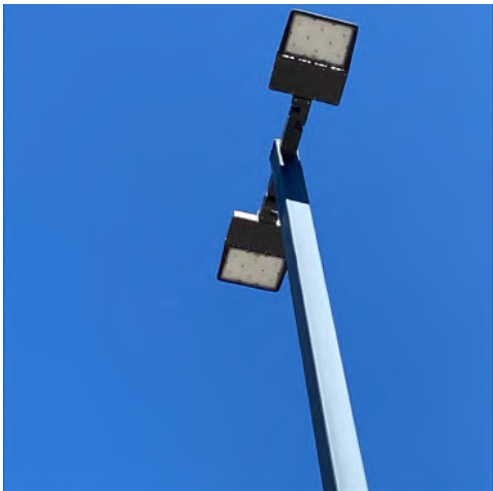
<p>Carpark column LED lighting in satisfactory condition.</p>

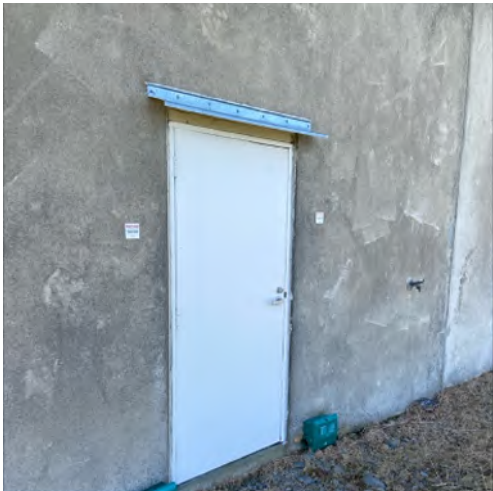
<p>No emergency lighting on external escape routes.</p>
<p>59</p>
