TECHNICAL DUE DILIGENCE REPORT

32 JAMAICA DRIVE

GRENADA NORTH

Date: 12 December 2018

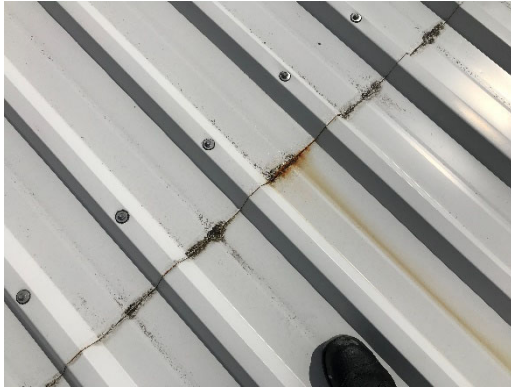
- 6) Metal roof sheets were noted to overlapped in localised areas, with roof sheets in direct contact with one another. This will cause the coating to the sheets to deteriorate over time as the sheets rub against each other through differential thermal movement. Over time, this will cause corrosion to set in – minor corrosion has been noted along the length of the roof sheets in these locations. The two options for repair would include;

1.3. Corrosion along length of overlap joint

- OR
 - (b) Treat existing sheets of corrosion along full length of sheets and reapply a coating. Repeat this process once every 2 years.

For the purposes of our maintenance schedule, we have allowed to undertake option B as this is considered to be the most cost effective solution.

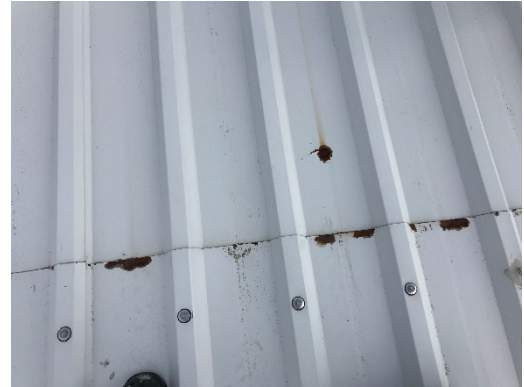
1.4. Corrosion along length of overlap joint

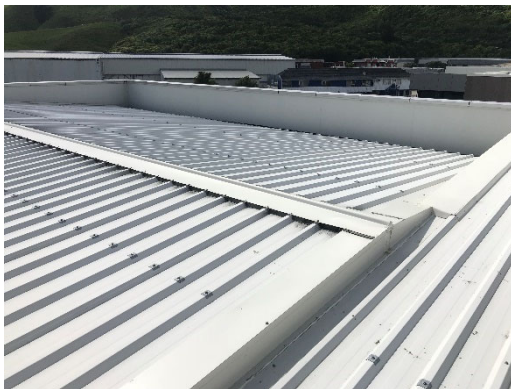
- 14) Detailing between office and warehouse roof areas noted to be poor and not in line with best practice for metal roofing. It is recommended that the corresponding location internally is monitored and in the event of leaking, the junction be redetailed in line with the NZ Metal Roof and Wall Cladding Code of Practice.

1.5. Poor detailing to office/warehouse junction

3.5	Penetrations	HVAC penetrations poorly sealed.	Allow to install back flashings.		\$ 15,000			\$ 15,000								
3.6	Detailing	Detailing between office and warehouse roofs noted to be poor.	Allow sum to supply and install purpose made flashing.		\$ 5,000			\$ 5,000

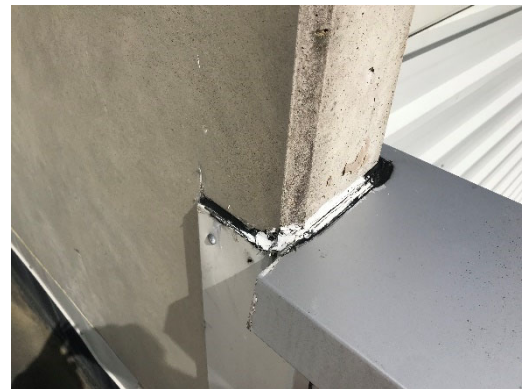
- 15) Detailing between the office roof parapet wall and the concrete tilt slab wall is reliant on silicone. It is recommended that this junction be redetailed with a purpose made flashing.

1.6. Poor detailing to parapet/tilt slab junction

3.7	Detailing	Detailing between parapet wall and tilt slab noted to be poor.	Allow sum to supply and install purpose made flashing.		\$ 5,000			\$ 5,000								
4	Building 3

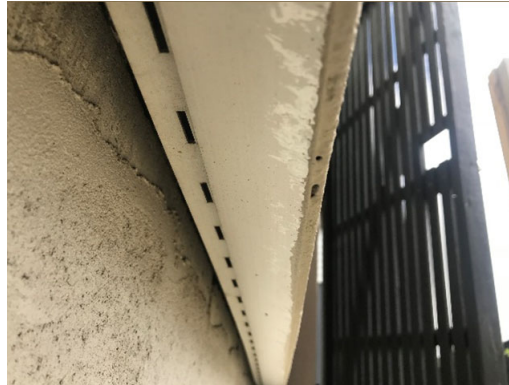
- This product appears to have weep holes to the underside of the panels which should allow moisture to escape should it enter into the unit (see photograph 1.7 below).

1.7. Weep holes visible to underside of panel

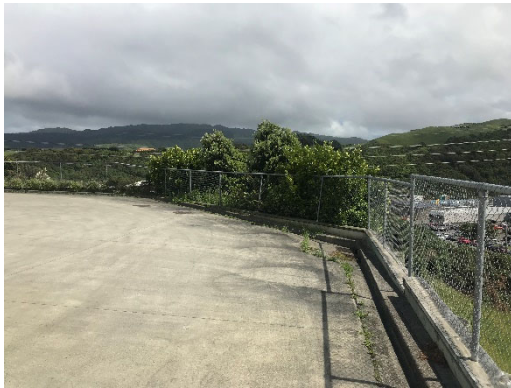
- 31) There is evidence of ground movement adjacent to the retaining wall to the north east corner of the site. It is unknown if this is an ongoing structural concern or if this has occurred due to settlement following construction – however the ground in this location is approximately 25 metres from Building 1 and as such it is considered unlikely to be causing any risk to the building. It is recommended that the ground be monitored in this location and a structural engineer be consulted in the event that movement continues. See photographs 1.8 and 1.9 below.

1.8. Railings above retaining wall noted to be falling outwards

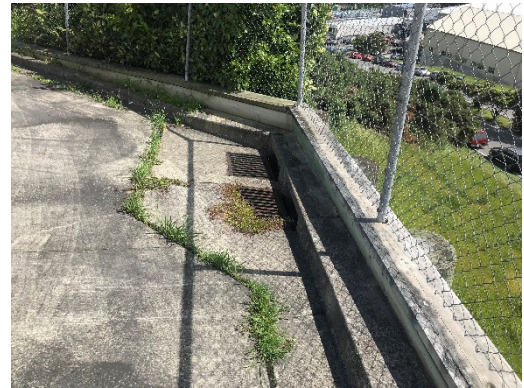
1.9. Grass growth occurring where joints are opening up

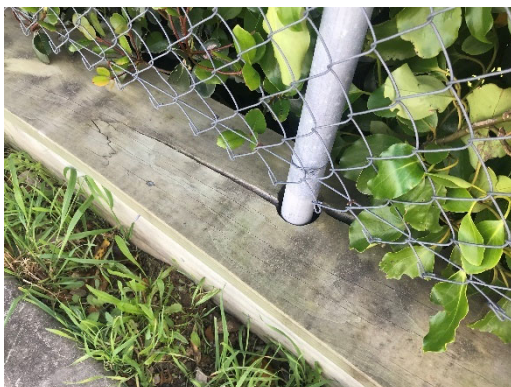
1.10. Cracking to timber caused by movement against railing pole

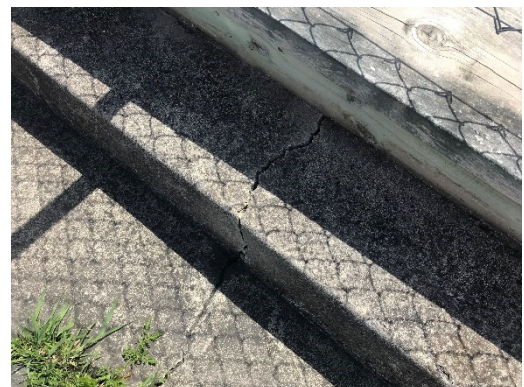
1.11. Cracking to concrete in vicinity of retaining wall

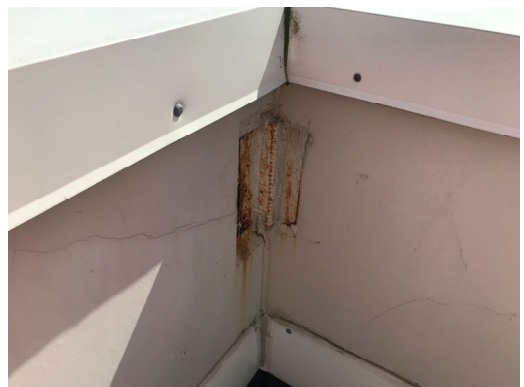
- 17) Concrete tilt slab walls are laterally secured utilising steel plates bolted from one tilt slab panel to the next. The steel plates are noted to be corroding in localised areas – this is concerning as steel expands as it corrodes and is noted to be causing the adjacent concrete to crack. The steel corrosion should be treated and the plates painted to prevent further corrosion from occurring.

1.6. Building 3 – Corroding Plate

The cracking should also be filled in and monitored. In the event of further cracking, it is recommended that a structural engineer be consulted.

4.1	Tilt Slabs	Steel plates to tilt slabs noted to be corroding in localised areas.	Treat corrosion and repaint. Rake out and fill in cracks to concrete.		\$ 4,000		\$ 2,000					\$ 2,000

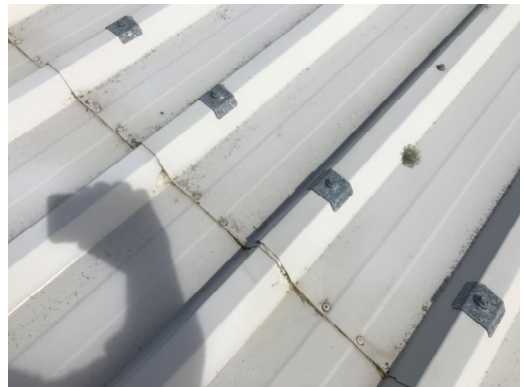
1.10. Building 2 – Poor Overlap Detail

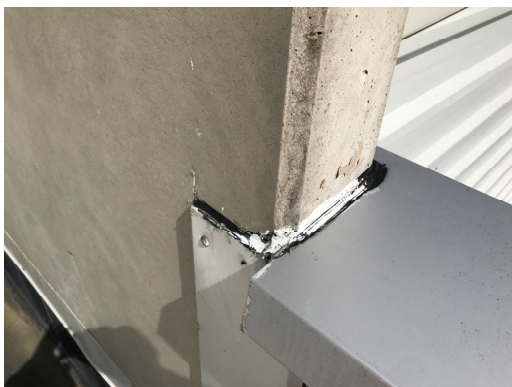
1.11. Building 2 – Poor Detailing

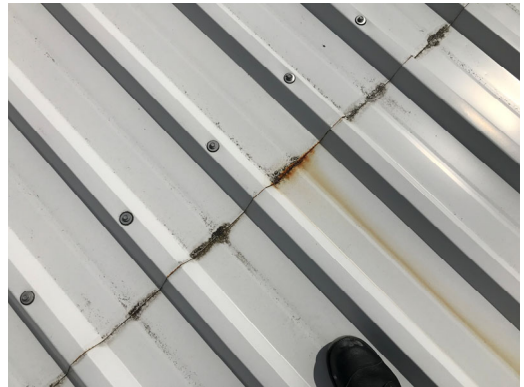
1.16. Building 1 – Poor Overlap Detail

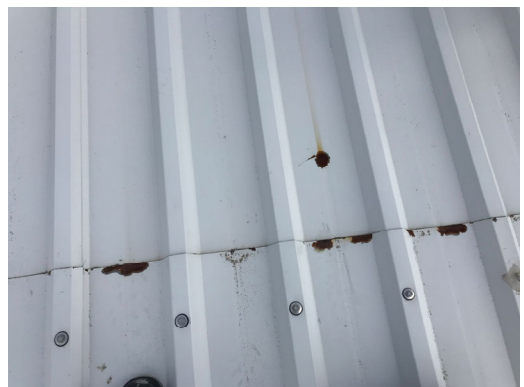
1.18. Building 1 – Poor Overlap Detail

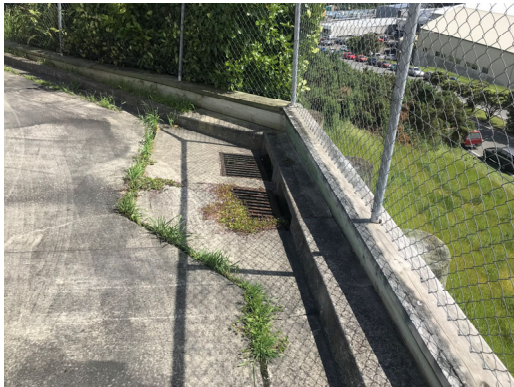
1.55. Evidence of subsidence to north east corner of site
