TECHNICAL DUE DILIGENCE REPORT

26 SHARPE ROAD HAMILTON

PMG Generation Fund Trustees Limited

Date: 18 November 2019

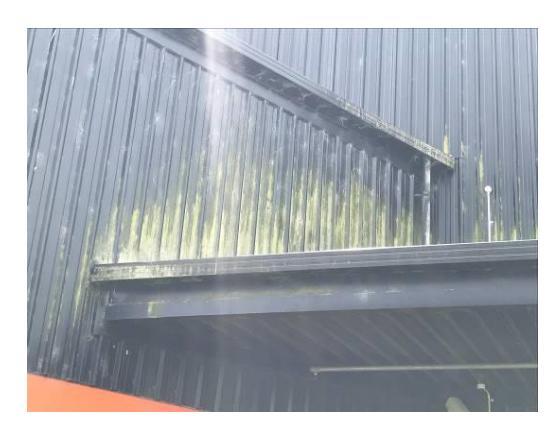
1.3. View of staining to cladding sheets

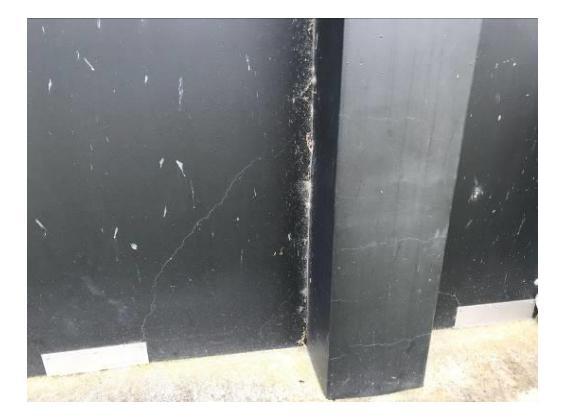
- 13. Impact damage was noted across the external areas generally. Hairline cracking was noted to the tilt slabs in localised areas this is believed to be due to settlement of the building does not raise structural concerns. It is advised to rake out and fill cracks and monitor for further movement.
- 14. There was a section of the tilt slab walls that had spalling. This should be repaired to prevent any significant damage to the building fabric.

1.5. View of hairline cracking to tilt-slab wall panels

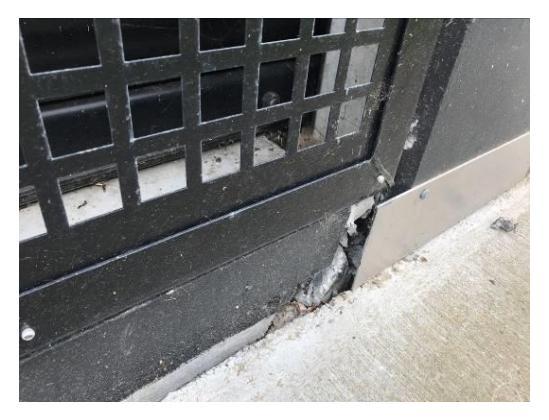
1.7. View of poor workmanship to floor slab

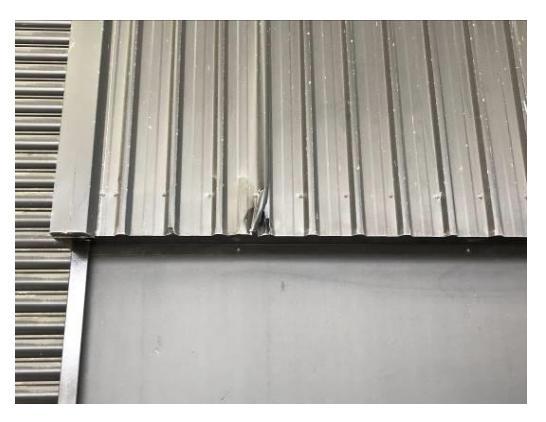
- 9. Metal profile cladding sheets appear to be well specified and installed and subject to maintenance should be expected to last over and above the next 10 years. Various areas of impact damage were noted in line with the building's use and periodic repair and replacement of the sheets will be required.
- 10. The windows/glazed sections to the office areas comprised aluminium frame with glazing seals. These windows were in serviceable condition.
- 11. Roller shutter doors appear serviceable. An allowance should be made to overhaul roller shutter doors over 10-year period.
- 12. Powder coated fire exit doors noted to be in serviceable condition.

1.10. View of impact damage to cladding sheets

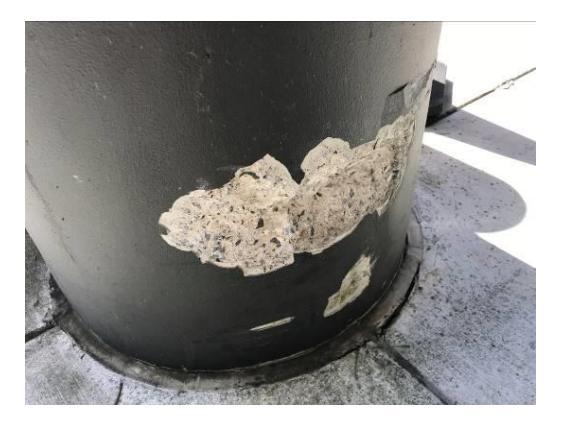
1.13. View of damage to concrete pillar

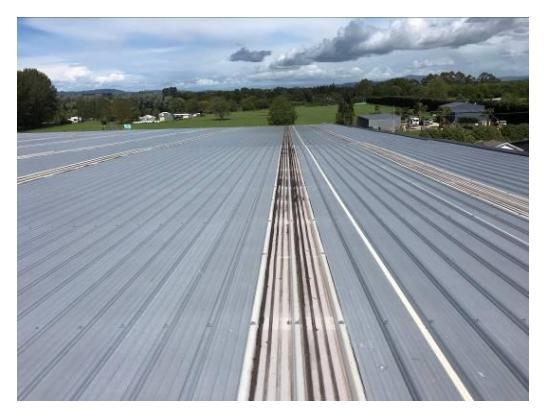
- 4. Skylights are generally in reasonable condition throughout the roof however it appears these are not currently cleaned or maintained. These skylights would require regular cleaning and spot maintenance. Over a number of years these skylights would also suffer from solar degradation.

1.16. View of dirty roof lights

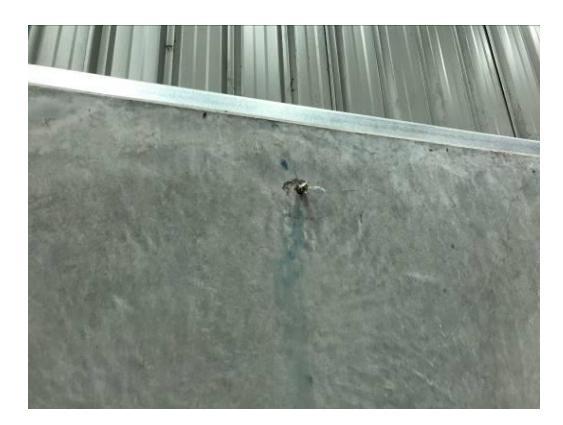
1.24. View of redundant fixings to tilt-slab wall panels

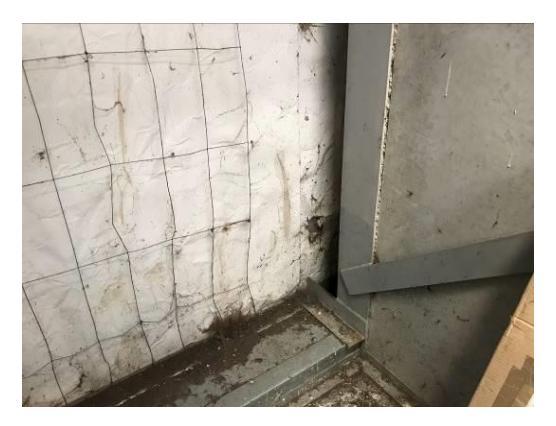
1.26. View of dirty sarking and damaged mesh wiring

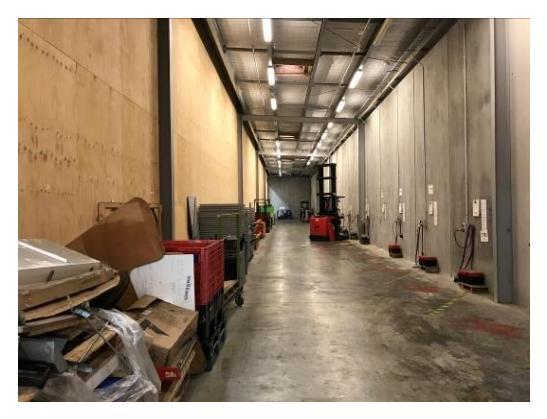
1.28. View of staining to floor slab

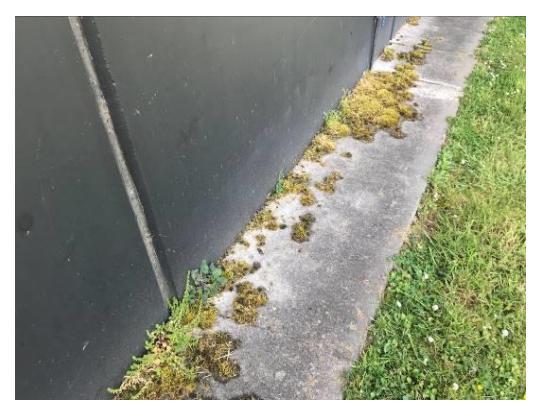
1.35. View of moss and vegetation growth

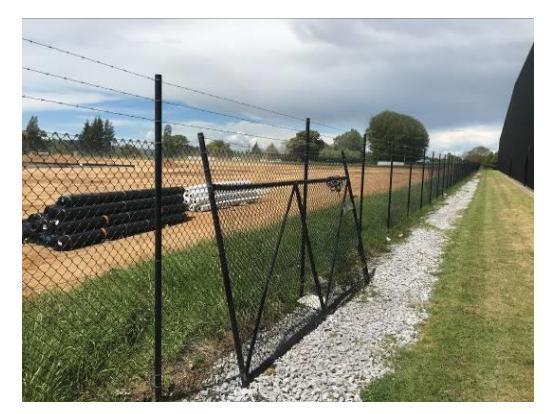
1.34. View of perimeter fencing and removed gate

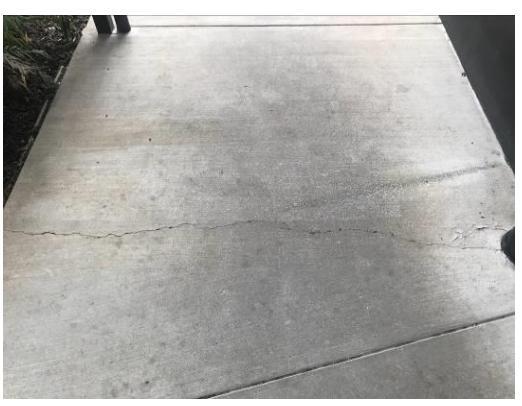
1.36. View of cracking to pedestrian walkway areas

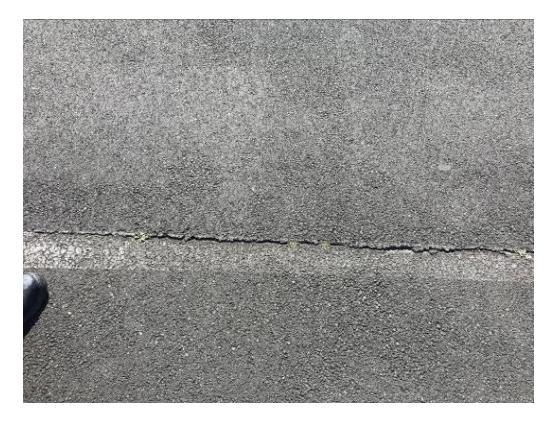
1.39. View of poor workmanship to asphalt

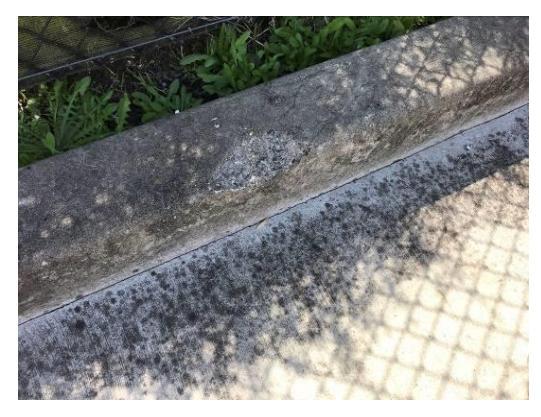
1.41. View of spalling to concrete kerb stones

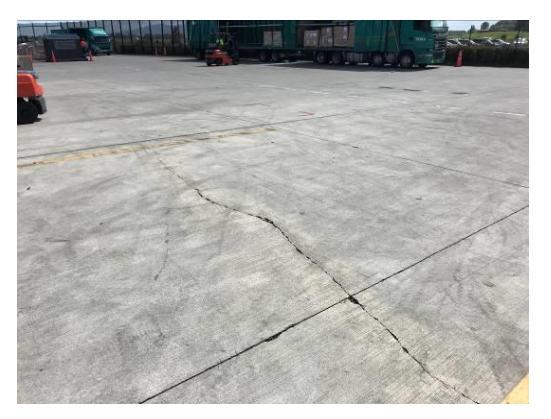
- 15. There was cracking noted to the service yard likely from the heavy transport vehicles within this area. This should be repaired by the tenant as part of their lease obligations.

1.40. View of cracking to concrete sections of loading yards

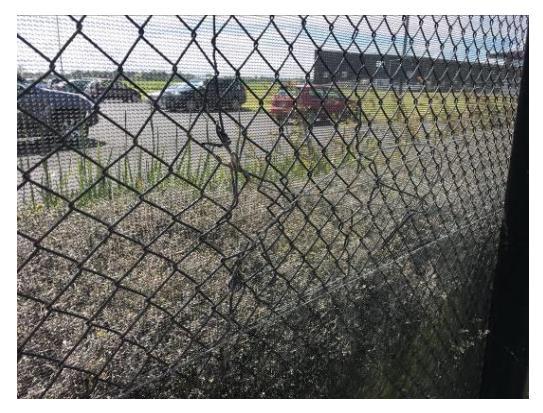
- 16. Drainage to the site is provided by a number of grated drainage outlets. No sub ground drainage inspections were undertaken.
- 17. Perimeter fences noted to be in serviceable condition throughout with various areas of impact damage noted in line with the building's use and periodic replacement of fencing will be required.

1.42. View of damage to perimeter fencing
