TECHNICAL DUE DILIGENCE REPORT

65B MAIN HIGHWAY

ELLERSLIE

Date: 19 January 2019

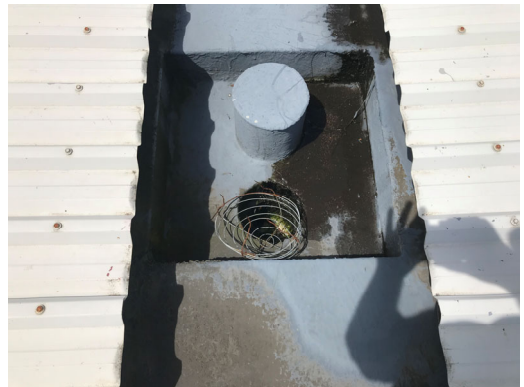
1.10. Sump gutters within valley gutters

- 2) The membrane to the valley gutters was noted to be deteriorating with areas of corrosion visible to the metal substrate beneath. It is recommended that the gutters be replaced within 5 years.
