TECHNICAL DUE DILIGENCE REPORT

20-28 Sir William Pickering Drive,
Christchurch

Date: 27th November 2017
CBRE Ref: 49211286

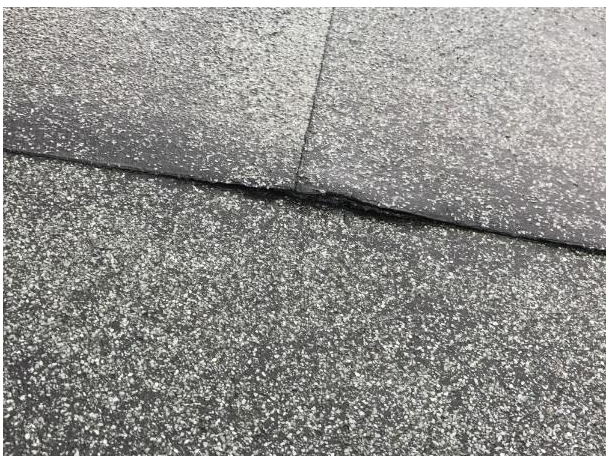
- Joints to felt roofing starting to fail and sheets lifting at edges.
 - Gutters choking, surface water not draining and ponding to surface.
 - A number of areas were noted to be brittle and de-bonding from substrate which has led to bubbling of roof coverings and is likely to be a source of ongoing water ingress as sheet become brittle and cracks appear.

B1 – joints starting to lift at lapped edges

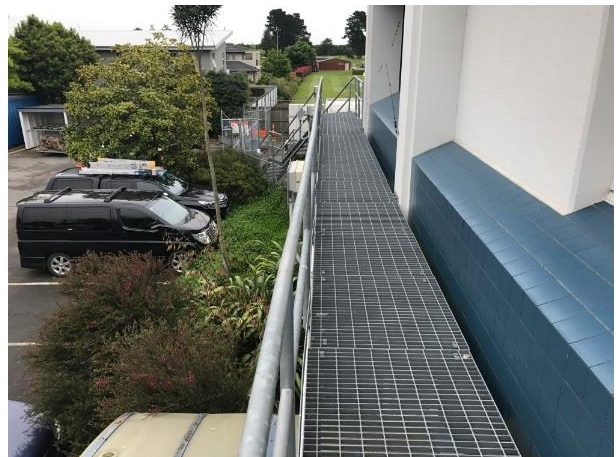
B1 – New metal external fire escape stair

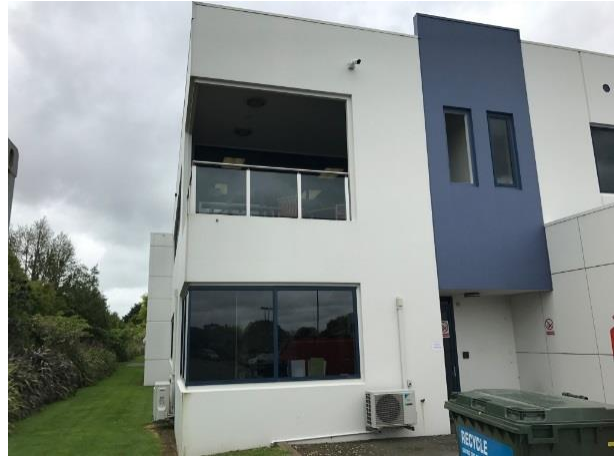
B2 – SW corner & semi enclosed deck area

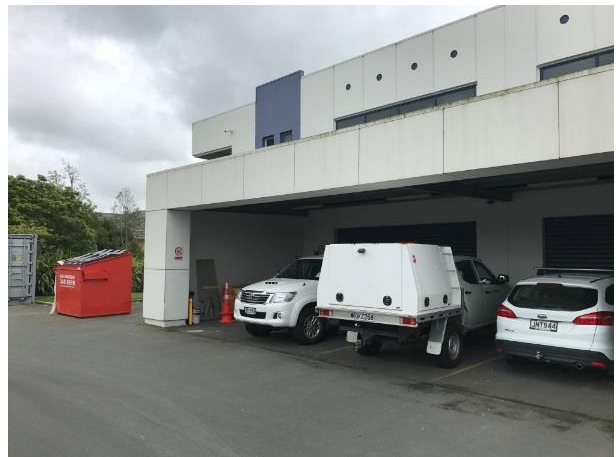
B2 – covered carport and garages

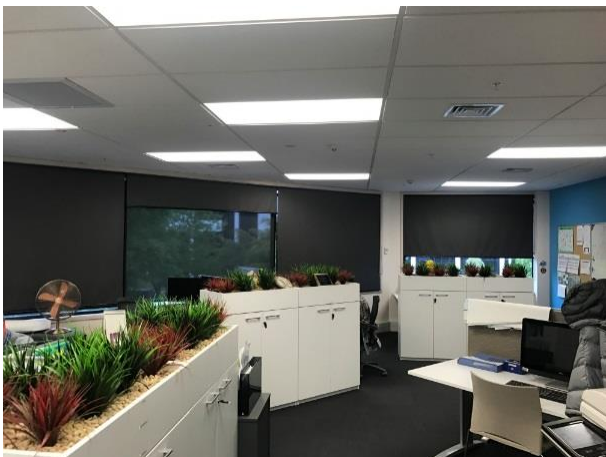
B1 – typical internal office

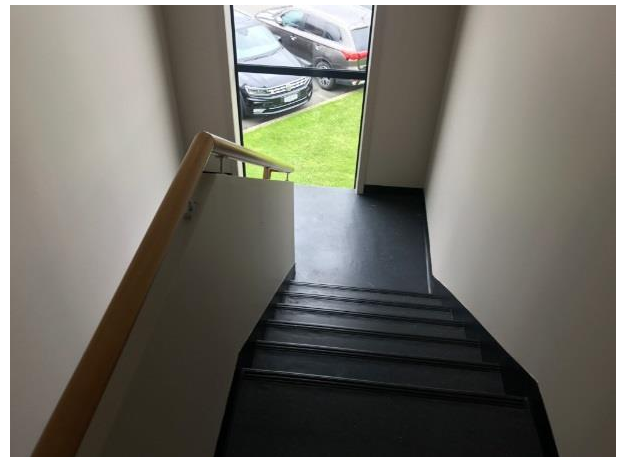
B2 – Internal fire escape stair

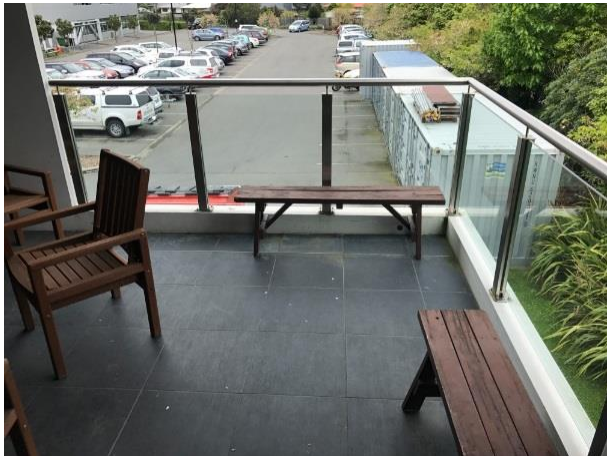
B2 – semi enclosed deck area

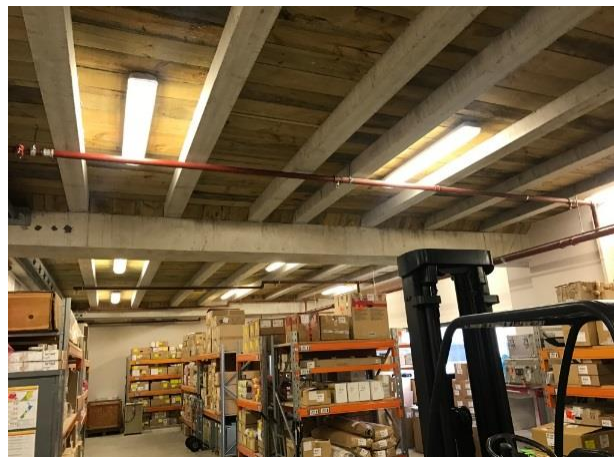
B2 – storage area to south end of building

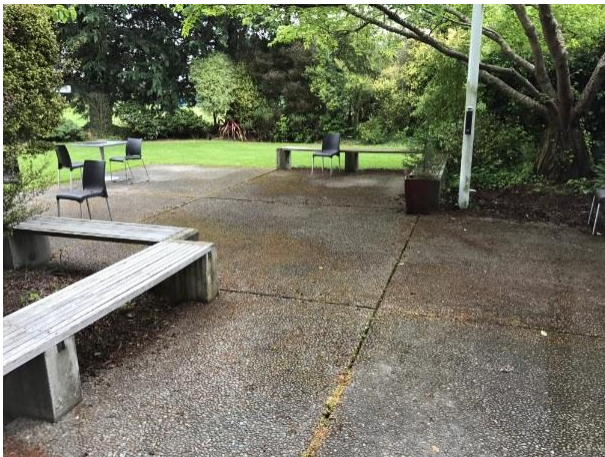
Hard standing to NW corner of B1.

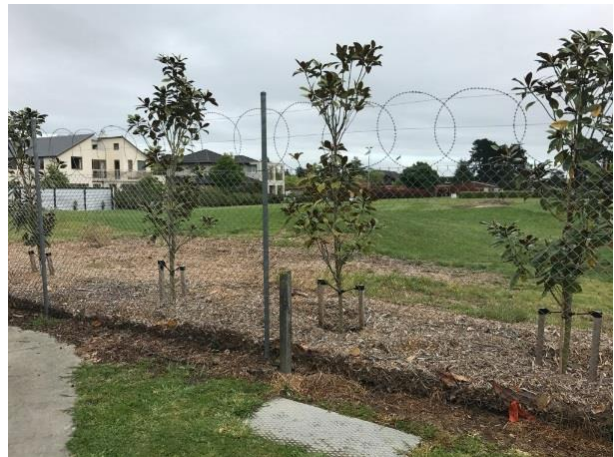
Chain-link perimeter fence & razor wire.

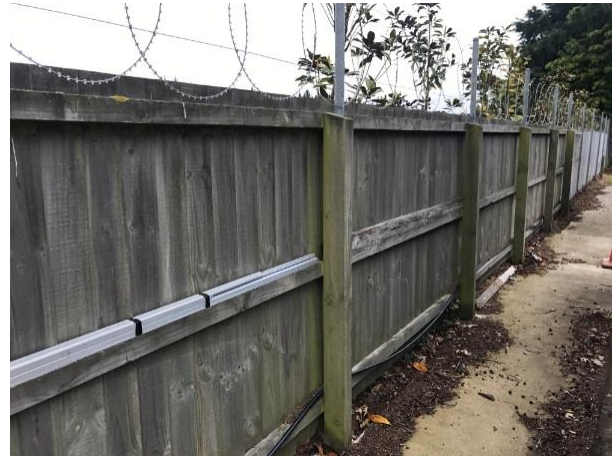
Timber perimeter fence.

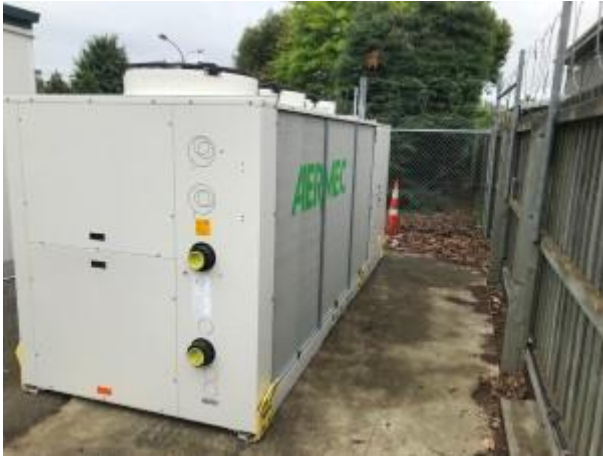
- Andy Herd Building (AHB) (Building 1)
 - The chilled water plant is currently being refurbished with a new Aermec air cooled chiller being installed to replace and exist system that comprised two Multistack chillers and pumps. The Aermec chiller has an onboard hydronic kit of pumps. The chiller is located on the ground at the rear of the building.

New Aermec chiller waiting to be installed

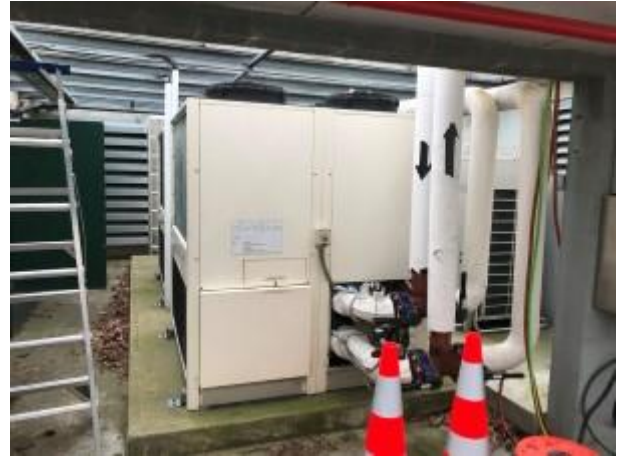
Old Multistack chillers

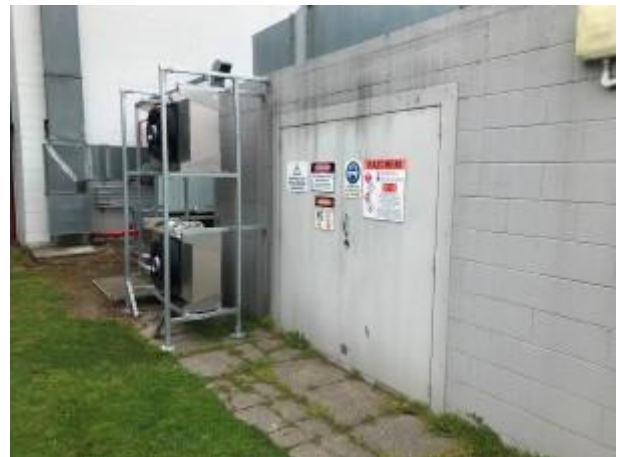
Air cooled CRAC condensers

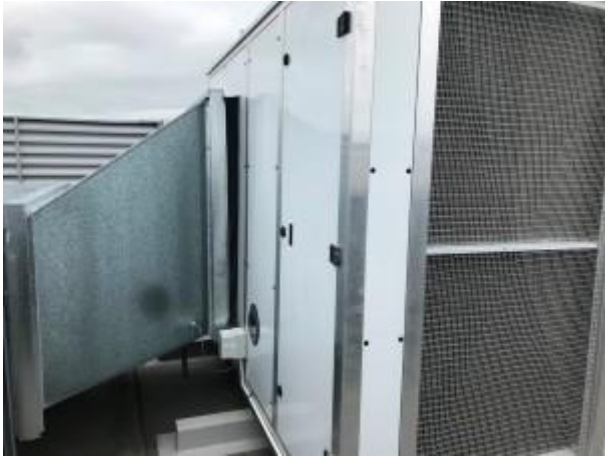
- The outside air units will need to be overhauled in the long term.
- Ventilation systems will need some attention in the long term.
- There are individual packaged split units on the site that will need to be replaced as they fail.

Outside air preconditioner

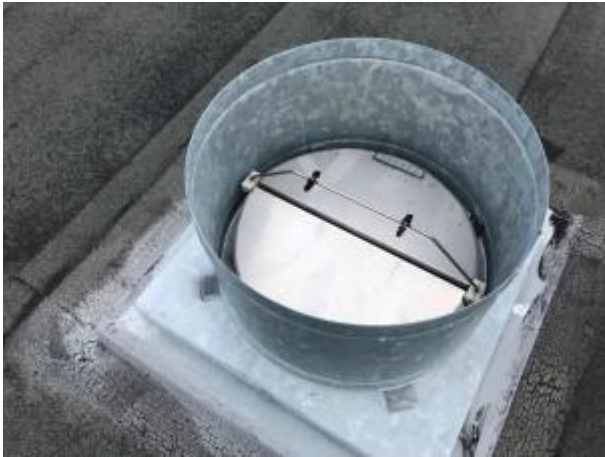
Heat relief fans – (suspected of being smoke relief)

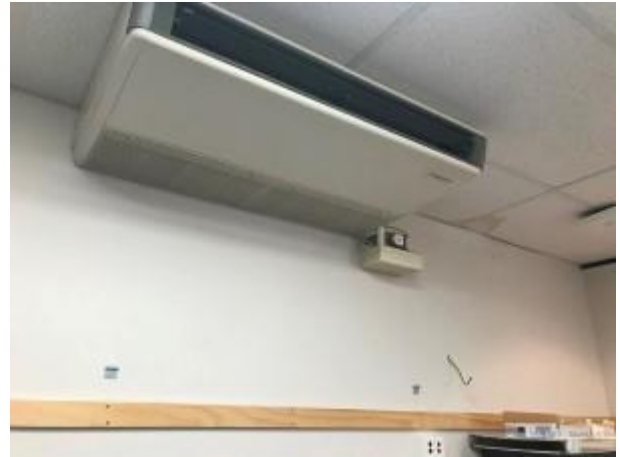
Ceiling hung split unit

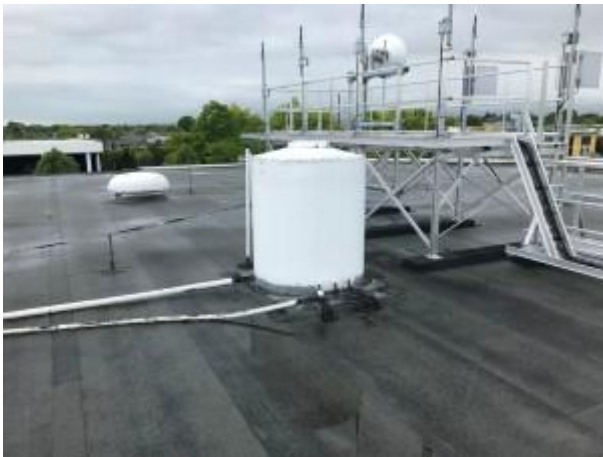
- Hydraulic services appear in reasonable condition with reasonable maintenance.
- The two header tanks on the roof of the building will need to be replaced in the medium term.
- Hot water system will need to be replaced as they fail.

Cold water header tank
