Technical Due Diligence Report For and on behalf of AUGUSTA FUNDS **MANAGEMENT** Anglesea Medical Centre, Corner of Anglesea and Thackeray Streets Hamilton JUNE 2020 P19-0406

REPORT TITLE	Technical Due Diligence Report
JOB NUMBER	P19-0406
CLIENT	Augusta Funds Management
CLIENT CONTACT	Joel Lindsey

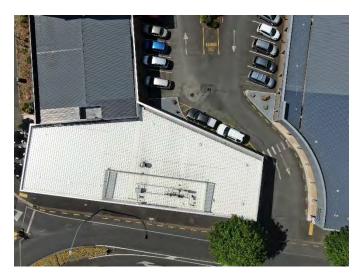
Photograph 1.

General view of the roof covering to Building 1.

No safe internal access to the roof covering was available.

We recommended safe internal access to the roof is provided for maintenance contractors.

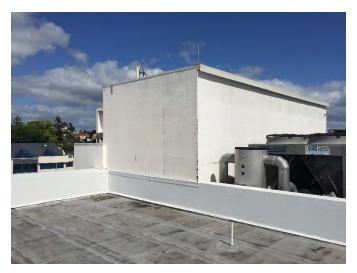
Photograph 8.

No barriers or fall restraint/arrest system have been installed to the south portion of the roof.

We recommend the roof fall arrest/restraint system is recommenced and certified before

Access to the roof covering should be limited until the system has been certified.

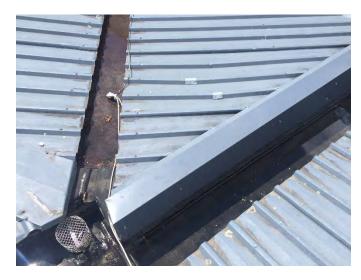
Photograph 25.

Membrane gutters have been installed to the main roofs.

Bubbling and blistering of the membrane was noted to all roof sections

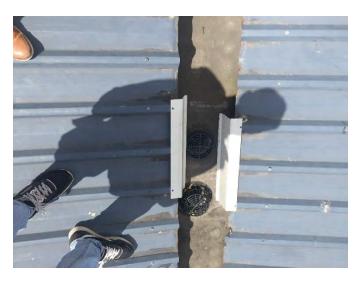
Photograph 28.

Membrane gutters have been installed to the main roofs.

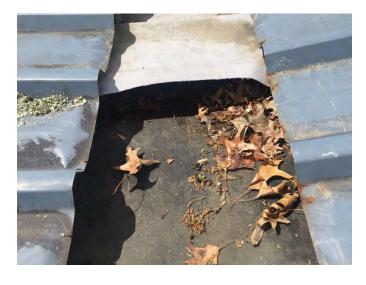
Photograph 31.

Membrane gutters have been installed to the main roofs.

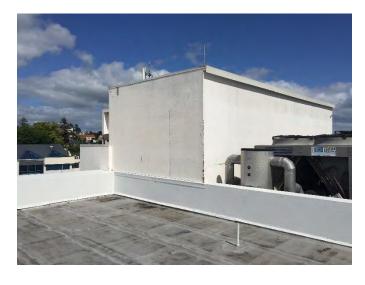
Photograph 34.

Direct fixed fibre cement cladding has been installed to the south and west elevations of the main building and all elevations of the lift plant room.

Replacement/over-cladding of the fibre cement sheet cladding to the balcony balustrades on level 2 was being undertaken during our inspection.

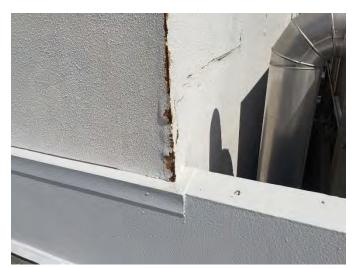
Photograph 35.

Direct fixed fibre cement cladding has been installed to the south and west elevations of the main building and all elevations of the lift plant room.

Cracking and broken sections of cladding were noted to the fibre cement sheet cladding and will be allowing moisture past the cladding and onto the frame.

Replacement/over-cladding of the fibre cement sheet cladding to the balcony balustrades on level 2 was being undertaken during our inspection.

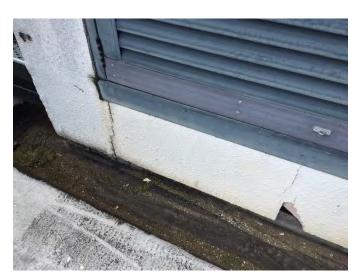
Photograph 36.

Direct fixed fibre cement cladding has been installed to the south and west elevations of the main building and all elevations of the lift plant room.

Cracking and broken sections of cladding were noted to the fibre cement sheet cladding and will be allowing moisture past the cladding and onto the frame.

Replacement/over-cladding of the fibre cement sheet cladding to the balcony balustrades on level 2 was being undertaken during our inspection.

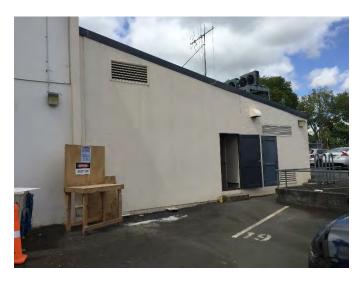
Photograph 37.

Direct fixed fibre cement cladding has been installed to the south and west elevations of the main building and all elevations of the lift plant room.

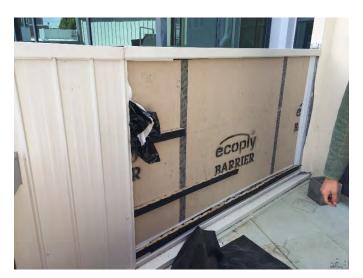
Photograph 42.

Replacement/over-cladding of the fibre cement sheet cladding to the balcony balustrades on level 2 was being undertaken during our inspection.

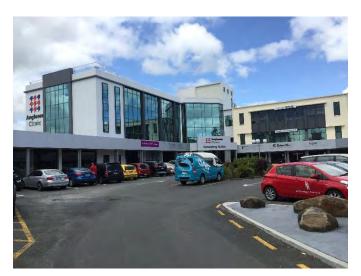
Photograph 45.

Sections of blockwork and plaster to the north and east elevation were in the process of being repainted during our inspection.

Sections of plaster to the remaining elevations are in a satisfactory condition with no cracks noted.

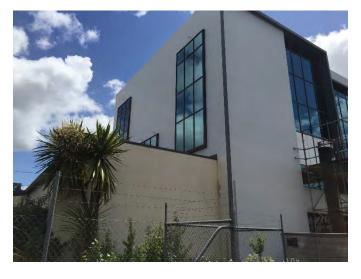
Photograph 46.

Sections of blockwork and plaster to the north and east elevation were in the process of being repainted during our inspection.

Sections of plaster to the remaining elevations are in a satisfactory condition with no cracks noted.

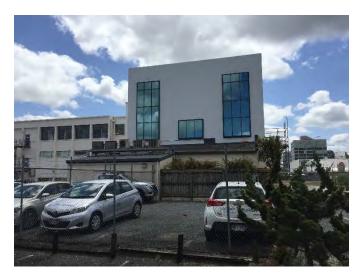
Photograph 47.

Sections of blockwork and plaster to the north and east elevation were in the process of being repainted during our inspection.

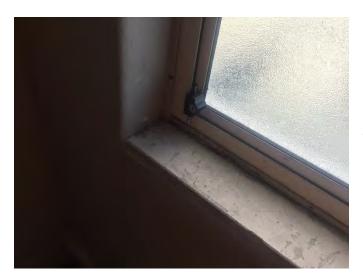
Photograph 50.

Single glazed metal window joinery has been installed to the west elevation. The joinery has a painted finish.

Flaking paint was noted to the window joinery.

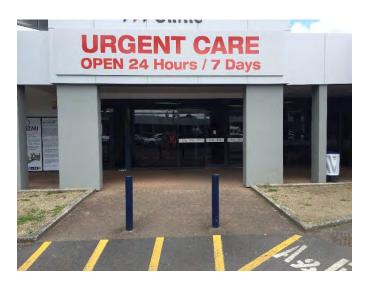
Photograph 52.

Combination of single glazed aluminium doors, aluminium panel doors and aluminium glazed panel automatic doors.

General atmospheric debris was noted to the doors throughout.

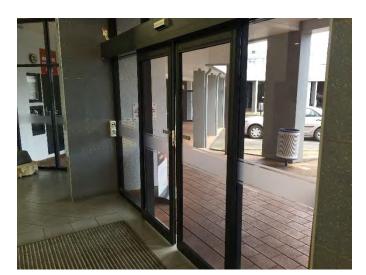
Photograph 53.

Combination of single glazed aluminium doors, aluminium panel doors and aluminium glazed panel automatic doors.

General atmospheric debris was noted to the doors throughout.

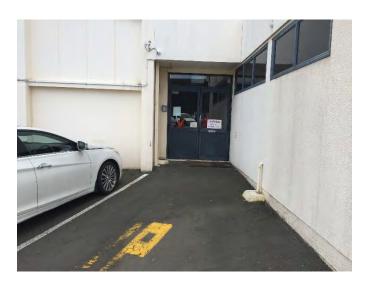
Photograph 54.

Combination of single glazed aluminium doors, aluminium panel doors and aluminium glazed panel automatic doors.

General atmospheric debris was noted to the doors throughout.

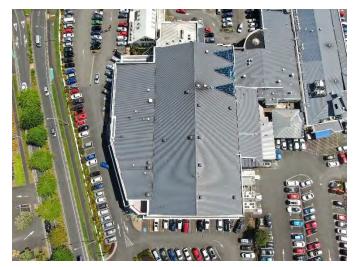
Photograph 55.

General view of the profiled metal roof covering to building 3.

Heavy atmospheric build-up was noted around the extractor fan outlets throughout the roof covering.

We were advised that the skylights and seals have recently been replaced as part of ongoing maintenance.

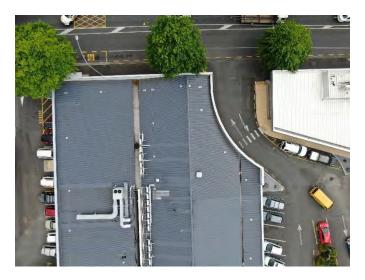
Photograph 56.

General view of the profiled metal roof covering to building 3.

Heavy atmospheric build-up was noted around the extractor fan outlets throughout the roof covering.

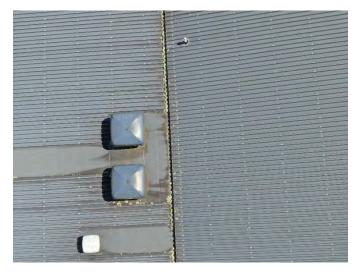
Photograph 57.

Heavy atmospheric build-up was noted around the extractor fan outlets throughout the roof covering.

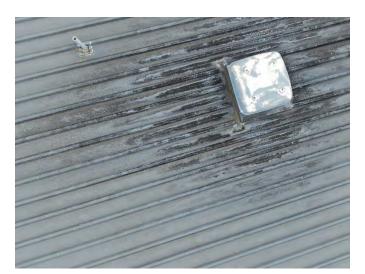
Photograph 58.

Heavy atmospheric build-up was noted around the extractor fan outlets throughout the roof covering.

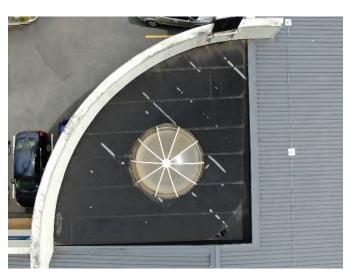
Photograph 59.

Rubber membrane roofs have been installed to various sections of the roof area. The membranes are original to the building and are approximately 12 years old.

Heavy atmospheric build-up was noted around the extractor fan outlets throughout the roof covering.

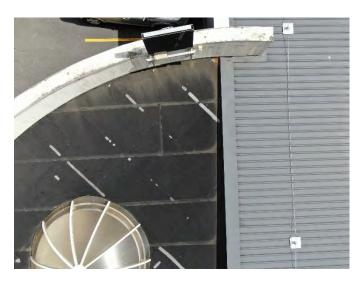
Photograph 60.

Rubber membrane roofs have been installed to various sections of the roof area. The membranes are original to the building and are approximately 12 years old.

Heavy atmospheric build-up was noted around the extractor fan outlets throughout the roof covering.

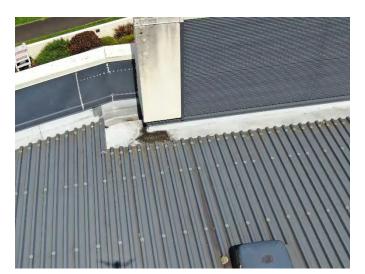
Photograph 61.

Rubber membrane gutters have been installed to various sections of the roof area. The membranes are original to the building and are approximately 12 years old.

Heavy atmospheric build-up was noted throughout the gutters. Vegetation growth was noted to the gutters. No ongoing maintenance appears to be carried out.

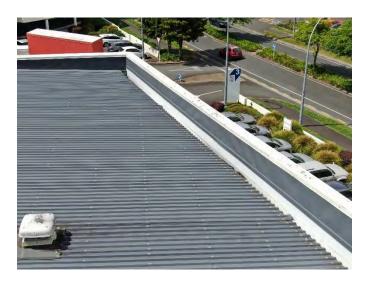
Photograph 62.

Rubber membrane gutters have been installed to various sections of the roof area. The membranes are original to the building and are approximately 12 years old.

Heavy atmospheric build-up was noted throughout the gutters. Vegetation growth was noted to the gutters. No ongoing maintenance appears to be carried out.

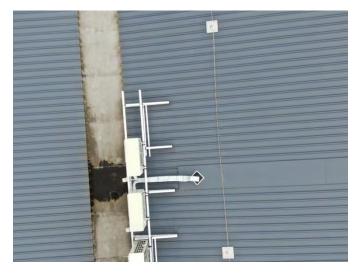
Photograph 63.

Rubber membrane gutters have been installed to various sections of the roof area. The membranes are original to the building and are approximately 12 years old.

Heavy atmospheric build-up was noted throughout the gutters. Vegetation growth was noted to the gutters. No ongoing maintenance appears to be carried out.

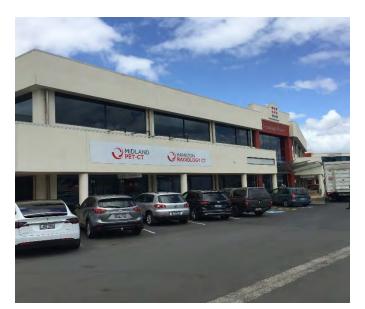
Photograph 67.

General view of the EIFS cladding to the east elevation.

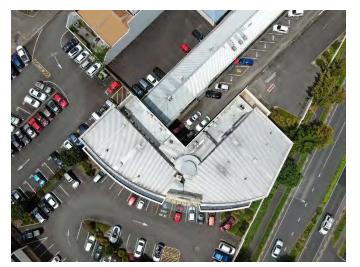
Photograph 80.

Numerous metal roof fixings have been over tightened, resulting in deflection of the roof covering. As a result a number of roof fixings are loose and proud of the roof surface.

Poorly formed roof to wall junctions were noted between the roof and EIFS cladding. The apron flashings terminate within the cladding with no stop-end to direct the water away from the face of the cladding.

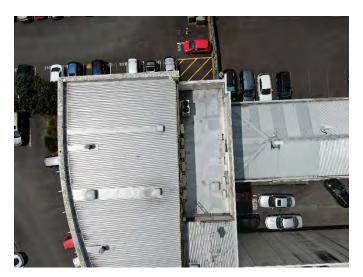
Photograph 81.

Several penetrations through the roof covering were noted, the penetrations have been flashed with a combination of pan and EPDM boot flashings. Atmospheric build-up was noted to the roof covering.

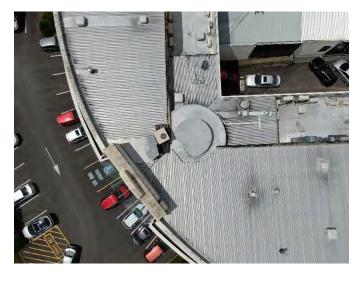
Photograph 82.

Several penetrations through the roof covering were noted, the penetrations have been flashed with a combination of pan and EPDM boot flashings. Atmospheric build-up was noted to the roof covering.

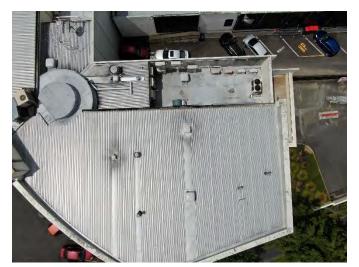
Photograph 83.

Several poorly formed junctions were noted to the cladding and include;

Poorly formed roof to wall junctions were noted between the roof and EIFS cladding. The apron flashings terminate within the cladding with no stop-end to direct the water away from the face of the cladding.

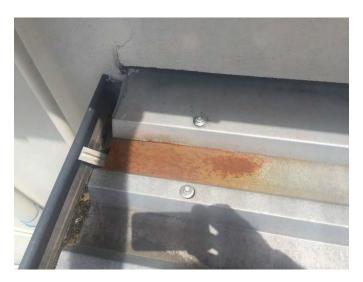
Photograph 84.

Several poorly formed junctions were noted to the cladding and include;

Poorly formed roof to wall junctions were noted between the roof and EIFS cladding. The apron flashings terminate within the cladding with no stop-end to direct the water away from the face of the cladding.

Lack of adequate clearance between the EIFS cladding and roof surfaces.

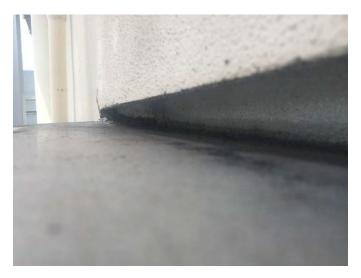
Photograph 85.

Several poorly formed junctions were noted to the cladding and include;

Poorly formed roof to wall junctions were noted between the roof and EIFS cladding.

Lack of adequate clearance between the EIFS cladding and roof surfaces.

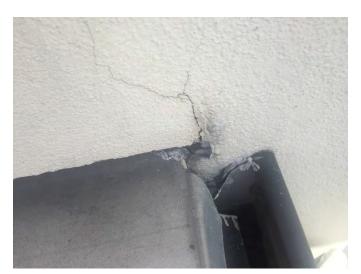
Photograph 86.

Several poorly formed junctions were noted to the cladding and include;

Poorly formed roof to wall junctions were noted between the roof and EIFS cladding.

Lack of adequate clearance between the EIFS cladding and roof surfaces.

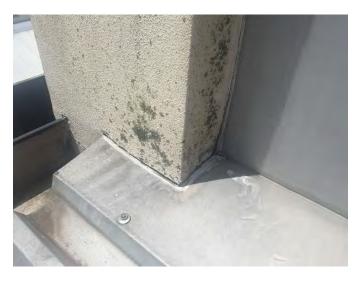
Photograph 87.

Several poorly formed junctions were noted to the cladding and include;

Poorly formed roof to wall junctions were noted between the roof and EIFS cladding.

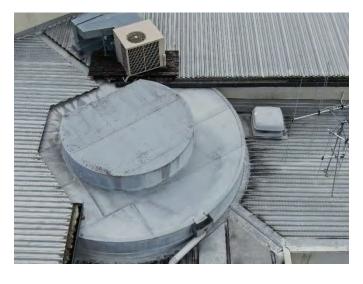
Photograph 91.

A membrane roof covering has been installed to the top of the lift shaft.

Blistering and loss of adhesion was noted to the membrane at the joints and junctions.

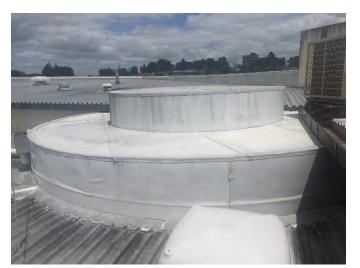
A membrane roof covering has been installed to the top of the lift shaft.

Blistering and loss of adhesion was noted to the membrane at the joints and junctions.

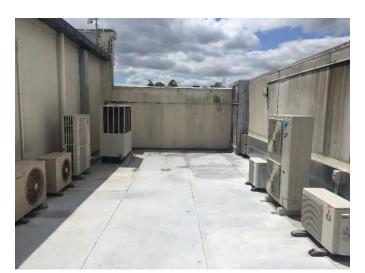
Photograph 98.

Degradation and splitting of the tilt-slab polysulphide mastic joints was noted in isolated locations.
