TECHNICAL DUE DILIGENCE REPORT

213-221 TUAM STREET
CHRISTCHURCH

PMG Direct Office
Fund

Date:
24 January
2020

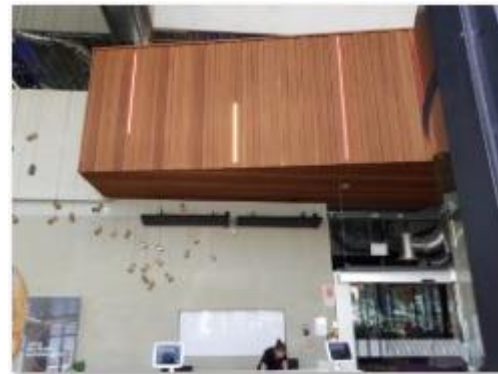
M2 – Electric heaters at reception

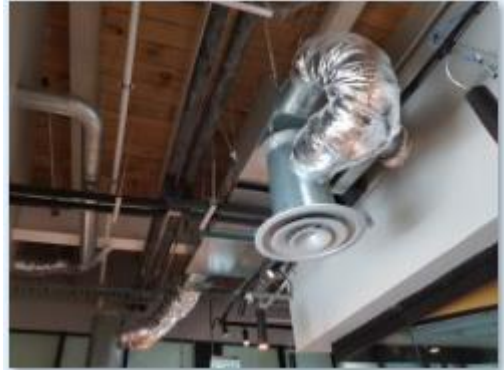
M4 – Typical exposed supply duct and Grille

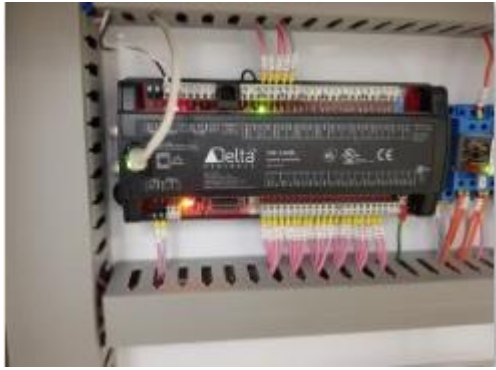
M9 – HVAC Controller

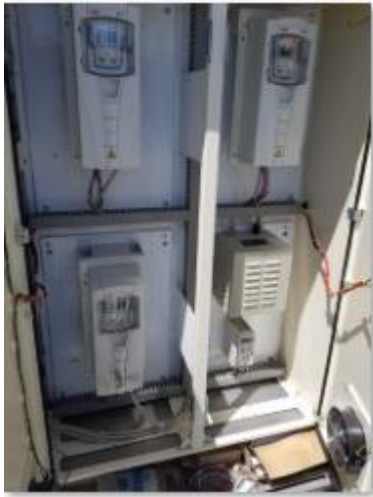
M15 – HVAC Roof mounted VSDs

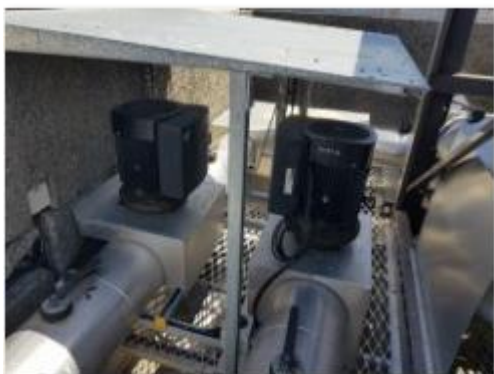
M17 – Chilled water pumps and pipe work on Roof

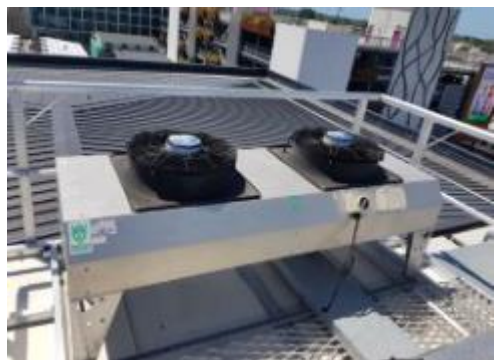
M19 –HVAC Dry cooler on top of AHU

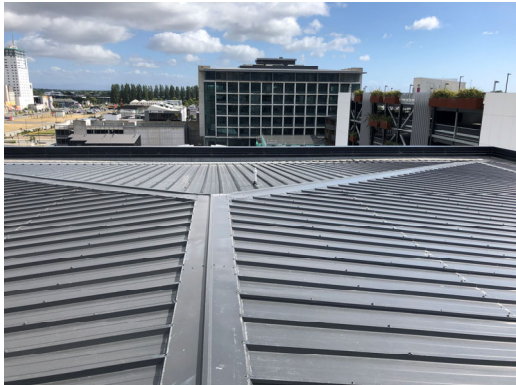
1.1. General view of roof areas

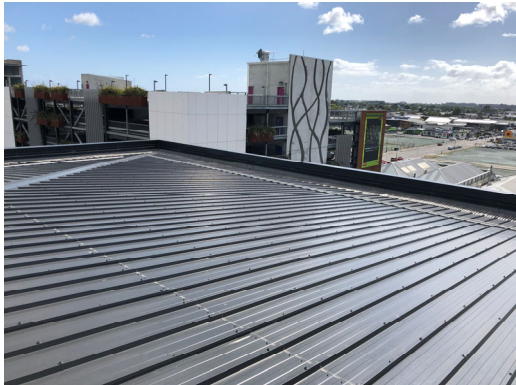
1.2. General view of roof areas

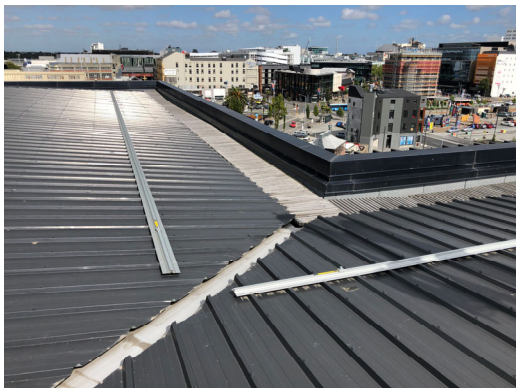
1.3. General view of roof areas

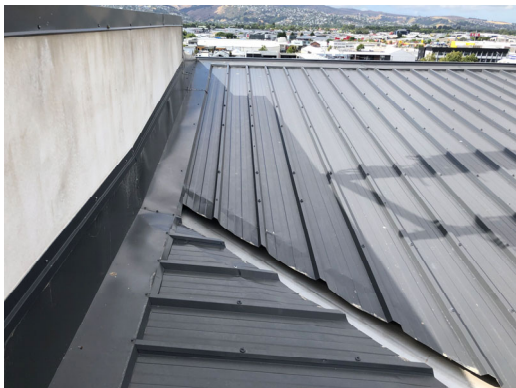
1.4. General view of roof areas

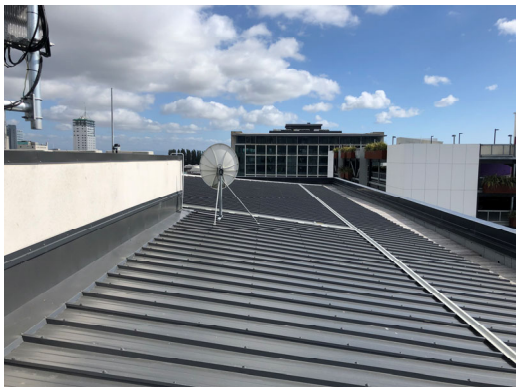
1.6. General view of roof areas

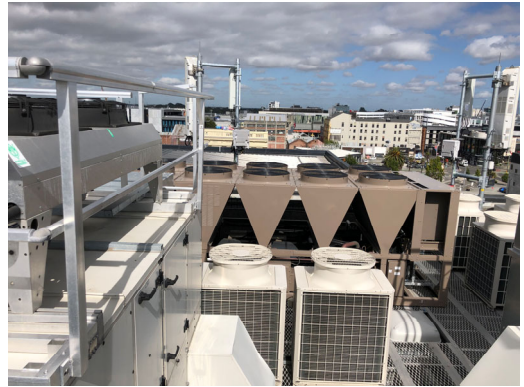
1.8. General view of plant areas

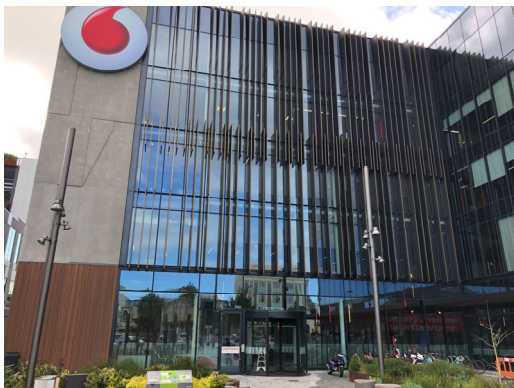
1.11. View of external elevations

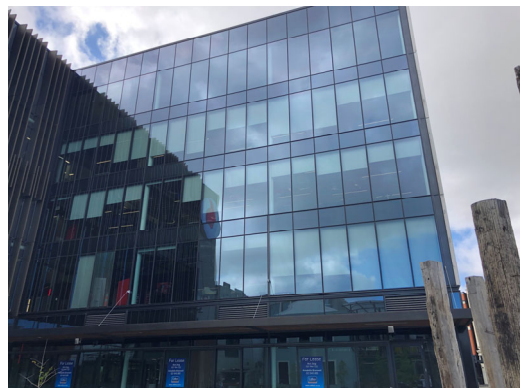
1.12. View of external elevations

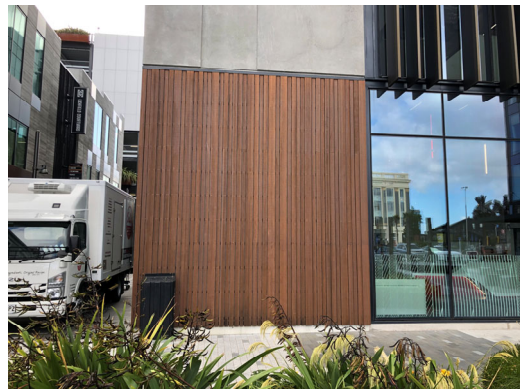
1.16. Vertical stained timber cladding

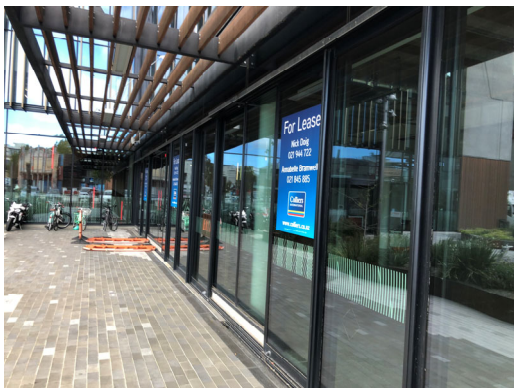
1.23. View of office frontage

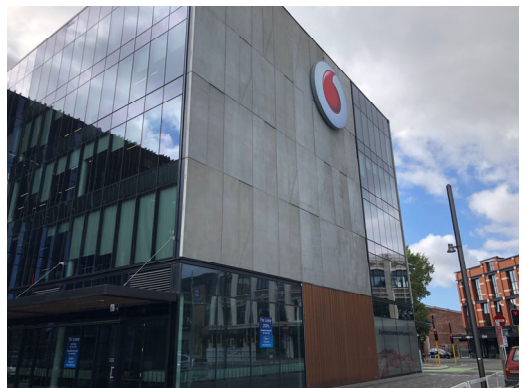
1.24. Concrete panels to external elevation

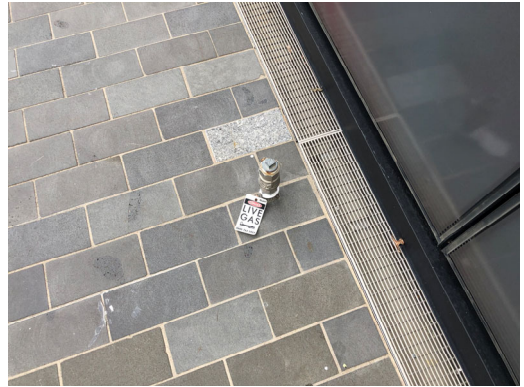
1.26. View of gas supply point

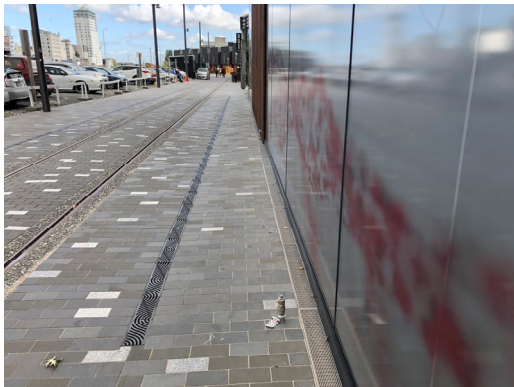
1.27. General view of tram lines and side road

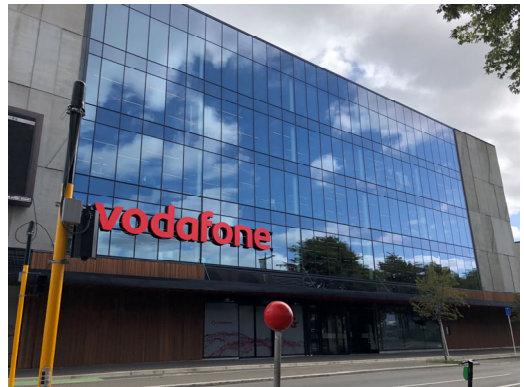
1.28. General view of south facing elevation

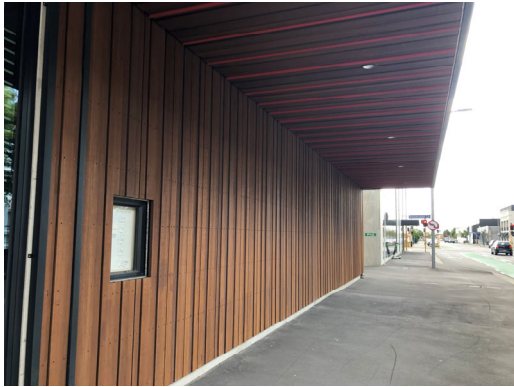
1.31. View of timber cladding to south elevation

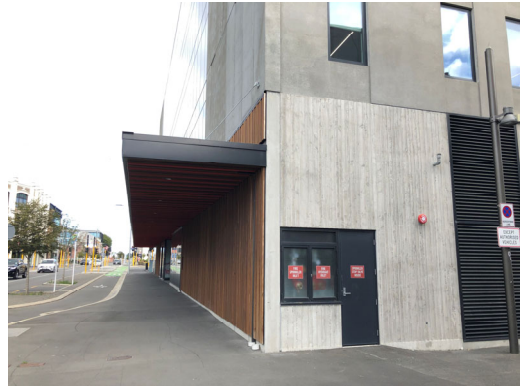
1.32. South east corner of building

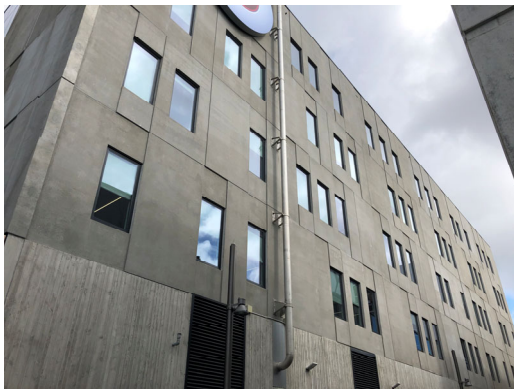
1.33. View of east elevation

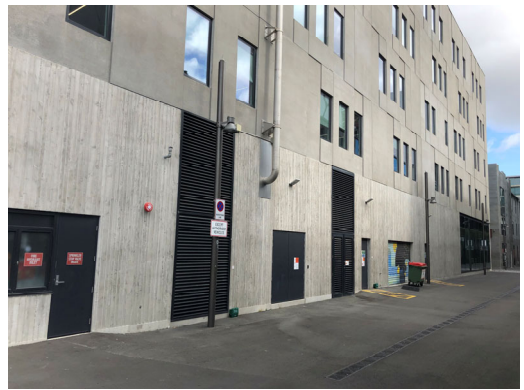
1.34. View of east elevation

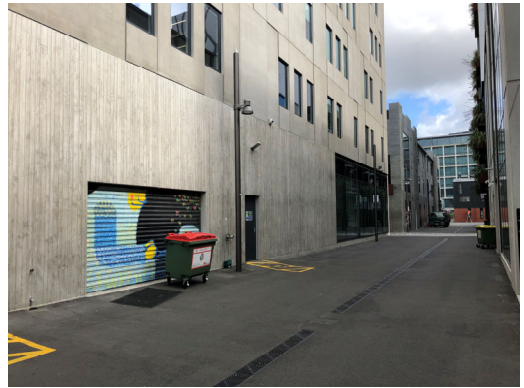
1.36. General view of east access road

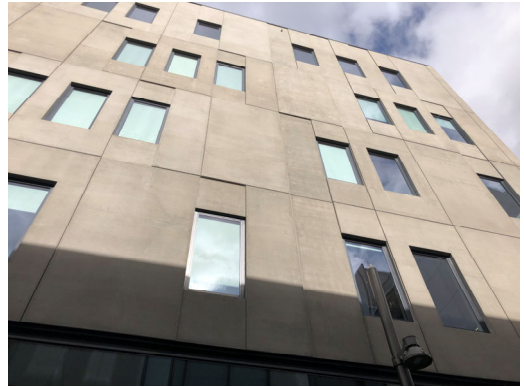
1.38. Precast concrete elevations

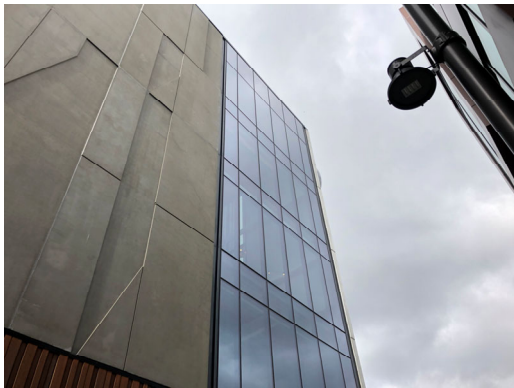
1.41. General view of north elevation
