TECHNICAL DUE DILIGENCE REPORT

Castle Rock Business Park

Mary Muller Drive

Date: 14th September 2018

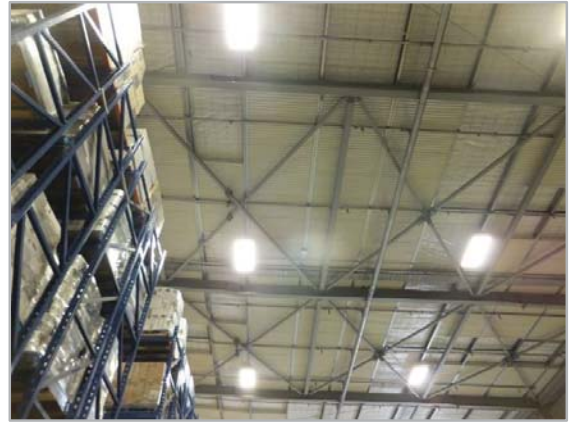
20. Diagonal Bracing Used to Unit 9 Roof Structure

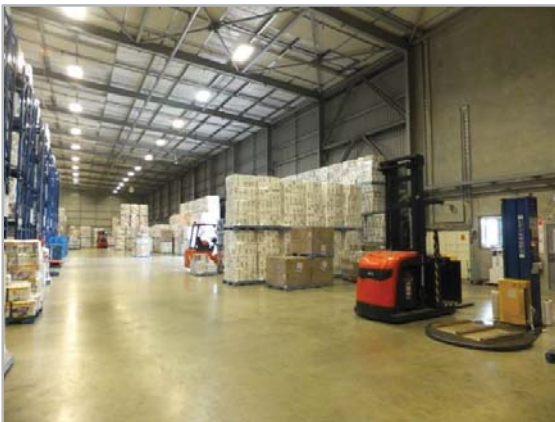
21. Diagonal Bracing Used to Unit 9 Columns

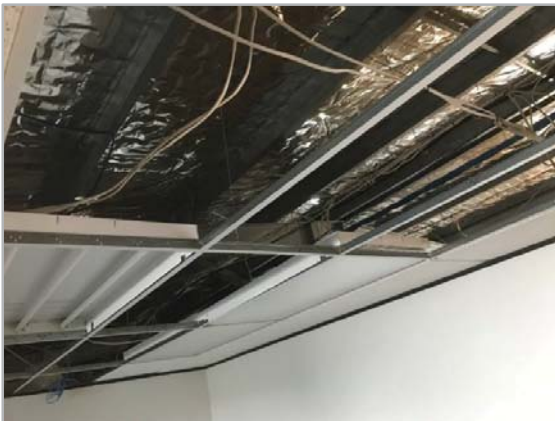
23. Underside of Roof, Unit 10A Chapmans Road

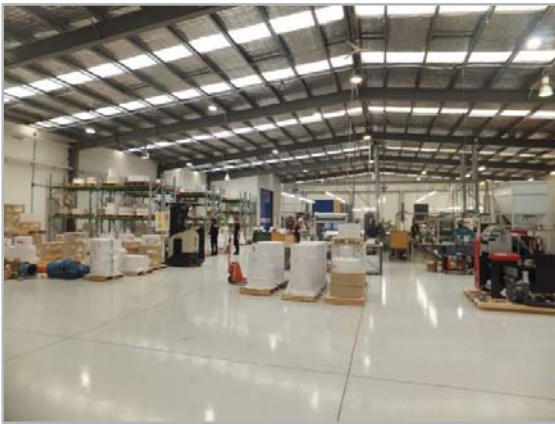
33. Painted Floor Slab, Unit 6

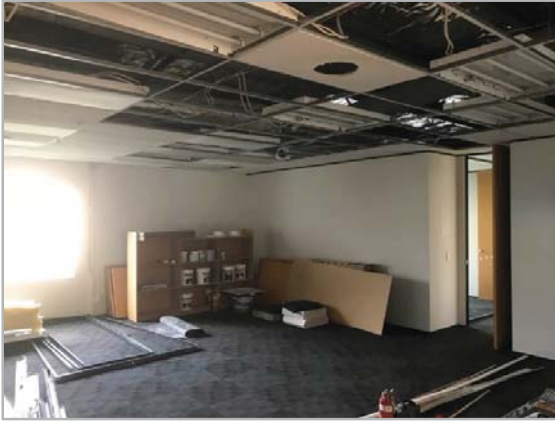
37. Internal Area Requiring Refurbishment, Unit 10A Chapmans Road

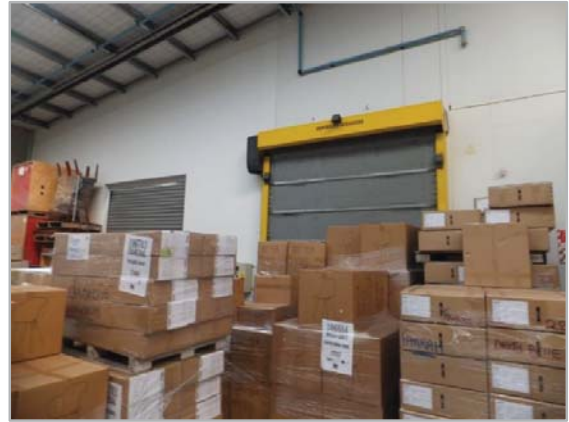
38. Roller Shutter Openings in Inter-Tenancy Wall, Unit 15

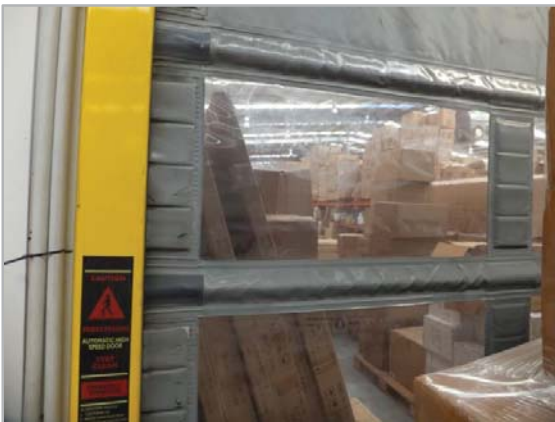
39. Poor Security in Inter-Tenancy Wall, Unit 15

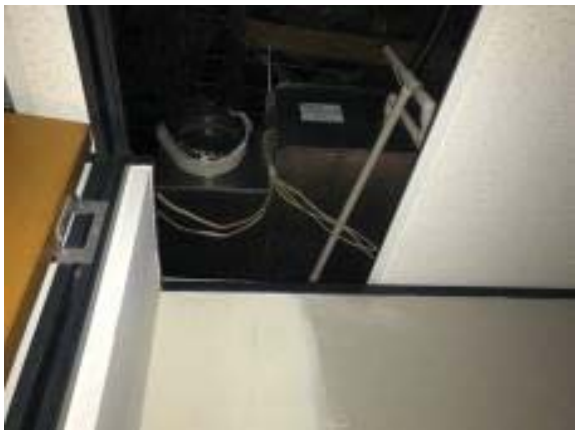
3. Vacancy ceiling works
