# TECHNICAL DUE DILIGENCE REPORT

255-257 GYMPIE ROAD  
KEDRON QLD 4031

Reliant Party: Augusta Funds Management

Date: December 2018

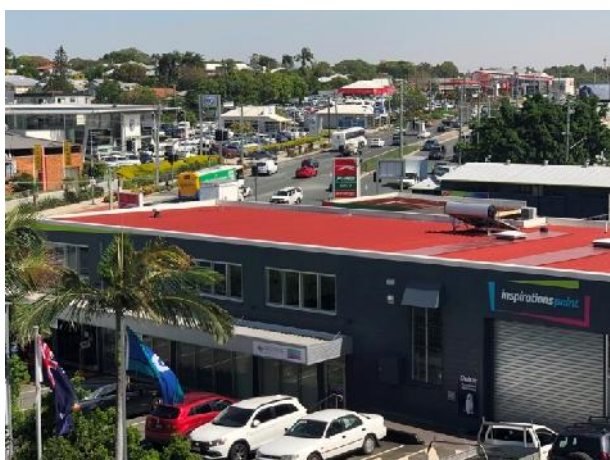
Building A1/3 Capping scribe break sealed

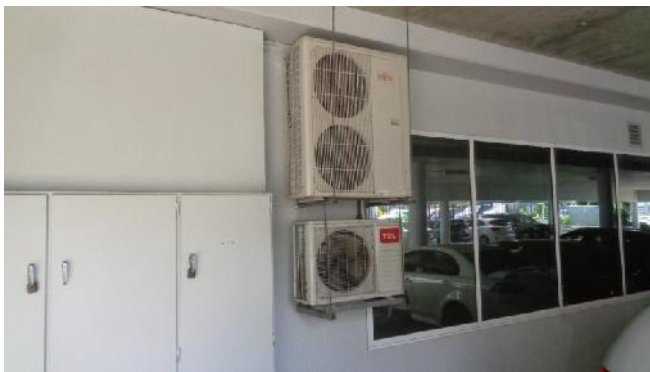
Hail damaged condenser
