Red Flag Report

For and on behalf of
**CENTURIA FUNDS
MANAGEMENT (NZ) LIMITED**

6-14 Chappie Place
Hornby
Christchurch
New Zealand

FEBRUARY 2026
P25-0161

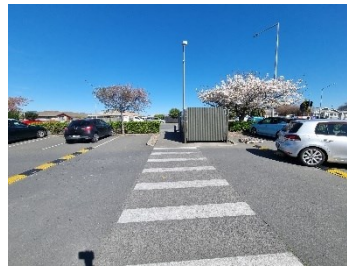
16. Bin structures to south and east of carparks. Bin structure to south obstructed view of and from crossing.

Code	Defect	Recommendation	Timescale (yrs)	Approximate Cost
●	<p>Impact damage and general deterioration of the panels to enclosure.</p> <p>Bin enclosure to the west of the site (facing retail unit 3) blocks visibility of pedestrians waiting at the designated crossing.</p>	<p>Replace the freestanding bin structures in the long term.</p> <p>Consider relocating the bin enclosure towards the west of the site, adjacent to the crossing.</p>	10	\$15,000

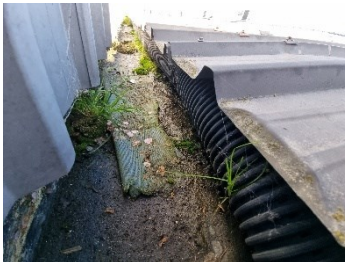
33. Block C - Vegetation and silt build-up in internal gutters throughout.

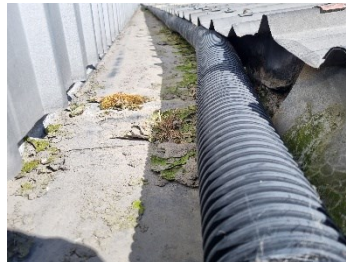
34. Block C - Coil drain installed to base of roof sheets at membrane upstand.

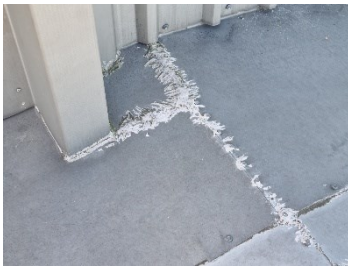
39. Block C - Sealant applied to flashing junctions in several locations across roofs.

●	All Blocks - Sealant applied at various flashing junctions around service penetrations. Sealant is not a long-term solution and will allow moisture ingress over time.	Block A & B – Replace all sealant finishes on an annual basis. Block C - Replace all flashings during roof replacement works.	5-10 Years *Subject to recommended repairs being undertaken as outlined within the attached FHS report.	Included in roof replacement above.
●	All Blocks - Confirm whether design/ composition of composite panels poses a fire risk. Drawings and specification documents reference 'Alucobond' 6mm panelling but do not specify the exact type.	Allow for further investigation to confirm type and flammability of panelling.	1	\$4,500
●	Block B – Reports of historic and intermittent moisture internal moisture ingress around penetrations. No access available to Block B roof.	Further investigation required. Undertake additional roof investigation to confirm source of moisture ingress and acceptable repair solution.	1	\$2,500

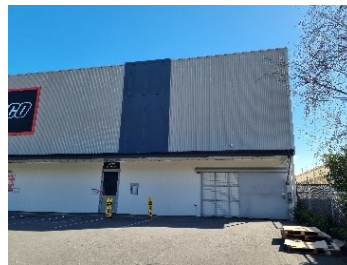
46. Block C - Aluminium composite panels utilised to localised areas.

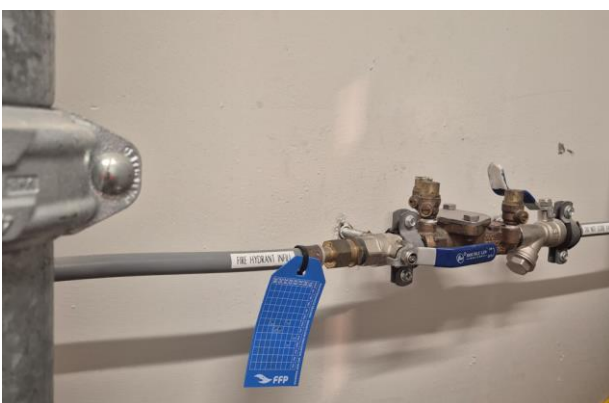
F5 – Building Hydrant water infill. Note BFP test tag due to test

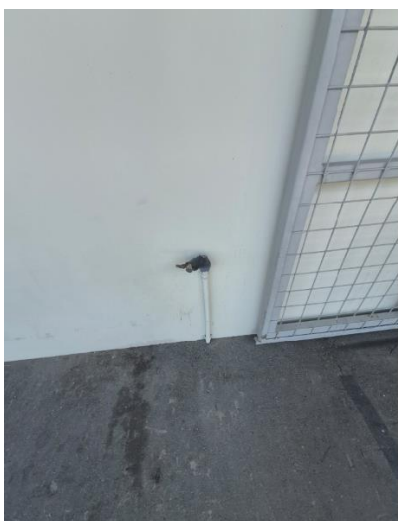
H11 –External hosetap without vacuum breaker

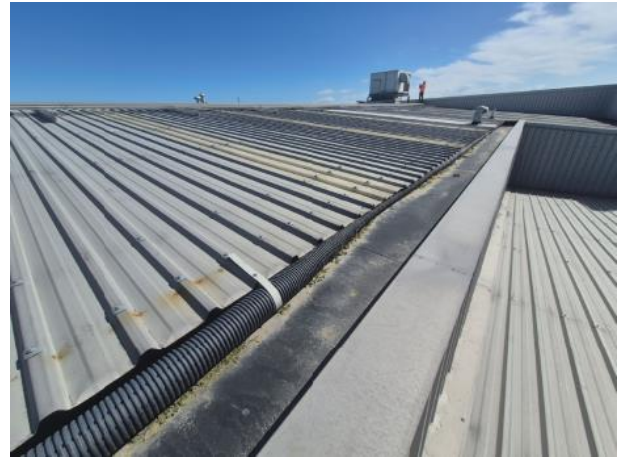
H16 – Block C roof internal gutter with drainage coil

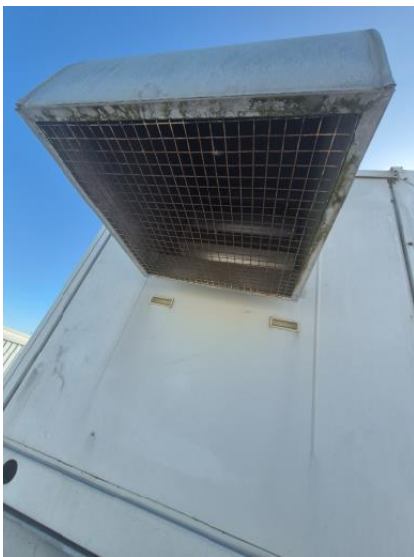
M2 – Block C PAC unit with moderate corrosion on chassis rails

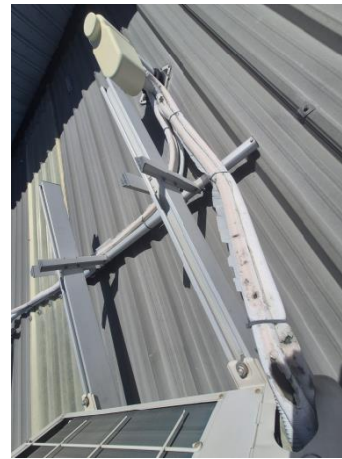
M8 – AC outdoor units with split insulation at seam leaving refrigerant. exposed

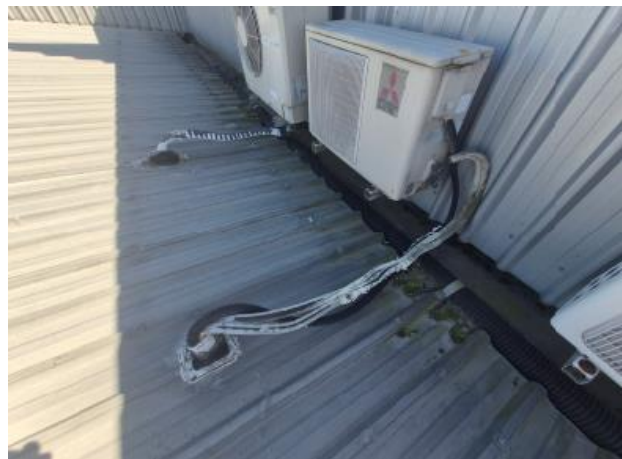
M10 – AC outdoor units with split insulation at seam leaving refrigerant pipework exposed

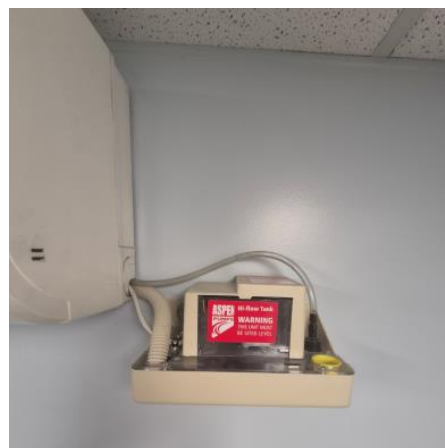
M12 – Block A & B tenancy Comms Room Hi-wall condensate pump

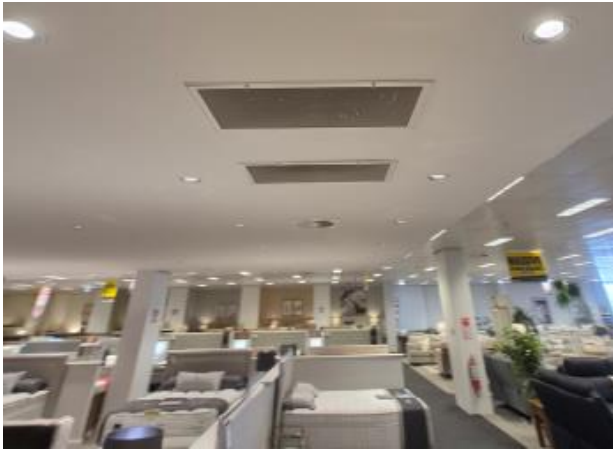
M13 – Block A & B tenancy typical return diffuser

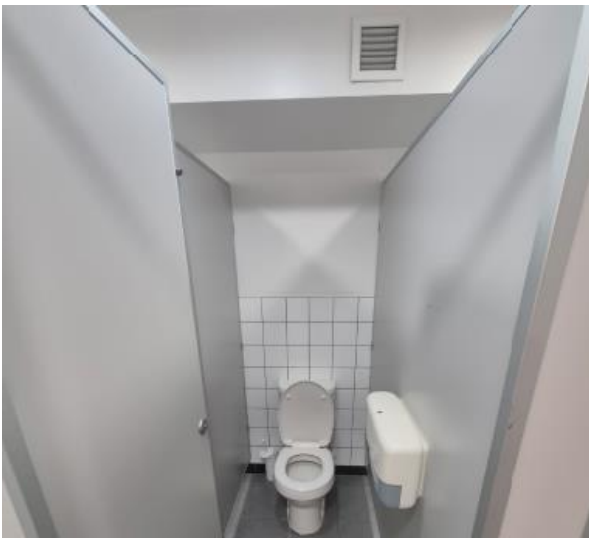
M15 – Block A & B WC extract linear diffuser

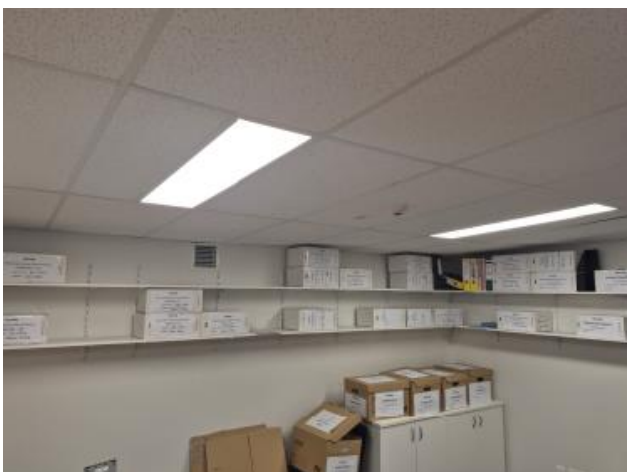
M17 – Block A & B Level 1 Admin return diffuser

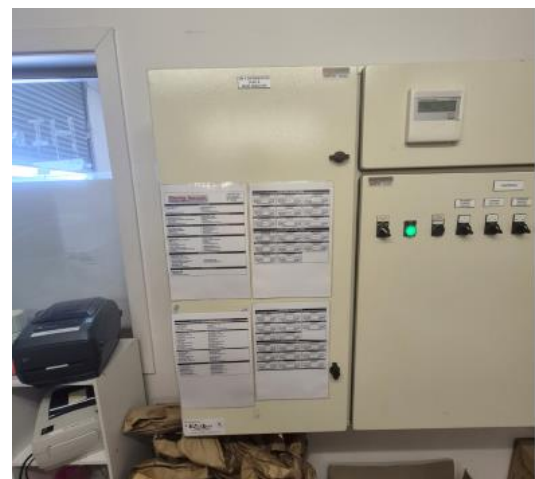
M18 – Block A & B mechanical services switchboard with Mitsubishi Lossnay controller and various fan controls

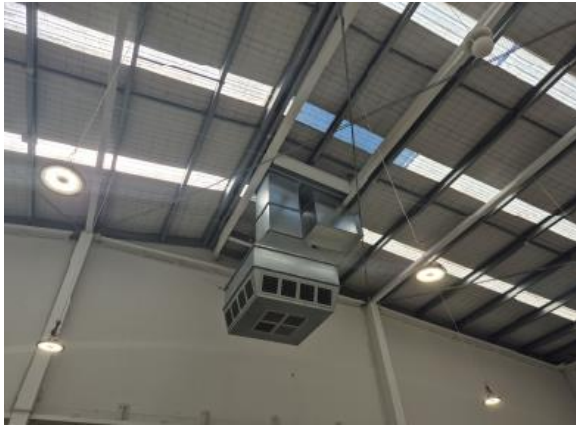
M19 – Block C tenancy typical PAC unit downward supply and return plenum diffuser

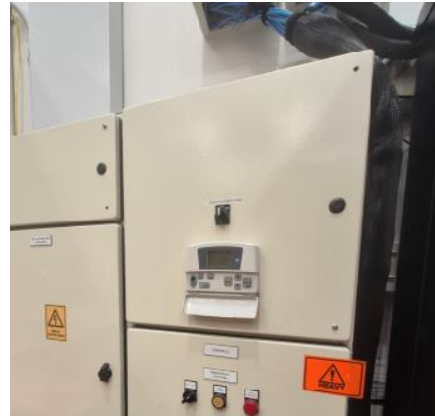
M20 – Block C PAC controller and WC extract fan controls

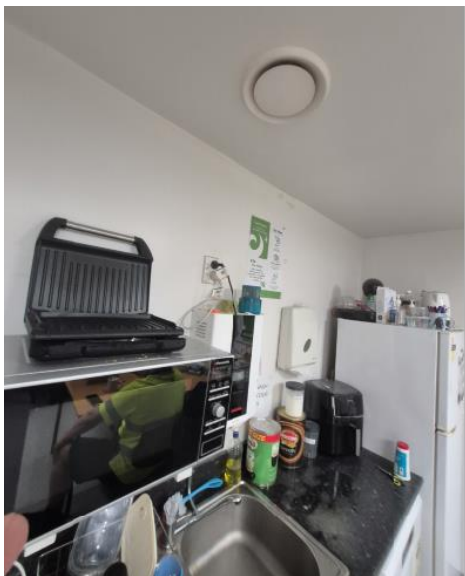
M21 – Block C tenancy staff kitchenette extract diffuser

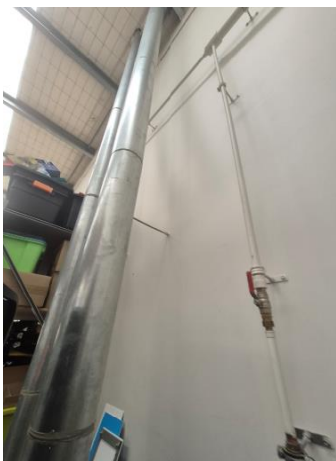
M23 – Block C tenancy WC and Kitchen extract ductwork
