Land Information Memorandum

Property address:
2 Mary Muller Drive

LIM number: 70211569
Page 1

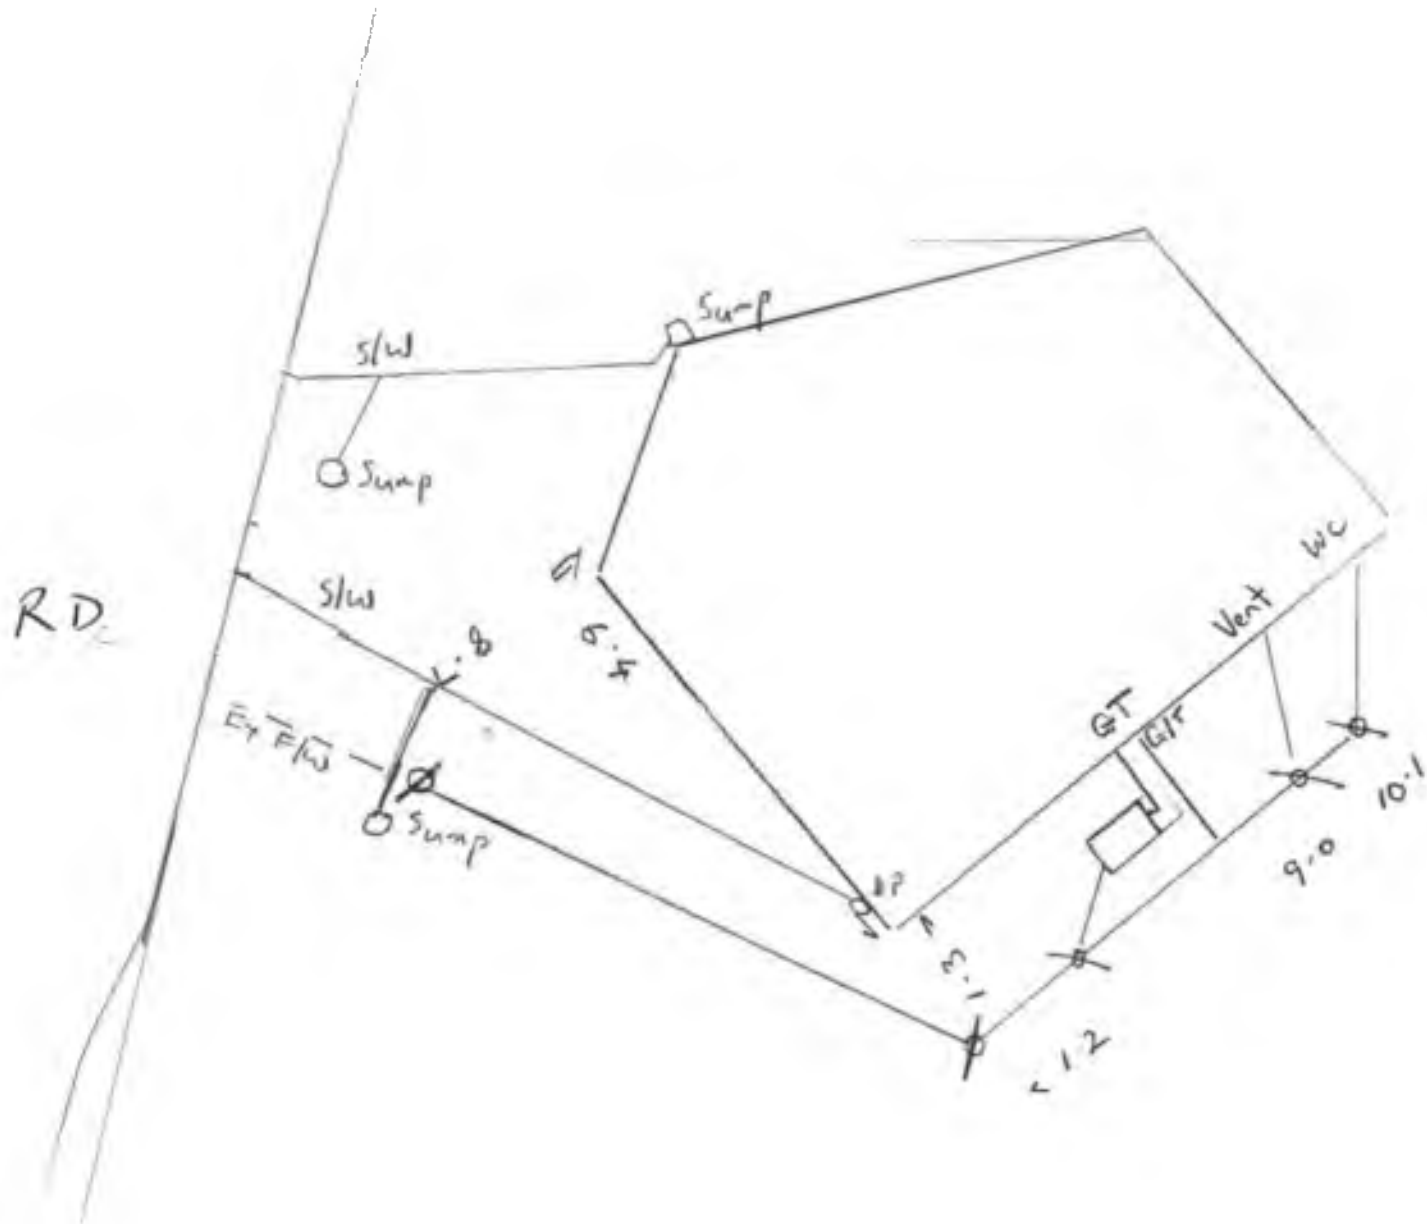
Mary Miller Drive 225' Sewer
Main Repair and New 100' PVC
Sewer Lat to No 5/06 Calcom
Consent 10062360.

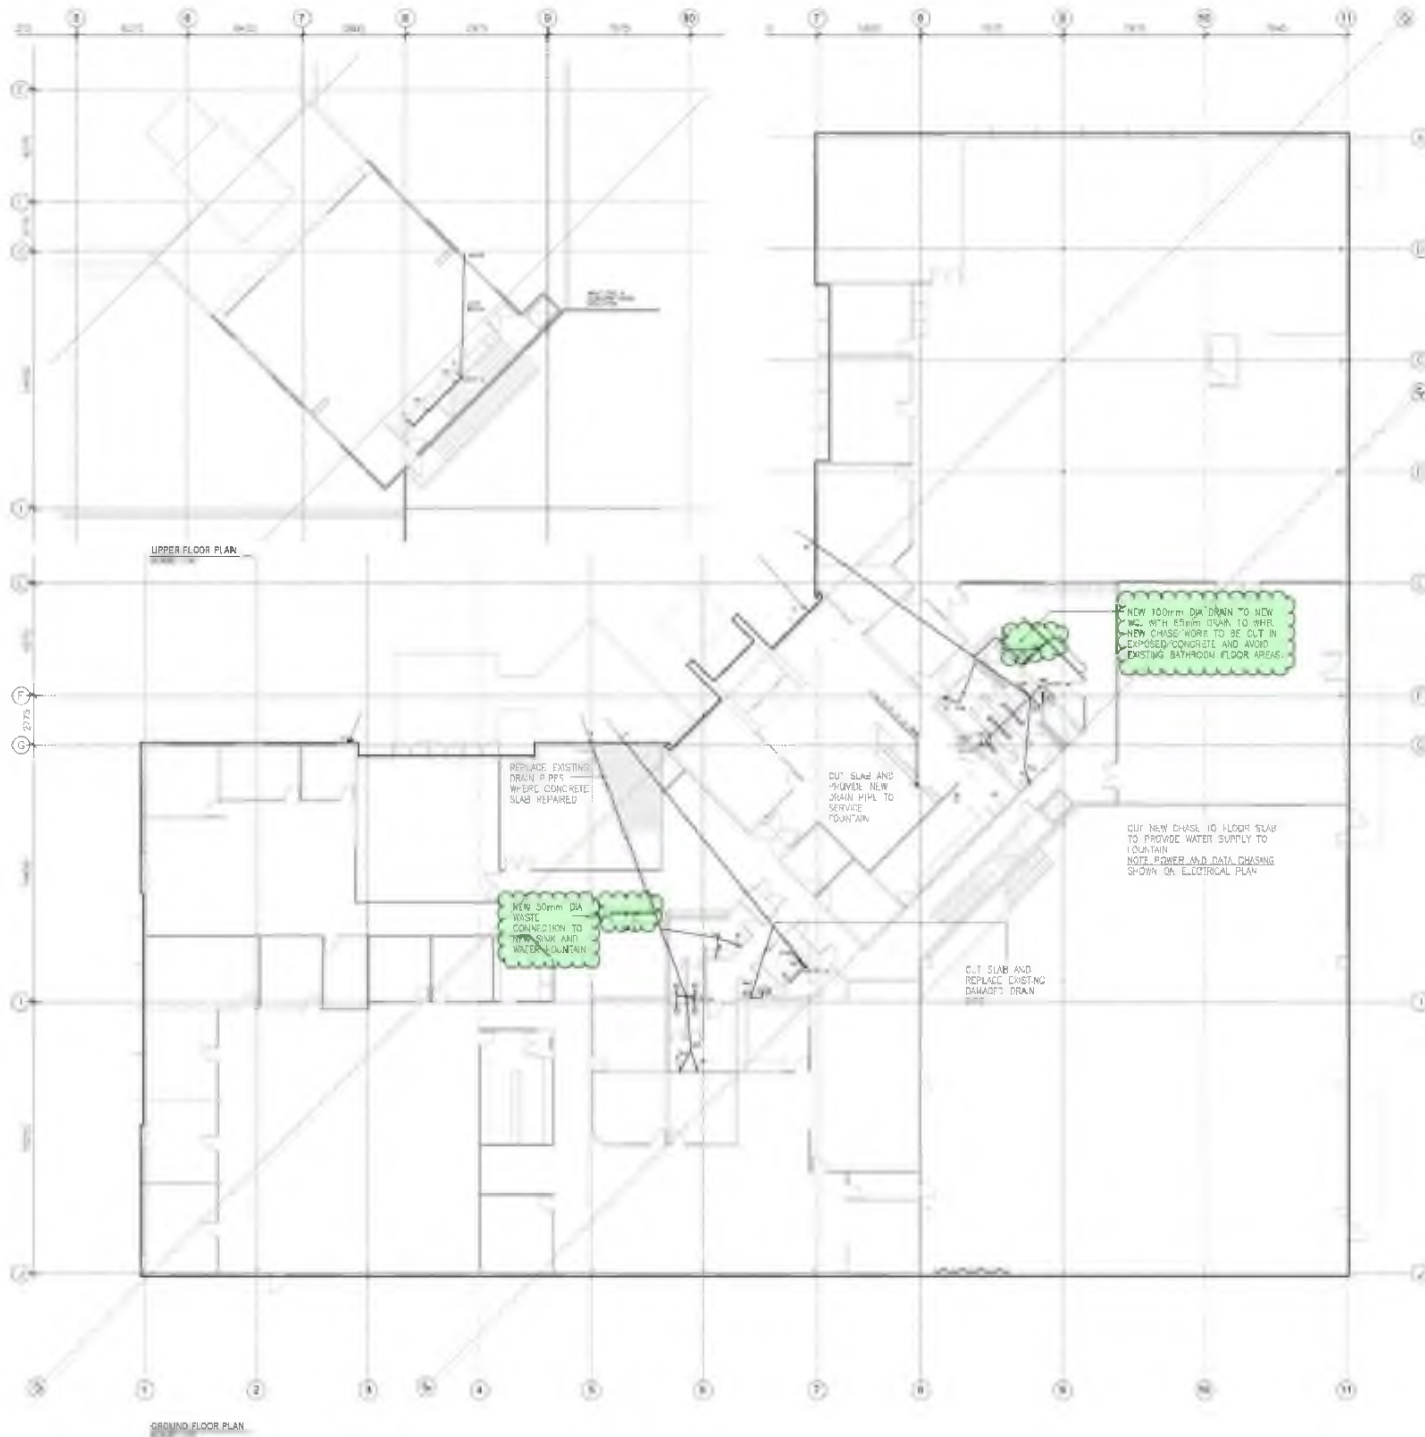
1. 100mm dia drain to new WC, with 50mm drain to whirl. New chase hole to be cut in exposed concrete and avoid existing bathroom floor areas.

3. Cut slab and repair new drain pipe to service fountain.

5. Cut slab and replace existing damaged drain.

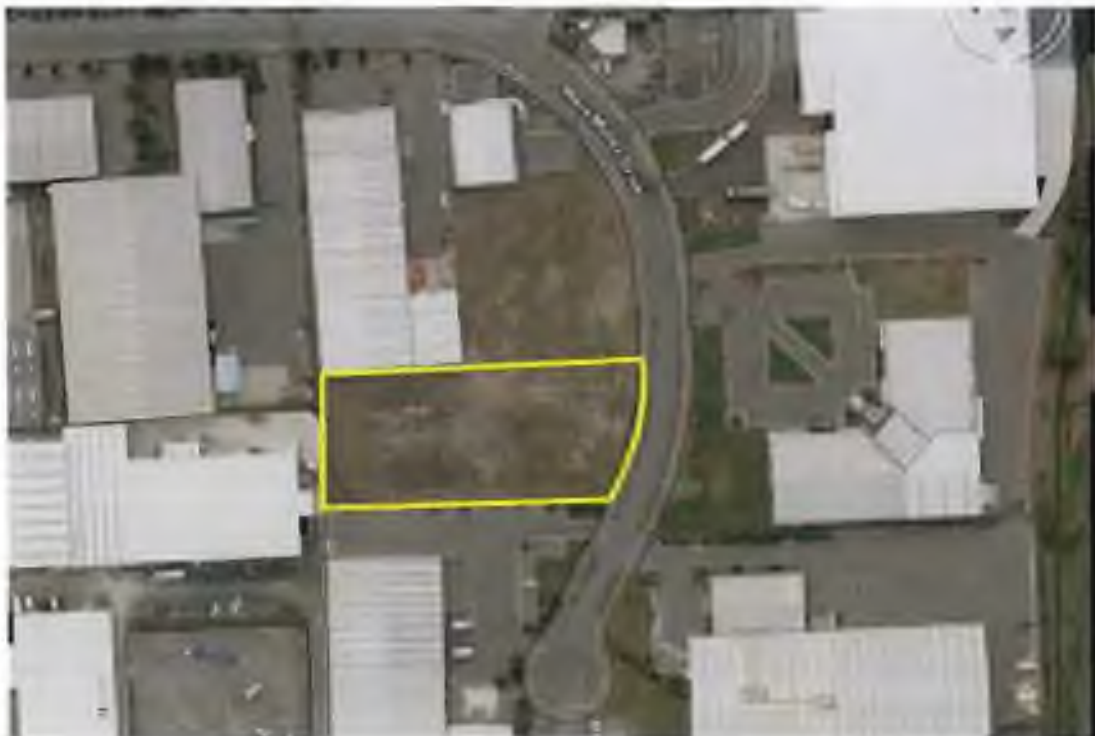
Diagram 1: Site location plan (approximate boundary in yellow), (source: Canterbury Recovery, Project Orbit, photo from 24 February 2011).

The Wyatt Print building is located immediately south of the site, and the Bidvest coolstore is located to the west. Refer to Diagram 1.

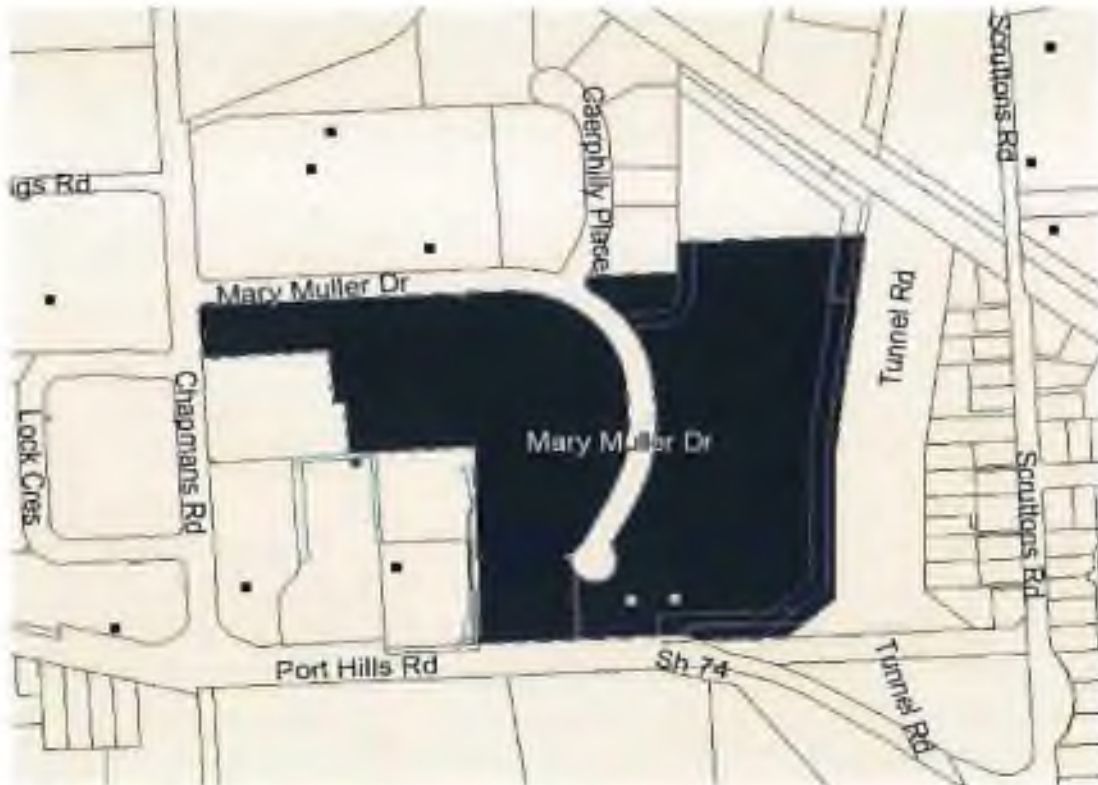
Diagram 2: Lot 2 DP306637, (shaded in black) Source: Quick Map, March 2012.

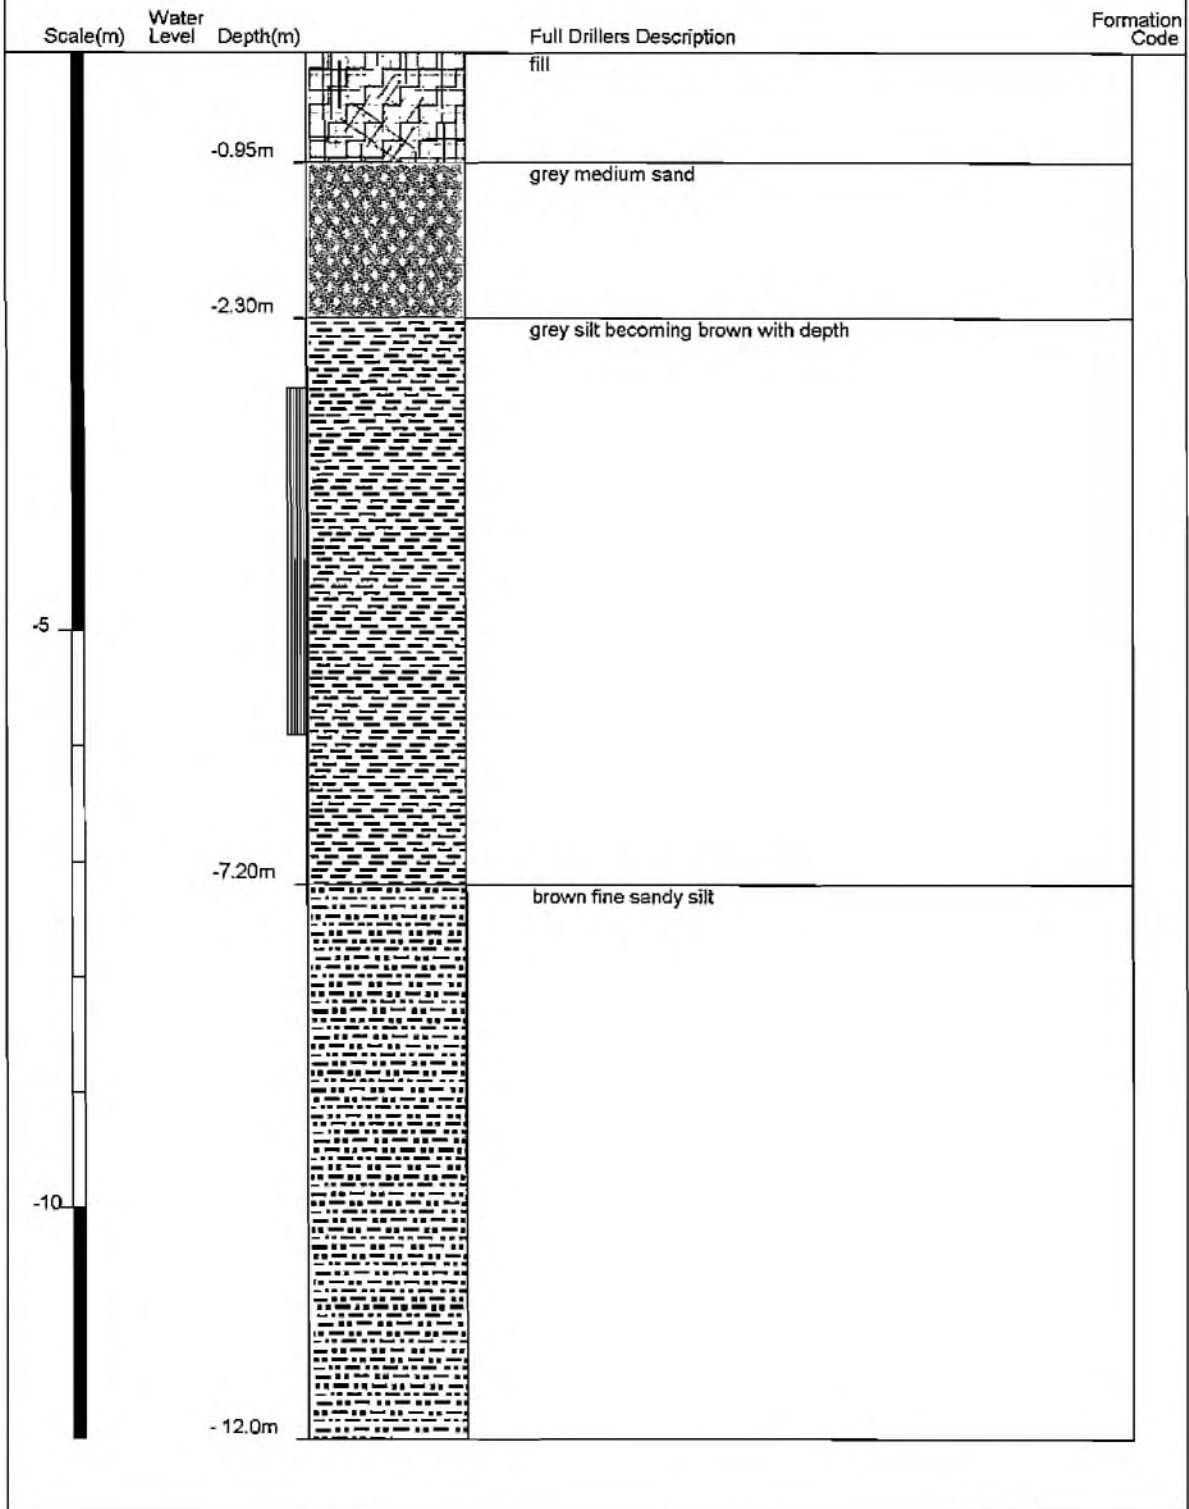
Bore or Well No: M36/1170

Gridref: M36:852-375 Accuracy : 4 (1=best, 4=worst)
 Ground Level Altitude : 4.8 +MSD
 Driller : Job Osborne (& Co/Ltd)
 Drill Method : Unknown
 Drill Depth : -18.2m Drill Date : 1/05/1961

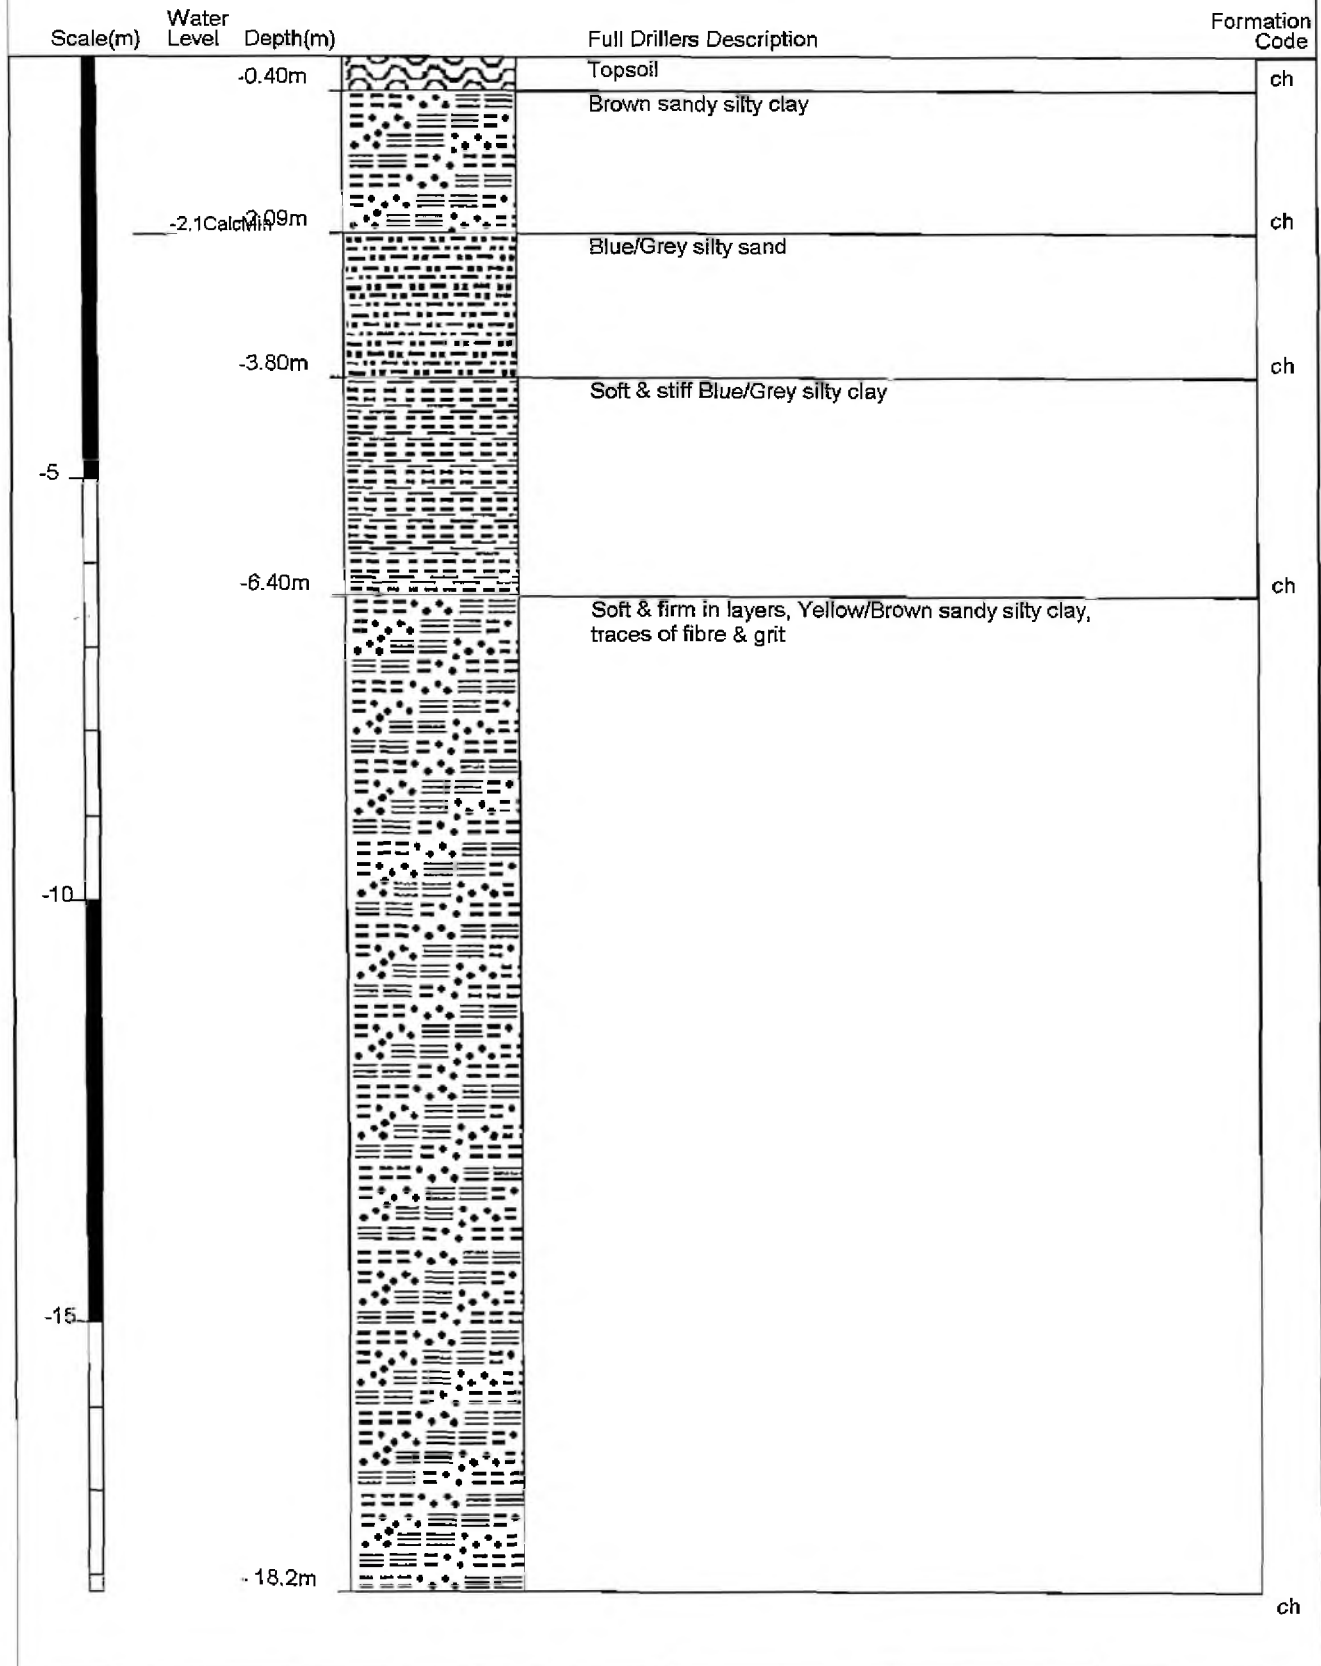
Bore or Well No: M36/3883

Gridref: M36:8449-3767 Accuracy : 4 (1=best, 4=worst)
 Ground Level Altitude : 2.6 +MSD
 Driller : Canterbury Drilling Company
 Drill Method : Cable Tool
 Drill Depth : -16m Drill Date : 12/03/1987

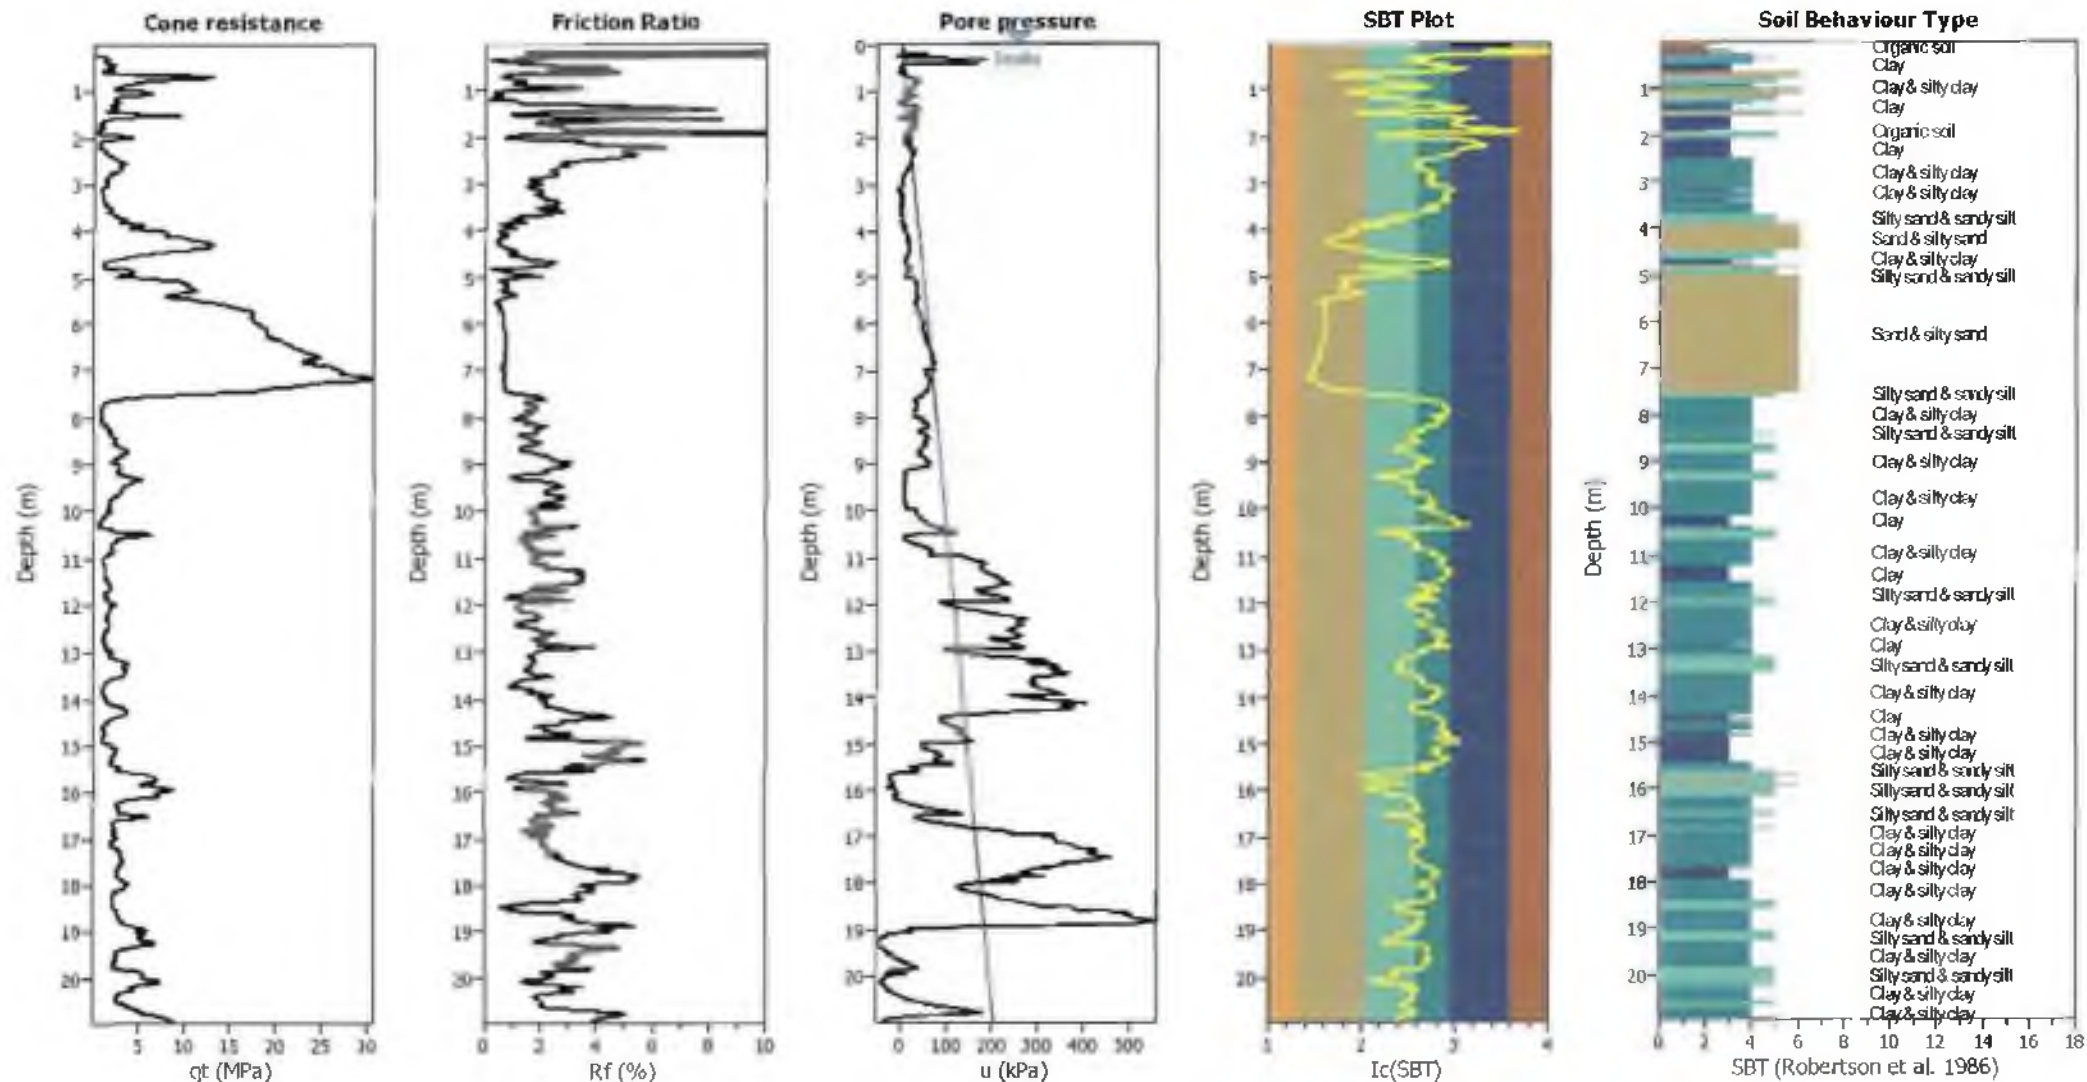
CPT basic interpretation plots

Input parameters and analysis data

Analysis method:	NCEER (1998)	Depth to water table (erthq.):	0.50 m	Fill weight:	N/A
Fines correction method:	NCEER (1998)	Average results interval:	3	Transition detect. applied:	No
Points to test:	Based on Ic value	Ic cut-off value:	2.60	K _a applied:	Yes
Earthquake magnitude M _w :	7.50	Unit weight calculation:	Based on SBT	Clay like behavior applied:	Sands only
Peak ground acceleration:	0.15	Use fill:	No	Limit depth applied:	No
Depth to water table (Insitu):	0.00 m	Fill height:	N/A	Limit depth:	N/A

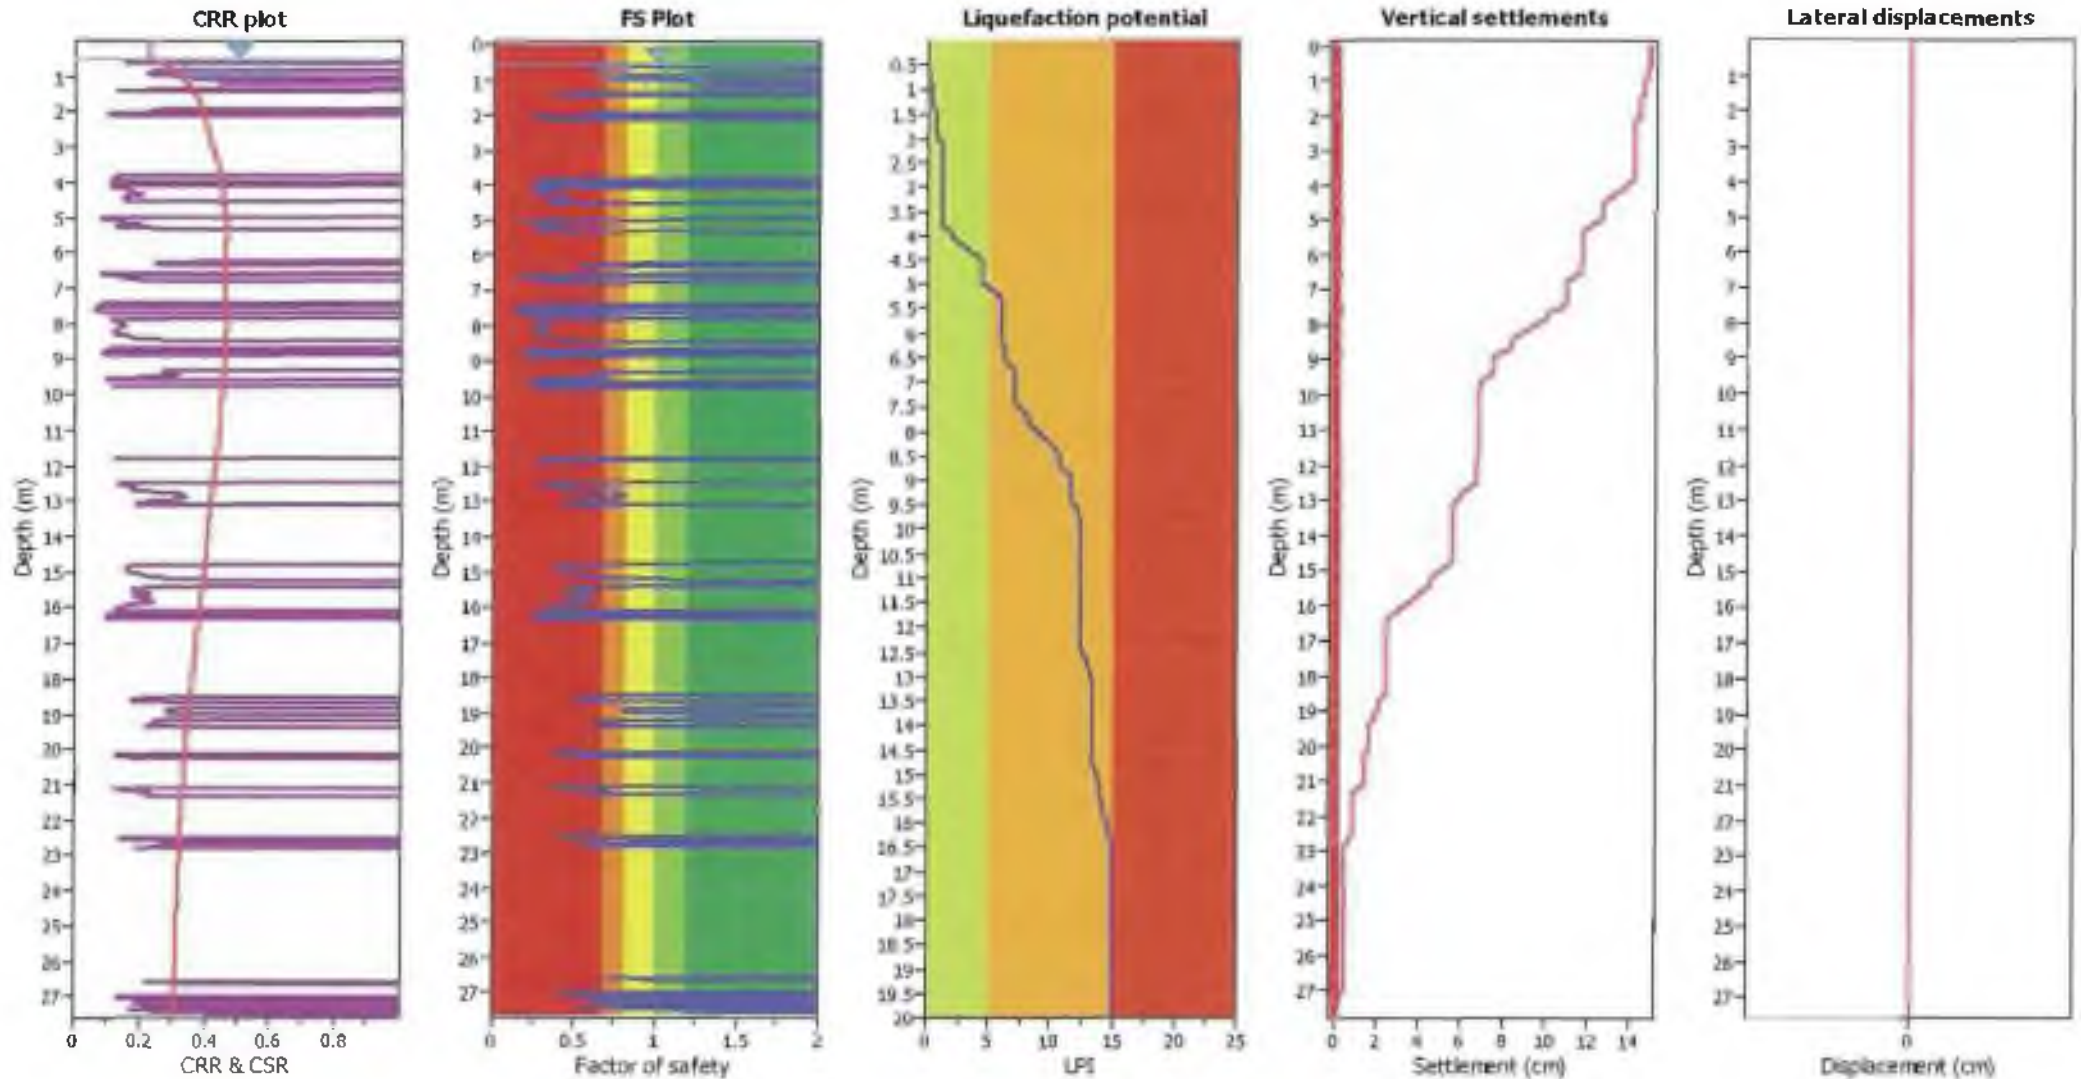
Liquefaction analysis overall plots

Analysis method:	NCEER (1998)	Depth to water table (earthq.):	0.50 m	Fill weight:	N/A
Fines correction method:	NCEER (1998)	Average results interval:	3	Transition detect. applied:	No
Points to test:	Based on Ic value	Ic cut-off value:	2.60	K_{σ} applied:	Yes
Earthquake magnitude M_w :	7.50	Unit weight calculation:	Based on SBT	Clay like behavior applied:	Sands only
Peak ground acceleration:	0.35	Use fill:	No	Limit depth applied:	No
Depth to water table (Inst):	2.50 m	Fill height:	N/A	Limit depth:	N/A

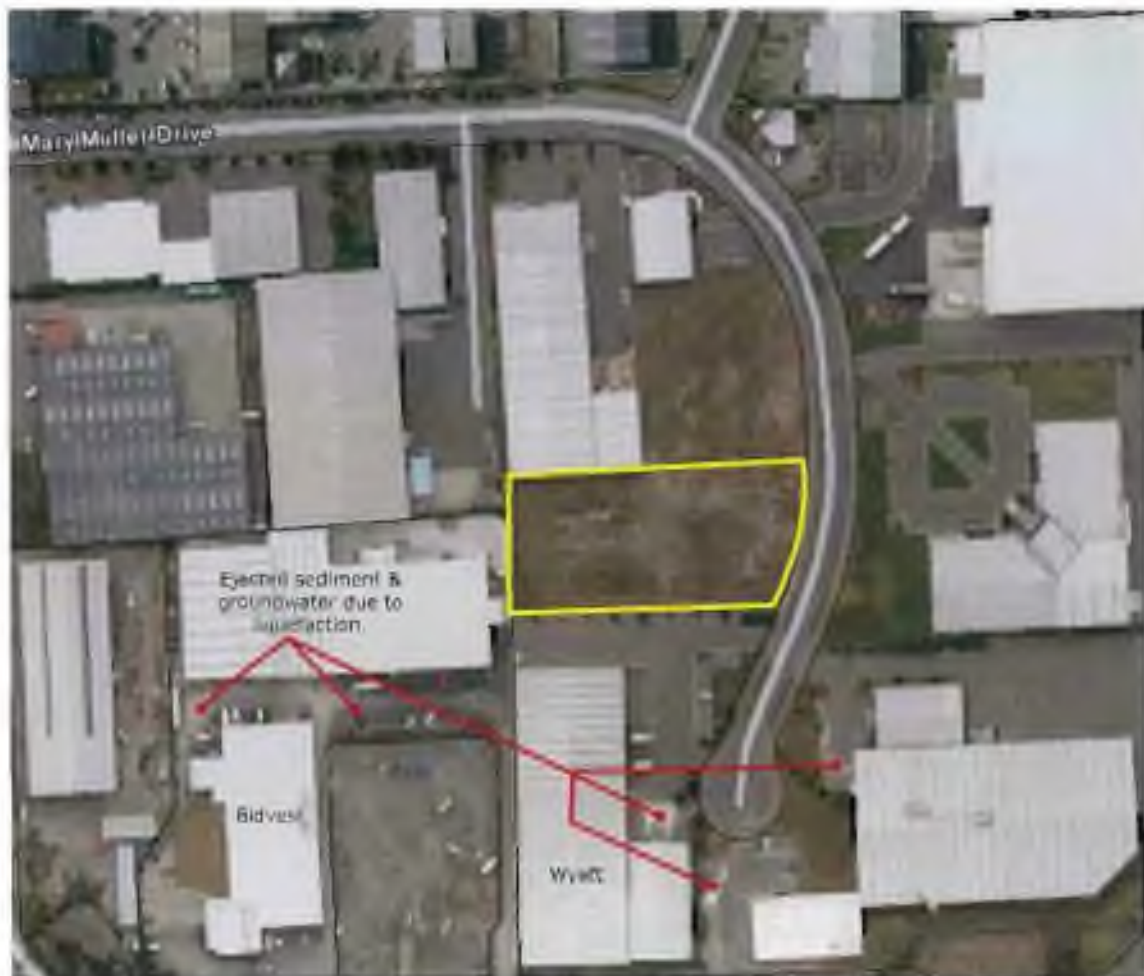
16. APPENDIX E – OBSERVED LAND DAMAGE

Land Damage on Mary Muller Drive. The approximate site boundary is in yellow. Source: Canterbury Recovery, Project Orbit. Photographs taken 24 February 2011.

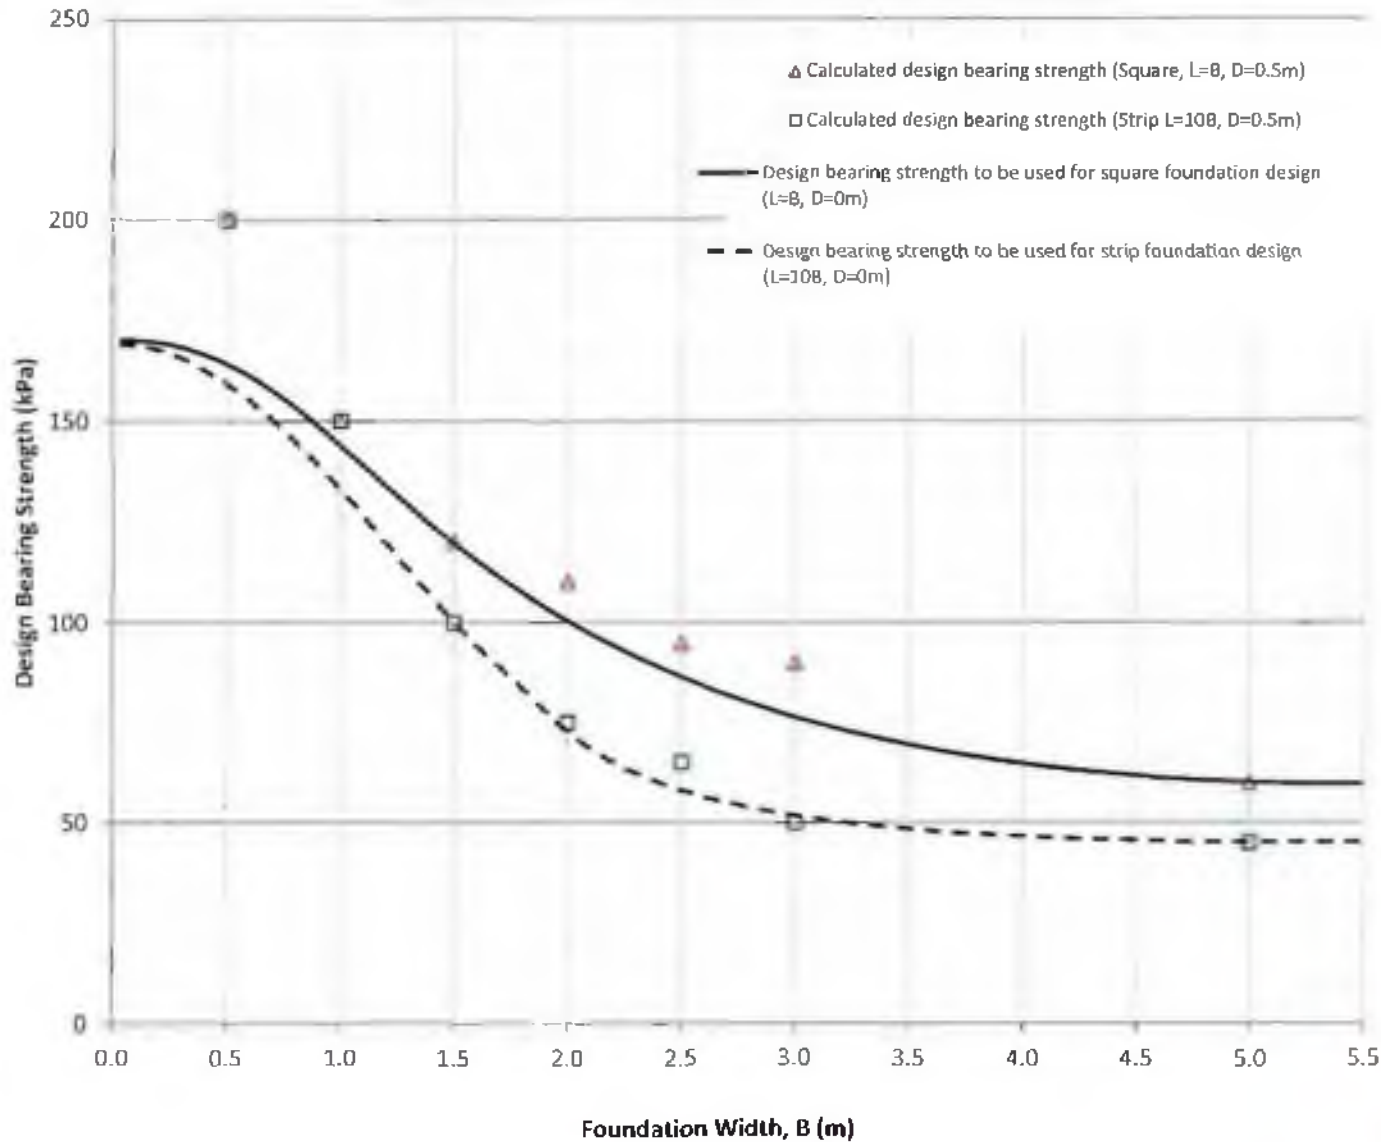
BEARING CAPACITY CONTROL OF SHALLOW FOUNDATIONS

Notes:

Foundation depth, $D = 0m$ below existing GL

Assumes 2m depth of compacted AP65 hardfill to underside of foundation, with min width $B+2T$

Structural Engineer should also design bearing strength of chart 'Settlement Control of Shallow Foundations'.

Design bearing strength = $0.5 \times$ Ultimate bearing strength [in accordance with NZBC Verification Method BM1/VMA4, Table 1, For bearing and passive earth pressure (all other load combinations)]

Design bearing strength at smaller foundation width has been conservatively limited as shown to take into account the presence of lower soil layers, or inferred geotechnical conditions indicated from other test results at an adjacent site.

- Support the building on strip or pad foundations for the office and factory buildings that extend through all fill materials and bear onto insitu silts at around 2m depth, with a maximum design bearing strength determined using the ultimate bearing capacities shown on the charts in Appendix E and F, and
- Ensure that all building foundations and floor slabs are well-reinforced and connected to limit the effects of differential settlement and provide a resilient foundation system, and
- Limit the floor load for all floor slabs constructed over densified historic fill to **20kPa** in order to limit calculated floor settlements under static conditions to around 25mm over 50 years.

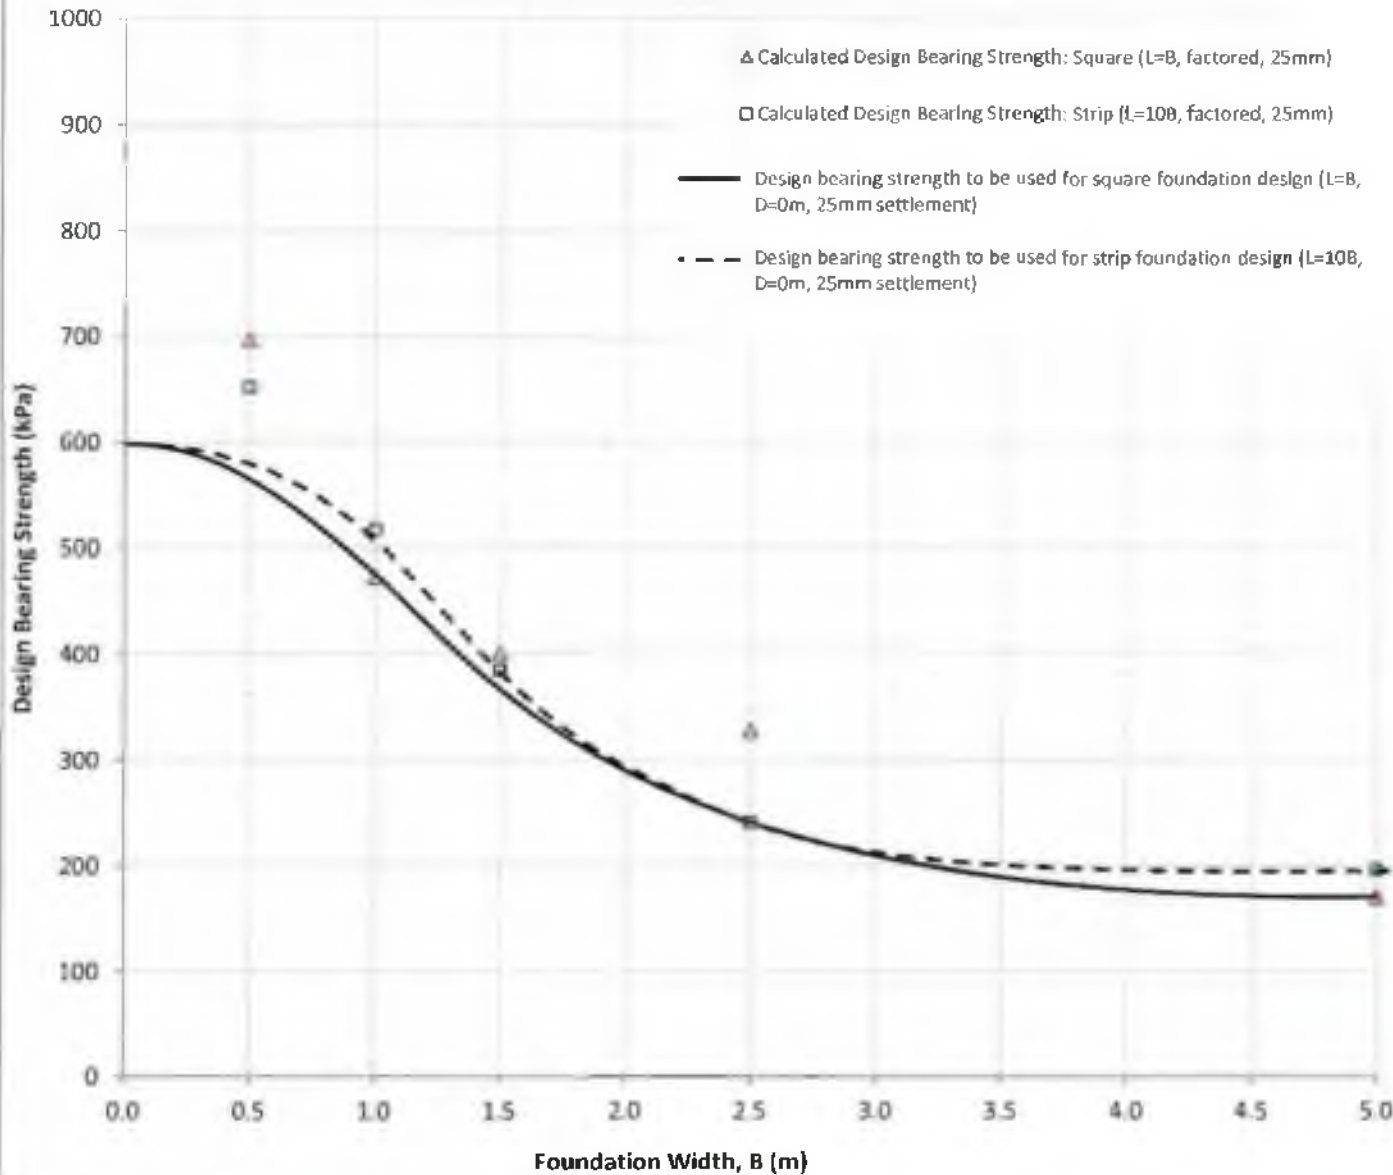
SETTLEMENT CONTROL OF SHALLOW FOUNDATIONS

Notes:

Foundation depth, $D = 0\text{m}$ below existing GI.

Assumes 2m depth of compacted AP65 hardfill to underside of foundation, with minimum width $B \geq 2T$ (m)

Duration = 50 years, max 25mm total settlement under non-seismic conditions, calculated using Schmertmann method.

Structural Engineer should also check bearing capacity of foundations, refer to 'Bearing Capacity of Shallow Foundations' chart.

Design bearing strength = $0.5 \times$ Ultimate bearing strength [in accordance with NZBC Verification Method BM1/VM4, Table 1, For bearing and passive earth pressure (all other load combinations)]

Design bearing strength at smaller foundation width has been conservatively limited as shown to take into account the presence of lower soil layers, or inferred geotechnical conditions indicated from other test results at an adjacent site.

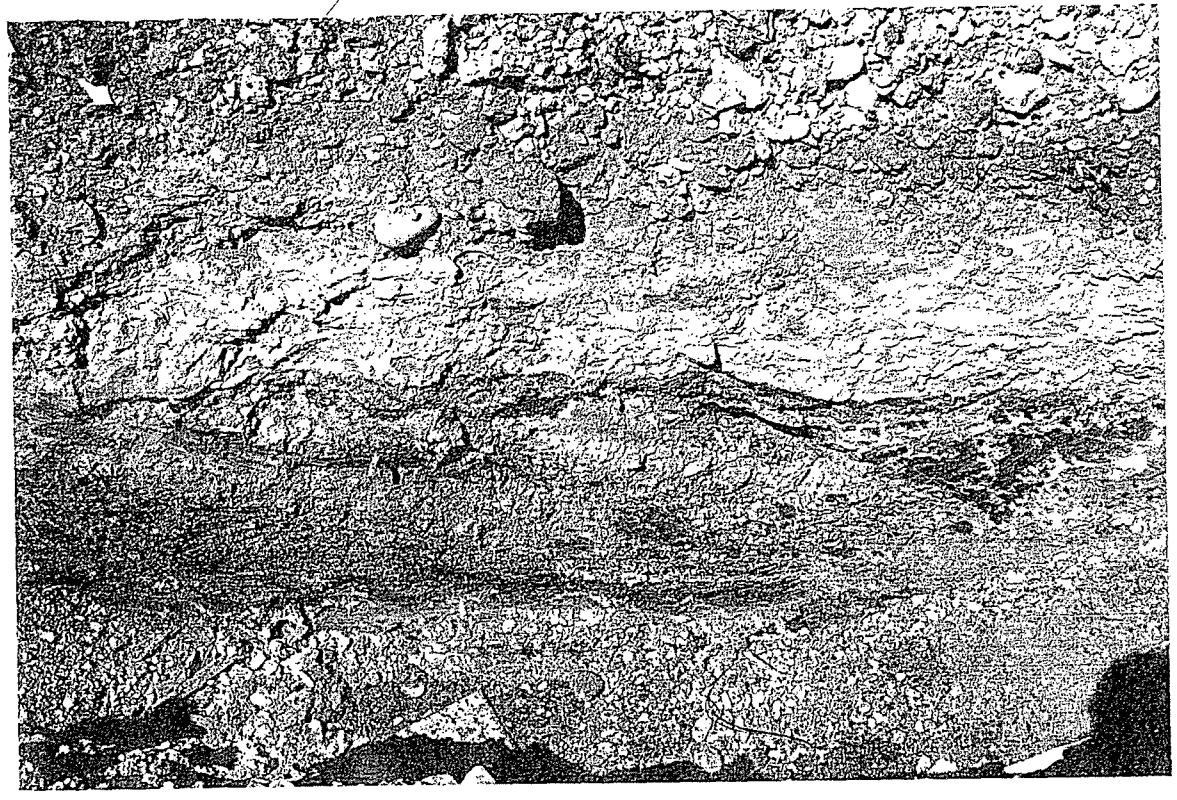
SITE INVESTIGATION
 PROJECT: PROPOSED SUBDIVISION OF PT. R.S.274

DEPTH GL= 0.0	HOLE No. 19.	
	Firm Gravelly Silt.	
0.5	silt, some stones & building rubble.	0.5
1.0	limit of trench. solid layer of brick prevented further excavation	1.0
1.5		1.5
2.0		2.0
2.5		2.5

NOTES.
 No density test.

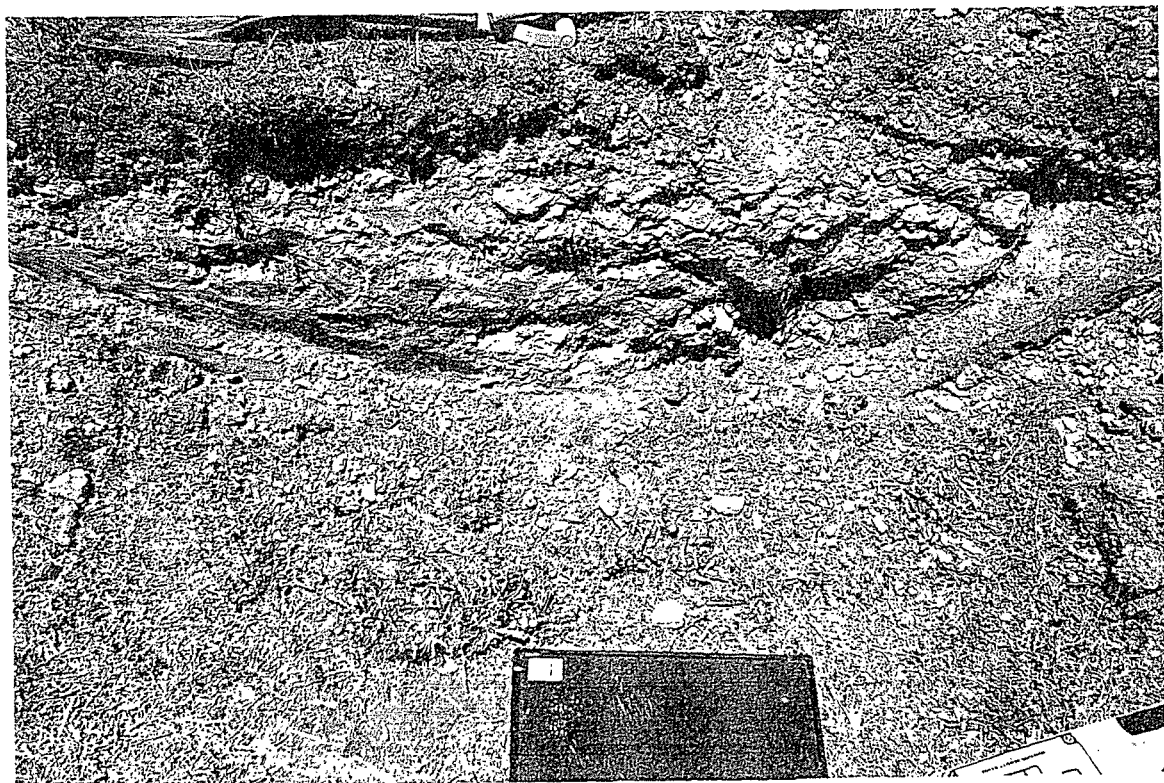
SITE INVESTIGATION
 PROJECT: PROPOSED SUBDIVISION OF PT. R.S. 274

DEPTH GL= 0.0	HOLE No. 15	
	Gravelly silt fill.	
0.5	layer of concentrated building rubble.	0.5
1.0	Gravelly silt fill with thin layers of black ash	1.0
1.5		1.5
2.0	becoming generally uniform silt. water table at approximately 1-8M.	2.0
2.5		2.5

NOTES.
 No Density test.

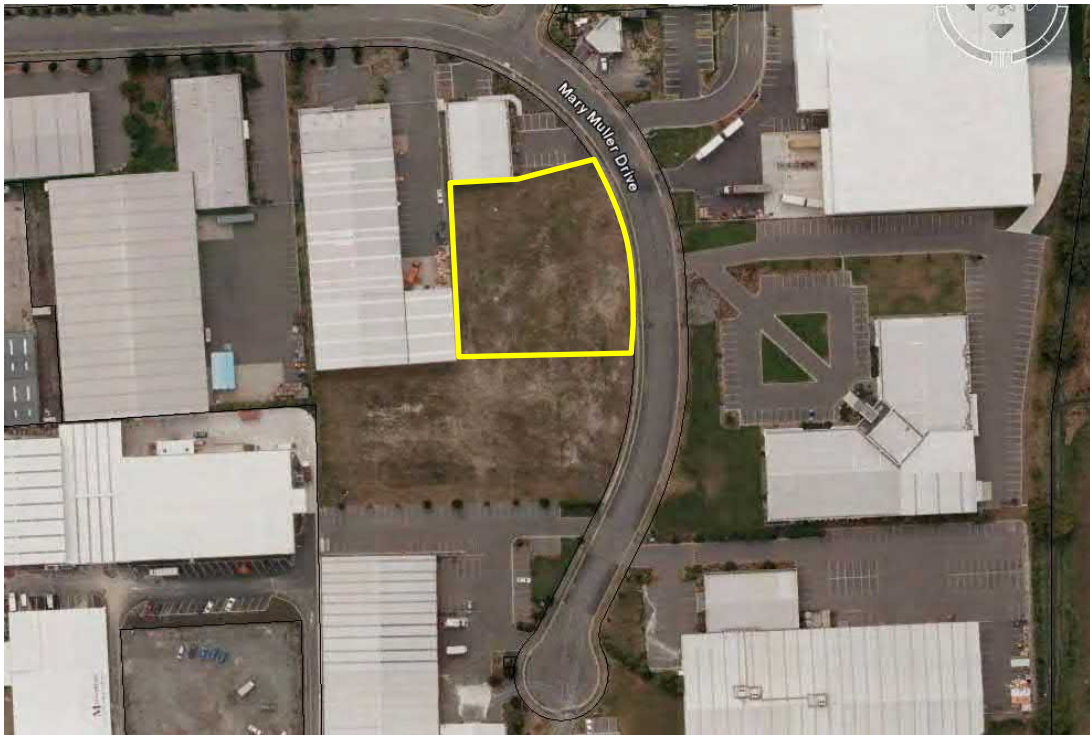
Diagram 1: Site location plan with approximate boundary in yellow (source: Canterbury Recovery, Project Orbit, photo from 24 February 2011).

The Wyatt Print building is located south of the site, Geon to the west, and the Bidvest coolstore is located to the southwest. Refer to Diagram 1.
