Land Information Memorandum

Property address:
2 Mary Muller Drive

LIM number: 70211569
Page 1

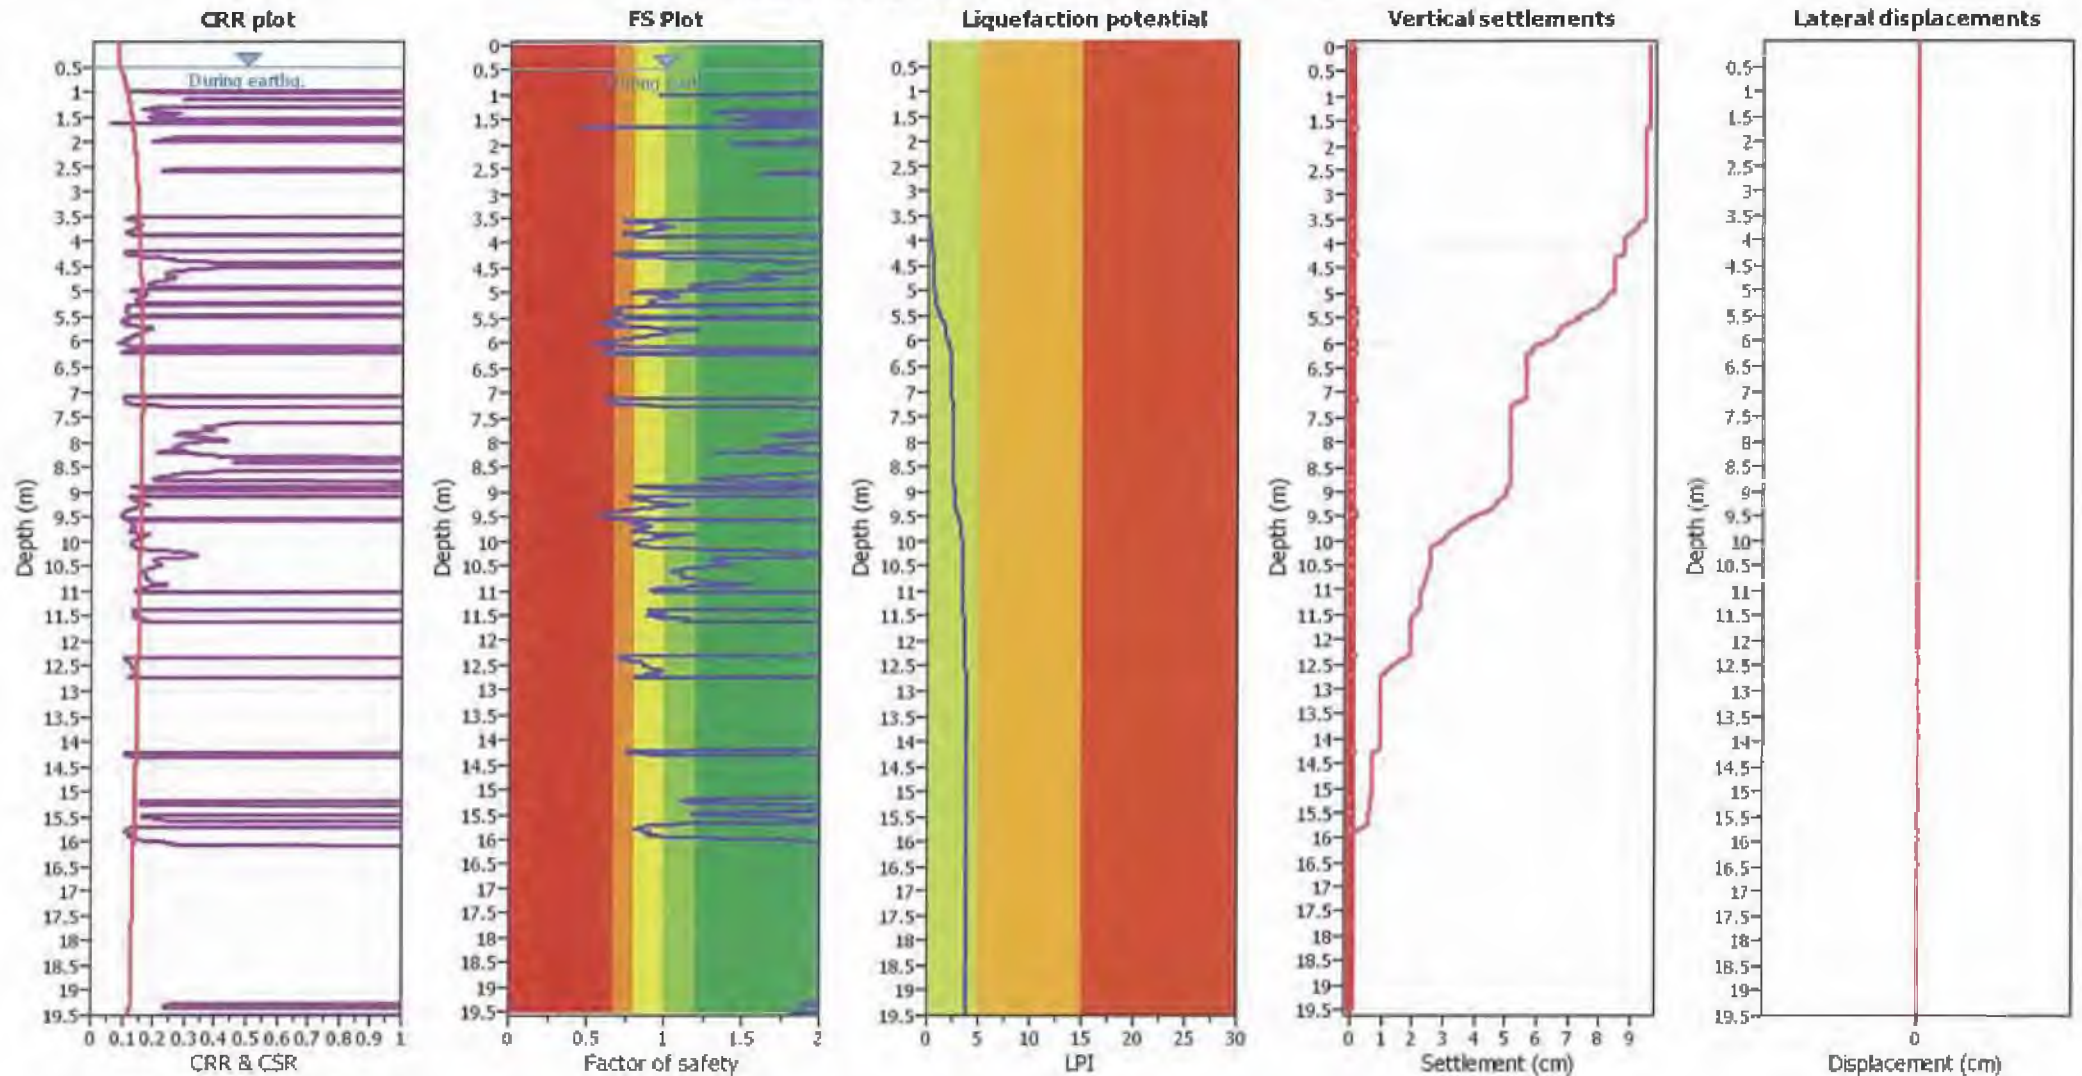
Liquefaction analysis overall plots

Serviceability Limit State (SLS): M7.5, 0.13g peak horizontal ground acceleration

Analysis method:	NCEER (1998)	Depth to water table (earthq.):	0.50 m	Fill weight:	N/A
Fines correction method:	NCEER (1998)	Average results interval:	3	Transition detect. applied:	No
Points to test:	Based on I_c value	I_c cut-off value:	2.60	K_0 applied:	Yes
Earthquake magnitude M_w :	7.50	Unit weight calculation:	Based on SBT	Clay like behavior applied:	Sands only
Peak ground acceleration:	0.13	Use fill:	No	Limit depth applied:	No
Depth to water table (insitu):	2.50 m	Fill height:	N/A	Limit depth:	N/A

- Very high risk
- High risk
- Low risk

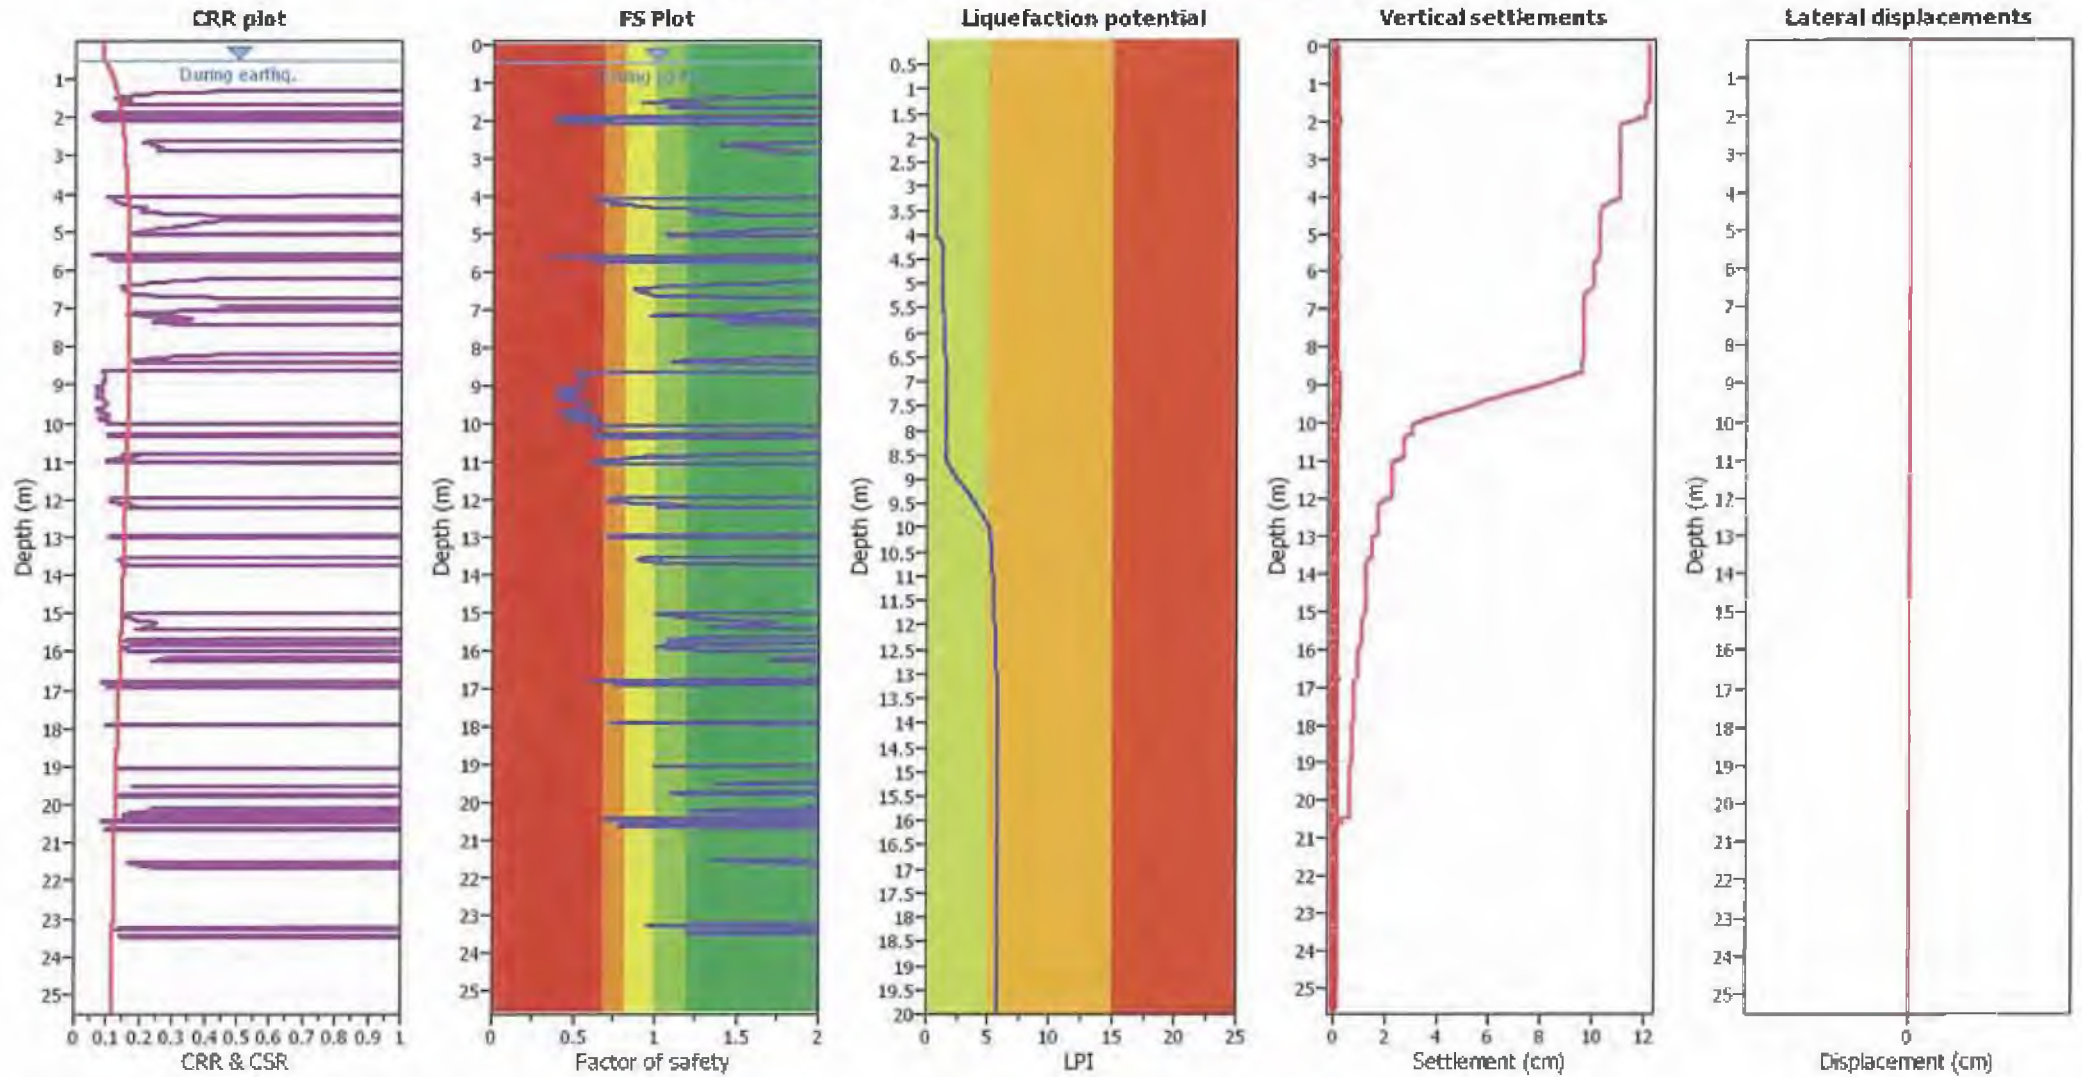
Liquefaction analysis overall plots

Input parameters and analysis data

Analysis method:	NCEER (1998)	Depth to water table (earthq.):	0.50 m	Fill weight:	N/A
Fines correction method:	NCEER (1998)	Average results interval:	3	Transition detect. applied:	No
Points to test:	Based on Ic value	Ic cut-off value:	2.60	K_{σ} applied:	Yes
Earthquake magnitude M_w :	7.50	Unit weight calculation:	Based on SBT	Clay like behavior applied:	Sands only
Peak ground acceleration:	0.13	Use fill:	No	Limit depth applied:	No
Depth to water table (insitu):	2.50 m	Fill height:	N/A	Limit depth:	N/A

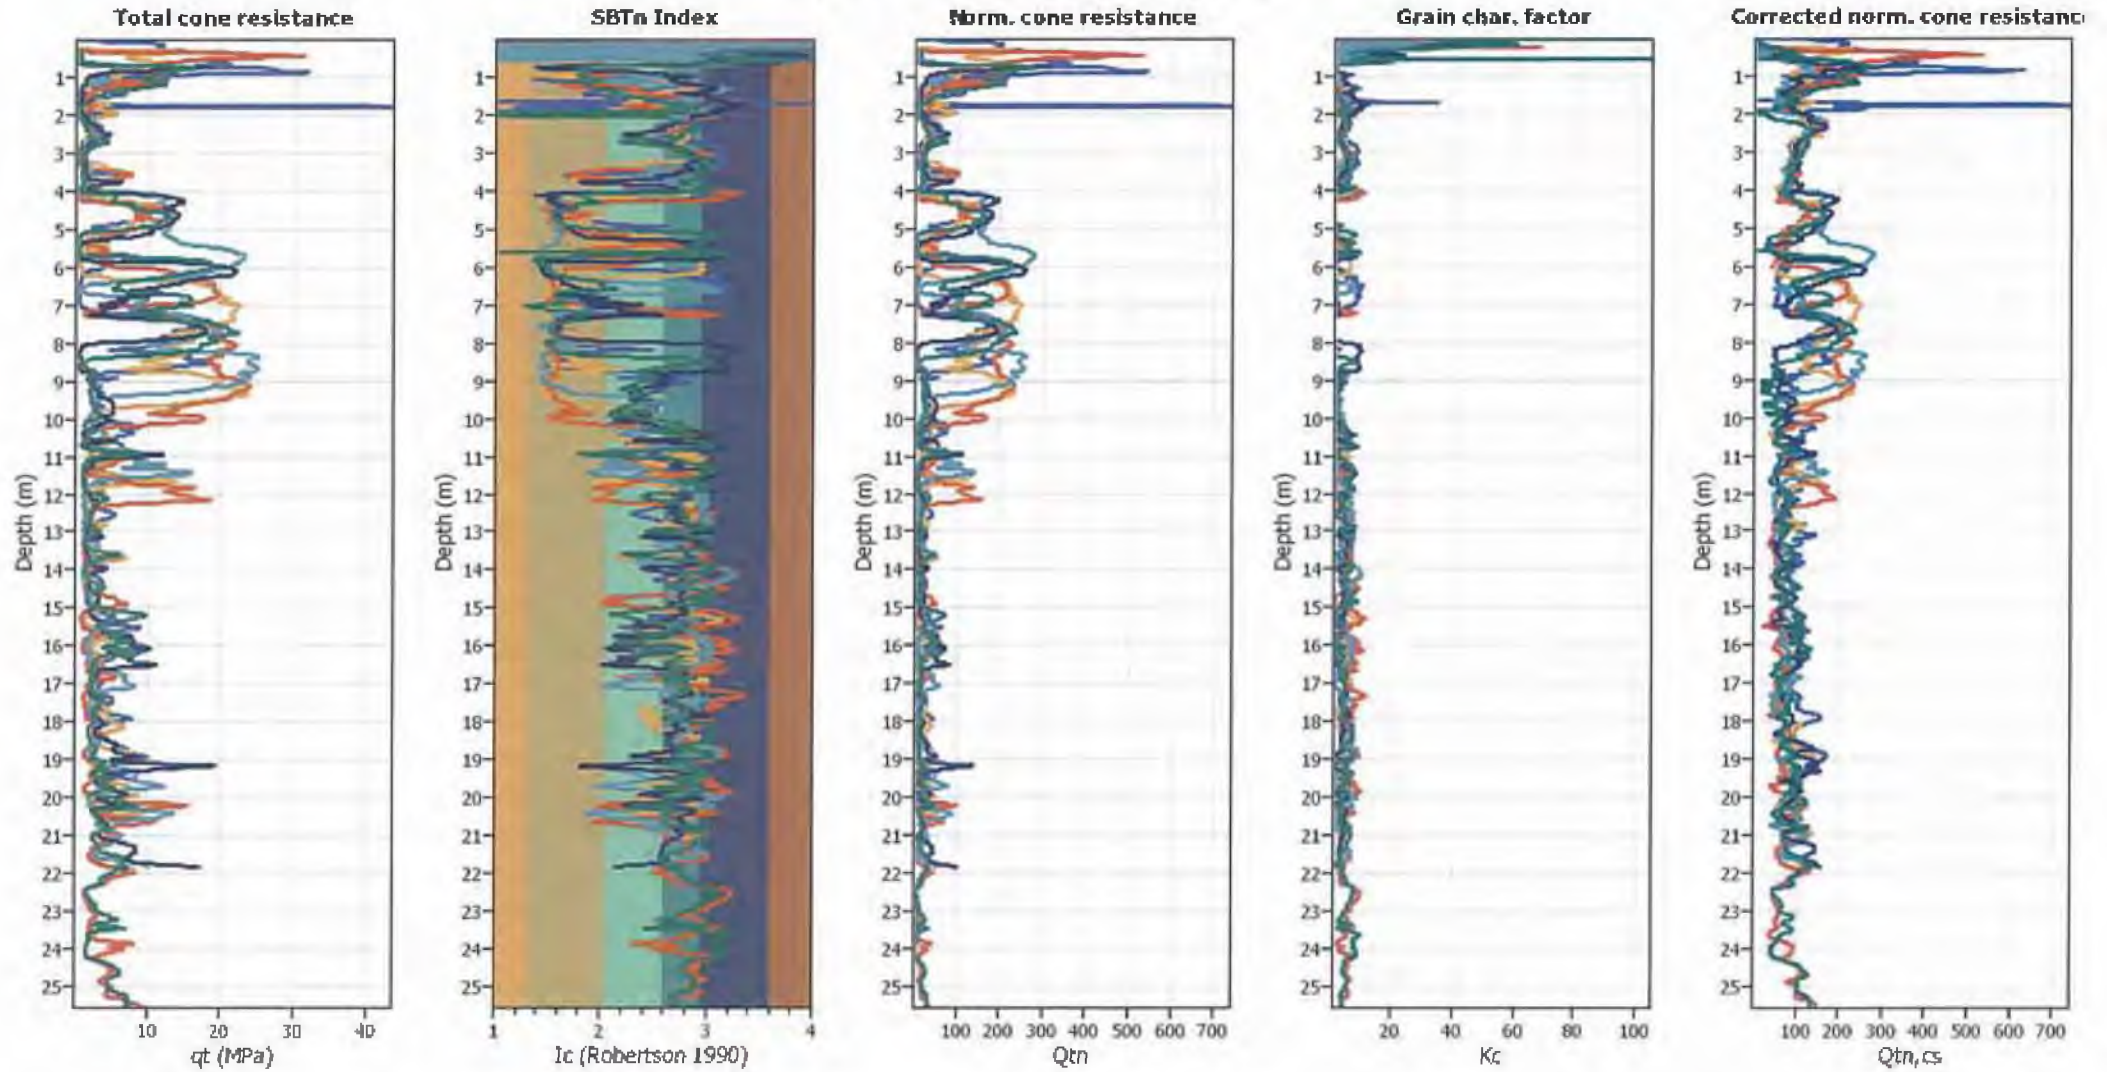
Overlay Intermediate Results

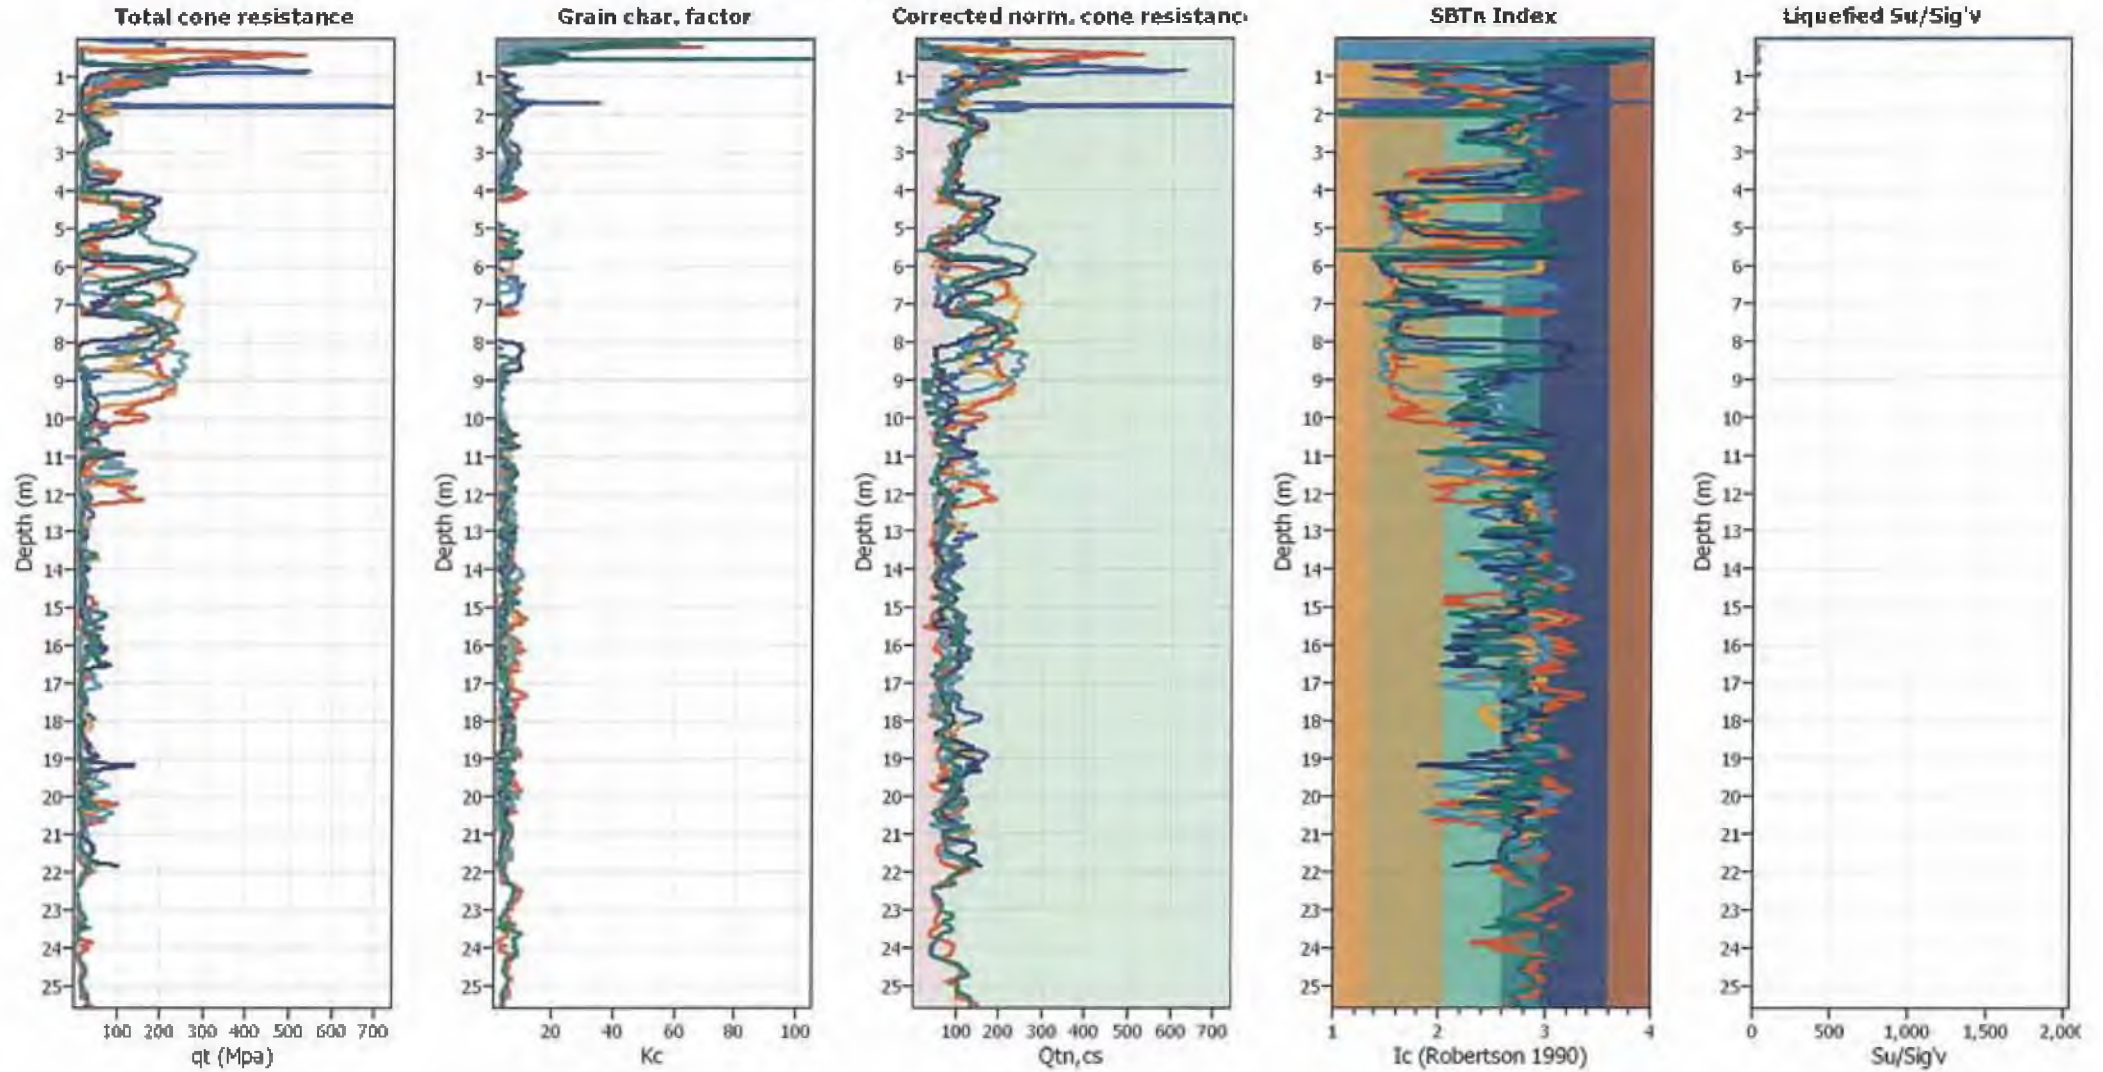
Overlay Strength Loss Plots

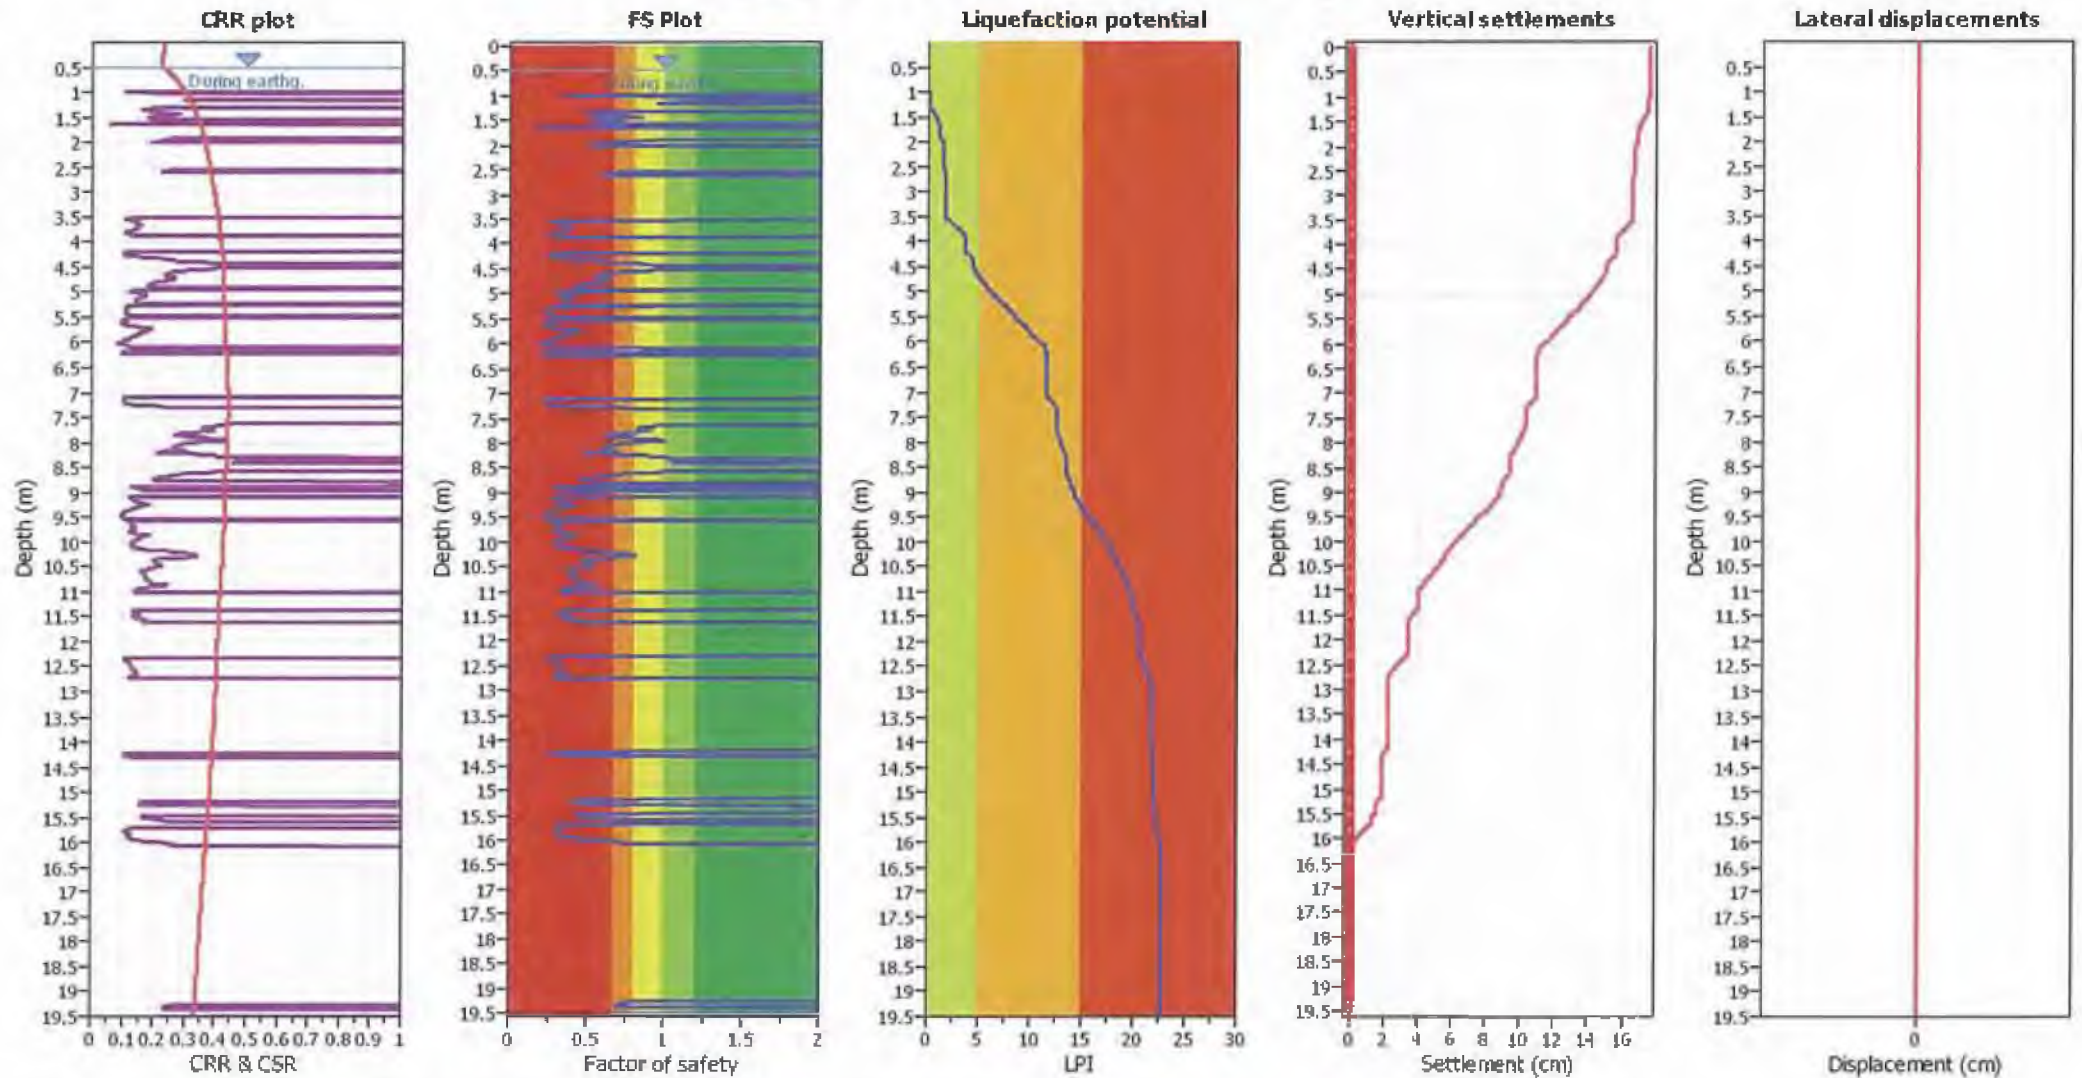
Liquefaction analysis overall plots

Ultimate Limit State (ULS): M7.5, 0.35g peak horizontal ground acceleration

Input parameters and analysis data

Analysis method:	NCEER (1998)	Depth to water table (earthq.):	0.50 m	Fill weight:	N/A
Fines correction method:	NCEER (1998)	Average results interval:	3	Transition detect applied:	No
Points to test:	Based on Ic value	Ic cut-off value:	2.60	K ₀ applied:	Yes
Earthquake magnitude M _w :	7.50	Unit weight calculation:	Based on SBT	Clay like behavior applied:	Sands only
Peak ground acceleration:	0.35	Use fill:	No	Limit depth applied:	No
Depth to water table (insitu):	2.50 m	Fill height:	N/A	Limit depth:	N/A

Under the ULS (0.35g) scenario, the LPI increased to 'high to very high risk' of liquefaction damage to shallow building foundations. Refer to Appendix C.

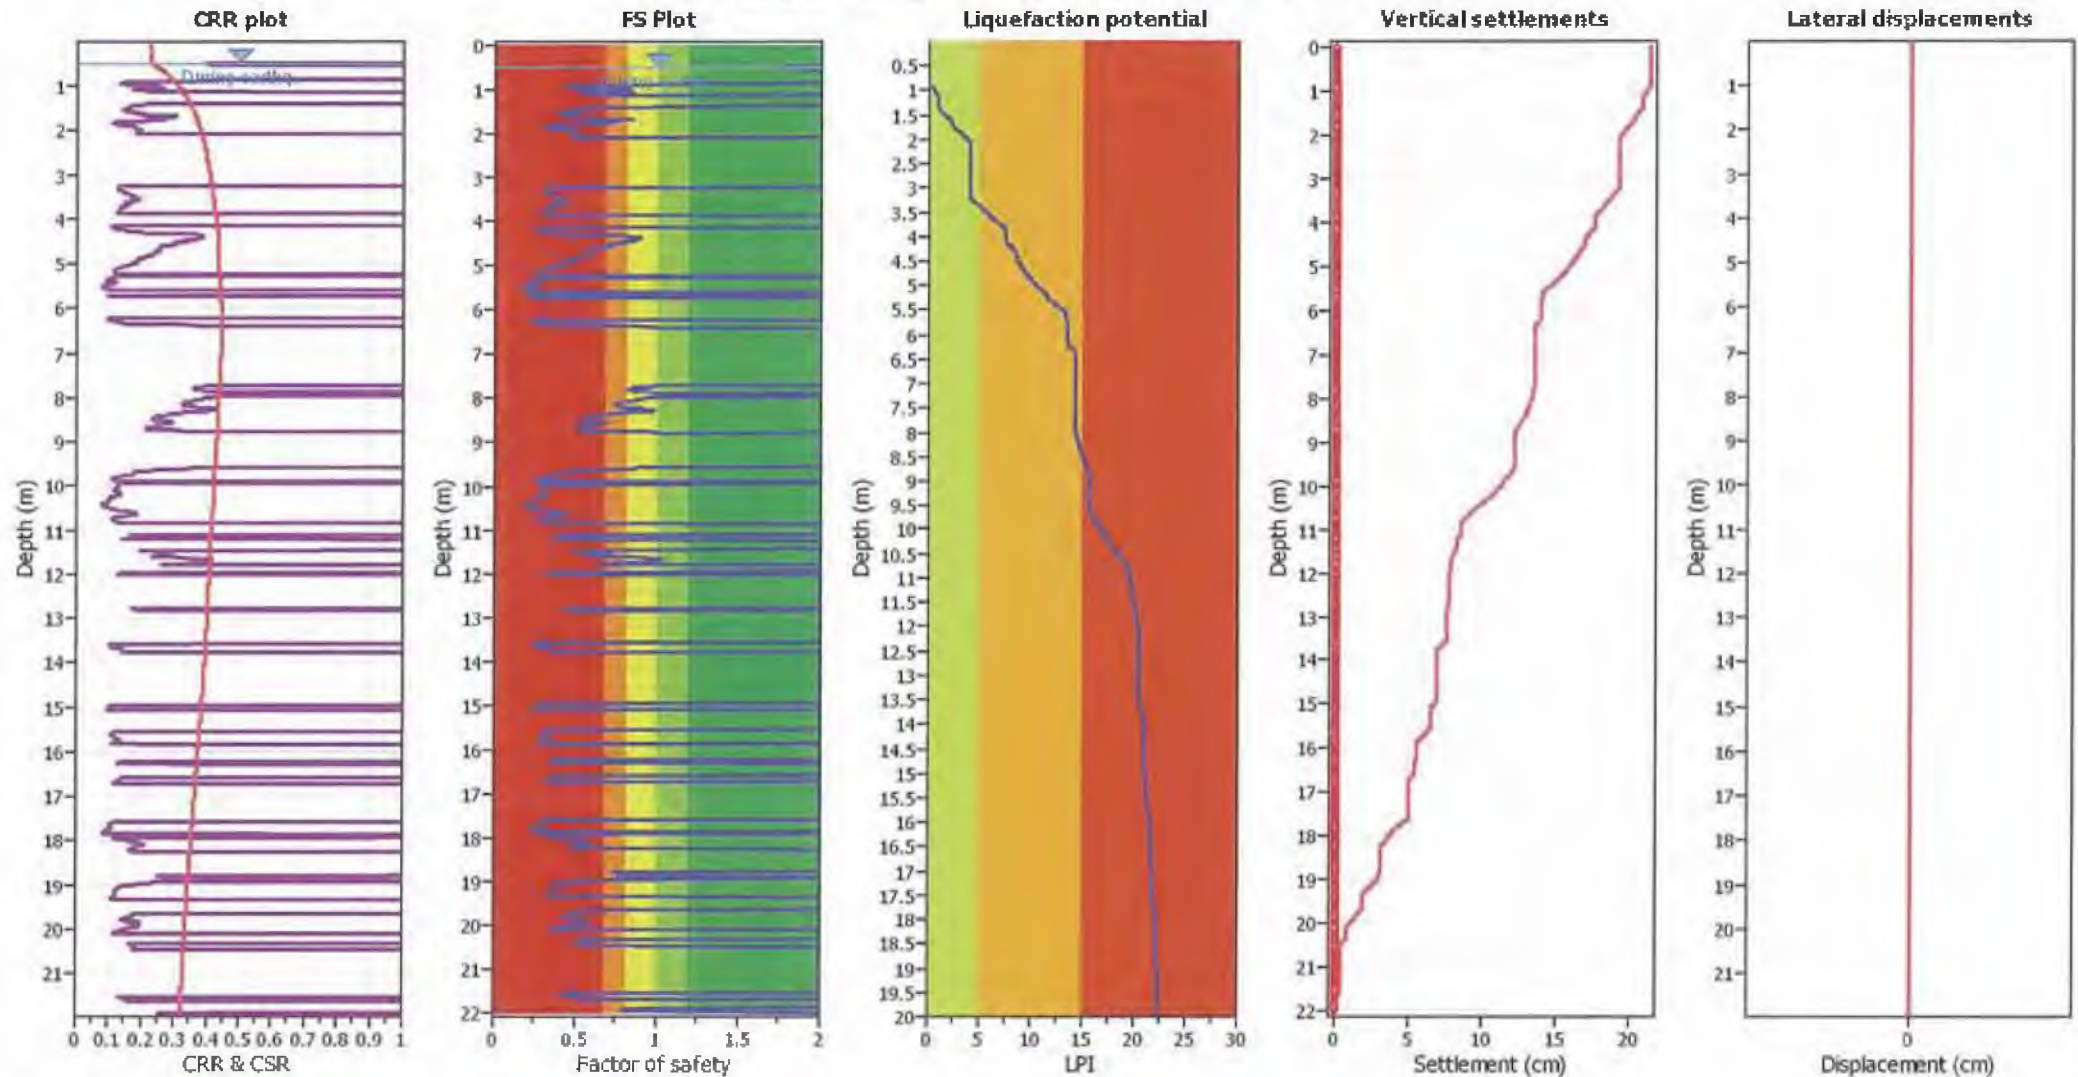
Liquefaction analysis overall plots

Input parameters and analysis data

Analysis method:	NCEER (1998)	Depth to water table (earthq.):	0.50 m	Fill weight:	N/A
Fines correction method:	NCEER (1998)	Average results interval:	3	Transition detect. applied:	No
Points to test:	Based on I_c value	I_c cut-off value:	2.60	K_o applied:	Yes
Earthquake magnitude M_w :	7.50	Unit weight calculation:	Based on SBT	Clay like behavior applied:	Sands only
Peak ground acceleration:	0.35	Use fill:	No	Limit depth applied:	No
Depth to water table (in situ):	2.50 m	Fill height:	N/A	Unit depth:	N/A

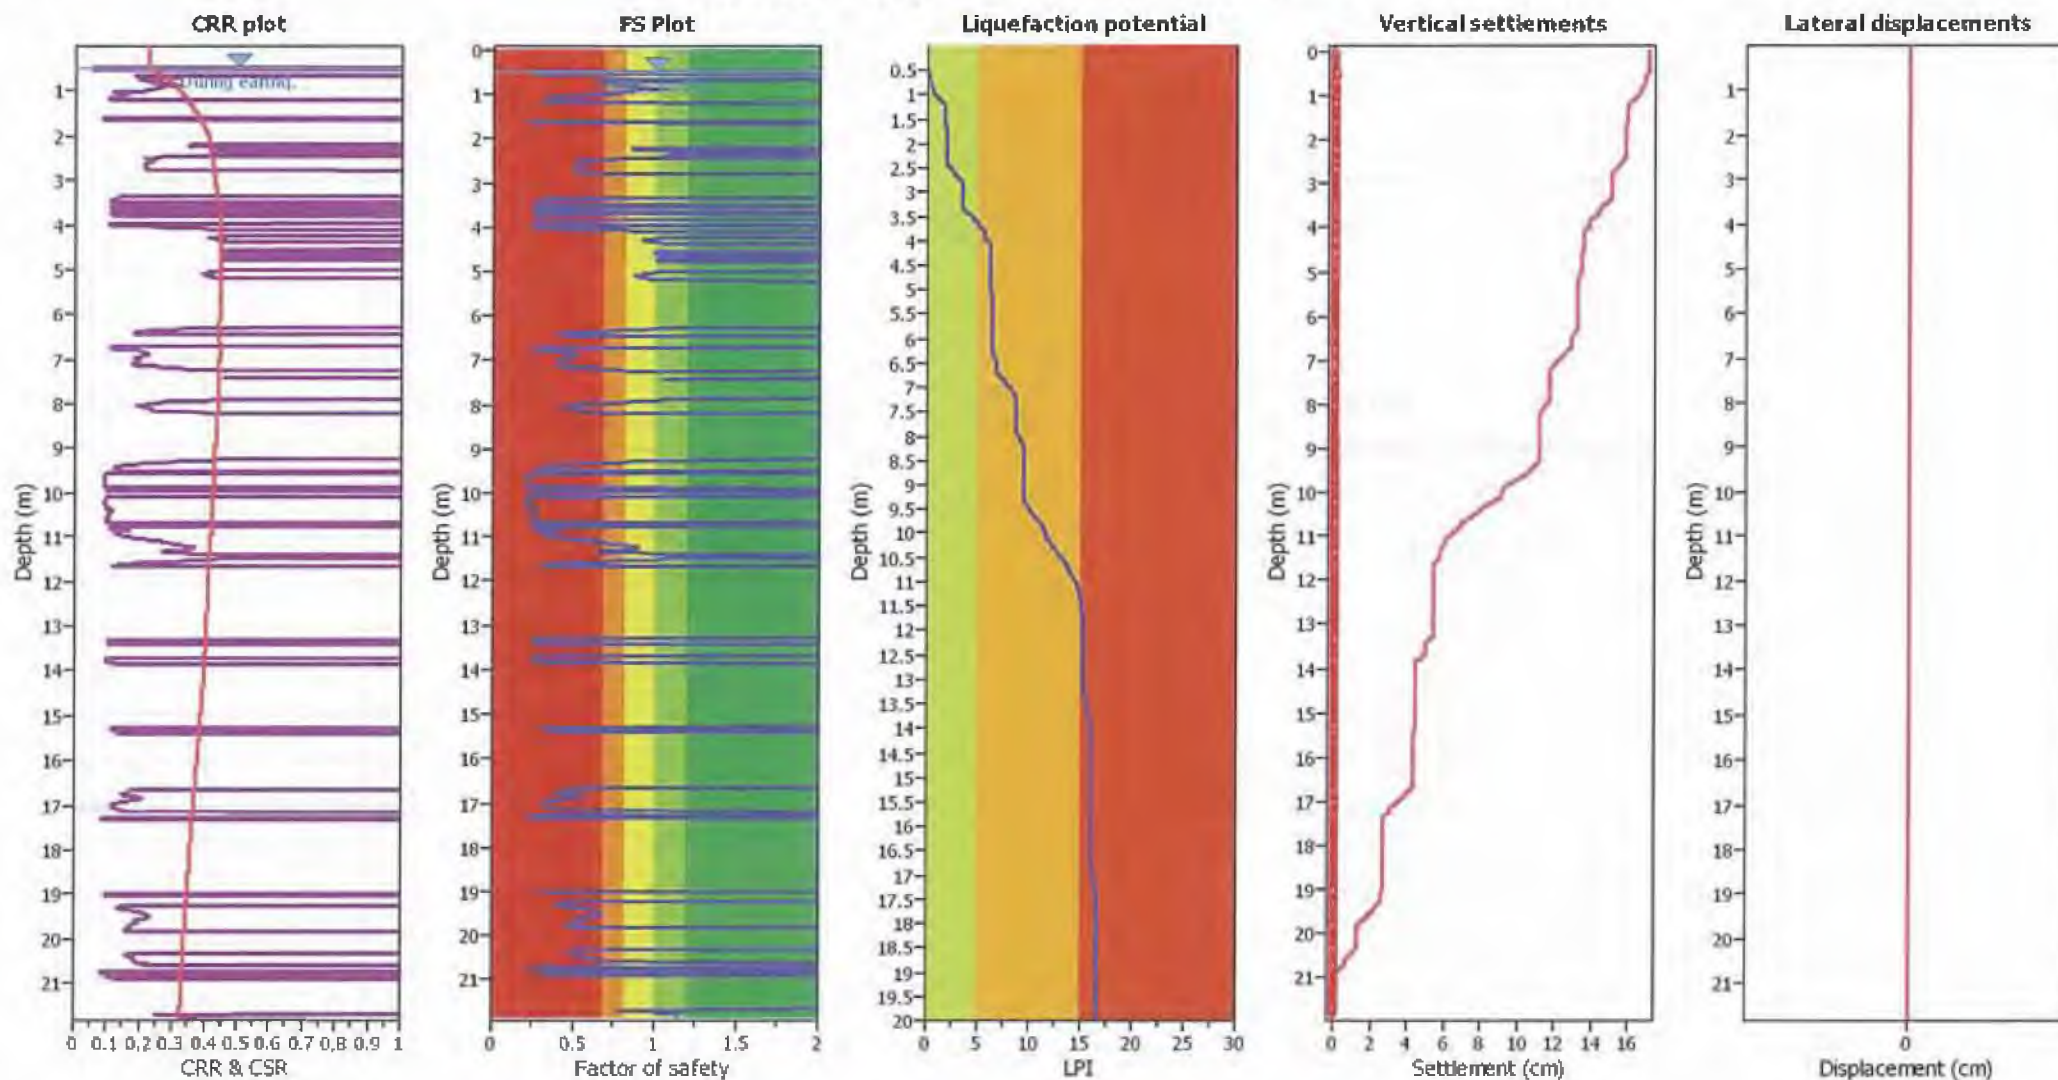
Liquefaction analysis overall plots

Input parameters and analysis data

Analysis method:	NCEER (1998)	Depth to water table (earthq.):	0.50 m	Fill weight:	N/A
Fines correction method:	NCEER (1998)	Average results interval:	3	Transition detect. applied:	No
Points to test:	Based on I_c value	LC cut-off value:	2.60	K_v applied:	Yes
Earthquake magnitude M_w :	7.50	Unit weight calculation:	Based on SBT	Clay like behavior applied:	Sands only
Peak ground acceleration:	0.35	Use fill:	No	Limit depth applied:	No
Depth to water table (insitu):	2.50 m	Fill height:	N/A	Limit depth:	N/A

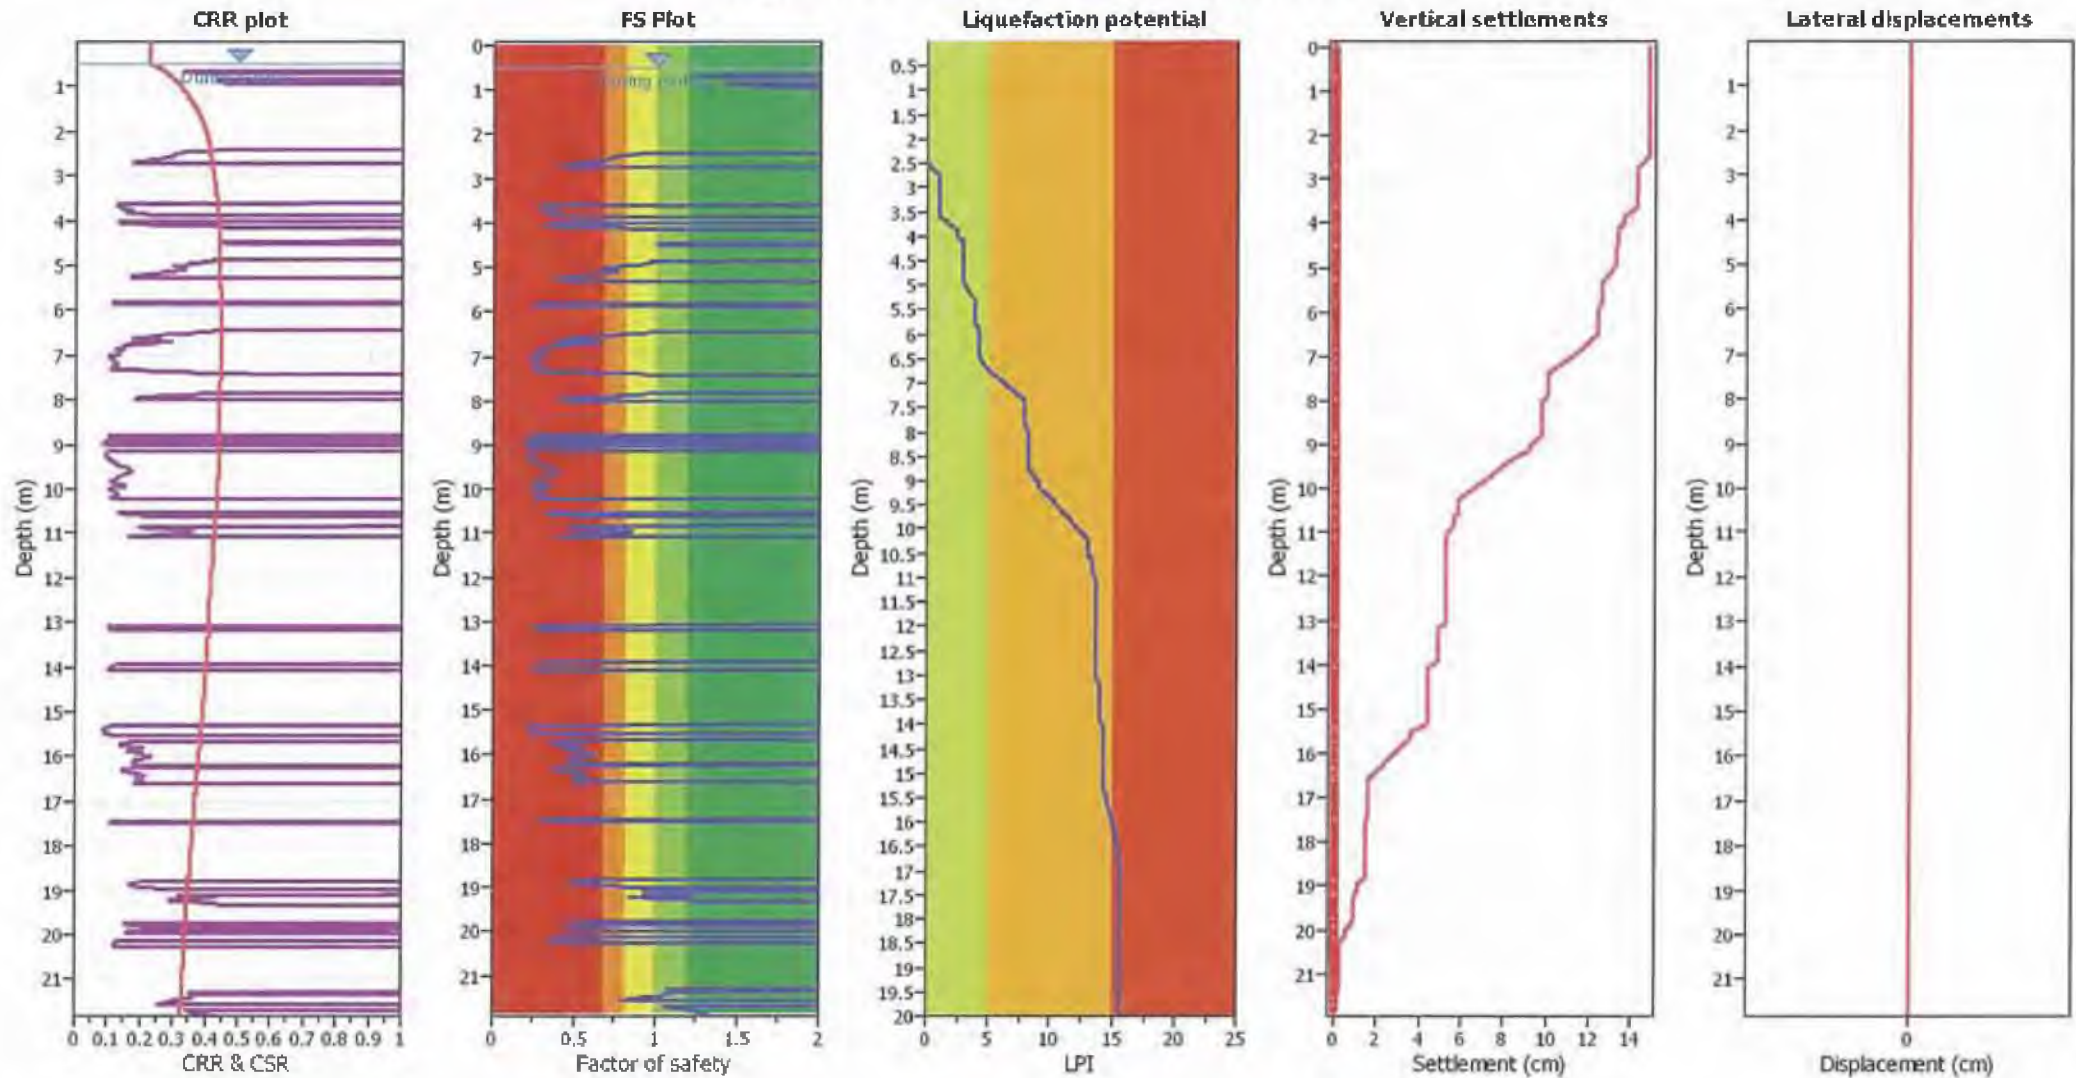
Liquefaction analysis overall plots

Input parameters and analysis data

Analysis method:	NCEER (1998)	Depth to water table (earthq.):	0.50 m	Fill weight:	N/A
Flines correction method:	NCEER (1998)	Average results interval:	3	Transition detect, applied:	No
Points to test:	Based on t_c value	t_c cut-off value:	2.60	K_0 applied:	Yes
Earthquake magnitude M_w :	7.50	Unit weight calculation:	Based on SBT	Clay like behavior applied:	Sands only
Peak ground acceleration:	0.35	Use fill:	No	Limit depth applied:	No
Depth to water table (instku):	2.50 m	Fill height:	N/A	Limit depth:	N/A

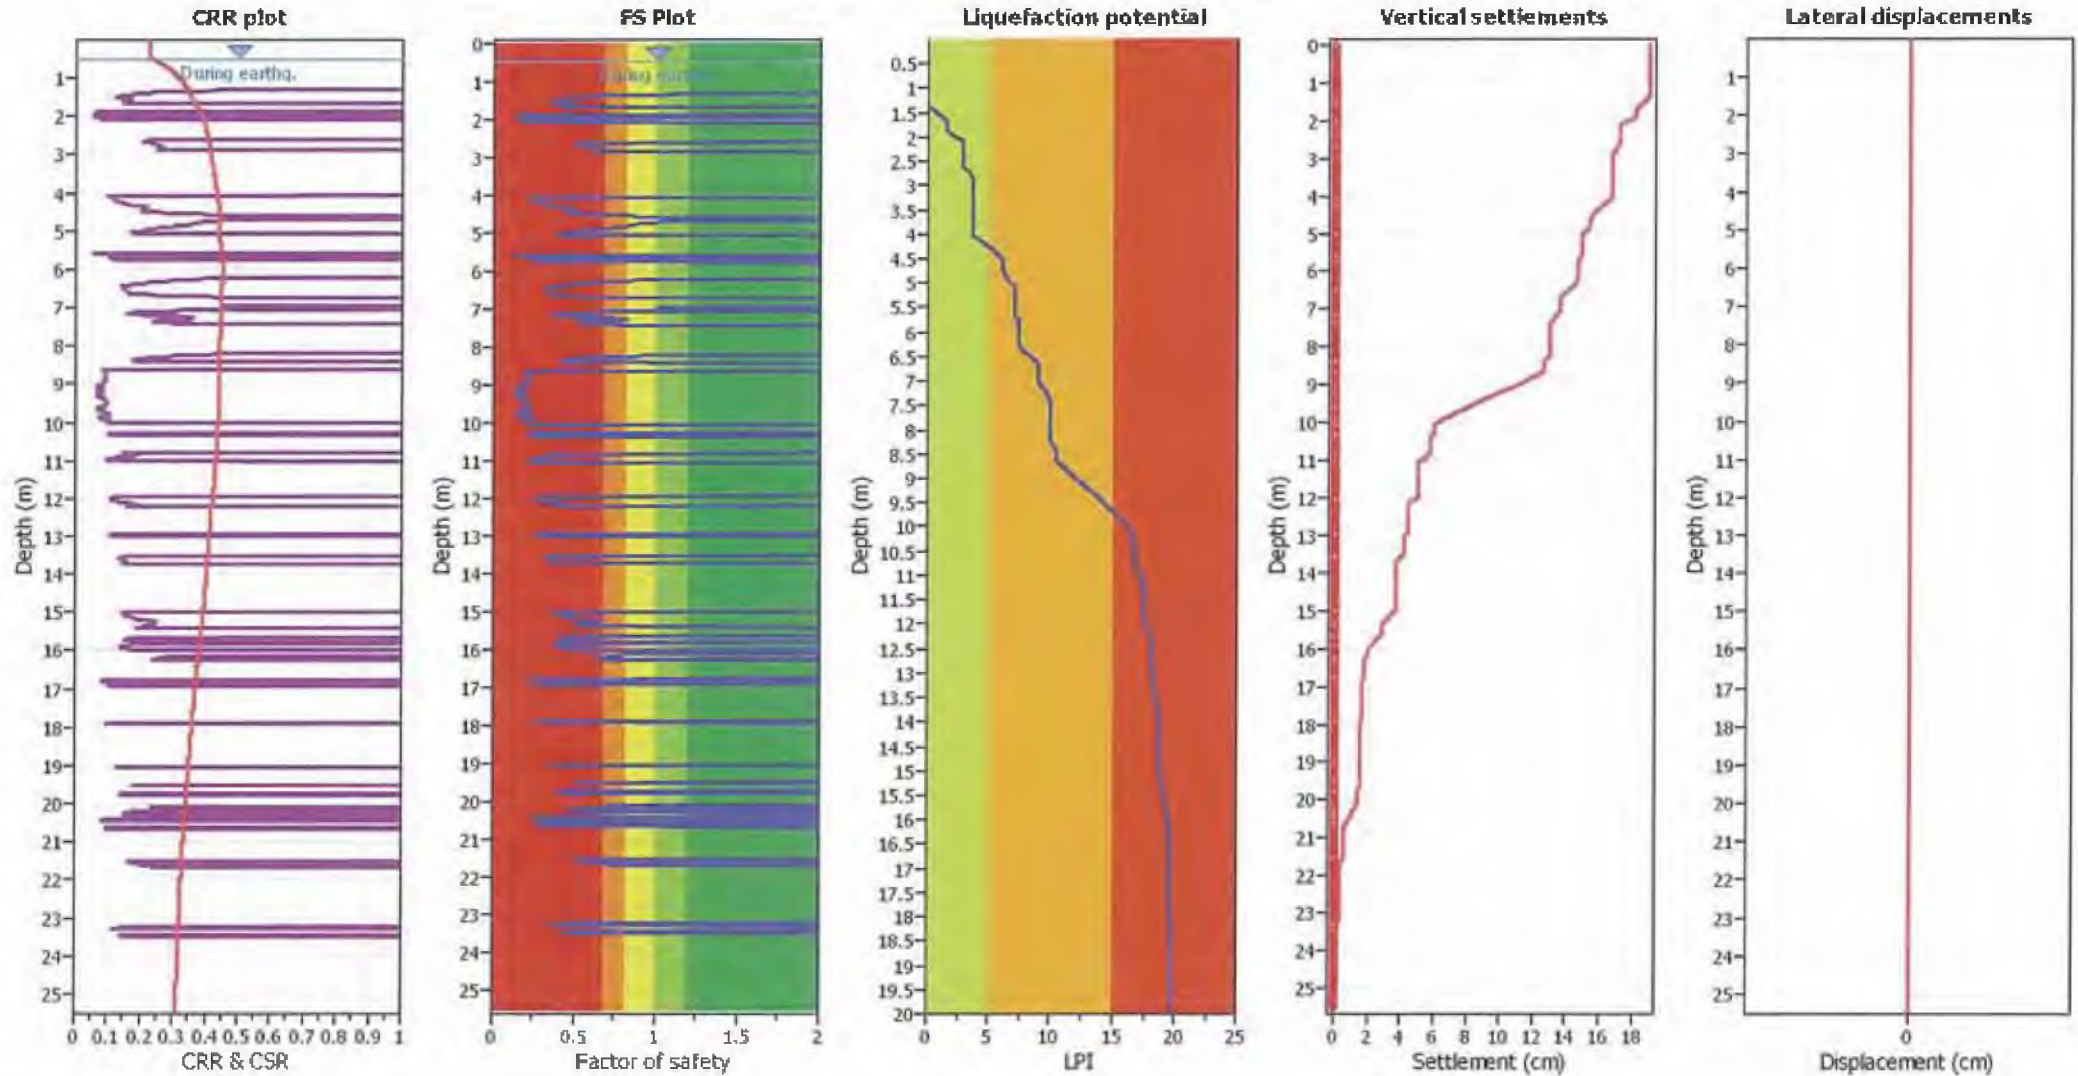
Liquefaction analysis overall plots

Input parameters and analysis data

Analysis method:	NCEER (1998)	Depth to water table (earthq.):	0.50 m	Fill weight:	N/A
Flines correction method:	NCEER (1998)	Average results interval:	3	Transition detect. applied:	No
Points to test:	Based on I _c value	I _c cut-off value:	2.60	K ₀ applied:	Yes
Earthquake magnitude M _w :	7.50	Unit weight calculation:	Based on SBT	Clay like behavior applied:	Sands only
Peak ground acceleration:	0.35	Use fill:	No	Limit depth applied:	No
Depth to water table (insitu):	2.50 m	Fill height:	N/A	Limit depth:	N/A
