Land Information Memorandum

Property address:
2 Mary Muller Drive

LIM number: 70211569
Page 1

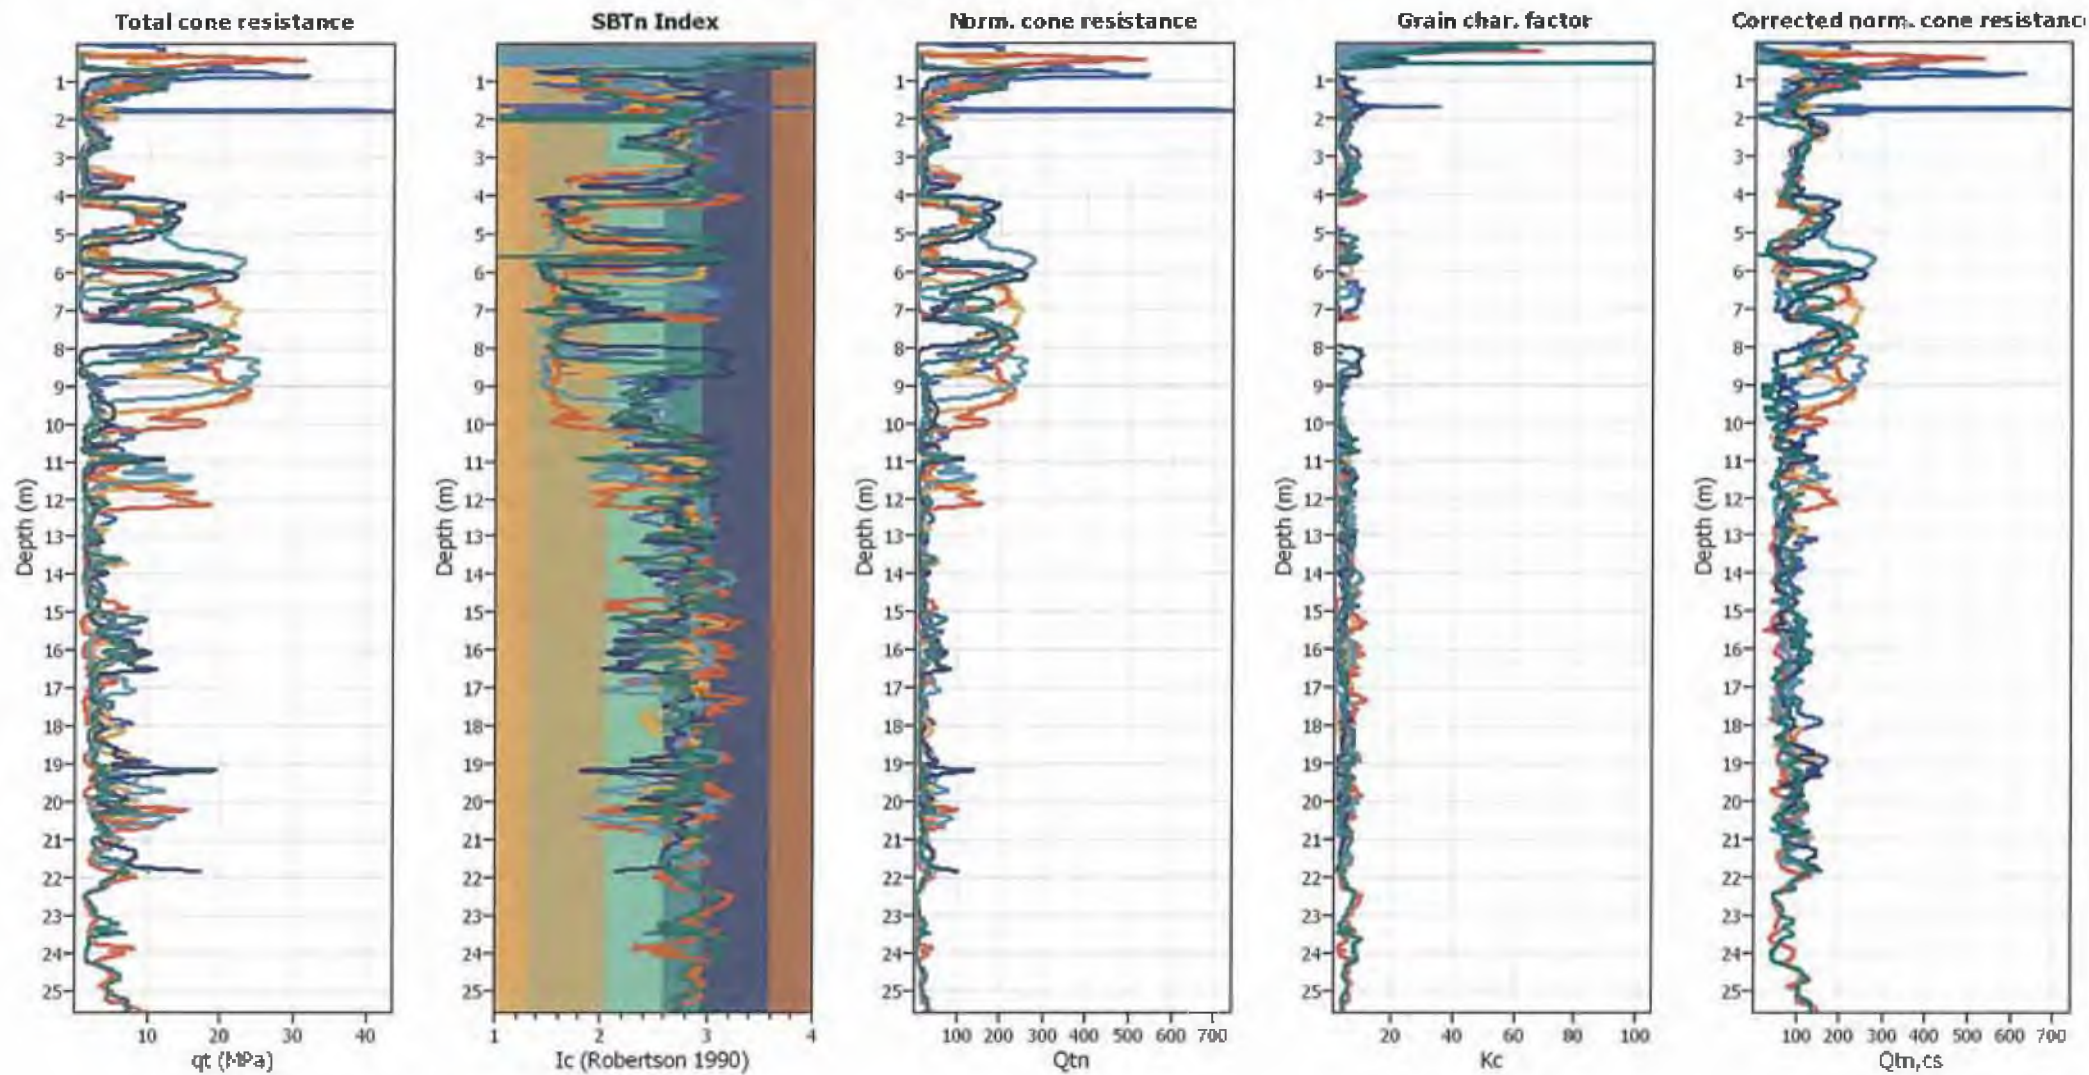
Overlay Intermediate Results

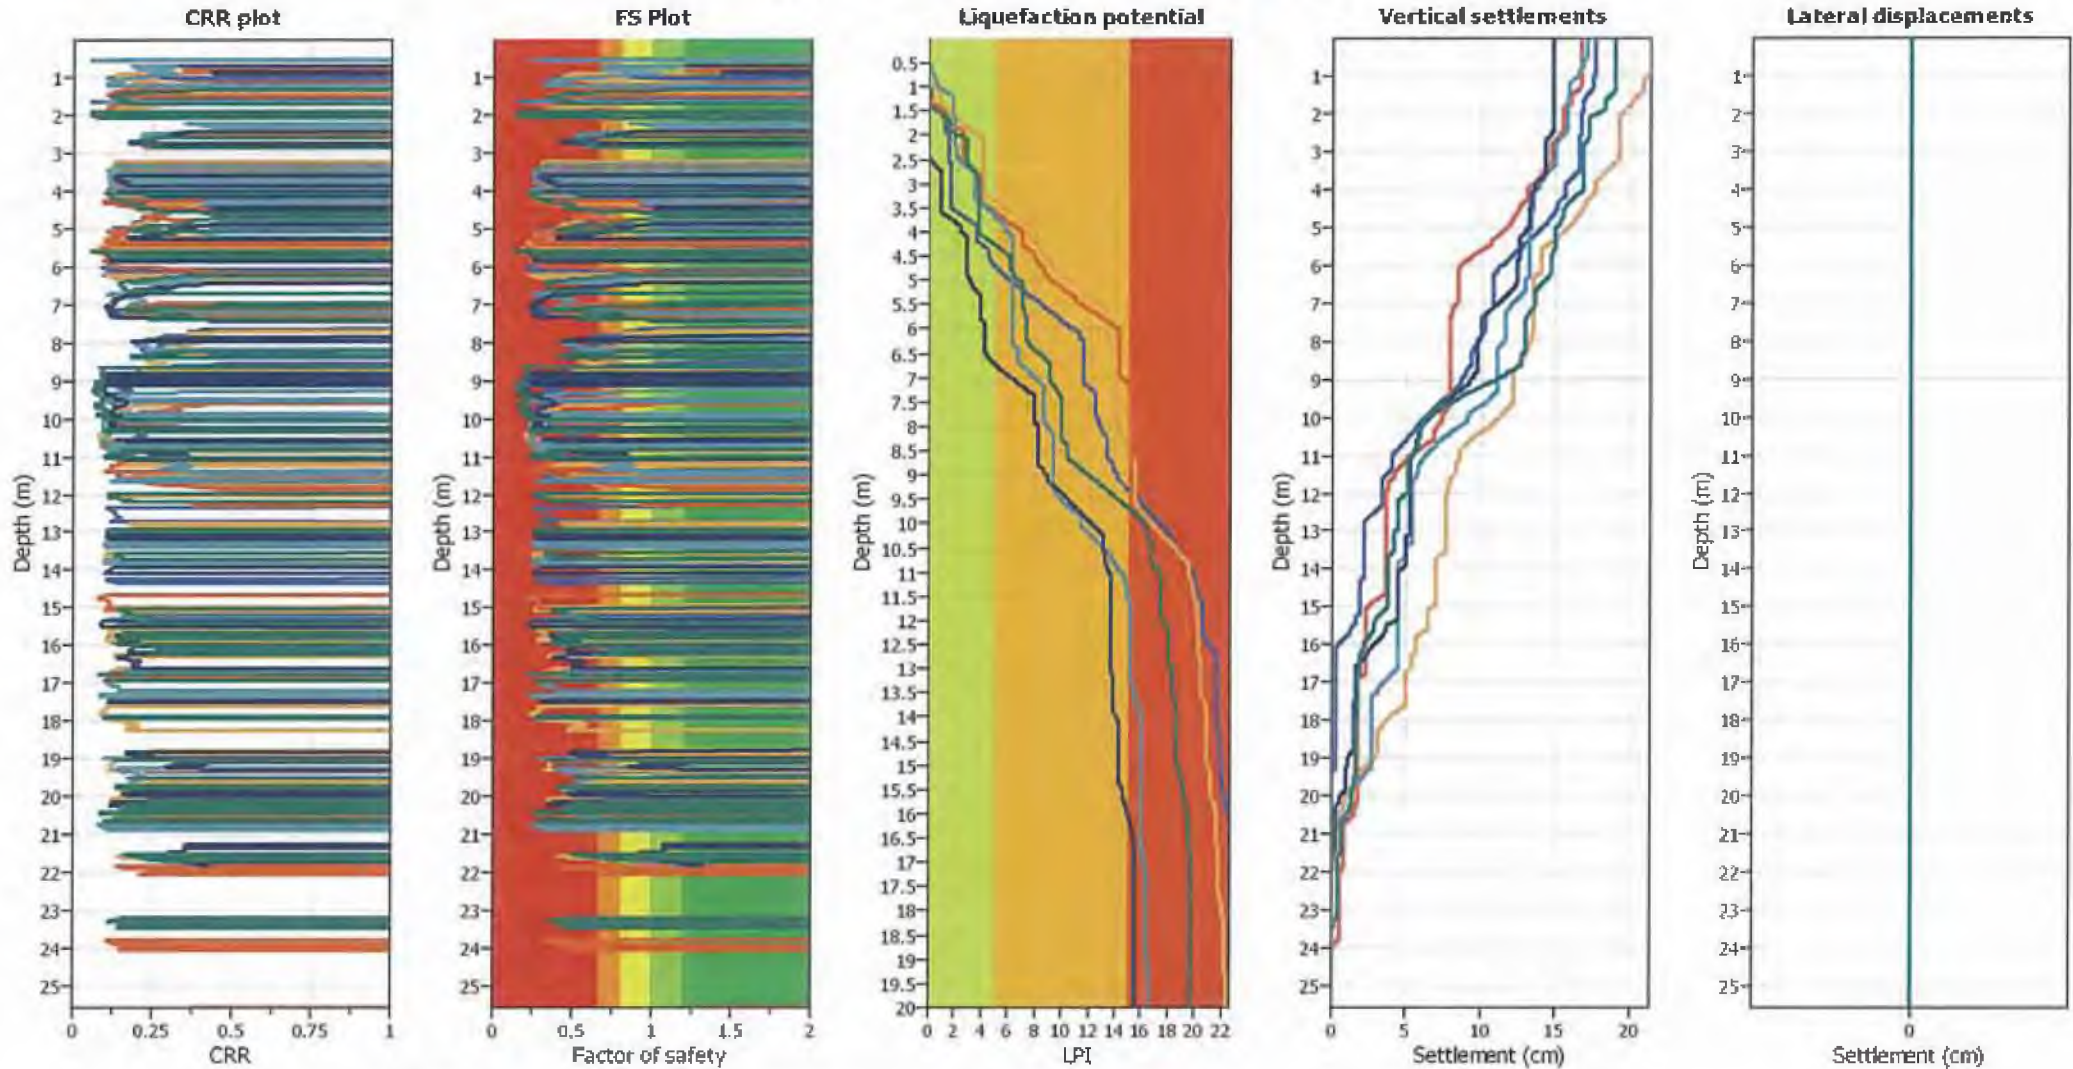
Overlay Cyclic Liquefaction Plots

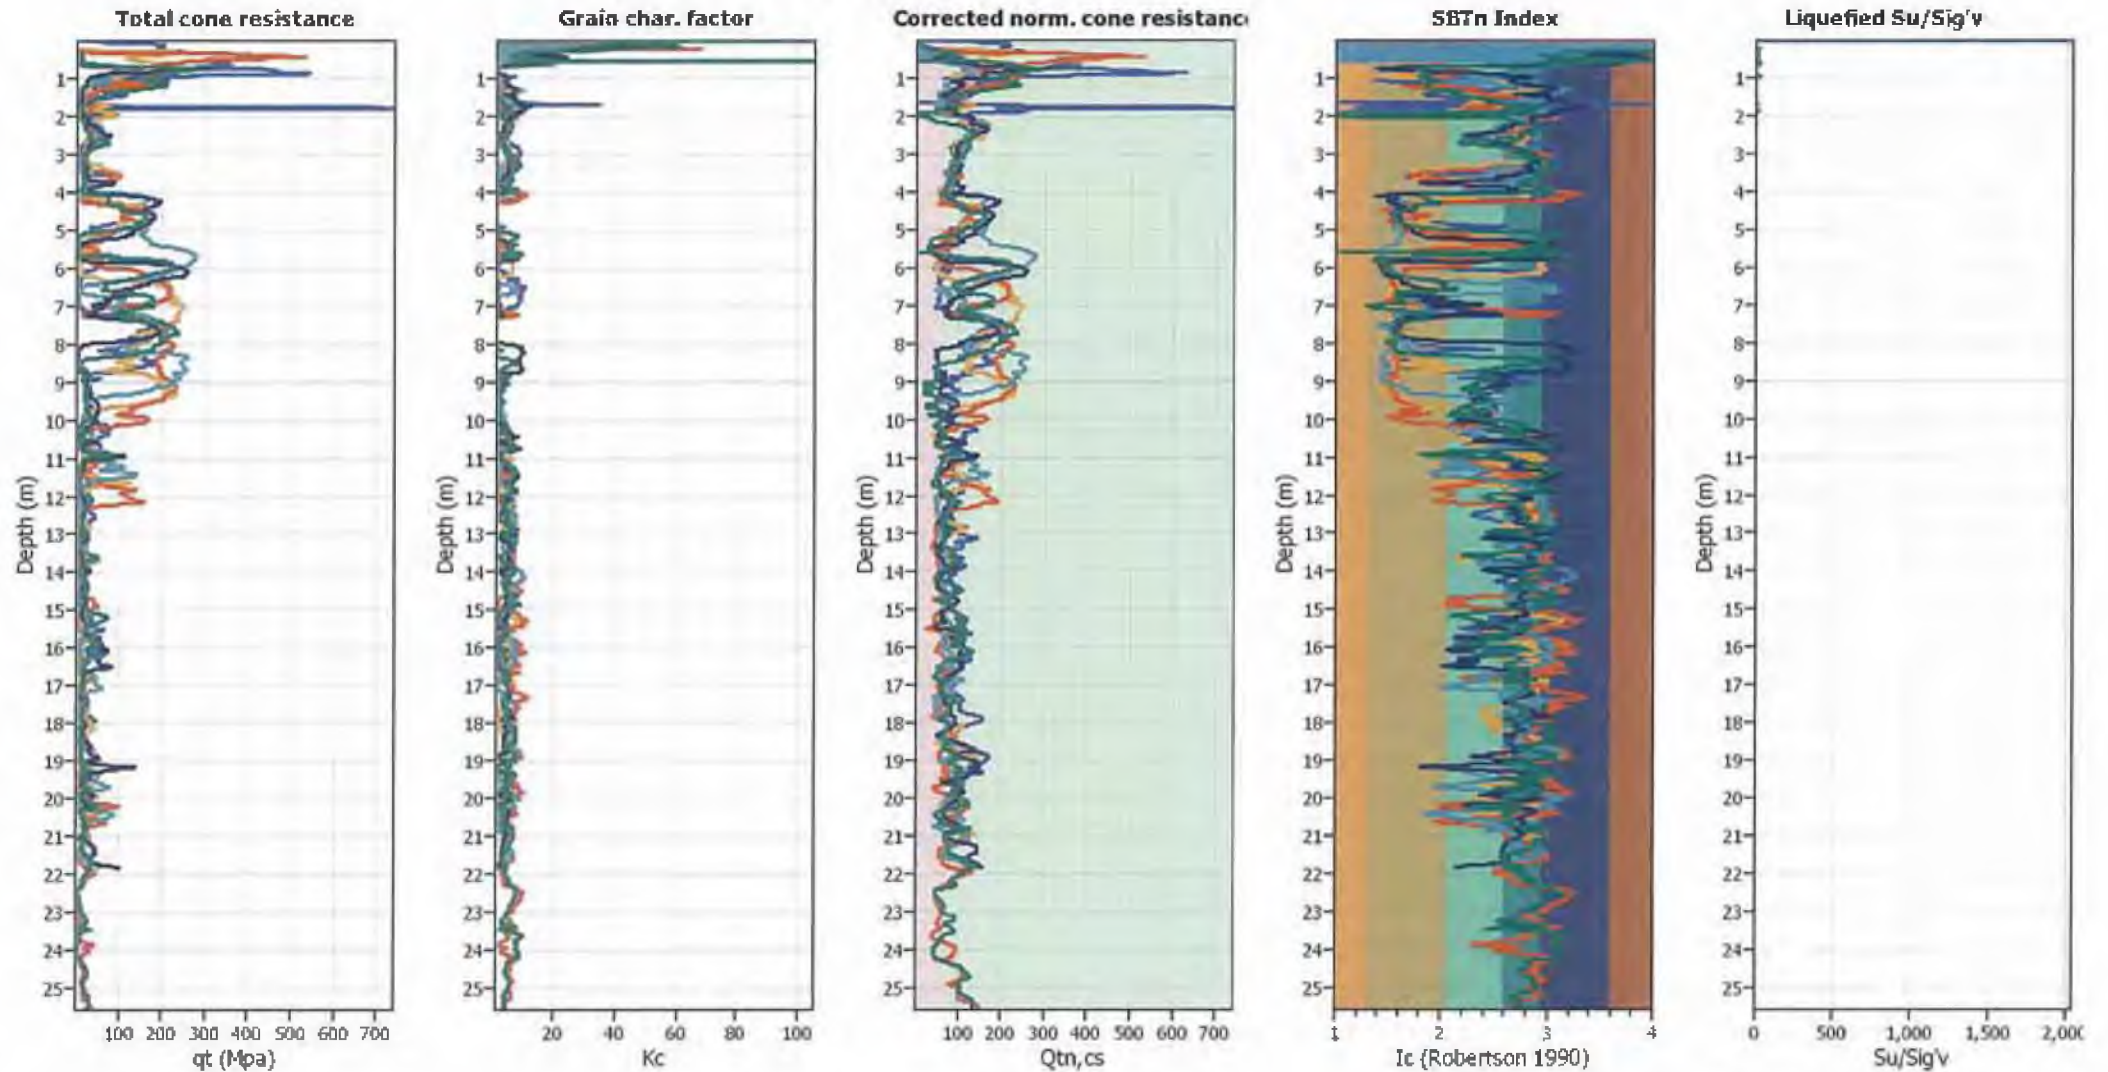
Overlay Strength Loss Plots

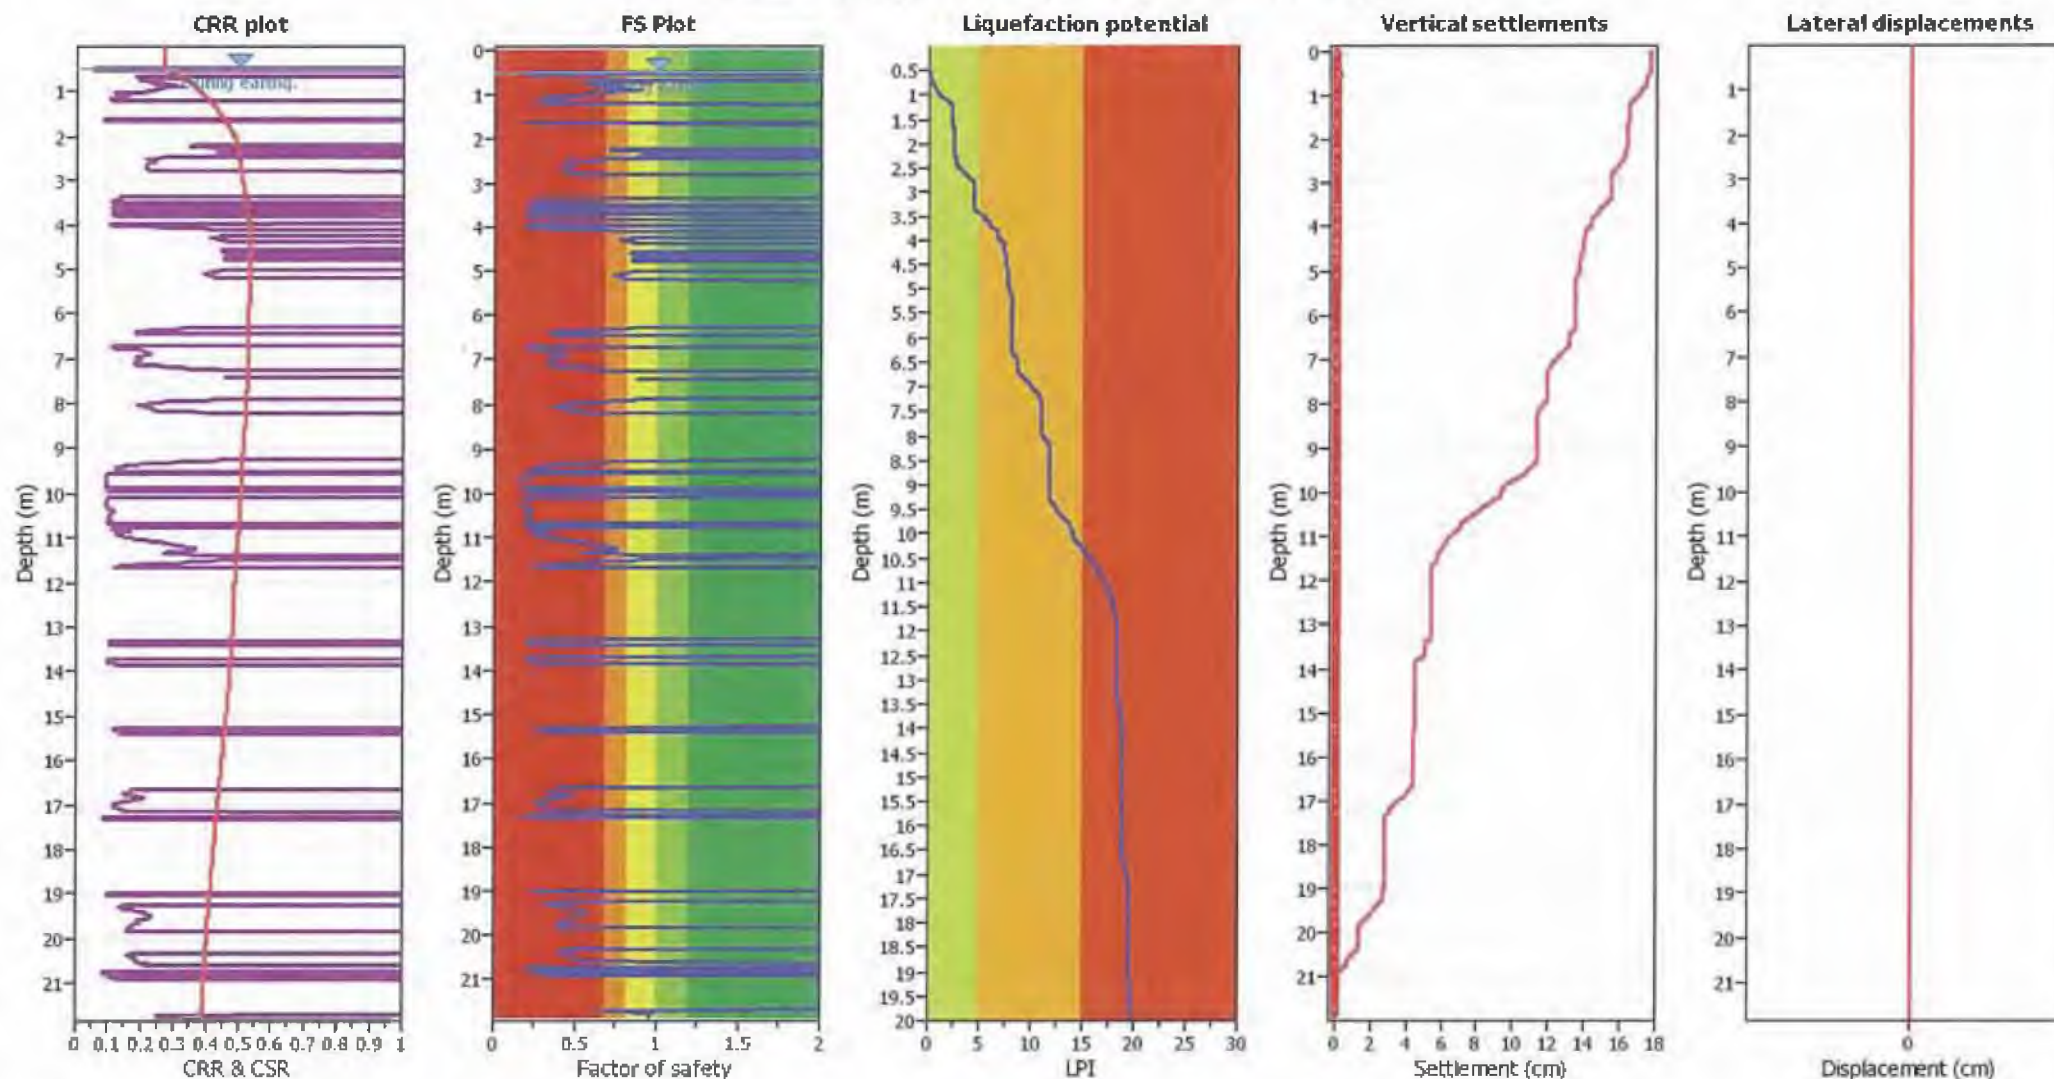
Liquefaction analysis overall plots

Input parameters and analysis data

Analysis method:	NCEER (1998)	Depth to water table (earthq.):	0.50 m	Fill weight:	N/A
Fines correction method:	NCEER (1998)	Average results interval:	3	Transition detect, applied:	No
Points to test:	Based on Ic value	Ic cut-off value:	2.60	K _s applied:	Yes
Earthquake magnitude M _w :	6.30	Unit weight calculation:	Based on SBT	Clay like behavior applied:	Sands only
Peak ground acceleration:	0.65	Use fill:	No	Limit depth applied:	No
Depth to water table (Insitu):	2.50 m	Fill height:	N/A	Limit depth:	N/A

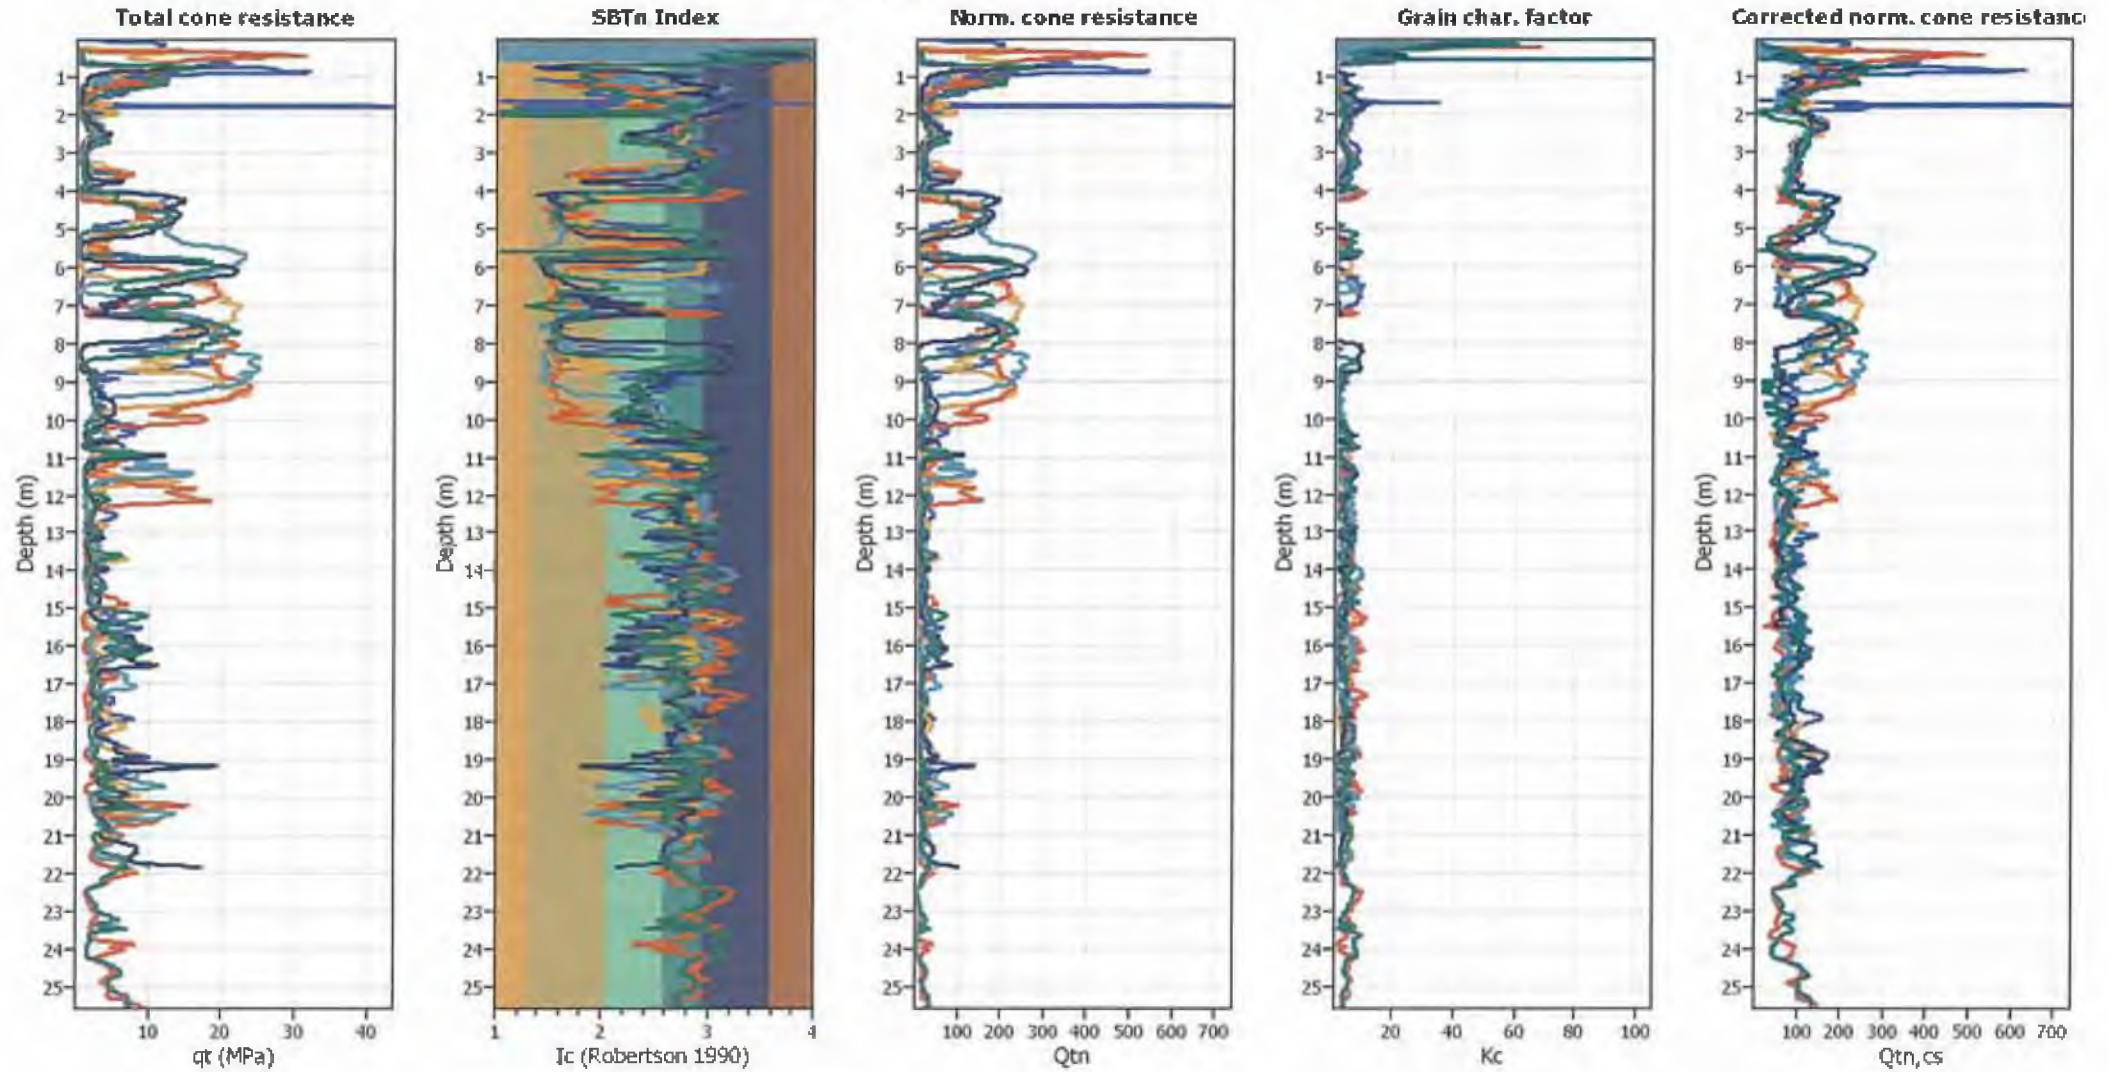
Overlay Intermediate Results

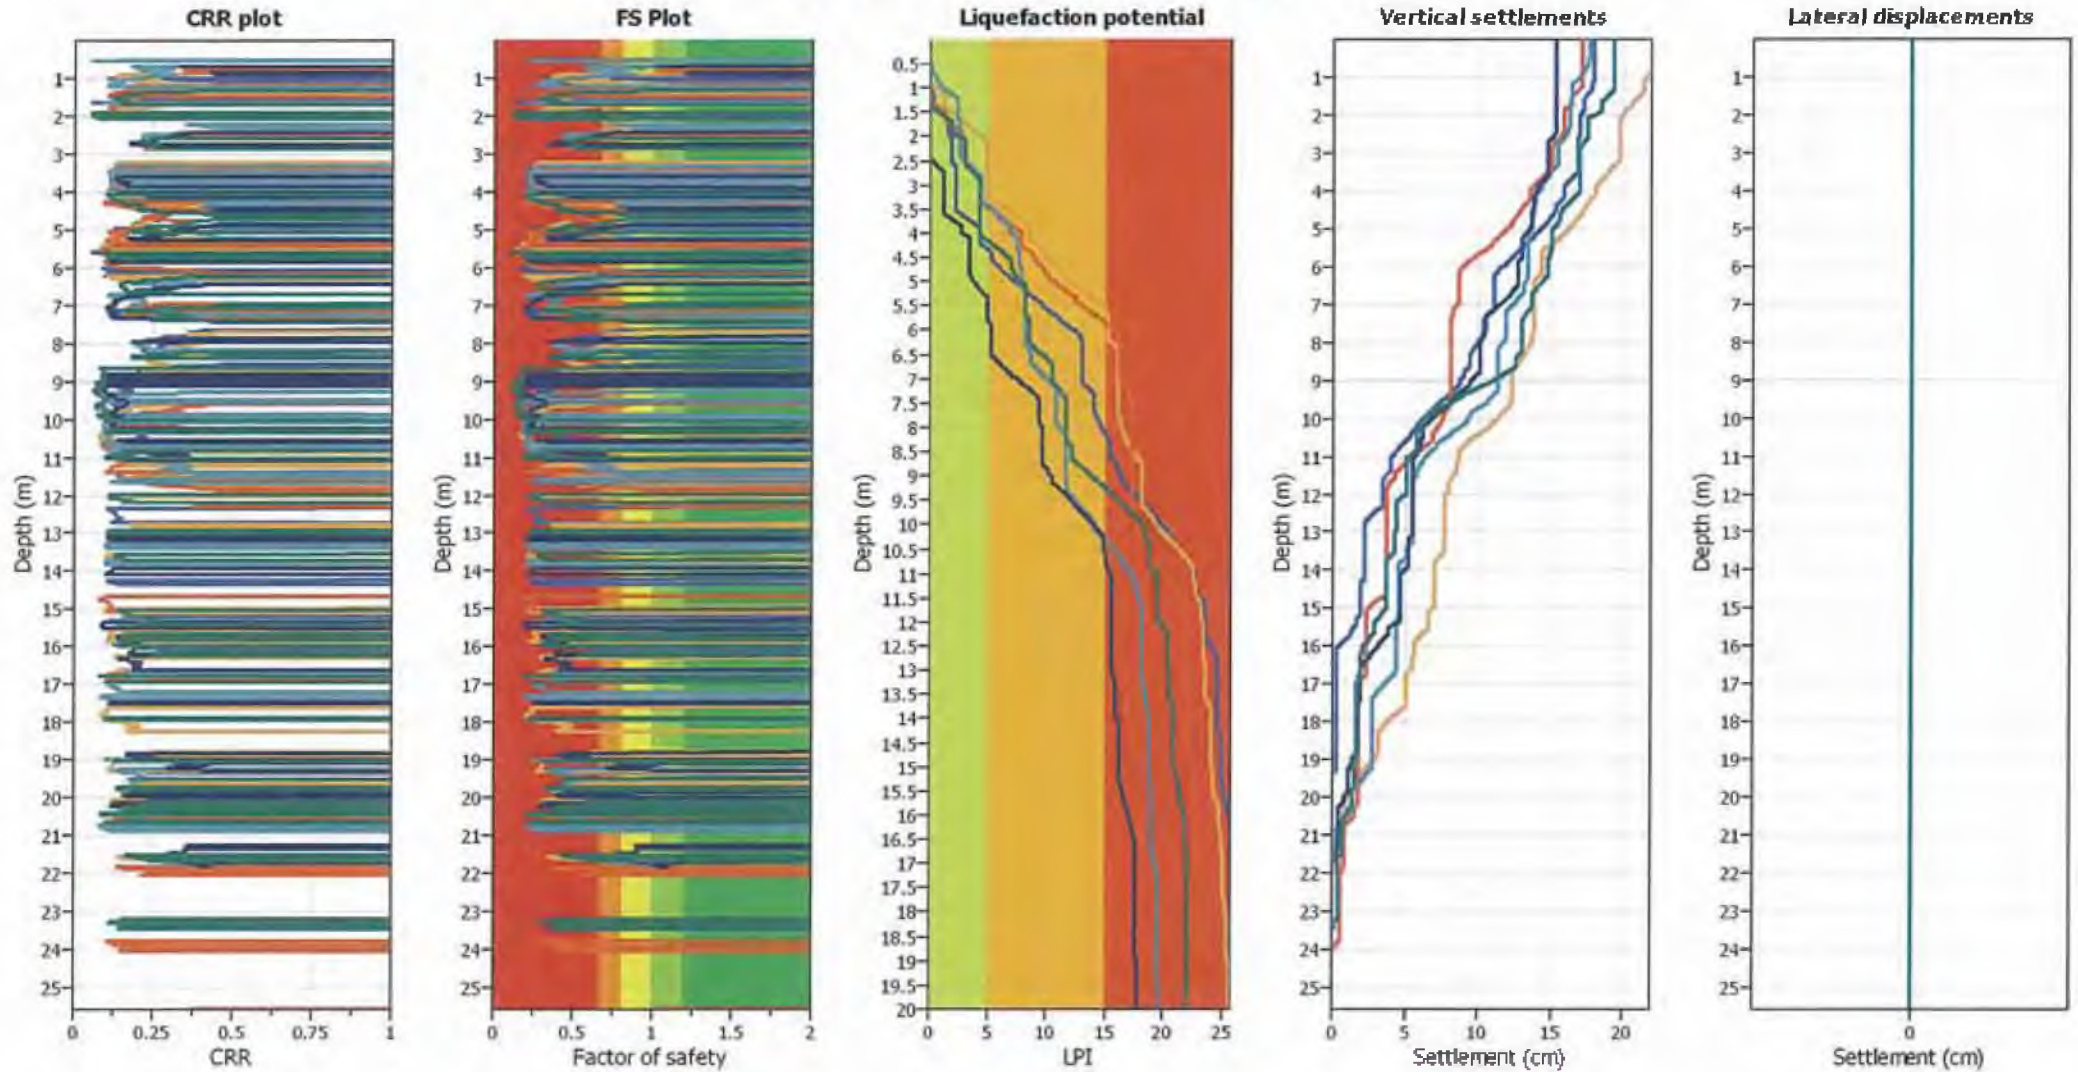
Overlay Cyclic Liquefaction Plots

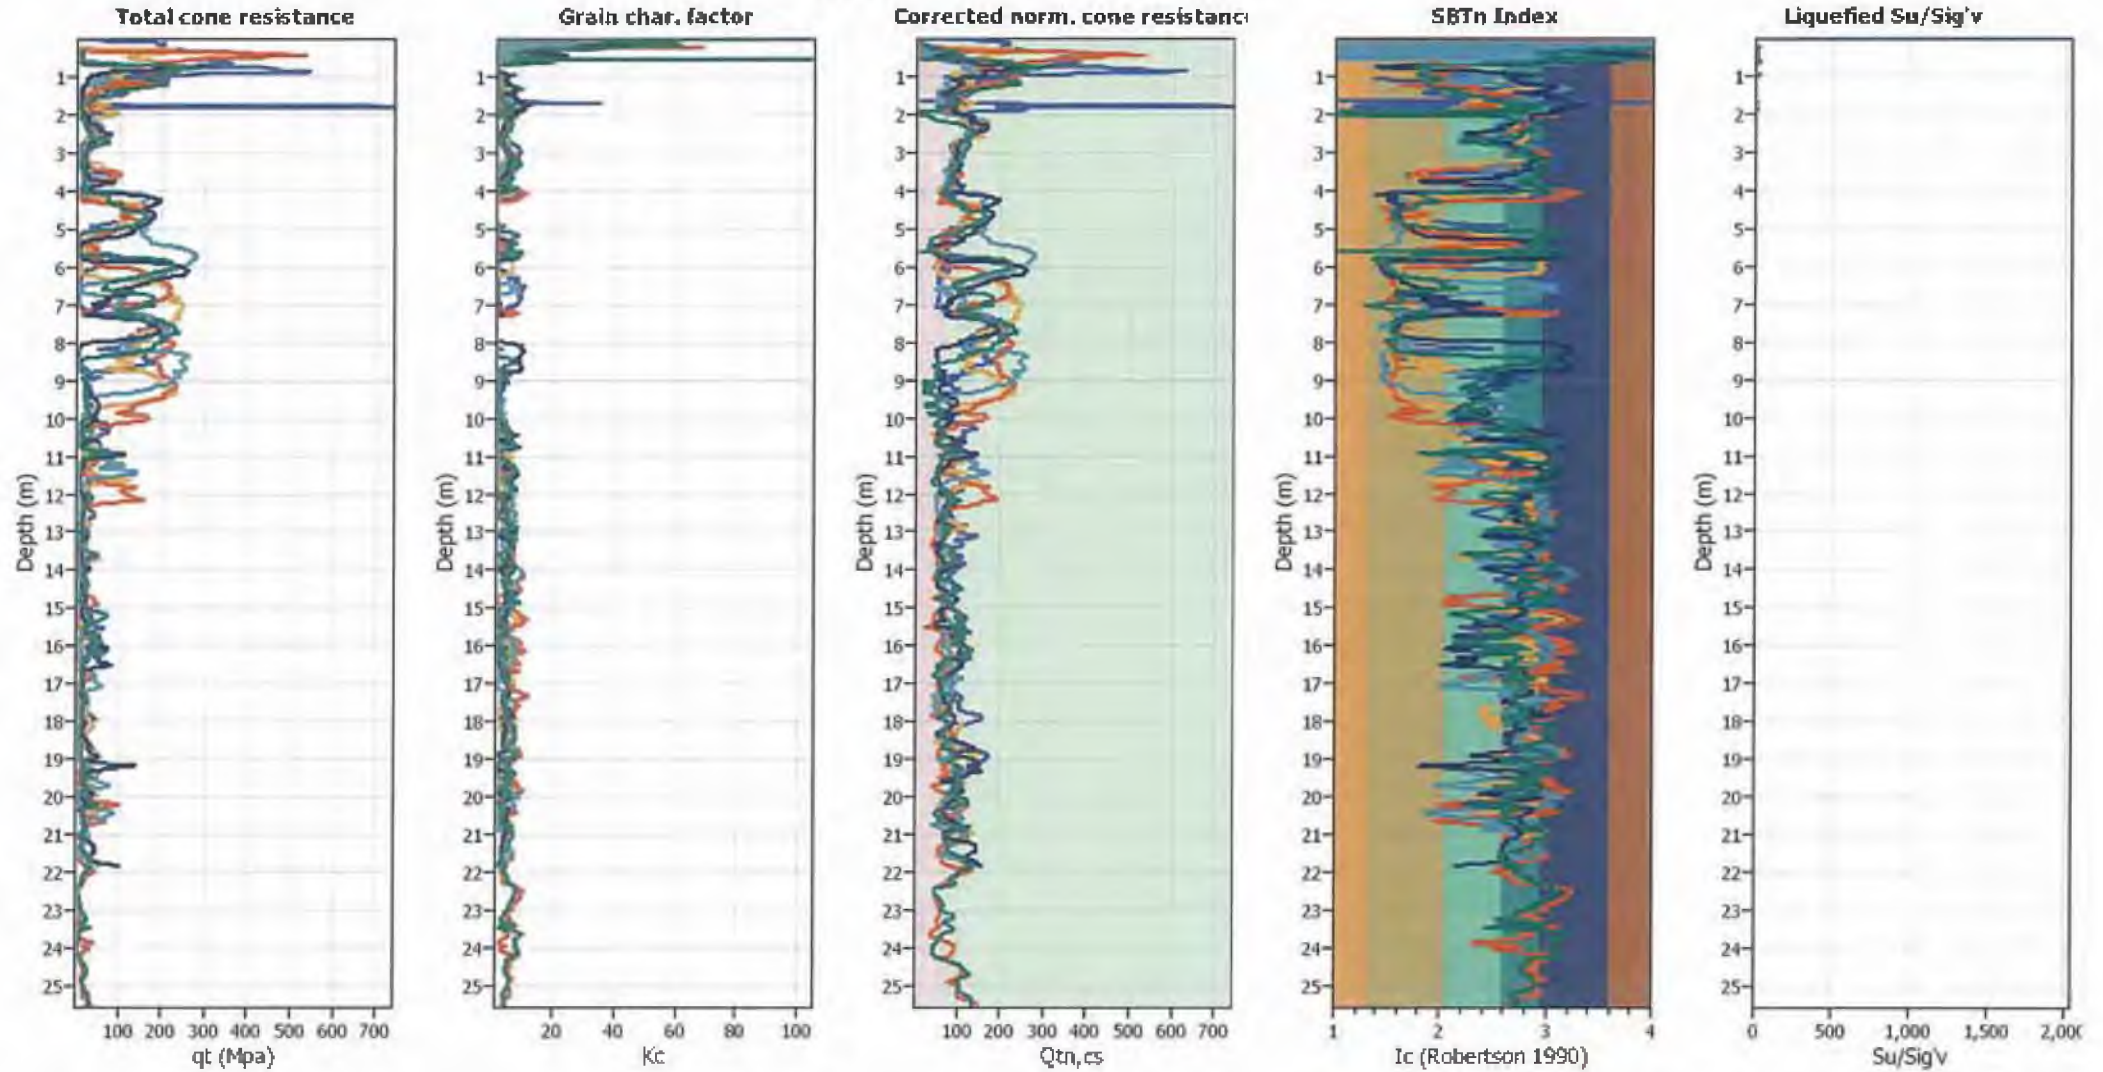
Overlay Strength Loss Plots

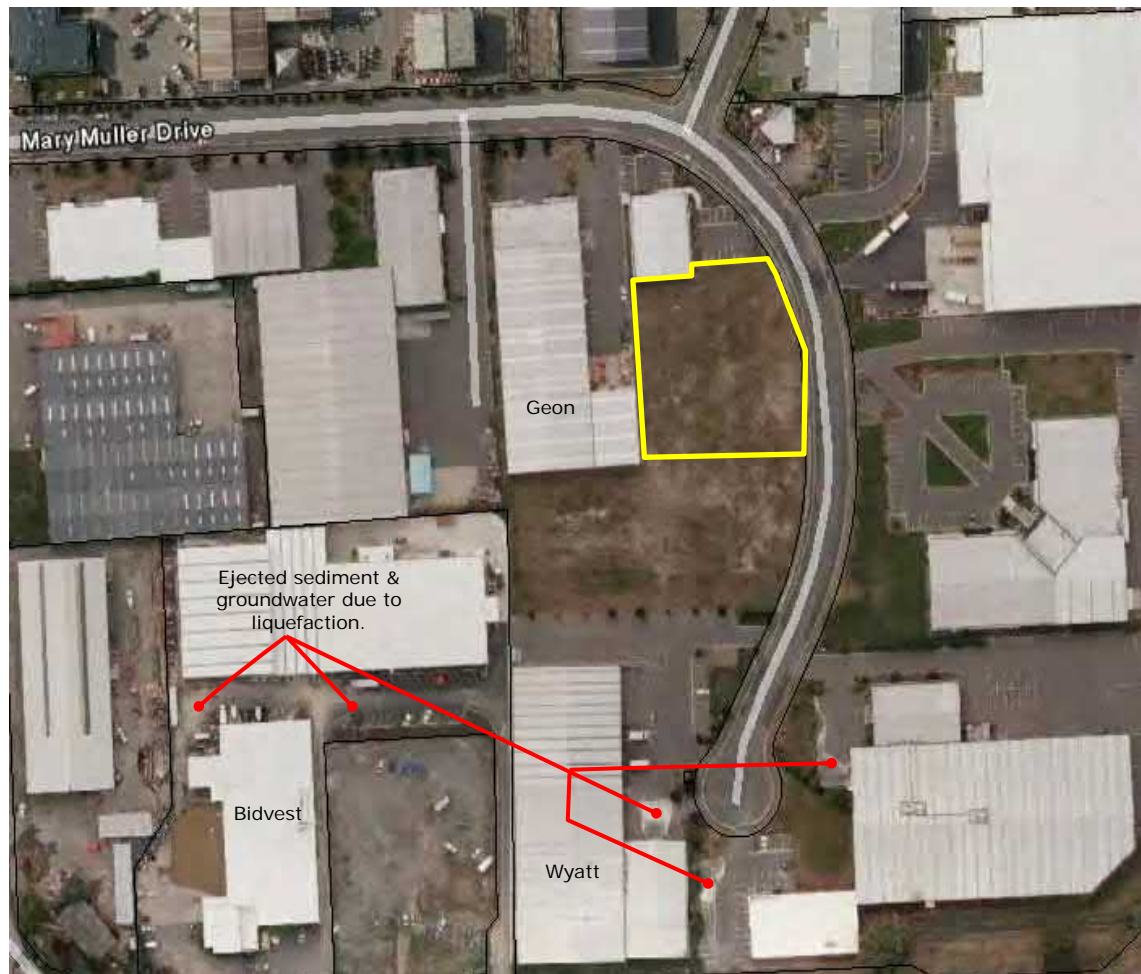
Land Damage on Mary Muller Drive. The approximate site boundary is in yellow. Source: Canterbury Recovery, Project Orbit. Photographs taken 24 February 2011.

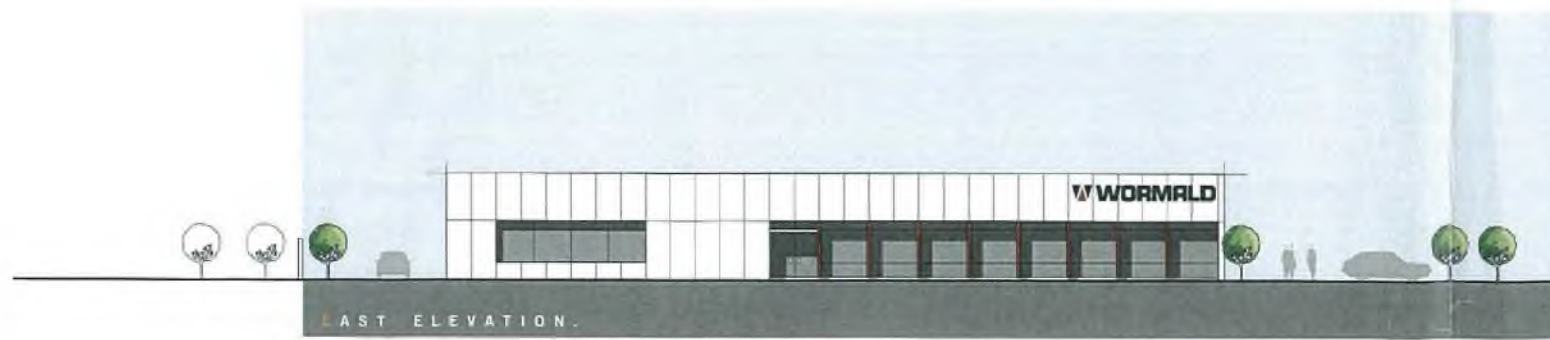
EAST ELEVATION.

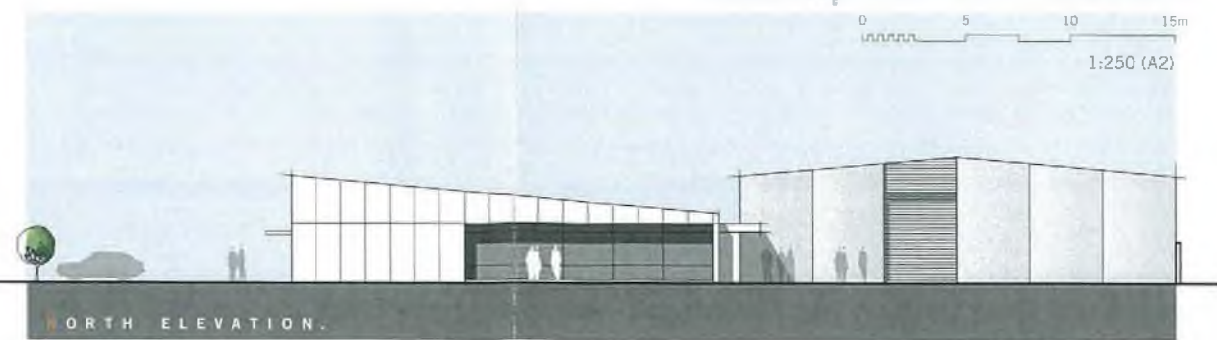
NORTH ELEVATION.

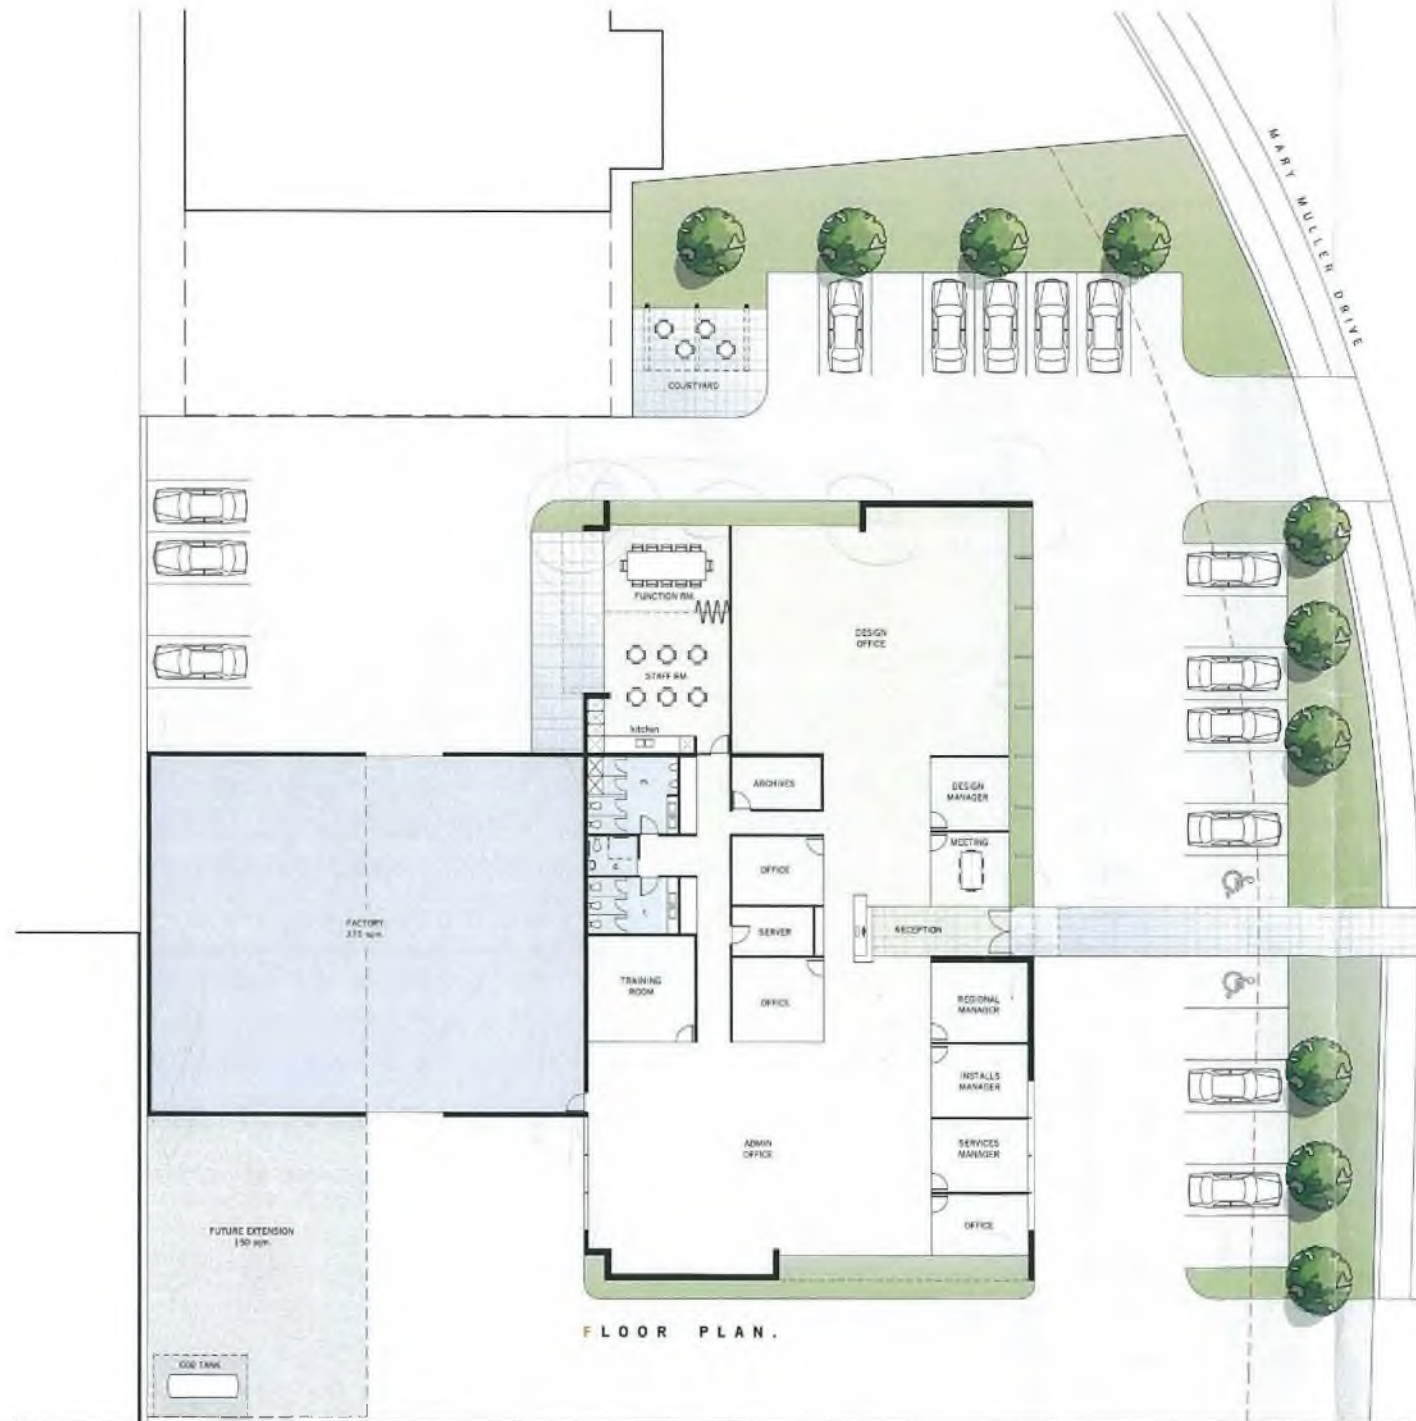
FLOOR PLAN.

SITE AREA: 8245 sqm.
 OFFICES FLOOR AREA: 750 sqm.
 FACTORY FLOOR AREA: 375 sqm.
 TOTAL: 1125 sqm.

CARPARKING REQUIREMENTS
 STAFF: 24
 VISITORS: 2
 DISABLED: 2
 95 PERCENTILE: 1
 HQV: 1
 CYCLES: 4
 CAR PARKS PROVIDED: 27

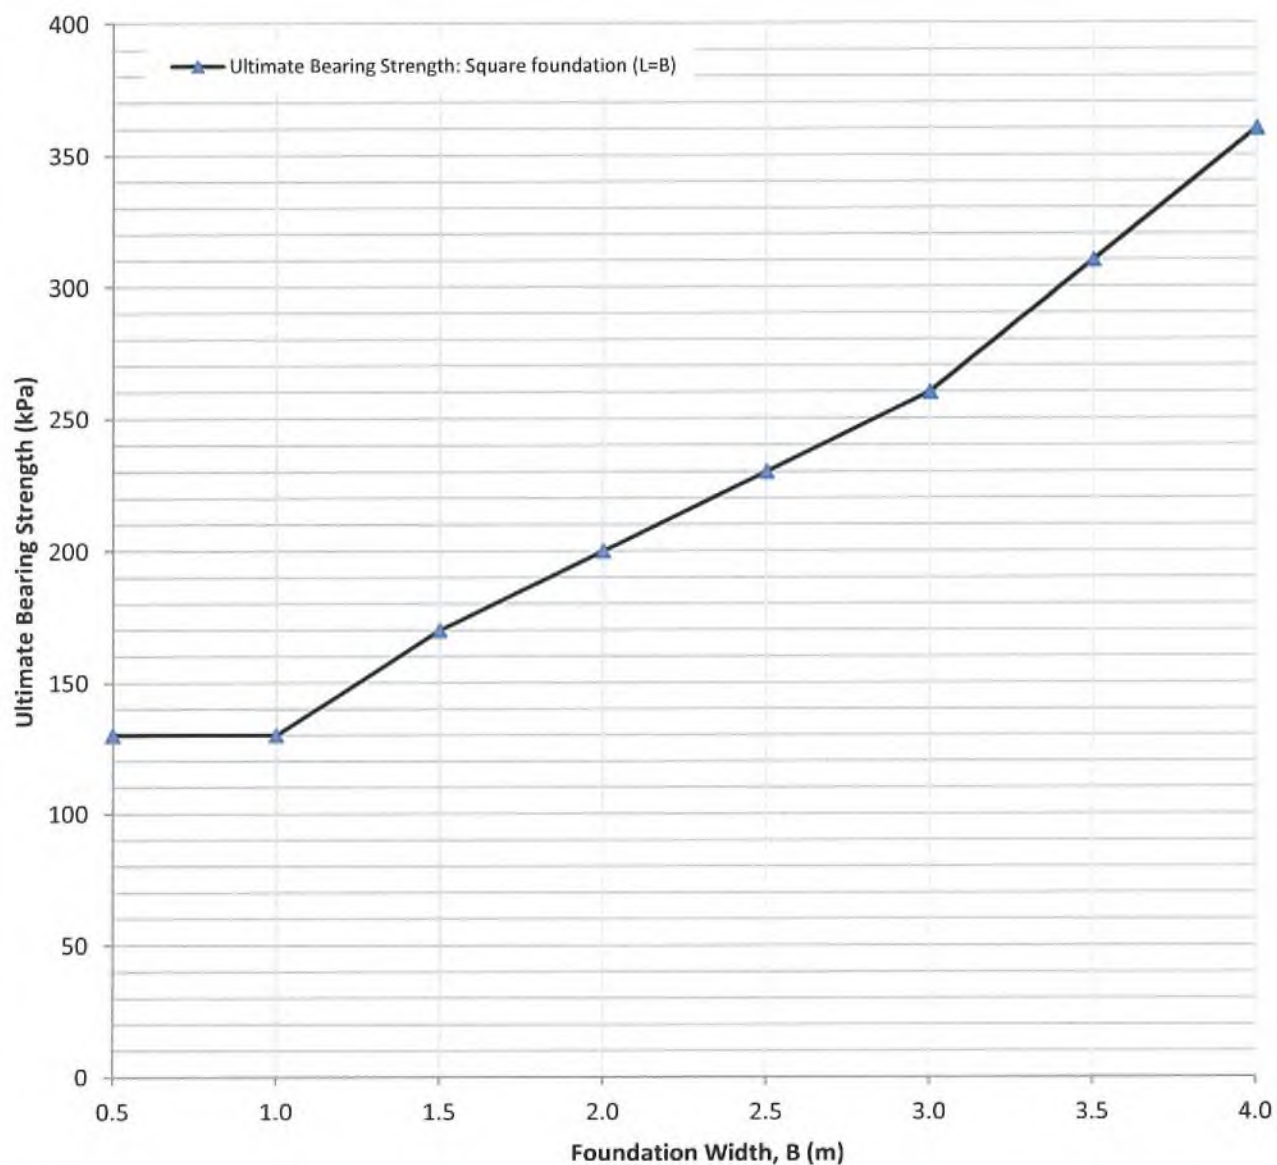
BEARING CAPACITY OF SHALLOW FOUNDATIONS

Foundation depth = 2m below existing GL.

Assumes foundation extends through any fill materials, and bears onto insitu soils.

Structural Engineer should also design bearing strength of chart 'Settlement Control of Shallow Foundations'.

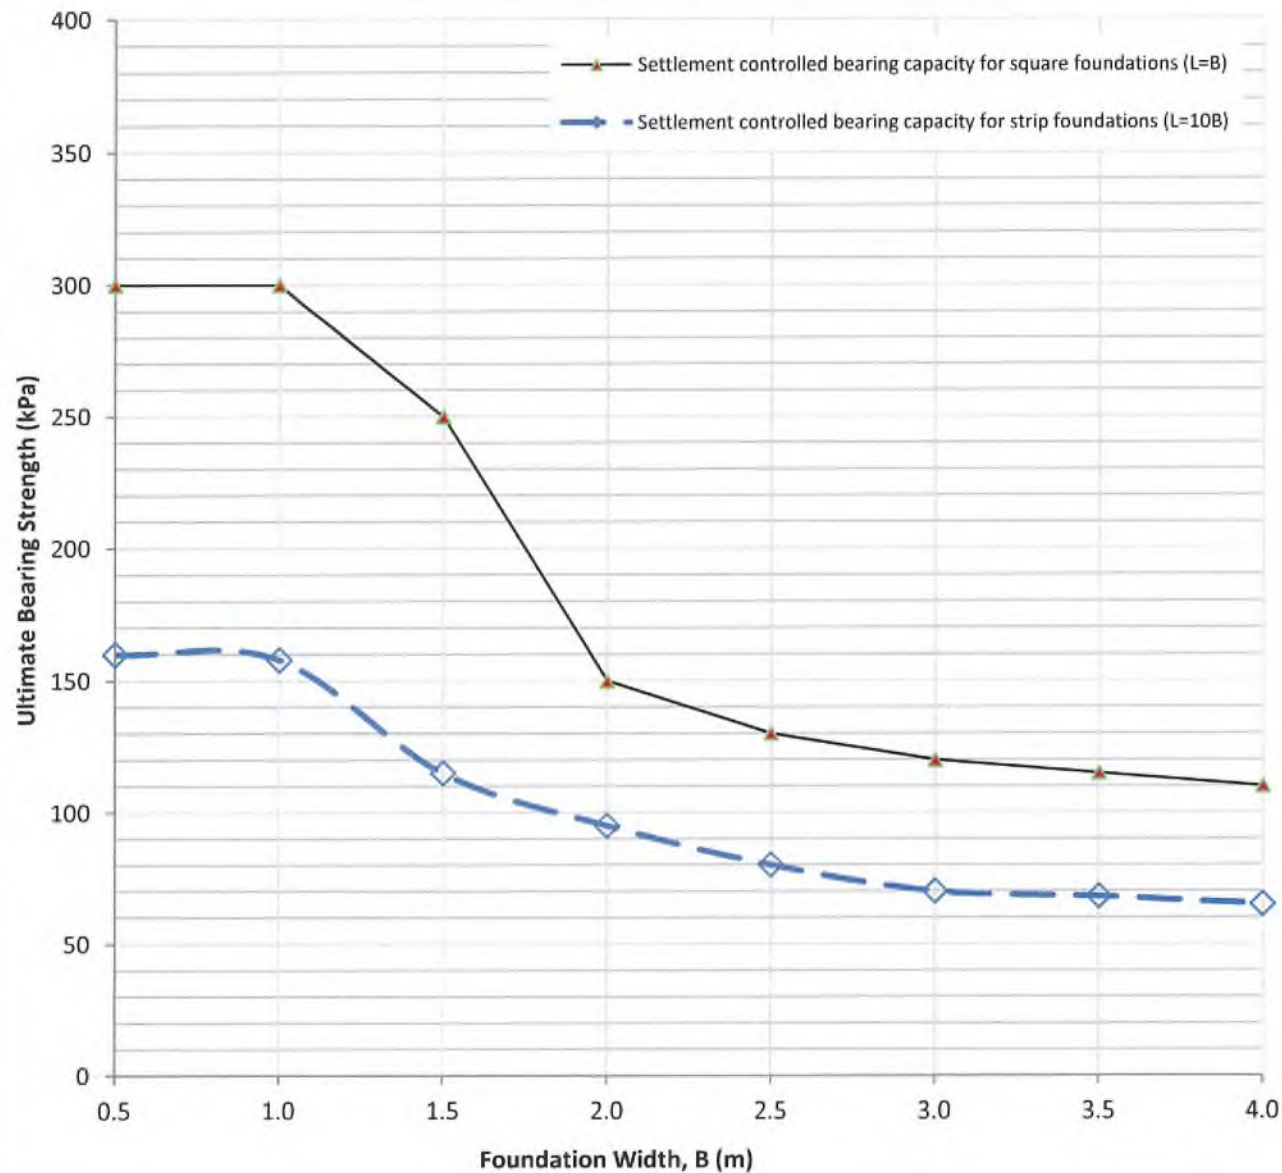
SETTLEMENT CONTROL OF SHALLOW FOUNDATIONS

Foundation depth = 2m below existing GL.

Assumes foundation extends through any fill materials, and bears onto insitu soils.

Duration = 50 years, max 25mm total settlement under non-seismic conditions, calculated using Modulus of Elasticity.

Structural Engineer should also check bearing capacity of foundations, refer to 'Bearing Capacity of Shallow Foundations' chart.

Ultimate bearing capacity at smaller foundation width has been conservatively limited as shown to take into account the presence of lower soil layers.
