Land Information Memorandum

Property address:
2 Mary Muller Drive

LIM number: 70211569
Page 1

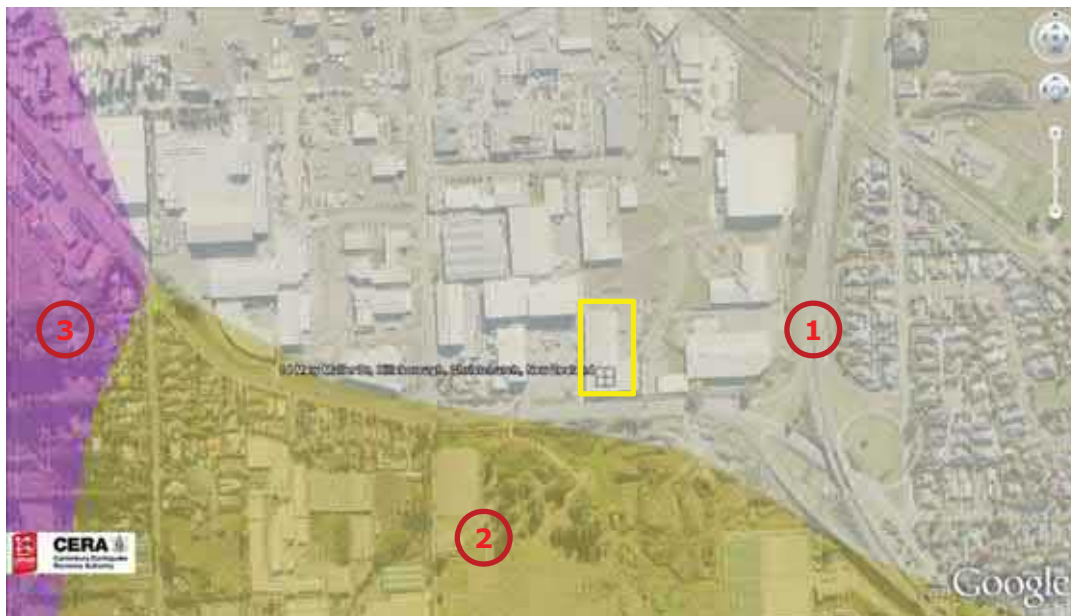
Figure 1: Geological map of Christchurch with aerial photograph.

The geological map of Christchurch indicates the site is underlain by 'Sand, silt and peat of lagoons and estuaries (Avon/Heathcote)' and is considered a 'Holocene estuary deposits'¹. Refer to Figure 1 and **Error! Reference source not found.**

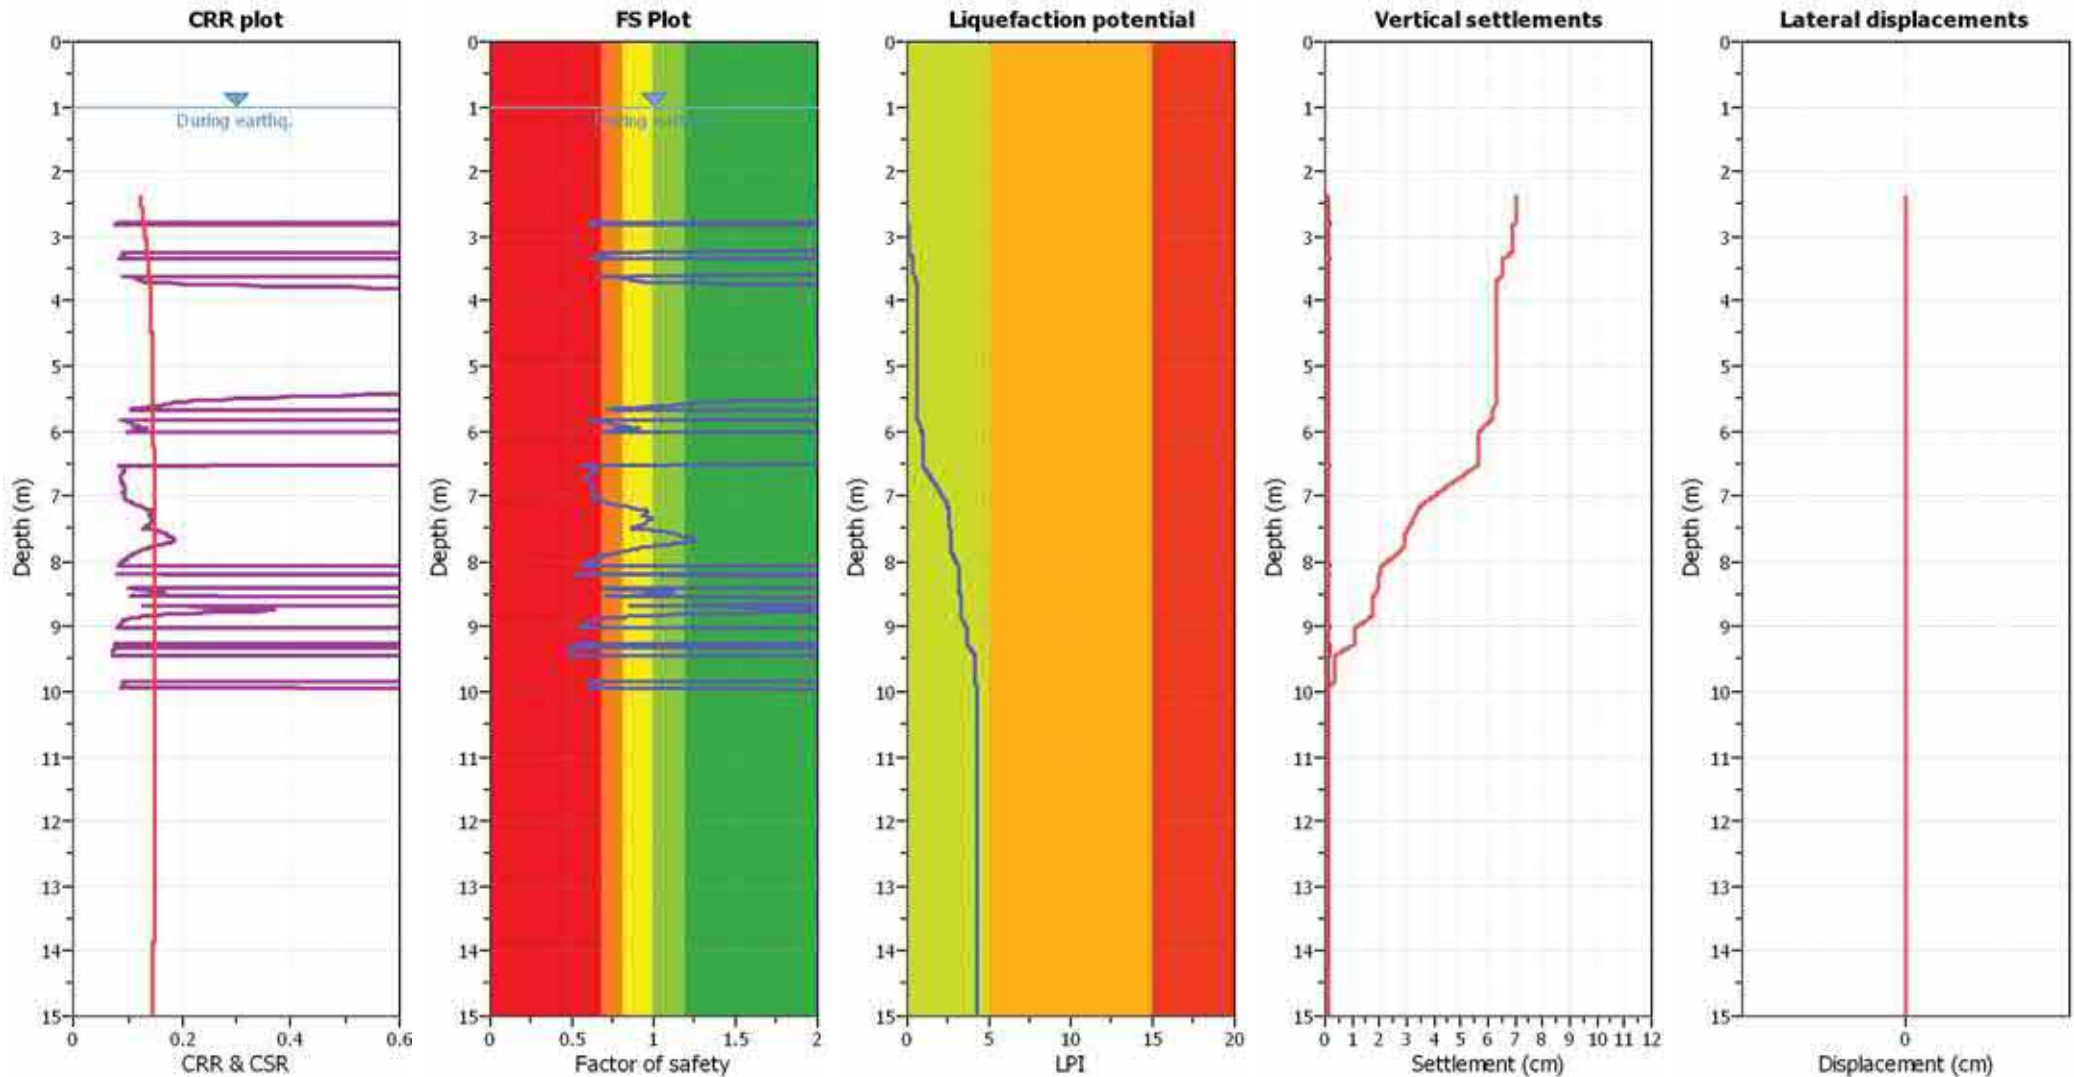
Liquefaction analysis overall plots

Analysis method:	I&B (2008)	Depth to GWT (erthq.):	1.00 m	Fill weight:	N/A
Fines correction method:	R&W (1998)	Average results interval:	3	Transition detect. applied:	No
Points to test:	Based on Ic value	Ic cut-off value:	2.60	K _s applied:	Yes
Earthquake magnitude M _w :	7.50	Unit weight calculation:	Based on SBT	Clay like behavior applied:	Sands only
Peak ground acceleration:	0.13	Use fill:	No	Limit depth applied:	Yes
Depth to water table (insitu):	1.00 m	Fill height:	N/A	Limit depth:	10.00 m

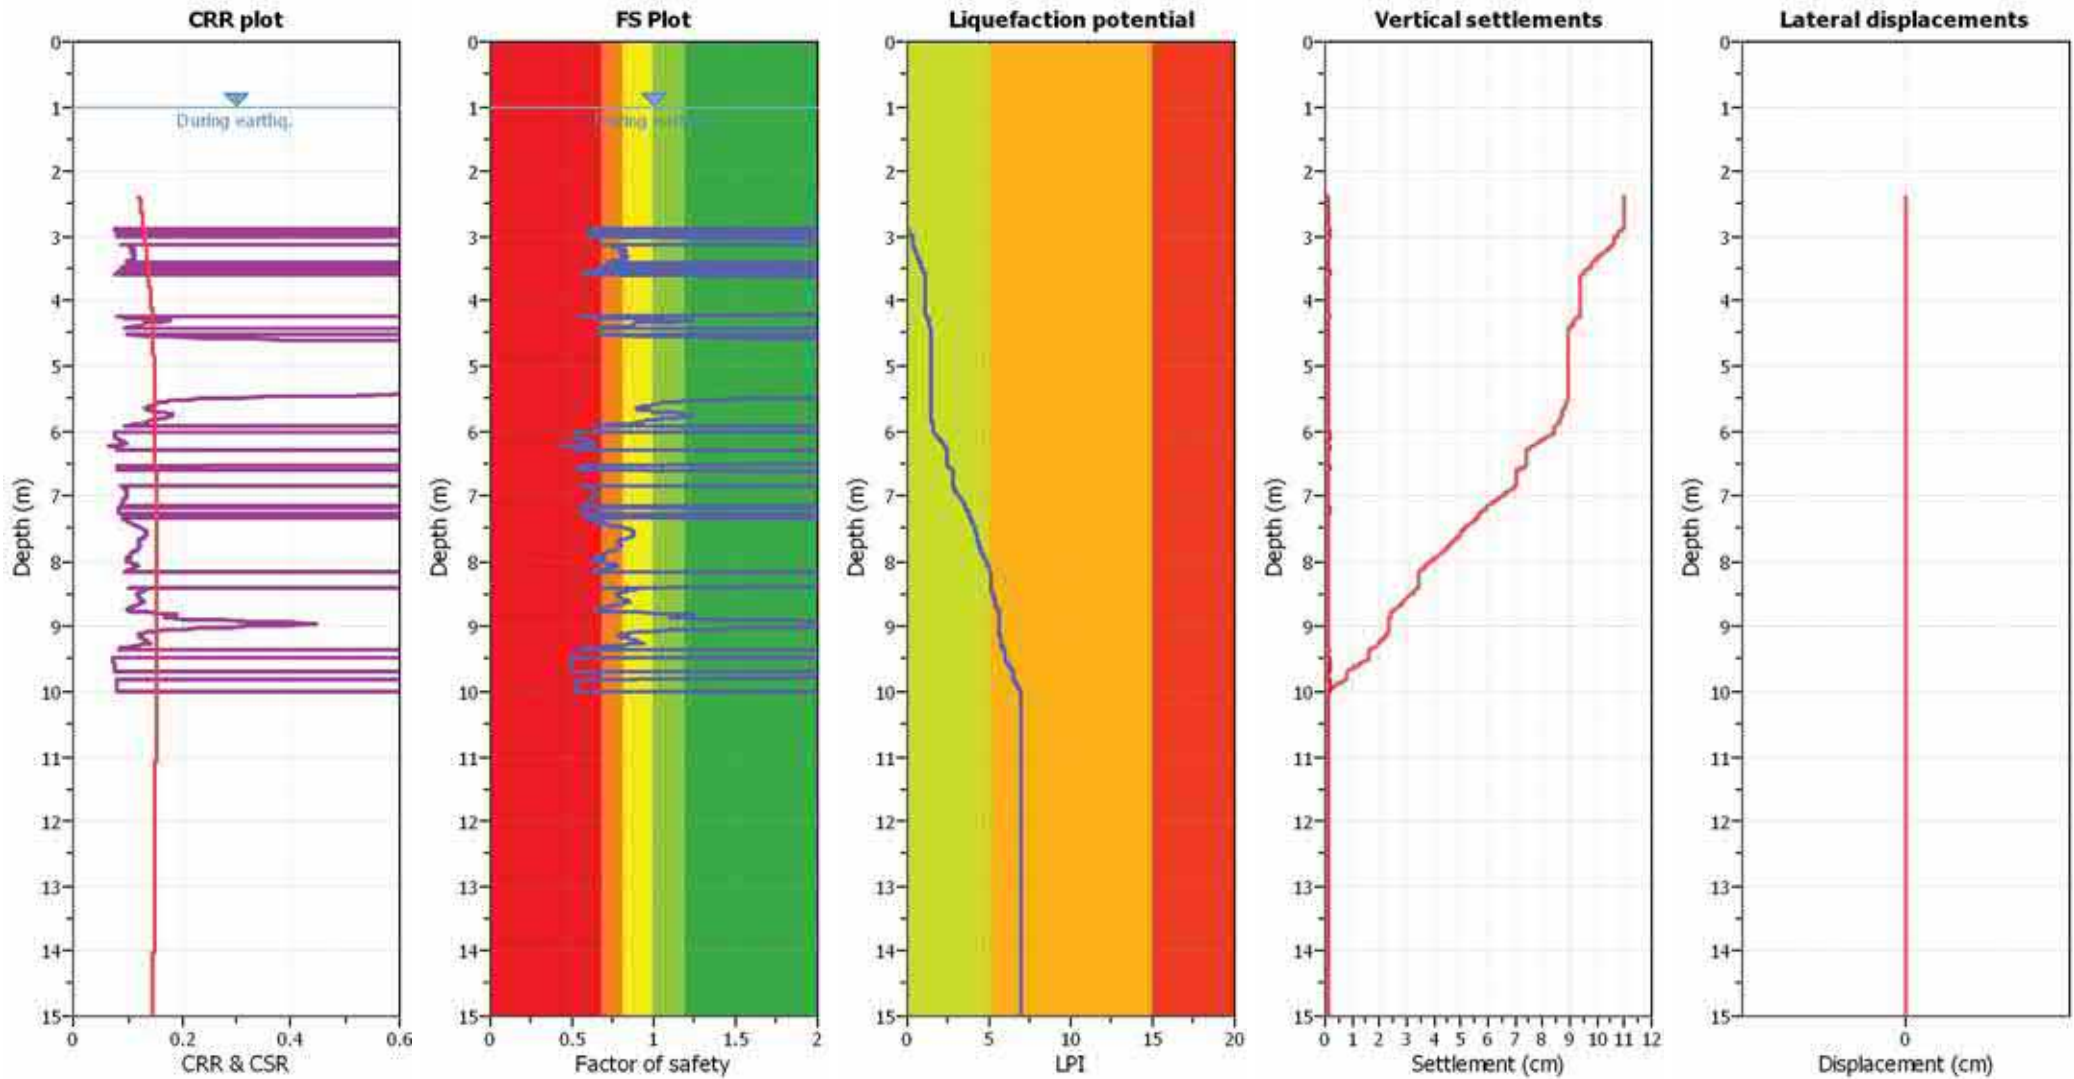
Liquefaction analysis overall plots

Analysis method:	I&B (2008)	Depth to GWT (erthq.):	1.00 m	Fill weight:	N/A
Fines correction method:	R&W (1998)	Average results interval:	3	Transition detect. applied:	No
Points to test:	Based on Ic value	Ic cut-off value:	2.60	K _σ applied:	Yes
Earthquake magnitude M _w :	7.50	Unit weight calculation:	Based on SBT	Clay like behavior applied:	Sands only
Peak ground acceleration:	0.13	Use fill:	No	Limit depth applied:	Yes
Depth to water table (insitu):	1.00 m	Fill height:	N/A	Limit depth:	10.00 m

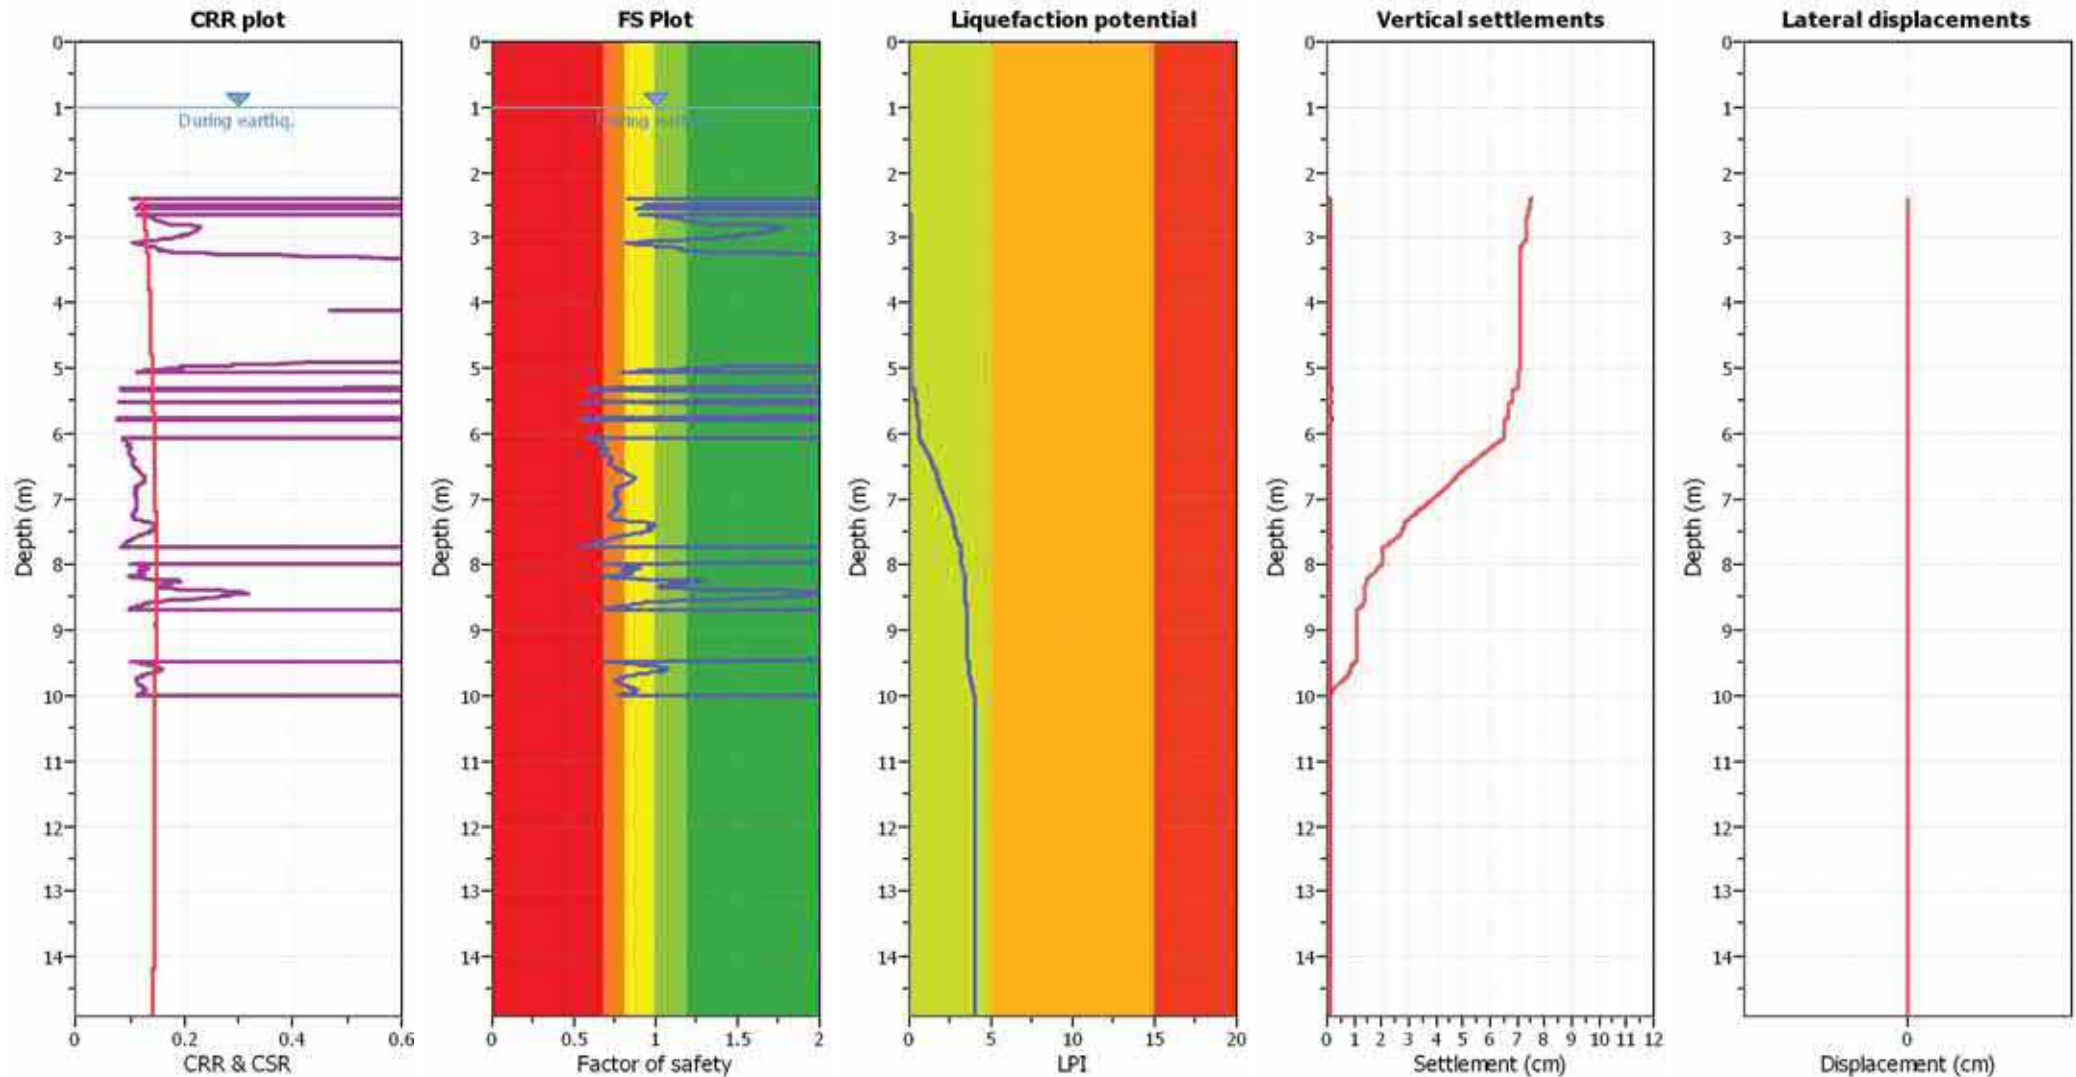
Liquefaction analysis overall plots

Analysis method:	I&B (2008)	Depth to GWT (erthq.):	1.00 m	Fill weight:	N/A
Fines correction method:	R&W (1998)	Average results interval:	3	Transition detect. applied:	No
Points to test:	Based on Ic value	Ic cut-off value:	2.60	K_p applied:	Yes
Earthquake magnitude M_w :	7.50	Unit weight calculation:	Based on SBT	Clay like behavior applied:	Sands only
Peak ground acceleration:	0.13	Use fill:	No	Limit depth applied:	Yes
Depth to water table (insitu):	1.00 m	Fill height:	N/A	Limit depth:	10.00 m

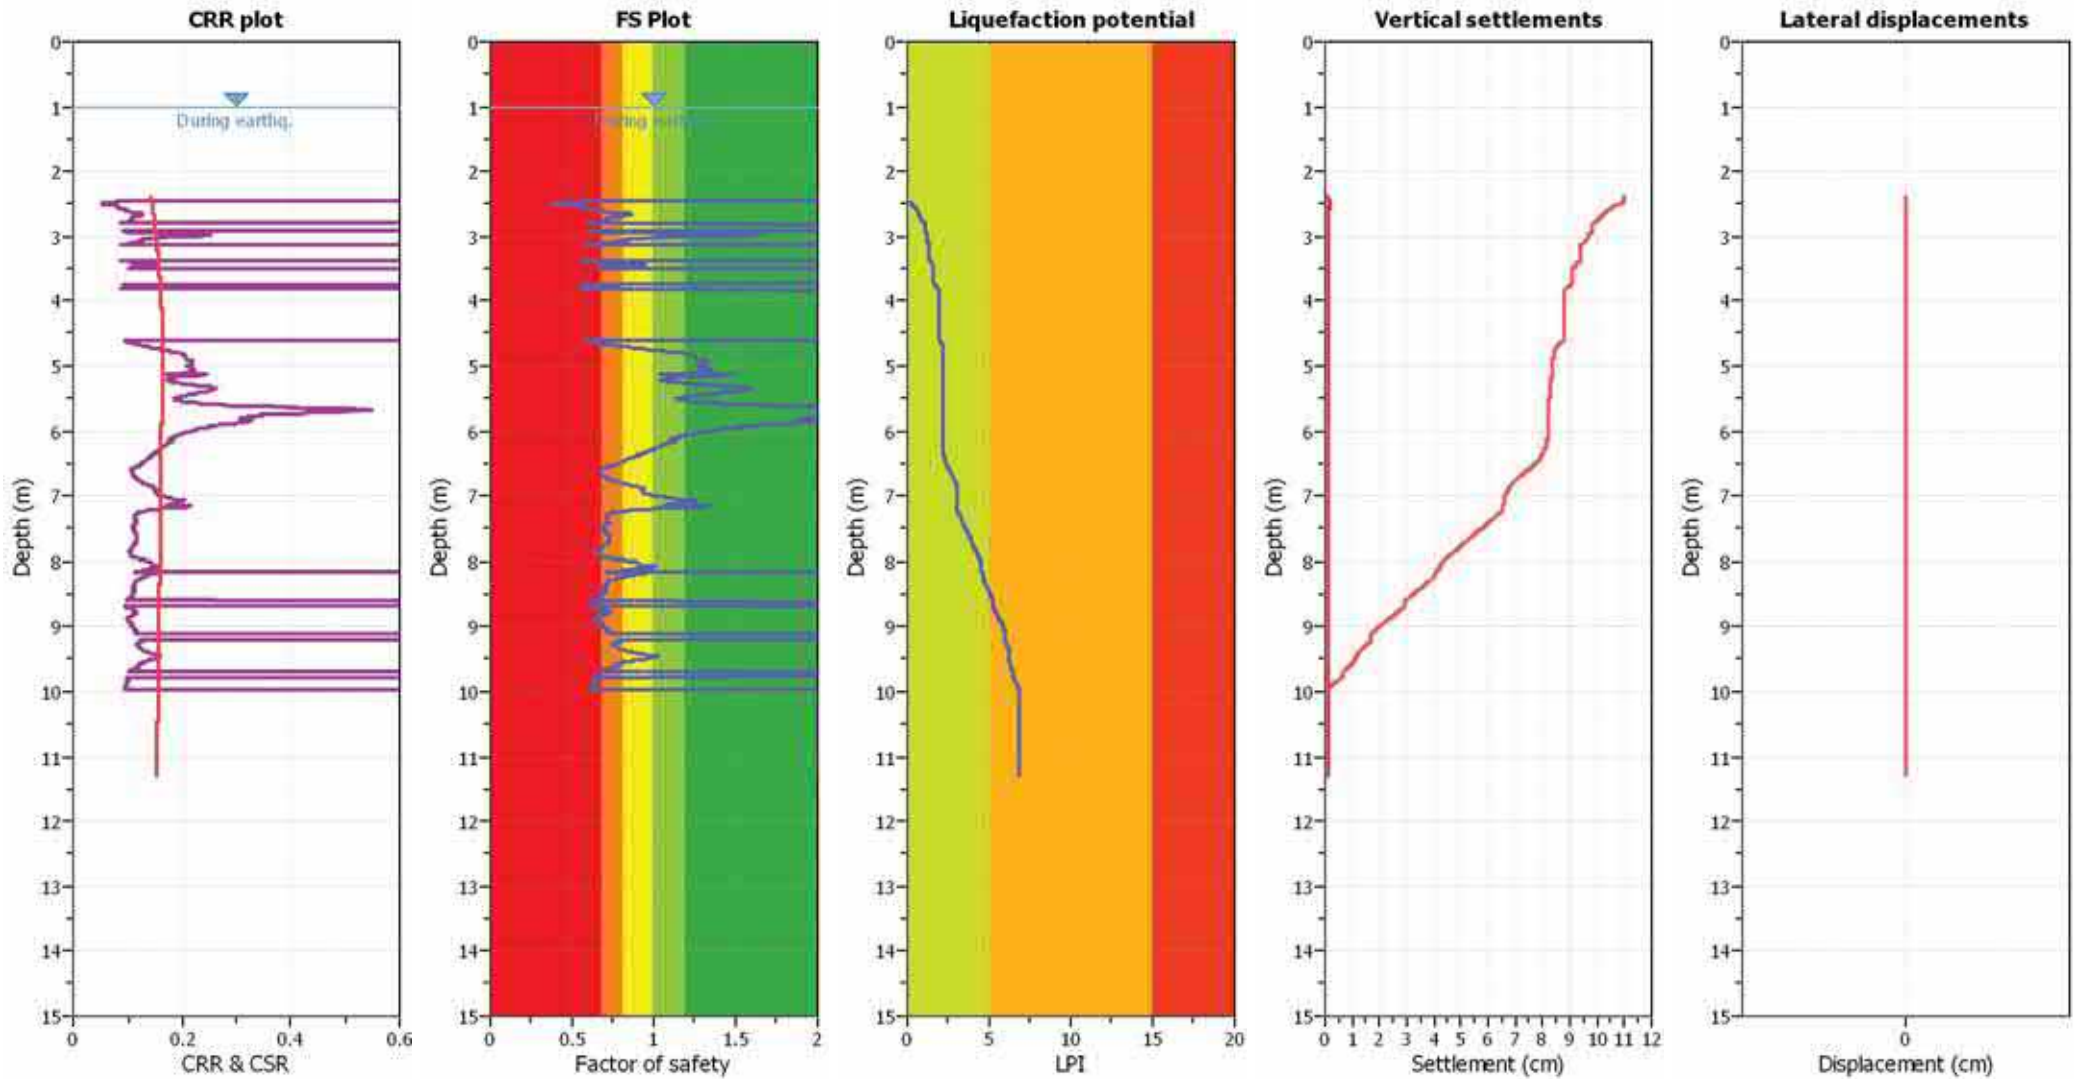
Liquefaction analysis overall plots

Analysis method:	I&B (2008)	Depth to GWT (erthq.):	1.00 m	Fill weight:	N/A
Fines correction method:	R&W (1998)	Average results interval:	3	Transition detect. applied:	No
Points to test:	Based on Ic value	Ic cut-off value:	2.60	K _σ applied:	Yes
Earthquake magnitude M _w :	7.50	Unit weight calculation:	Based on SBT	Clay like behavior applied:	Sands only
Peak ground acceleration:	0.13	Use fill:	No	Limit depth applied:	Yes
Depth to water table (insitu):	1.00 m	Fill height:	N/A	Limit depth:	10.00 m

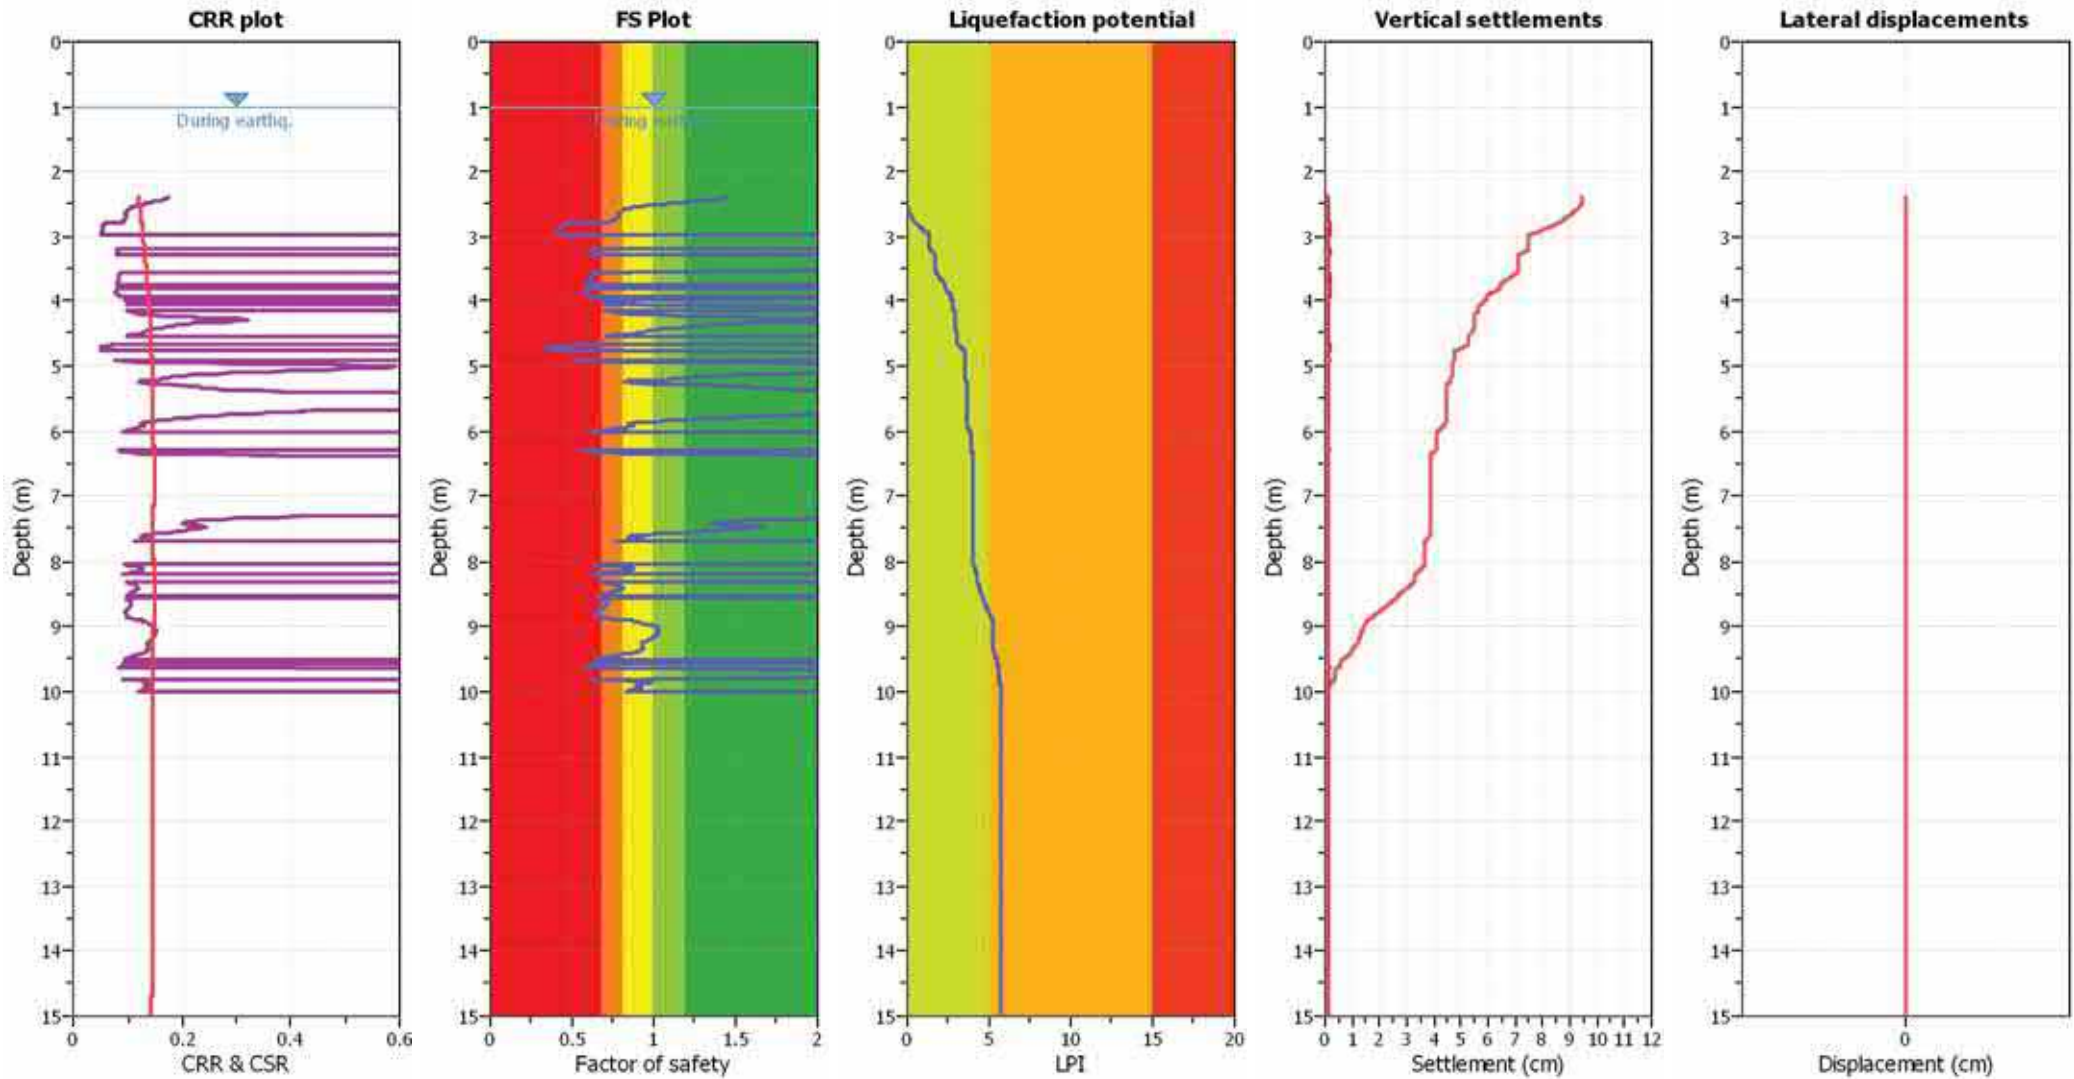
Liquefaction analysis overall plots

Analysis method:	I&B (2008)	Depth to GWT (erthq.):	1.00 m	Fill weight:	N/A
Fines correction method:	R&W (1998)	Average results interval:	3	Transition detect. applied:	No
Points to test:	Based on Ic value	Ic cut-off value:	2.60	K ₀ applied:	Yes
Earthquake magnitude M _w :	7.50	Unit weight calculation:	Based on SBT	Clay like behavior applied:	Sands only
Peak ground acceleration:	0.13	Use fill:	No	Limit depth applied:	Yes
Depth to water table (insitu):	1.00 m	Fill height:	N/A	Limit depth:	10.00 m

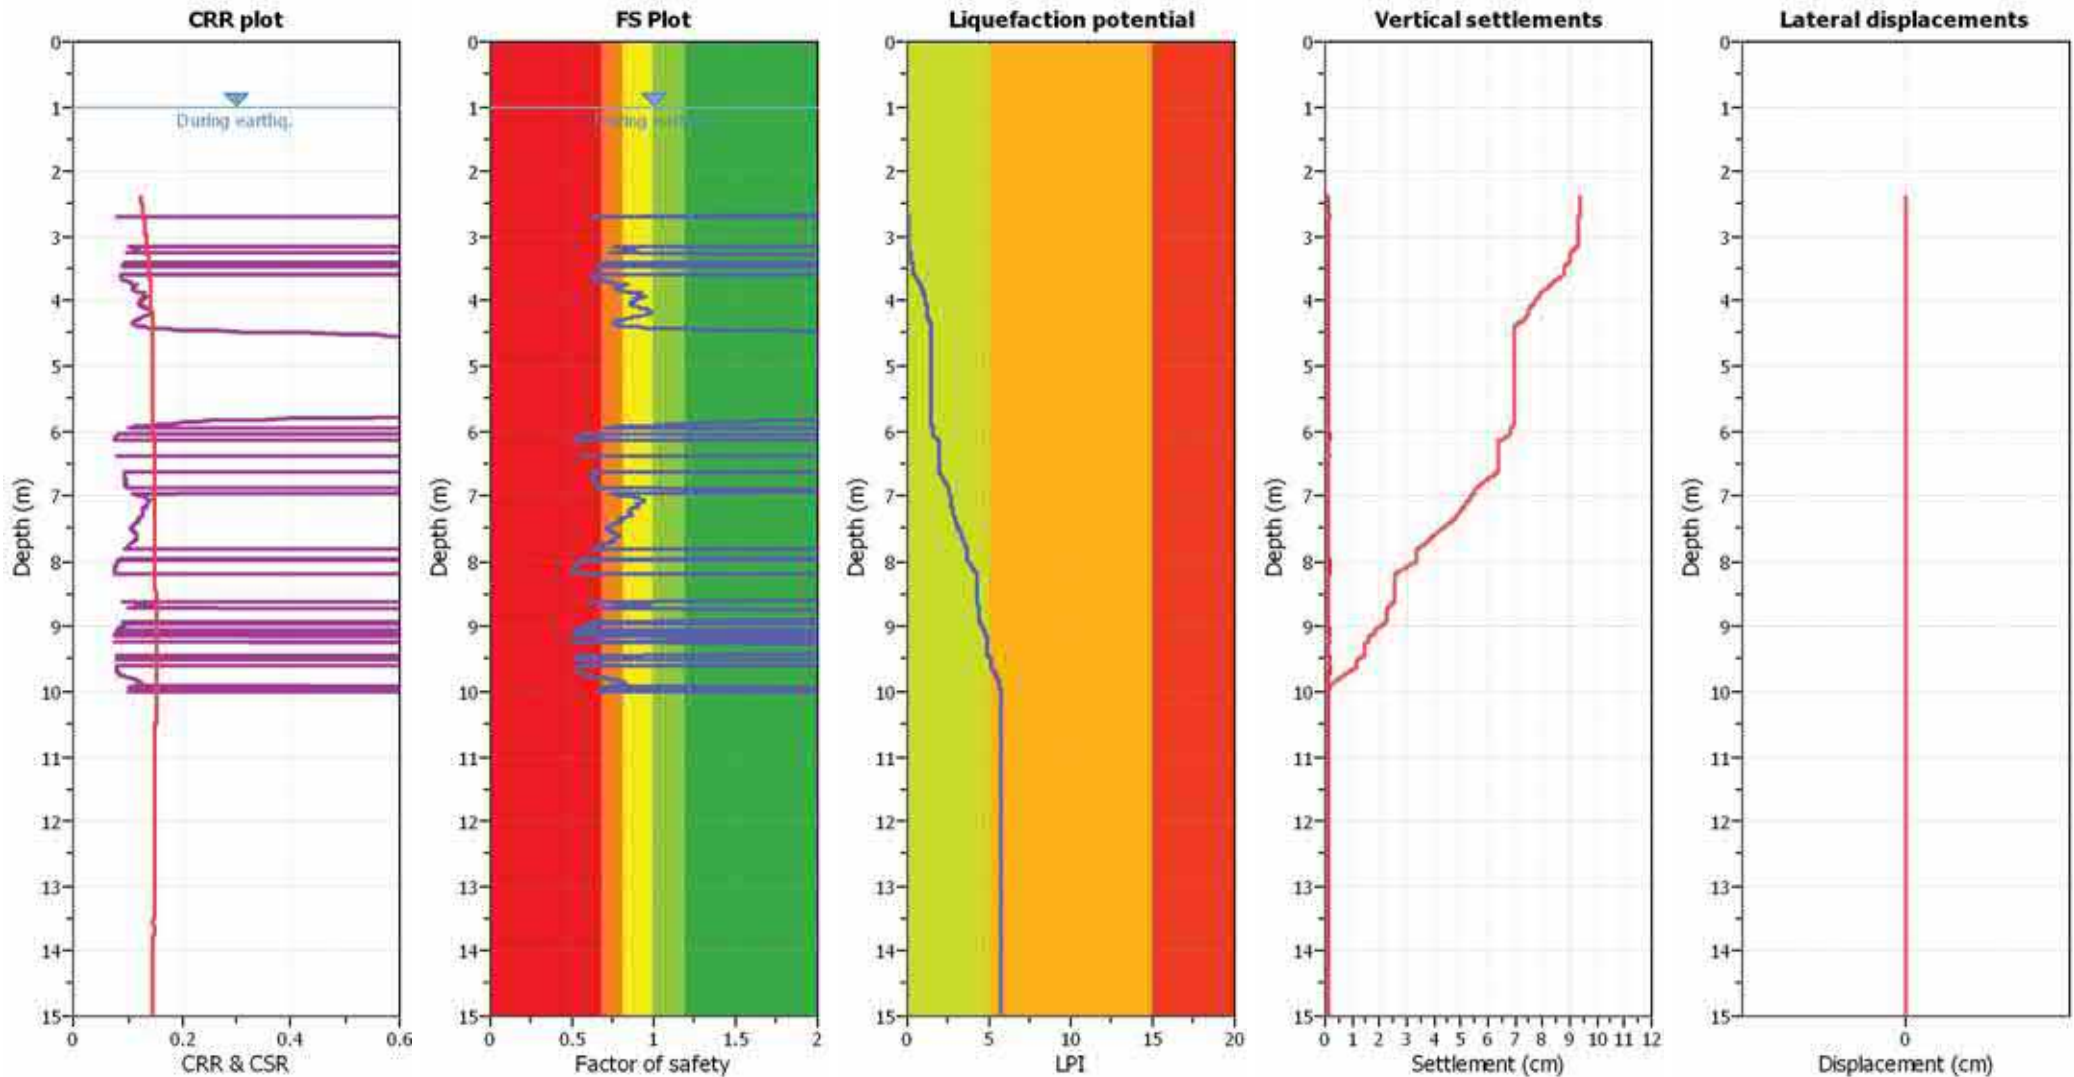
Liquefaction analysis overall plots

Analysis method:	I&B (2008)	Depth to GWT (erthq.):	1.00 m	Fill weight:	N/A
Fines correction method:	R&W (1998)	Average results interval:	3	Transition detect. applied:	No
Points to test:	Based on Ic value	Ic cut-off value:	2.60	K _σ applied:	Yes
Earthquake magnitude M _w :	7.50	Unit weight calculation:	Based on SBT	Clay like behavior applied:	Sands only
Peak ground acceleration:	0.13	Use fill:	No	Limit depth applied:	Yes
Depth to water table (insitu):	1.00 m	Fill height:	N/A	Limit depth:	10.00 m

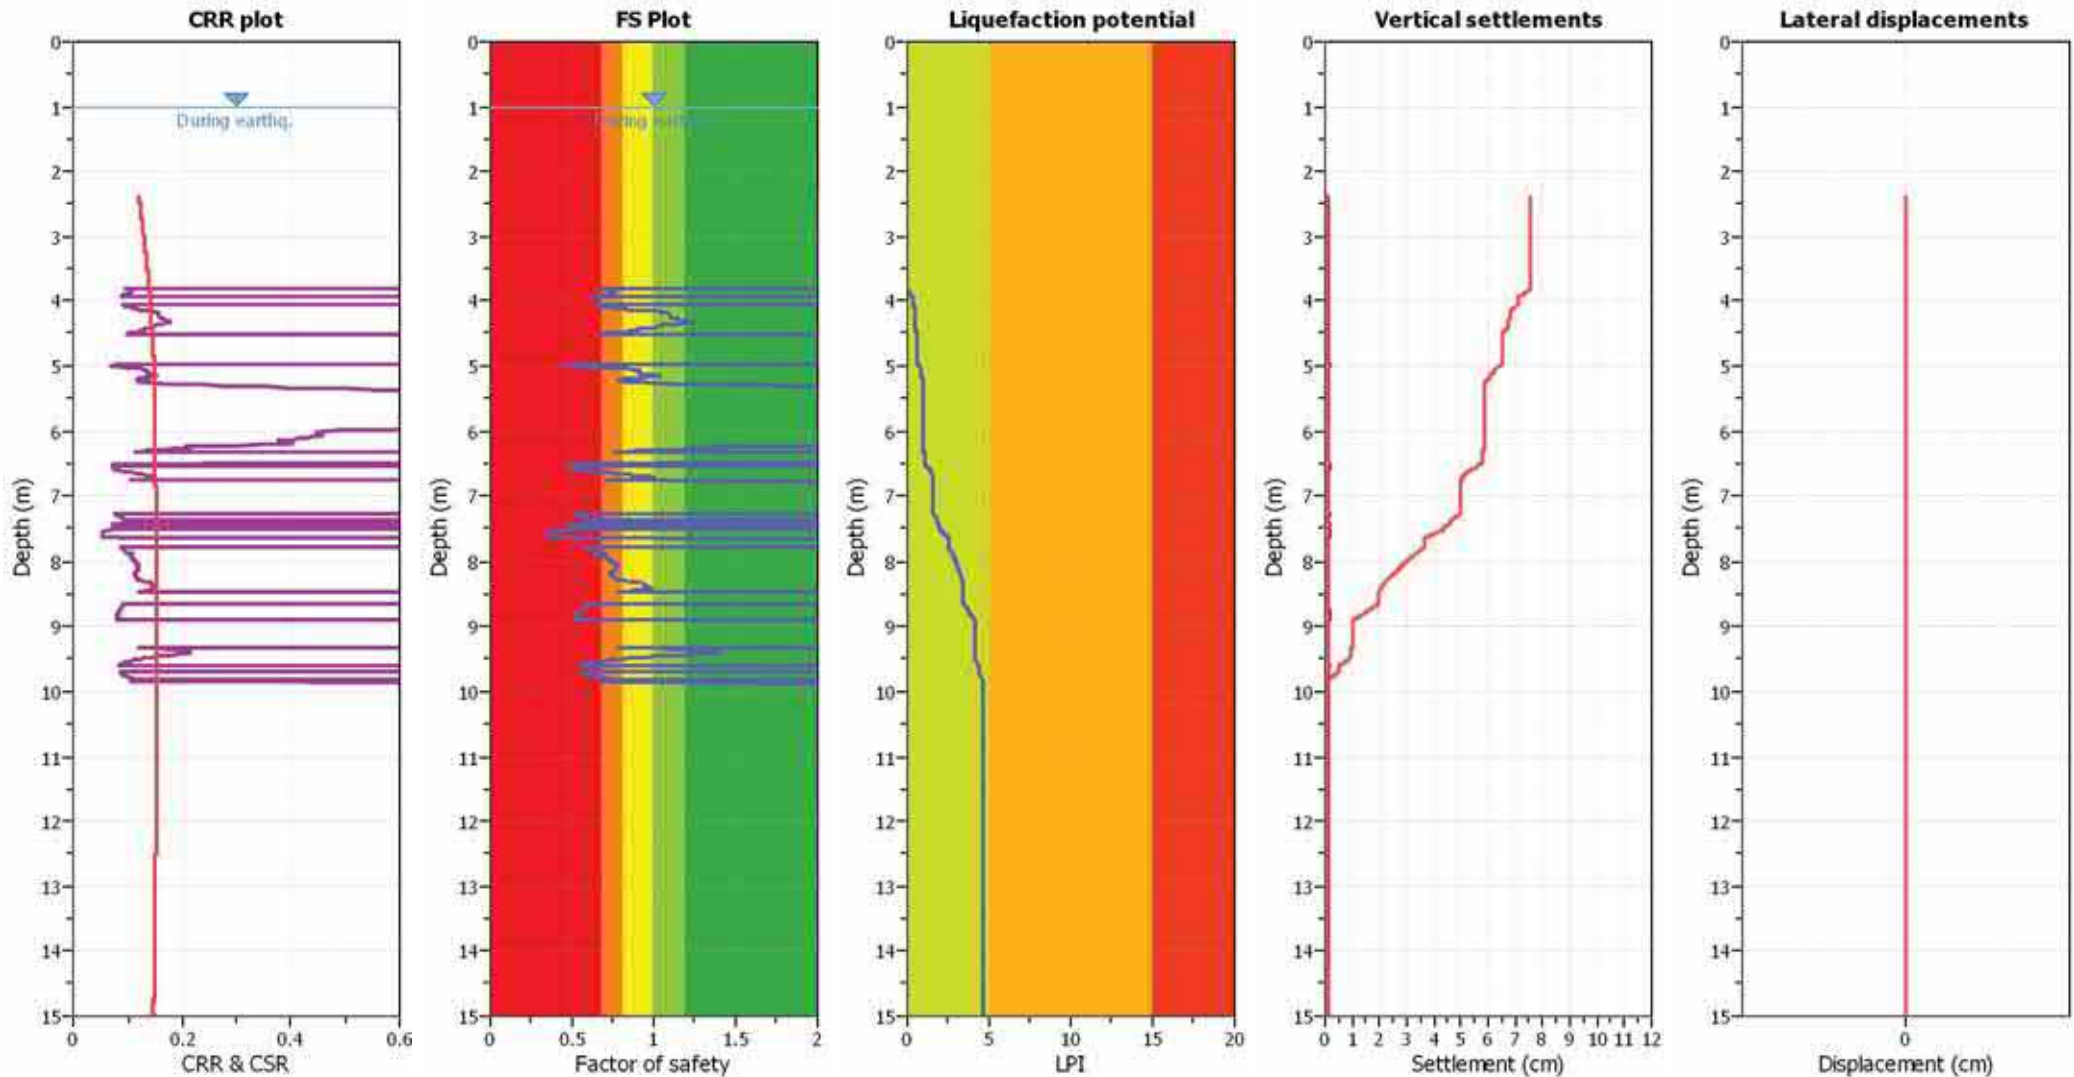
Liquefaction analysis overall plots

Analysis method:	I&B (2008)	Depth to GWT (erthq.):	1.00 m	Fill weight:	N/A
Fines correction method:	R&W (1998)	Average results interval:	3	Transition detect. applied:	No
Points to test:	Based on Ic value	Ic cut-off value:	2.60	K ₀ applied:	Yes
Earthquake magnitude M _w :	7.50	Unit weight calculation:	Based on SBT	Clay like behavior applied:	Sands only
Peak ground acceleration:	0.13	Use fill:	No	Limit depth applied:	Yes
Depth to water table (insitu):	1.00 m	Fill height:	N/A	Limit depth:	10.00 m

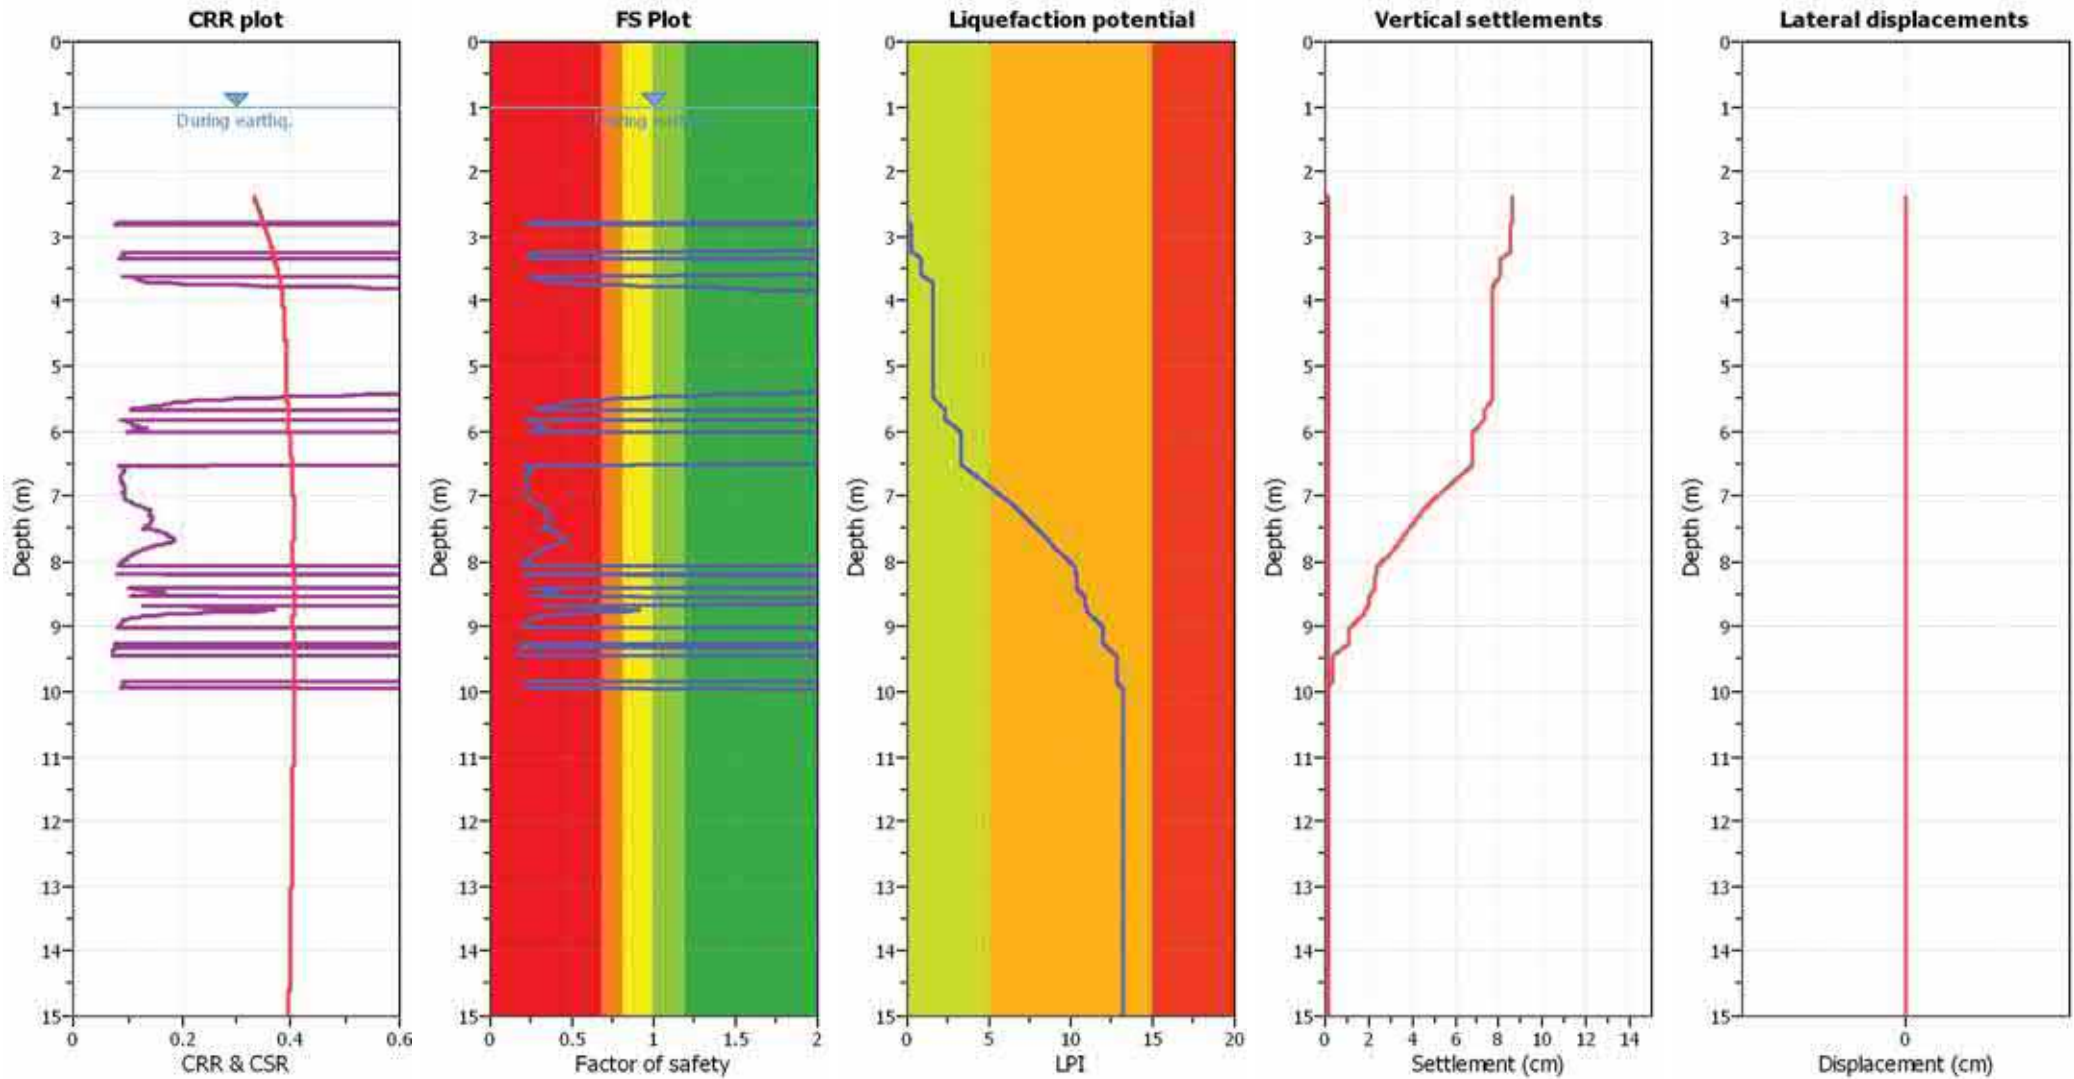
Liquefaction analysis overall plots

Analysis method:	I&B (2008)	Depth to GWT (erthq.):	1.00 m	Fill weight:	N/A
Fines correction method:	R&W (1998)	Average results interval:	3	Transition detect. applied:	No
Points to test:	Based on Ic value	Ic cut-off value:	2.60	K _σ applied:	Yes
Earthquake magnitude M _w :	7.50	Unit weight calculation:	Based on SBT	Clay like behavior applied:	Sands only
Peak ground acceleration:	0.35	Use fill:	No	Limit depth applied:	Yes
Depth to water table (insitu):	1.00 m	Fill height:	N/A	Limit depth:	10.00 m

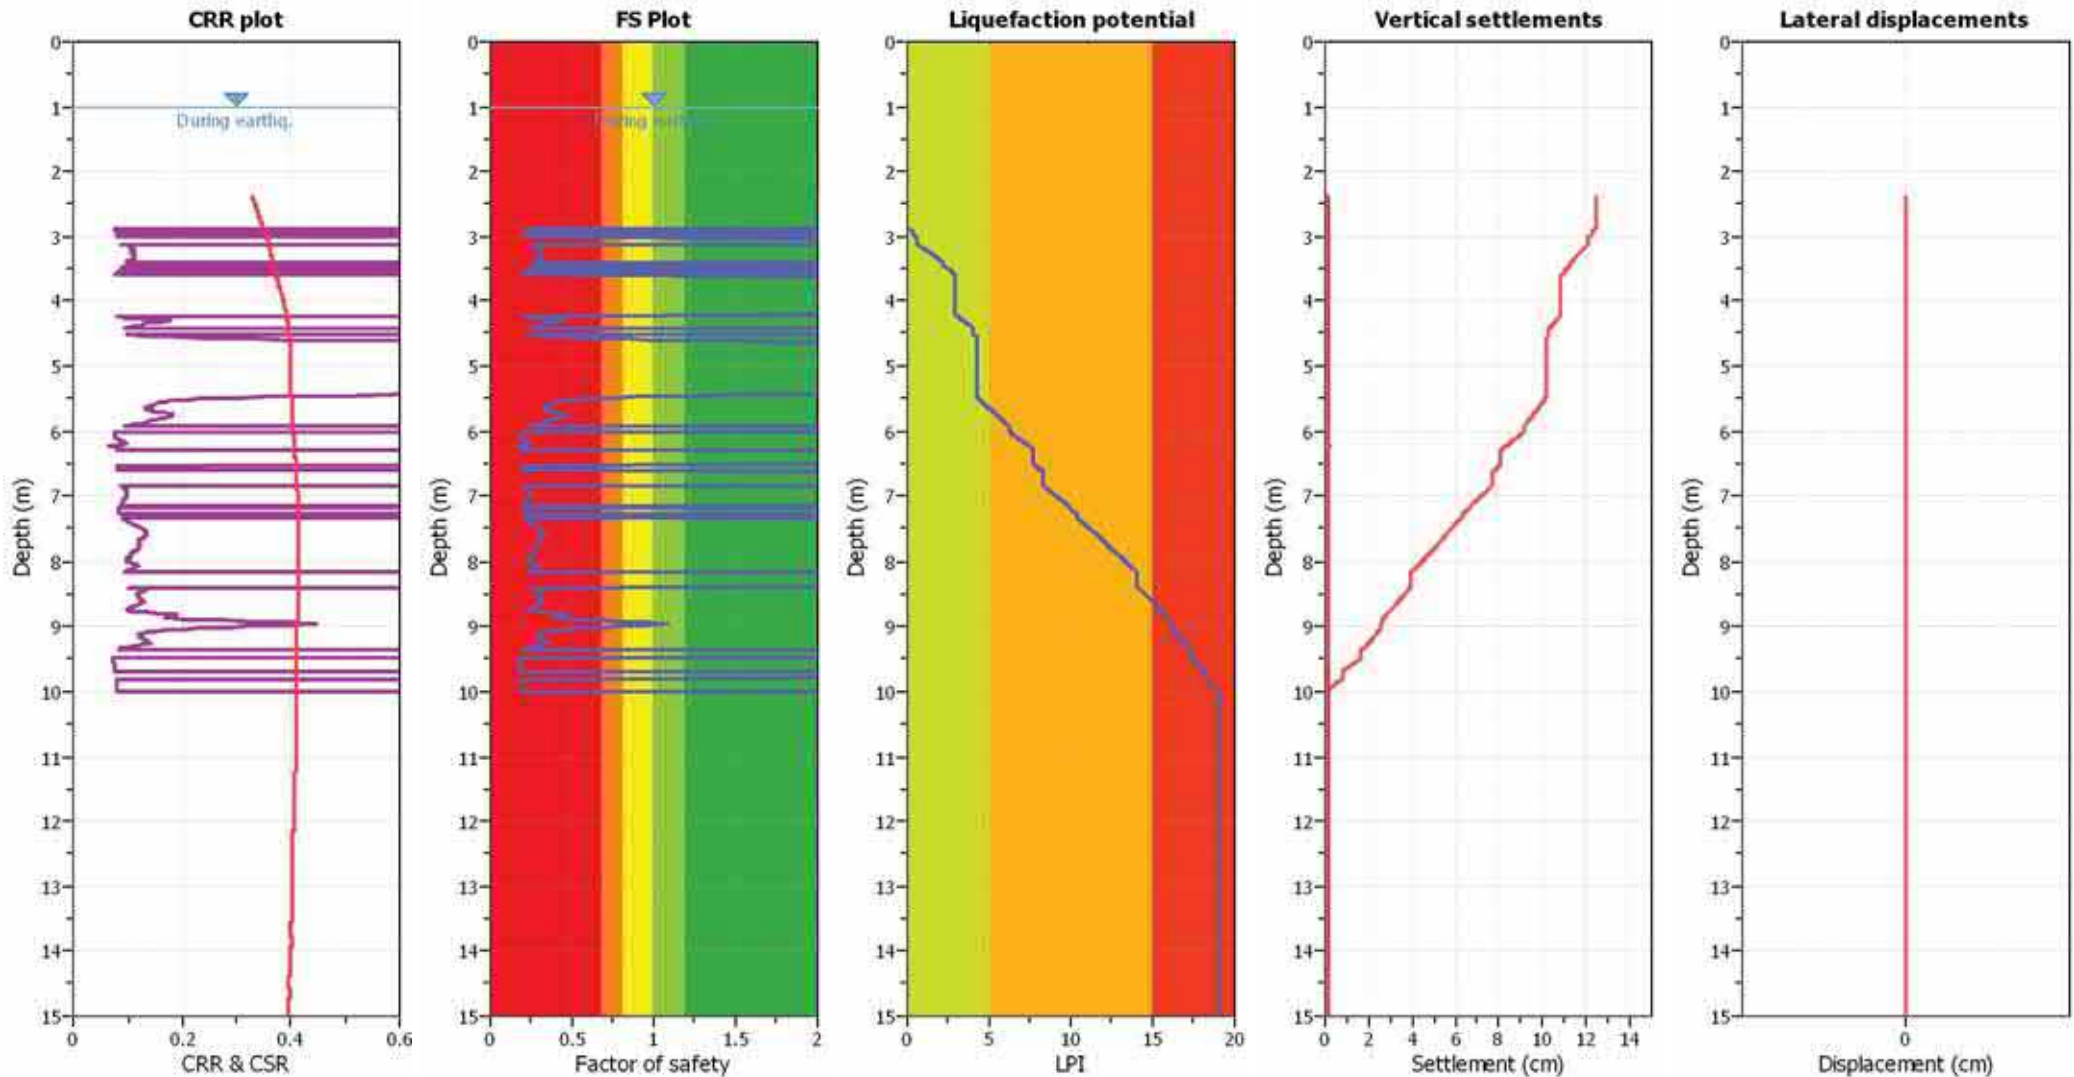
Liquefaction analysis overall plots

Analysis method:	I&B (2008)	Depth to GWT (erthq.):	1.00 m	Fill weight:	N/A
Fines correction method:	R&W (1998)	Average results interval:	3	Transition detect. applied:	No
Points to test:	Based on Ic value	Ic cut-off value:	2.60	K _σ applied:	Yes
Earthquake magnitude M _w :	7.50	Unit weight calculation:	Based on SBT	Clay like behavior applied:	Sands only
Peak ground acceleration:	0.35	Use fill:	No	Limit depth applied:	Yes
Depth to water table (insitu):	1.00 m	Fill height:	N/A	Limit depth:	10.00 m
