Land Information Memorandum

Property address:
2 Mary Muller Drive

LIM number: 70211569
Page 1

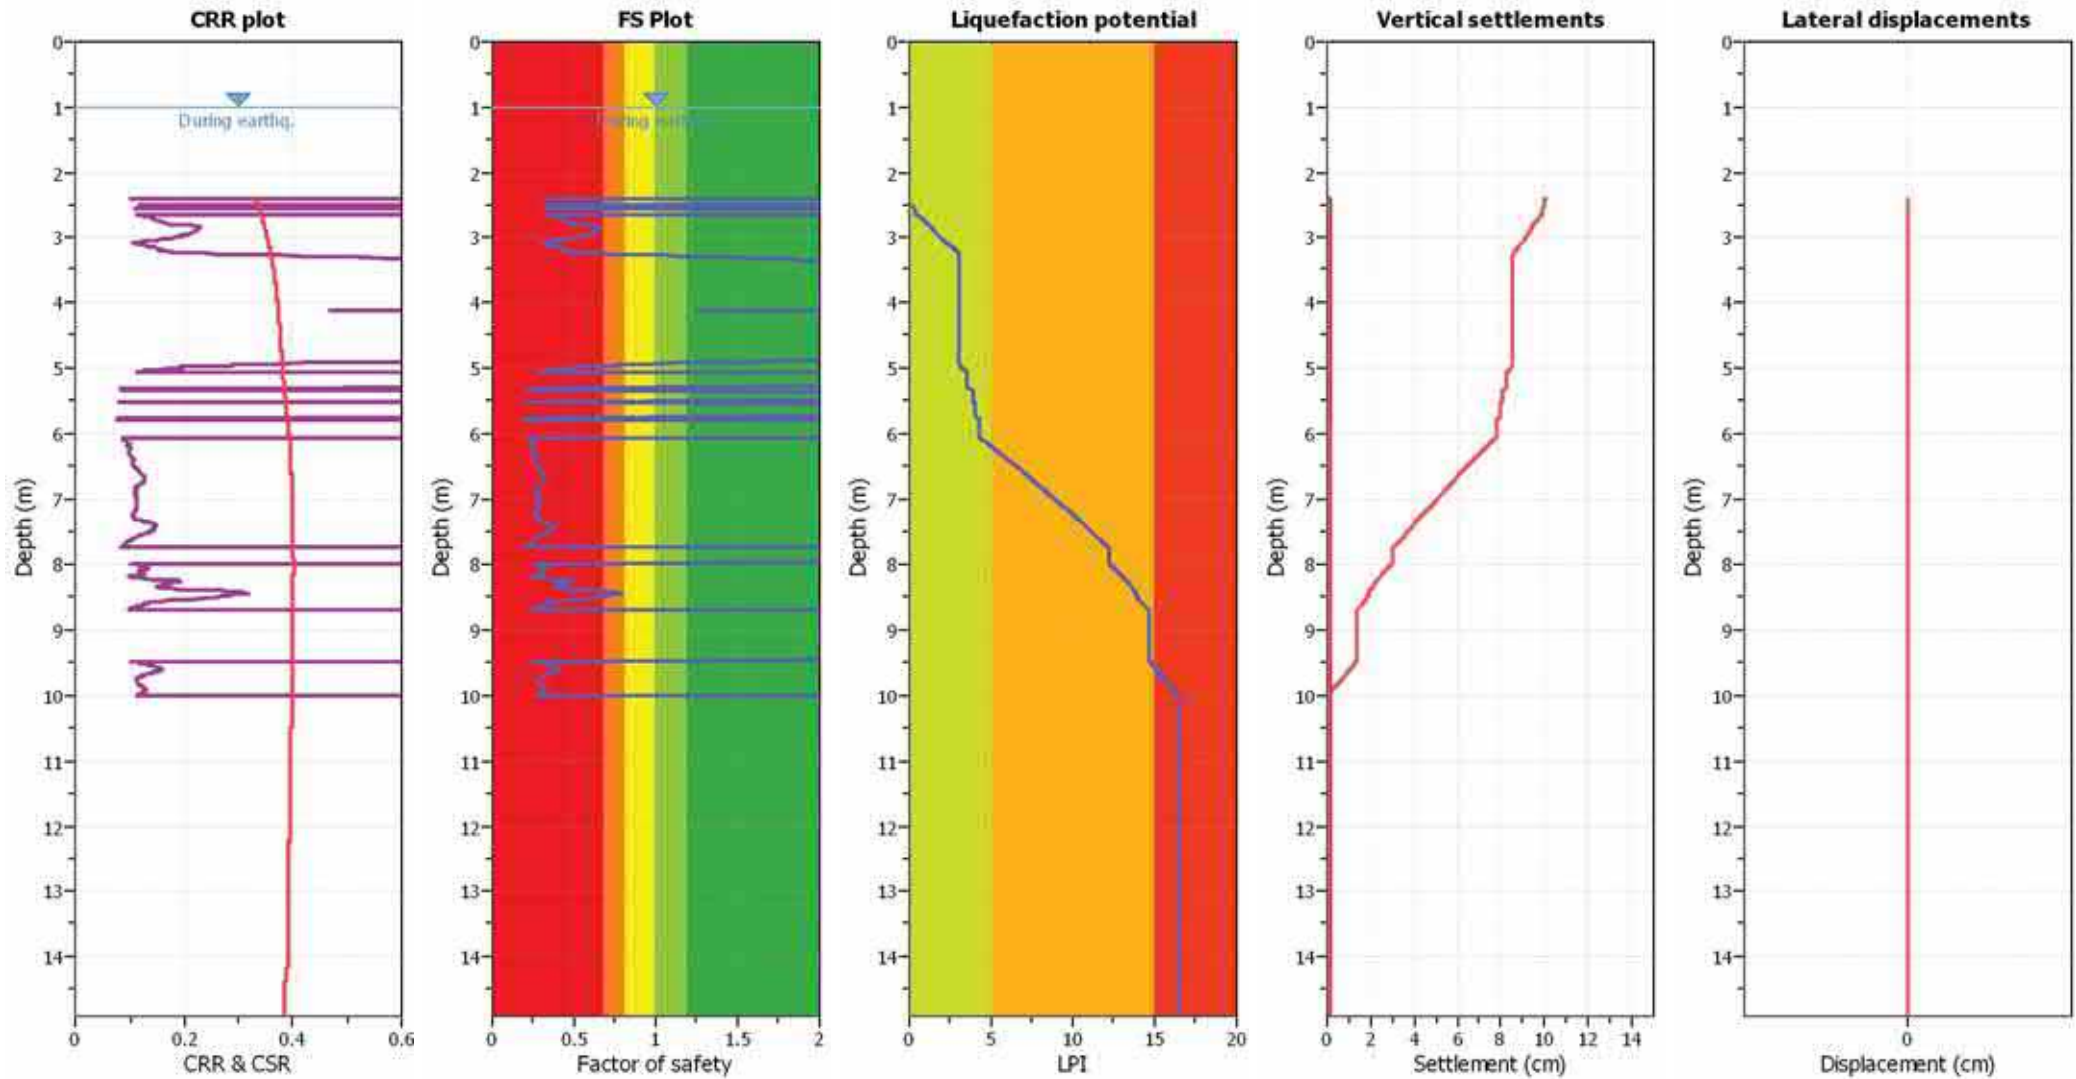
Liquefaction analysis overall plots

Analysis method:	I&B (2008)	Depth to GWT (erthq.):	1.00 m	Fill weight:	N/A
Fines correction method:	R&W (1998)	Average results interval:	3	Transition detect. applied:	No
Points to test:	Based on Ic value	Ic cut-off value:	2.60	K_s applied:	Yes
Earthquake magnitude M_w :	7.50	Unit weight calculation:	Based on SBT	Clay like behavior applied:	Sands only
Peak ground acceleration:	0.35	Use fill:	No	Limit depth applied:	Yes
Depth to water table (insitu):	1.00 m	Fill height:	N/A	Limit depth:	10.00 m

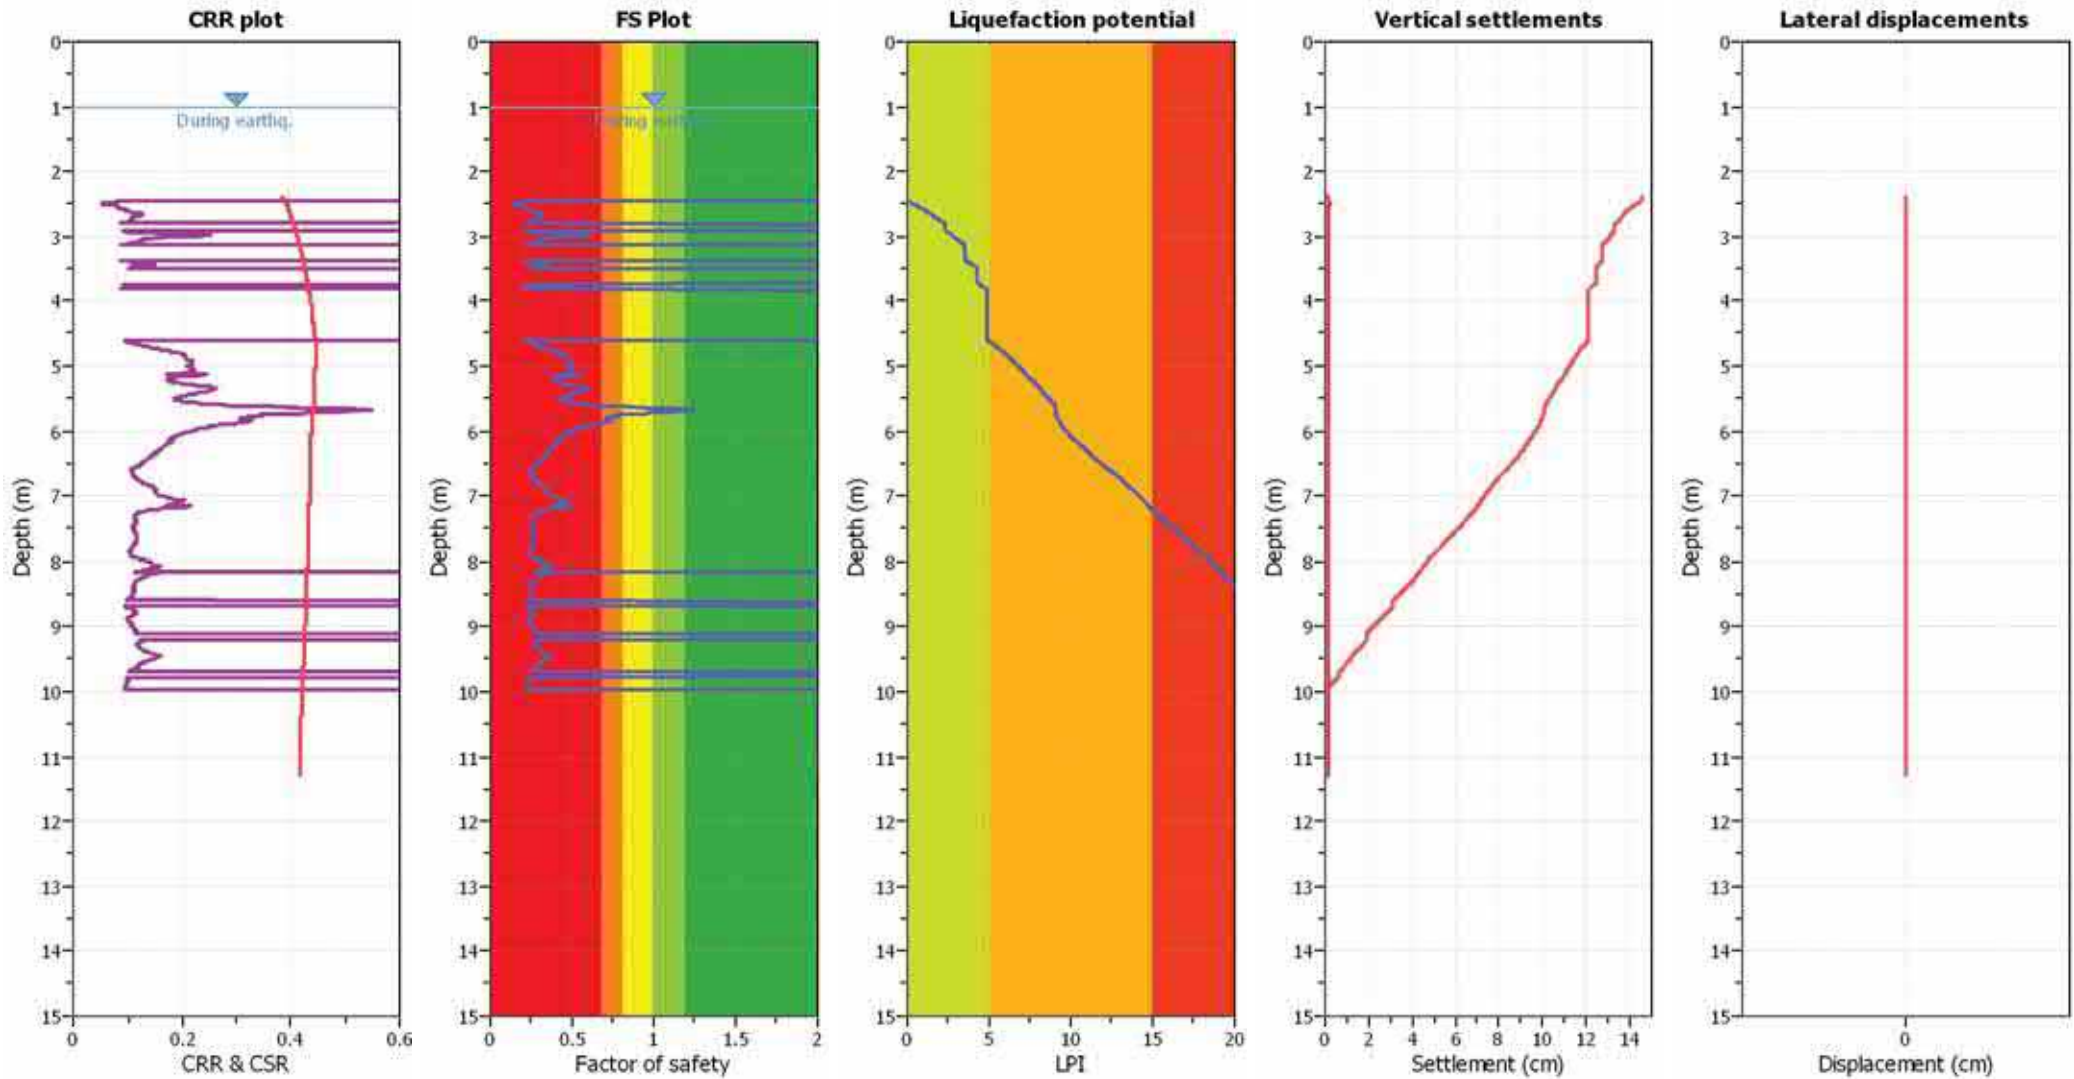
Liquefaction analysis overall plots

Analysis method:	I&B (2008)	Depth to GWT (erthq.):	1.00 m	Fill weight:	N/A
Fines correction method:	R&W (1998)	Average results interval:	3	Transition detect. applied:	No
Points to test:	Based on Ic value	Ic cut-off value:	2.60	K _σ applied:	Yes
Earthquake magnitude M _w :	7.50	Unit weight calculation:	Based on SBT	Clay like behavior applied:	Sands only
Peak ground acceleration:	0.35	Use fill:	No	Limit depth applied:	Yes
Depth to water table (insitu):	1.00 m	Fill height:	N/A	Limit depth:	10.00 m

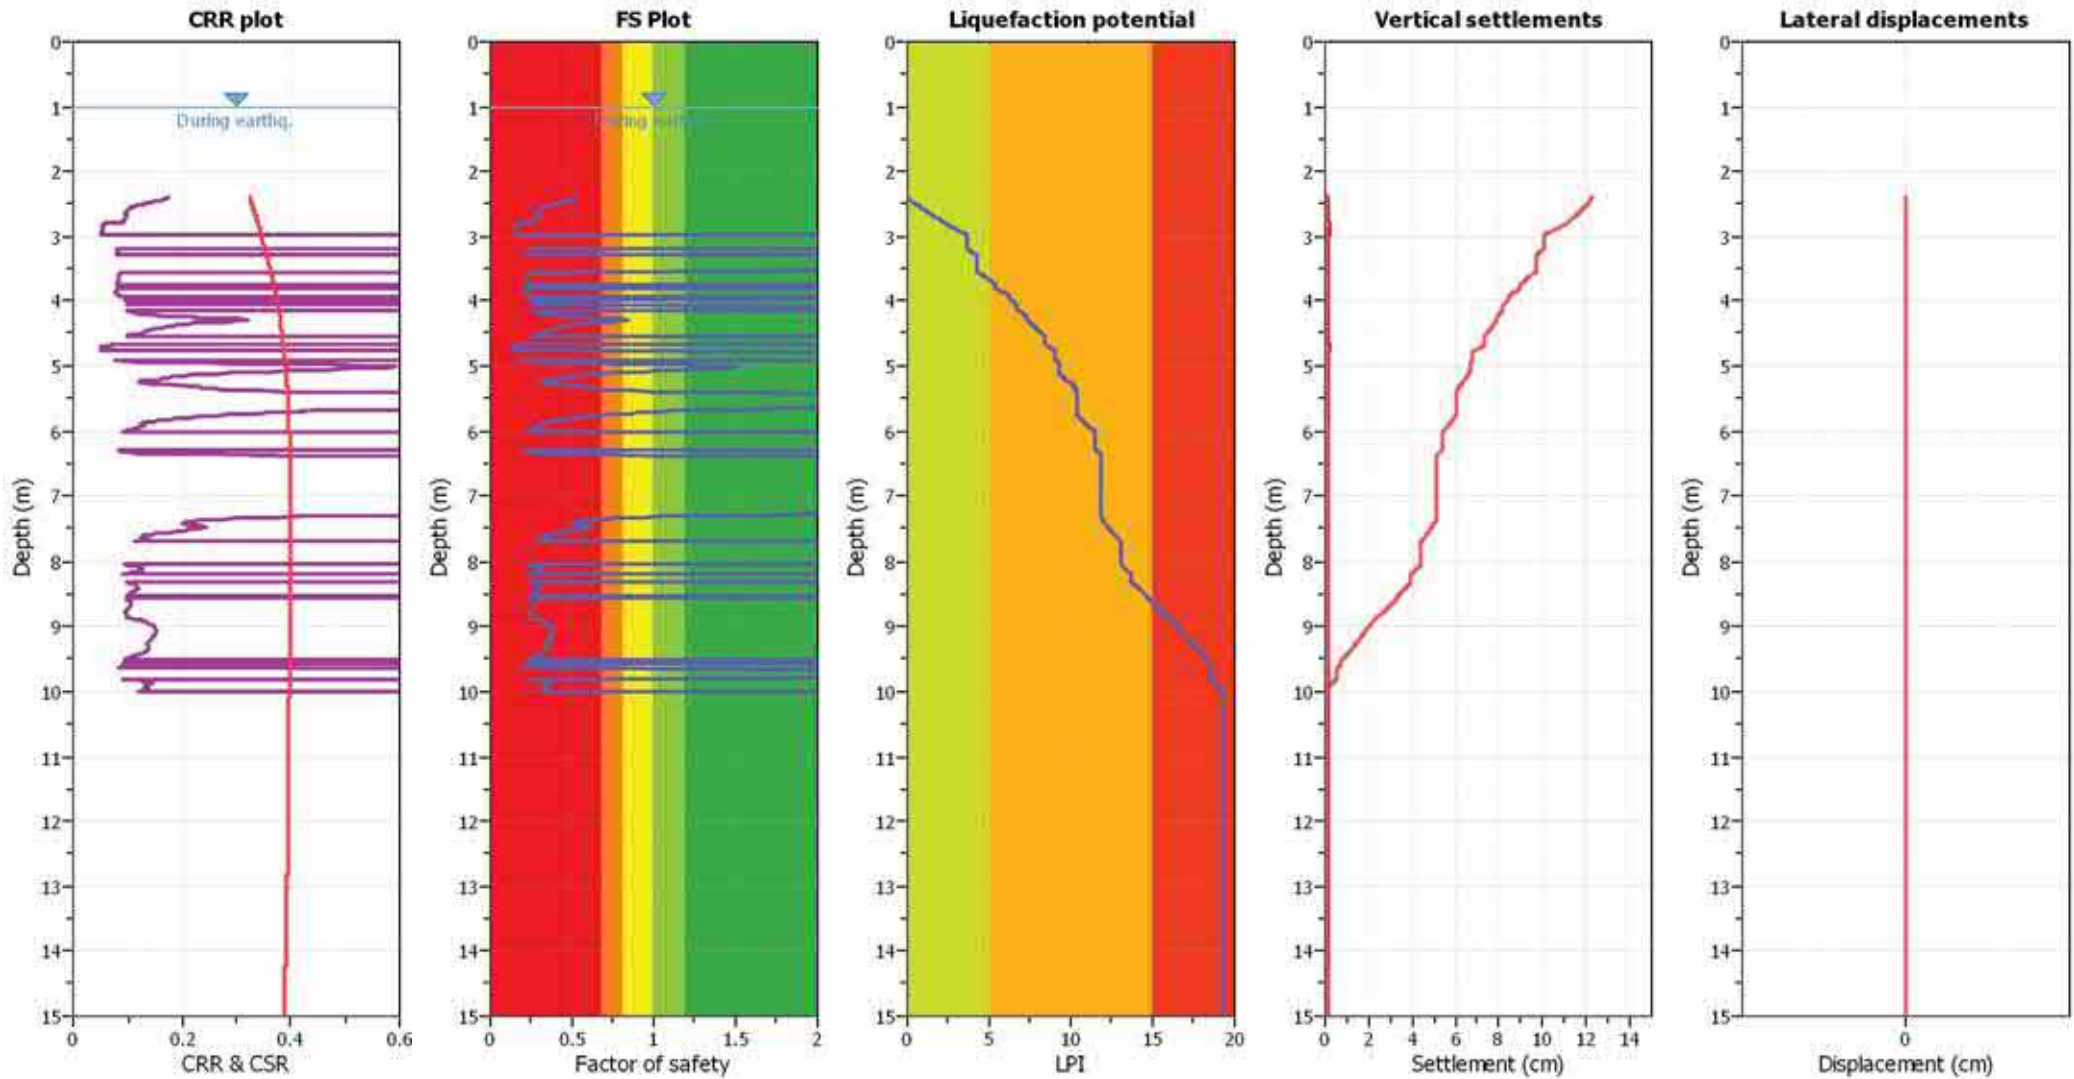
Liquefaction analysis overall plots

Analysis method:	I&B (2008)	Depth to GWT (erthq.):	1.00 m	Fill weight:	N/A
Fines correction method:	R&W (1998)	Average results interval:	3	Transition detect. applied:	No
Points to test:	Based on Ic value	Ic cut-off value:	2.60	K _σ applied:	Yes
Earthquake magnitude M _w :	7.50	Unit weight calculation:	Based on SBT	Clay like behavior applied:	Sands only
Peak ground acceleration:	0.35	Use fill:	No	Limit depth applied:	Yes
Depth to water table (insitu):	1.00 m	Fill height:	N/A	Limit depth:	10.00 m

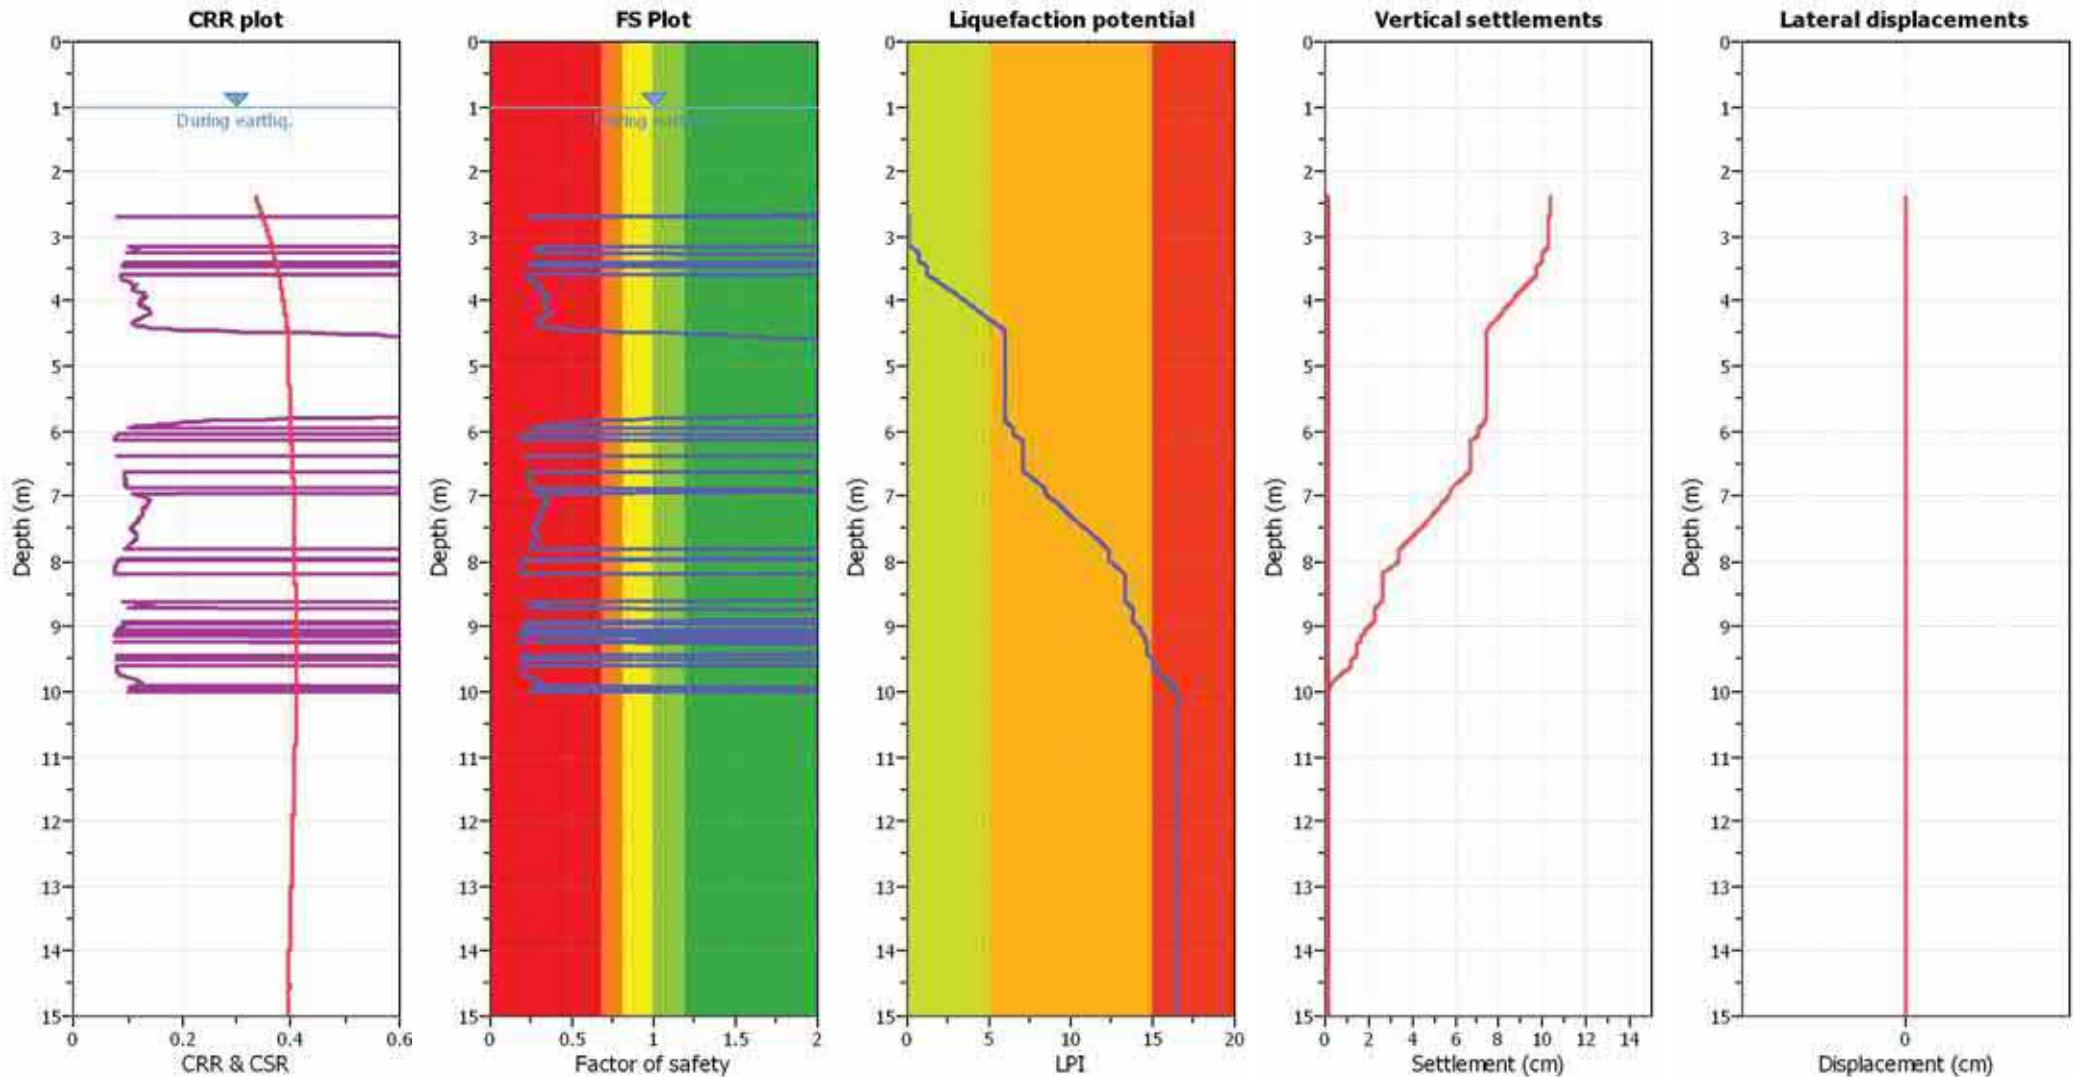
Liquefaction analysis overall plots

Analysis method:	I&B (2008)	Depth to GWT (erthq.):	1.00 m	Fill weight:	N/A
Fines correction method:	R&W (1998)	Average results interval:	3	Transition detect. applied:	No
Points to test:	Based on Ic value	Ic cut-off value:	2.60	K _σ applied:	Yes
Earthquake magnitude M _w :	7.50	Unit weight calculation:	Based on SBT	Clay like behavior applied:	Sands only
Peak ground acceleration:	0.35	Use fill:	No	Limit depth applied:	Yes
Depth to water table (insitu):	1.00 m	Fill height:	N/A	Limit depth:	10.00 m

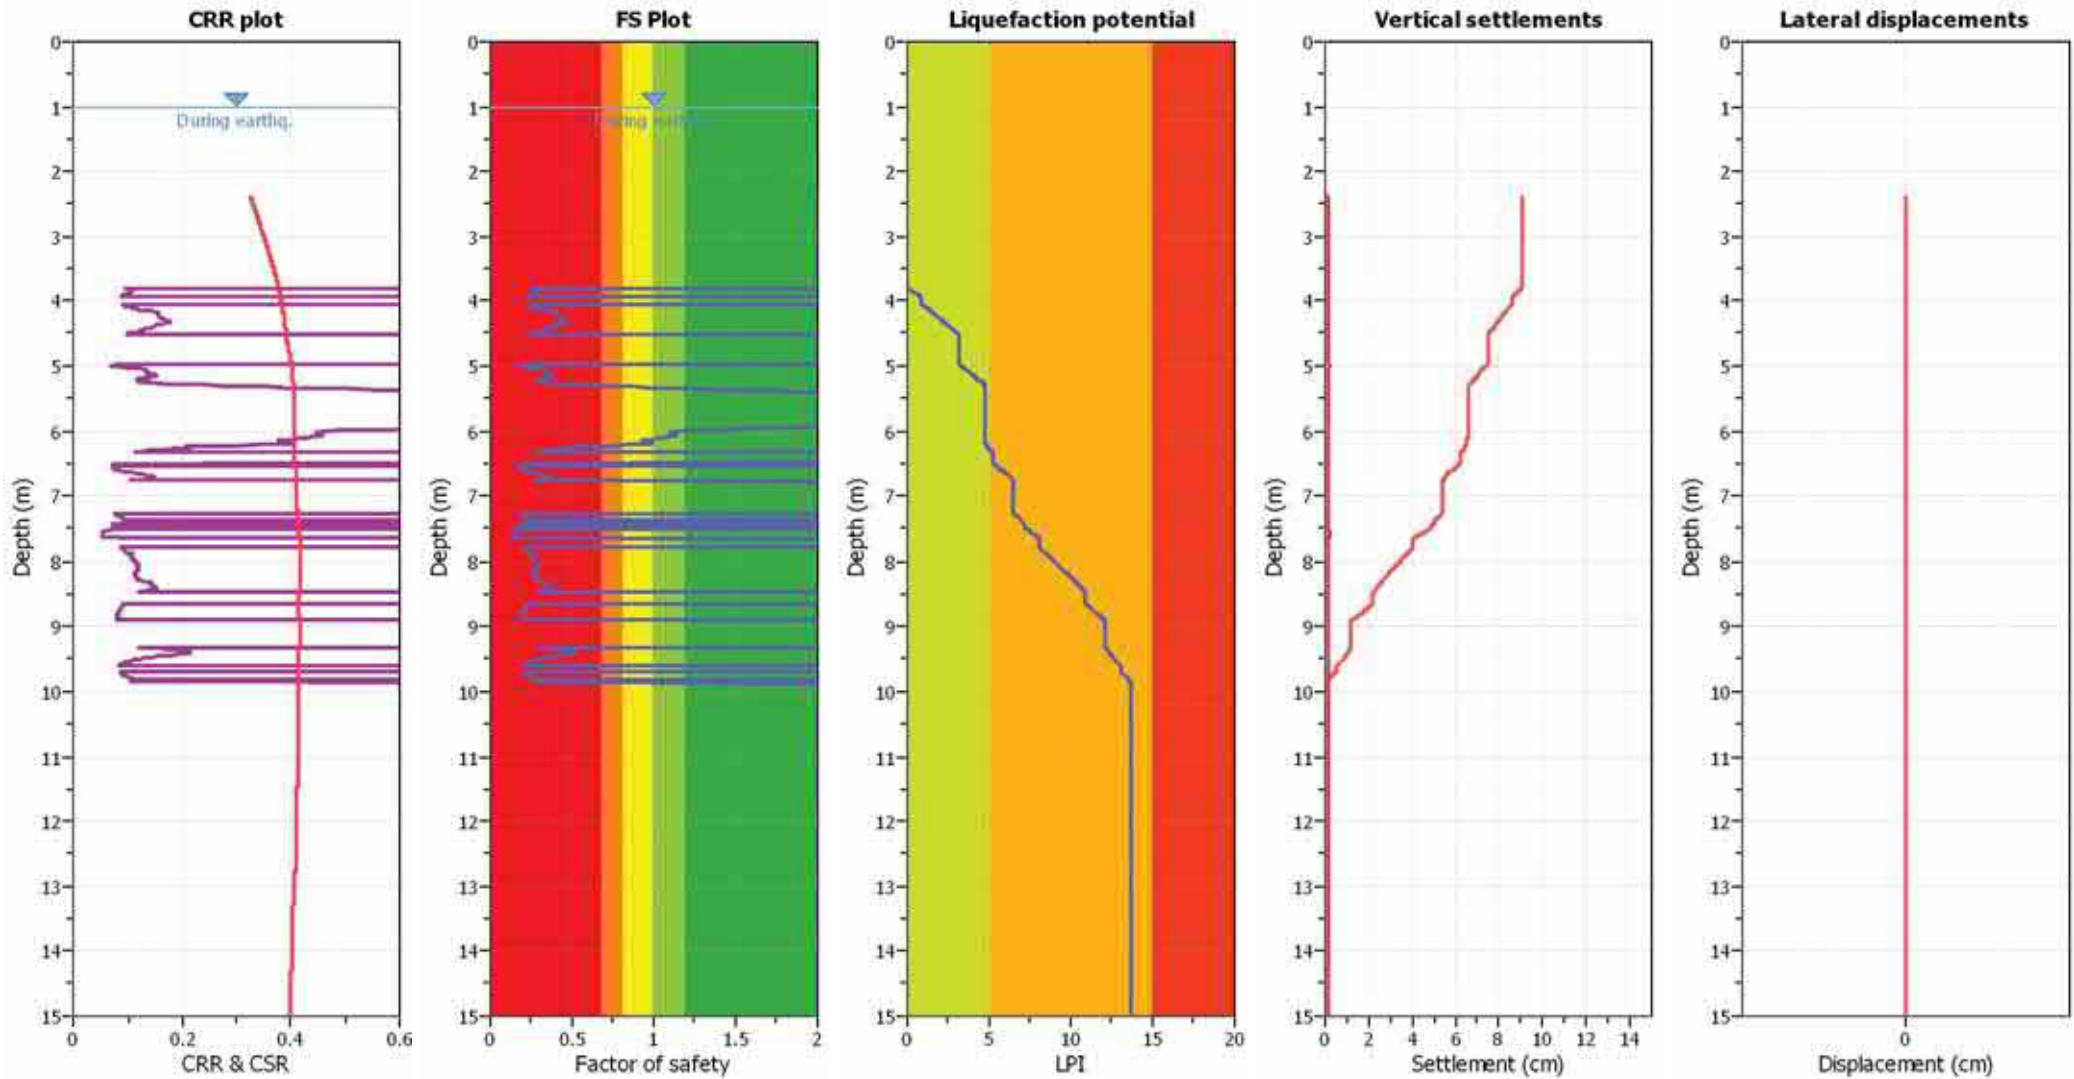
Liquefaction analysis overall plots

Analysis method:	I&B (2008)	Depth to GWT (erthq.):	1.00 m	Fill weight:	N/A
Fines correction method:	R&W (1998)	Average results interval:	3	Transition detect. applied:	No
Points to test:	Based on Ic value	Ic cut-off value:	2.60	K _σ applied:	Yes
Earthquake magnitude M _w :	7.50	Unit weight calculation:	Based on SBT	Clay like behavior applied:	Sands only
Peak ground acceleration:	0.35	Use fill:	No	Limit depth applied:	Yes
Depth to water table (insitu):	1.00 m	Fill height:	N/A	Limit depth:	10.00 m

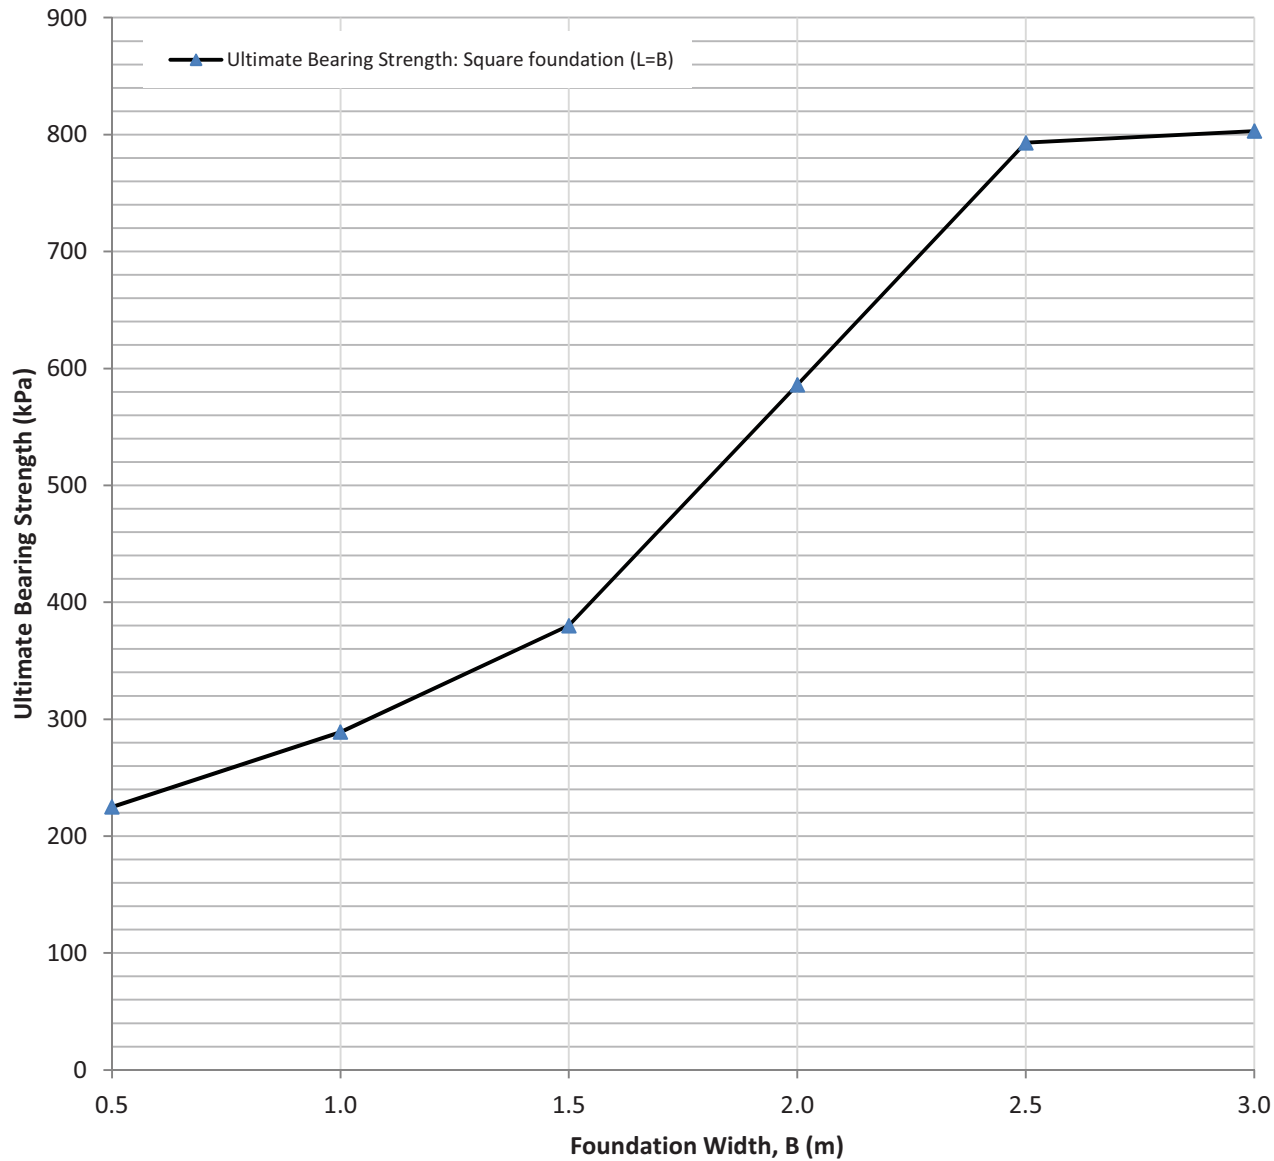
BEARING CAPACITY OF SHALLOW FOUNDATIONS

Foundation depth = 2.4m below existing GL.

Assumes foundation extends through any fill materials, and bears onto insitu soils.

Structural Engineer should also design bearing strength of chart 'Settlement Control of Shallow Foundations'.

Project: 14 Mary Muller Drive
Client: Castle Rock Properties Ltd.
Job #: 382221
Date: 18 December 2013
Title: Bearing Capacity of Shallow Foundations
Eliot Sinclair surveyors engineers planners

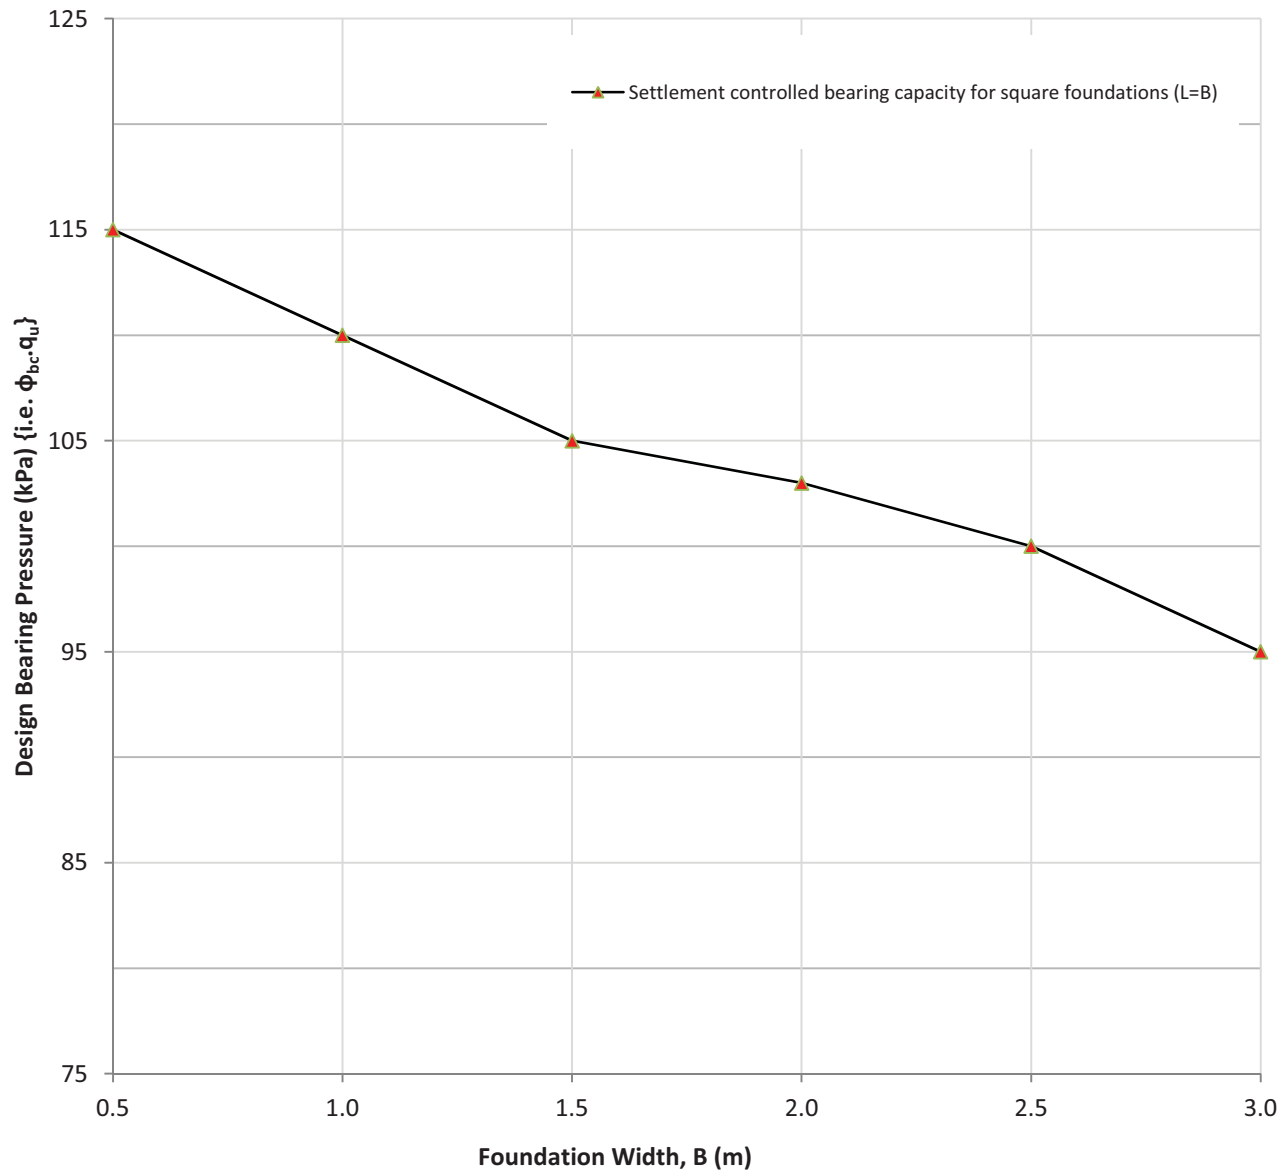
SETTLEMENT CONTROL OF SHALLOW FOUNDATIONS

Foundation depth = 2.4m below existing GL.

Assumes foundation extends through any fill materials, and bears onto insitu soils.

Duration = 50 years, max 25mm total settlement under non-seismic conditions, calculated using Modulus of Elasticity.

Structural Engineer should also check bearing capacity of foundations, refer to 'Bearing Capacity of Shallow Foundations' chart.

Ultimate bearing capacity at smaller foundation width has been conservatively limited as shown to take into account the presence of lower soil layers.

Project: 14 Mary Mullar Drive
Client: Castle Rock Properties Ltd
Job #: 382221
Date: 18 December 2013
Title: Settlement control of shallow foundations
Eliot Sinclair surveyors engineers planners

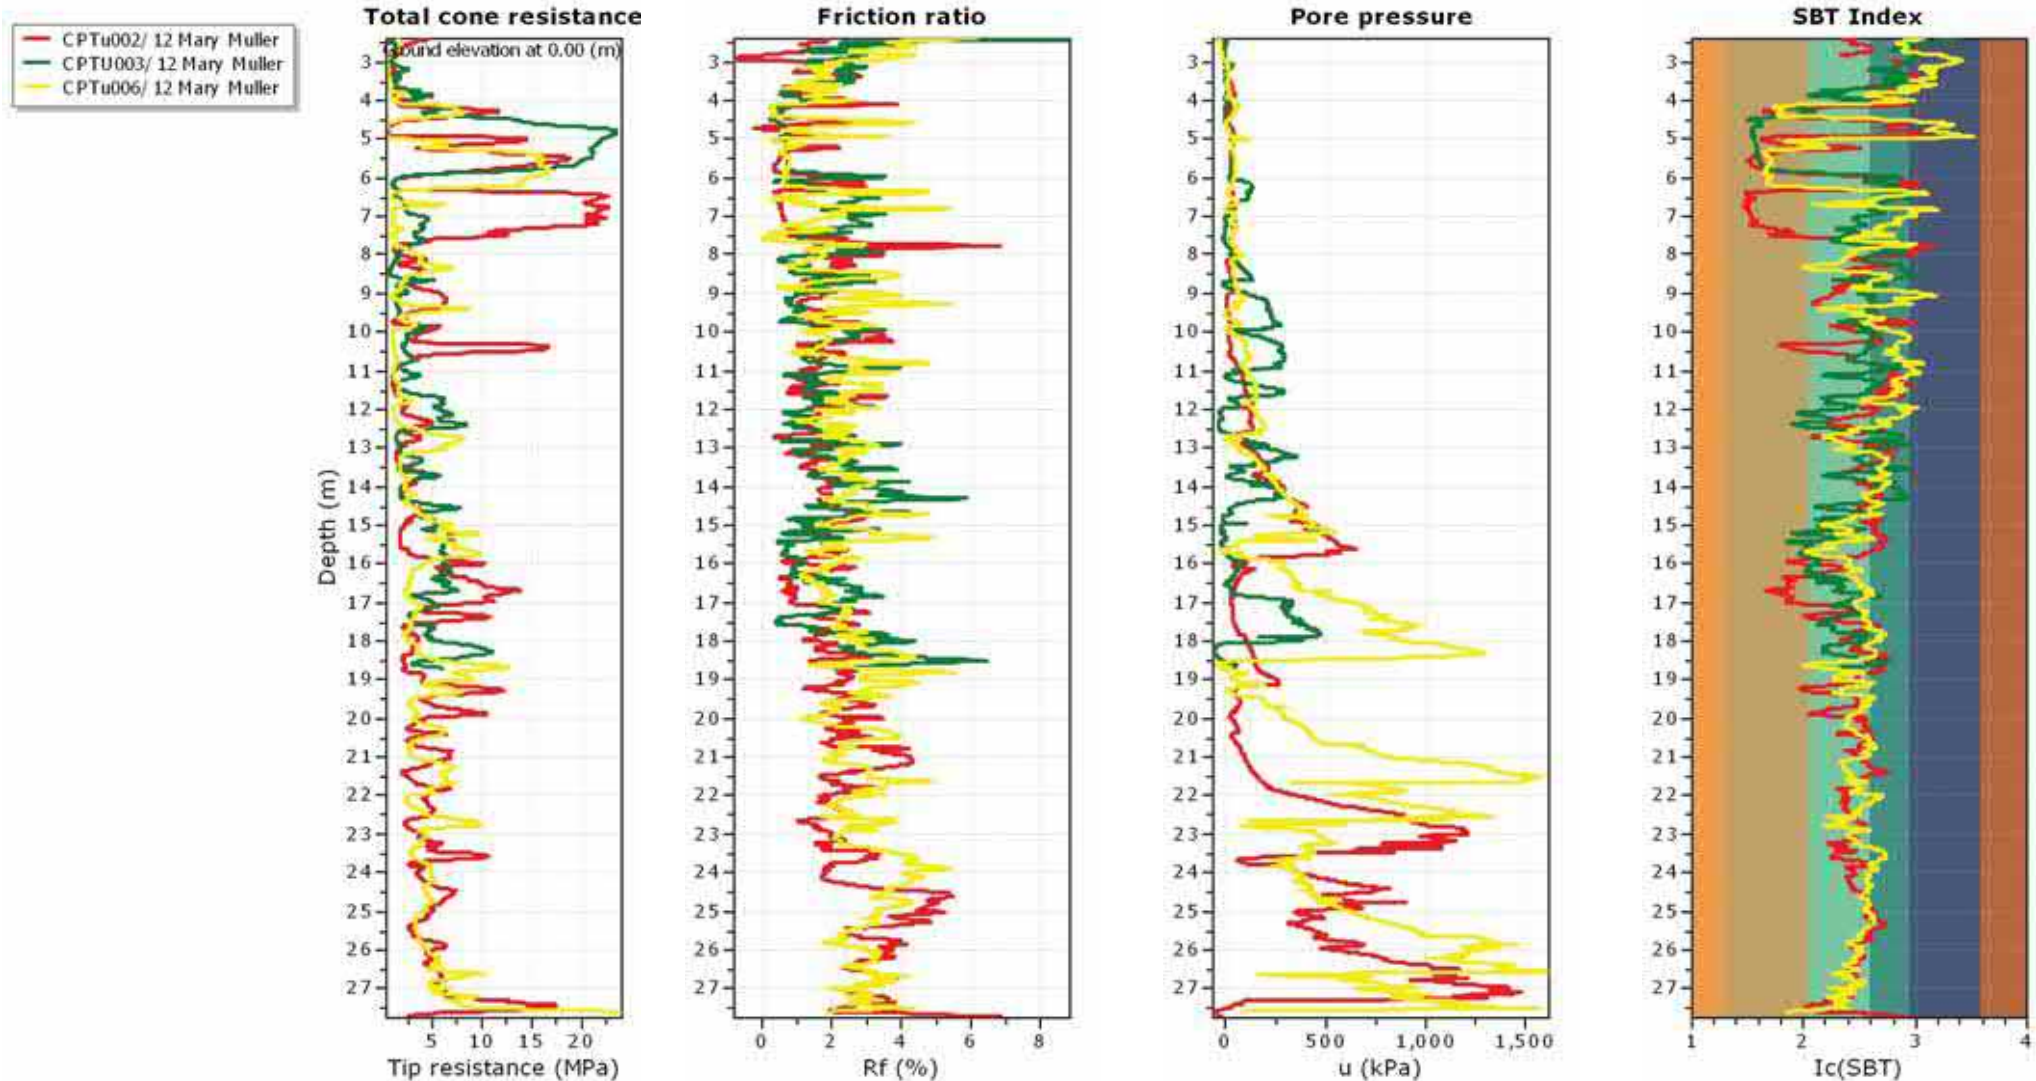
Overlay basic interpretation plots

Project: 382221 - 14 Mary Muller Drive, Hillsborough

Location: 12 Mary Muller Drive, Hillsborough

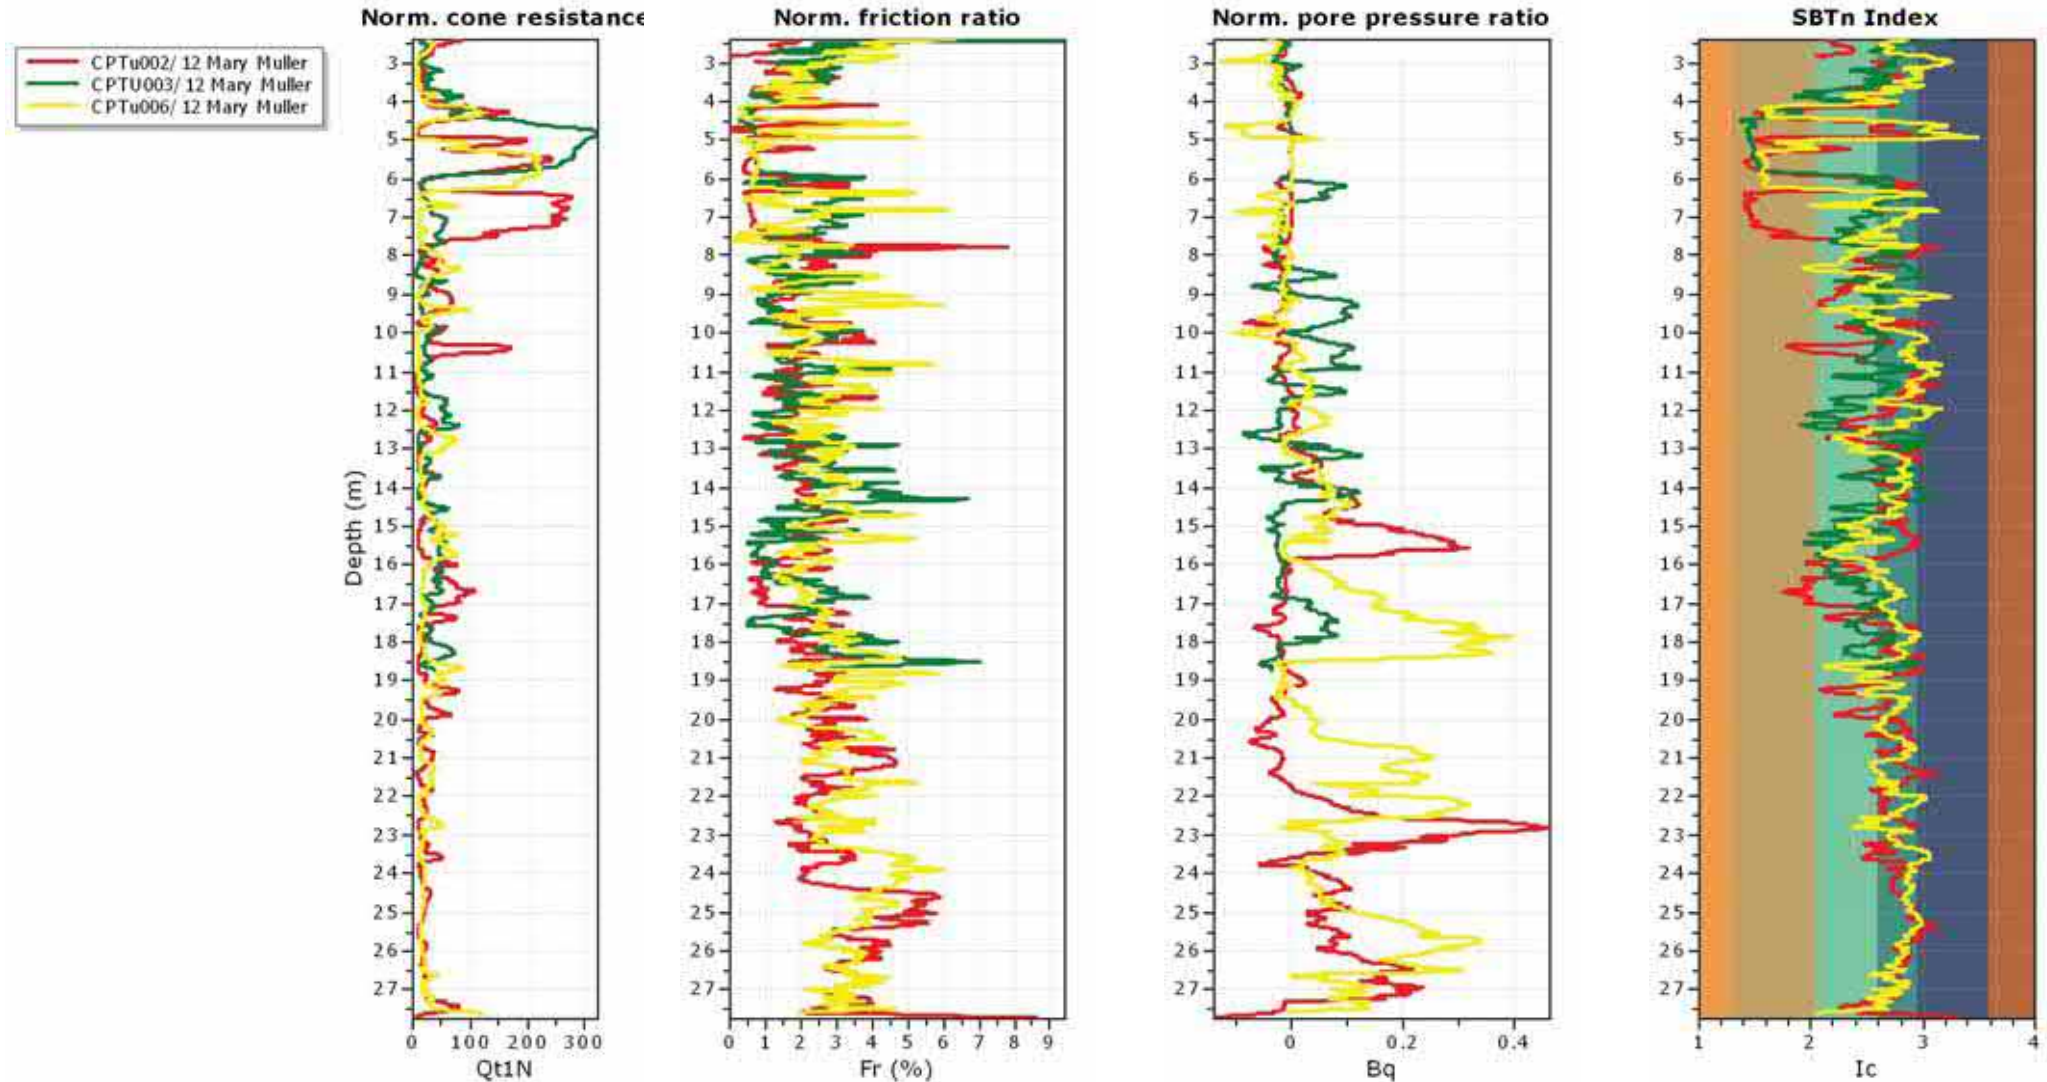
Normalized basic plots

Project: 382221 - 14 Mary Muller Drive, Hillsborough
Location: 12 Mary Muller Drive, Hillsborough

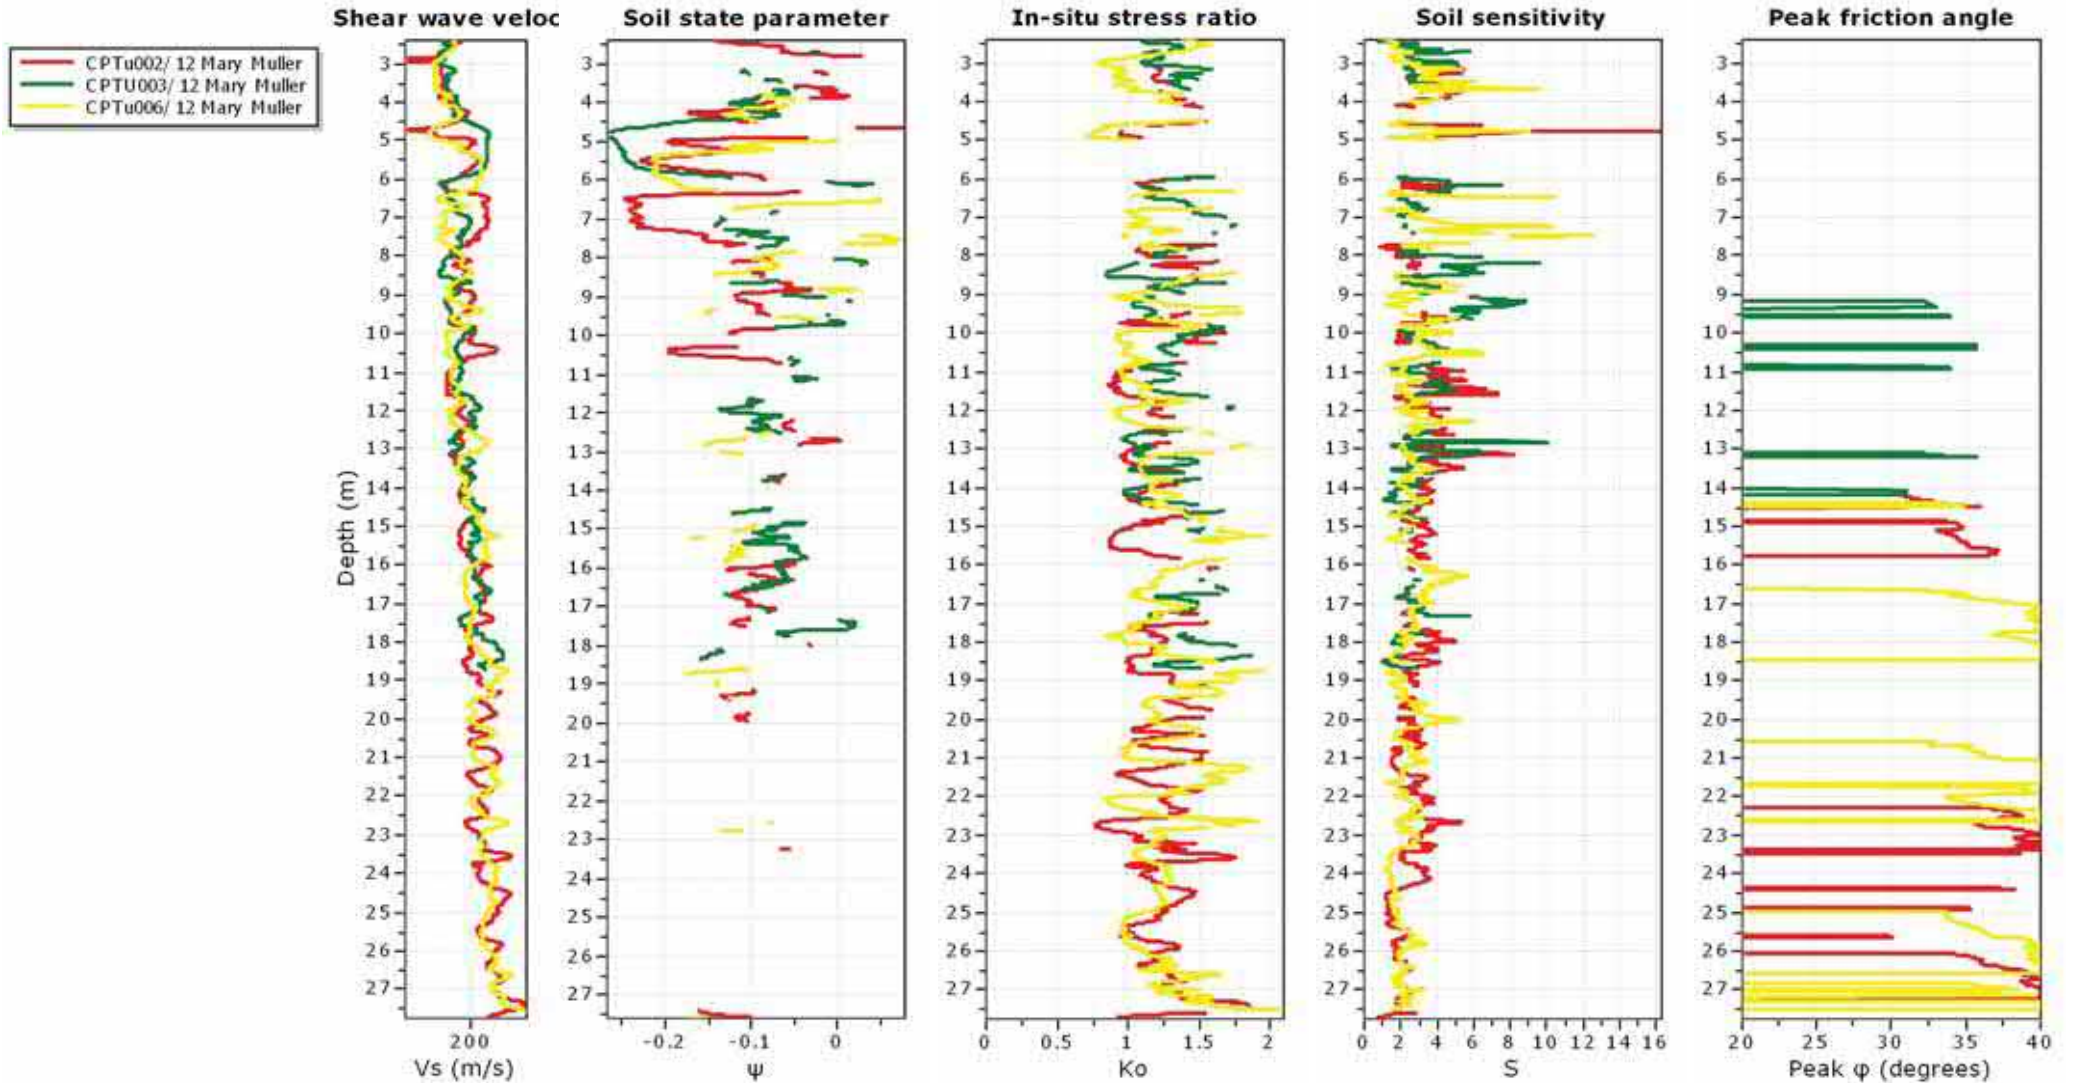
Overlay estimation plots (3)

Project: 382221 - 14 Mary Muller Drive, Hillsborough
Location: 12 Mary Muller Drive, Hillsborough

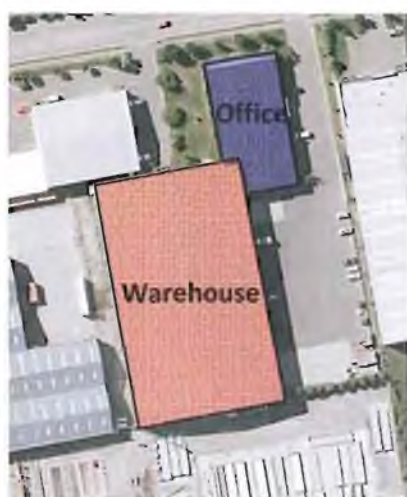
Figure 1: Google Earth image defining the office (purple) and warehouse (red) areas.

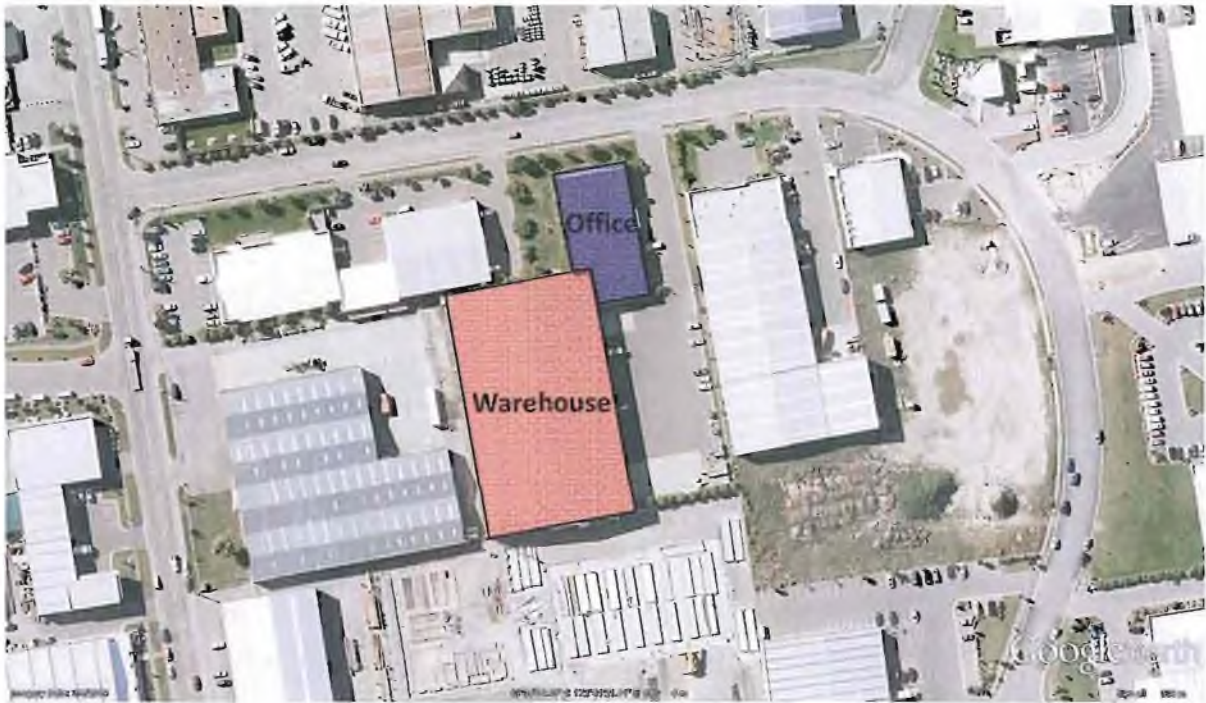
Figure 2: Google Earth image indicating building location with the warehouse (shaded red) and office (shaded purple) defined.

The building is located in an industrial area at 4 Mary Muller Drive. The building was originally constructed in 2000 with seismic strengthening added in 2012.
