Land Information Memorandum

Property address:
2 Mary Muller Drive

LIM number: 70211569
Page 1

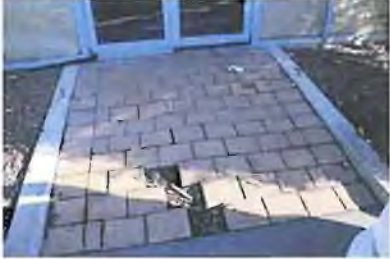
Element	Observations	Photographs
General Site	<ul style="list-style-type: none"> One sand boil observed located at the office entrance. Sand visible below tiles.

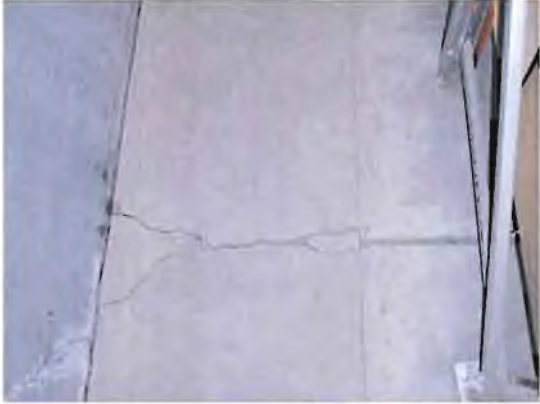
<p style="text-align: center;">Photo 1</p>

Foundations	<ul style="list-style-type: none"> Settlement of southern end wall. Gradient between primary superstructure elements approximately 1:700. 	
Ground floor slab	<ul style="list-style-type: none"> Increased width of ground floor slab control joints or saw cuts.

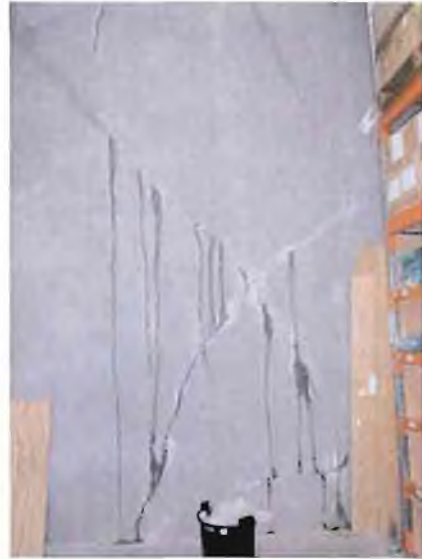
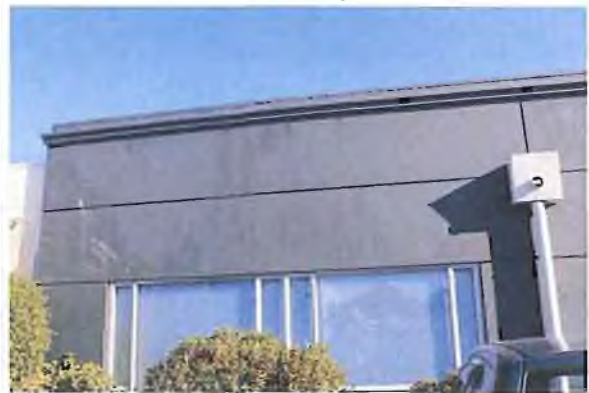
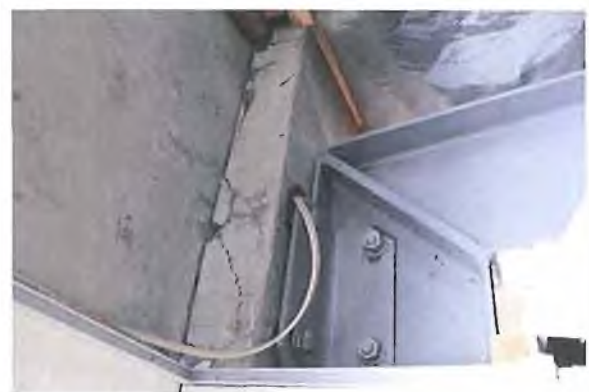
Concrete wall panels

- Cracking patterns observed to the warehouse and office concrete walls, consistent with face loading damage. Crack widths up to 1mm measured.
- Cracking of panels around fixings in office.

Larger format representative photographs of the damage described above are included in Appendix B.

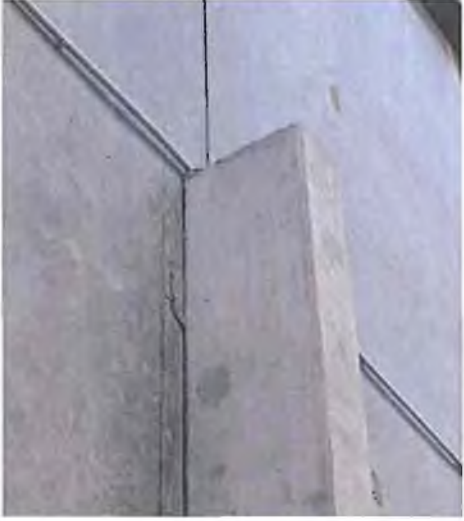
<p>Concrete columns</p>	<ul style="list-style-type: none"> • Cracking to columns less than 0.2mm wide. • Damage to column to panel fixing in one location

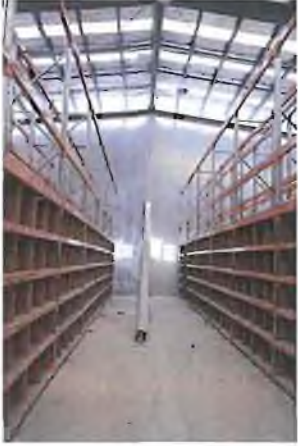
<p style="text-align: center;">Photo 7</p>

<p style="text-align: center;">Photo 6</p>
<p>Southern end wall</p>	<ul style="list-style-type: none"> • Southern end wall held plumb by props. Columns rotated outward by approximately 1.2 degrees due to rotation of the column foundations.
