TECHNICAL DUE DILIGENCE REPORT

65B MAIN HIGHWAY

ELLERSLIE

Date: 19 January 2019

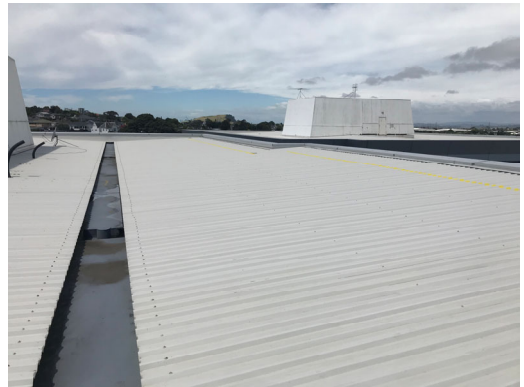
1.4. General view of roof sheets

- 1) The roof sheets are believed to be original to the building and have not been recoated since their installation. No corrosion was noted to the roof, however it is considered likely that roof sheets will require painting with localised roof fixings replaced within 10 years.

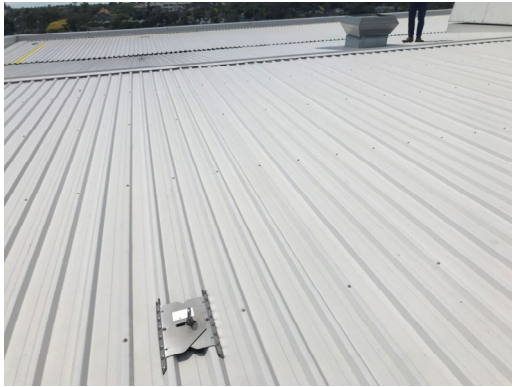
1.7. View of roof sheets

- 5) Localised roof repairs were noted to the roof sheets. Whilst no wide spread dents were noted across the roof, the presence of the repairs suggest that ongoing maintenance has been undertaken at roof level in the building's life.

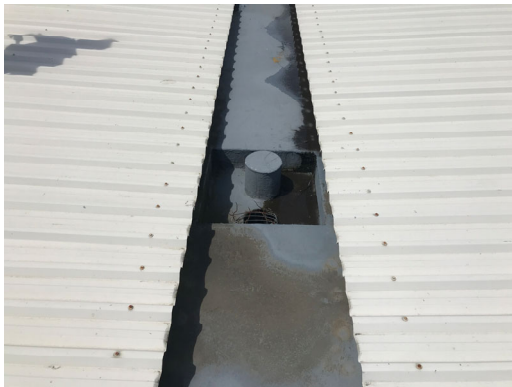
1.9. pWater inlet within valley gutters

- 2) The membrane to the valley gutters was noted to be deteriorating with areas of corrosion visible to the metal substrate beneath. It is recommended that the gutters be replaced within 5 years.

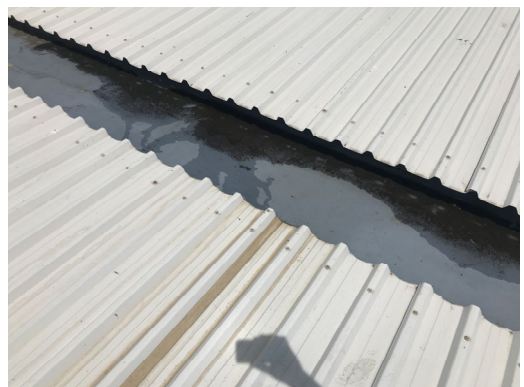
1.12. Plant discharging condensate water into gutters

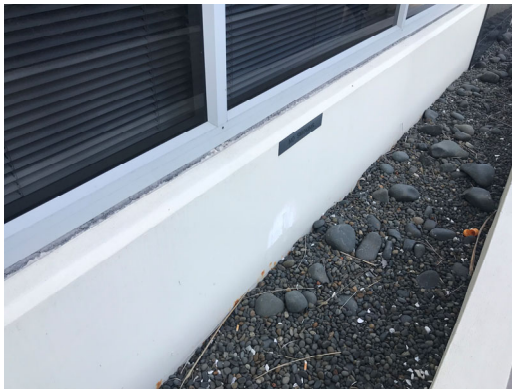
1.32. View of planter box adjacent to north east elevation

Destructive testing and visual observations revealed waterproofing membranes beneath tiled and tar-sealed surfaces were extensively degraded or were non-existent. Ponding was observed to the bottom of planter boxes indicating inadequate drainage. Visual deterioration to concrete surfaces and elevated moisture content readings to timber formwork throughout areas beneath the podium in the basement carpark were observed. Indications of spalling of concrete beams and corrosion to steel reinforcing were also identified.

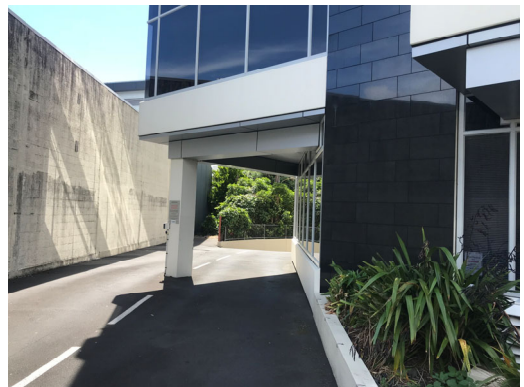
1.46. View of south corner of building – vehicle access available beneath building

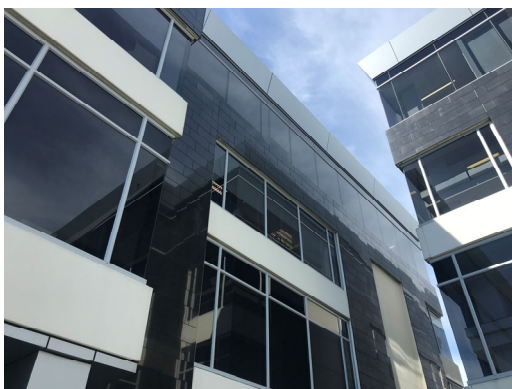
1.47. General view of south east elevation

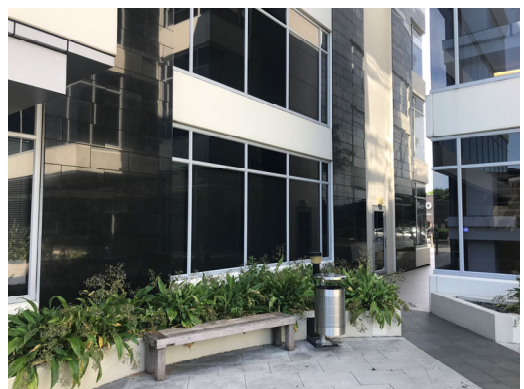
1.48. General view of south east elevation

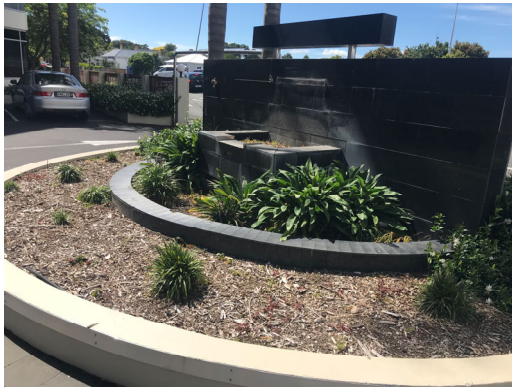
1.49. View of fountain to front elevation

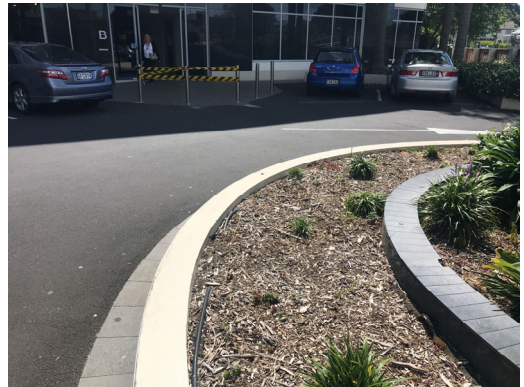
1.50. View of planting within fountain area

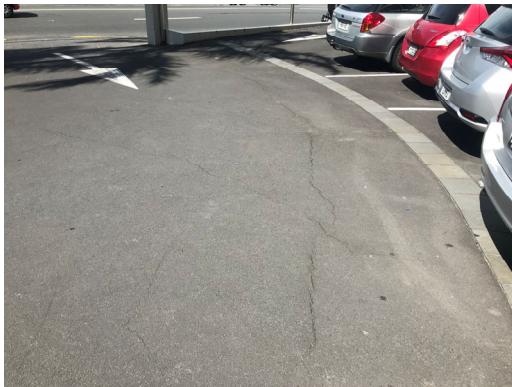
1.51. Asphalt driveway to front of site

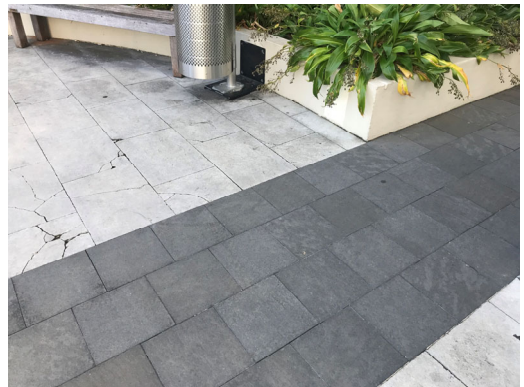
1.52. Tiled floor coverings to grounds
