TECHNICAL DUE DILIGENCE REPORT

20-28 Sir William Pickering Drive,
Christchurch

Date: 27th November 2017
CBRE Ref: 49211286

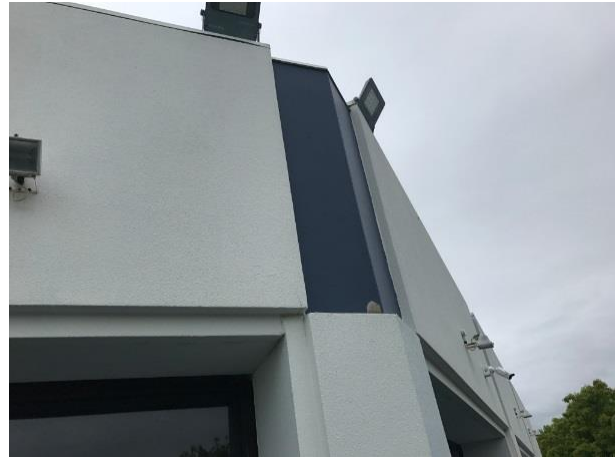
B1- Concrete frame high level junction

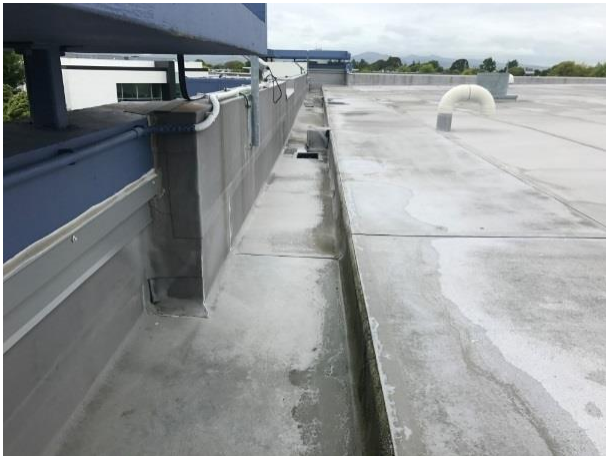
B2 – perimeter concealed gutter

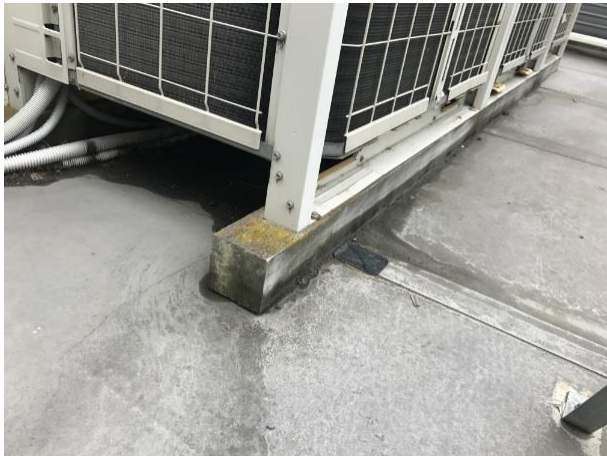
B2 – plant on timber plinths

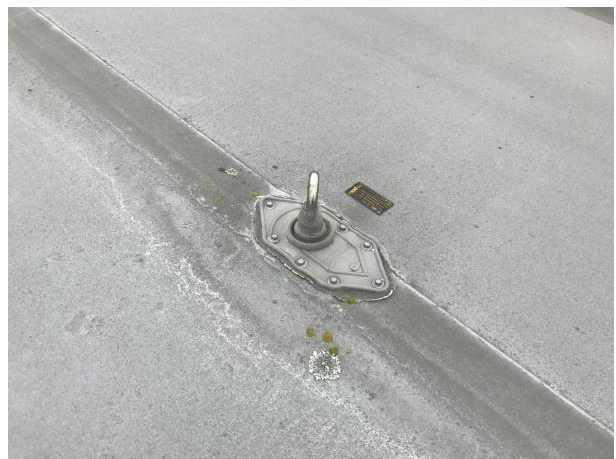
- The Static line system is fitted to roof, although no tags were noted. We are unaware if this system has been de-commissioned.
 - Penetrations have been sealed with a liquid applied coating, this is for the most part cracked and worn and required to be re-coated.

B2 – typical anchor point

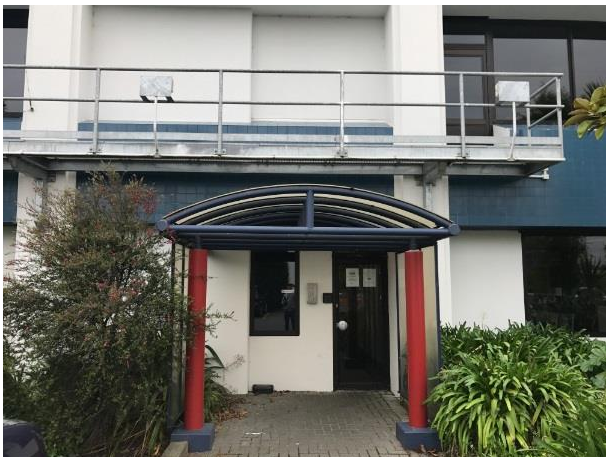
B1 – Canopy & new external fire escape stair

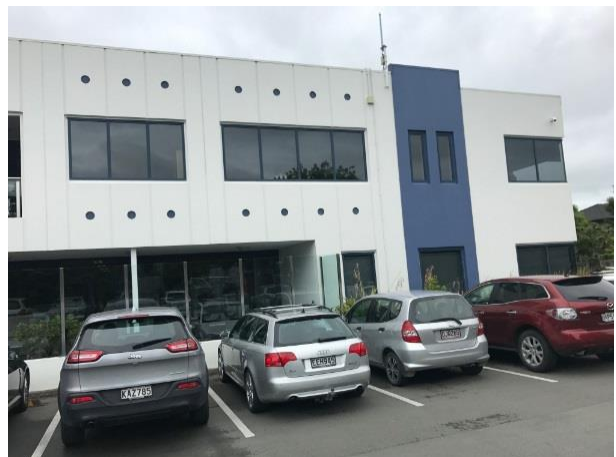
B2 – North elevation

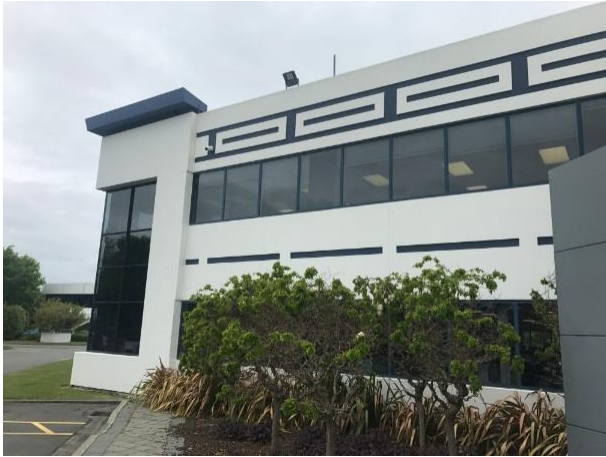
B2 – North elevation to modern extension

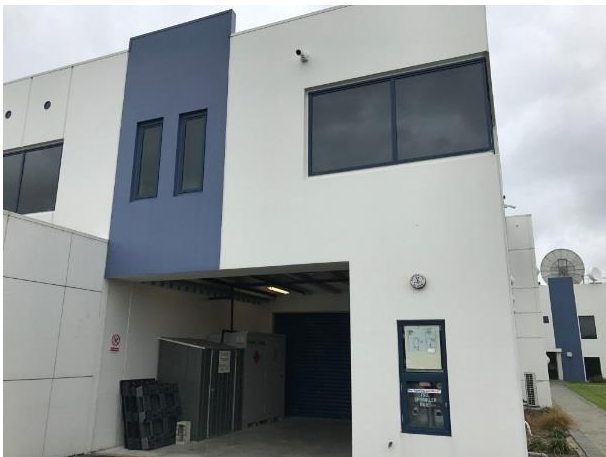
B2 – SE corner

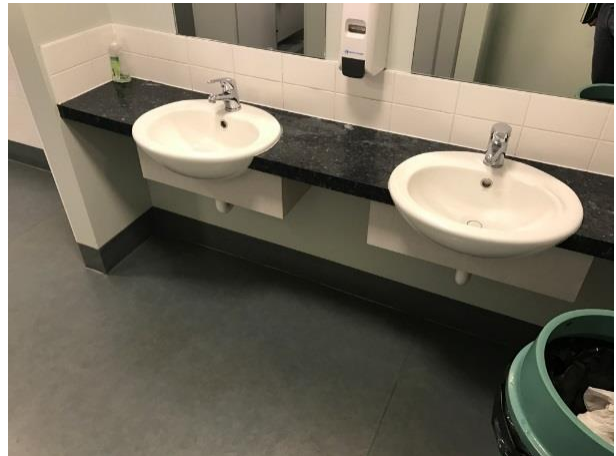
B2 – WHB's in male amenities

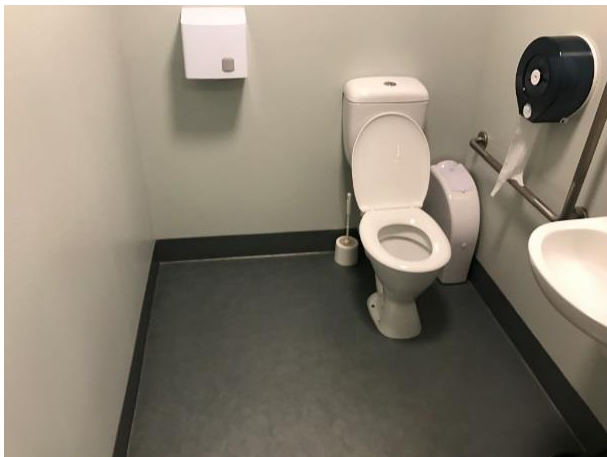
B2 – accessible WC

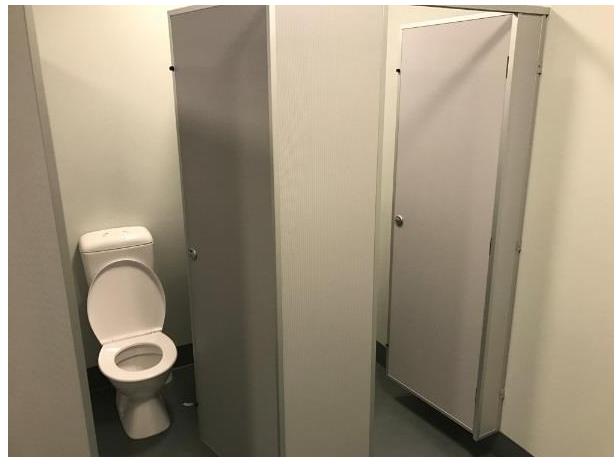
B2 – Male amenities

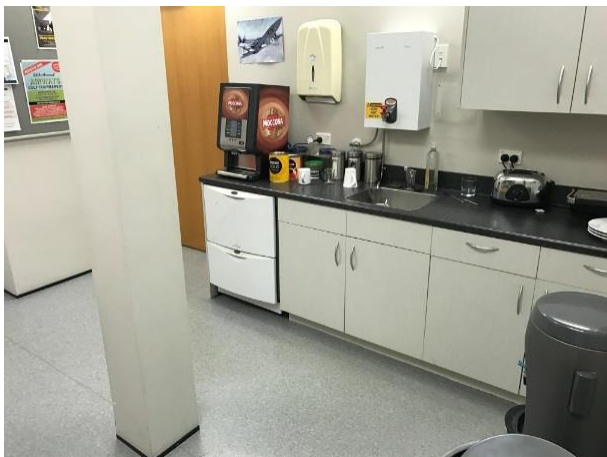
B2 – tea prep/kitchen facilities

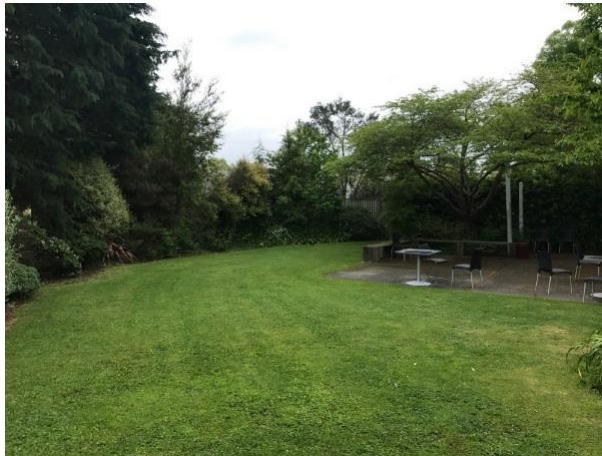
Grassed area to NW corner of B1.

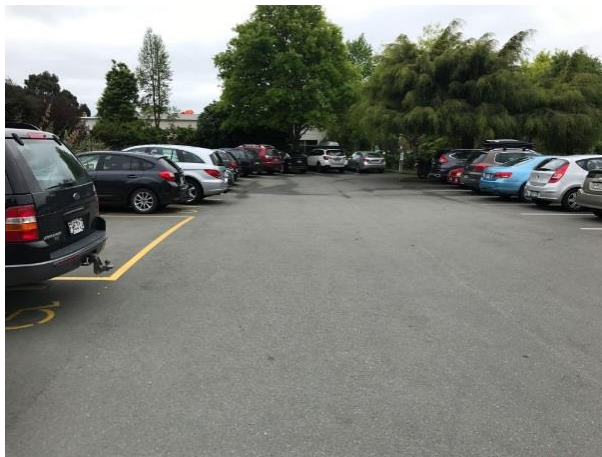
General view of parking area

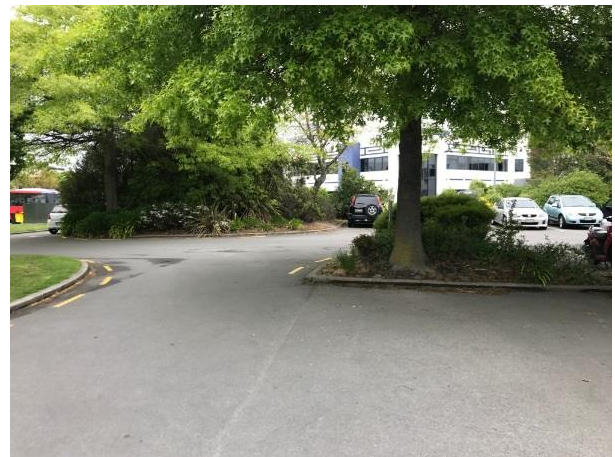
General view of parking area

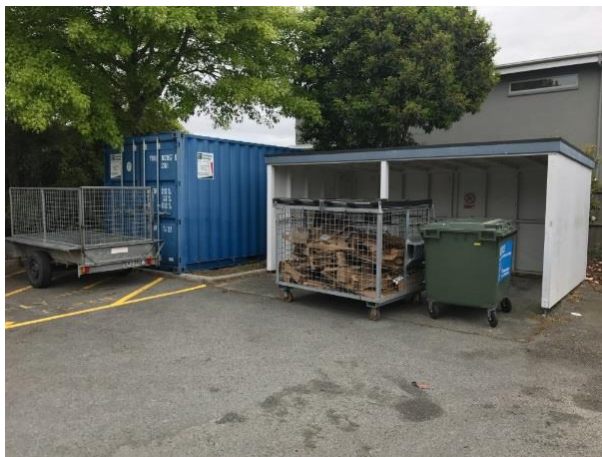
Bins store shed to SW corner of B1.

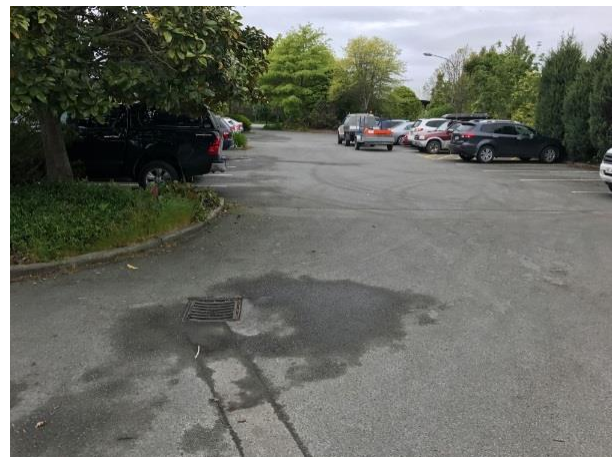
General view of parking area

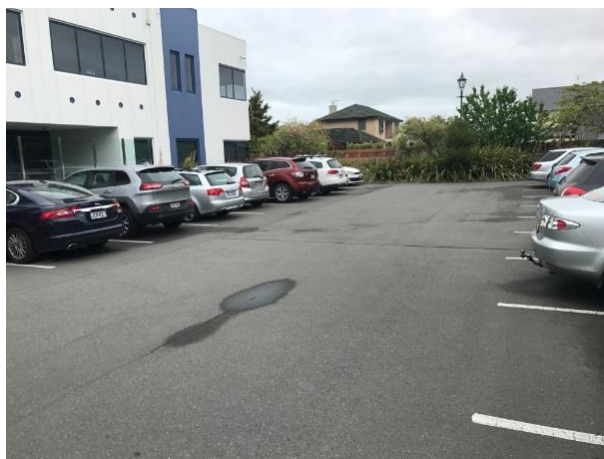
General view of parking area

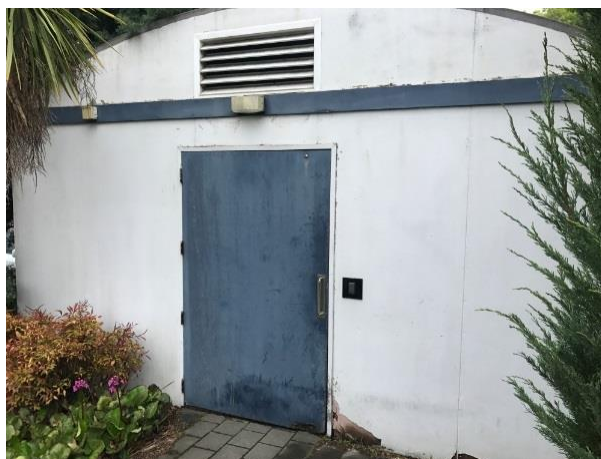
Bike store between buildings

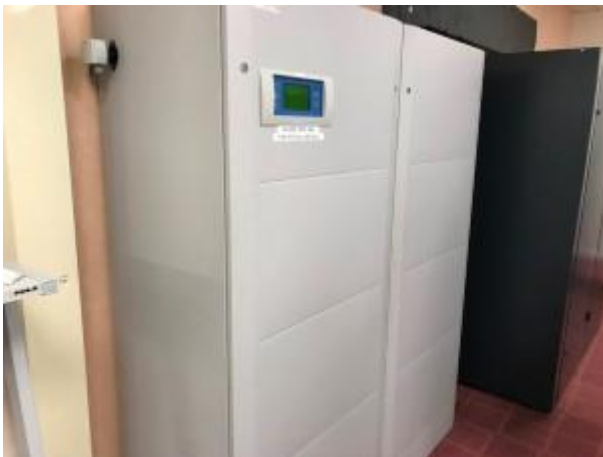
Air conditioning units are computer room air conditioning units (CRAC) or process coolers from either Stultz or Emmerson. They are close control units designed specifically for high sensible cooling loads experienced in a computer facility.

Typical CRAC

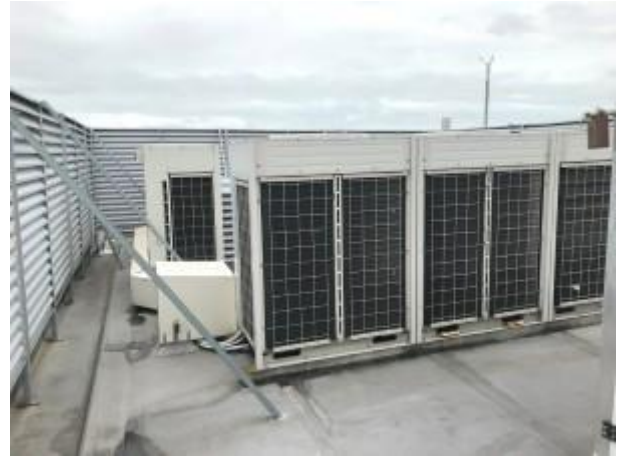
Aermec chillers – ADC

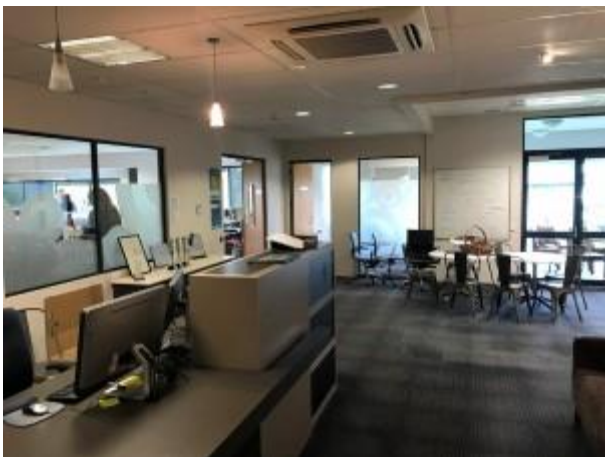
Cassette unit

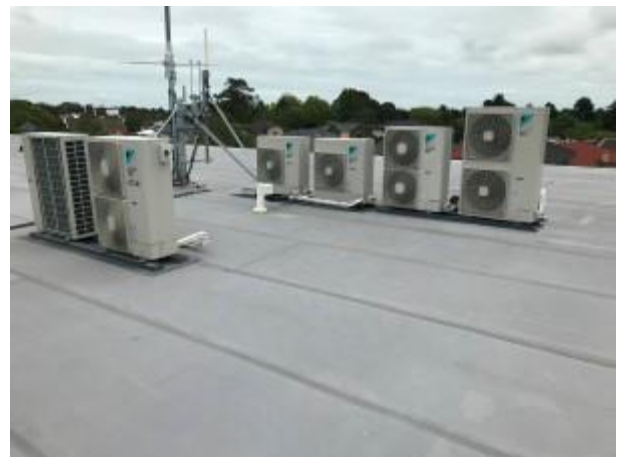
Outdoor units

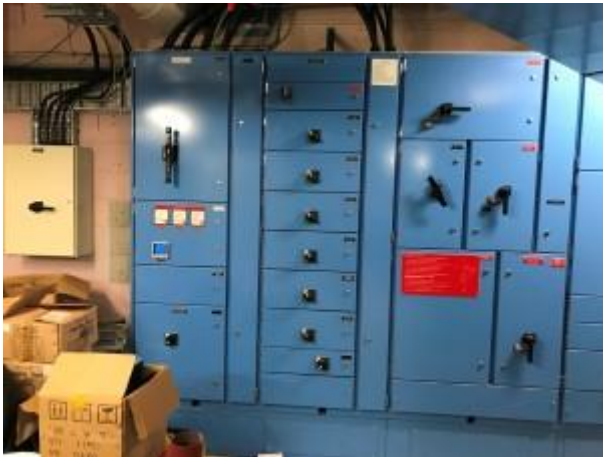
MSB

- Electrical services appear to be well maintained and in very good condition.
- Main switchboard (MSB) and distribution boards (DB) are generally in good condition and should not require attention until the extended reporting period.
- Emergency power generators are tenant property and are virtually new and should not require attention outside normal maintenance within the reporting period.
- The UPS installations is the property of the tenant.
- Emergency lighting appears conforming but there is some need for additional exit signage to promote the egress paths.

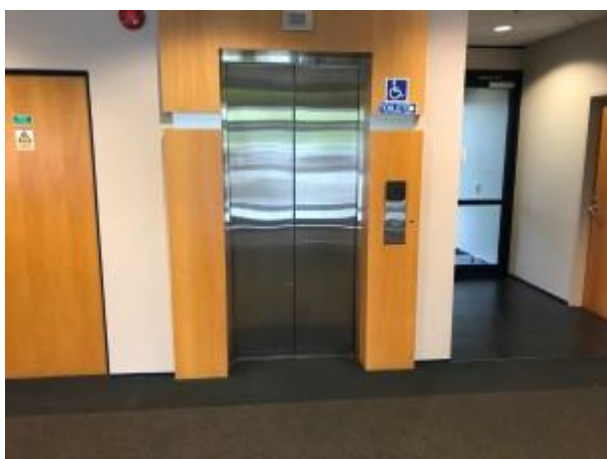
- Both lifts are at the end of their economic life and while they should be overhauled or replaced in the short term they appear to be in a condition that should keep them viable until the medium term. When replacement is planned MRL lifts could be considered.

B1 - lift
