TECHNICAL DUE DILIGENCE REPORT

Bethlehem Shopping Centre

19 Bethlehem Road

Date: 23 April 2021

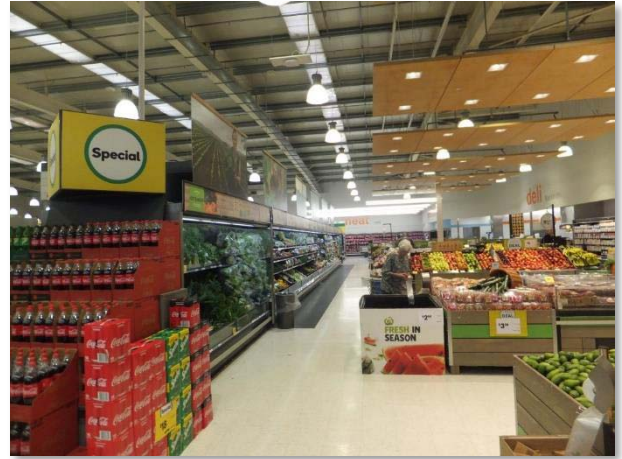
Supermarket roof structure

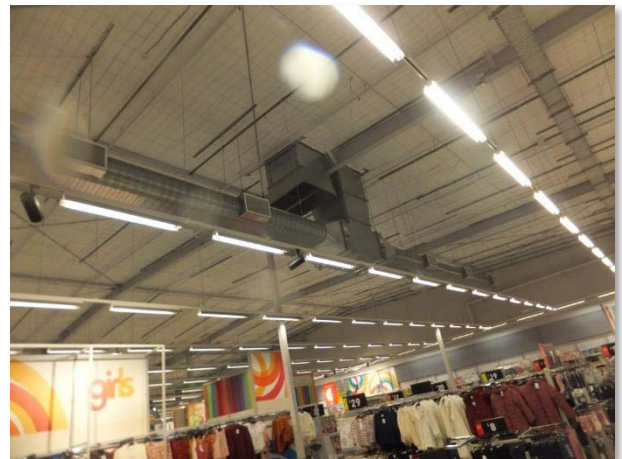
Portal frame to Block E

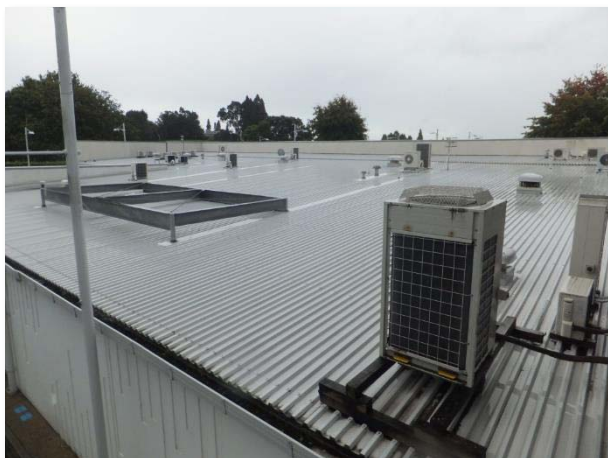
View over Block A roof

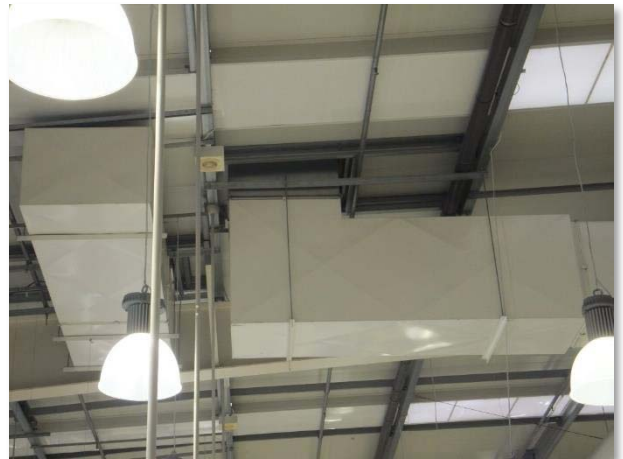
Supply and return air penetrations, supermarket

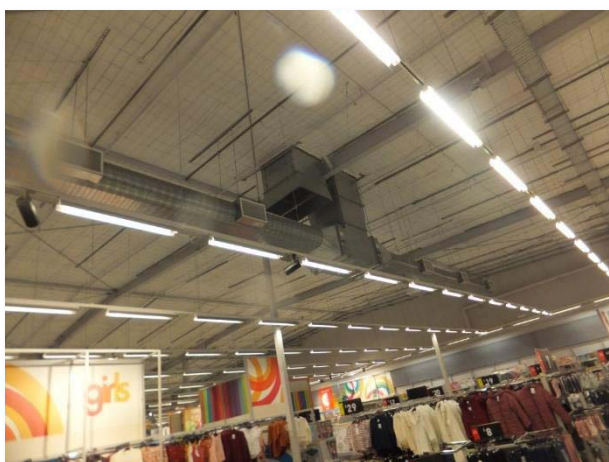
Supply and return air penetrations, K-Mart tenancy

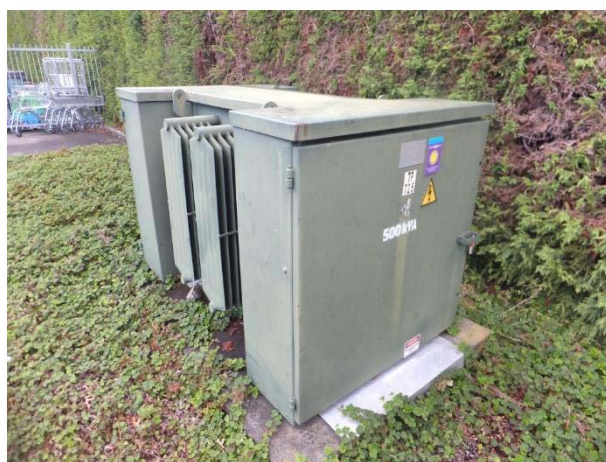
500kVA substation

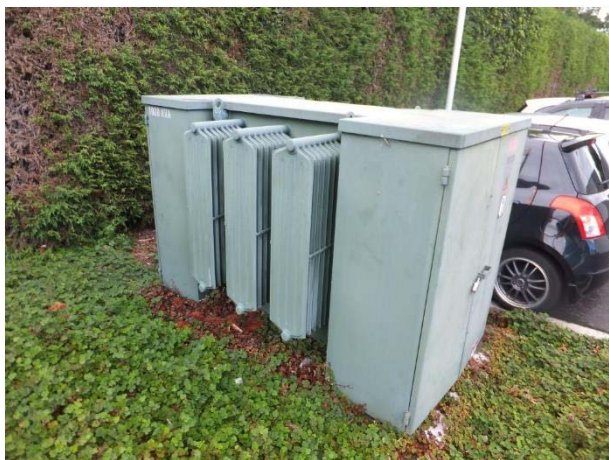
1,000 kVA substation

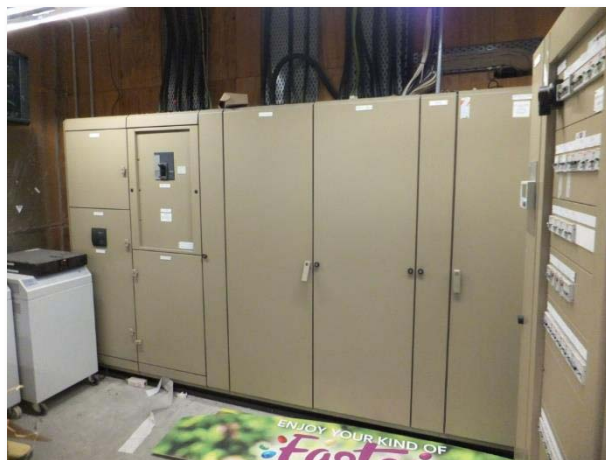
MSB, supermarket tenancy

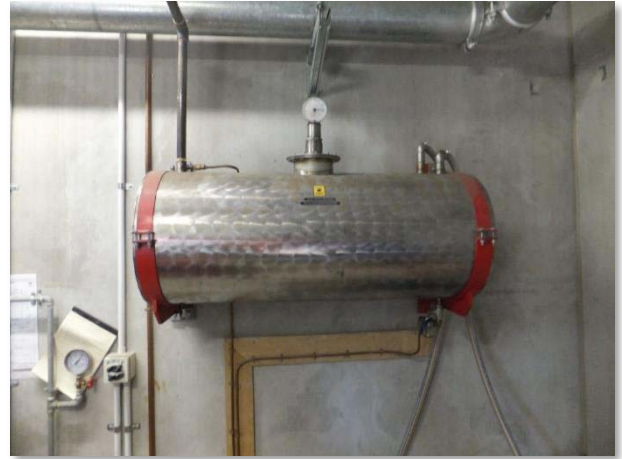
Diesel tank, Block E

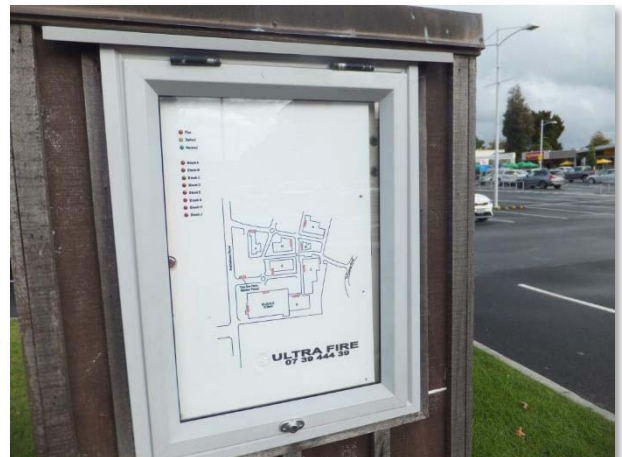
Site wide FIP in external areas

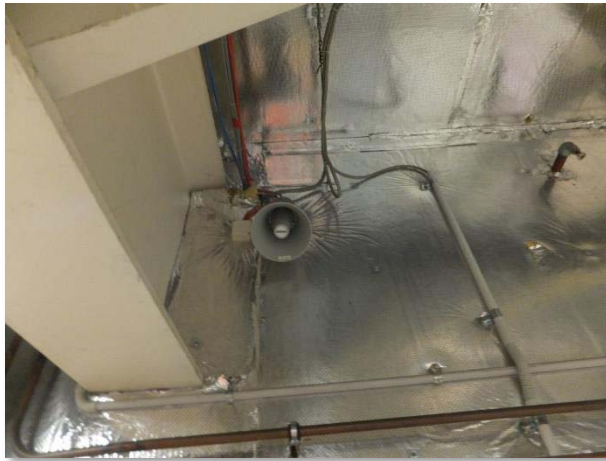
Fire alarm horn, supermarket tenancy

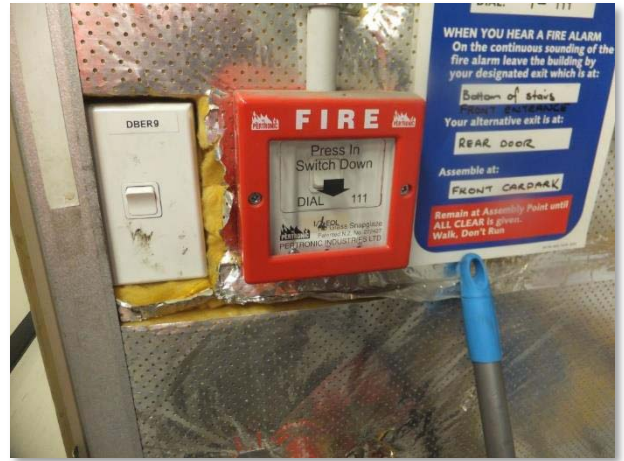
Typical MCP

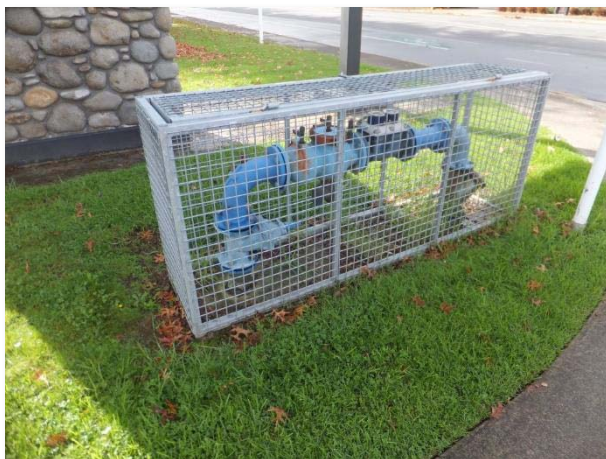
Incoming water main, Bethlehem Road boundary

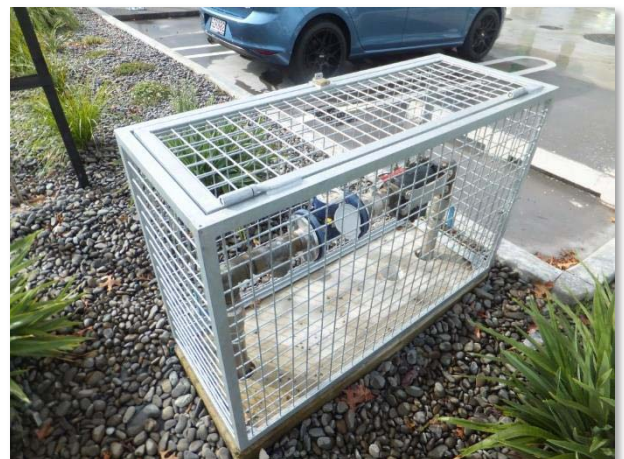
Incoming water main, State Highway 2 boundary

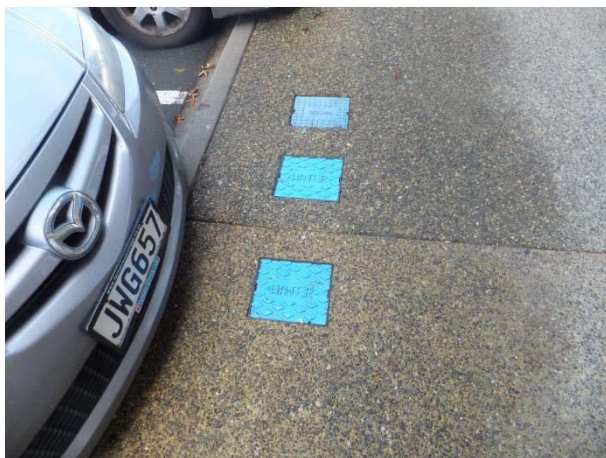
Water main stop taps to tenancies

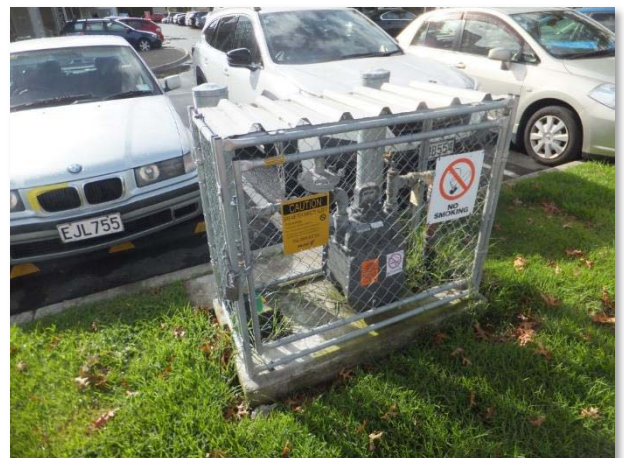
Incoming gas main, Bethlehem Road boundary

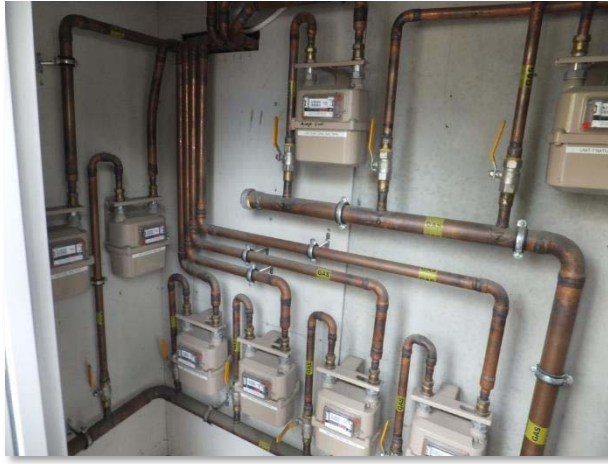
Tenancy gas metering
