TECHNICAL DUE DILIGENCE REPORT

213-221 TUAM STREET
CHRISTCHURCH

PMG Direct Office
Fund

Date:
24 January
2020

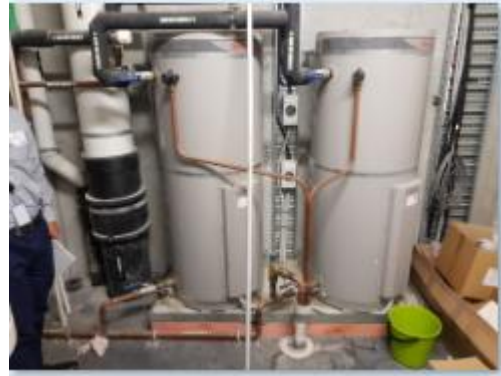
H4 – Domestic hot water heaters

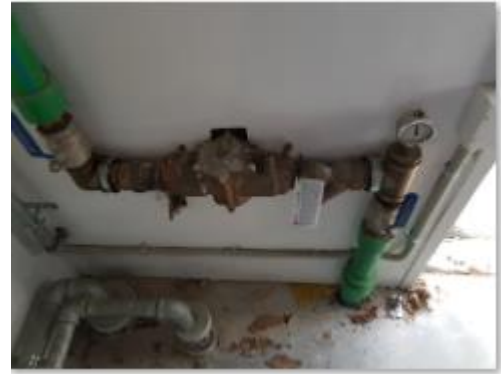
H6 – Main back flow prevention valves

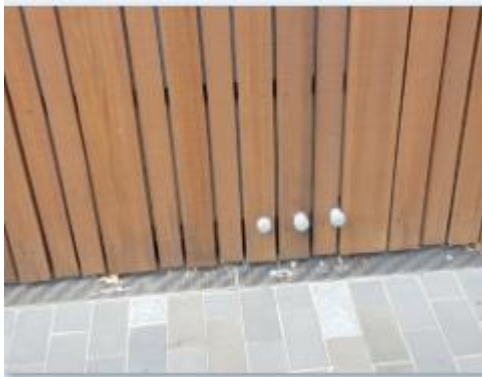
H7 – Tenant gas meter provisions

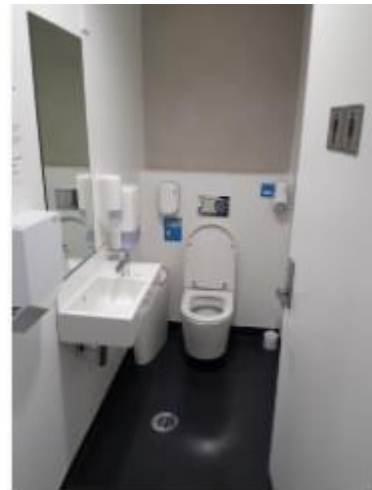
H8 – Typical unisex bathroom

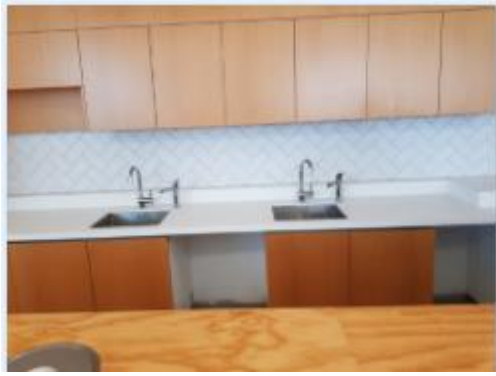
H9 – Typical Kitchenette

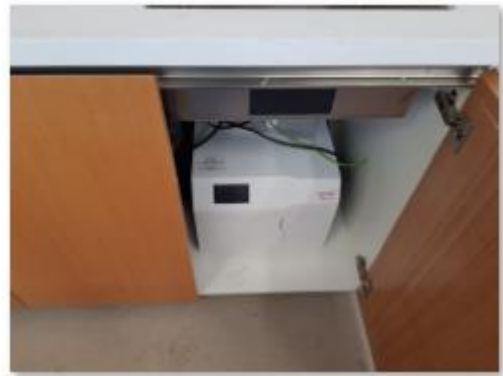
H10 – Zenith hot water unit

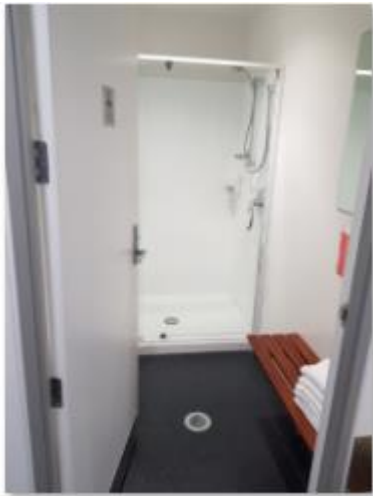
H11 – Typical unisex Shower

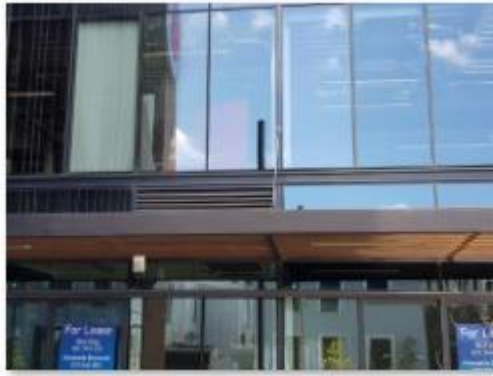
M3 – Tenant provision (louvre at façade)

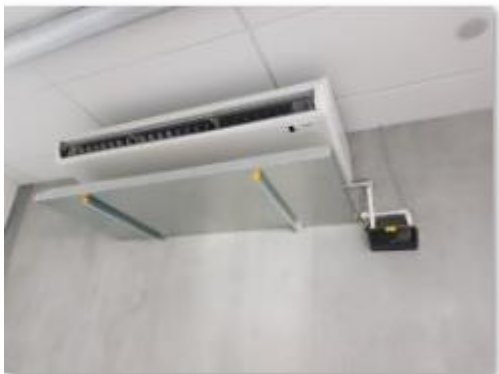
M5 – Under ceiling split unit in comms room, c/w safety tray and condensate pump.

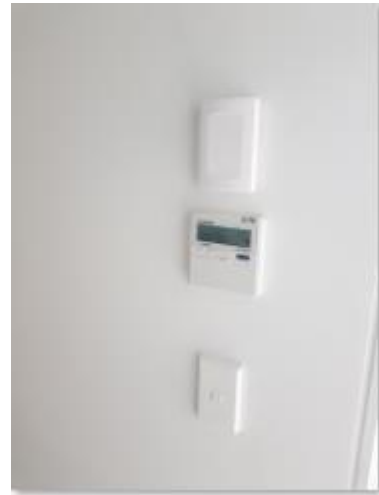
M6 – Typical wall controllers (comms room)

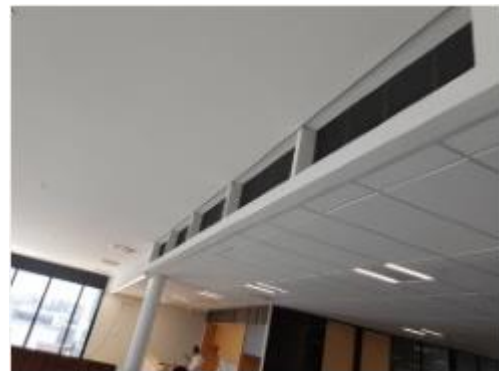
M8 – Return air grilles (atrium)

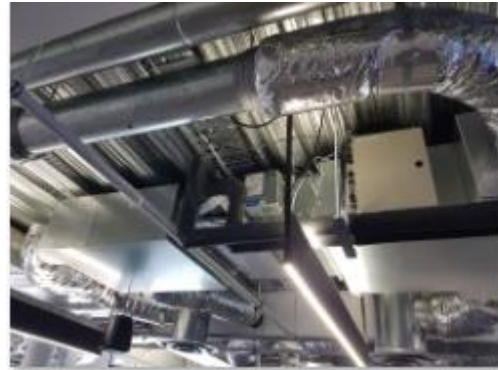
M10 – Typical FCU

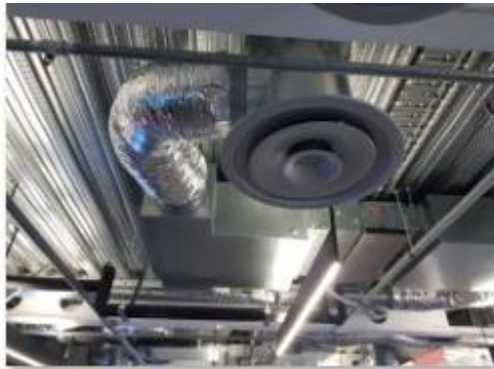
M11 – Typical supply grille

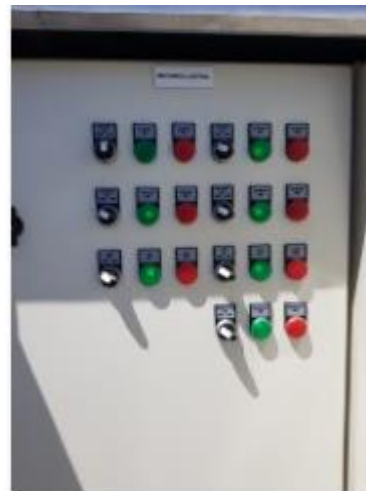
M14 – HVAC switch board

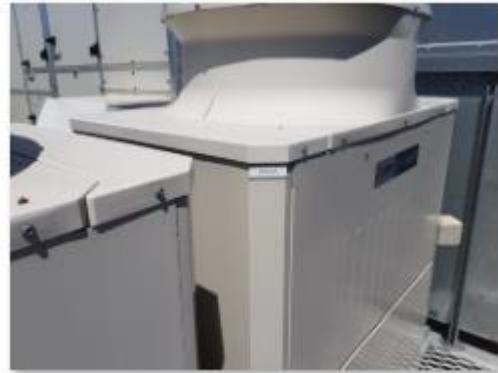
M16 – AHU VRF Outdoor Unit on Roof

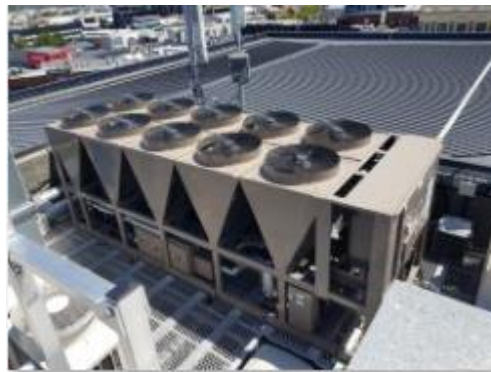
M18 – Chiller Unit on Roof

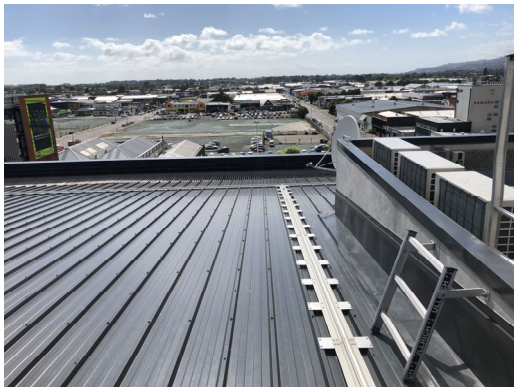
1.9. View of harness anchor points

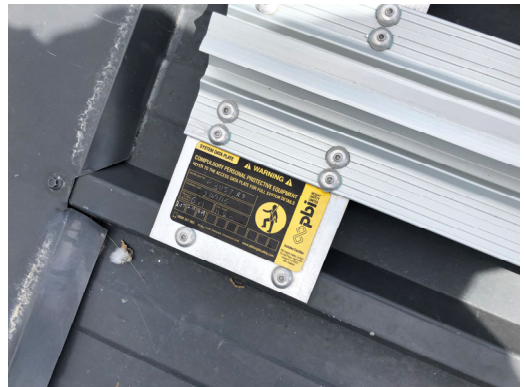
1.10. Harness anchor point information plate

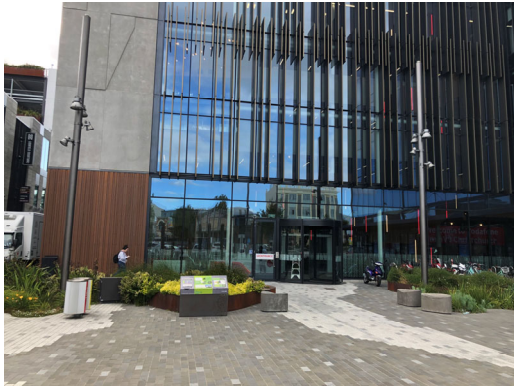
1.13. View toward main staff entrance

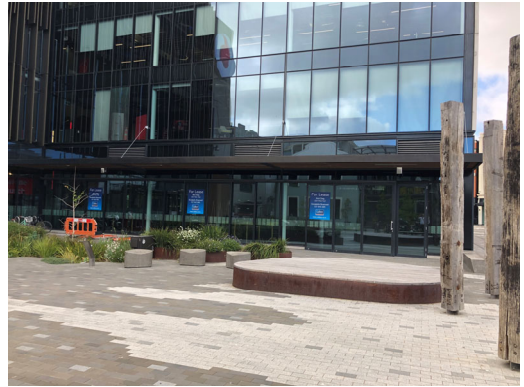
1.14. View of courtyard and external elevations

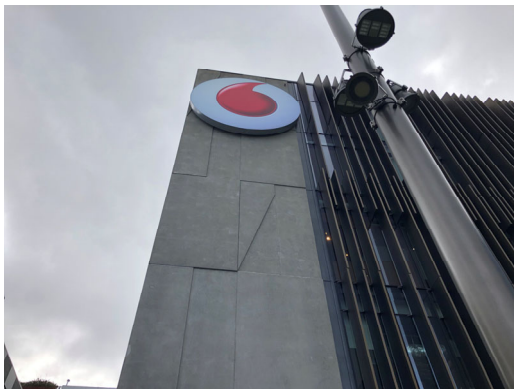
1.15. Wall mounted Tenant signage

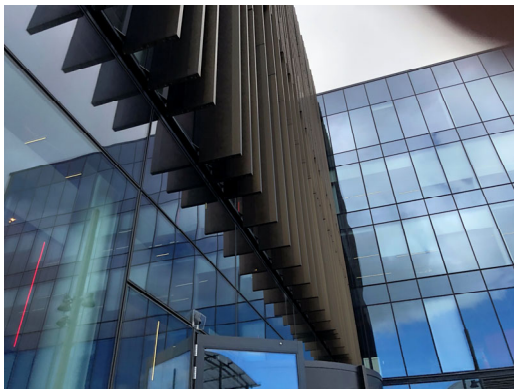
1.17. Wall mounted aluminium louvres

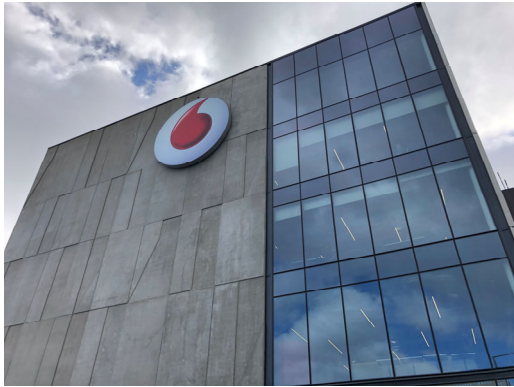
1.25. View of west facing elevation

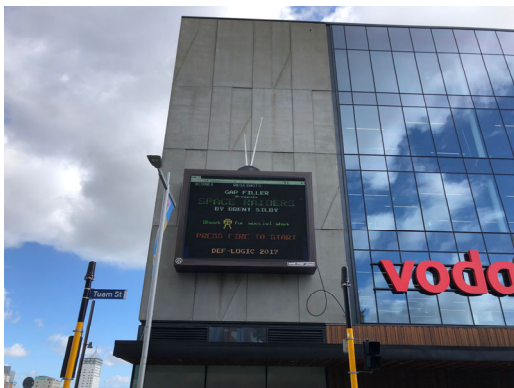
1.29. Wall mounted LED screen

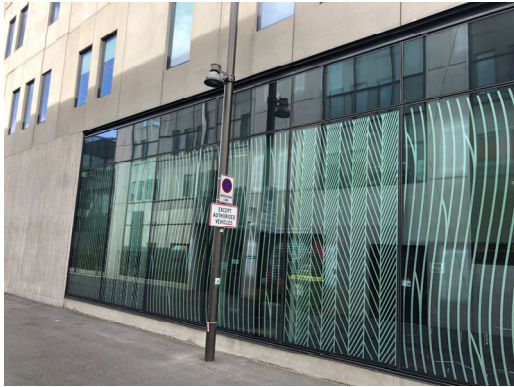
1.37. Aluminium office frontage

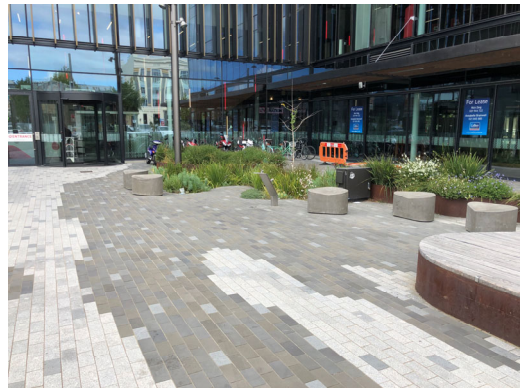
1.42. View of courtyard
