Red Flag Report

For and on behalf of
**CENTURIA FUNDS
MANAGEMENT (NZ) LIMITED**

6-14 Chappie Place
Hornby
Christchurch
New Zealand

FEBRUARY 2026
P25-0161

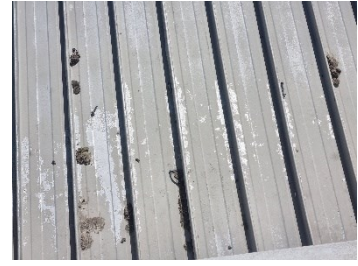
29. Block B - Surface finish of roof cladding delaminating exposing bare metal underneath.

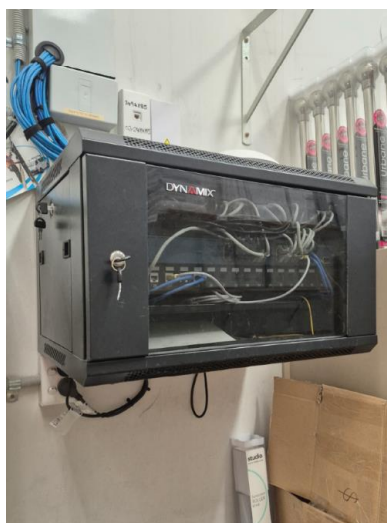
E5 – Datarack

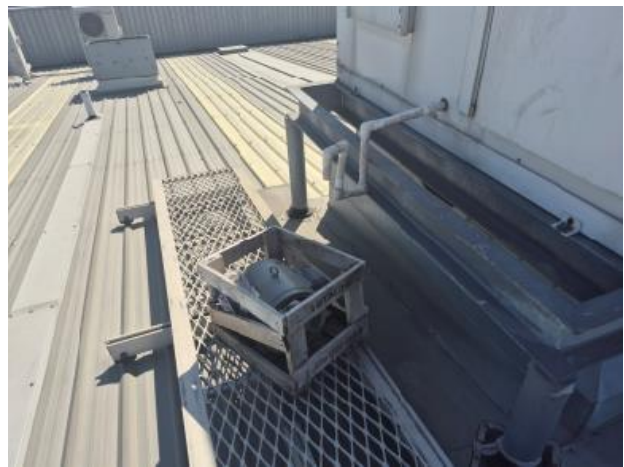
M4 – Block C PAC unit with fan motor left behind

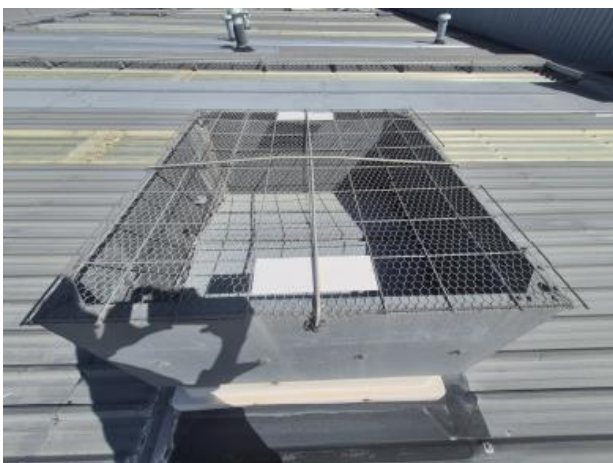
M5 – Smoke extract complete with bird/vermin mesh

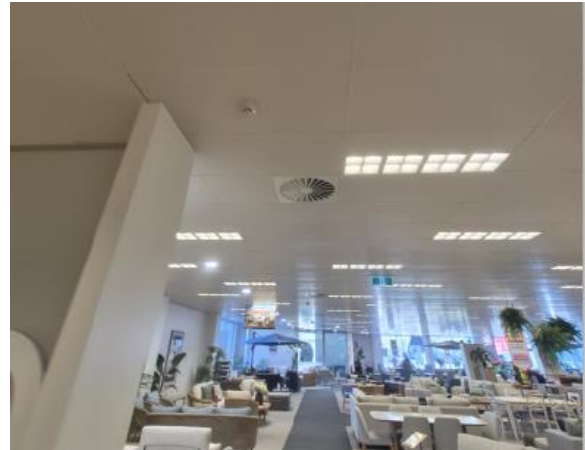
M14 – Block A & B tenancy typical supply air swirl diffuser

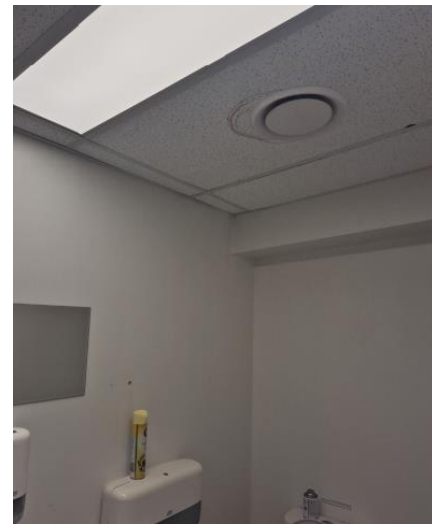
M16 – Block A & B Acc WC extract linear diffuser

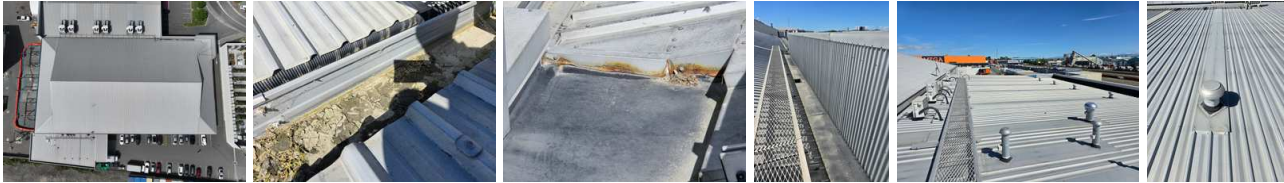
- The spouting around the perimeter of the main gable roof is made from Zincalume. This material is not suited to use in gutter applications and tends to corrode very quickly under a build-up of dirt. This spouting is starting to rust and will likely need replacement in the next 2 years. We consider this high priority as rust can transfer to the roofs below if left.
- Office roof penetrations. There are a number of vent penetrations through this roof that have no 'dry-pan' allowance on the cover-flashings. This is a common cause of leaks, but it is unlikely that all of these flashings will start to leak in the near future. Depending on budget, it may be preferable to address these if/when leaks occur.
- Rusting section of flashing at end of internal gutter.
- Sharp ends of cladding sheets have potential to cut Butynol gutter.

Priority 1 Repairs - Roof A Spoutings Rusted flashings Cladding	39,000.00
Priority 2 Repairs - Roof A Cover-flashings. Office	4,900.00

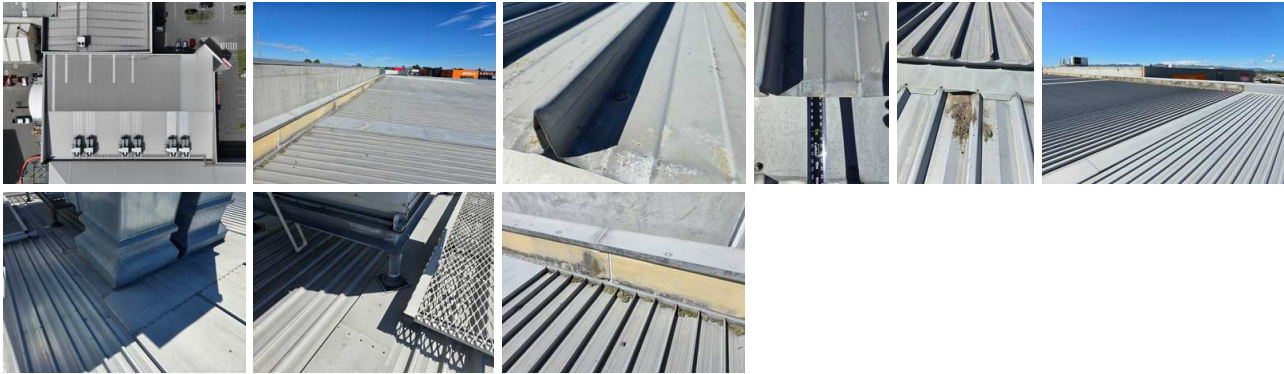
Roof B

- HVAC flashings. These units have cover-flashings that appear to be acceptable. However, these penetrations are all potential weak points, and some minor leaks may occur around the ducts. The cover-flashings to the plant deck legs have no 'dry-pan' allowance and may leak.

- The bottom end of these sheets has minimal overhang. This cannot be addressed without replacement of the sheets. Minor sporadic leaks may occur along this edge.

<p>Priority 1 Repairs - Roof B</p> <p>Parapet cladding Screws in pans. Dirt in stop-ends.</p>	<p>23,000.00</p>
<p>Priority 2 Repairs - Roof B</p> <p>Flashings to HVAC plant-deck legs.</p>	<p>7,500.00</p>

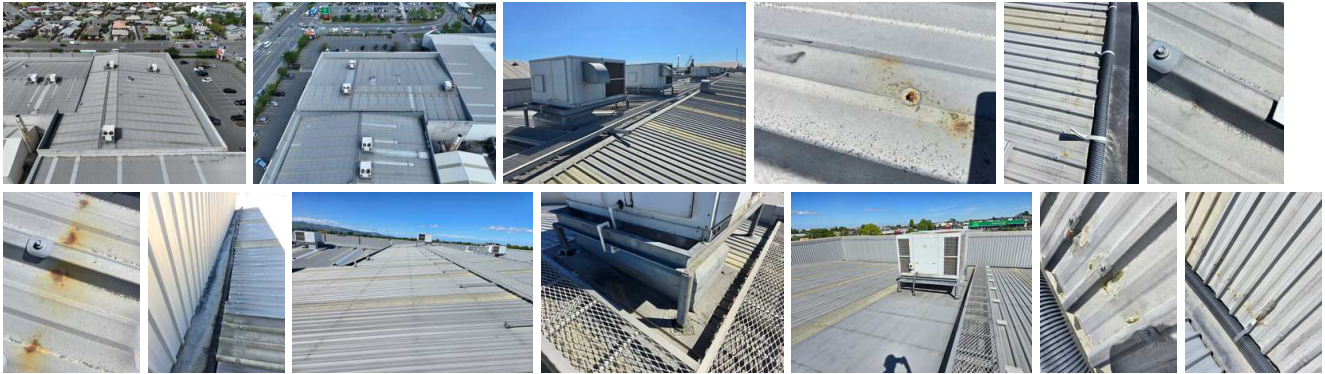
- Rust holes. Significant widespread rust holes were noted along the bottom span of the sheets on both sides of the roof. This is likely a result of moisture gathering on the edge of the Butynol gutter, either a result of condensation or dirt build-up in the gutter. We recommend all sheets on both sides have the bottom section cut away and sleeves fitted. This is not a long-term solution, but we would normally expect this to buy another 5-10 years.
- Vent penetrations. Most of the HVAC and small vent penetrations on this roof have no dry-pan allowance on the cover-flashings. Due to the age of these flashings, we would recommend proactive replacement of all cover-flashings if feasible.
- Skylights. The skylights on this roof are reaching the end of their life and should be replaced.

Priority 1 Repairs - Roof C Sleeves to rusted sheets.	8,200.00
Priority 2 Repairs - Roof C Skylights Vent flashings.	71,500.00
