# Technical Due Diligence Report

For and on behalf of  
**CENTURIA FUNDS  
MANAGEMENT (NZ) LIMITED**

196 Roydale Avenue  
Christchurch

**MAY 2021**  
**P21-0103**

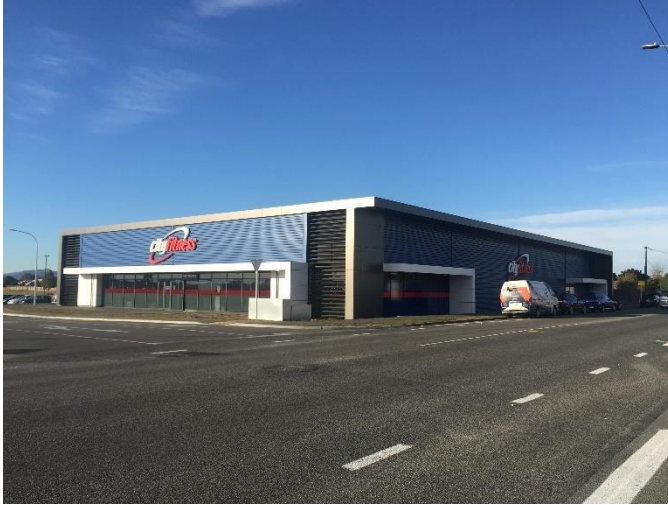
Photograph 1

General view of the property

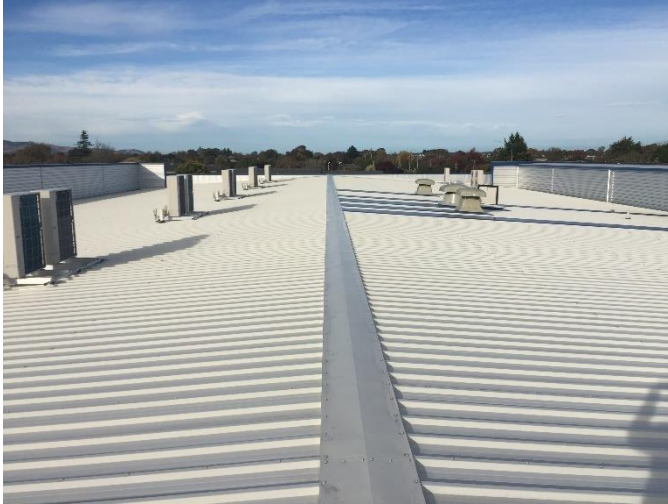
Photograph 4

Overview of the main roof

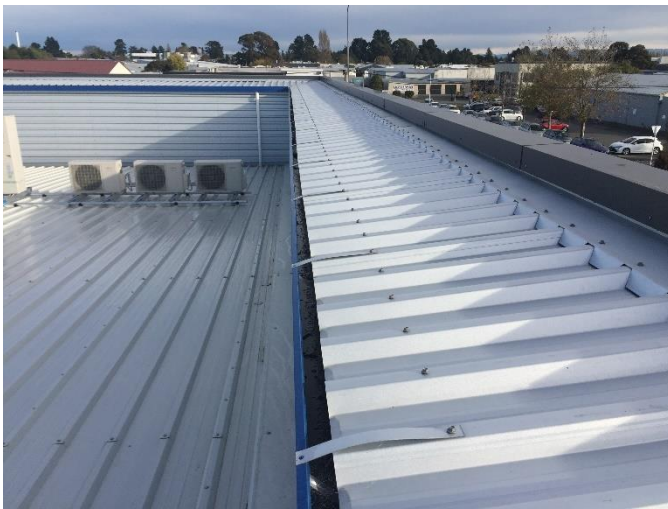
Photograph 5

Overview of the perimeter roof parapet

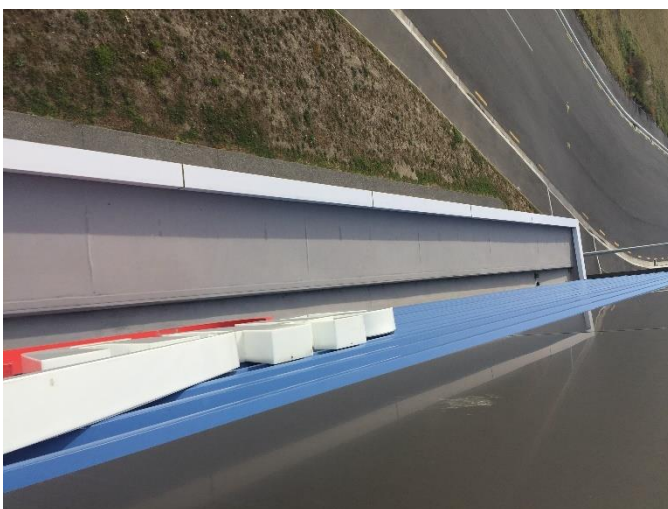
Photograph 6

Example of the cantilevered canopy, from above

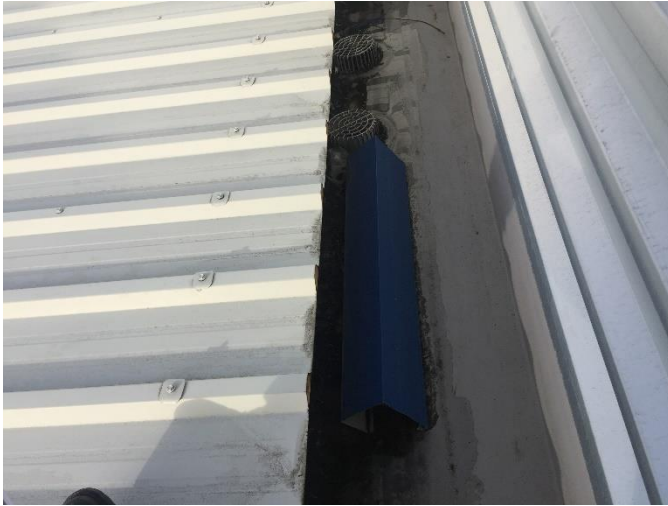
**Photograph 10**

Apparent left-over construction building materials within gutter and to isolated locations on the roof sheets

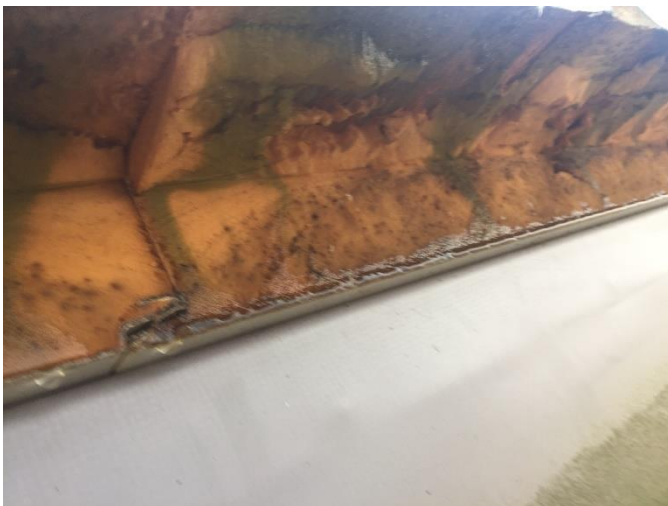
**Photograph 12**

The underside of the insulated Kingspan roof sheet, as viewed from the gutter.

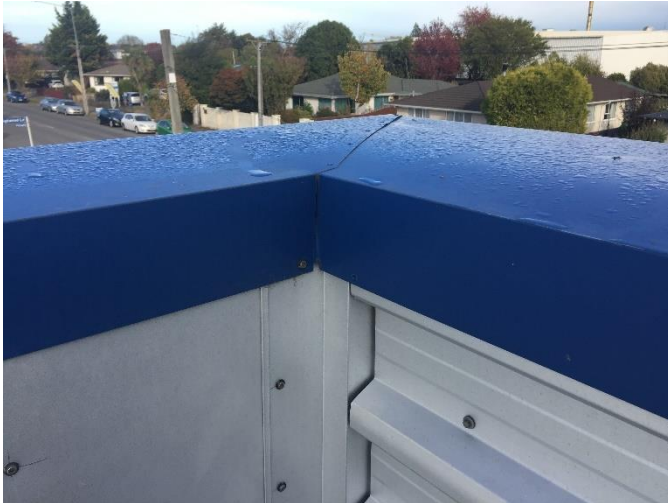
Photograph 13

The colorsteel parapet cap flashing was designed to sit at a fall, but in some instances the constructed fall is incorrect.

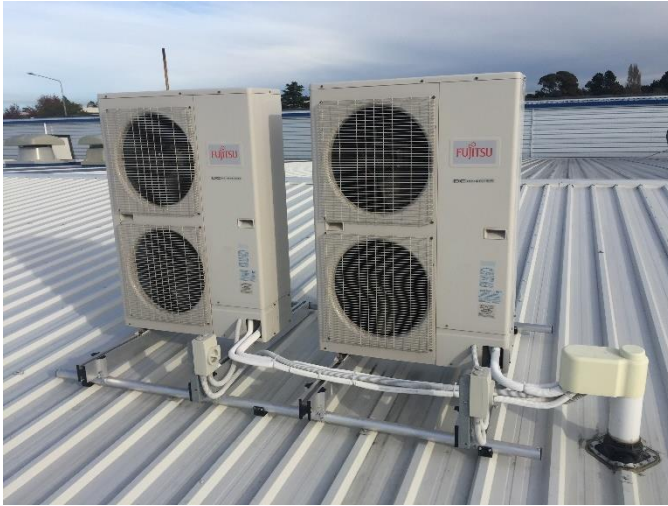
Photograph 19

Air Conditioning condensers, example

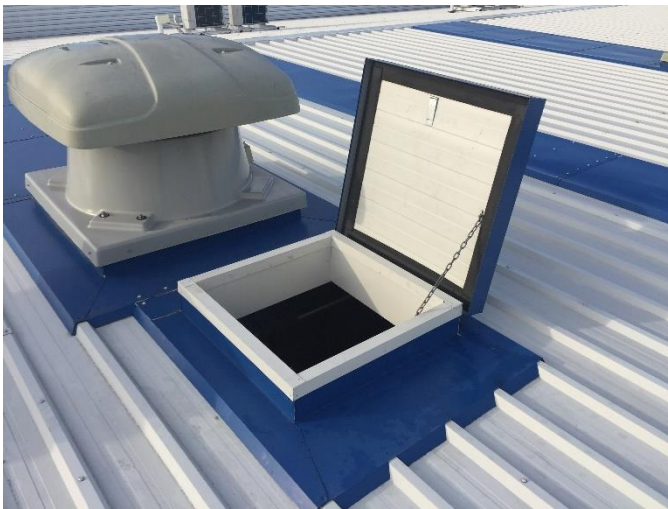
Photograph 20

The Monkey toe roof access hatch

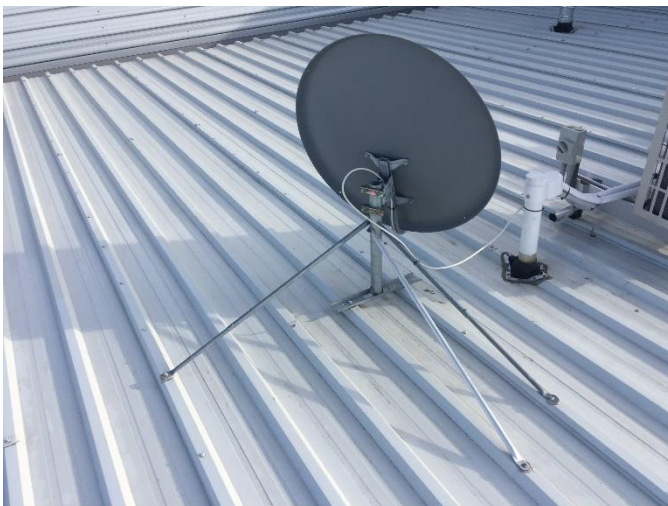
Photograph 21

Example how penetrations through the roof sheets have been treated

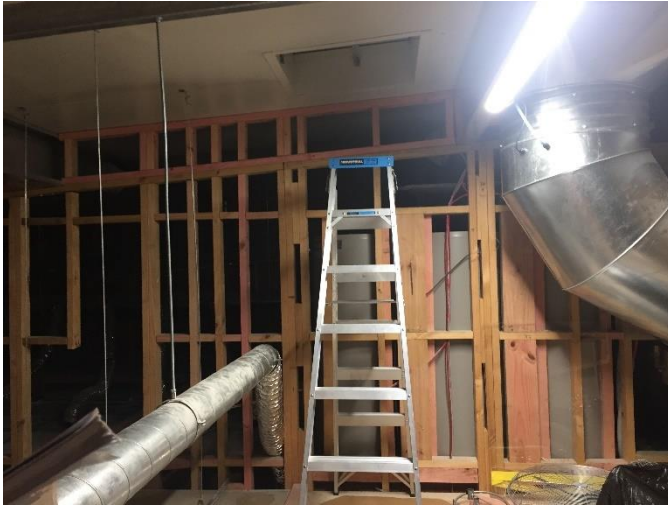
Photograph 22

Internally, above the male changing rooms, showing the room access provision

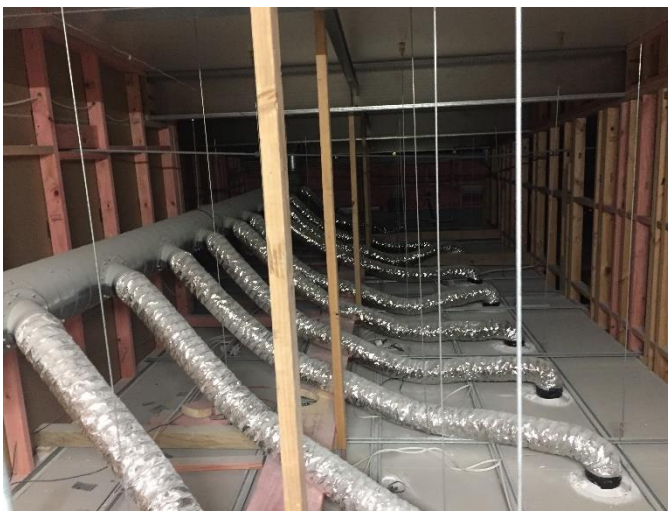
Photograph 23

The ceiling void above the changing rooms

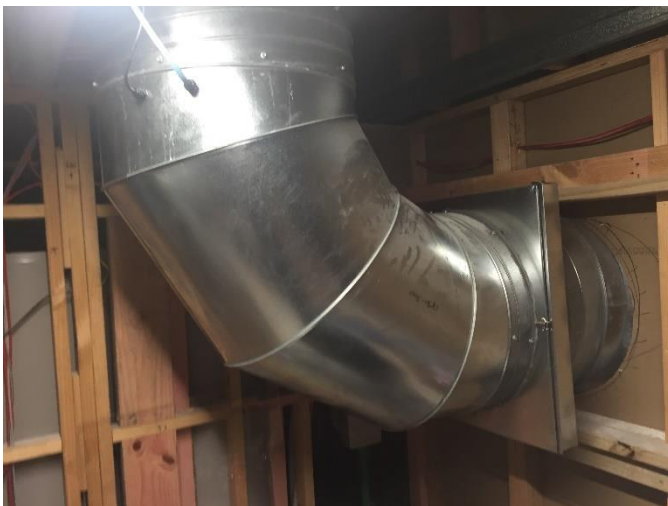
Photograph 24

Air conditioning duct insitu

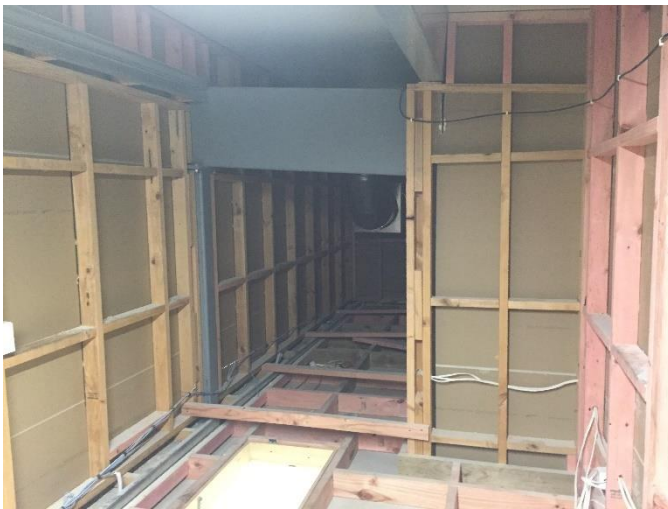
Photograph 26

Internal segregation extended to within the roof void

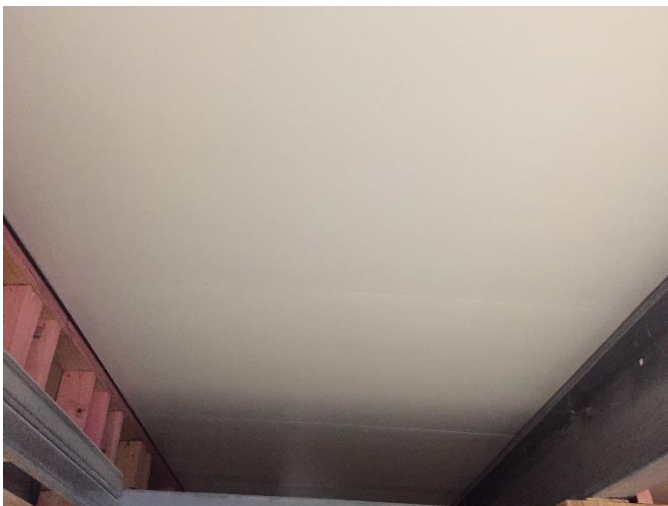
Photograph 27

Underside of the insulated Kingspan roof sheet

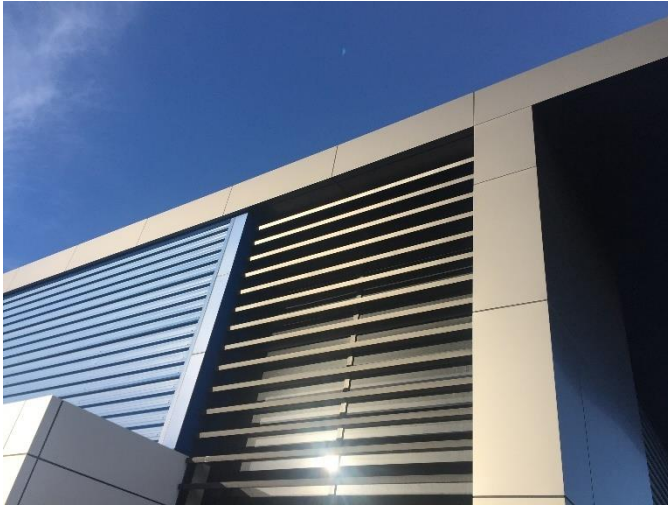
Photograph 28

Example interaction of external cladding panels and louvres

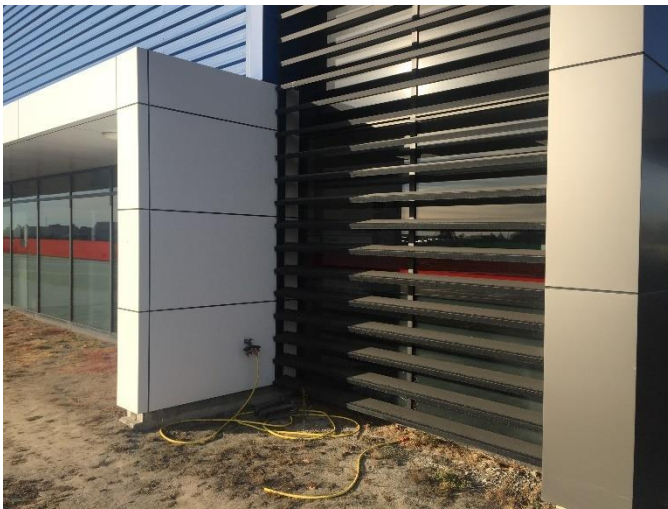
Photograph 29

Example interaction of external cladding panels and louvres

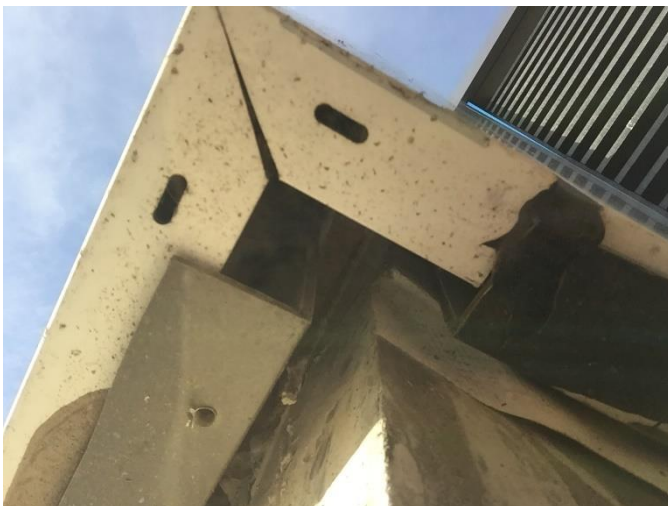
Photograph 30

The underside of the external cladding panel, at a corner junction

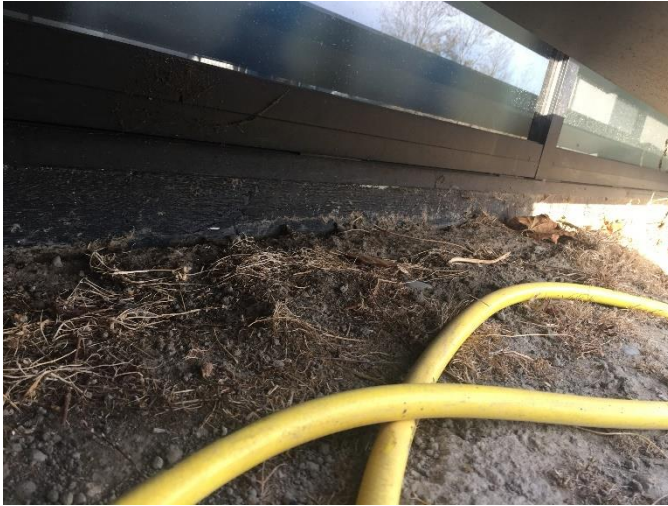
Photograph 31

Low level exposed concrete slab face beneath a shopfront joinery unit

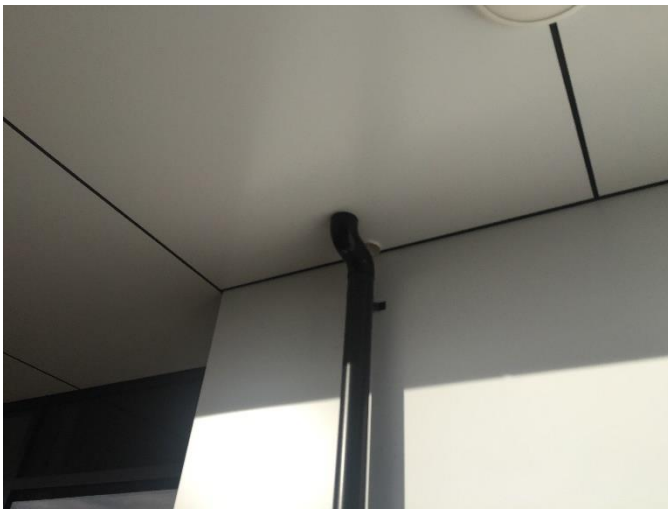
Photograph 32

Canopy room drainage from above, through structure and into 100 mm PVC downpipe

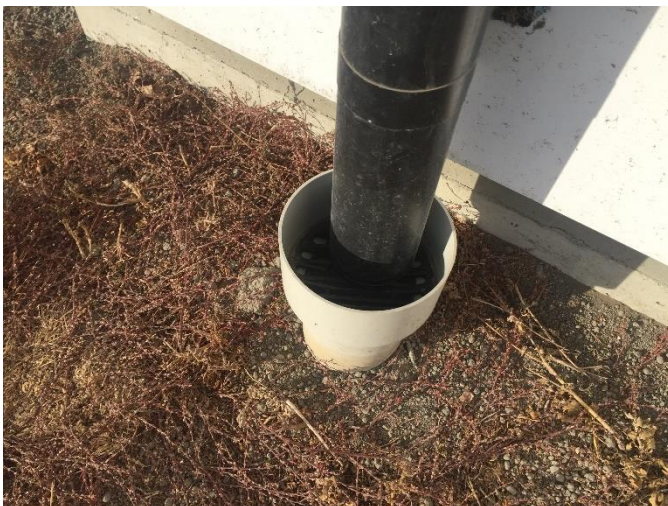
Photograph 33

Downpipe discharge in to below ground system

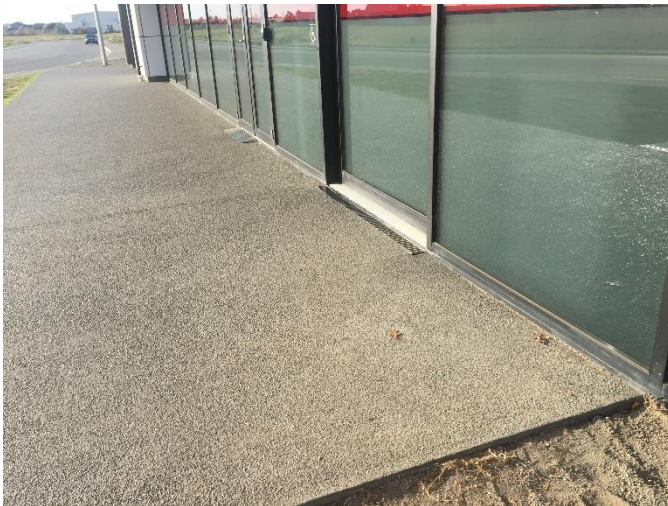
Photograph 34

Level main entrance, adjacent to accessible car parking spaces. In situ concrete laid to slight fall away from the building but also has a slot drain incorporated at the building entrance

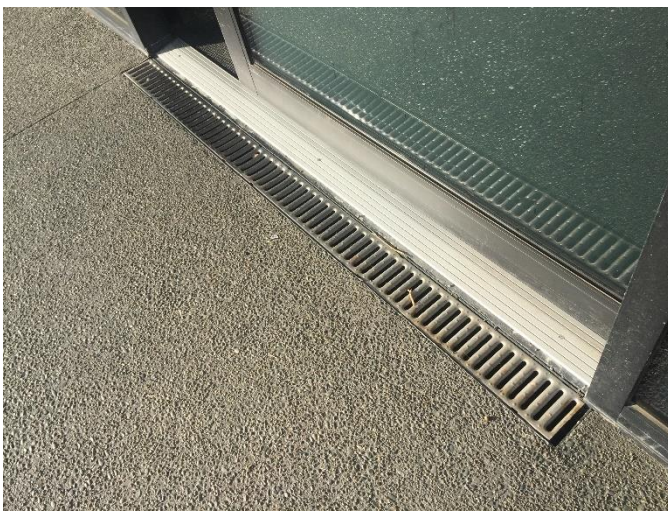
Photograph 35

Slot drain insitu, will need period clearing out of debris to remain effective

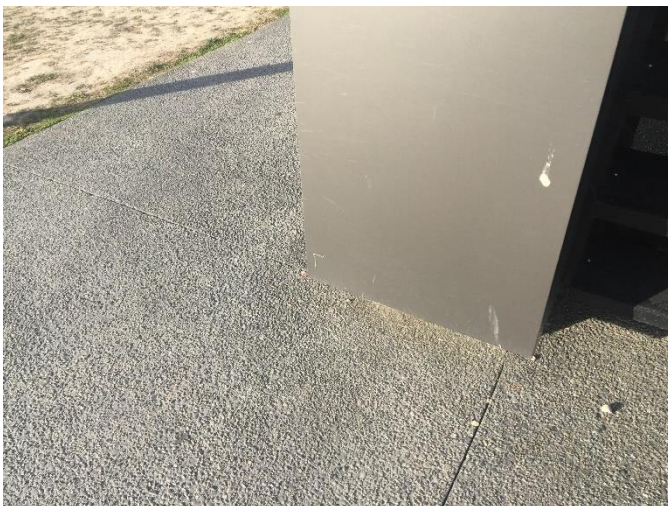
Photograph 36

Acceptable ground clearance for external cladding relative to hardstanding

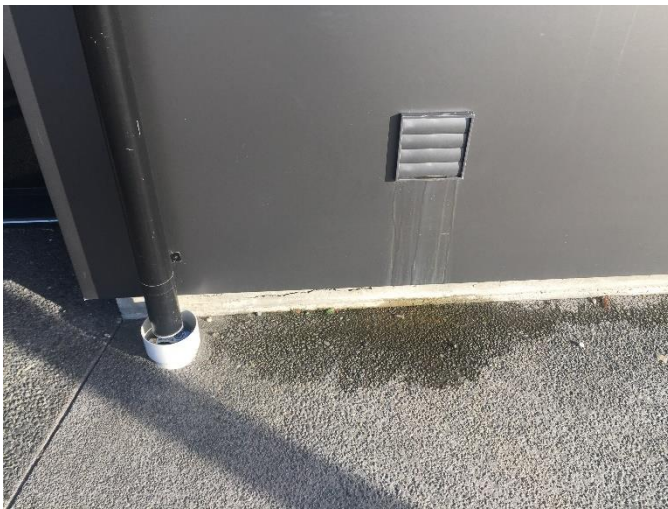
Photograph 38

Vent insitu, effective but condenser internally requires minor overhaul

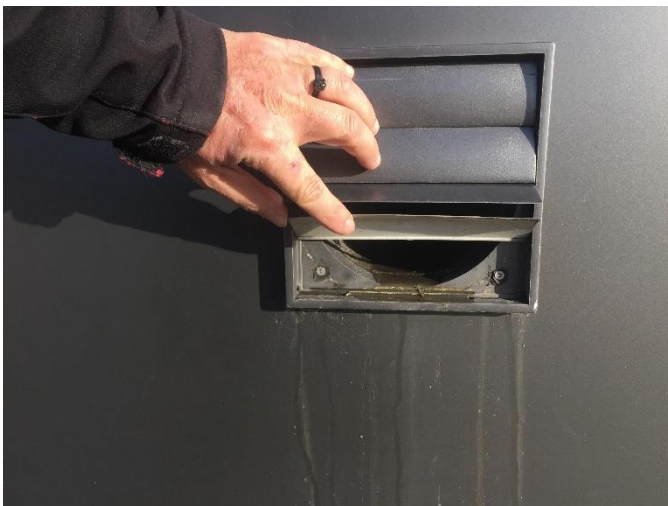
Photograph 39

Close up of the above vent

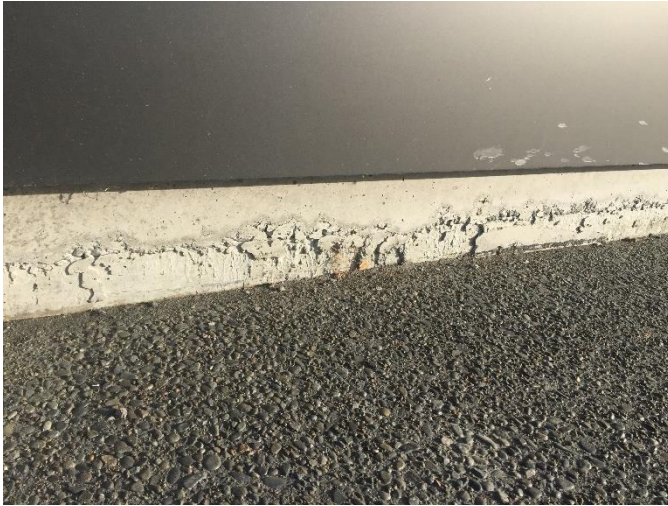
Photograph 43

As a reference, the face of timber shuttered in situ concrete floor slab

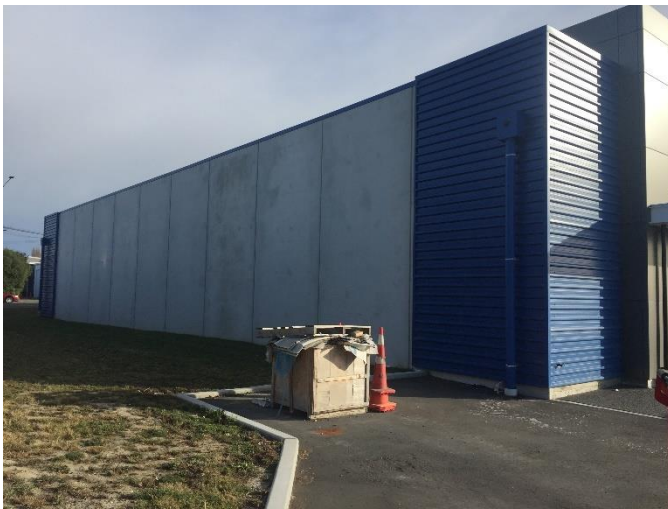
Photograph 44

The concrete panel to the west elevation

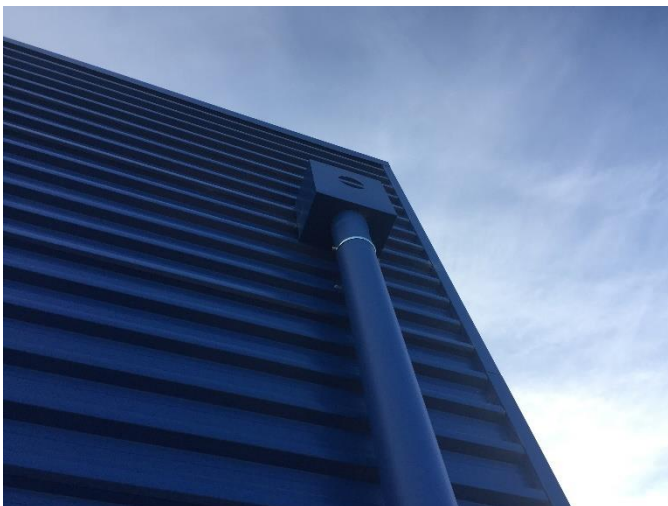
Photograph 45

Example of roof drainage, penetrating the parapet and discharging into a rain head, complete with overflow

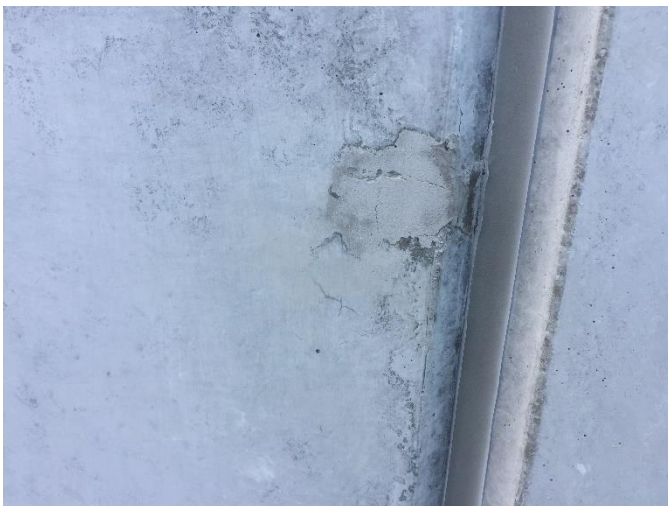
Photograph 48

Potential minor repair to concrete panel or infill of securing anchor points

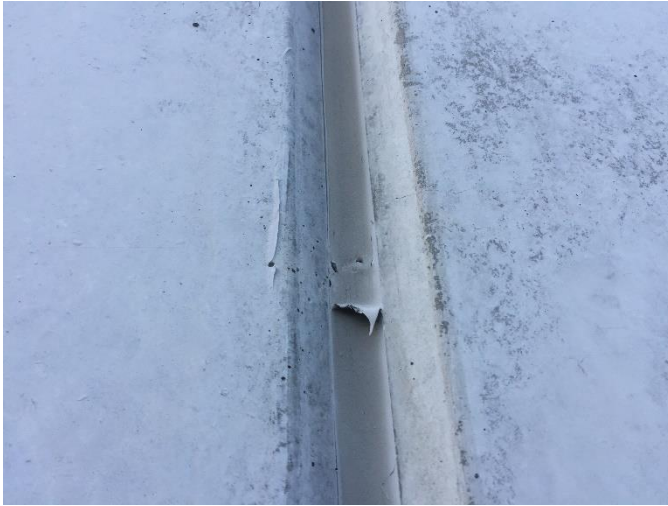
Photograph 49

Construction movement joints provided between concrete panels

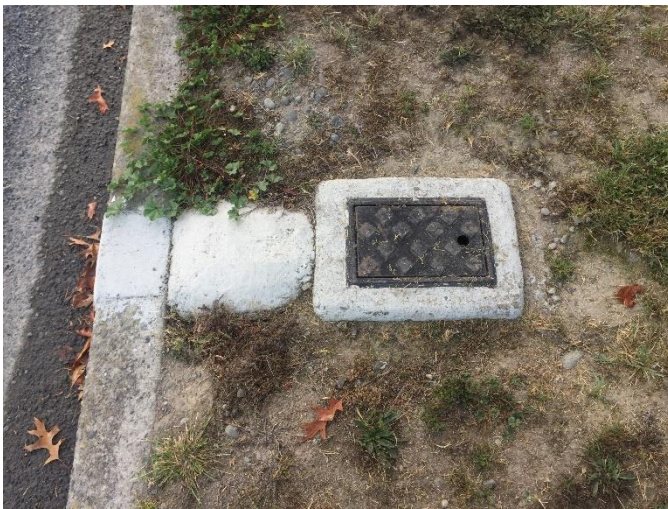
Photograph 50

Drainage inspection point

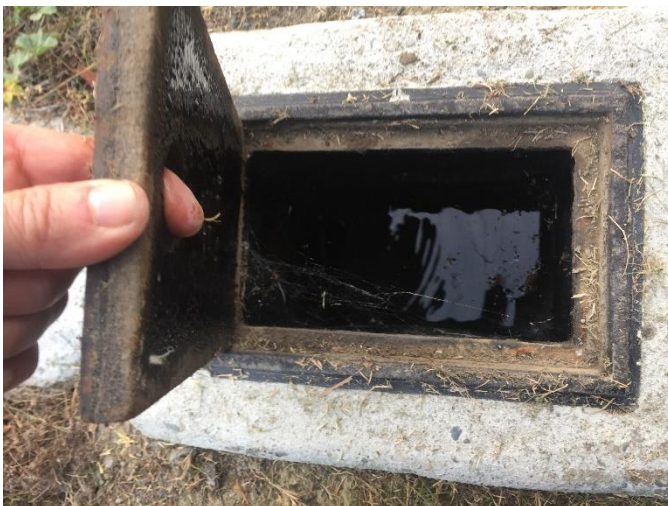
Photograph 51

The above inspection point filled with water

7.2.1 We would recommend that the entire drainage system is inspected and reviewed by a specialist, to confirm whether there are any issues present.

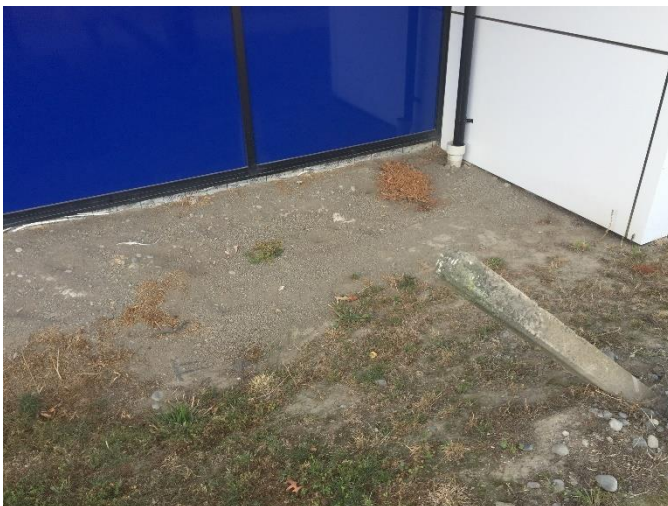
Photograph 54

Exposed earth local to the base of the northern elevation

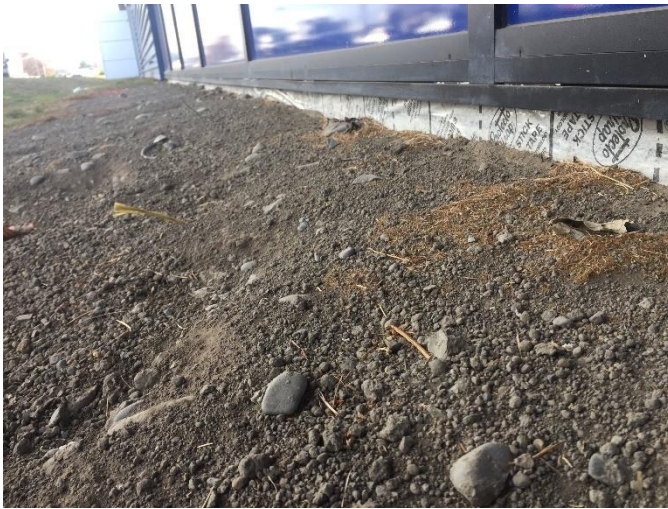
Photograph 55

Flashing band tape exposed to below shopfront joinery units, but extended up and over the concrete slab

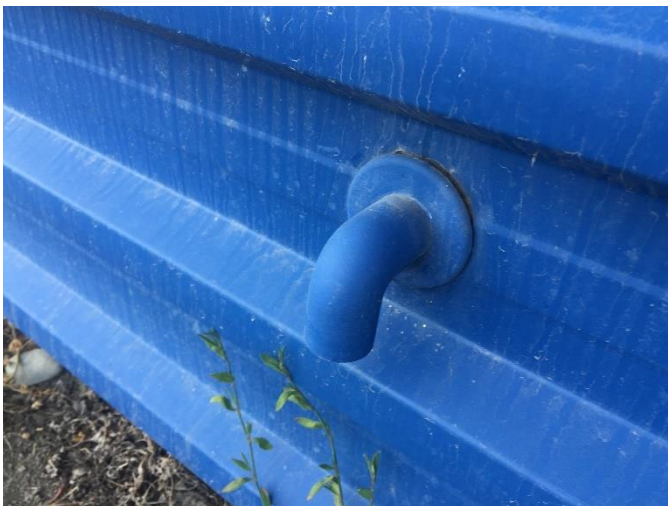
Photograph 57

Example penetration through the external cladding, well-formed and sealed overflow

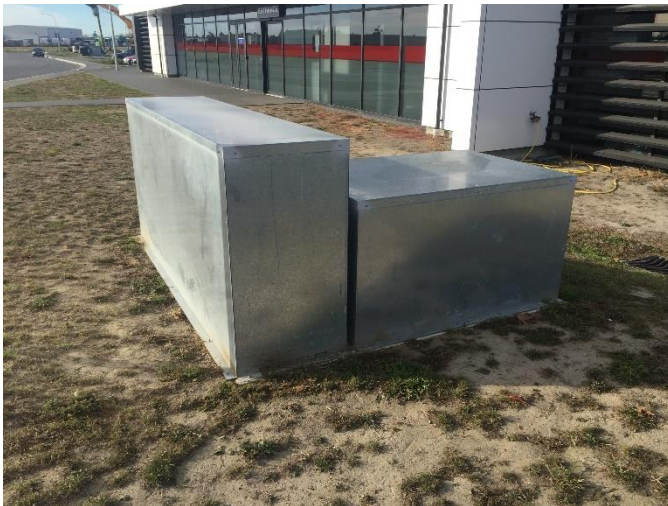
Photograph 60

Land drainage to south elevation, appears effective

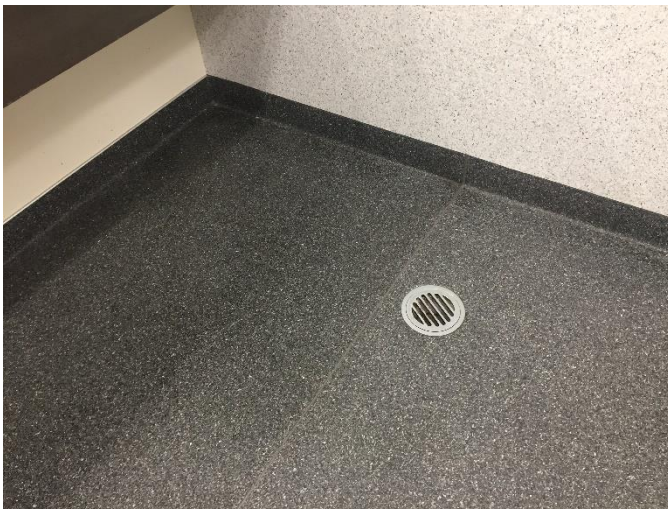
Photograph 85

Weld and joints to non-slip vinyl floor sheet

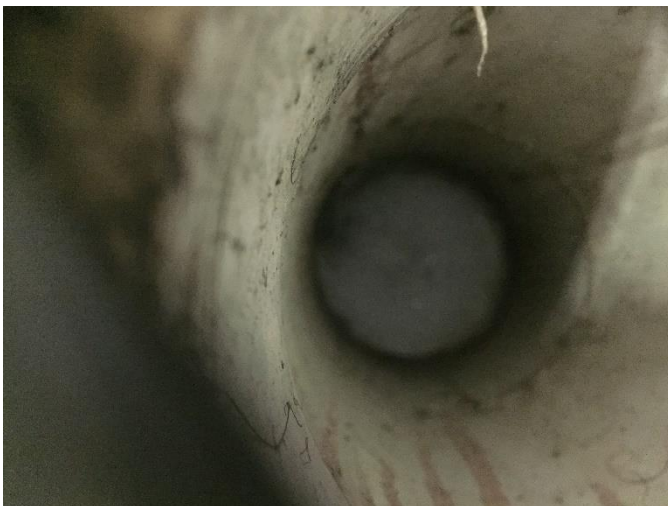
Photograph 86

Floor laid to fall into flush drain system

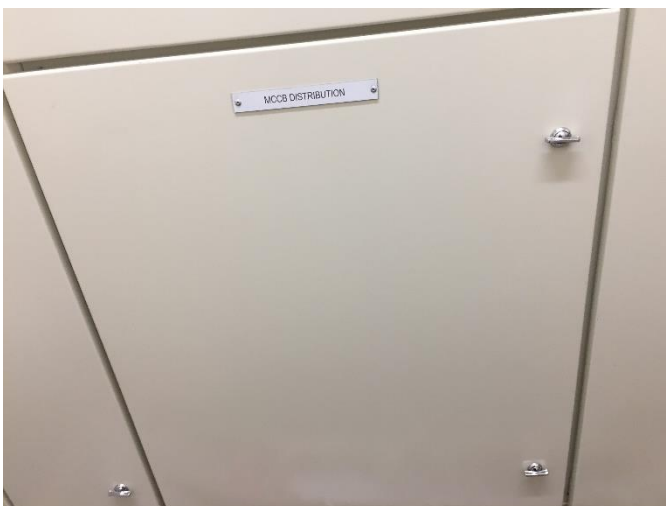
Photograph 107

Mechanical distribution board

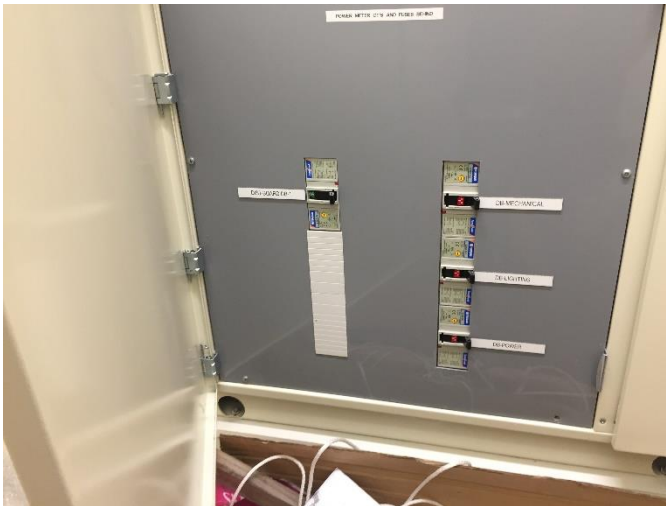
Photograph 108

MCCB Distribution board

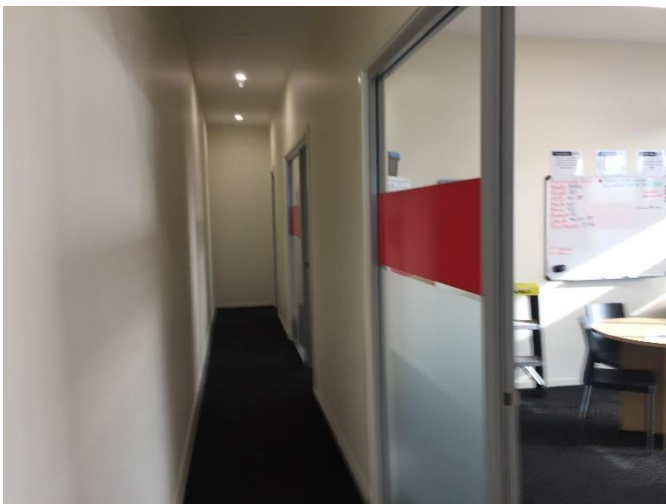
Photograph 113

Fire alarm

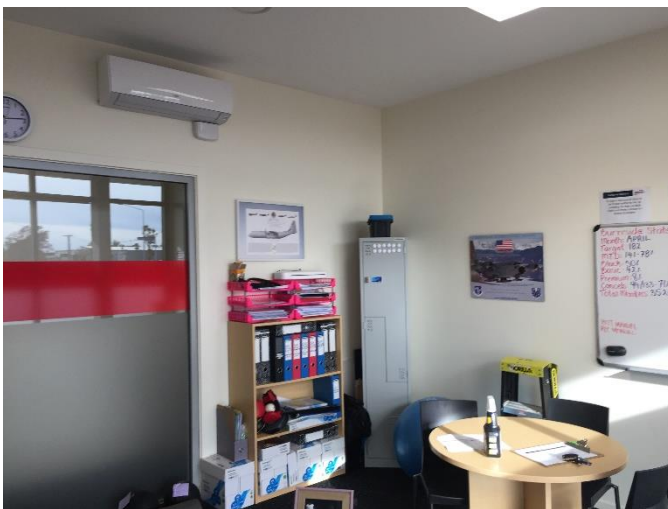
Photograph 115

Main office interior

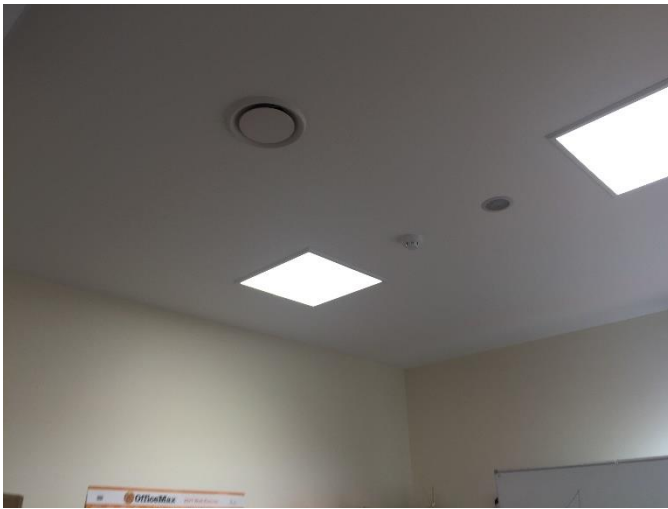
Photograph 117

Painted plasterboard ceiling and walls, sheet carpet and fluorescent light fittings
