Red Flag Condition Report

For and on behalf of
**CENTURIA FUNDS
MANAGEMENT LIMITED**

146 Shands Road
Hornby
Christchurch

**NOVEMBER 2024
P24-0230**

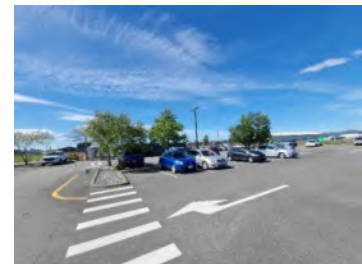
3. Typical view of carpark.

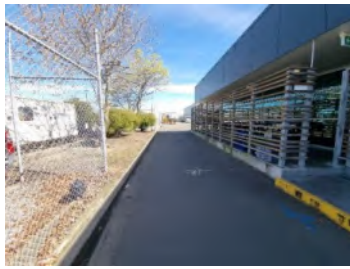
4. View of entrance pedestrian hardstanding and fencing.

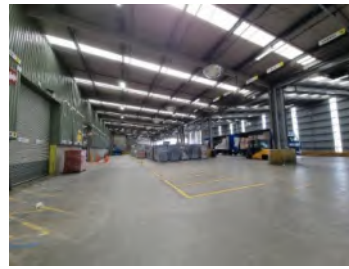
5. View of hardstanding beneath canopy to northeast.

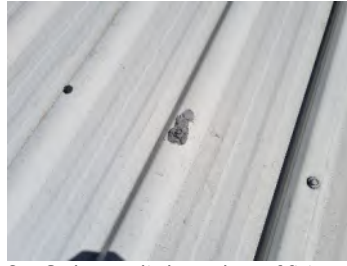
9. Sealant applied over the roof fixings.

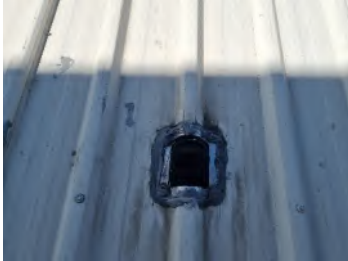
11. Boot flashings applied parallel to the sheet crests opposed to the preferred diagonal configuration. Sealant has been heavily applied around flashings and around service penetrations.

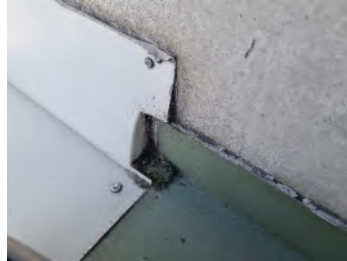
12. Flashings to the perimeter of the roof have not been chased into the adjoining concrete panels and rely on sealant for weathertightness. Flashings are of different style resulting in openings at flashing junctions.

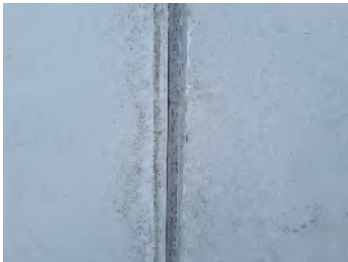
14. Seals to the panel junctions along the southeast wall have deteriorated and splitting was observed within the exterior flexible seal across the elevation.

Code	Ref	Defect	Recommendation	Timescale (yrs)	Approximate Cost
●	2.5.2	Widespread deterioration of flexible seals between concrete panels, predominantly along the northeast and southwest elevations.	Replace all flexible sealant strips between panels.	1	\$25,000
●	2.5.3	Cracking to the security office cladding and chipping to the base of the cladding sheets. Potential for moisture ingress behind cladding and damage to any internal framing as a result.	Replace cladding.	1	\$7,000
●	2.5.4	Surface fixed perimeter flashing upstands have not been chased into the perimeter walls of the lower-level office roof. Flashings have been installed in sections of differing design creating openings at flashing junctions.	Replace flashing and chase into walls.	2	\$2,500
●	2.5.5	Impact damage to the base of metal cladding panels along the northeast and southeast elevations.	Replace damaged sections of cladding.	3	\$50,000

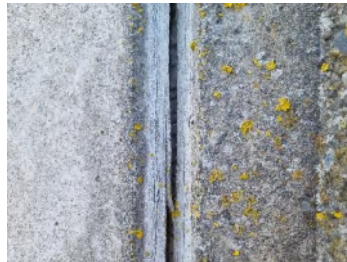
15. Seals to the panel junctions along the southwest wall have perished with splitting of the seals revealing the foam internal seal in numerous locations. Defect is evident across the elevation.

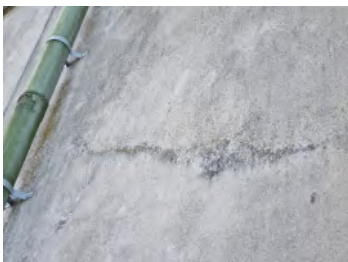
17. Localised spalling of panels adjacent to cracking and concrete infills around anchors in the panels to the southwest.

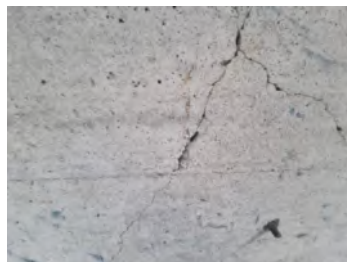
18. Cracking to the northeast panels (beneath the canopy) is wider to some areas.

●	2.5.6	Hairline cracking through concrete pre-cast panels.	Allow to fill cracks in concrete with epoxy solution.	3	\$2,500
●	2.5.7	Typical deterioration and patch repairs to the internal membrane guttering of the lower office roof.	Allow to uplift membrane covering and replace in the medium to long term. Rectification of the fall to the substrate may be required in the long term (10+ yrs).	8	\$5,500

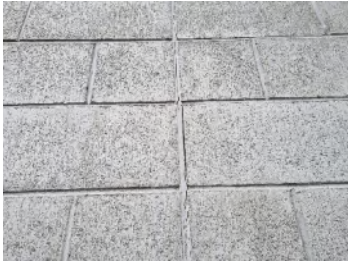
20. Splitting to the flexible seal along the control joint within the northwest fire wall (external view).

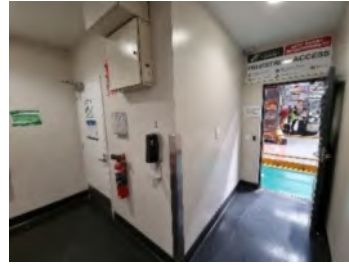
33. View of plasterboard partition walls.

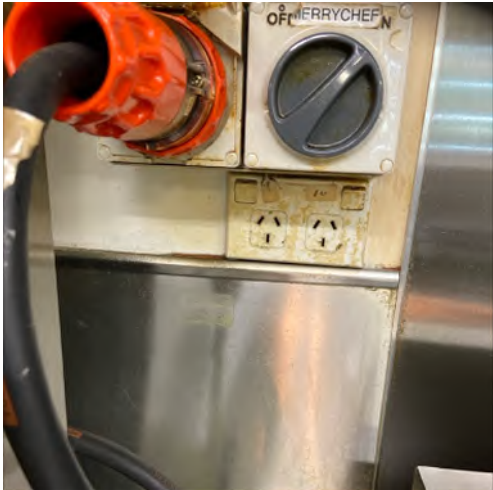
<p>General power outlets in kitchen near hot fat fryer.</p>
<p>22</p>

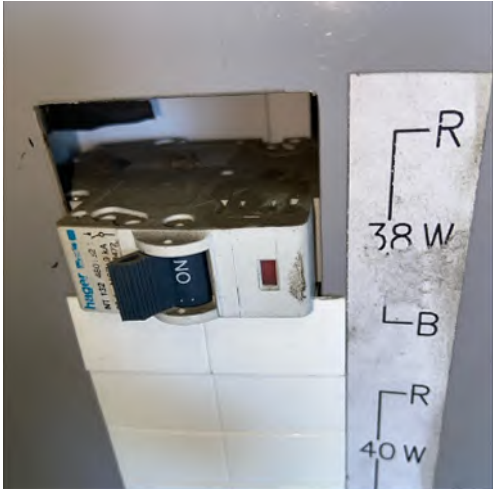
<p>MCBs dirty and exposed.</p>
<p>23</p>

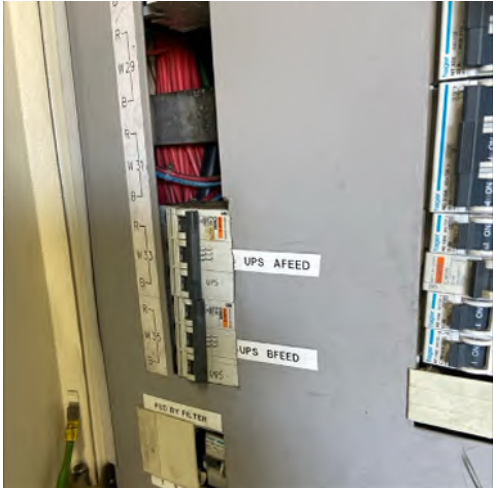
<p>Exposed openings.</p>

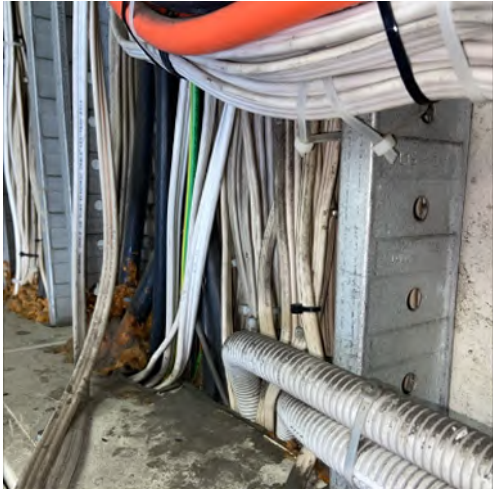
<p>Main switchboard openings at the topside panel.</p>
26

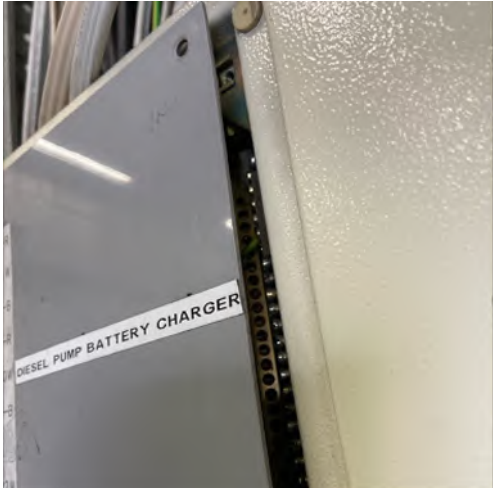
<p>DB escutcheon plates not secure</p>

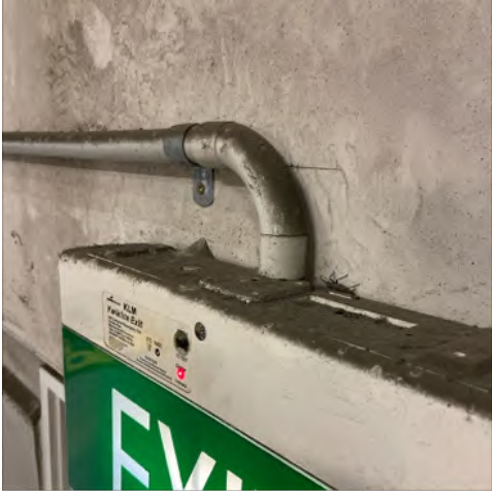
<p data-bbox="794 360 1236 394">Dirty emergency lights in warehouse areas.</p>
31

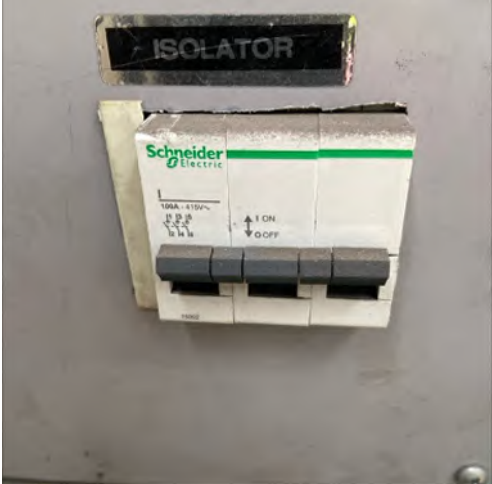
<p data-bbox="794 880 1023 913">Dirty main DB isolator.</p>
32

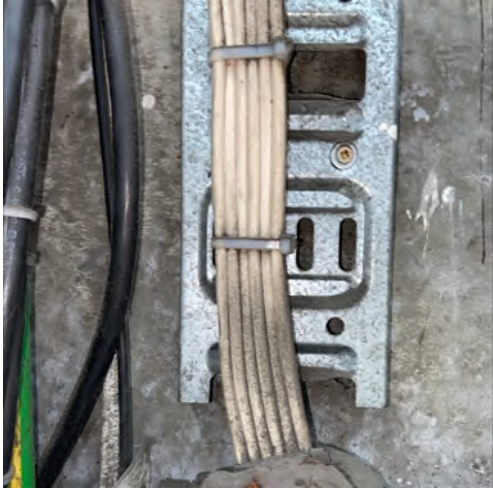
<p>Some wiring looks to be > 20 years. Rewiring should be planned within the next 8-10 years depending upon the confirmed age and fixed wire testing results.</p>
<p>34</p>

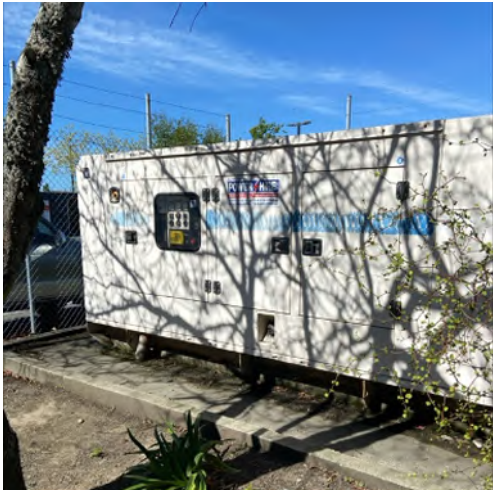
<p>Standby generator which we understand is on long-term hire.</p>
<p>55</p>
