TECHNICAL DUE DILIGENCE REPORT

32 JAMAICA DRIVE

GRENADA NORTH

Date: 12 December 2018

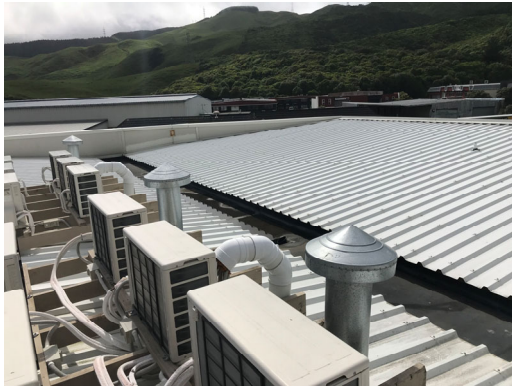
1.1. Building 3 Roof Coverings

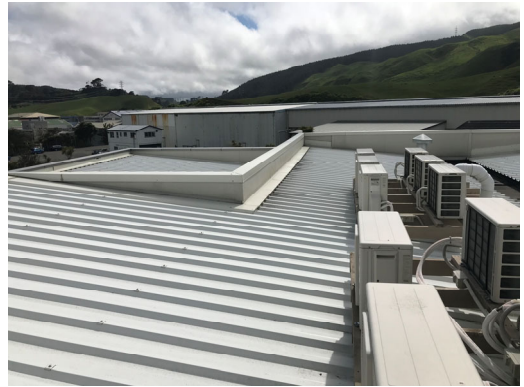
1.2. Building 3 Roof Coverings

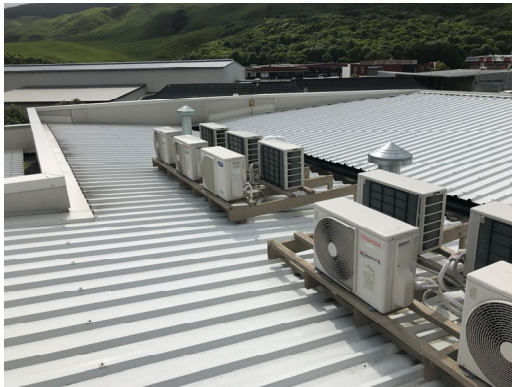
1.3. Building 3 – HVAC Plant

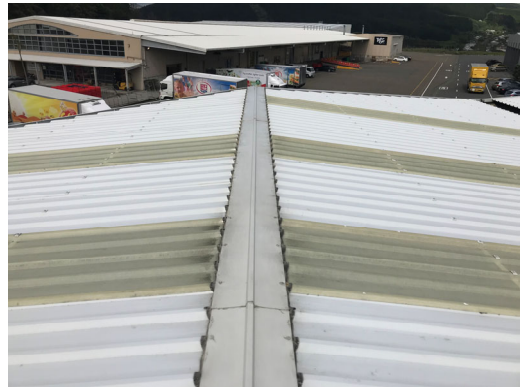
1.4. Building 3 – Ridge Flashings

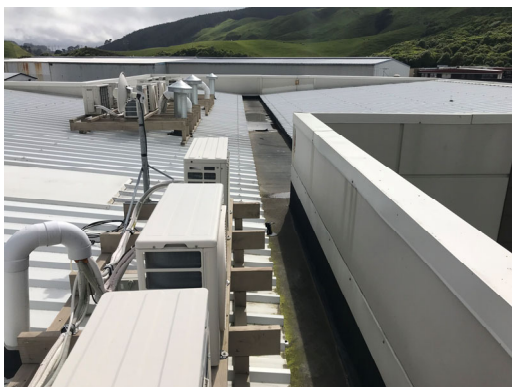
1.5. Building 3 – Membrane Gutters

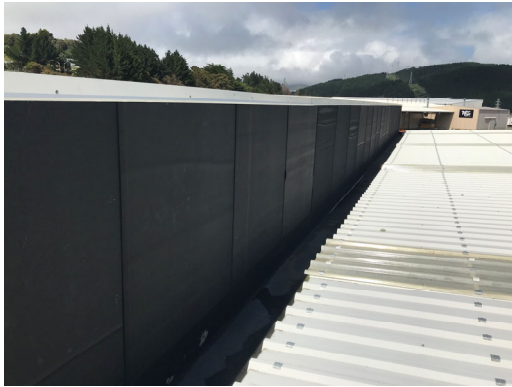
1.7. Building 2 – Membrane Flashings

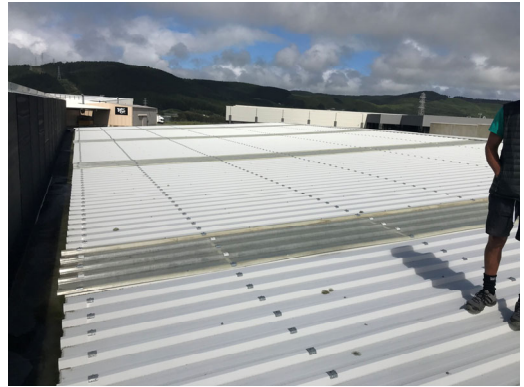
1.8. Building 2 – Roof Coverings

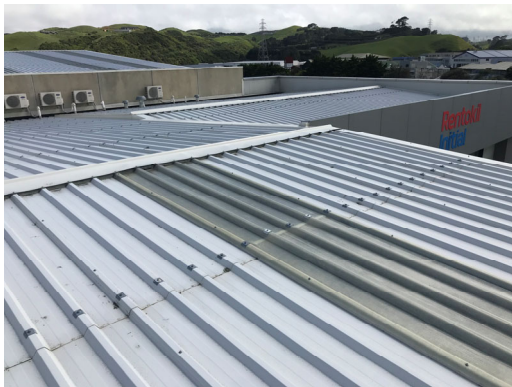
1.9. Building 2 – Roof Coverings

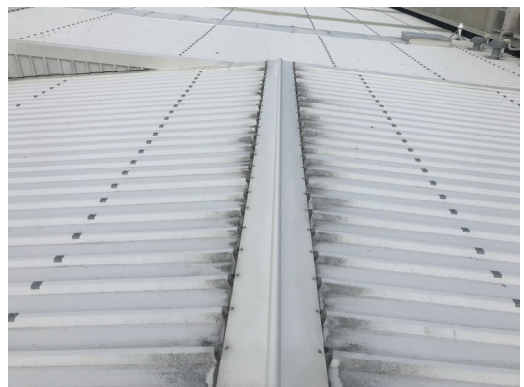
1.12. Building 2 – Roof Coverings

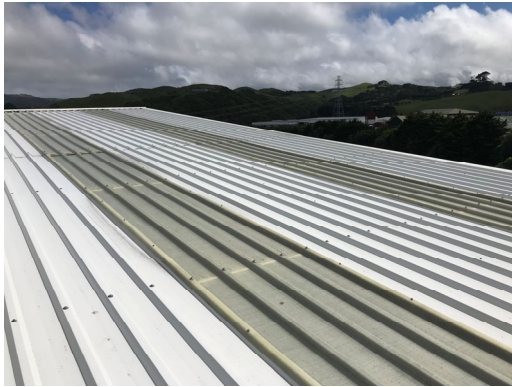
1.13. Building 1 – Roof Coverings

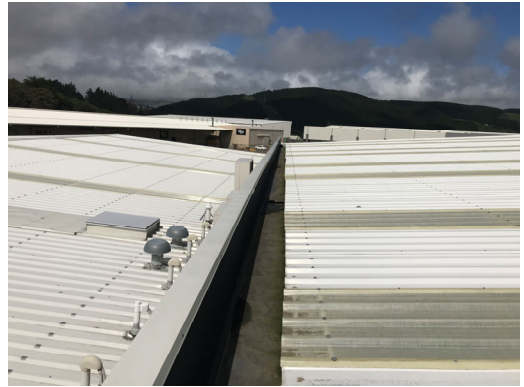
1.14. Building 1 – Membrane Gutters

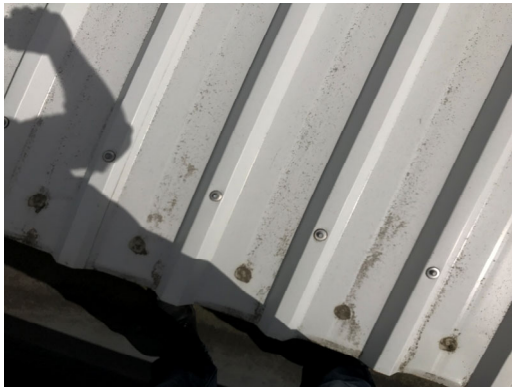
1.15. Building 1 – Roof Fixings

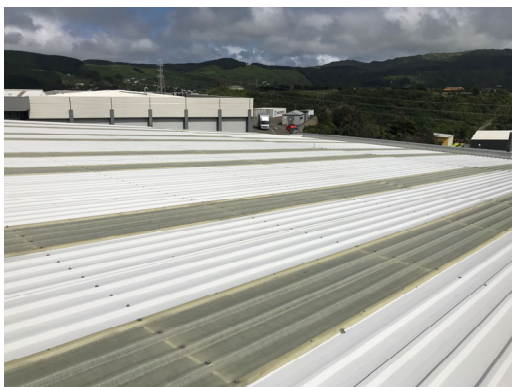
1.17. Building 1 – Roof Coverings

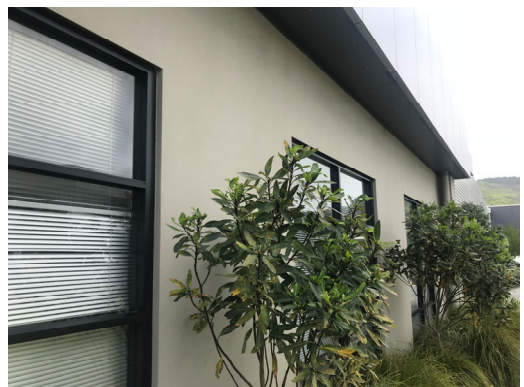
1.30. Building 1 – EIFS Cladding

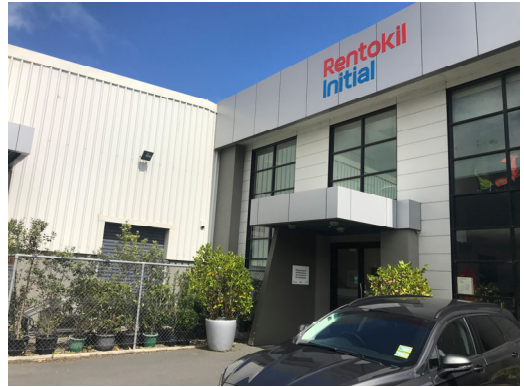
1.32. Building 2 – Junction between office/warehouse

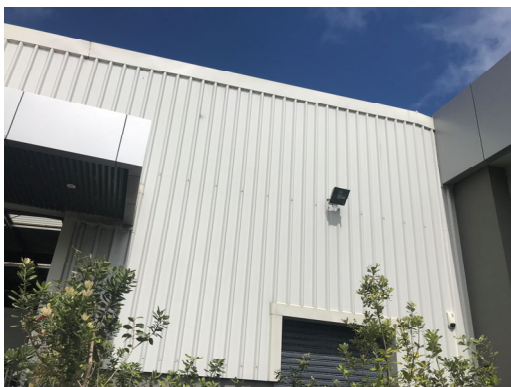
1.35. Building 2 – External Cladding

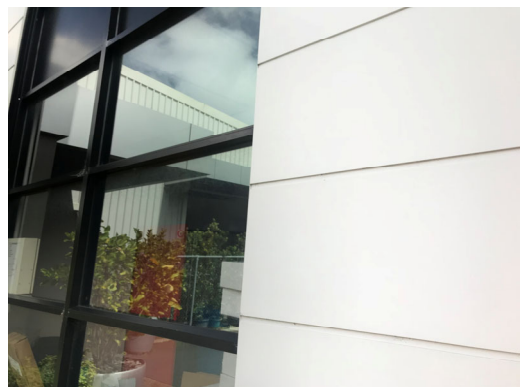
1.36. Building 2 – Fibre cement sheets/aluminium windows

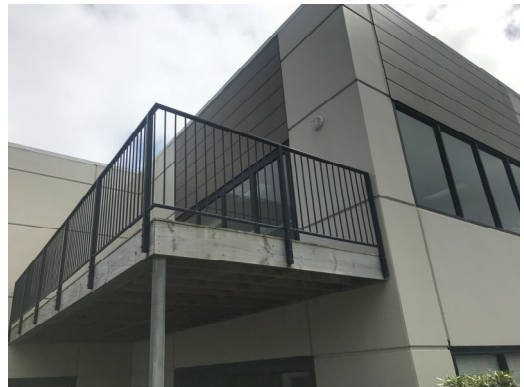
1.40. Building 3 – External Decking Area

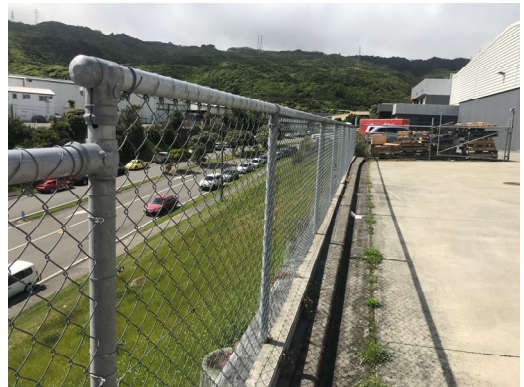
1.55. Evidence of subsidence to north east corner of site
